**Lucent Technologies**  
Bell Labs Innovations

**DEFINITY<sup>®</sup>**  
**Enterprise Communications Server**  
Release 6  
Maintenance for R6csi  
Volumes 1 and 2

555-230-129  
Comcode 108215690  
Issue 3  
May 1998

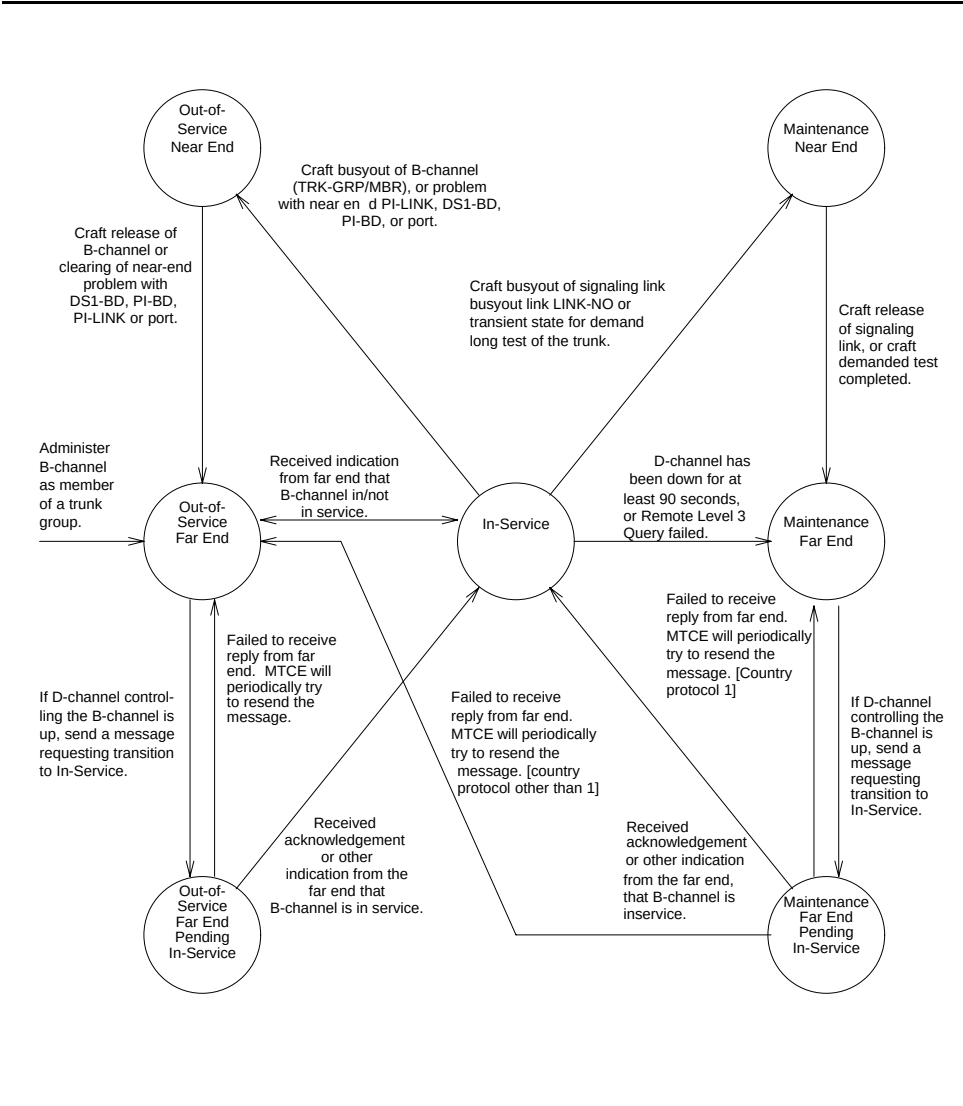
Figure 3-19. Common Progressions in Service States

The following diagram of the DS1 ISDN Trunk service states shows the common progression from one service state to another and the event that caused the change of state.

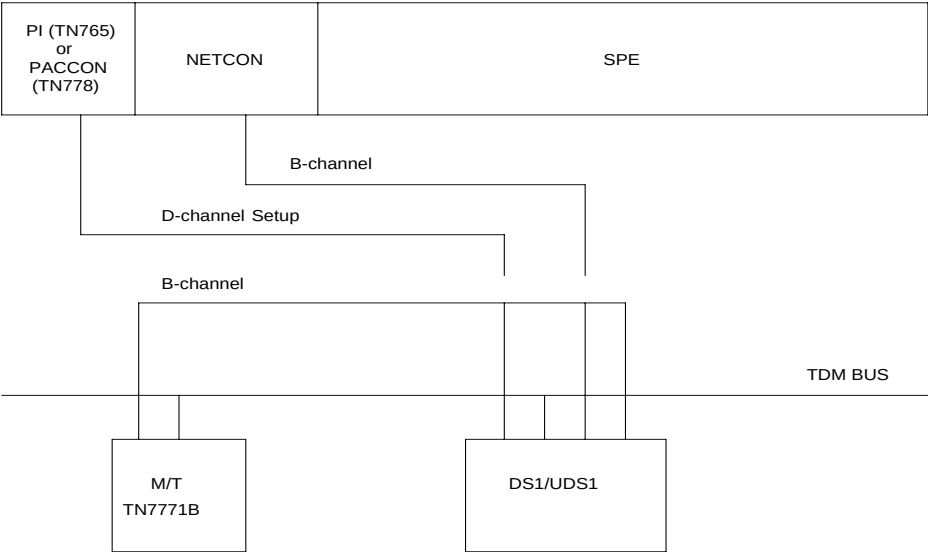
Figure 3-20. ISDN-PRI Outgoing Test Call

In the second method, the test call connection is established over the TDM Bus of the transmit and receive sides of the ISDN-PRI trunk to a digital trunk testing port on the Maintenance/Test circuit pack. The Maintenance/Test Digital Port generates a pseudo bit stream. A pictorial description of the outgoing ISDN-PRI test call connectivity is contained in [Figure 3-20](#).

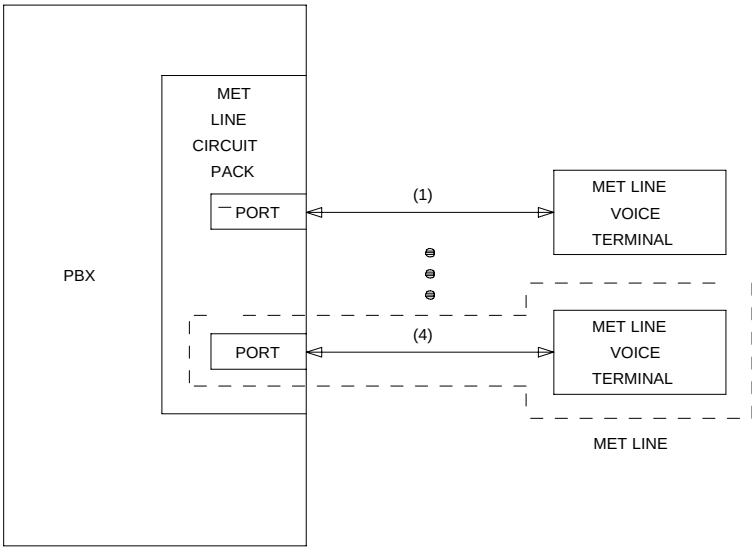
Figure 3-21. MET Line Interactions

The TN735 MET Line circuit pack supports four of these METsets. Each MET set uses three pairs of wires: an analog voice pair, a transmit pair, and a receive pair. Power is sent over the transmit and receive pairs. The MET Line circuit pack supports all 10-, 20-, and 30-button sets.

MET Line interactions are shown in [Figure 3-21](#).

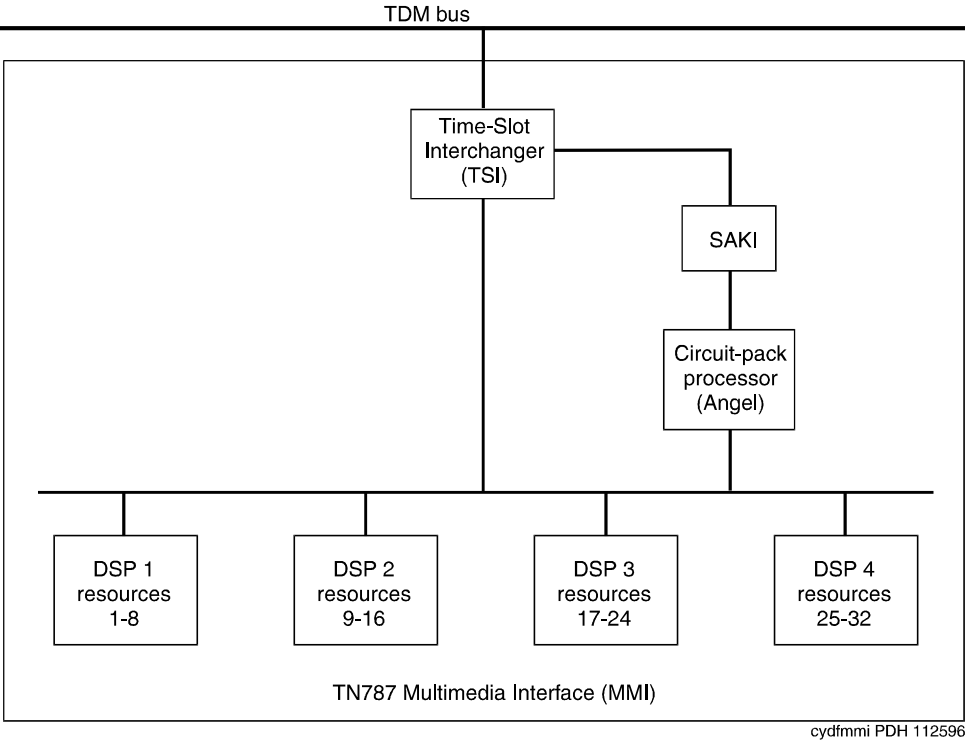
Figure 3-23. TN787 Multimedia Interface (MMI) Circuit Pack

All 8 resources that the circuit pack controls may be placed out of service by the failure of one of these DSPs.

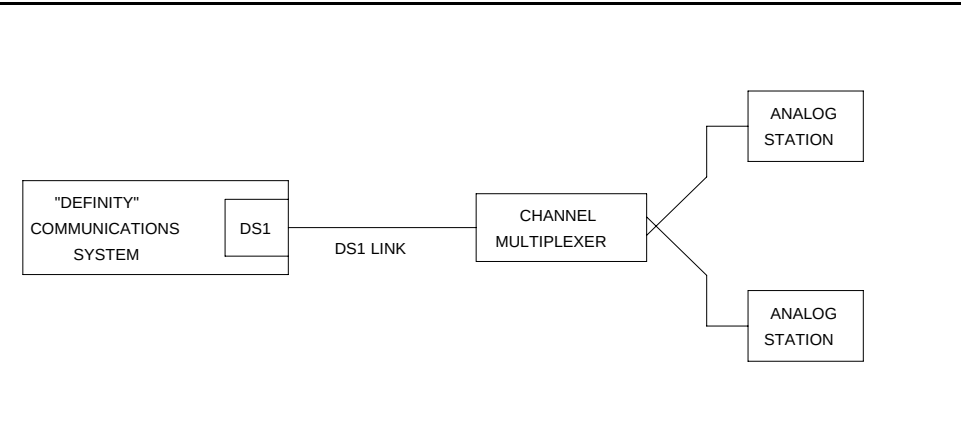
Figure 3-24. DS1 OPS Line Interactions

An analog Off-Premises Station (OPS) can be connected to the system through a DS1 link. A TN767 DS1 Interface circuit pack supports up to 24 DS1OPSs. Since the DS1OPS is an analog telephone set, a channel multiplexer is necessary as the remote DS1 endpoint that converts the digital signal of a DS1 port to the OPS Line and vice versa. See [Figure 3-24](#) for details.

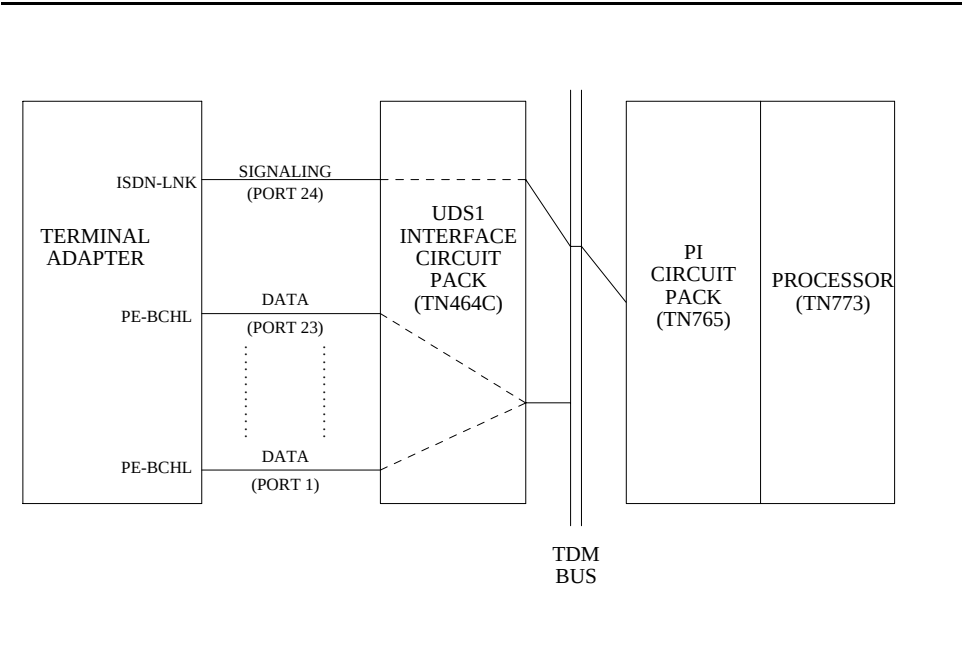
A PRI Endpoint Port is a port on a UDS1 interface circuit pack. Therefore, this port depends on the health of the UDS1 interface circuit pack for proper operation (see [Figure 3-25](#)). As noted earlier, a PRI Endpoint Port B-channel also depends on an ISDN-PRI Signaling Link Port D-channel (ISDN-LNK) to carry the signaling traffic. If there is a problem with the ISDN-PRI Signaling Link Port, the PRI Endpoint Port is affected. The ISDN-PRI Signaling Link Port, in turn, depends on the PKT-INT (Packet Interface).

Figure 3-25. PRI Endpoint Port Interactions [INTEL]

As is noted in the general description for a PRI Endpoint Port, the operation of the PRI Endpoint Port depends on the health of the UDS1 interface circuit pack and of the TN765 Processor Interface Link. This test checks the status of those critical elements.

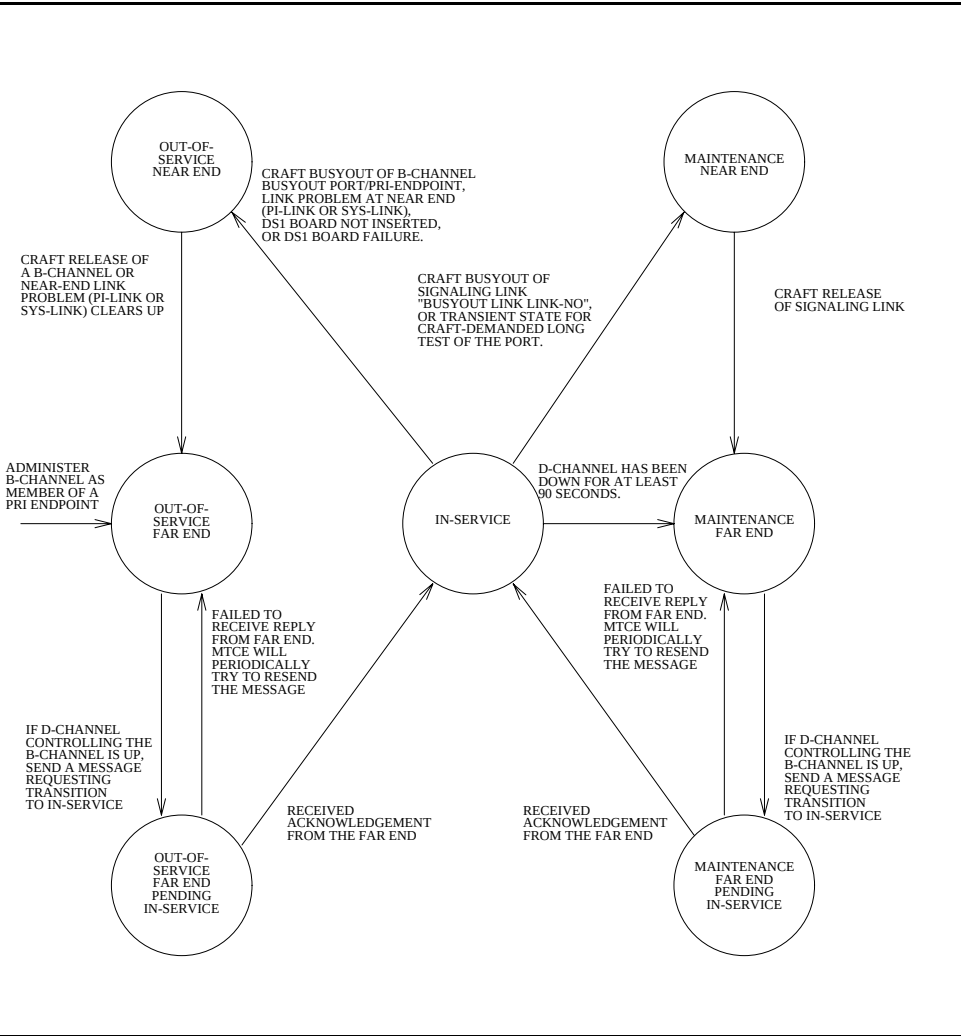
The following diagram of the PRI Endpoint Port service states shows the common progression from one service state to another and the event that caused the change of state.

Figure 3-26. Common Progressions in Service States

OOS/FE-PEND/INS (that is, out-of-service/far-end-Pending/in-service). The far-end has a certain amount of time to respond to the message. The service state reflects this pending state until the timer expires.

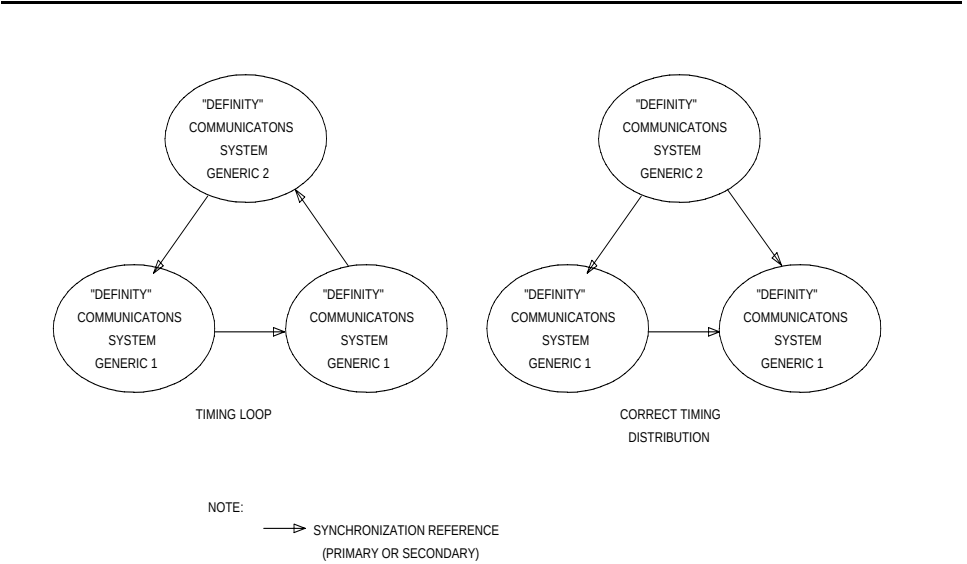
The system synchronization planner must avoid creating a *timing loop* when administering the primary and secondary synchronization references in a system. A timing loop exists whenever a system receives timing from another system whose timing reference is directly or indirectly derived from itself. Timing loops can lead to loss of digital data between systems that are exchanging data with any system within the loop. An invalid timing signal is also generated by any system within the loop, thus propagating the invalid timing signal to any system(s) using a system within the loop as a synchronization reference. [Figure 3-27](#) shows a timing loop and a correct distribution of timing between the systems.

Figure 3-27. Synchronization Timing Loop

A correctly designed network has no loops and each piece of equipment in the network is supplied by a clock of equal or lower stratum (that is, the inputs to a Stratum 3 clock should NEVER be from a Stratum 4 device). **It is strongly recommended that the network administrator be consulted before administering any synchronization changes.**

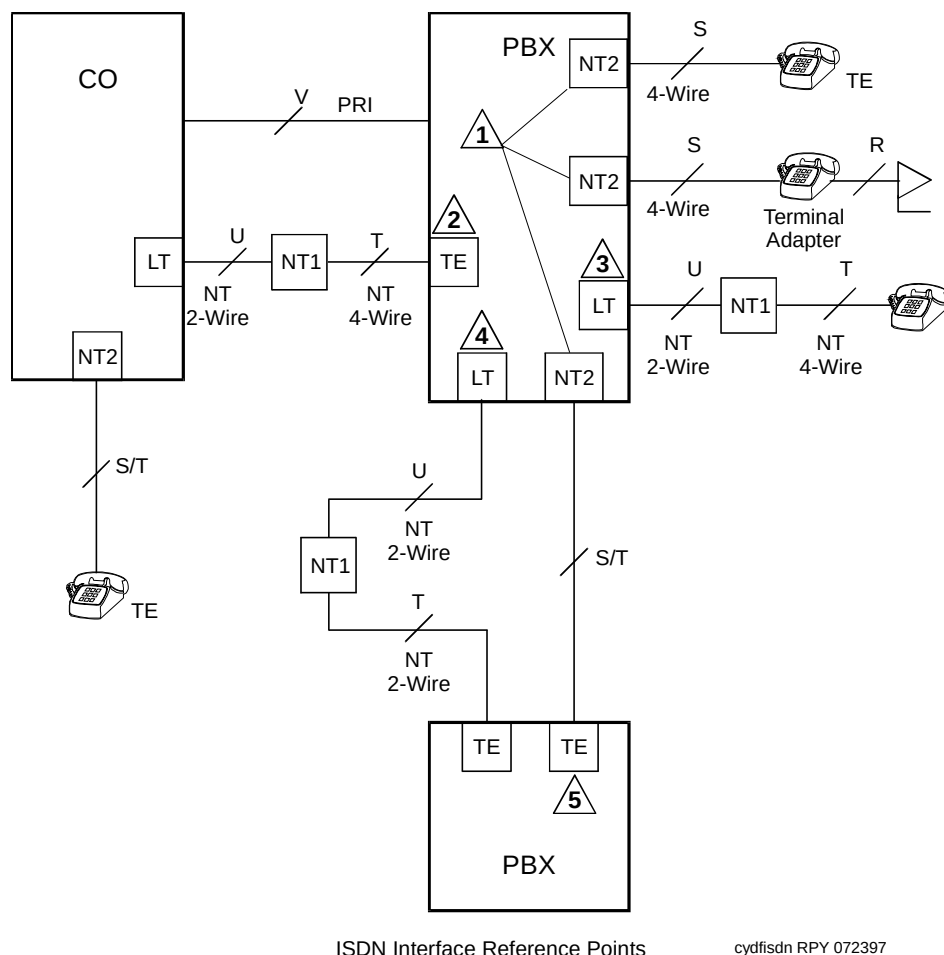
**Figure 3-29. Integrated Trunk-Side BRI, ISDN Interface Reference points**

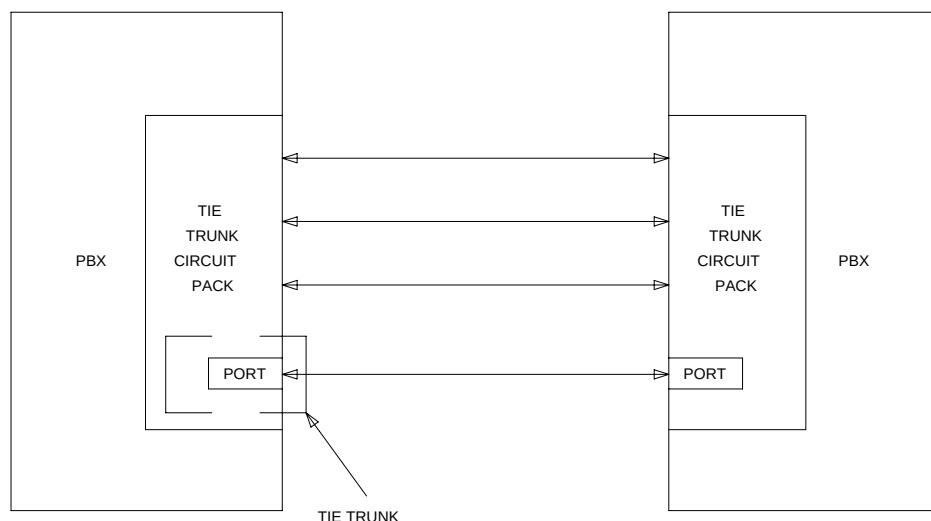
The Tie Trunk circuit pack fits into a port slot and contains four trunk circuits (see [Figure 3-30](#)). Each tie trunk for the TN497 circuit packs has 2-wire audio connection/signal leads (A and B).

**Figure 3-30. Tie Trunk Interactions**

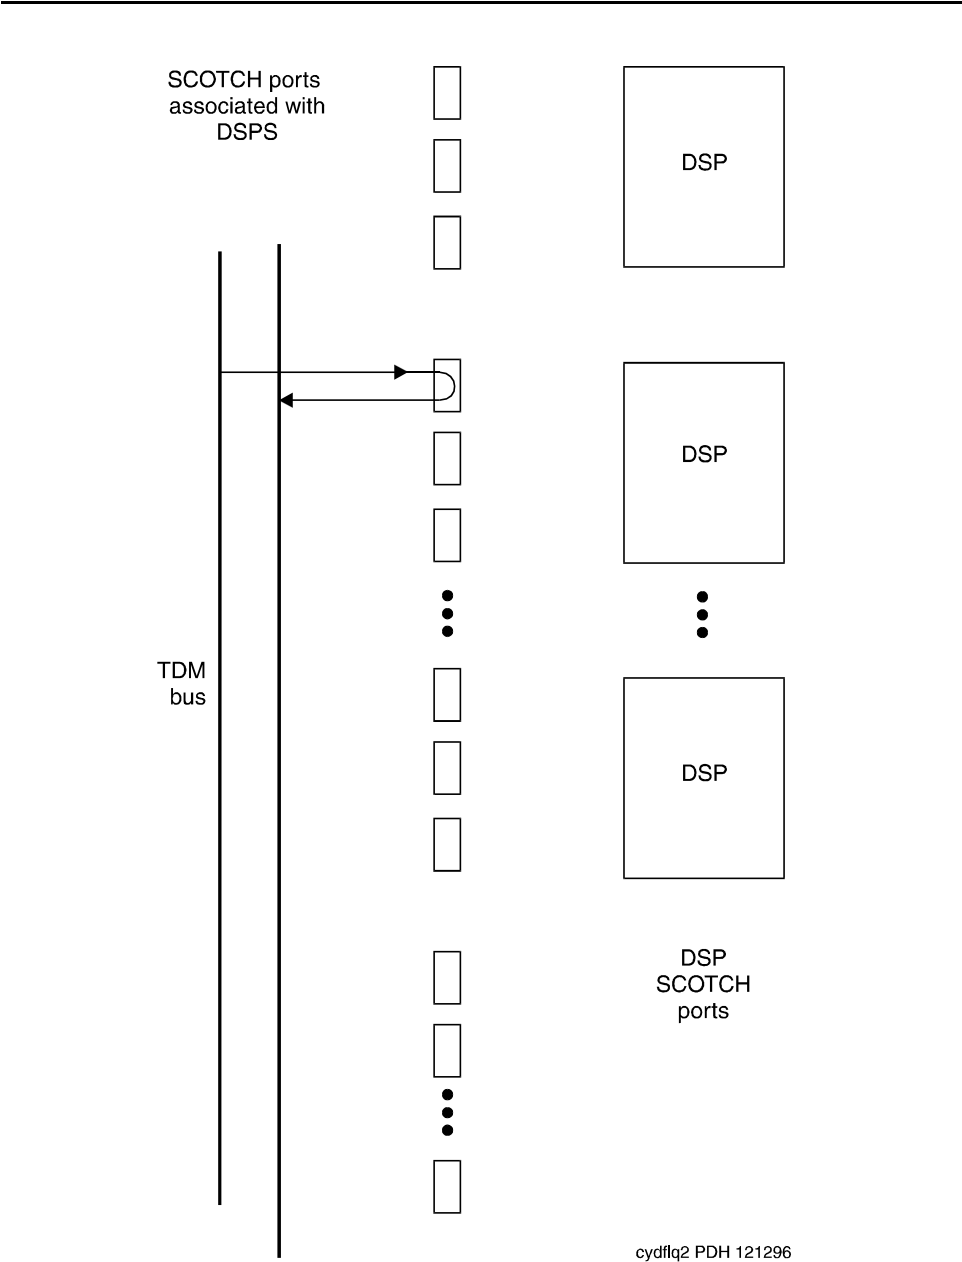
1. A looparound test across the TDM bus.
2. A conference circuit test.

The tests are run in the above order; if one test fails, an error code is returned and the remaining tests in the sequence are not executed.

Figure 3-31. VC Circuit Pack DSP Port Local TDM Loopback Test

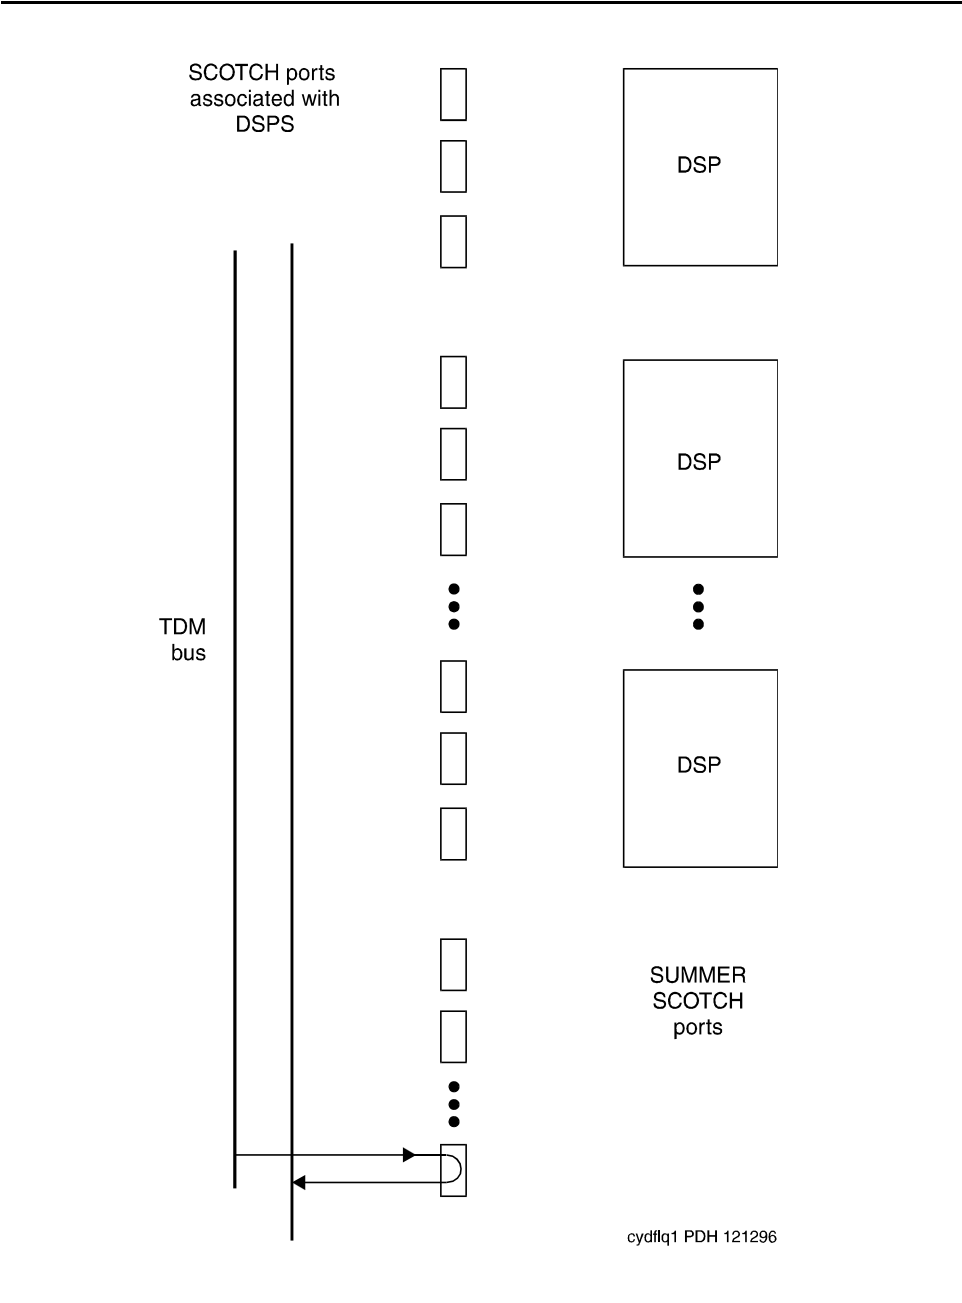
- A Looparound test across the TDM bus.
- A conference circuit test.

The tests are run in the above order. If the first test fails, the switch returns an error code, and the second test is not executed.

Figure 3-33. VC Circuit Pack Summer Port Loopback Test

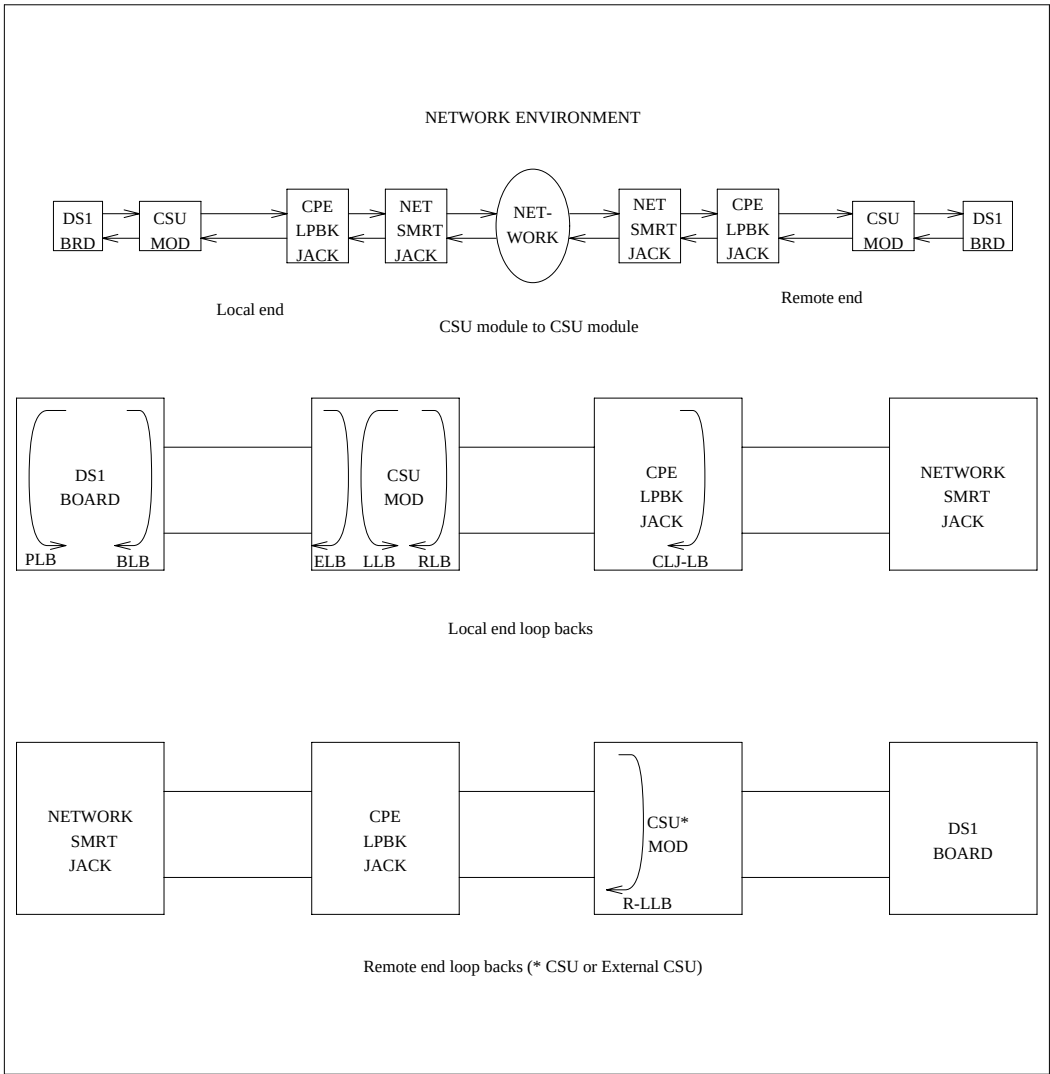
The TN464F and 120A1 CSU Module support on-demand loopback tests that assist in the detection of faults between the TN464F circuit pack and the CSU Module, between the Integrated CSU and the optional Customer Premises Loopback Jack, or between the Integrated CSU and remote CSU. These loopback tests are explained in detail later in this UDS1-BD section, but [Figure 3-34](#) gives a high level overview of the loopback points.

Figure 3-34. High Level Overview Of Loopback Points

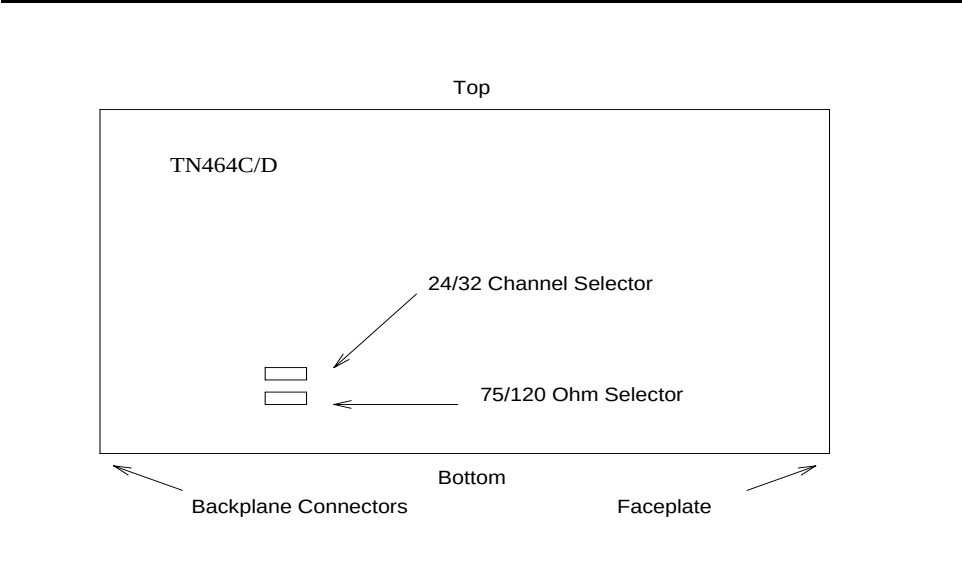
[Figure 3-35](#) through [Figure 3-37](#) show how to configure the circuit pack for 24-channel or 32-channel DS1. The channel selection must match the parameters administered on the corresponding DS1 Circuit Pack Form. (US applications use 24 Channels.)

Figure 3-35. TN464C/D DS1 Option Jumpers

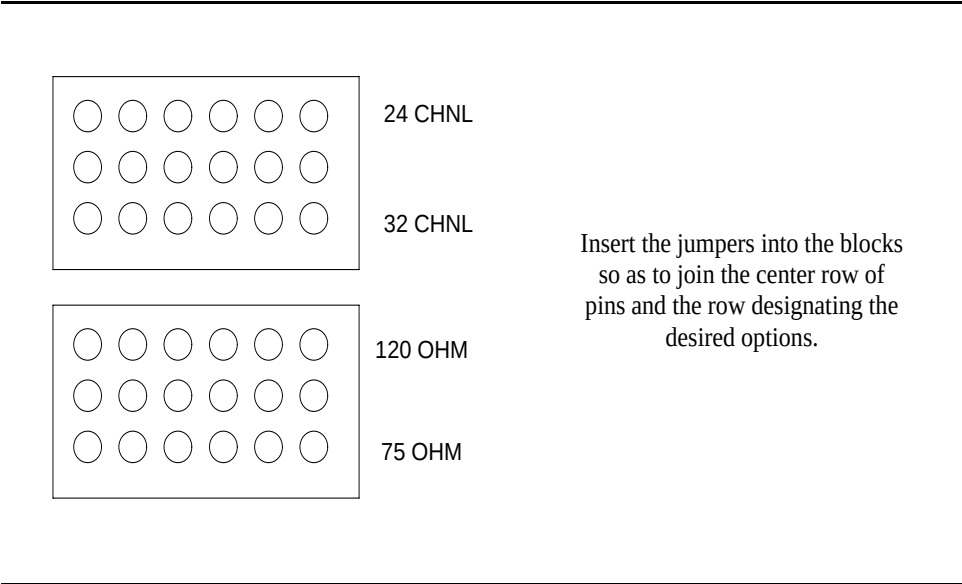
Figure 3-36. TN464C/D DS1 Option Jumpers

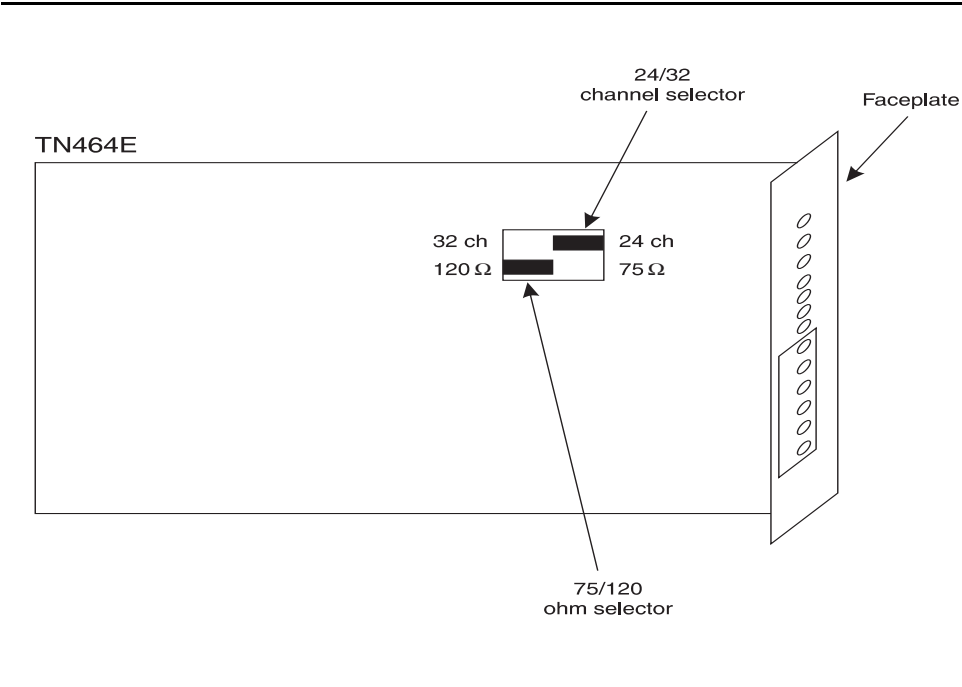
The option switch located on the component side of the TN464E/F circuit pack must be set correctly. [Figure 3-37](#) shows how to configure the circuit pack for 24-channel or 32-channel DS1. The channel selection must match the parameters administered on the corresponding DS1 Circuit Pack Form. (US applications use 24 Channels.)

Figure 3-37. TN464E/F DS1 Option switches
