**DEFINITY<sup>®</sup>**

**Enterprise Communications Server**

Release 7

Maintenance for R7csi

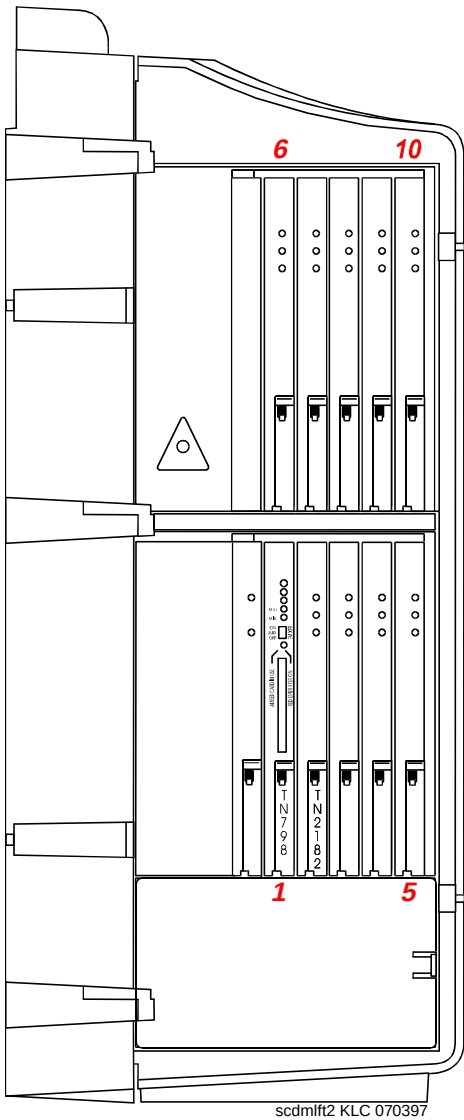
**Figure 1-3. Compact Modular Cabinet (CMC) slot configuration**

- The RISC-based TN798 Processor circuit pack must be located slot 1. [Figure 1-3](#) also shows the Flash Memory Card slot for translations.
- TN2182 Tone-Clock must be installed in slot 2. This is the only Tone-Clock circuit pack allowed in the CMC.
- Service circuit packs the only packs allowed in the CMC. These “universal” service packs can be located in any slot numbered 3-10.
- AUDIX, if present, requires 4 slots (slots 6-9 on the top row).

- The TN798 Processor circuit pack incorporates the RISC processor complex, the TN777B NETCON (including PCM flash card interface), and TN765 Processor Interface functions and is always found in slot 1 of the A carrier. (See [Figure 1-3](#))

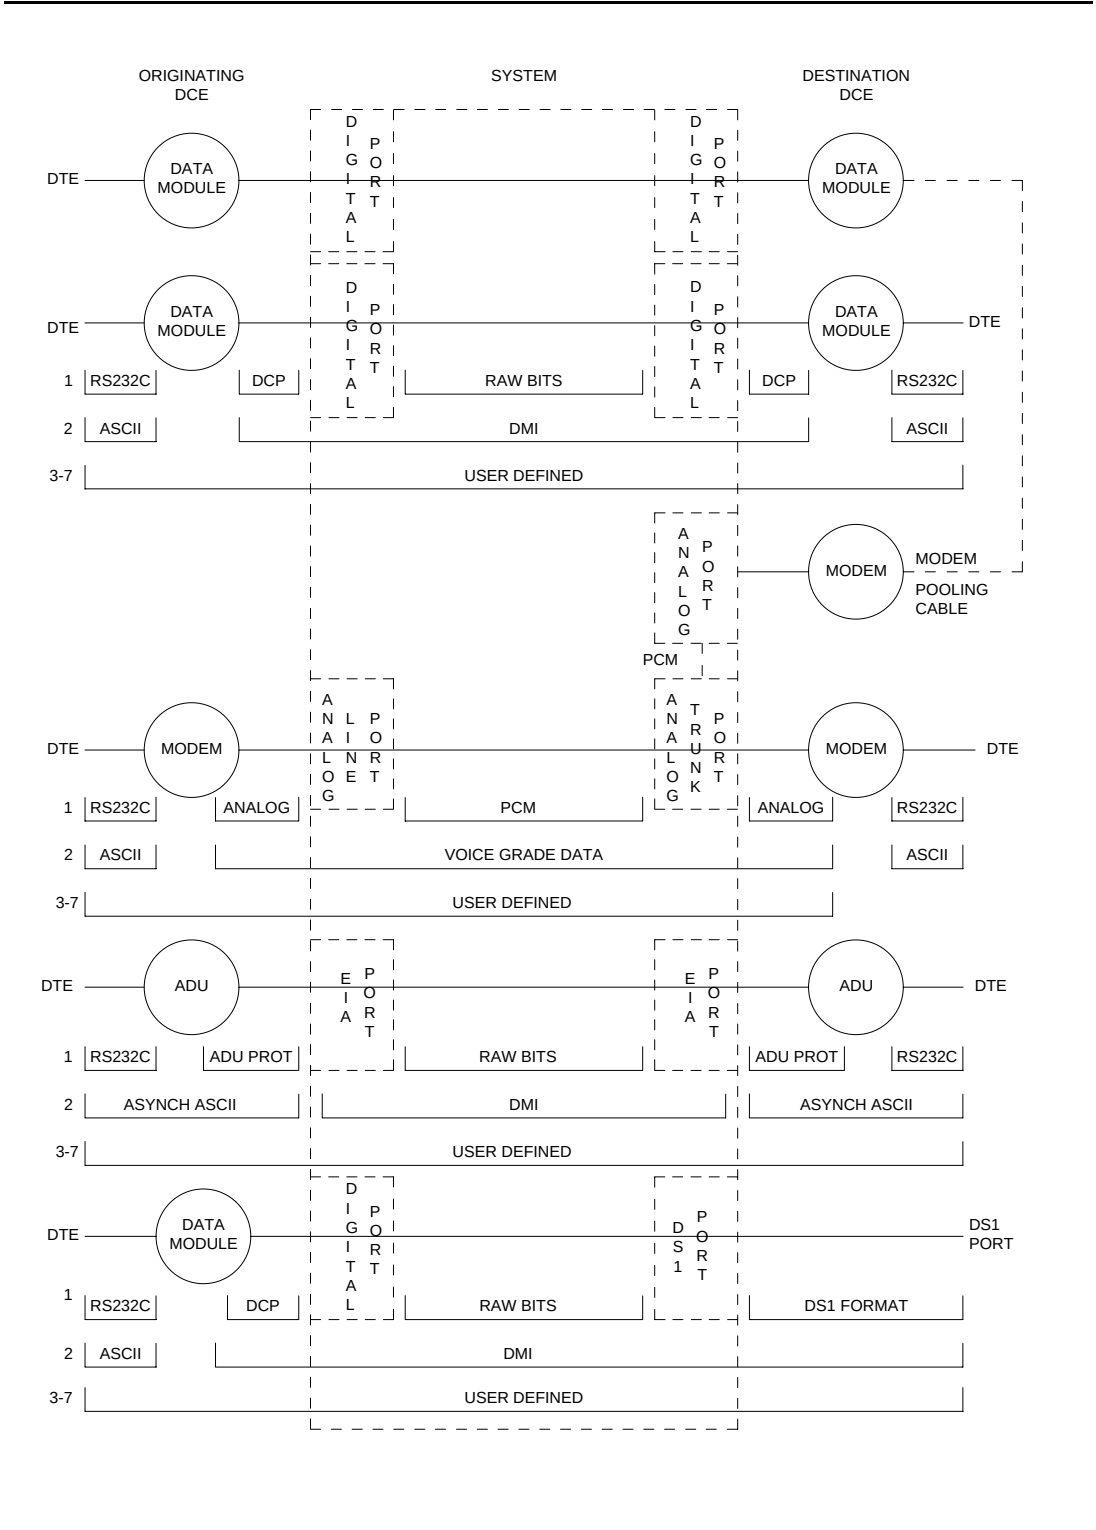
Figure 1-4. Data Transmission States

Layer 2, or the *data-link layer*, refers to code created and interpreted by the DCE. The originating equipment can send blocks of data with the necessary codes for synchronization, error control, or flow control. With these codes, the destination equipment checks the physical-link reliability, corrects any transmission errors, and maintains the link. When a transmission reaches the destination equipment, it strips any layer-2 information the originating equipment may have inserted. The destination equipment only passes to the destination DTE equipment the information sent by the originating DTE equipment. The originating DTE equipment can also add layer-2 code to be analyzed by the destination DTE equipment. The DCE equipment treats this layer as data and passes it along to the destination DTE equipment as it would any other binary bits.

Layers 3 to 7 (and the DTE-created layer 2) are embedded in the transmission stream and are meaningful only at the destination DTE equipment. Therefore, they are shown in the figure as “user-defined,” with no state changes until the transmission stream reaches its destination.

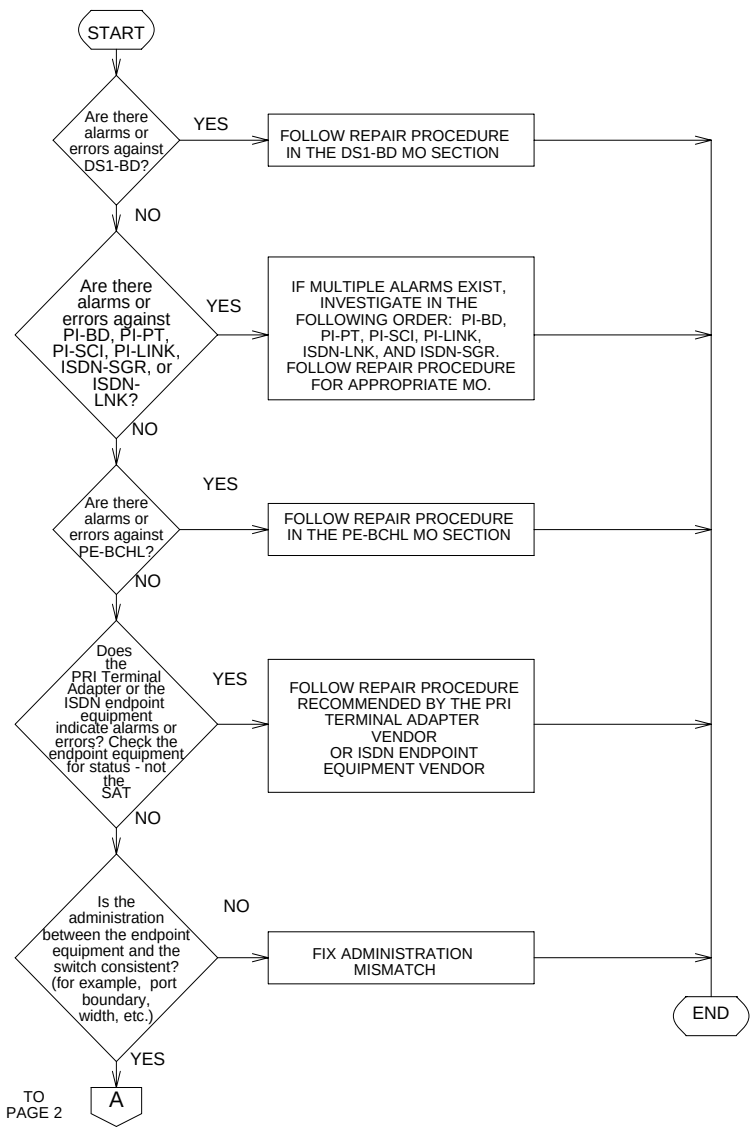
Figure 1-20. Processing of PRI Endpoint Problems (Page 1 of 2)

The following flowchart, [Figure 1-20](#) and [Figure 1-21](#), defines a layered approach when troubleshooting PRI endpoint problems. Since a problem at a lower layer affects upper layers, layers are investigated from low to high. In the flowchart, the DS1 facility is layer 1, the TN765 Processor Interface is layer 2, and the ISDN trunks are layer 3.

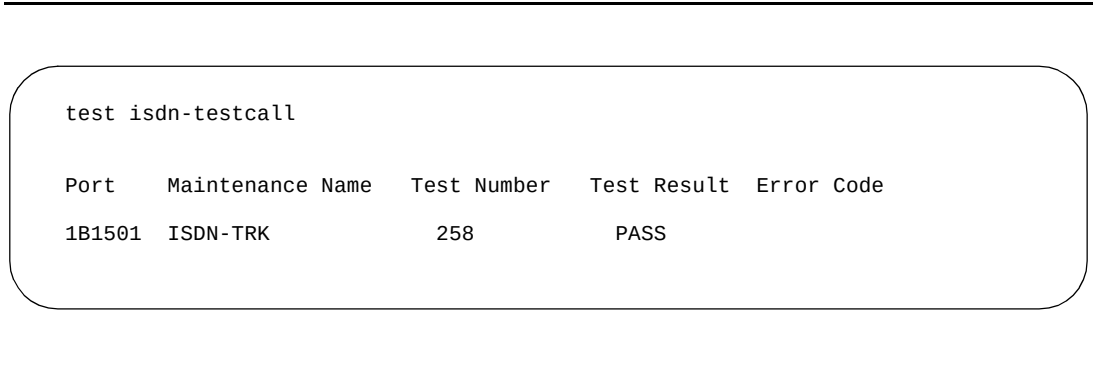
**Figure 1-22. Typical Response to Test ISDN-Testcall Command**

[Figure 1-22](#) shows a typical response to the **test isdn-testcall** command:

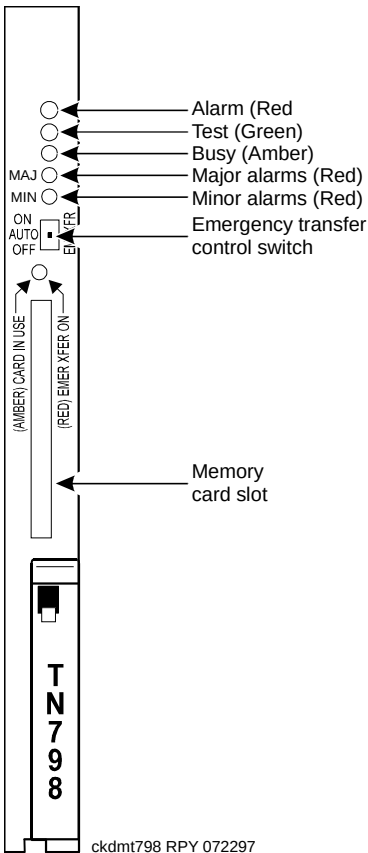
**Figure 1-28. LED Indicators on the TN798 Processor Circuit Pack**

The front panels of the Processor circuit pack and the Maintenance circuit pack are identical. Each has two groups of LEDs. One group indicates the status of the pack, and the other group (which includes the Major, Minor, and Warning alarms described in the [“Alarm and Error Reporting”](#) section) reflects maintenance conditions in the entire system. See [Figure 1-28](#).

**NOTE:**  
If the LED just above the Memory Card Slot is alternating red and amber, this indicates both card in use and emergency transfer.

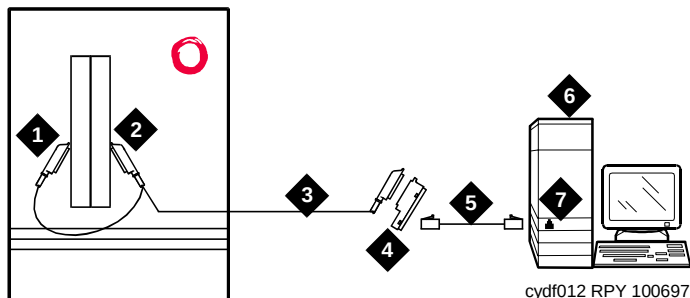
### Figure 1-29. Typical ESM connections

The Expansion Services Module (ESM) shown in [Figure 1-29](#) provides T.120 data sharing capability on a MMCH multipoint H.320 video conference. Each conference participant must have endpoints administered and a personal computer with the H.320 video application installed. The DEFINITY ECS must have the expansion service module installed.

1. Port B Y-cable connector to a TN787 Multimedia Interface (MMI) circuit pack
2. Port A Y-cable connector to a TN2207 PRI circuit pack
3. 25-pair Y-cable
4. 356A adapter
5. D8W cord connected to 356A adapter port 1
6. Expansion Service Module (ESM)
7. Port B on compatible primary rate interface (PRI) card

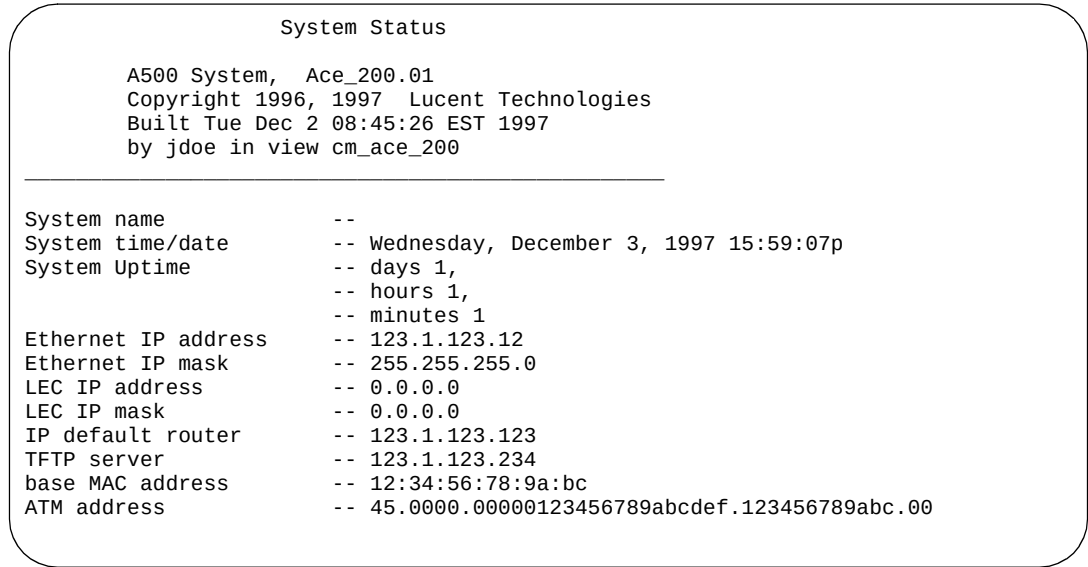
Figure 1-34. A500 screen output for status command

5. Enter **status** at the A500 : prompt. [Figure 1-34](#) shows the output from the status command.

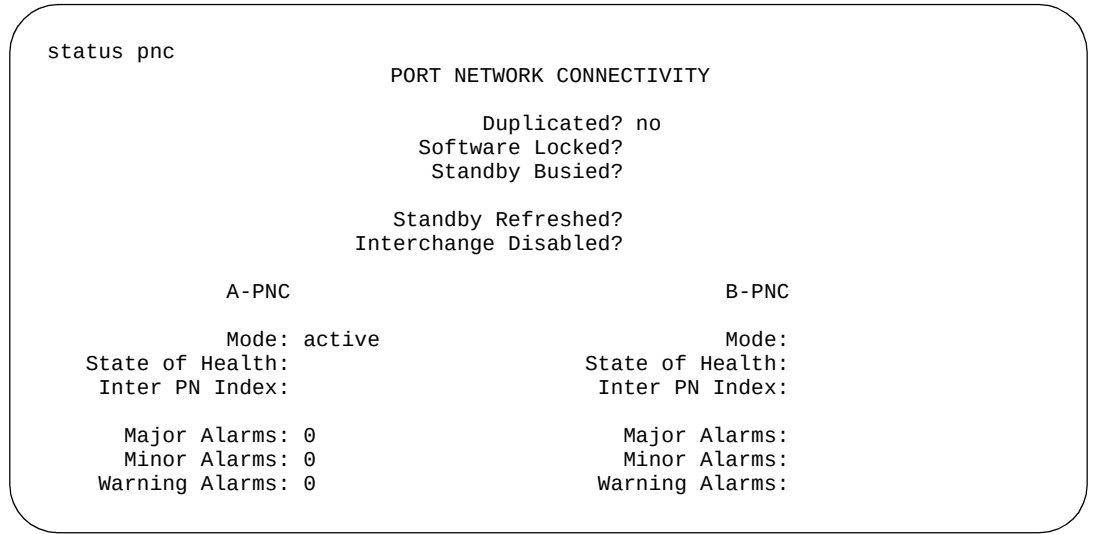
Figure 1-36. Screen output for status pnc command

2. Enter **status pnc** at the DEFINITY SAT. This display tells you which TN230X board is active in a duplicated system and how many alarms (if any) of each severity level have been logged for the board. [Figure 1-36](#) shows the output from this command.

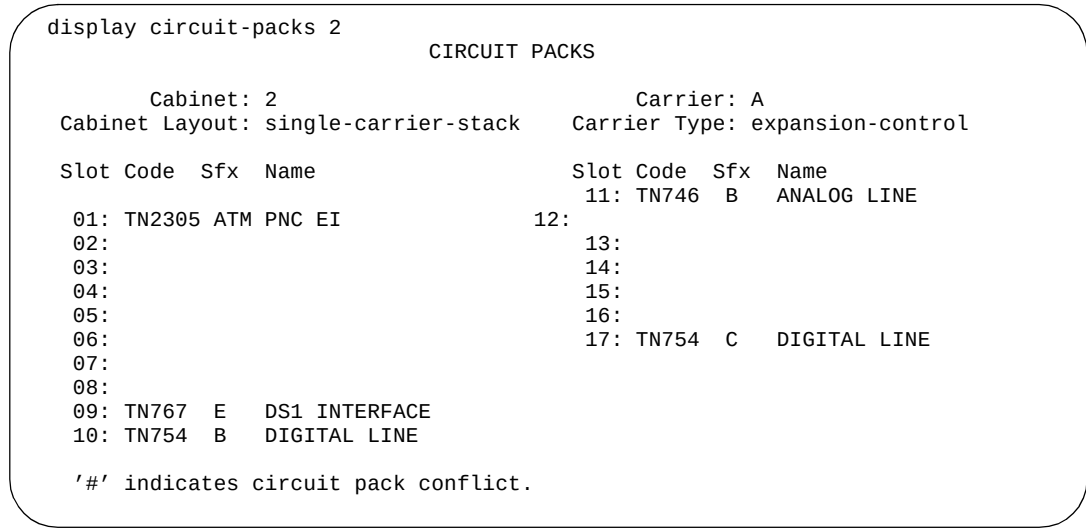
Figure 1-38. Screen output for display circuit-packs 2

3. Enter either **list configuration UUC** (for the carrier in which the ATM-EI packs reside) or **display circuit-packs cabinet** (non-control cabinet) at the DEFINITY SAT. This command tells you in more detail what boards are in which slots in each cabinet and carrier. Verify that the TN230Xs are physically located in the slots indicated on the display. [Figure 1-37](#) shows the output for the **display circuit-packs 1** command; [Figure 1-38](#) shows the output for the **display circuit-packs 2** command.

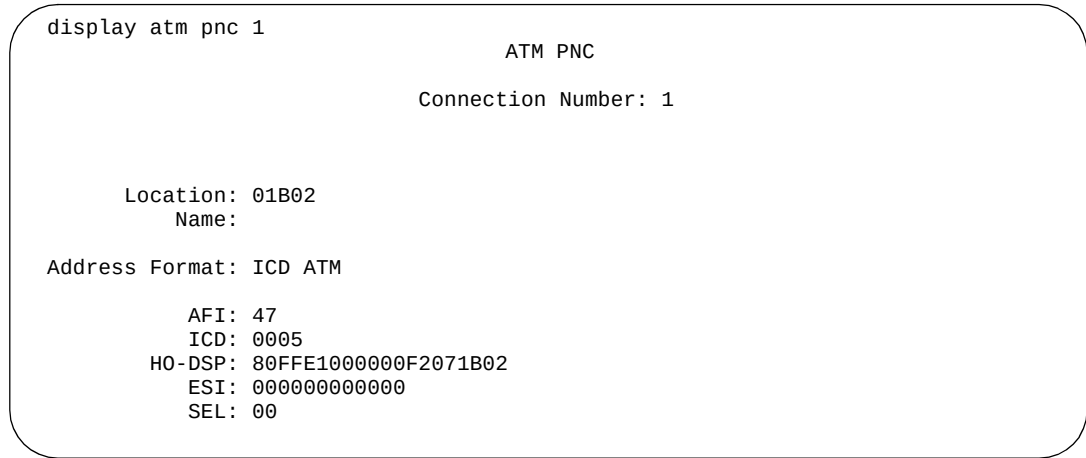
**Figure 1-39. Screen output for display atm pnc 1**

4. Enter **display atm pnc portnetwork** on the DEFINITY SAT.
- This display tells you the ATM addresses that have been administered for each TN230X. Verify that each ATM address (the concatenation of the five displayed hexadecimal fields) is correct and match those administered in the A500. See [“A500 Administration”](#) for more information.
- Administered with hard coded PNNI routes**
- If the port networks are addressed using *hard coded PNNI routes* in the A500, the display looks like [Figure 1-39](#) (pnc 1) and [Figure 1-40](#) (pnc 2).

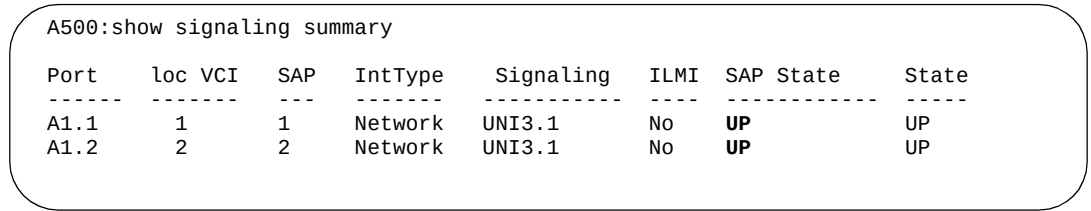
Figure 1-43. Screen output for the show signaling summary command

- 1. Enter **show signaling summary** on the A500 console. [Figure 1-43](#) shows the screen output.

- a. If an A500 port to which a DEFINITY port network is attached is not listed in this display, it is likely that the port was administered incorrectly as having no UNI signaling (**admin link** command).

| Field | Value |
|---|---|
| SAP State | May or may not be UP. Their values depend on more than just whether the port was marked as <b>UP</b> . (See highlighted data for SAP State in <a href="#">Figure 1-43</a> .) |

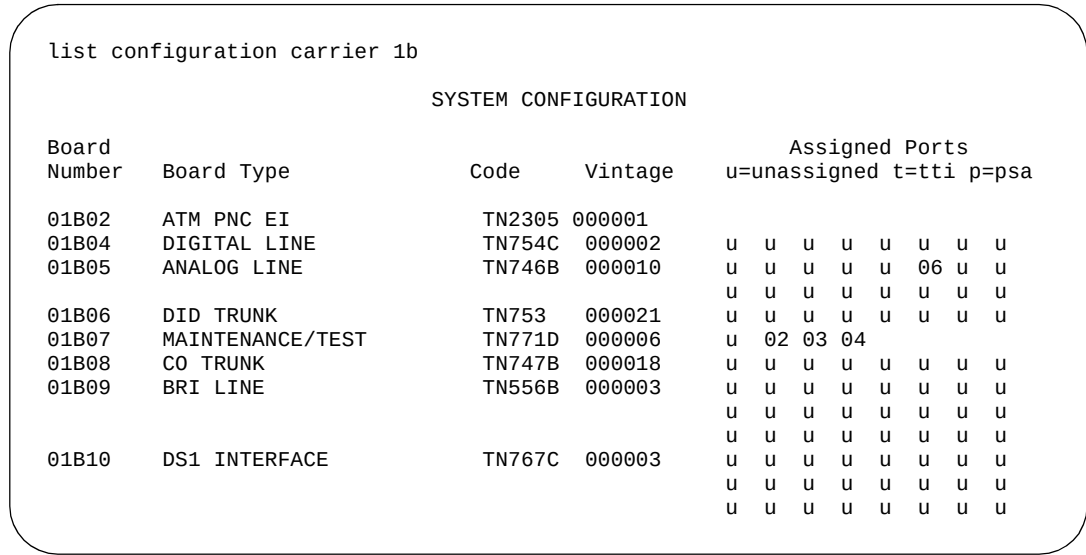
Figure 1-47. List configuration carrier 1b screen

1. Review the LED conditions for the TN230X:
  - Do the TN230X LEDs (see [Table 1-15](#)) indicate a normal operational state (any of the following):
    - Active in the PPN
    - Standby in the PPN
    - Archangel mode in the EPN
    - Standby in the EPN?
2. If after board insertion or a demand reset:
  - Do the TN230X LEDs indicate that it is booting?
  - Do the TN230X LEDs indicate it is downloading its DSPs?
  - Do the TN230X LEDs indicate that board insertion has not yet occurred?
  - Do the TN230X LEDs indicate a maintenance alarm?
3. Enter **list configuration carrier cabinetcarrier** on the DEFINITY SAT. See [Figure 1-47](#) (1b) and [Figure 1-48](#) (2a) below.

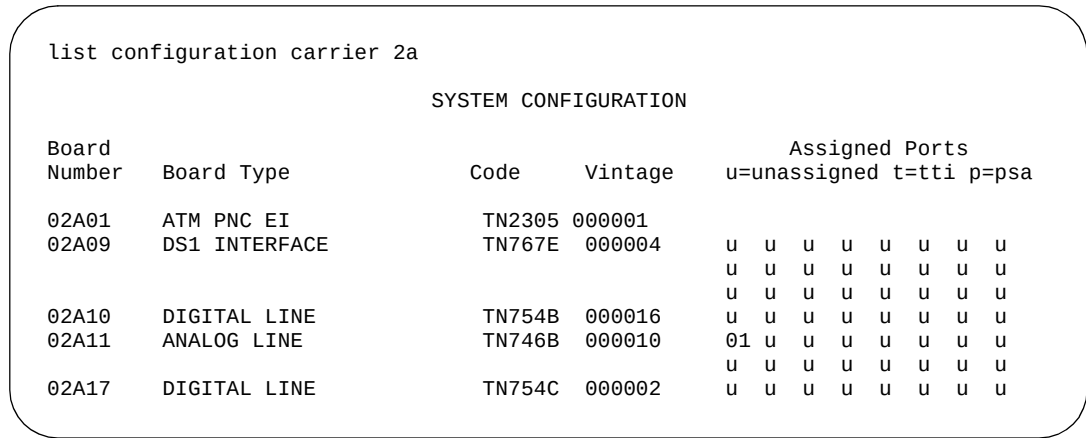
Figure 1-48. List configuration carrier 2a screen

- The TN230X board should be shown in the correct slot.
- Fields should have values as indicated below:

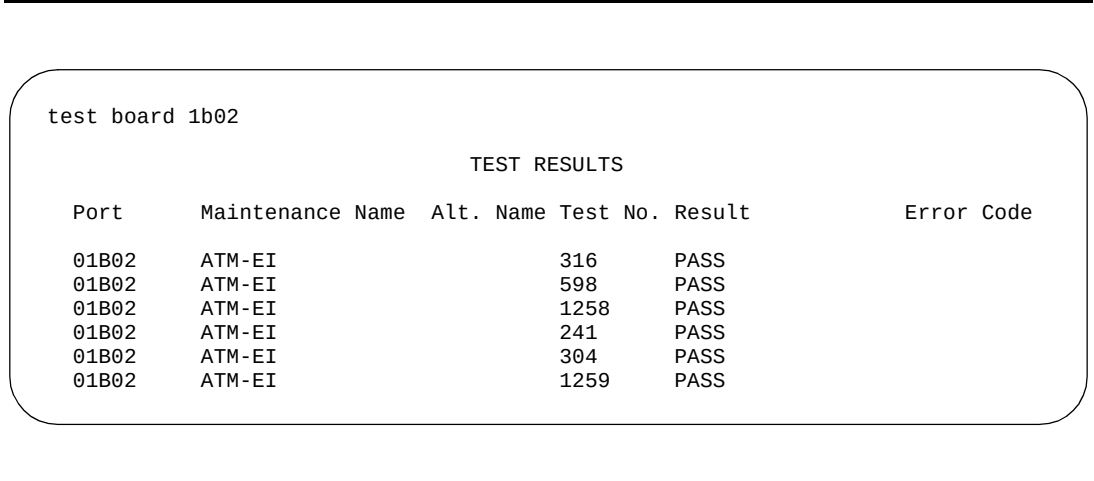
Figure 1-49. Screen output for the test board 1b02 command

4. If the TN230X is inserted and shows a vintage number, enter **test board cabinetcarrierslot** for this board on the DEFINITY SAT, as shown in [Figure 1-49](#) (1b02) and [Figure 1-50](#) (2a01).

- The Result should be PASS for each test number. If the any of the tests fail, refer to [“ATM-BCH \(ATM B-Channel Trunk\)”](#).

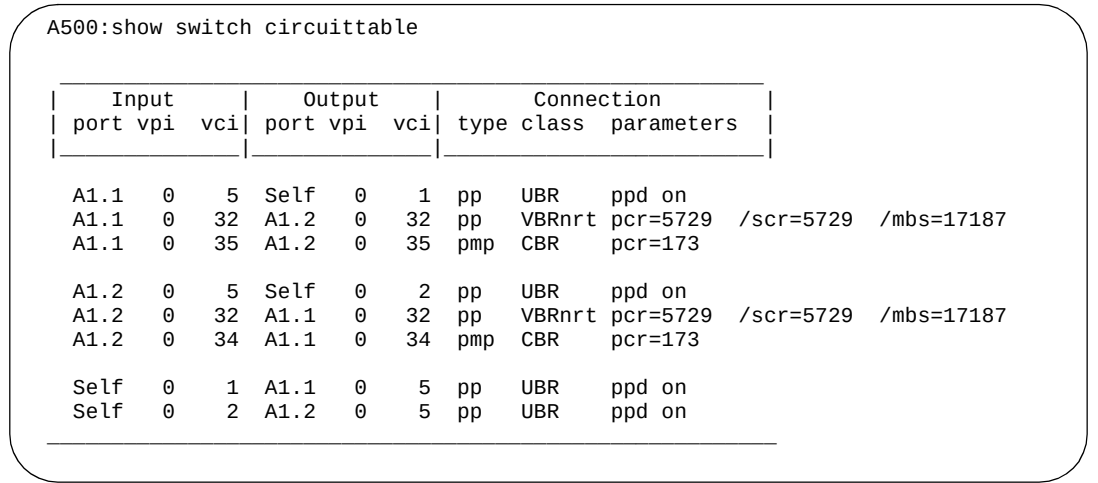
Figure 1-59. A500: show switch circuittable screen

1. Enter **show switch circuittable** on the A500 console. [Figure 1-59](#) shows the screen output.

- The pp UBR virtual circuits between A500 ports A1.1 (PPN) and Self (A500) and between A1.2 (EPN) and Self (A500) are ATM signaling channels between the port network and the A500.
- They are used to request connection setups and releases to other end points such as another port network.
- These are established by each TN230X when it comes up, independent of DEFINITY Call Processing.
- Other UBR virtual circuits may exist between A500 ports that are not associated with DEFINITY port networks and may be signaling channels for other applications (for example, data network traffic).

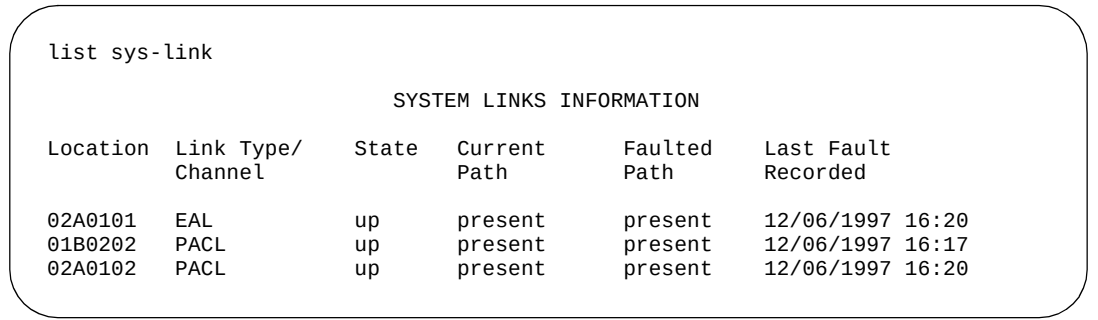
Figure 1-60. List sys-link screen

- Do you get a dial tone on a set on the port network in question?
  - Can you ring a set on the EPN dialing from the PPN and vice versa?
1. Enter **list sys-link** on the DEFINITY SAT. [Figure 1-60](#) shows the screen output.

Ensure that the fields have the values indicated below.

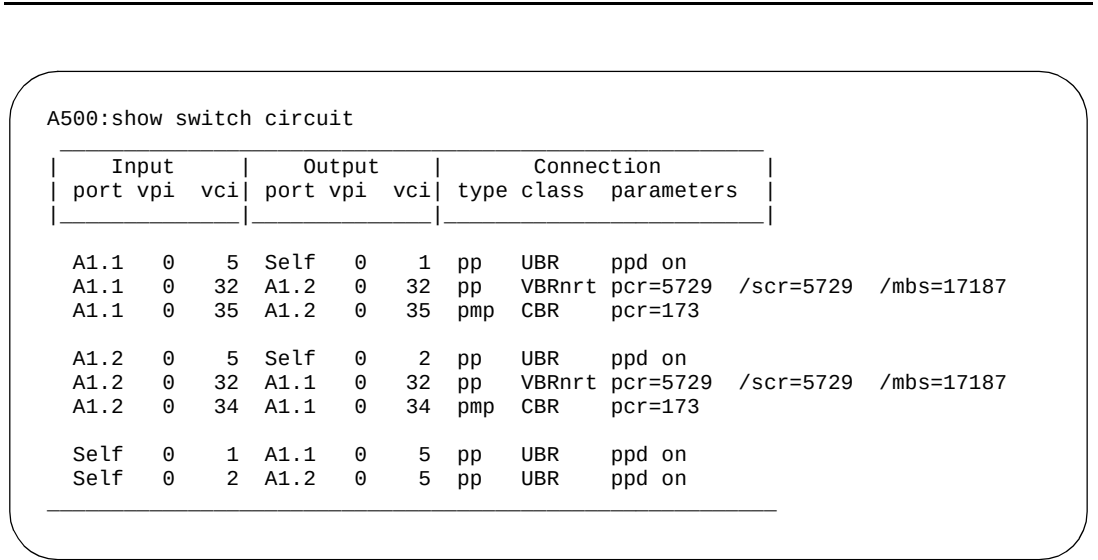
Figure 1-61. A500: show switch circuit screen

2. Enter **show switch circuittable** on the A500 console. [Figure 1-61](#) shows the screen output.

- The pp VBRnrt (Variable Bit Rate) virtual circuits between A500 ports A1.1 (PPN) and A1.2 (EPN) are used for signaling between the PPN and each EPN.
- These are established once upon initialization under control of DEFINITY Call Processing. They represent the ATM Control Link (ACL) and Expansion Archangel Link (EAL).
- VBRnrt virtual circuits are also be used for ISDN channels between Definity port networks.
- Other VBRnrt virtual circuits may exist between A500 ports that are not associated with DEFINITY port networks. A common use of VBRnrt circuits is multimedia and video-conferencing systems.

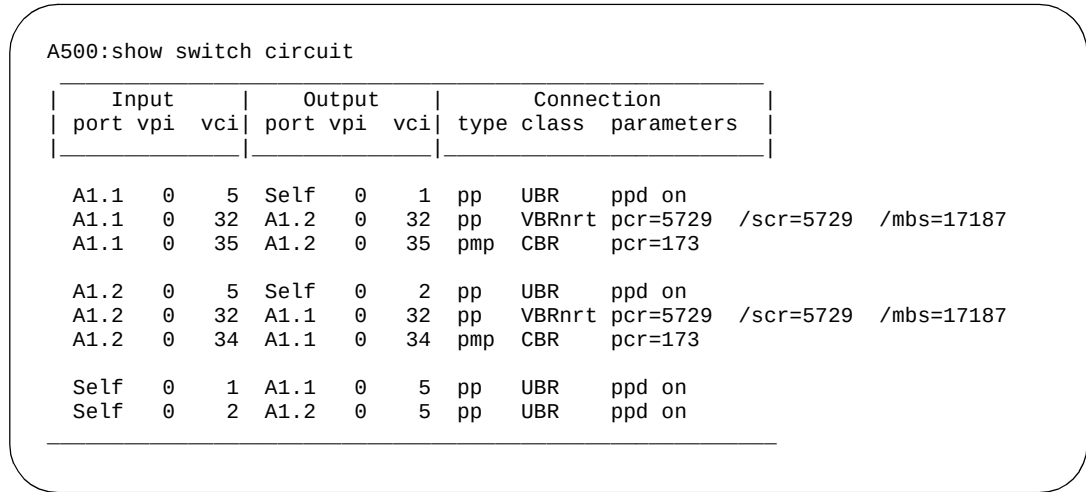
Figure 1-62. A500:show switch circuit screen

- Can you talk both ways on a set on one port network dialed from another port network and vice versa?
1. Enter **show switch circuit** on the A500 console. [Figure 1-62](#) shows the screen output.

- The pmp CBR (Constant Bit Rate) virtual circuits (VCs) between A500 port A1.1 (PPN) and A500 port A1.2 (EPN) are used for talk paths between port networks (PPN to EPN, EPN to PPN, or EPN to EPN).

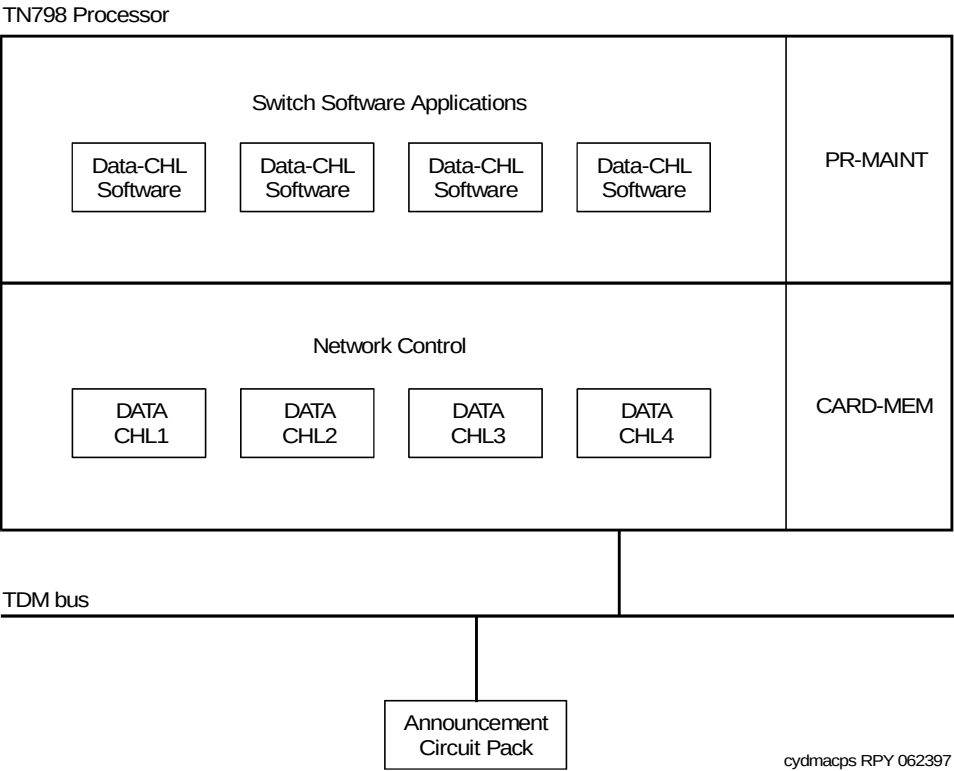
**Figure 3-2. Connection of announcement circuit pack to the system**

[Figure 3-2](#) shows the connection of the Announcement Circuit Pack to the system. To save or restore announcements, an ANNOUNCEMENT Data Extension must be administered, and at least one DATA-CHL (Network Control Data Channel) must be in the in-service/idle state.

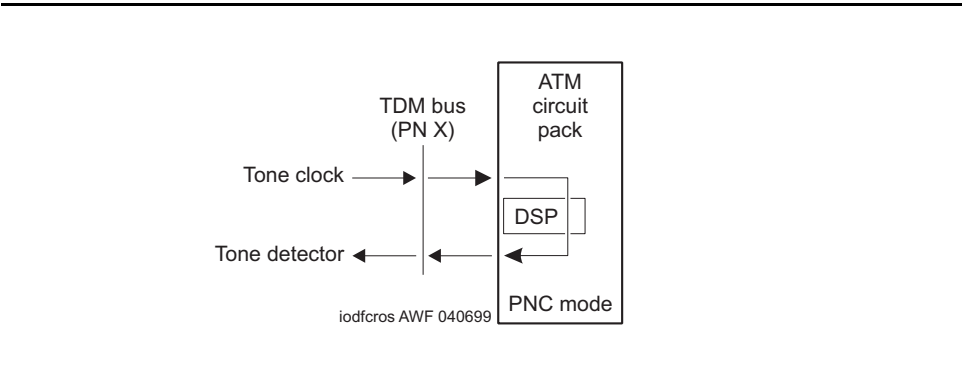
Figure 3-3. NPE Cross Talk Test #6 schematic

This test is non-destructive. The NPE Cross Talk test verifies that the selected TDM bus time slot never crosses over to time slots reserved for other connections. The test also checks for cross connections, where the board talks/listens to time slots other than those specified. Since this test uses many system resources (TDM time slots, tone generator, tone detector, and others), it runs as a part of a demand test only.

This test fails if either the TDM programmable logic and/or the interface to the DSP is not operating properly. Failure of these components may result in one-way or noisy connections. Refer to [Figure 3-3](#) for a schematic of this test.

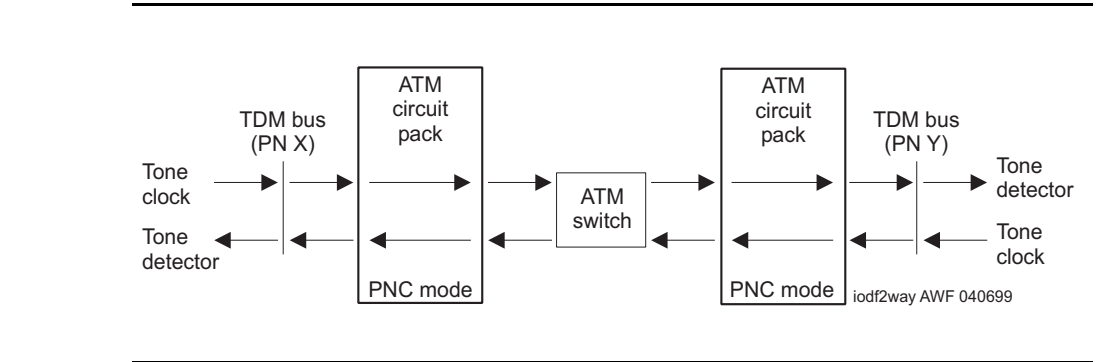
In this test the second ATM-EI may be in any port network outside the port network of the ATM-EI under test. Therefore if the test should fail in any direction, the test is repeated with a different port network, if available, which aids the fault isolation procedure.

The test results indicate if the test failed in one or both directions. The test aborts if the ATM-EIs do not exist on both ends (for example, the EIs are not administered correctly). If the test passes, the TDM and ATM framer interfaces of both ATM-EIs are functioning properly. If the test fails, a series of tests are run on the board. [Figure 3-4](#) shows a schematic of this test.

**Figure 3-4. Expansion Interface 2-Way Transmit Test #241**  
**PN X and PN Y represent any of 43 possible port networks.**

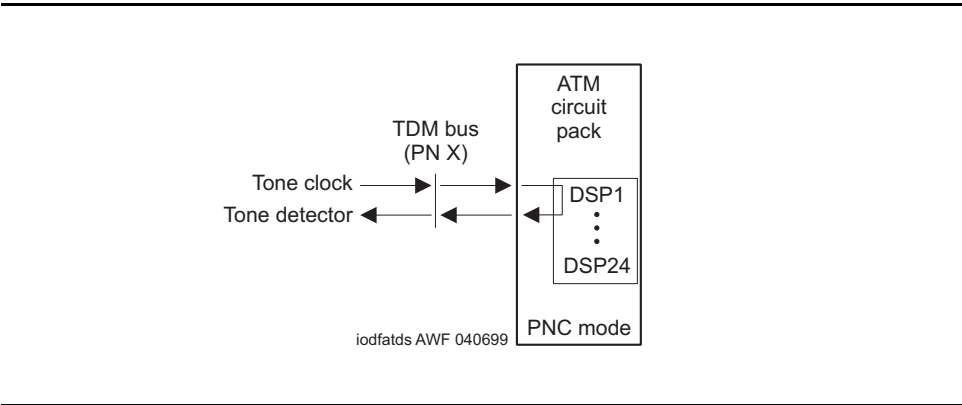
Figure 3-6. ATM Board DSP Test (#1258)

This test is non-destructive and is designed to test the board's interface to the TDM bus and the functions of all 24 on-board DSPs (Digital Signal Processors). This looparound test is completely on-board, and the results for each DSP are saved until all DSPs are tested.

If the test fails for all DSPs, a MAJOR alarm is raised against the board. If the test fails for one or more DSPs, the test fails and a MINOR alarm is raised. If a DSP is "busy," the test for that particular DSP is considered passed. The test aborts if the system resources (for example, the TDM time slots, tone generator, and others) are not available. This test applies to all ATM-EIs, both active and standby, and is run as part of craft short and long testing, periodic, scheduled, initialization, and error analysis testing. Refer to [Figure 3-6](#) for a diagram of this looparound test.

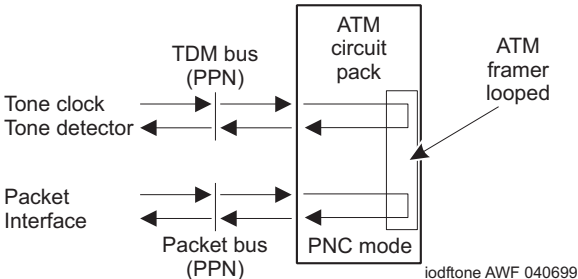
**Figure 3-7. ATM Board Framer Looparound Test (#1260)**

This test places the ATM circuit pack in ATM framer looparound mode. Once the board receives this message, it creates a dummy virtual circuit that originates and ends on the same board, without leaving the board. This test verifies both the TDM path and the Packet Path. If the TDM test path passes, then the packet path is tested. Definitions of each test path are:

- **The circuit (TDM) path:** one of the tone generators sends a bit pattern is through a TDM bus time slot to the ATM framer. The pattern is converted into ATM cells and looped back to the ATM-EI board, which converts the cell back into the bit pattern and puts it on a pre-determined time slot. A tone detector tests for the bit pattern and reports the test result. This test verifies that a large portion of the ATM-EIs circuit paths are functioning correctly. [Figure 3-7](#) shows a diagram of the test.

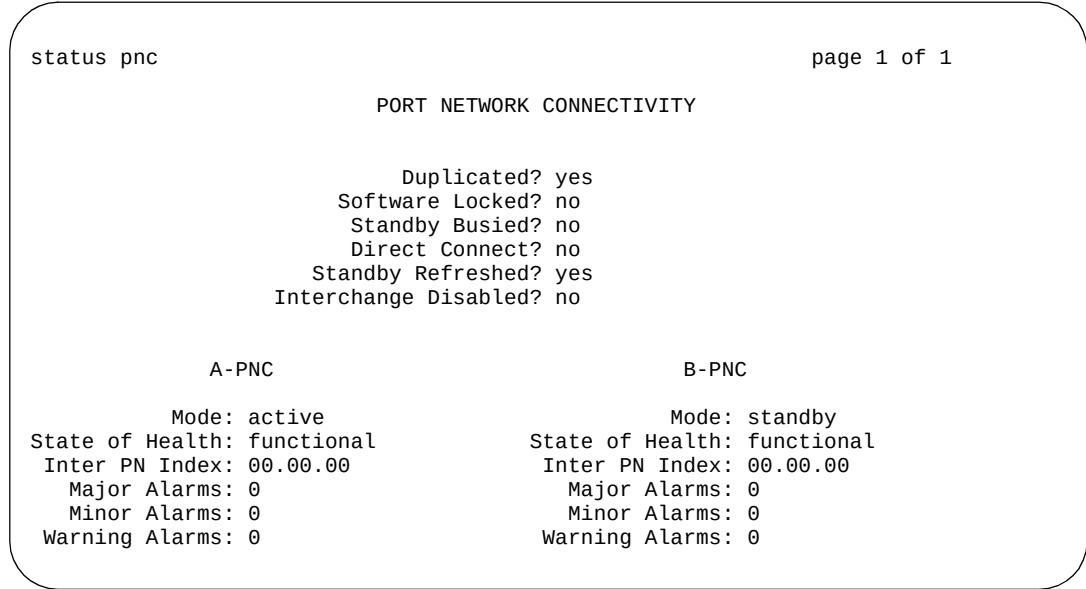
Figure 3-11. Status PNC screen with standby PNC fully In-Service

PNC-DUP software monitors the health of the two PNCs as determined by their state of health (SOH) vectors, and initiates an interchange when the health of the active falls below that of the standby (unless prevented from doing so by a PNC lock, busyout, or antithrashing mechanism). Potentially service-disrupting faults that occur in PNC components are reported to PNC-DUP and incorporated in the state of health for the affected PNC. The SOHs of both PNCs are displayed on the **status pnc** screen, as shown in [Figure 3-11](#).

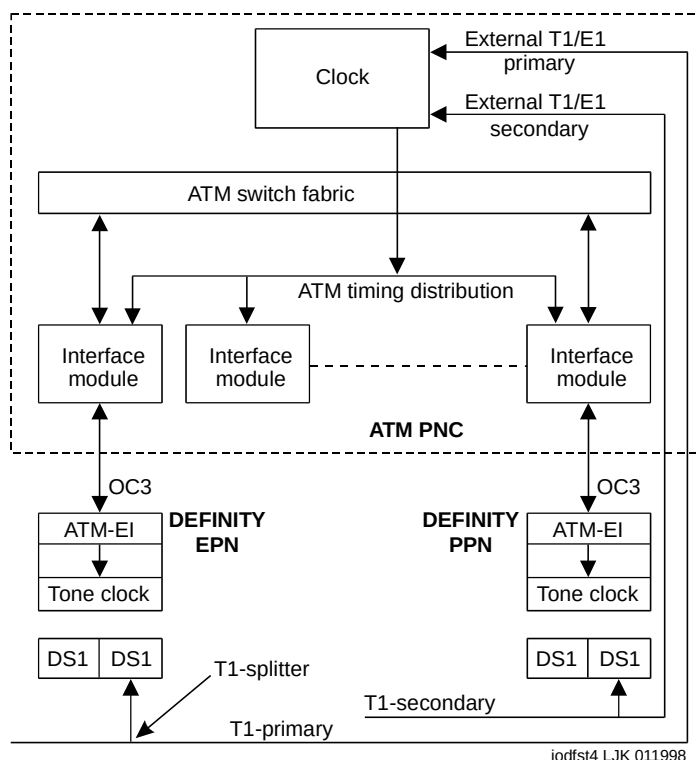
**Figure 3-12. Stratum 4 synchronization with simplex ATM PNC**

If the primary synchronization reference in [Figure 3-12](#) is providing a valid timing signal, then the flow of system synchronization would travel from the DS1 interface circuit pack in the EPN to the ATM switch. The primary DS1 interface

If the primary synchronization reference is not providing a valid timing signal, the system automatically switches to the secondary synchronization reference. If the primary synchronization reference is invalid, and if the secondary reference does not provide a valid timing signal or is not administered as a synchronization reference, the switch infers that the local oscillator of the ATM switch provides the system timing source. If the system is using the local oscillator of the ATM switch as the system timing source because the primary and secondary references are providing invalid timing signals, when either the primary or secondary reference becomes valid again, the system switches back to the primary or secondary source. When both the primary and secondary source become valid, the system switches to the primary source, since the primary source is always preferred over the secondary source when both sources are equally healthy.

[Figure 3-12](#) depicts a simplex ATM PNC with T1/OC3 synchronization reference into the ATM switch.

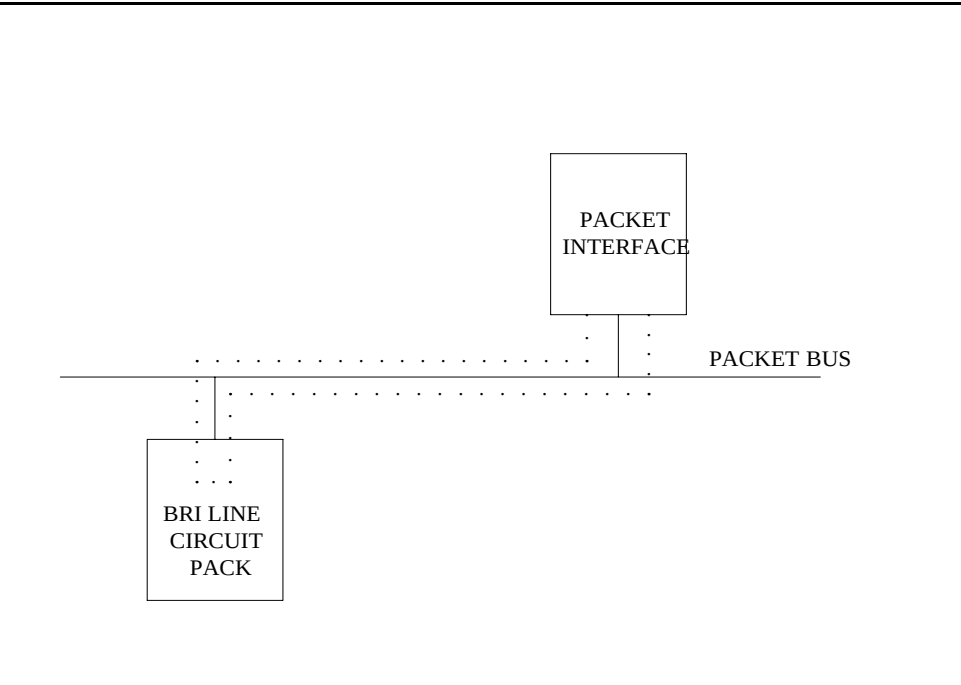
**Figure 3-14. Path of the BRI Port Local LAN Loop Around**

the port are in-progress. Failures of this test indicate either on-board faults associated with the BRI-PORT hardware on the circuit pack or problems with the LAN Bus, which is used to form connectivity between the switch and the BRI-PORT.

The dotted lines in [Figure 3-14](#) show how a Loop Around Test is performed across the Packet Bus for the D-channel.

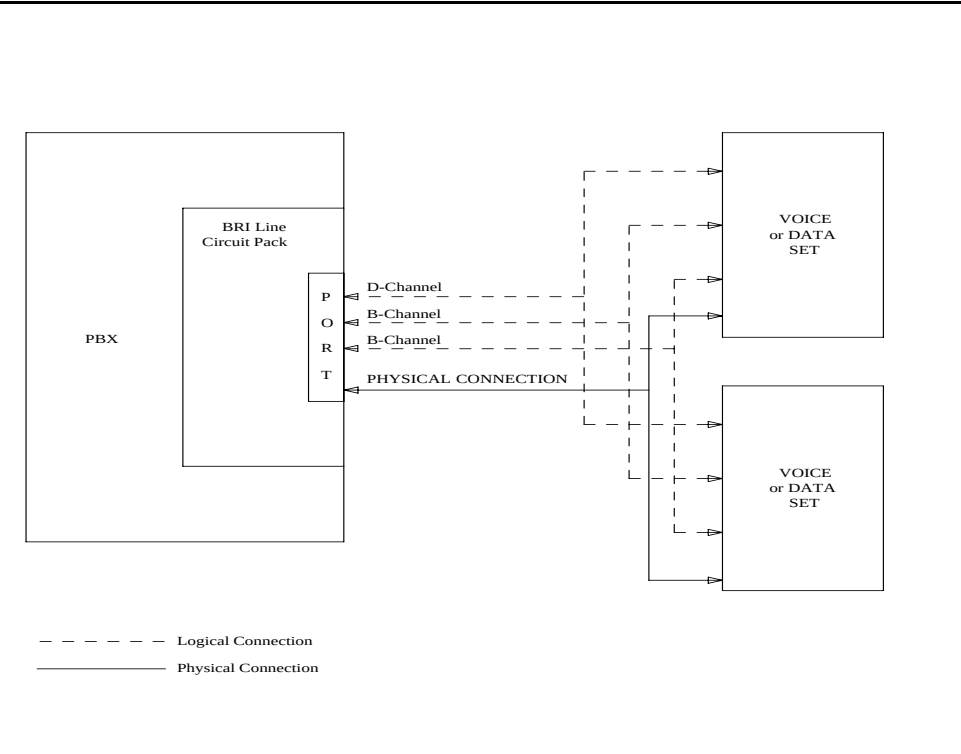
**Figure 3-16. ISDN-BRI Set Interactions**

[Figure 3-16](#) illustrates the physical connection (solid line) between an ISDN-BRI Circuit Pack and a voice or voice/data set. Each physical connection allows for two B-channels, as stated above, plus one D-channel. Each ISDN-BRI circuit pack can support up to 12 of these PHYSICAL connections to different voice and voice/data sets or ASAI and Lucent adjuncts.

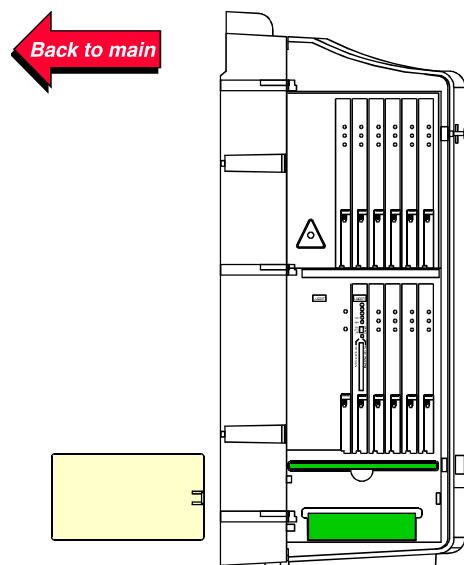
**Figure 3-17. Fan/Filter Removal**

1. Remove the left door.
2. Remove the fan/filter access panel. See [Figure 3-17](#).

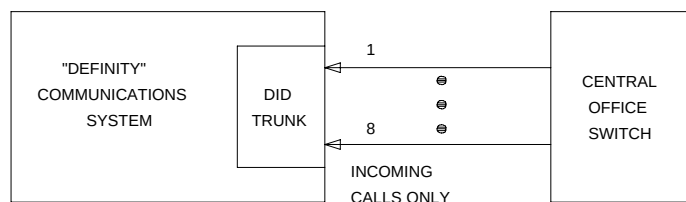
**Figure 3-18. DID Trunk Interactions**

The DID Trunk circuit packs support eight, incoming-only, ports. Each port provides an interface between the 2-wire analog line from the CO and the DEFINITY system. The DID port receives 3 to 5 digits from the CO that is used to directly connect an outside caller to the called station without assistance from an attendant. See [Figure 3-18](#).

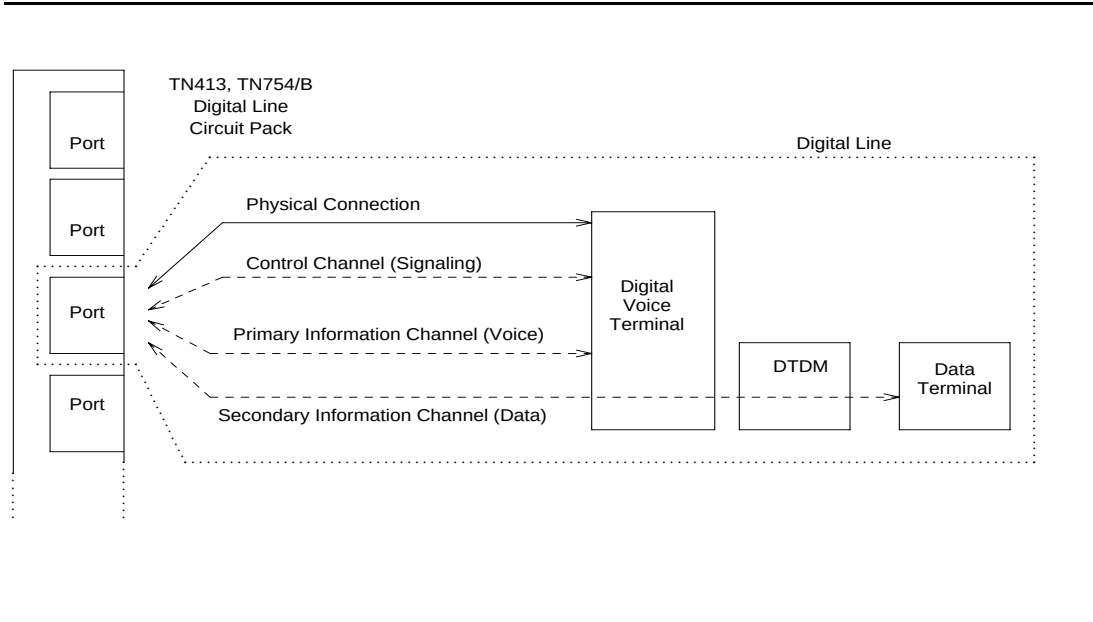
**Figure 3-19. Digital Line Connectivity**

It should be noted that TN2181 and TN2224 support both modes as shown in [Figure 3-19](#) and [Figure 3-20](#).

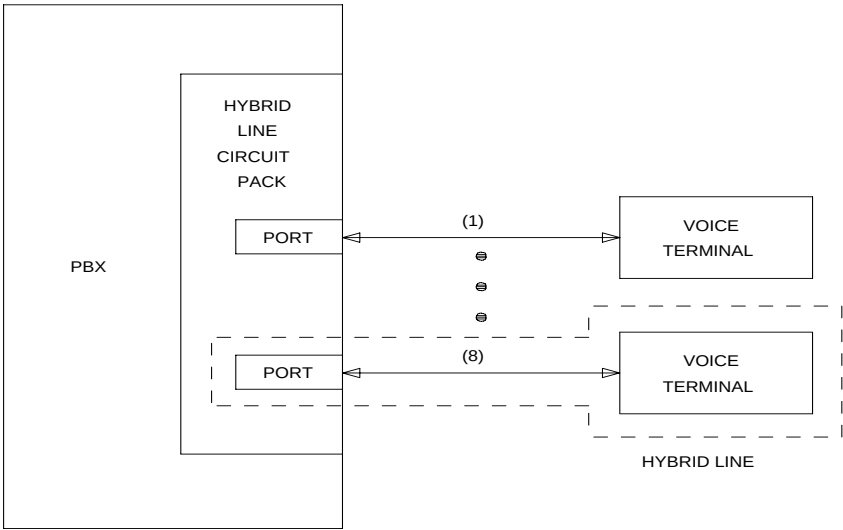
Figure 3-22. Hybrid Station Interactions

The TN762B Hybrid Line circuit pack supports eight of these multifunction analog telephone sets, as shown in the following figure. The Hybrid Line sets use three pairs of wires: an analog voice pair, a transmit/receive pair, and a power pair.

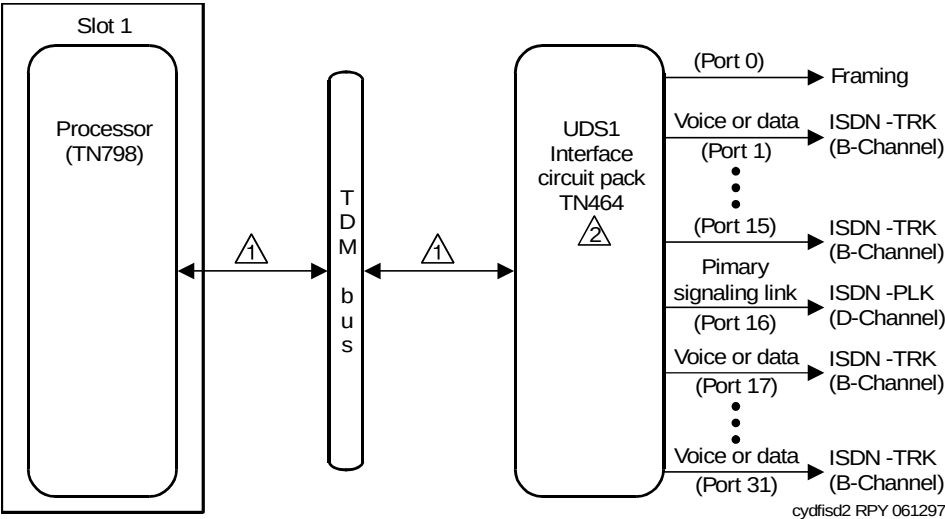
Figure 3-23. ISDN-PRI Signaling Link Port Interactions (32-Channel - TN464)

In a 32-channel system (see [Figure 3-23](#)), the DS1 ISDN Trunk or PRI endpoint port (B-channels) may use any of the ports 1-15 or 17-31, but the ISDN-PRI Signaling Link Port must be the 16th port on the TN464C (or higher) circuit pack. In certain configurations (NFAS), the 16th port may be used as a B-channel. Refer to the ["ISDN-SGR \(ISDN-PRI Signaling Group\)"](#) Maintenance documentation for further details.

1. B- and D-channel messages are routed over the TDM Bus. For additional reliability, a duplex D-channel can be administered for a signaling group and located on a different TN464C (or higher) circuit pack.
2. TN464C or higher

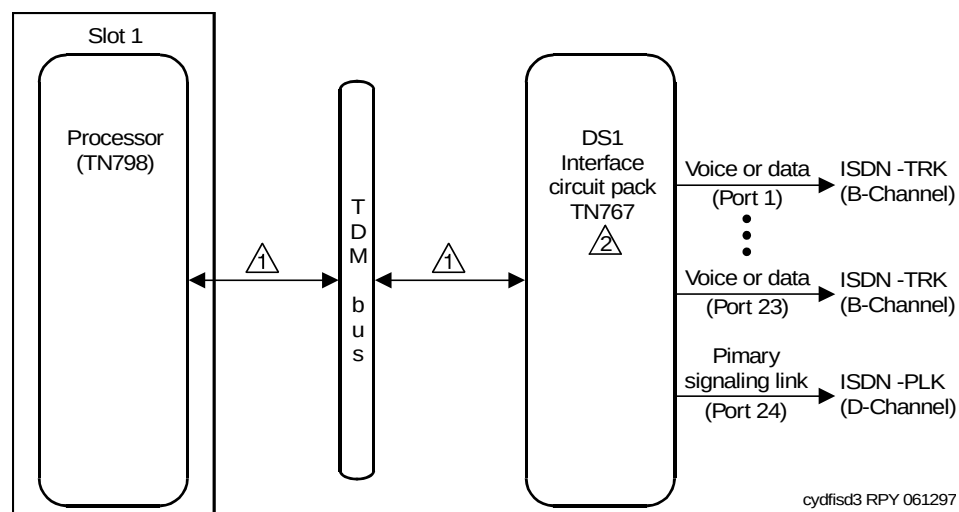
Figure 3-24. ISDN-PRI Signaling Link Port Interactions (24 Channel - TN767/464C)

In a 24-channel system, the DS1 ISDN Trunk or PRI endpoint port (B-channels) may use any of the first 23 ports. The ISDN-PRI Signaling Link Port must be the 24th port (See [Figure 3-24](#)). In certain configurations (NFAS), the 24th port may be used as a B-channel. Refer to the ISDN-PRI Signaling Group (ISDN-SGR) Maintenance documentation for further details.

1. B- and D-channel messages are routed over the TDM Bus. For additional reliability, a duplex D-channel can be administered for a signaling group and located on a different TN464C (or higher) circuit pack.
2. TN767B (or higher) or TN464C (or higher)
