**DEFINITY<sup>®</sup>**

**Enterprise Communications Server**

Release 7

Maintenance for R7csi

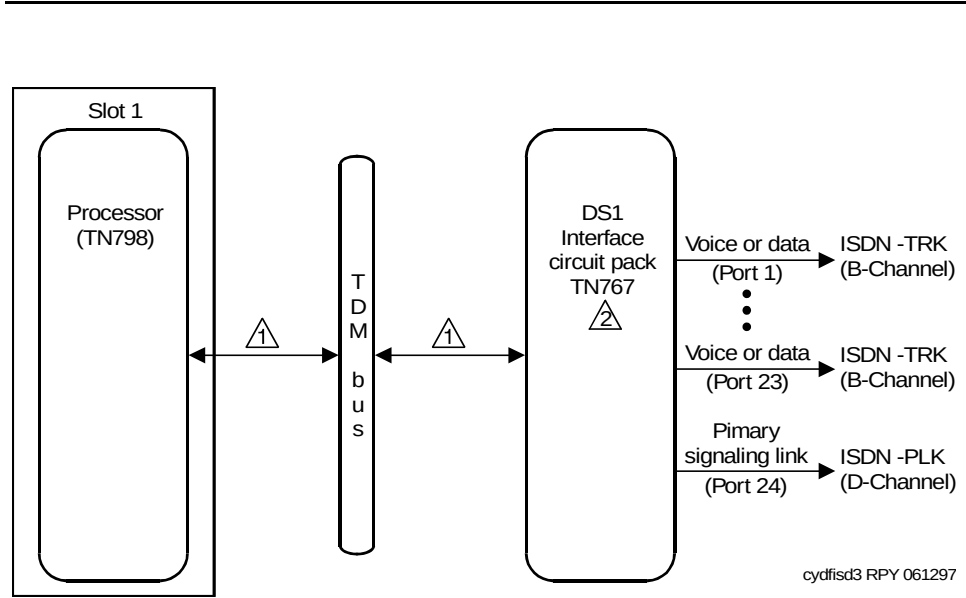
Figure 3-25. ISDN-PRI Signaling Link Port Interactions (24 Channel - TN767/464C)

For 24-channel interfaces, the first 23 ports on the circuit pack are used as B-channels. The 24th port may be used as a B-channel or as a D-channel depending on the type of Signaling Group used (see [Figure 3-25](#)).

1. B- and D-channel messages are routed over the TDM Bus. For additional reliability, a duplex D-channel can be administered for a signaling group and located on a different TN464C (or higher) circuit pack.
2. TN767B (or higher) or TN464C (or higher)

The ISDN-PRI Signaling Link Port itself depends on the health of the DS1/UDS1 Interface circuit pack on which it resides. This test will fail if there are problems with either the ISDN-PRI Primary D-channel port or the DS1/UDS1 circuit pack. See [Figure 3-25](#) for DS1 connections, [Figure 3-26](#) for UDS1 connections.

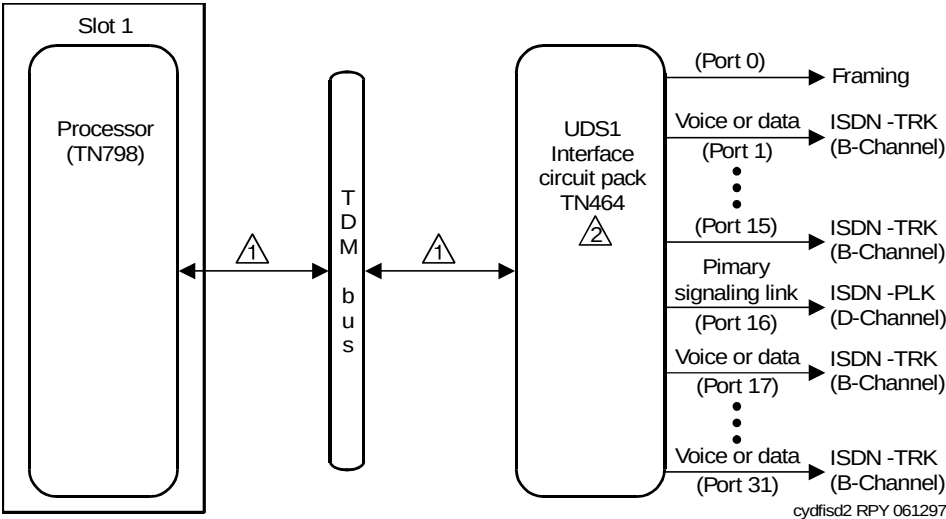
Figure 3-26. ISDN-PRI Signaling Link Port Interactions (32-Channel - TN464)

For 32-channel interfaces, ports 1-15 and 17-31 on the circuit pack are used as B-channels. The 16th port may be used as a B-channel or as a D-channel depending on the type of Signaling Group used (see [Figure 3-26](#)).

1. B- and D-channel messages are routed over the TDM Bus. For additional reliability, a duplex D-channel can be administered for a signaling group and located on a different TN464C (or higher) circuit pack.
2. TN464C or higher

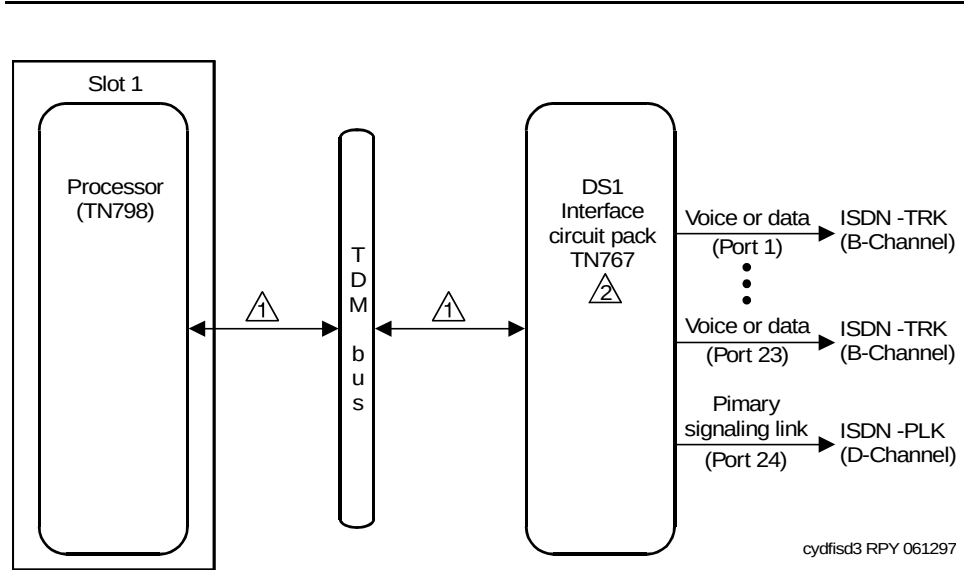
On 24-channel interfaces, any of the first 23 ports on the DS1/UDS1 interface circuit pack can be a B-channel. The 24th port may be used as a B-channel or as a D-channel depending on the type of ISDN-PRI Signaling Group (ISDN-SGR) to which it belongs.

1. B- and D-channel messages are routed over the TDM Bus. For additional reliability, a duplex D-channel can be administered for a signaling group and located on a different TN464C (or higher) circuit pack.
2. TN767B (or higher) for DS1; TN464C (or higher) for UDS1

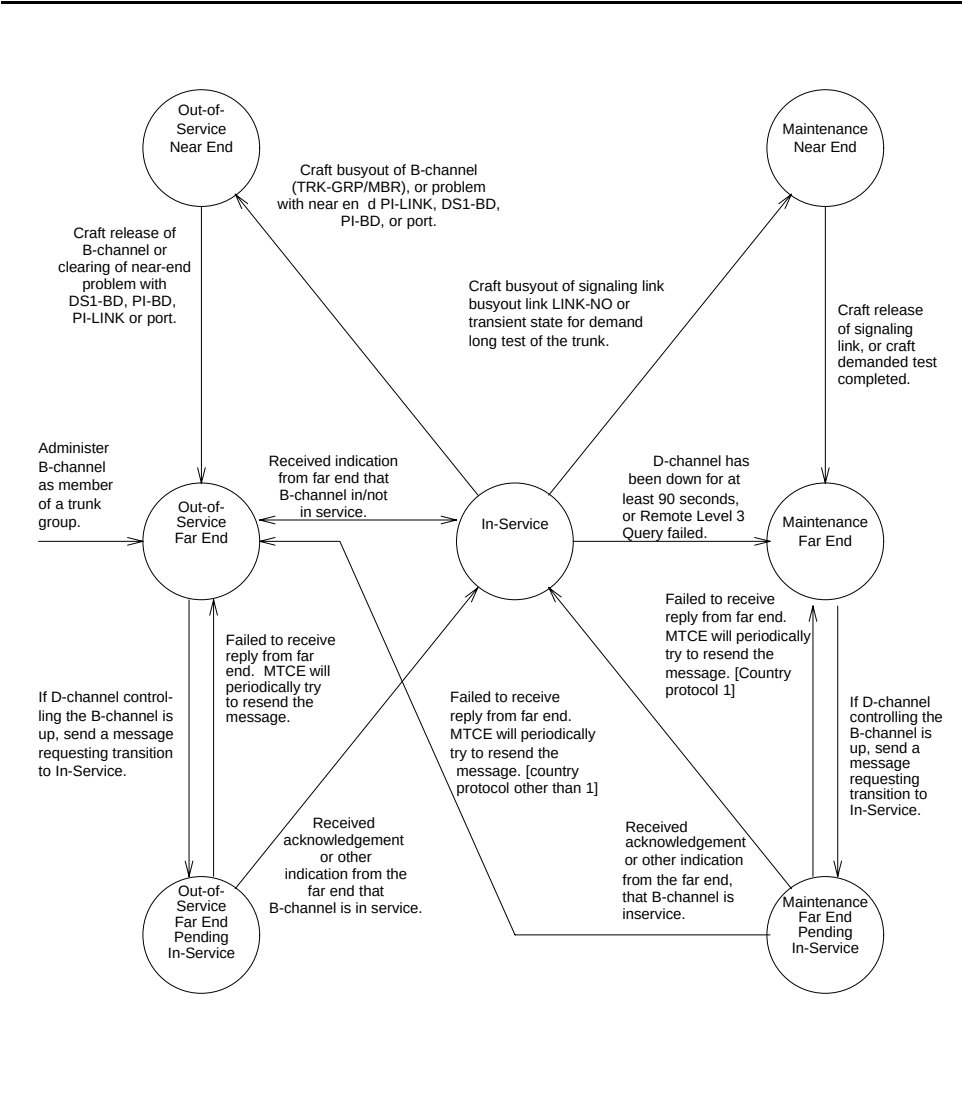
Figure 3-29. Common Progressions in Service States

The following diagram of the DS1 ISDN Trunk service states shows the common progression from one service state to another and the event that caused the change of state.

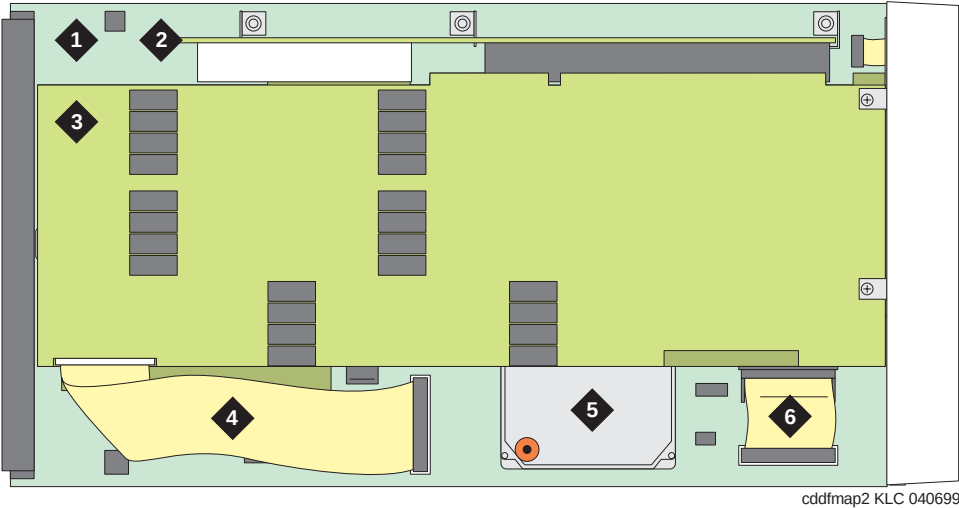
Figure 3-34. TN802 board assembly and cables (side view)

Figure 3-34 shows a side view of the thee boards and interconnecting cables that make up the TN802.

- c. Check the internal cables on the TN802 circuit pack (Notes 4 and 6 in [Figure 3-34](#)).
  - d. Try pinging another device on the same subnet.
  - e. Try pinging the gateway to the rest of the network from the subnet.

- a. Check that the internal cables on the TN802 circuit pack (Notes 4 and 6 in [Figure 3-34](#)) have not worked loose.
  - b. Otherwise, replace the circuit pack.
3. At the command prompt, type **ping 10.32.64.97** (the internal IP trunk server address) and press Enter.

The TN802 hard drive (Note 5 in Figure 3-34) is field-replaceable.

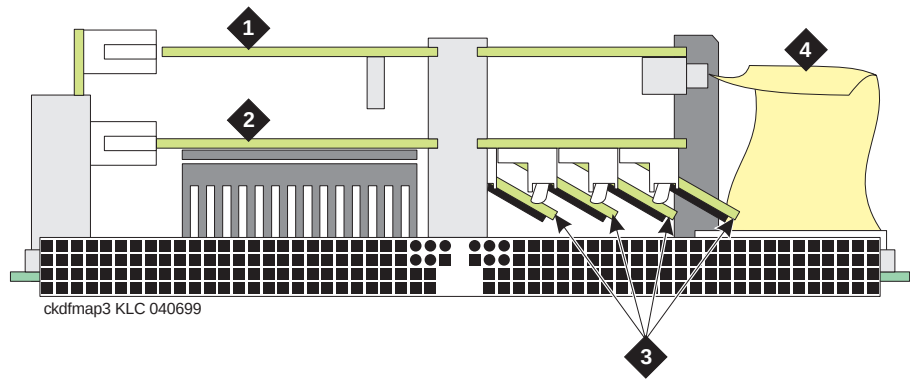
Figure 3-35. TN802 board assembly and cables (end view)

Figure 3-35 shows the end view of the three boards and interconnecting cables on the TN802.

1. Analogic board

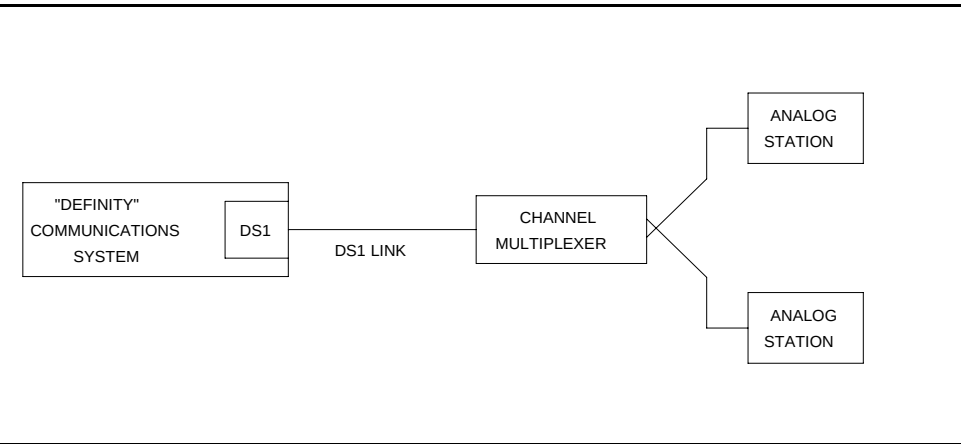
Figure 3-39. DS1 OPS Line Interactions

An analog Off-Premises Station (OPS) can be connected to the system through a DS1 link. A TN767 DS1 Interface circuit pack supports up to 24 DS1OPSs. Since the DS1OPS is an analog telephone set, a channel multiplexer is necessary as the remote DS1 endpoint that converts the digital signal of a DS1 port to the OPS Line and vice versa. See [Figure 3-39](#) for details.

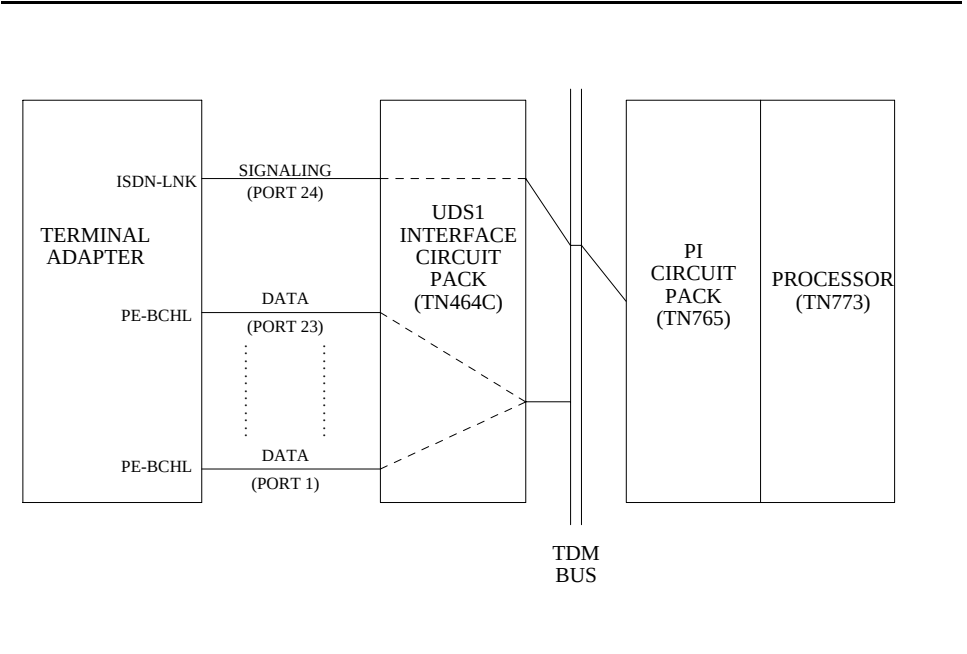
**Figure 3-40. PRI Endpoint Port Interactions [INTEL]**

A PRI Endpoint Port is a port on a UDS1 interface circuit pack. Therefore, this port depends on the health of the UDS1 interface circuit pack for proper operation (see [Figure 3-40](#)). As noted earlier, a PRI Endpoint Port B-channel also depends on an ISDN-PRI Signaling Link Port D-channel (ISDN-LNK) to carry the signaling traffic. If there is a problem with the ISDN-PRI Signaling Link Port, the PRI Endpoint Port is affected. The ISDN-PRI Signaling Link Port, in turn, depends on the PKT-INT (Packet Interface).

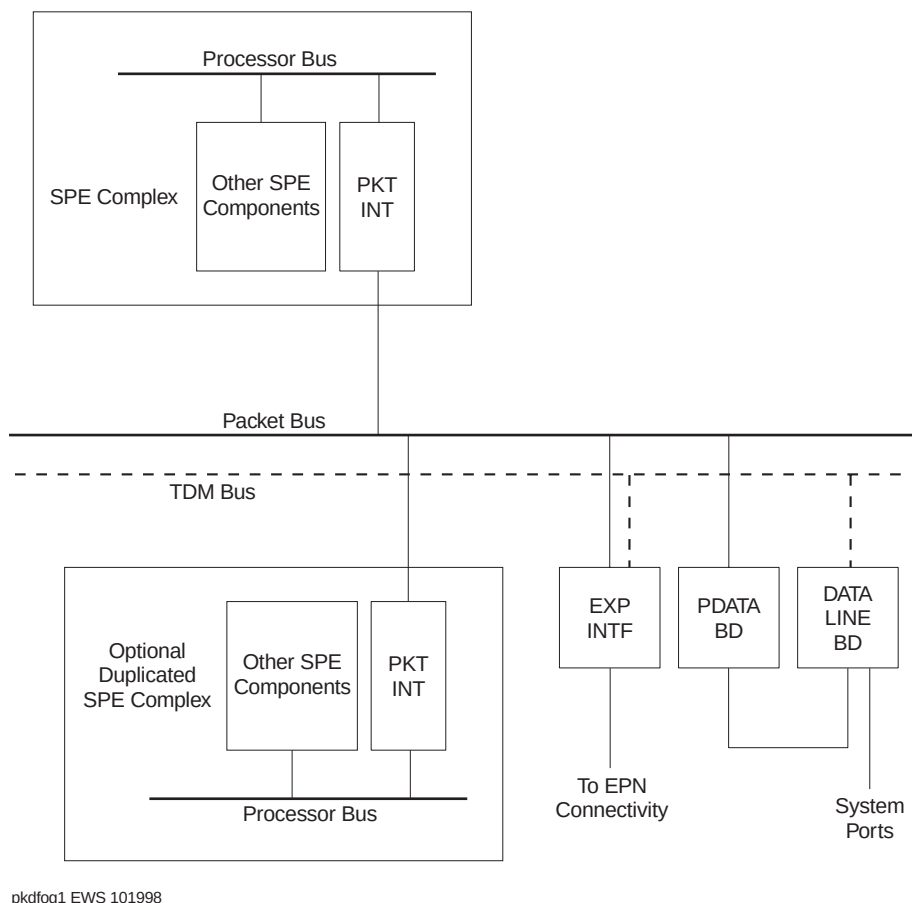
- Distributed Communication System (DCS)
  - Audio Information Exchange (AUDIX)
  - Messaging Service Adjunct (MSA)
  - Call Management System (CMS)
  - Outgoing Call Management (OCM)
  - Adjunct Switch Application Interface (ASAI)
- b. System links
- ISDN PRI D channel signaling links
  - ISDN BRI D channel broadcast and point-to-point signaling links
  - Adjunct Switch Application Interface (ASAI) links
  - Remote Socket Links (RSL) and Remote Socket Control Links (RSCL)

**Figure 3-42. Packet Interface connections**

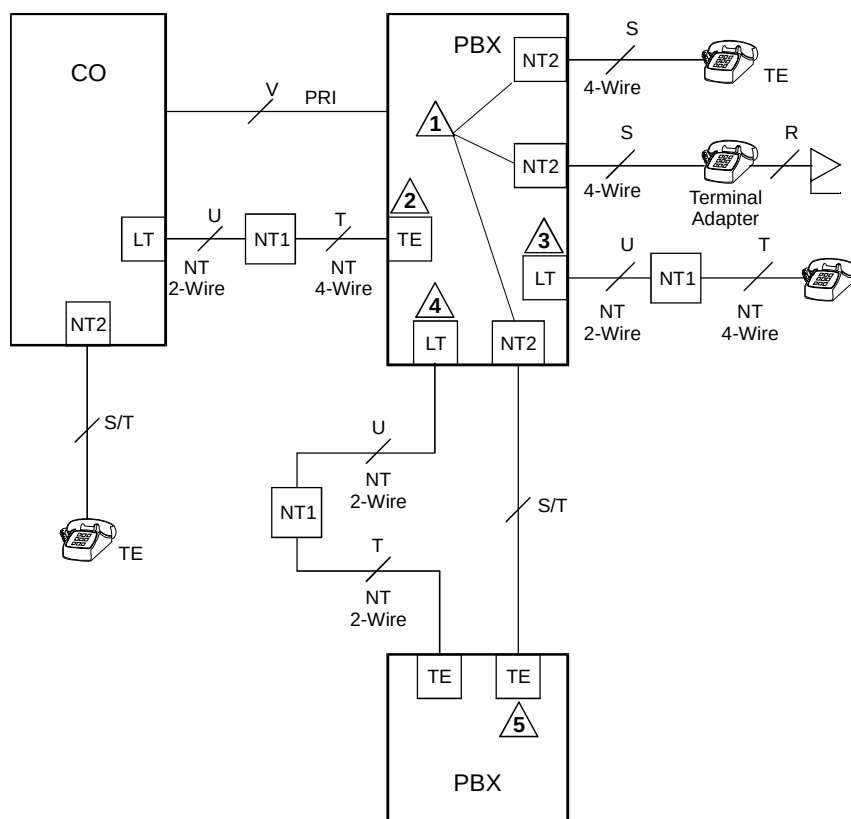
## ISDN Interface Reference Points

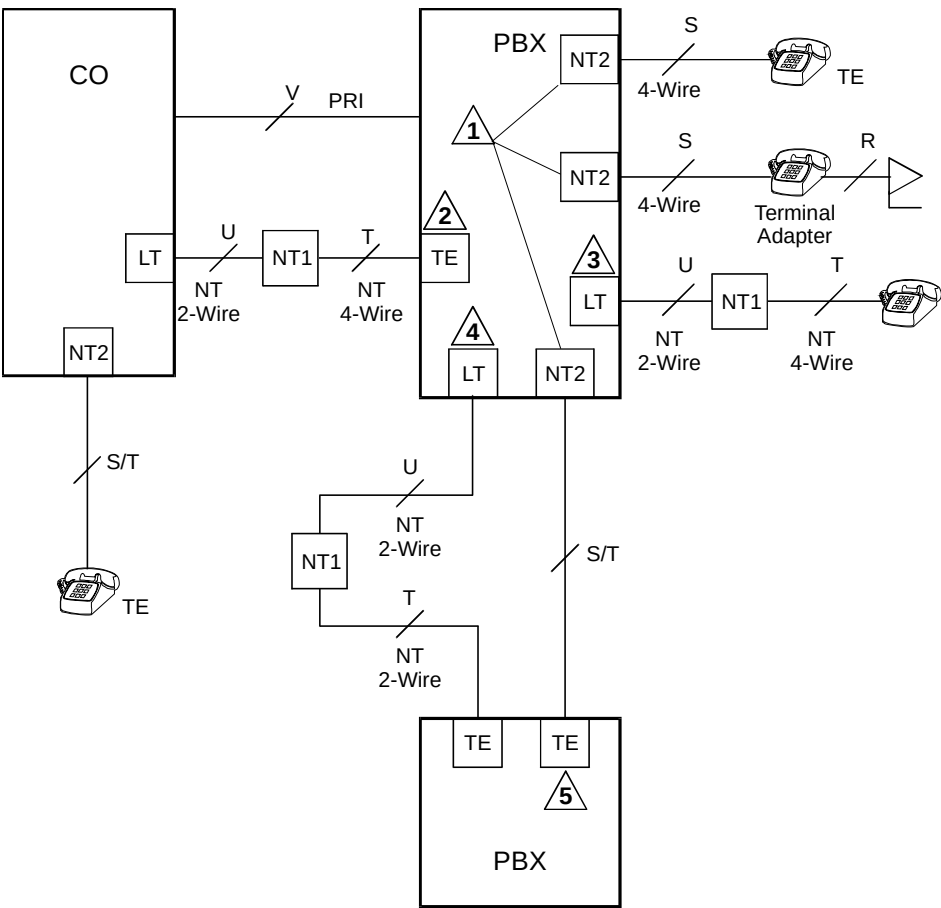
ISDN Interface Reference Points

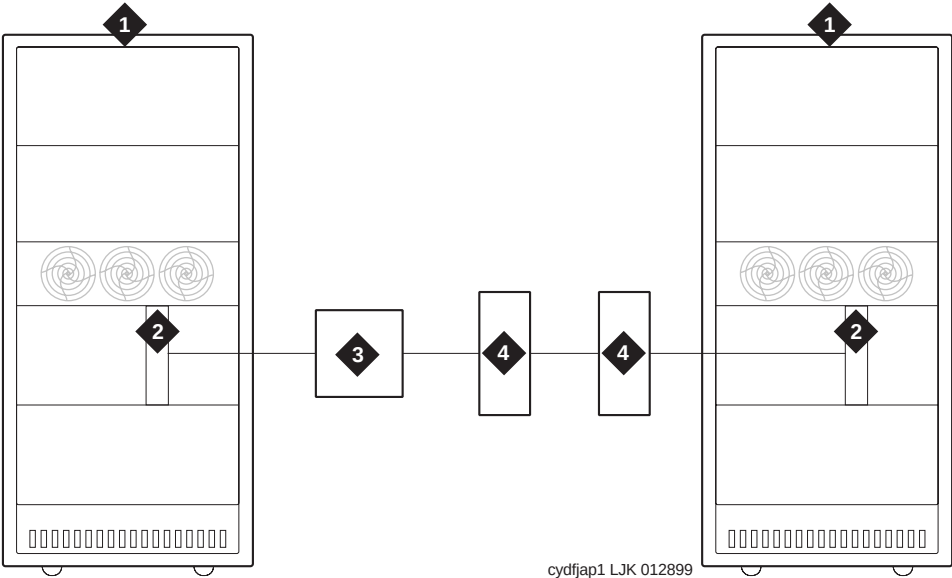
[Figure 3-47](#) shows the hardware connections for public network access in Japan. The upgrade procedure requires removing the JRC (Japan Radio Corporation) external converter in [Figure 3-47](#).

| 1. DEFINITY Release 7 | 3. JRC (Japan Radio Corporation) external converter |

**Figure 3-47. Japanese TTC public network connections**

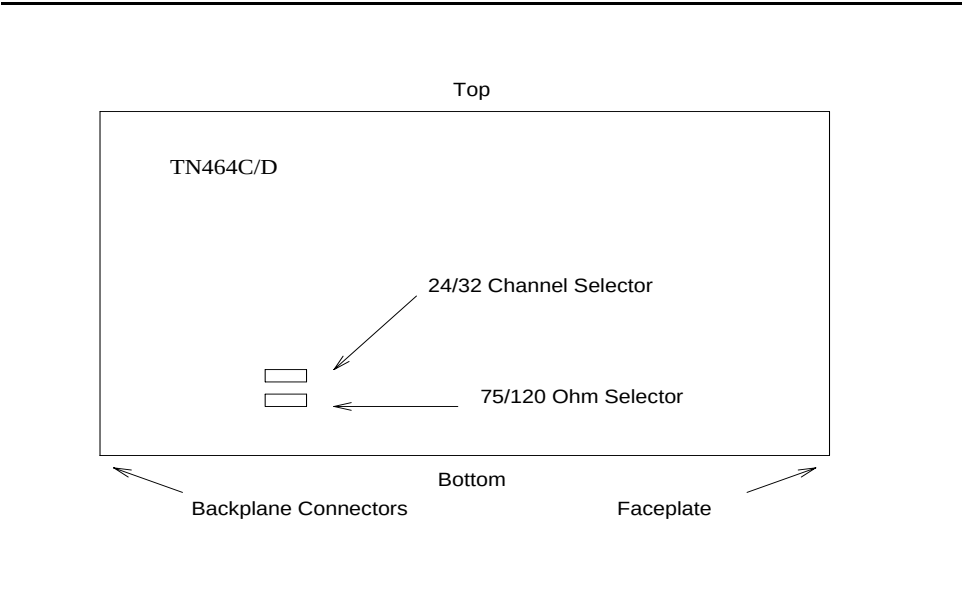
[Figure 3-50](#) through [Figure 3-52](#) show how to configure the circuit pack for 24-channel or 32-channel DS1. The channel selection must match the parameters administered on the corresponding DS1 Circuit Pack Form. (US applications use 24 Channels.)

**Figure 3-50. TN464C/D DS1 Option Jumpers**

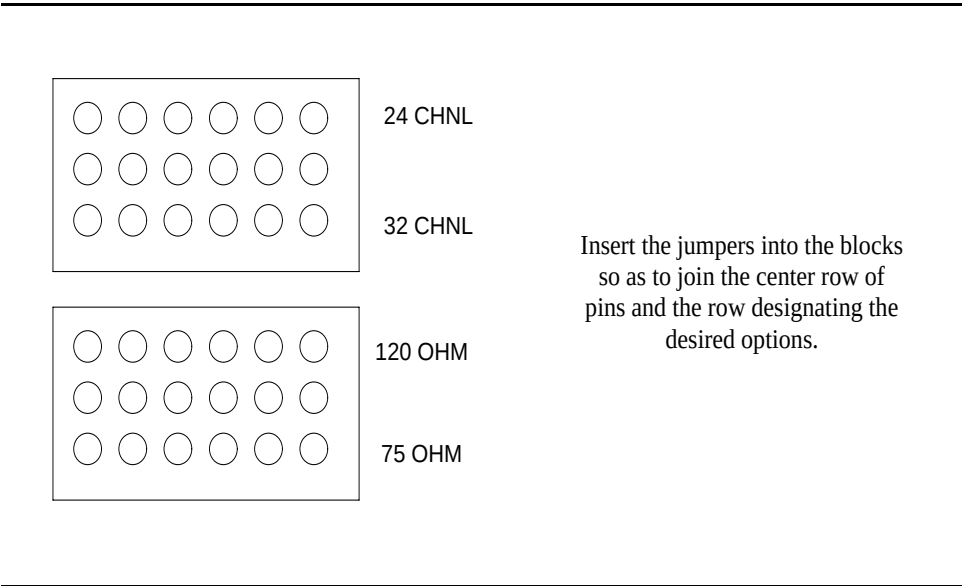
Figure 3-51. TN464C/D DS1 Option Jumpers

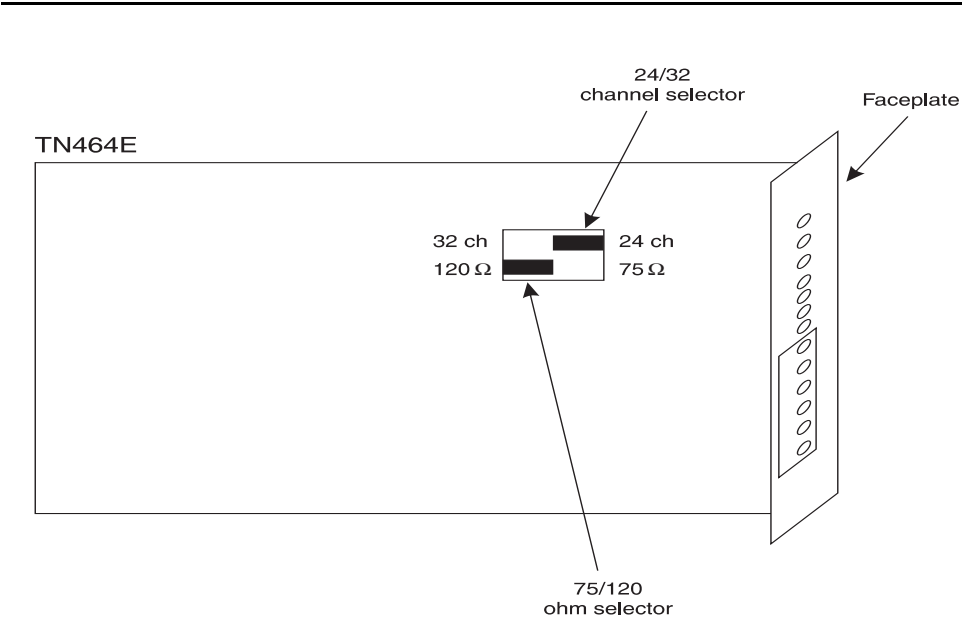
The option switch located on the component side of the TN464E/F circuit pack must be set correctly. [Figure 3-52](#) shows how to configure the circuit pack for 24-channel or 32-channel DS1. The channel selection must match the parameters administered on the corresponding DS1 Circuit Pack Form. (US applications use 24 Channels.)

Figure 3-52. TN464E/F DS1 Option switches

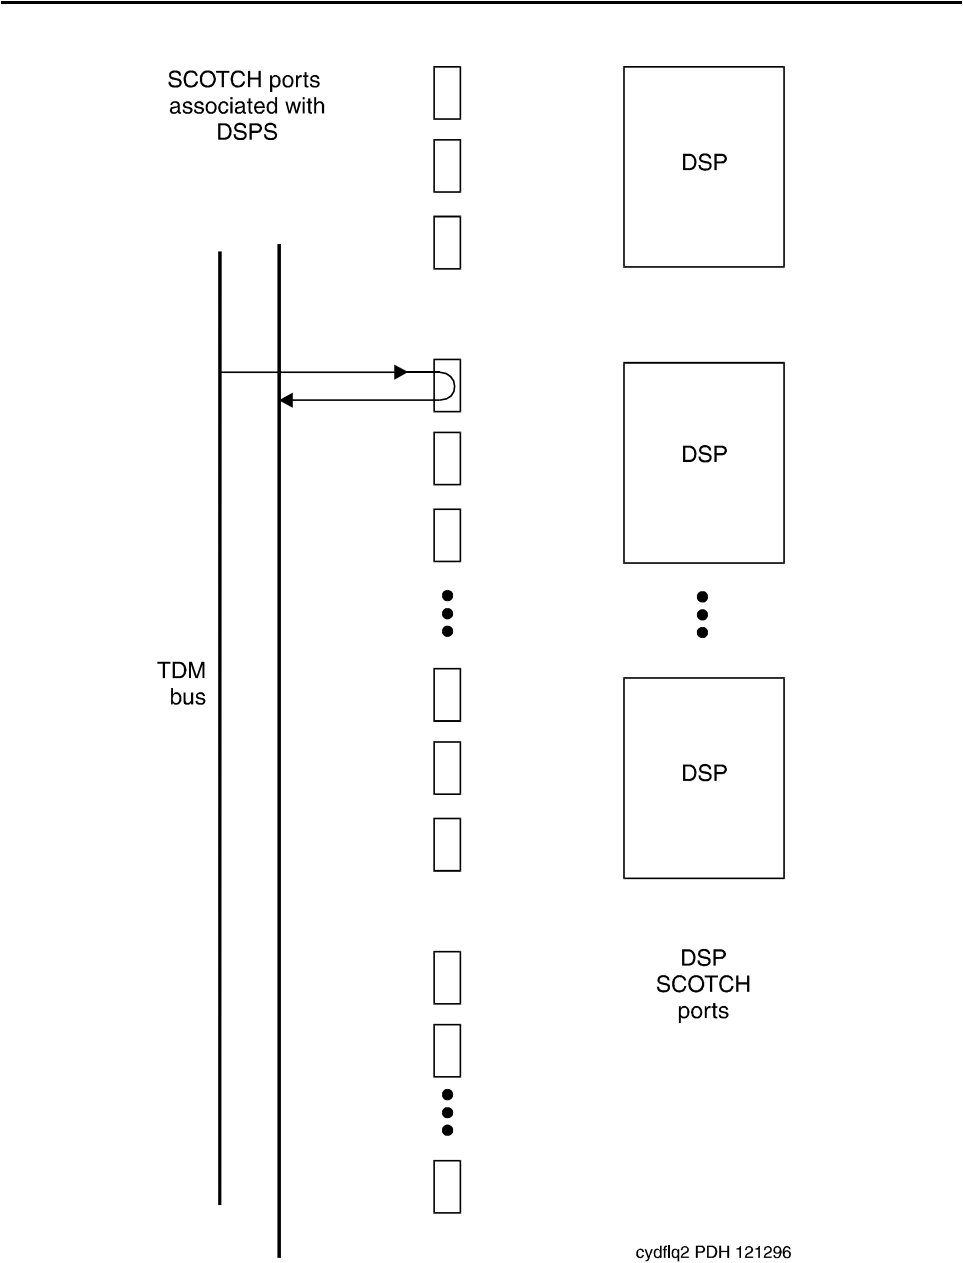
This test verifies the connectivity of a VC DSP Port across the TDM bus. It aborts if calls associated with the port are in progress. Failure of this test indicates an on-board fault associated with the port hardware on the circuit pack. The Loopback Test runs the following tests (refer to [Figure 3-53](#)):

1. A looparound test across the TDM bus.
2. A conference circuit test.

**Figure 3-53. VC Circuit Pack DSP Port Local TDM Loopback Test**

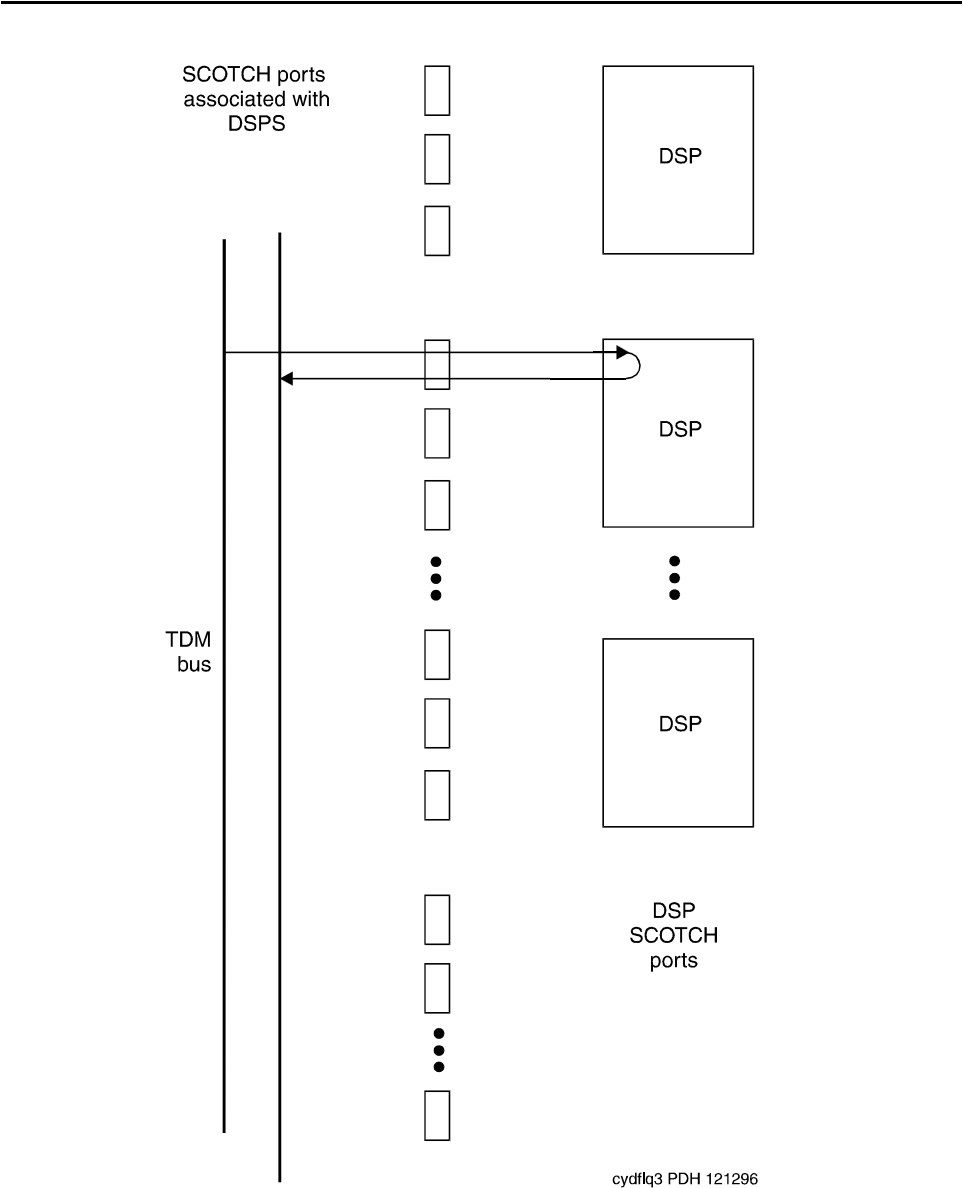
This test verifies the connectivity of a VC-DSPPT across the TDM bus as shown in [Figure 3-54](#). It aborts if calls associated with the port are in progress. Failure of this test indicates an on-board fault associated with the port hardware on the circuit pack.

Figure 3-54. VC Circuit pack DSP Port DSP Looparound Test
