555-231-101  
Issue 2  
January, 1996

# **DEFINITY® COMMUNICATIONS SYSTEM Multimedia Link**

User Manual and Technical Reference

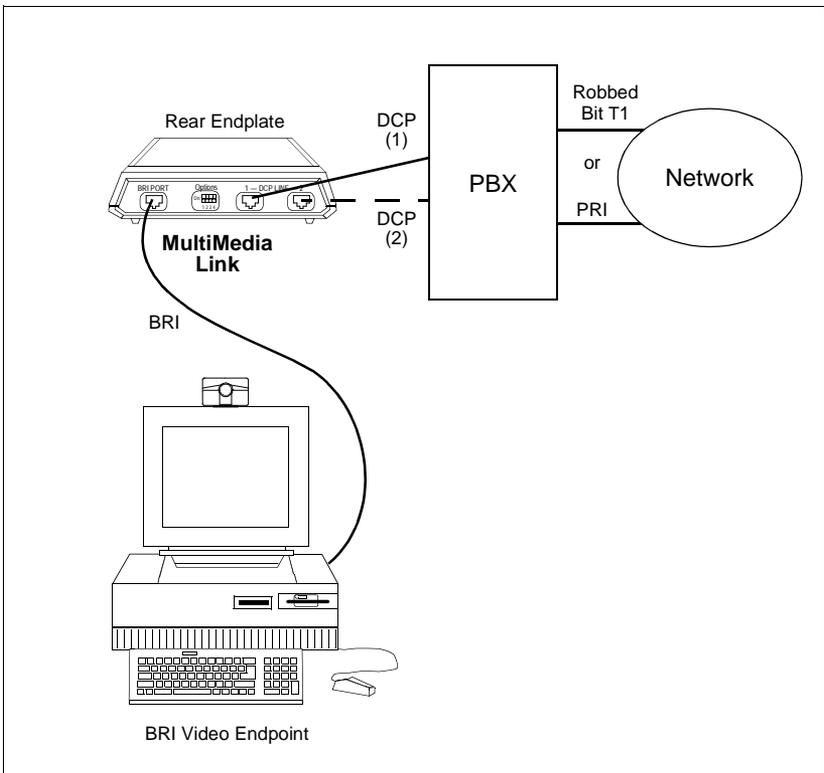
FIGURE 1 MultiMedia Link in a System Configuration

The DEFINITY® Communications System MultiMedia Link is a protocol converter which enables the connection of an Integrated Services Digital Network (ISDN) Basic Rate Interface (BRI) data or video endpoint to an AT&T Private Branch Exchange (PBX) via AT&T's proprietary Digital Communications Protocol (DCP). These PBXs include older PBXs such as System 75 or System 85 as well as the newer DEFINITY Communications Systems and AT&T's Multipoint Control Unit (MCU) Version 3.0. For connectivity to the outside world, however, the PBX must be equipped with digital trunks that are administered for data calling. Figure 1 shows MultiMedia Link in a system configuration.

The MultiMedia Link connects to the PBX via one or two **4-wire** DCP lines. The MultiMedia Link cannot use 2-wire DCP lines. System 85 and DEFINITY G2 and G3 PBXs can be administered to support dual simultaneous data calls on a single DCP line. Other switches cannot support two simultaneous data calls on one DCP line and require connection to two DCP ports on the switch.

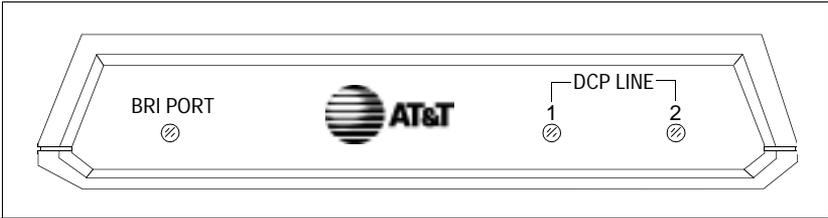
**FIGURE 2 Front Panel**

The front panel of the MultiMedia Link is shown in Figure 2. The three dual color status LEDs are described in Table 1. In addition to indicating status during normal operation, the LEDs also indicate the result of the self-test when initially powered.

LED	LED Condition	Status
BRI Port	Off	Idle
	Flashing green	Incoming call
	Steady green	Active call
	Flashing red	Self test failed
	Steady red	BRI link down
DCP Line 1	Steady green	Two links established
	Steady orange	One link established
	Steady red	No links established
	Flashing red, orange, or green	In loopback mode
DCP Line 2	Steady orange	Link established
	Steady red	No link established
	Flashing red, orange, or green	In loopback mode

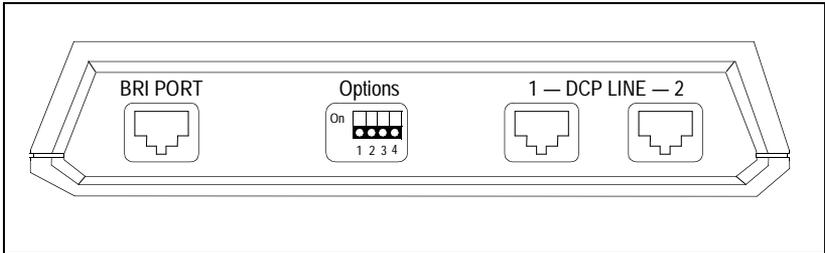
**FIGURE 3 Back Panel**

The back panel of the MultiMedia Link is shown in Figure 3. The connectors located on the back panel are described in Table 2.

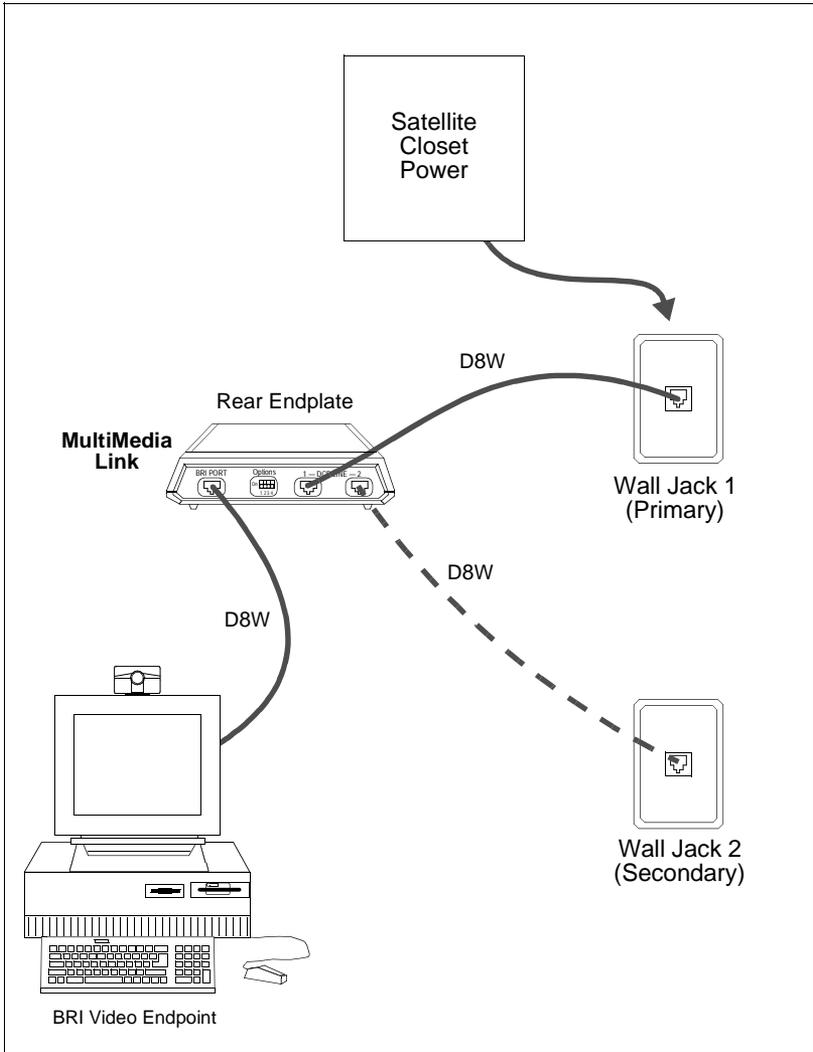
**FIGURE 4** Typical Installation with Satellite Closet Mounted Power Supply

Figure 4 shows a typical installation using a satellite closet mounted power supply.

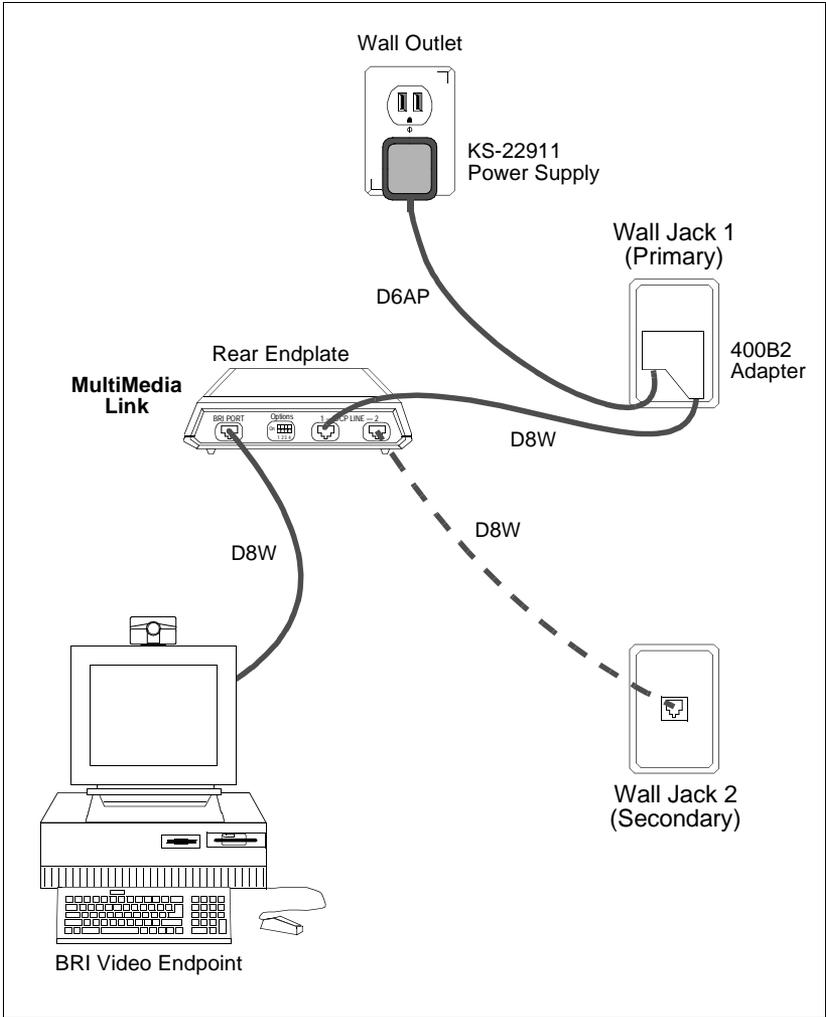
**FIGURE 5** Typical Installation with KS-22911 Power Supply

Figure 5 shows a typical installation using a KS-22911 power supply.

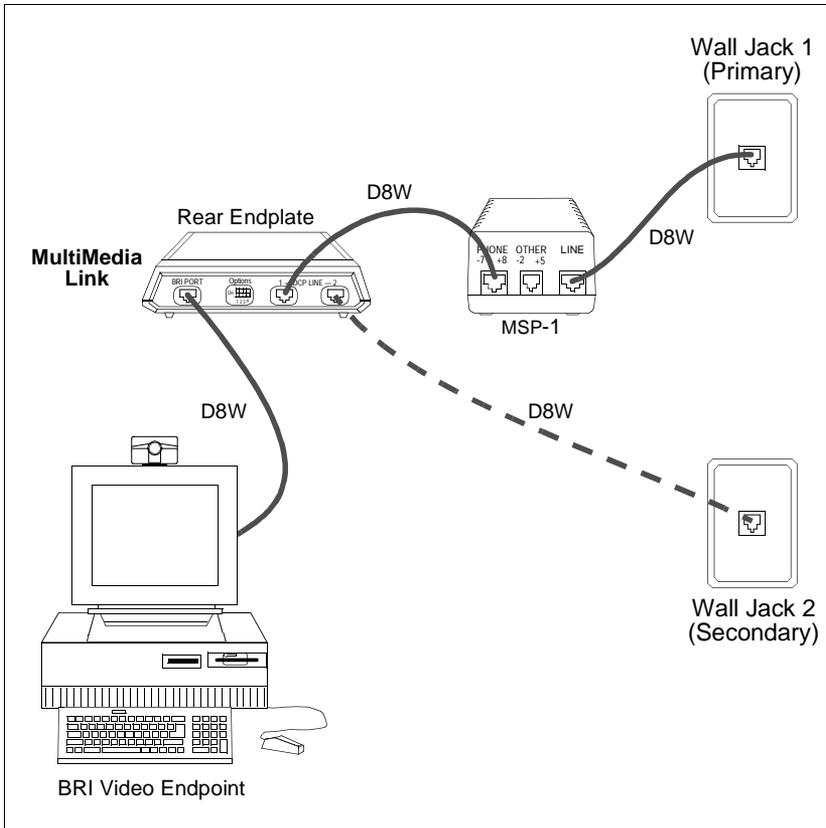
**FIGURE 6** Typical Installation with MSP-1 Power Supply

Figure 6 shows a typical installation using an MSP-1 power supply.
