**DEFINITY®**

# **Enterprise Communications Server**

Release 8.2

Maintenance for R8.2csi

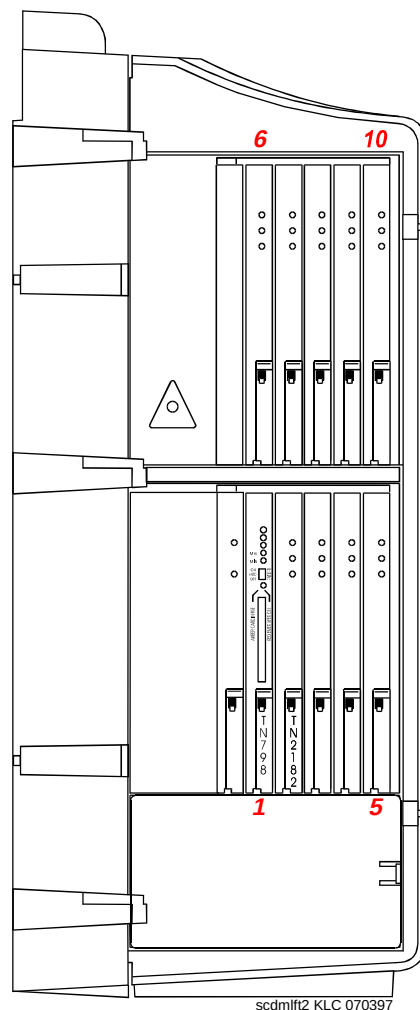
**Figure 1-1. Compact Modular Cabinet (CMC) slot configuration**

- The RISC-based TN798 Processor circuit pack must be located slot 1. [Figure 1-1](#) also shows the Flash Memory Card slot for translations.
- TN2182 Tone-Clock must be installed in slot 2. This is the only Tone-Clock circuit pack allowed in the CMC.
- Service circuit packs the only packs allowed in the CMC. These “universal” service packs can be located in any slot numbered 3-10.
- AUDIX, if present, requires 4 slots (slots 6-9 on the top row).
- MAPD requires 2 slots if administered in slot 7, otherwise, installation requires 3 slots.

- The CMC cabinet has 2 shelves of 5 slots each (1-5, 6-10) as shown in [Figure 1-1](#). This means that slots 5 and 6 are not contiguous like they are in other DEFINITY cabinet types and that Multi-Function boards such as the TN566 and the MAPD boards (TN800, TN801, and TN802) must be installed in specific slots. For example:

- The TN798 Processor circuit pack incorporates the RISC processor complex, the TN777B NETCON (including PCM flash card interface), and TN765 Processor Interface functions and is always found in slot 1 of the A carrier. (See [Figure 1-1](#))

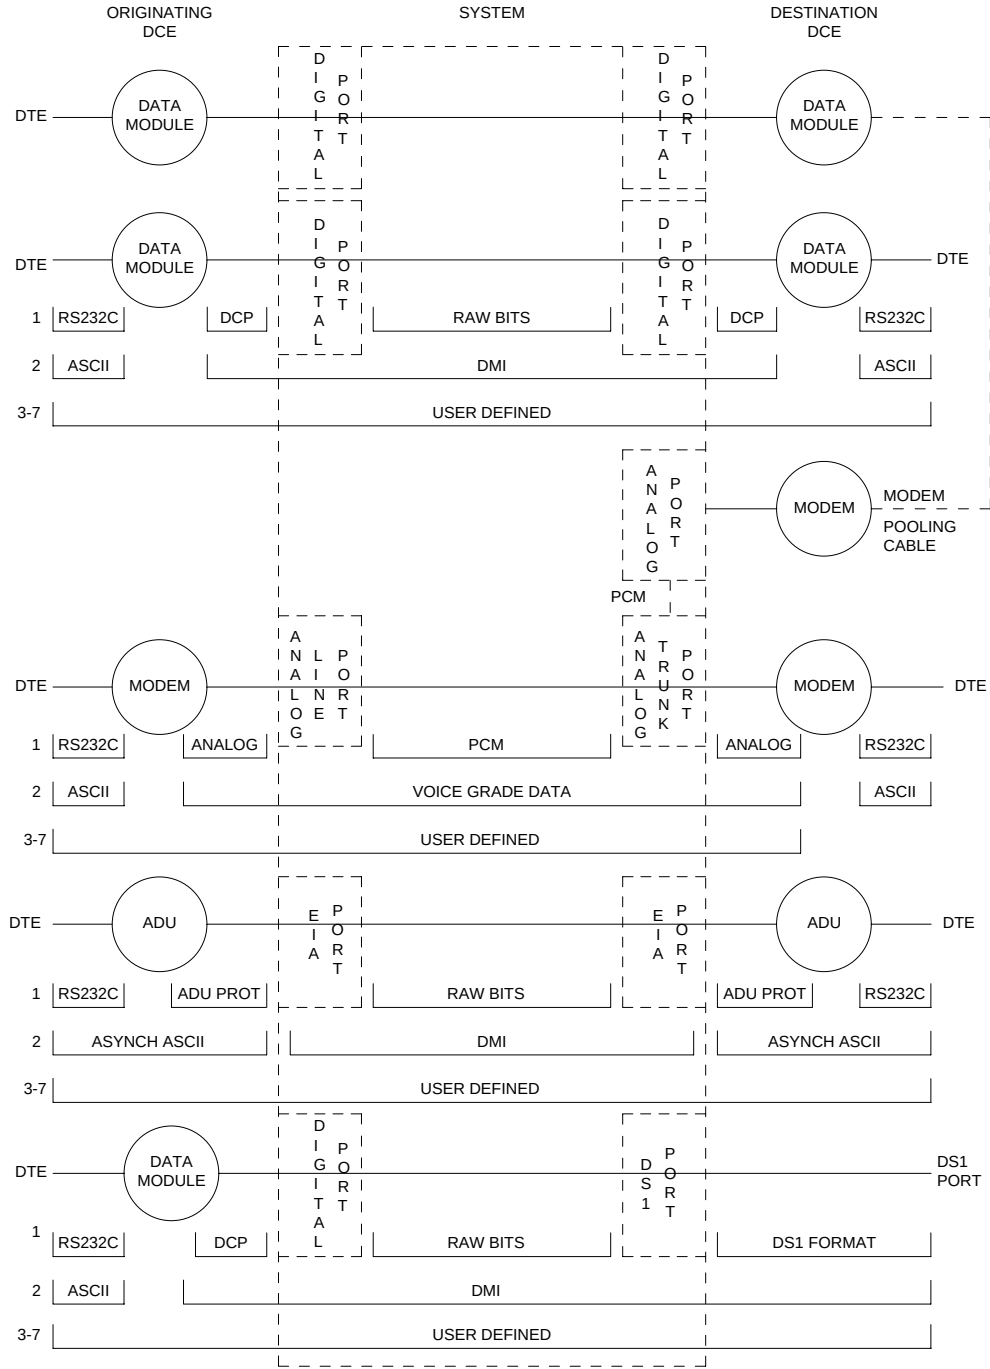
Figure 1-2. Data Transmission States

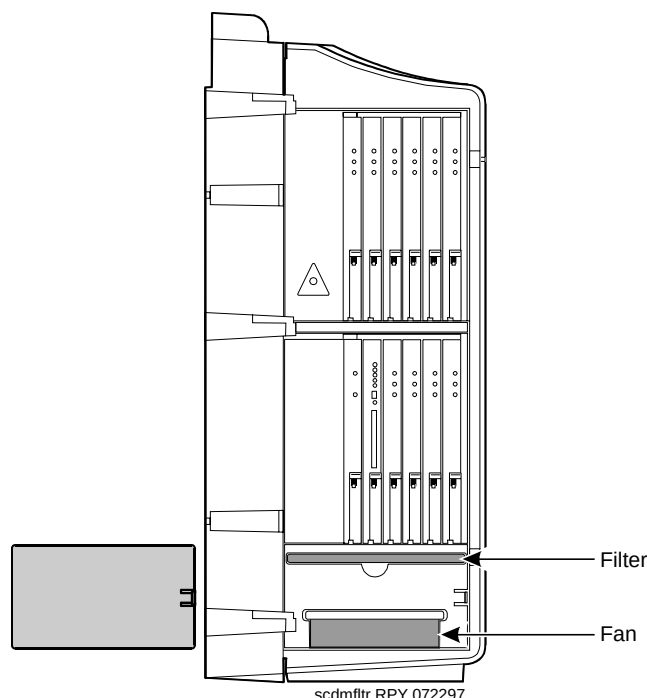
**Figure 1-3. Fan/Filter Removal**

1. Remove the left door.
2. Remove the fan/filter access panel. See [Figure 1-3](#).

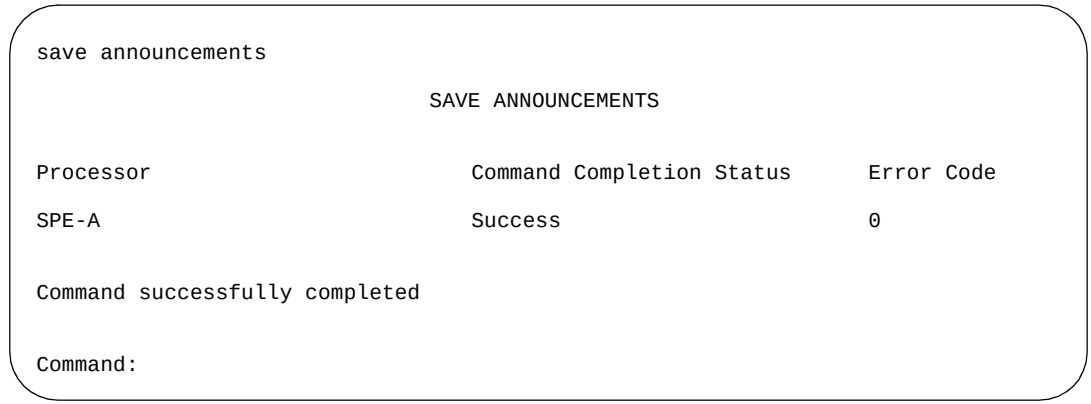
Figure 1-12. Save Announcements screen

- 4. Verify that the command successfully completes. If not, an error message appears. In such a case, refer to the “Translation Card Errors” section.
- 5. If the system is equipped with a TN750 Announcement circuit pack, the recorded announcements can be saved using the **save announcement** commands. Enter the command and press Enter. The following display appears:

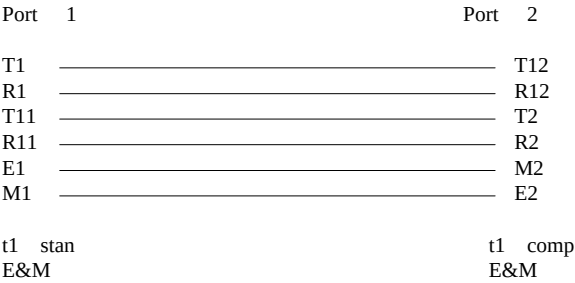
- 11. At the cross-connect field, disconnect outside trunk facilities from the Tie Trunk ports and mark the disconnected wires for later reconnecting the Tie Trunk ports back to normal operation. The D Impact Tool (AT-8762) is required to perform this step.
- 12. Use jumper wires (DT 24M-Y/BL/R/G and DT 24P-W/BRN) and the D Impact Tool to connect wiring between the two ports assigned in Step 9 at the cross-connect field. For example, if the two ports on the Analog Tie Trunk circuit pack are port 1 and 2, connect the wirings as shown below:

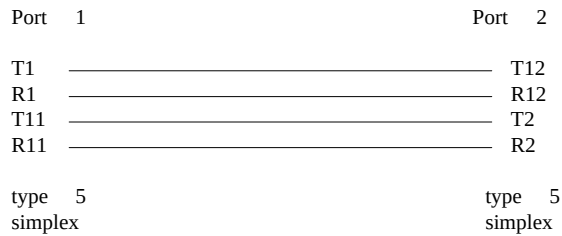
4. Locate the Tie Trunk port terminal connections at the cross-connect field.  
See [Table 1-6](#).
5. At the cross-connect field, disconnect outside trunk facilities from the Analog Tie Trunk ports and mark the disconnected wires for later when the Tie Trunk ports are placed back into normal operation. The D Impact Tool (AT-8762) is required to perform this step.
6. Use jumper wires (DT 24M-Y/BL/R/G) and the D Impact Tool to connect wiring between the two ports assigned in Step 4 at the cross-connect field. For example, if the two ports on the Analog Tie Trunk circuit pack are ports 1 and 2, connect the wirings as shown below:

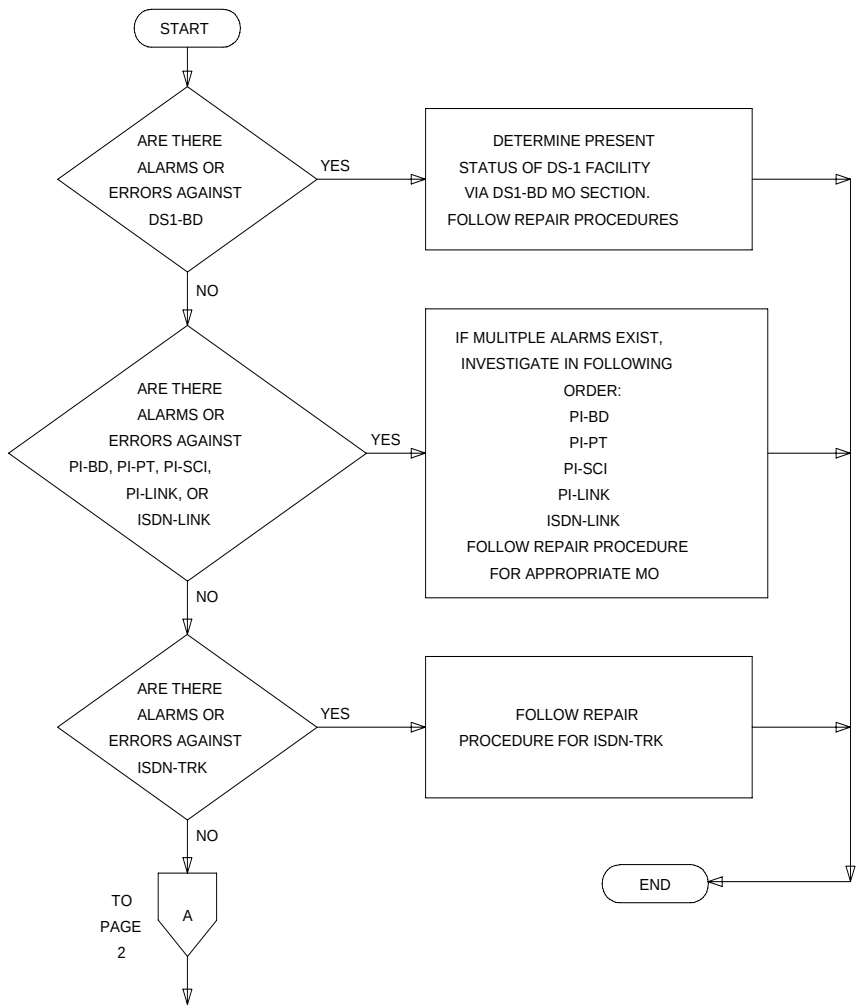
Figure 1-16. Processing of ISDN-PRI Problems (Page 1 of 2)

The following flowchart, [Figure 1-16](#) and [Figure 1-17](#), defines a layered approach when troubleshooting ISDN-PRI problems. Since a problem at a lower layer affects upper layers, layers are investigated from low to high. In the flowchart, the DS1 facility is layer 1, the TN765 Processor Interface is layer 2, and the ISDN trunks are layer 3. Transient problems are diagnosed on Page 2 of the flowchart, [Figure 1-17](#).

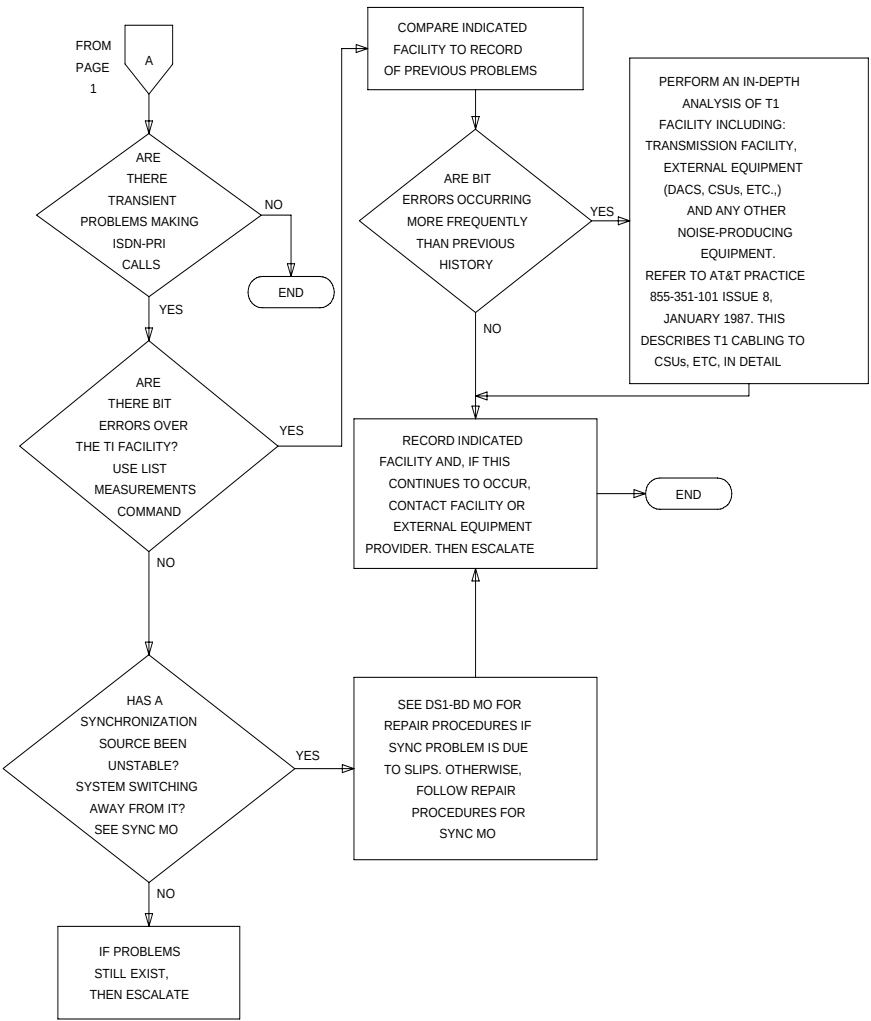
Figure 1-17. Processing of ISDN-PRI Problems (Page 2 of 2)

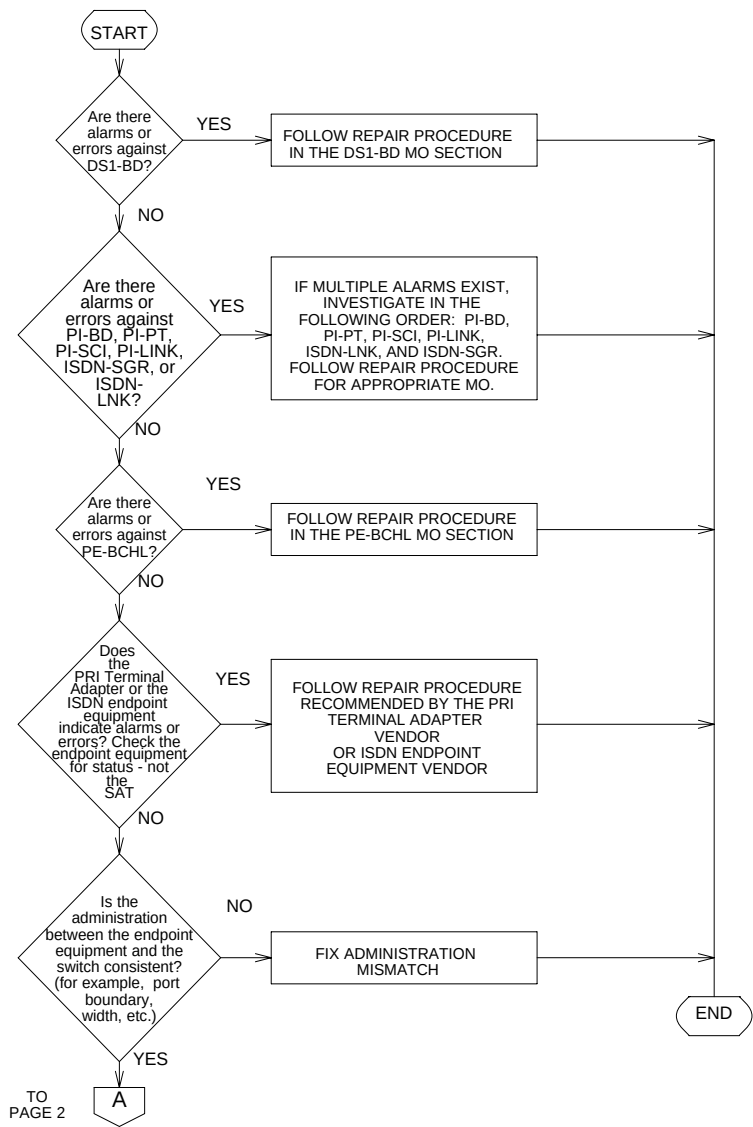
Figure 1-18. Processing of PRI Endpoint Problems (Page 1 of 2)

The following flowchart, [Figure 1-18](#) and [Figure 1-19](#), defines a layered approach when troubleshooting PRI endpoint problems. Since a problem at a lower layer affects upper layers, layers are investigated from low to high. In the flowchart, the DS1 facility is layer 1, the TN765 Processor Interface is layer 2, and the ISDN trunks are layer 3.

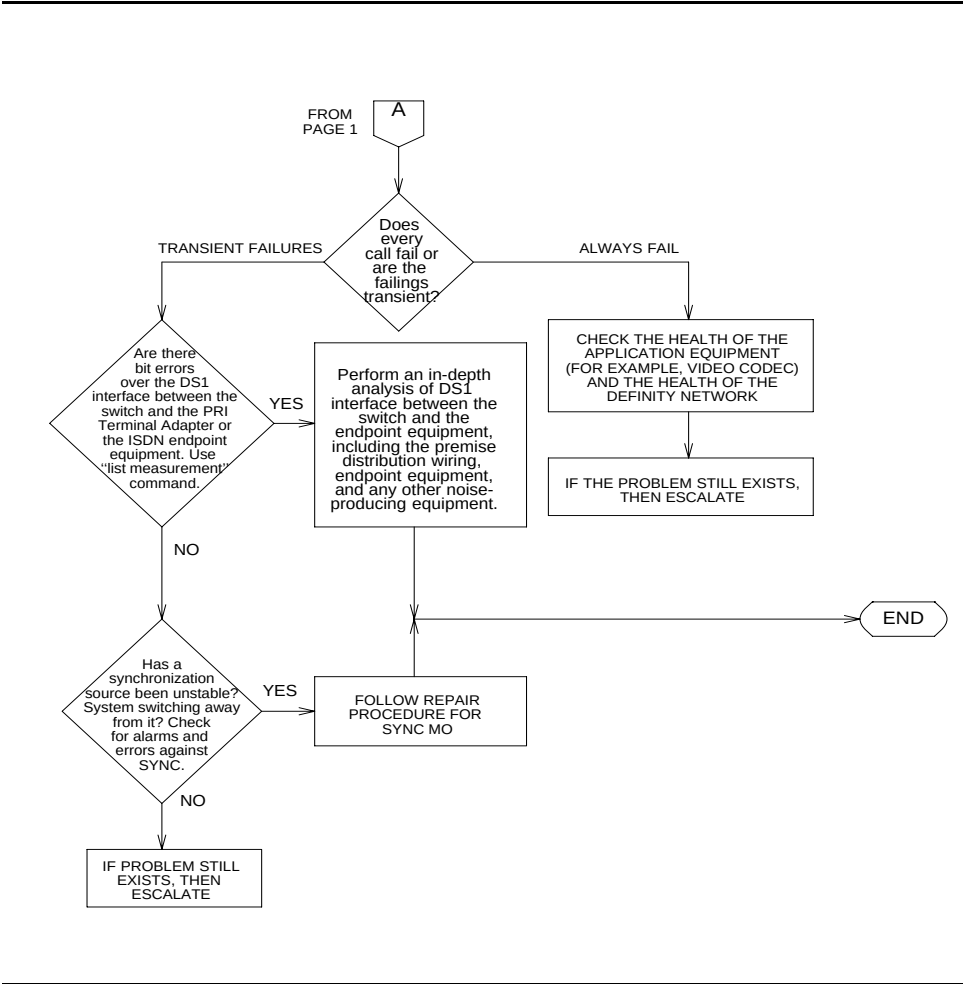
Figure 1-19. Processing of PRI Endpoint Problems (Page 2 of 2)

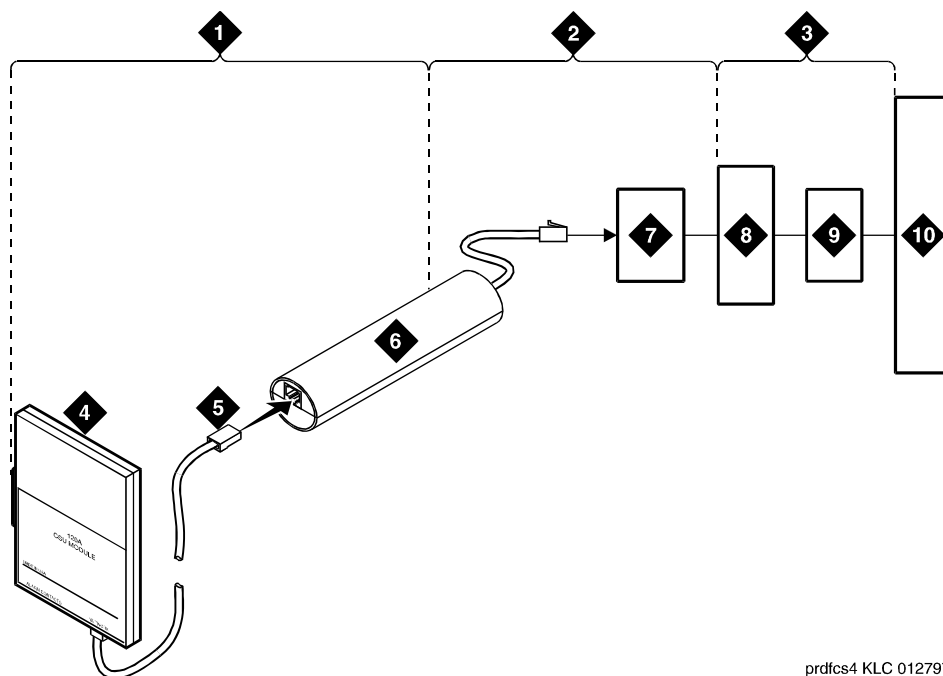
**Figure 1-22. Network Interface at Extended Demarcation Point (Smart Jack Inaccessible)**

1. If there is no extended demarcation point, install the loopback jack directly at the network interface point as shown in [Figure 1-21](#).
2. If there is an extended demarcation point and the Smart Jack is not accessible, install the loopback jack as shown in [Figure 1-22](#).
3. If there is an extended demarcation point, but the Smart Jack is accessible, install the loopback jack as shown in [Figure 1-23](#).

Fiber MUXes can take the place of Interface termination feeds as shown in [Figure 1-21](#), [Figure 1-22](#), [Figure 1-23](#), and [Figure 1-24](#). Test these spans using the same procedures as metallic spans. Note the following points:

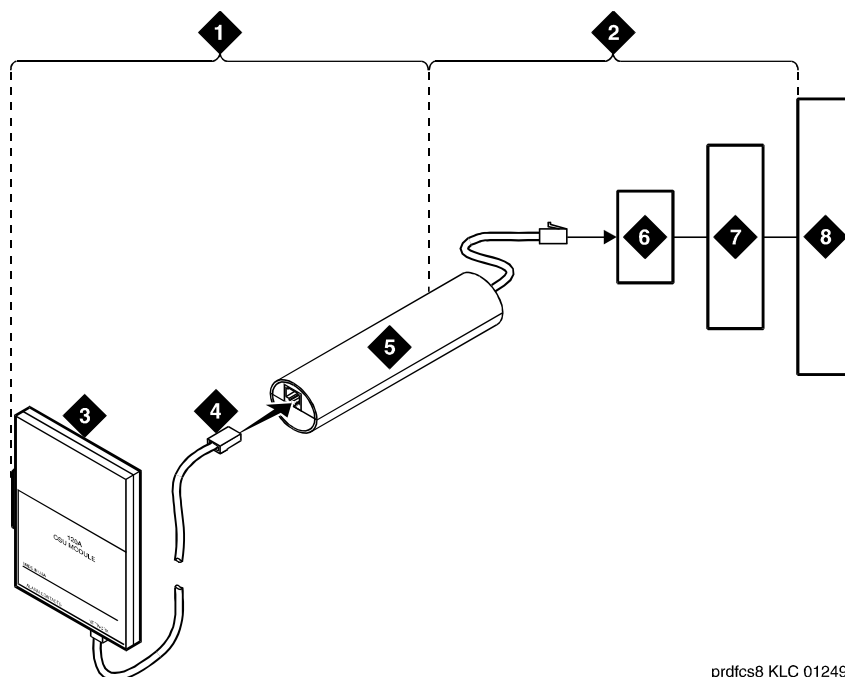
**Figure 1-24. Network Interface at "Dumb" Block**

1. Install the loopback jack at the point where the cabling from the ICSU plugs into the “dumb” block. If there is more than one “dumb” block, choose the one that is closest to the Interface Termination feed or the fiber MUX. This provides maximum coverage for loopback jack tests. Refer to [Figure 1-24](#) and [Figure 1-25](#).

When the loopback jack is added to a span that does not contain a Smart Jack, the span is divided into 2 sections. See [Figure 1-24](#) and [Figure 1-25](#).

1. Test customer premises wiring (section 1 in [Figure 1-24](#)) from the ICSU to the loopback jack as described in the "DS1 Span Test" section.
2. Test the loopback jack-to-"dumb" block and "dumb" block-to-CO wiring (section 2 in [Figure 1-24](#)). This can be done using a loopback that "overlaps" the section of the span. Any of the following loopbacks can do this:

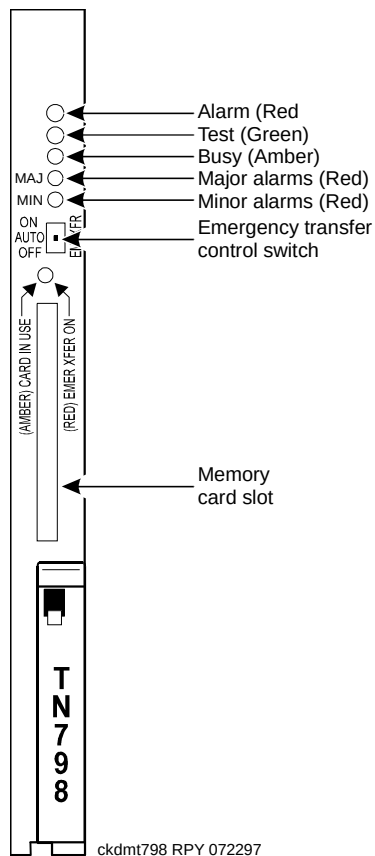
Figure 1-26. LED Indicators on the TN798 Processor Circuit Pack

**NOTE:**  
If the LED just above the Memory Card Slot is alternating red and amber, this indicates both card in use and emergency transfer.

The front panels of the Processor circuit pack and the Maintenance circuit pack are identical. Each has two groups of LEDs. One group indicates the status of the pack, and the other group (which includes the Major, Minor, and Warning alarms described in the [“Alarm and Error Reporting”](#) section) reflects maintenance conditions in the entire system. See [Figure 1-26](#).

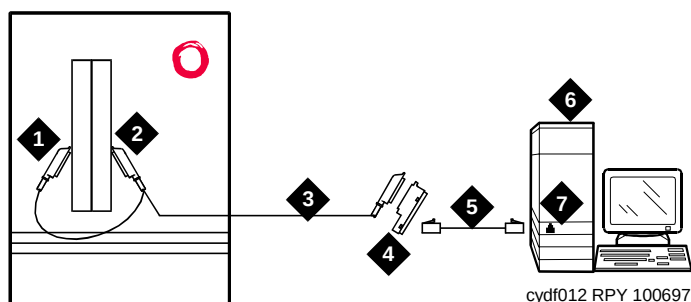
1. Port B Y-cable connector to a TN787 Multimedia Interface (MMI) circuit pack
2. Port A Y-cable connector to a TN2207 PRI circuit pack
3. 25-pair Y-cable
4. 356A adapter
5. D8W cord connected to 356A adapter port 1
6. Expansion Service Module (ESM)
7. Port B on compatible primary rate interface (PRI) card

Figure 1-27. Typical ESM connections

The Expansion Services Module (ESM) shown in [Figure 1-27](#) provides T.120 data sharing capability on a MMCH multipoint H.320 video conference. Each conference participant must have endpoints administered and a personal computer with the H.320 video application installed. The DEFINITY ECS must have the expansion service module installed.

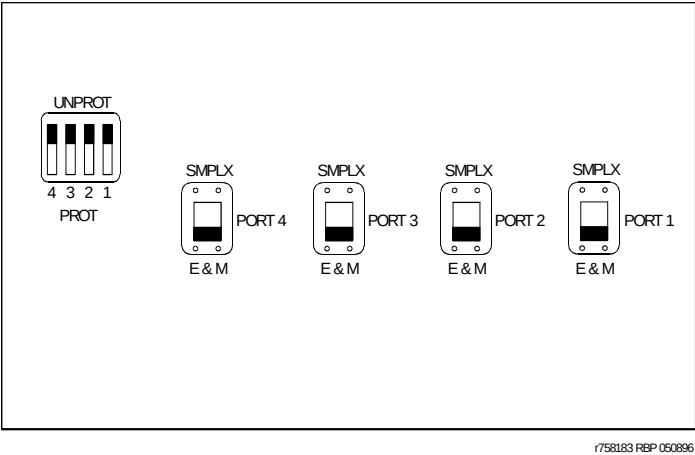
Figure 1-28. TN760D Tie Trunk Circuit Pack (Component Side)

To choose the preferred signaling format ([Table 1-10](#) and [Table 1-11](#)), set the switches on the TN760D and administer the port using [Figure 1-28](#) and [Table 1-12](#).

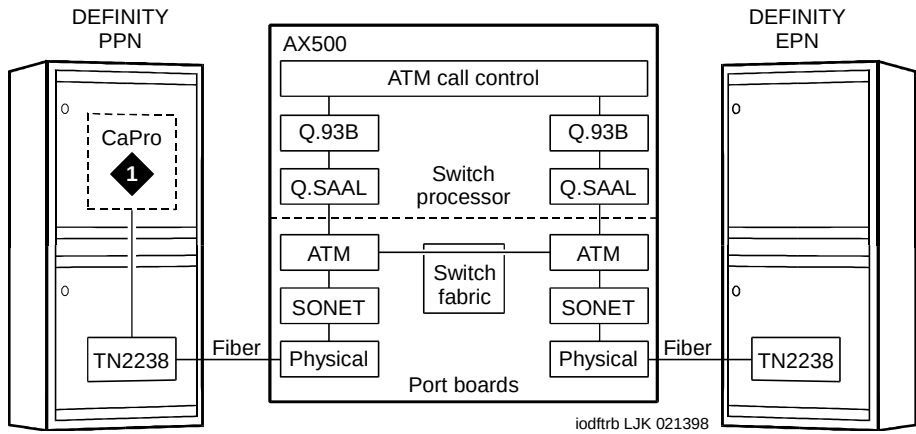
Figure 1-30. ATM troubleshooting schematic

**NOTE:**  
The CaPro element (Note 1 in [Figure 1-30](#)) is a software module within the DEFINITY PPN.

This section provides tips for DEFINITY ATM PNC when interfacing with the ATM switch. Throughout this section, refer to [Figure 1-30](#), using *TN2238* for R6.3 systems, and *TN230X* for Release 7 and later.

In the ATM PNC configuration, the proprietary Center Stage Switch (CSS) is replaced by the ATM network. Since the CSS switch nodes are replaced by the ATM network in the ATM PNC configuration, the SNI boards are no longer needed. In place of SNI board, the ATM EI boards are connected to an ATM switch port over a fiber optic cable. The port on the ATM switch is under the control of ATM switch maintenance software. Refer to [Figure 1-30](#) in the “[ATM Tips](#)” section in Chapter 1 for a schematic of these connections.

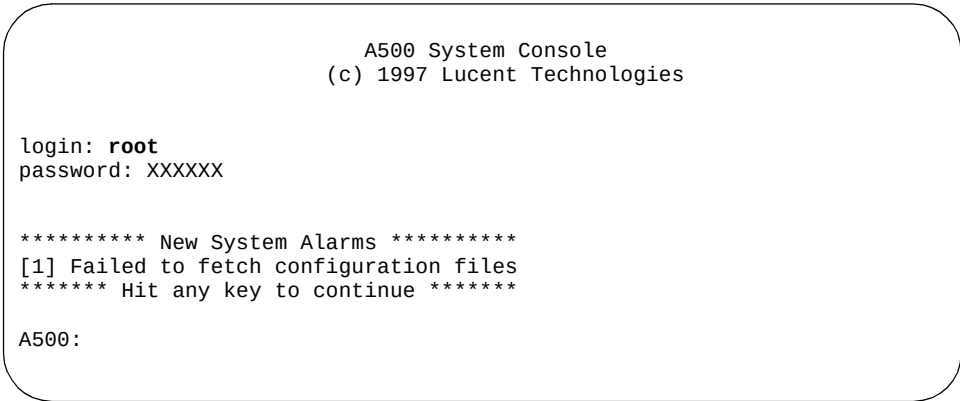
Figure 1-31. A500 login screen

- Are any A500 yellow fault LEDs lit?
- Are the remaining A500 LEDs in a normal state ([Table 1-15](#) above)?
- Can you log into the A500 console using the diagnostic account **root** from the local console terminal or through telnet? (See [Figure 1-31](#) below.)

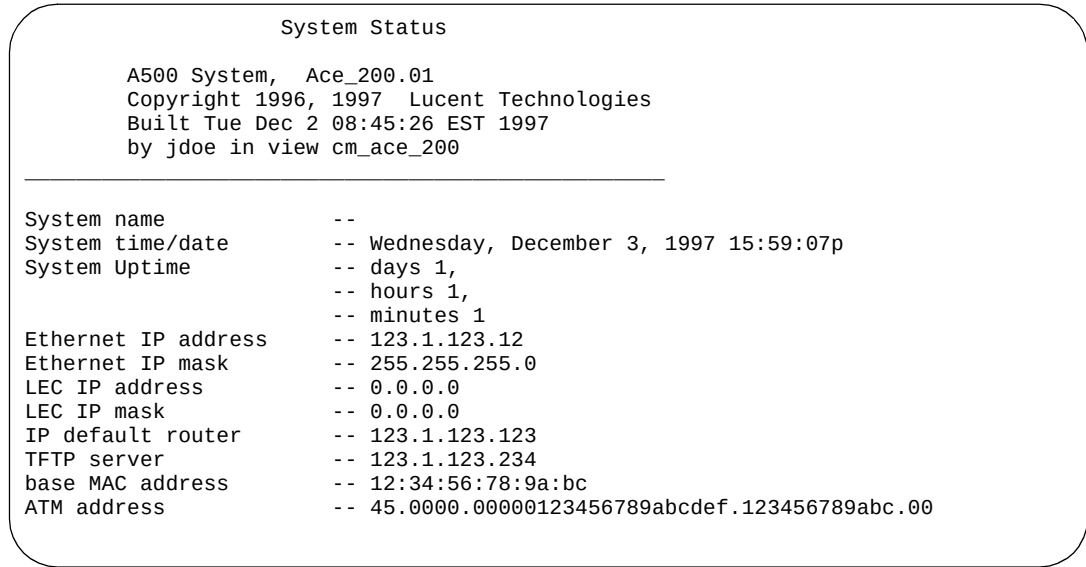
Figure 1-32. A500 screen output for status command

5. Enter **status** at the A500: prompt. [Figure 1-32](#) shows the output from the status command.

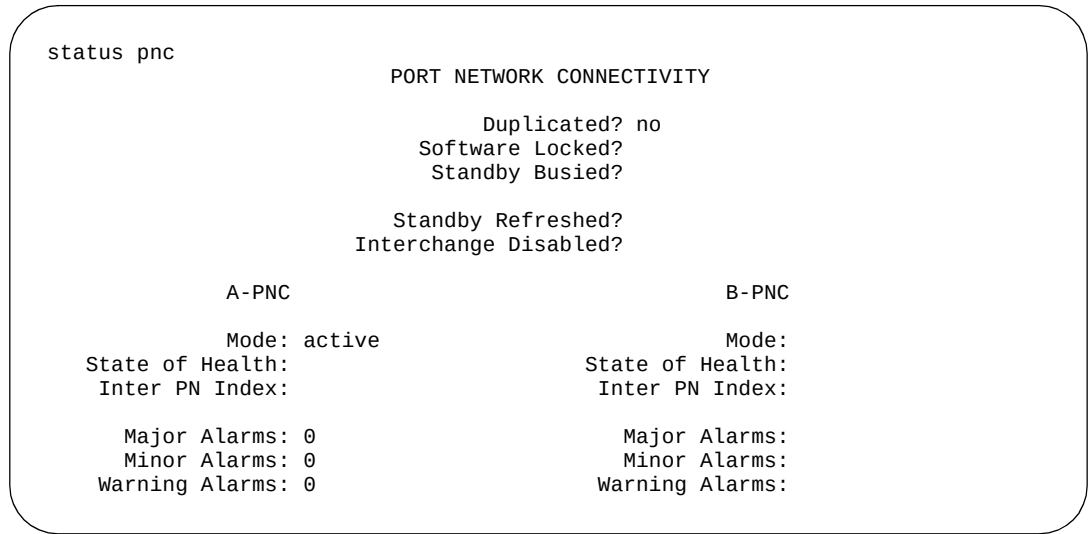
Figure 1-34. Screen output for status pnc command

2. Enter **status pnc** at the DEFINITY SAT. This display tells you which TN230X board is active in a duplicated system and how many alarms (if any) of each severity level have been logged for the board. [Figure 1-34](#) shows the output from this command.

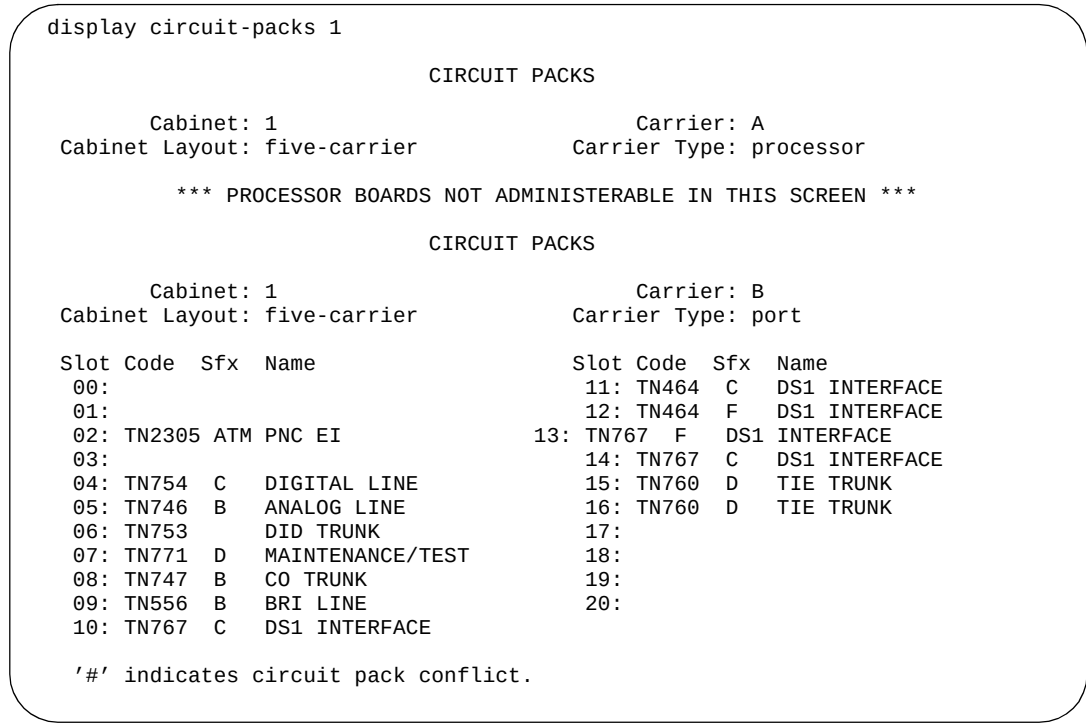
Figure 1-35. Screen output for display circuit-packs 1

3. Enter either **list configuration UUC** (for the carrier in which the ATM-EI packs reside) or **display circuit-packs cabinet** (non-control cabinet) at the DEFINITY SAT. This command tells you in more detail what boards are in which slots in each cabinet and carrier. Verify that the TN230Xs are physically located in the slots indicated on the display. [Figure 1-35](#) shows the output for the **display circuit-packs 1** command; [Figure 1-36](#) shows the output for the **display circuit-packs 2** command.

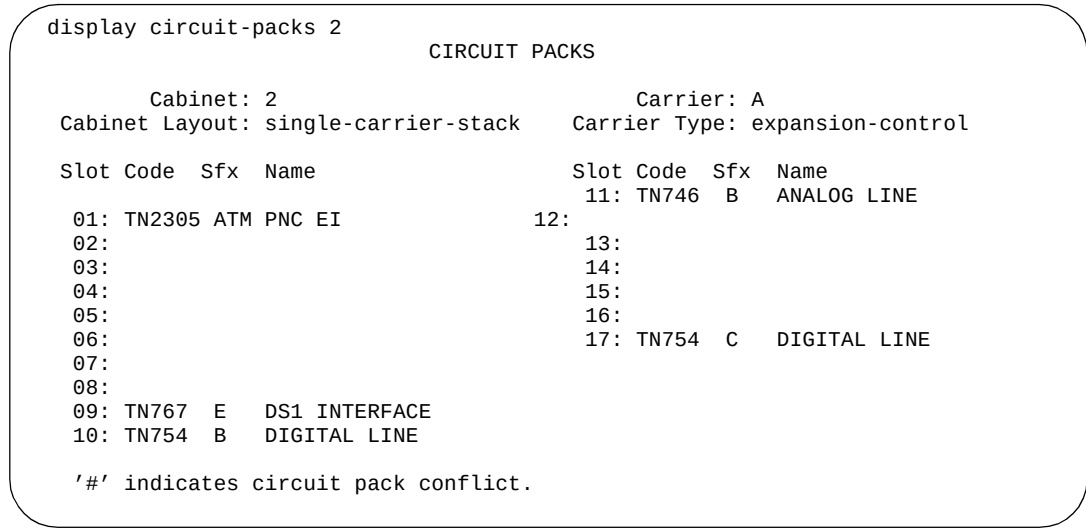
Figure 1-36. Screen output for display circuit-packs 2

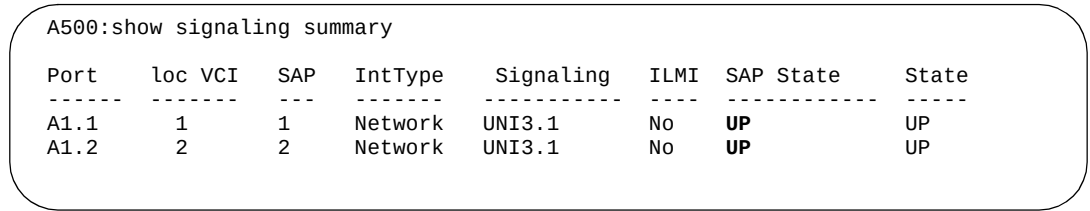
Figure 1-41. Screen output for the show signaling summary command

- a. If an A500 port to which a DEFINITY port network is attached is not listed in this display, it is likely that the port was administered incorrectly as having no UNI signaling (**admin link** command).

1. Enter **show signaling summary** on the A500 console. [Figure 1-41](#) shows the screen output.

| Field | Value |
|---|---|
| SAP State | May or may not be UP. Their values depend on more than just whether the port was marked as <b>UP</b> . (See highlighted data for SAP State in <a href="#">Figure 1-41</a> .) |

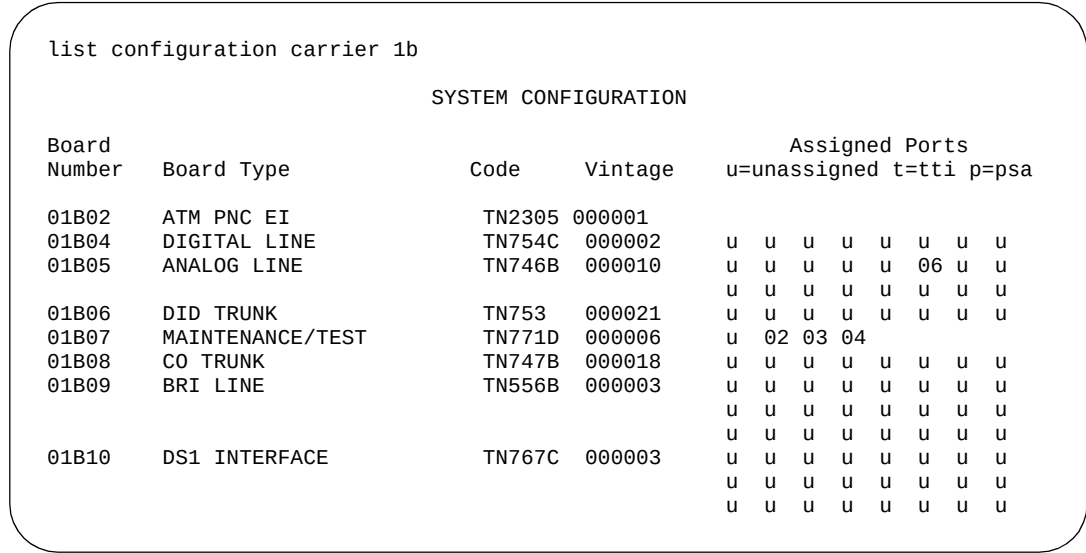
Figure 1-45. List configuration carrier 1b screen

1. Review the LED conditions for the TN230X:
  - Do the TN230X LEDs (see [Table 1-14](#)) indicate a normal operational state (any of the following):
    - Active in the PPN
    - Standby in the PPN
    - Archangel mode in the EPN
    - Standby in the EPN?
2. If after board insertion or a demand reset:
  - Do the TN230X LEDs indicate that it is booting?
  - Do the TN230X LEDs indicate it is downloading its DSPs?
  - Do the TN230X LEDs indicate that board insertion has not yet occurred?
  - Do the TN230X LEDs indicate a maintenance alarm?
3. Enter **list configuration carrier *cabinetcarrier*** on the DEFINITY SAT. See [Figure 1-45](#) (1b) and [Figure 1-46](#) (2a) below.

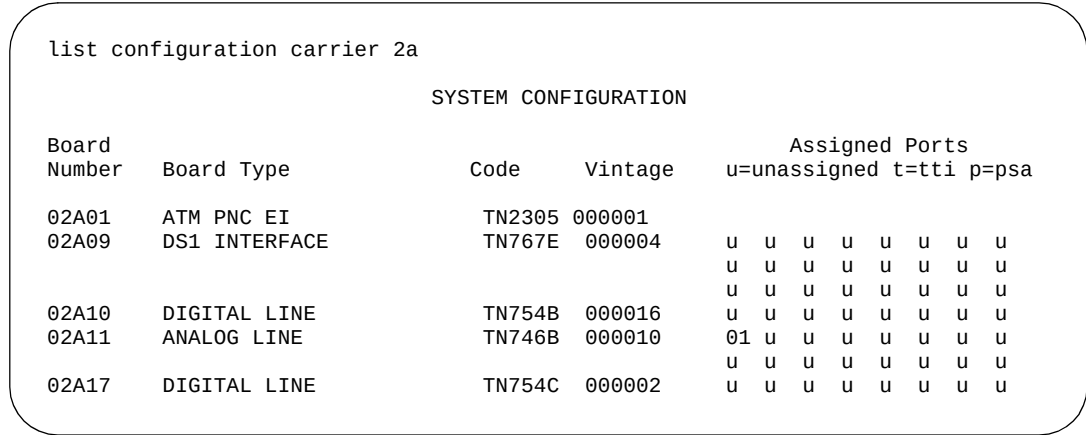
Figure 1-46. List configuration carrier 2a screen

- The TN230X board should be shown in the correct slot.
- Fields should have values as indicated below:

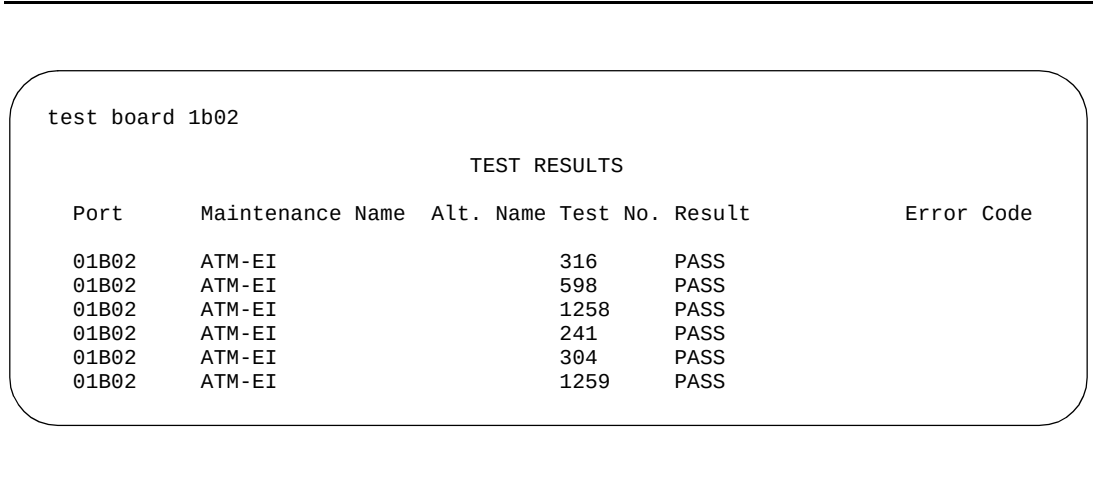
Figure 1-47. Screen output for the test board 1b02 command

- The Result should be PASS for each test number. If the any of the tests fail, refer to [“ATM-BCH \(ATM B-Channel Trunk\)”](#).

4. If the TN230X is inserted and shows a vintage number, enter **test board cabinetcarrierslot** for this board on the DEFINITY SAT, as shown in [Figure 1-47](#) (1b02) and [Figure 1-48](#) (2a01).

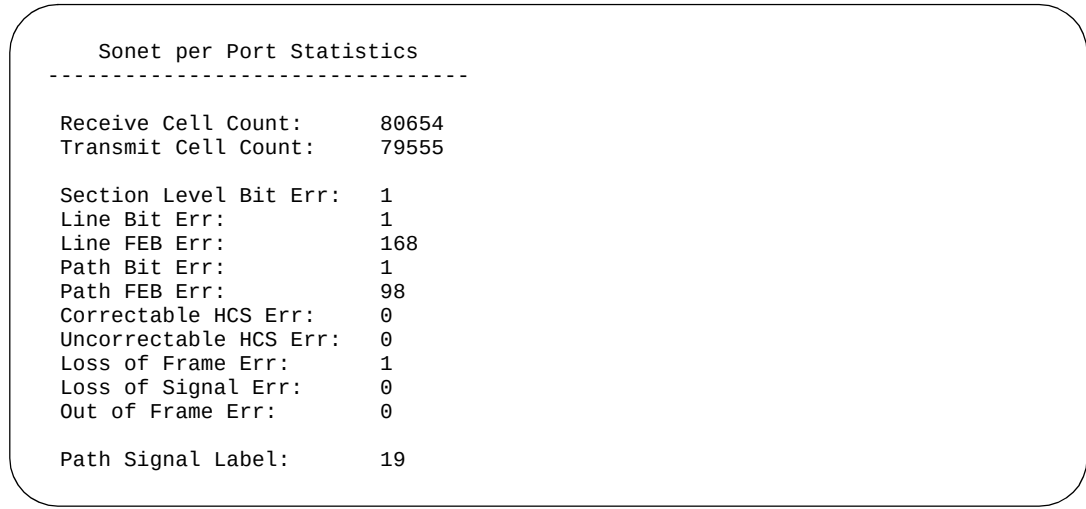
Figure 1-51. A500: show stats sonet a1.2 screen

1. Enter **show stats sonet *port*** on the A500 console. [Figure 1-51](#) shows the screen output.

The following examples point to port A1.2 as the port of interest.

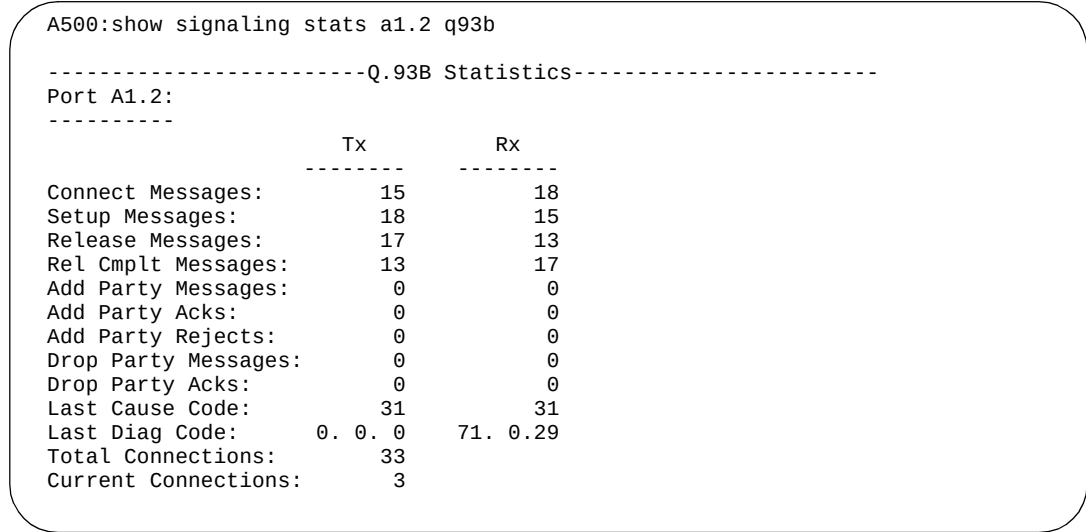
Figure 1-53. A500:show signaling stats A1.2 q93b

1. Enter **show signaling stats port q93b** (or the port of interest) on the A500 console. [Figure 1-53](#) shows the screen output.

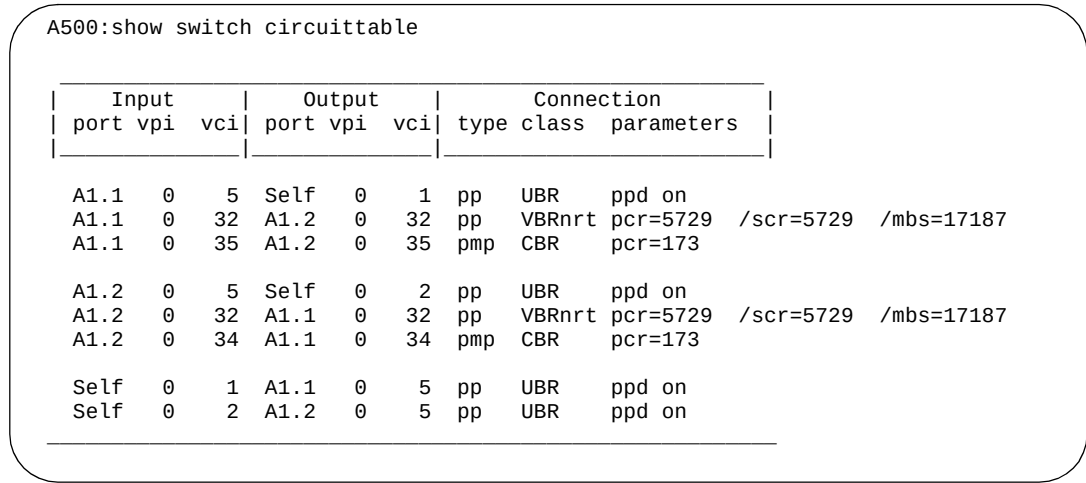
Figure 1-57. A500: show switch circuittable screen

1. Enter **show switch circuittable** on the A500 console. [Figure 1-57](#) shows the screen output.

- The pp UBR virtual circuits between A500 ports A1.1 (PPN) and Self (A500) and between A1.2 (EPN) and Self (A500) are ATM signaling channels between the port network and the A500.
- They are used to request connection setups and releases to other end points such as another port network.
- These are established by each TN230X when it comes up, independent of DEFINITY Call Processing.
- Other UBR virtual circuits may exist between A500 ports that are not associated with DEFINITY port networks and may be signaling channels for other applications (for example, data network traffic).

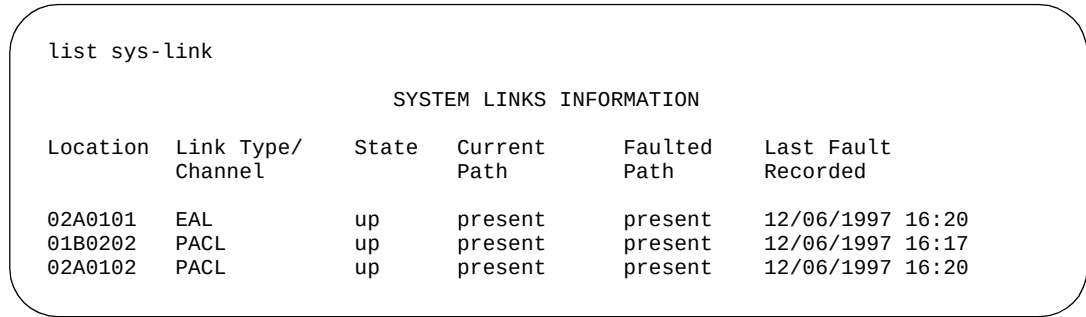
Figure 1-58. List sys-link screen

- Do you get a dial tone on a set on the port network in question?
  - Can you ring a set on the EPN dialing from the PPN and vice versa?
1. Enter **list sys-link** on the DEFINITY SAT. [Figure 1-58](#) shows the screen output.

Ensure that the fields have the values indicated below.

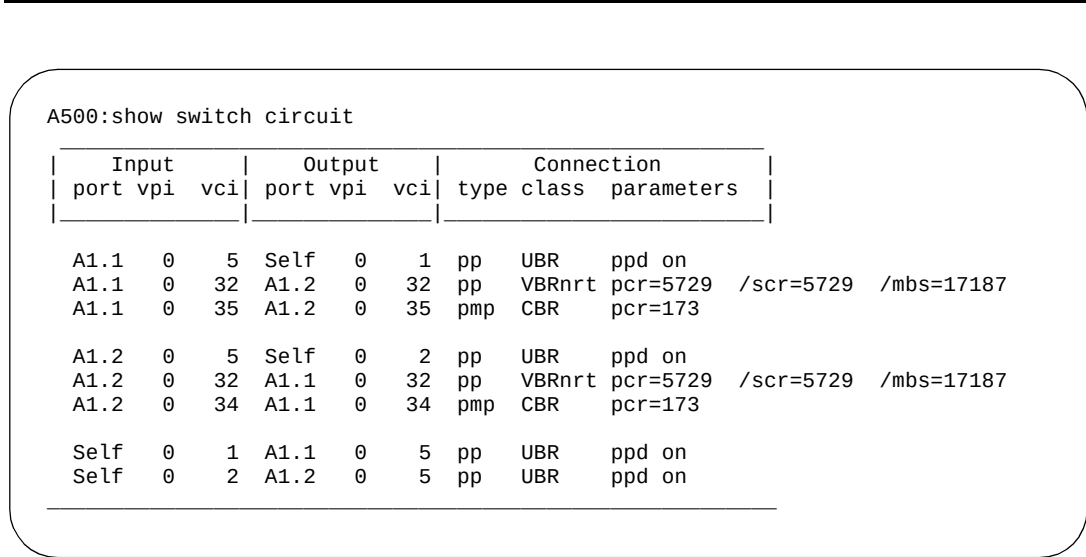
Figure 1-59. A500: show switch circuit screen

2. Enter **show switch circuittable** on the A500 console. [Figure 1-59](#) shows the screen output.

- The pp VBRnrt (Variable Bit Rate) virtual circuits between A500 ports A1.1 (PPN) and A1.2 (EPN) are used for signaling between the PPN and each EPN.
- These are established once upon initialization under control of DEFINITY Call Processing. They represent the ATM Control Link (ACL) and Expansion Archangel Link (EAL).
- VBRnrt virtual circuits are also be used for ISDN channels between Definity port networks.
- Other VBRnrt virtual circuits may exist between A500 ports that are not associated with DEFINITY port networks. A common use of VBRnrt circuits is multimedia and video-conferencing systems.

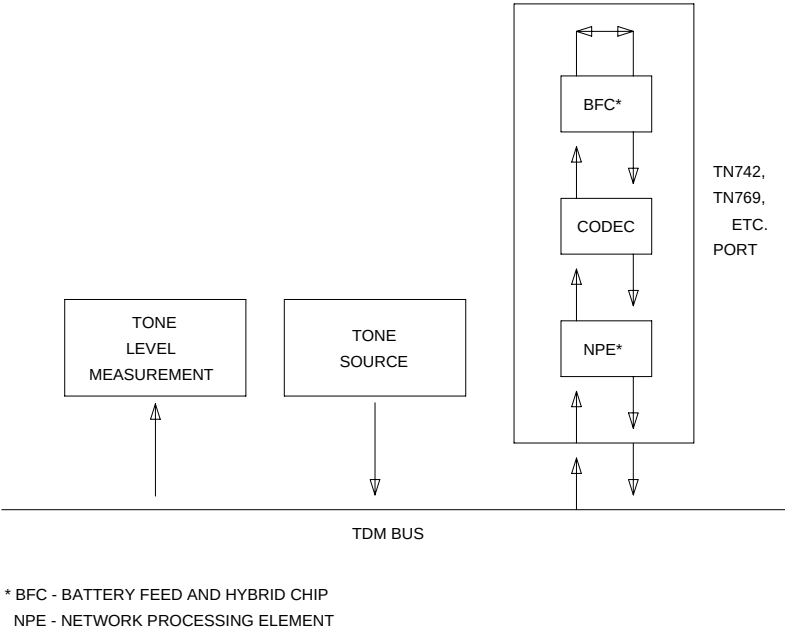
This Loop Around Test is sensitive to the length of the loop, the equipment in the loop, or the equipment terminating the loop, such as off-premises stations. If this test is causing a false alarm, then disable the test by changing the Tests field to "no" using the **change station** command for this station.

Figure 3-1. Analog Loop Around and Conference Test

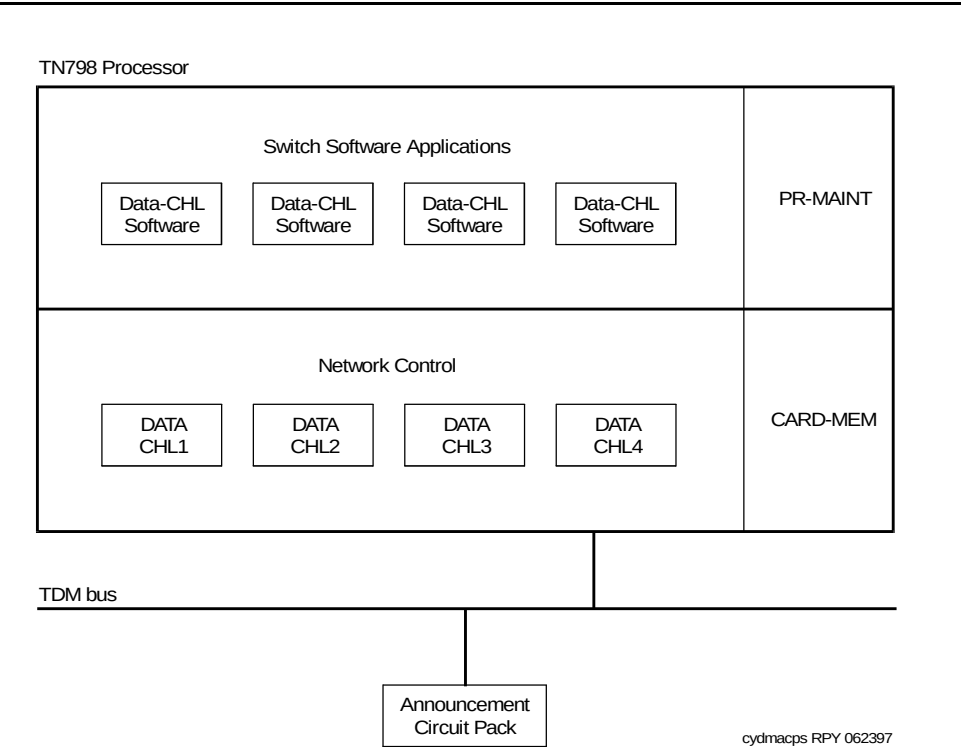
[Figure 3-2](#) shows the connection of the Announcement Circuit Pack to the system. To save or restore announcements, an ANNOUNCEMENT Data Extension must be administered, and at least one DATA-CHL (Network Control Data Channel) must be in the in-service/idle state.

Figure 3-2. Connection of announcement circuit pack to the system

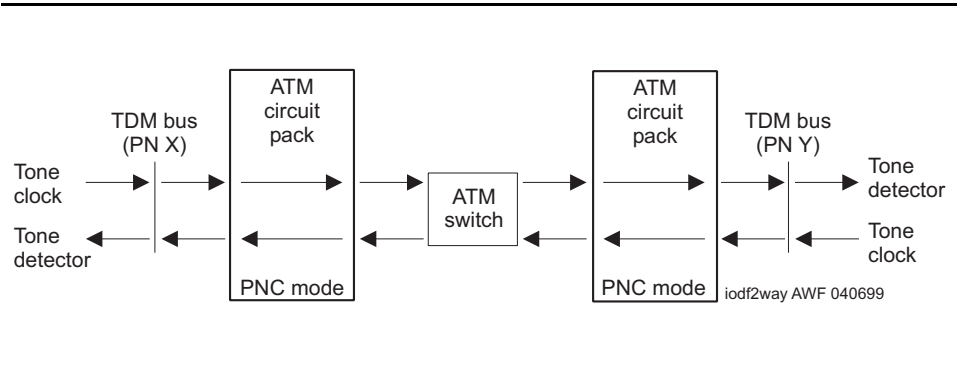
In this test the second ATM-EI may be in any port network outside the port network of the ATM-EI under test. Therefore if the test should fail in any direction, the test is repeated with a different port network, if available, which aids the fault isolation procedure.

The test results indicate if the test failed in one or both directions. The test aborts if the ATM-EIs do not exist on both ends (for example, the EIs are not administered correctly). If the test passes, the TDM and ATM framer interfaces of both ATM-EIs are functioning properly. If the test fails, a series of tests are run on the board. [Figure 3-3](#) shows a schematic of this test.

**Figure 3-3. Expansion Interface 2-Way Transmit Test #241**  
PN X and PN Y represent any of 43 possible port networks.

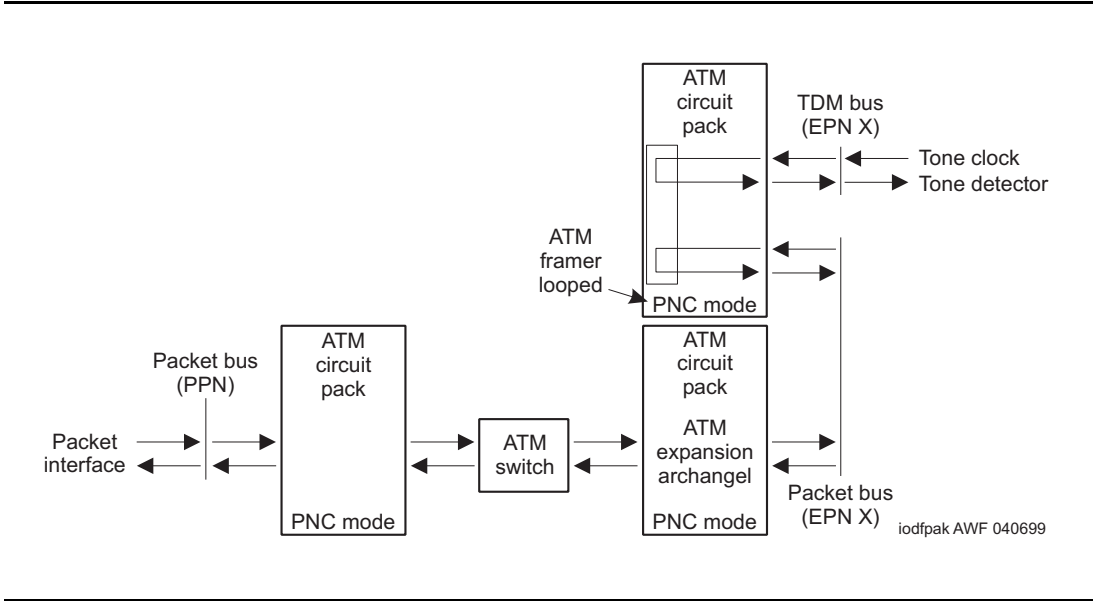
- **Packet path:** the Packet Interface circuit pack sends packet data to the ATM framer interface, where it is mapped into ATM cells and then looped around internally. The cells are converted back to packet data after it has been looped. This portion of the test verifies correct operation of the ATM-EI's Packet bus interface and a large portion of the ATM-EI's packet paths. [Figure 3-6](#) shows the packet switched signal path for the ATM circuit pack.

**Figure 3-6. ATM Board Framer Looparound Test (#1260)**  
**(non-EAA, Packet Path)**
