**DEFINITY®**

# **Enterprise Communications Server**

Release 8.2

Maintenance for R8.2csi

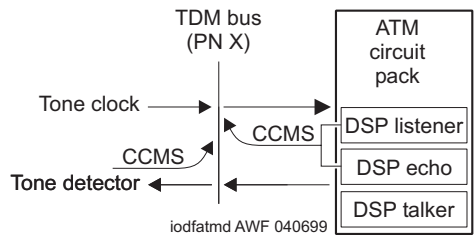
If the test fails for all DSPs, a MAJOR alarm is raised against the board. If the test fails for one or more DSPs, a MINOR alarm is raised. If a DSP is “busy,” the test for that particular DSP is considered passed. The test aborts if the system resources (for example, the TDM time slots, tone generator, and others) are not available.

This test applies to TN2305 and TN2306 ATM-EIs, both active and standby, and is run as part of craft short and long testing, periodic, scheduled, initialization, and error analysis testing. Refer to [Figure 3-8](#) for a diagram of this looparound test.

Figure 3-8. ATM Board DSP Test (#1293)

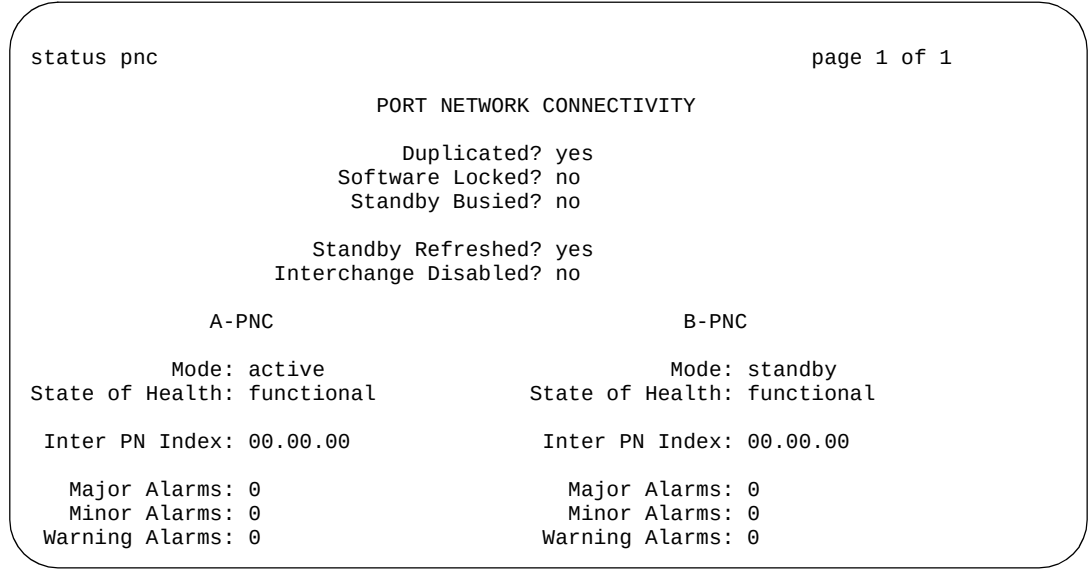
Figure 3-9. Status PNC screen with standby PNC fully In-Service

PNC-DUP software monitors the health of the two PNCs as determined by their state of health (SOH) vectors, and initiates an interchange when the health of the active falls below that of the standby (unless prevented from doing so by a PNC lock, busyout, or antithrashing mechanism). Potentially service-disrupting faults that occur in PNC components are reported to PNC-DUP and incorporated in the state of health for the affected PNC. The SOHs of both PNCs are displayed on the **status pnc** screen, as shown in [Figure 3-9](#).

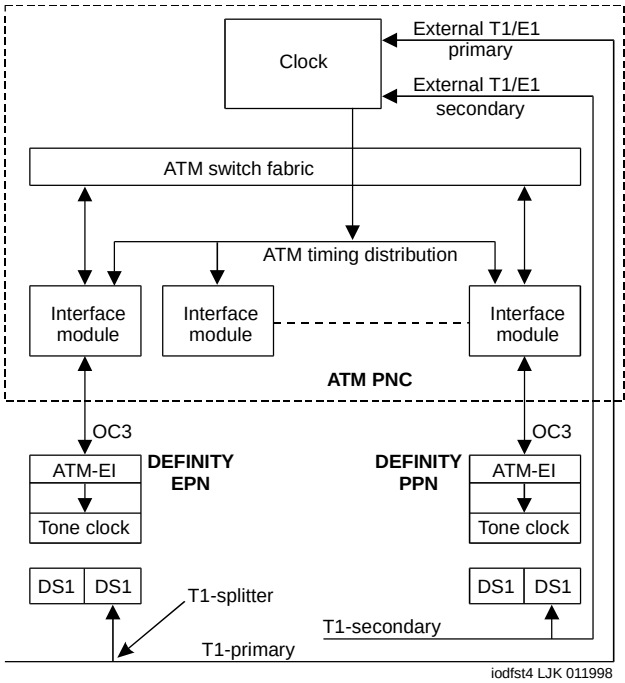
[Figure 3-10](#) depicts a simplex ATM PNC with T1/OC3 synchronization reference into the ATM switch.

Figure 3-10. Stratum 4 synchronization with simplex ATM PNC

**NOTE:**  
The TN722 DS1 Interface circuit pack does not provide a synchronization reference as reliably as the TN767 or TN464C circuit packs. Therefore, administer the TN767 or TN464C circuit packs as the primary or secondary sources.

If the primary synchronization reference in [Figure 3-10](#) is providing a valid timing signal, then the flow of system synchronization would travel from the DS1 interface circuit pack in the EPN to the ATM switch. The primary DS1 interface circuit pack provides a timing signal for the ATM switch clock circuitry.

If the primary synchronization reference is not providing a valid timing signal, the system automatically switches to the secondary synchronization reference. If the primary synchronization reference is invalid, and if the secondary reference does not provide a valid timing signal or is not administered as a synchronization reference, the switch infers that the local oscillator of the ATM switch provides the system timing source. If the system is using the local oscillator of the ATM switch as the system timing source because the primary and secondary references are providing invalid timing signals, when either the primary or secondary reference becomes valid again, the system switches back to the primary or secondary source. When both the primary and secondary source become valid, the system switches to the primary source, since the primary source is always preferred over the secondary source when both sources are equally healthy.

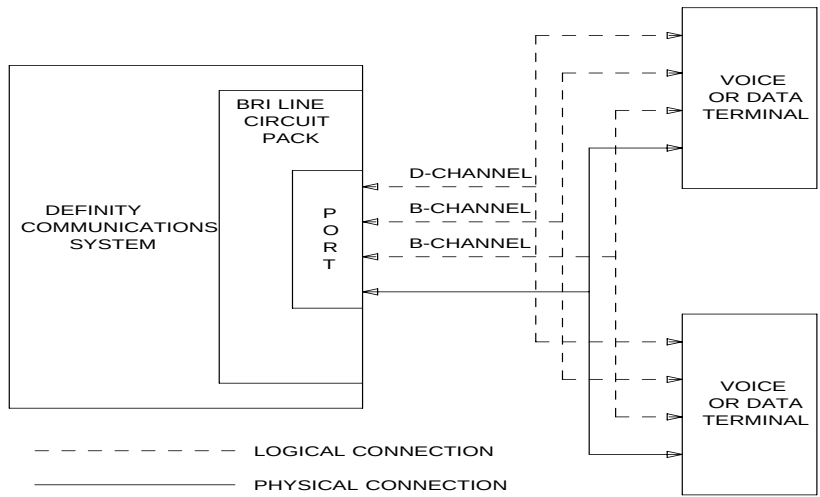
[Figure 3-11](#) illustrates the physical connection (solid line) between an ISDN-BRI Port and its associated ISDN-BRI set(s). Each physical connection allows for two B-channels and one D-channel. Each ISDN-BRI circuit pack can support up to 12 of these *physical* connections to different voice and voice/data sets or ASAI or Lucent adjuncts. On a TN2198 each ISDN-BRI circuit pack can support up to 12 *physical* connections to a NT1, which, in turn, connects to 2 terminals.

Figure 3-11. ISDN-BRI Port Interactions

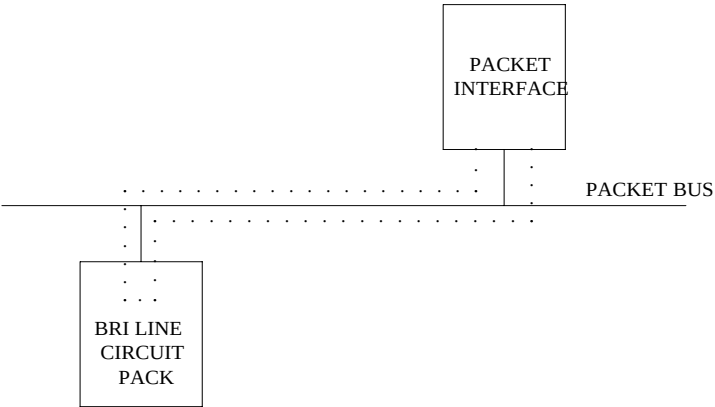
The dotted lines in [Figure 3-12](#) show how a Loop Around Test is performed across the Packet Bus for the D-channel.

Figure 3-12. Path of the BRI Port Local LAN Loop Around

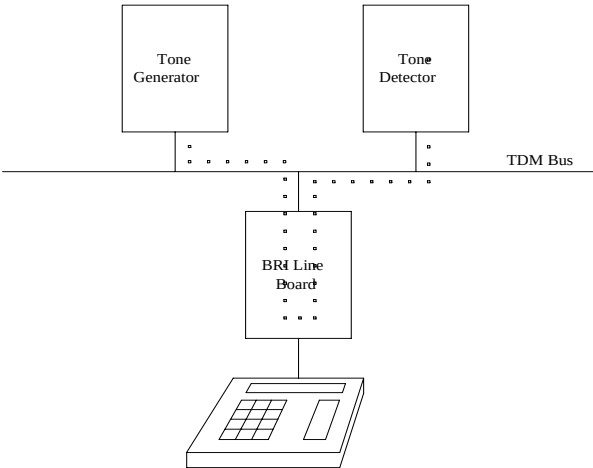
The dotted lines in [Figure 3-13](#) show how a Loop Around Test is performed for the B-channels. The figure shows a terminal connected to a BRI line board using a TN556. If a TN2198 is used, the terminal would be connected to a NT1, and the NT1 to the BRI board.

Figure 3-13. Path of the BRI Port Local TDM Loop Around

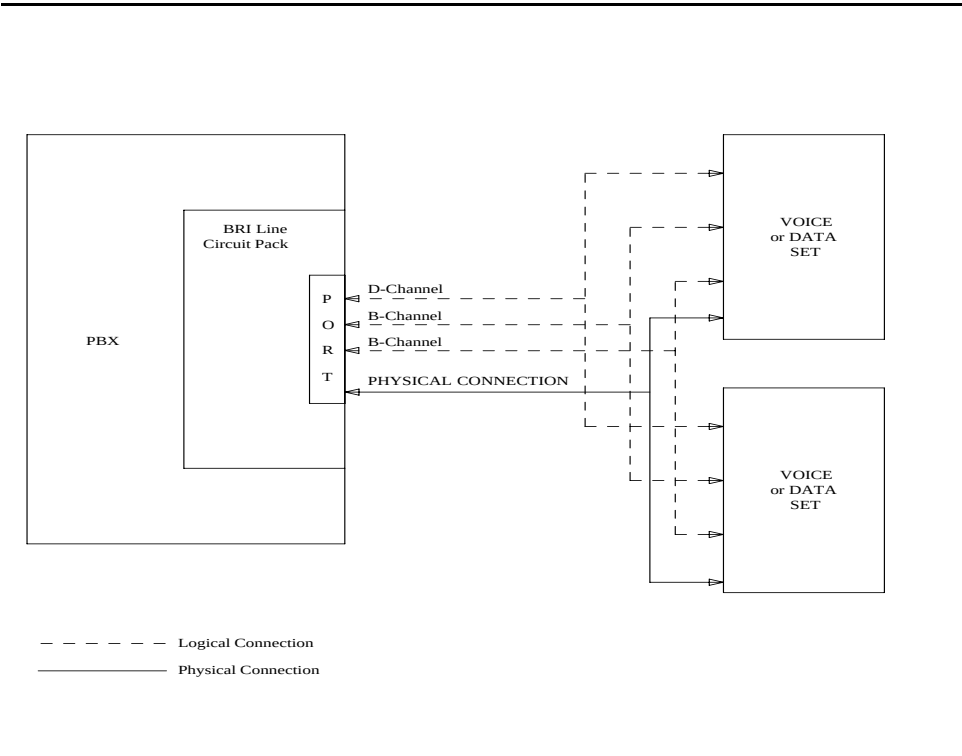
[Figure 3-14](#) illustrates the physical connection (solid line) between an ISDN-BRI Circuit Pack and a voice or voice/data set. Each physical connection allows for two B-channels, as stated above, plus one D-channel. Each ISDN-BRI circuit pack can support up to 12 of these PHYSICAL connections to different voice and voice/data sets or ASAI and Lucent adjuncts.

**Figure 3-14. ISDN-BRI Set Interactions**

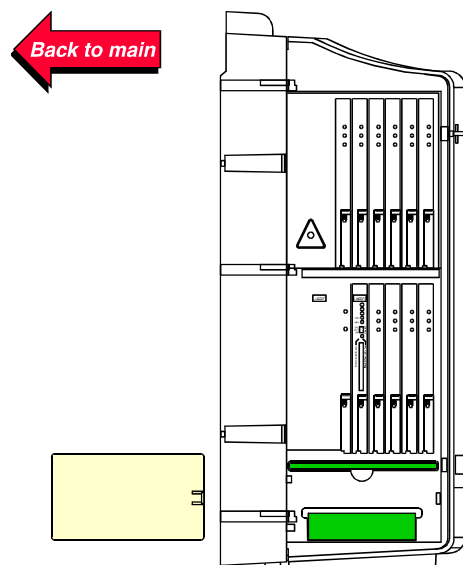
**Figure 3-15. Fan/Filter Removal**

1. Remove the left door.
2. Remove the fan/filter access panel. See [Figure 3-15](#).

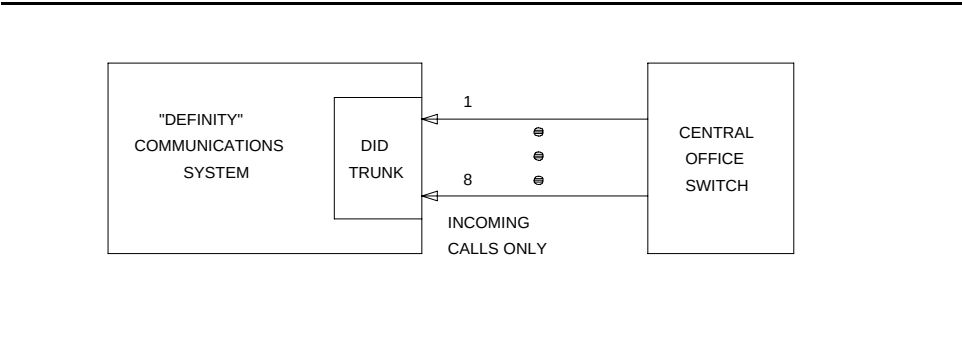
The DID Trunk circuit packs support eight, incoming-only, ports. Each port provides an interface between the 2-wire analog line from the CO and the DEFINITY system. The DID port receives 3 to 5 digits from the CO that is used to directly connect an outside caller to the called station without assistance from an attendant. See [Figure 3-16](#).

Figure 3-16. DID Trunk Interactions

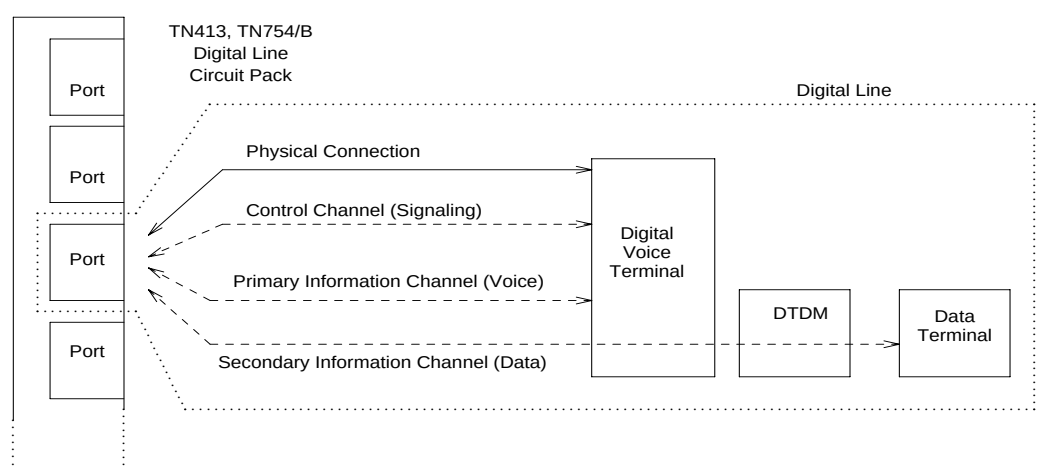
It should be noted that TN2181 and TN2224 support both modes as shown in [Figure 3-17](#) and [Figure 3-18](#).

Figure 3-17. Digital Line Connectivity

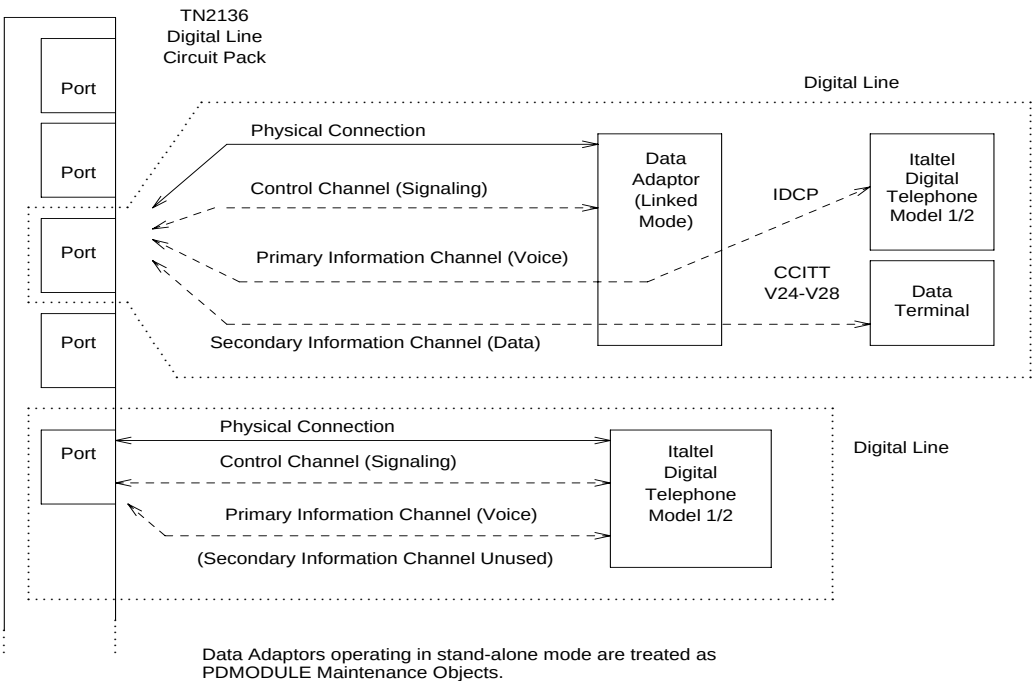
Figure 3-18. Digital Line Connections

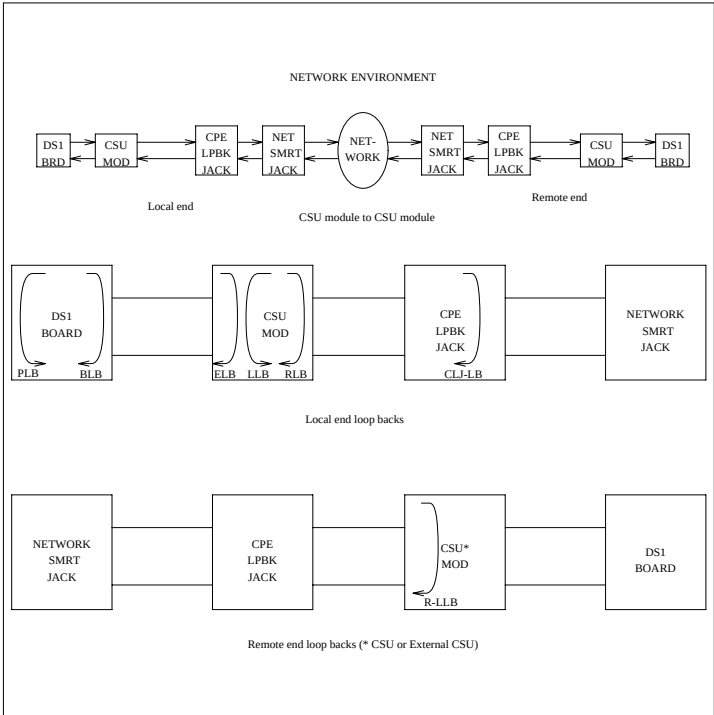
The TN767E and 120A1 CSU Module support on-demand loopback tests that assist in the detection of faults between the TN767E circuit pack and the CSU Module, between the Integrated CSU and the optional Customer Premises Loopback Jack, or between the Integrated CSU and remote CSU. These loopback tests are explained in detail later in this DS1-BD section, but [Figure 3-19](#) gives a high level overview of the loopback points.

- PLB = Payload Loopback
- BLB = Board Loopback
- ELB = Equipment Loopback
- LLB = Line Loopback
- RLB = Repeater Loopback
- CLJ = Loopback Jack Loopback
- R-LLB = Remote Line Loopback
- SMRT = Smart Jack
- LPBK = Loopback

Figure 3-19. High Level Overview Of Loopback Points

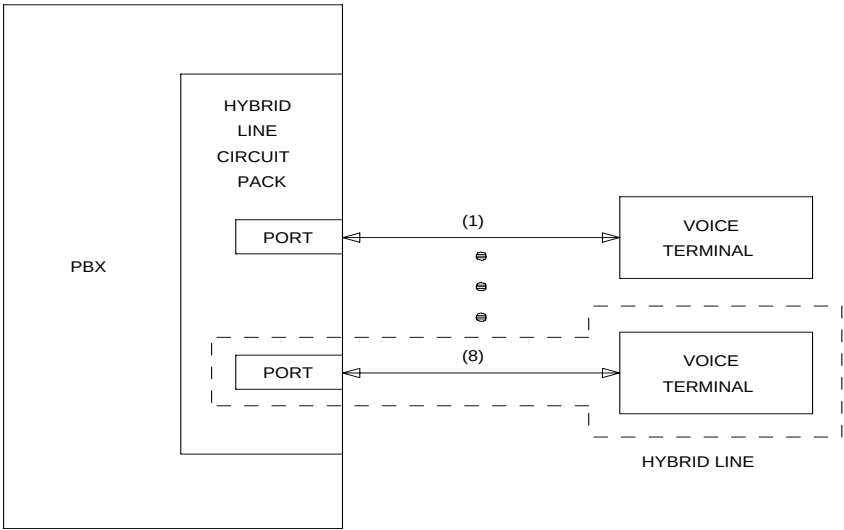
Figure 3-20. Hybrid Station Interactions

The TN762B Hybrid Line circuit pack supports eight of these multifunction analog telephone sets, as shown in the following figure. The Hybrid Line sets use three pairs of wires: an analog voice pair, a transmit/receive pair, and a power pair.

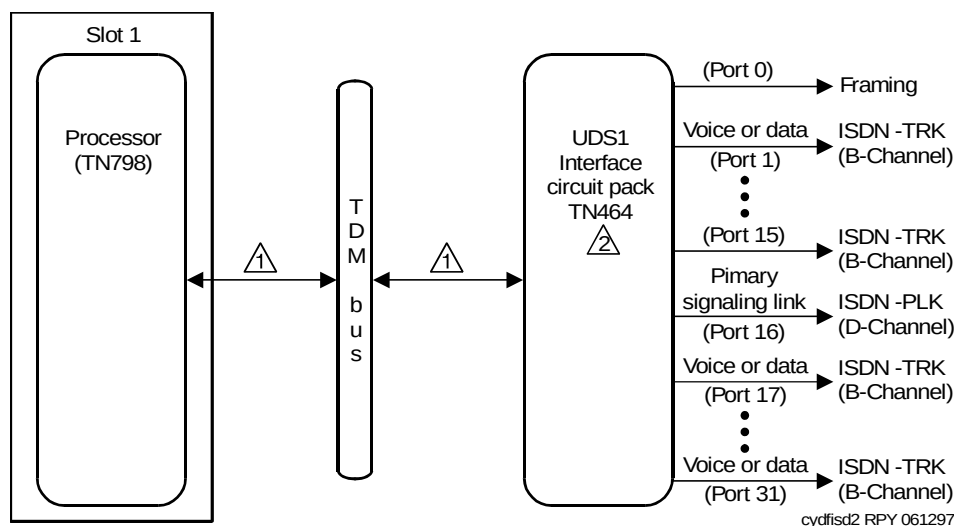
**Figure 3-21. ISDN-PRI Signaling Link Port Interactions (32-Channel - TN464)**

In a 32-channel system (see [Figure 3-21](#)), the DS1 ISDN Trunk or PRI endpoint port (B-channels) may use any of the ports 1-15 or 17-31, but the ISDN-PRI Signaling Link Port must be the 16th port on the TN464C (or higher) circuit pack. In certain configurations (NFAS), the 16th port may be used as a B-channel. Refer to the ["ISDN-SGR \(ISDN-PRI Signaling Group\)"](#) Maintenance documentation for further details.

1. B- and D-channel messages are routed over the TDM Bus. For additional reliability, a duplex D-channel can be administered for a signaling group and located on a different TN464C (or higher) circuit pack.
2. TN464C or higher

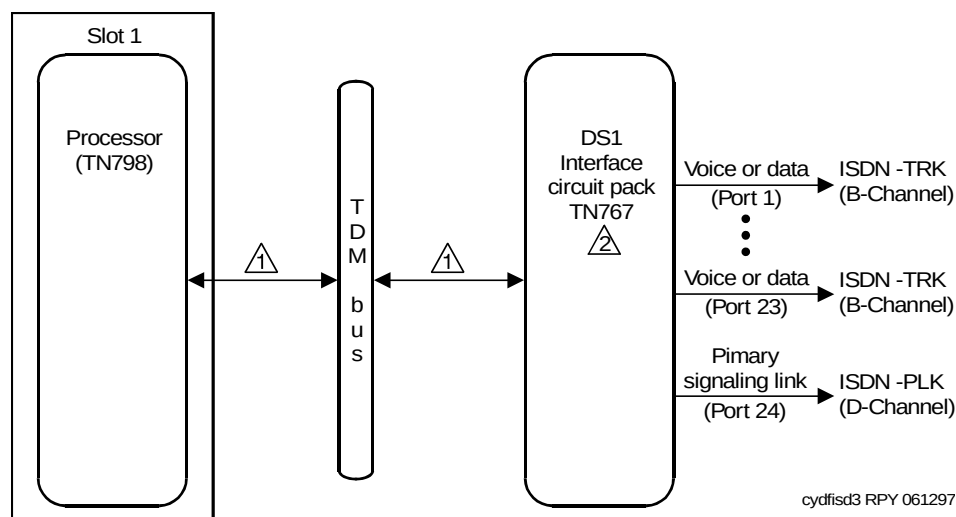
**Figure 3-22. ISDN-PRI Signaling Link Port Interactions (24 Channel - TN767/464C)**

In a 24-channel system, the DS1 ISDN Trunk or PRI endpoint port (B-channels) may use any of the first 23 ports. The ISDN-PRI Signaling Link Port must be the 24th port (See [Figure 3-22](#)). In certain configurations (NFAS), the 24th port may be used as a B-channel. Refer to the ISDN-PRI Signaling Group (ISDN-SGR) Maintenance documentation for further details.

1. B- and D-channel messages are routed over the TDM Bus. For additional reliability, a duplex D-channel can be administered for a signaling group and located on a different TN464C (or higher) circuit pack.
2. TN767B (or higher) or TN464C (or higher)

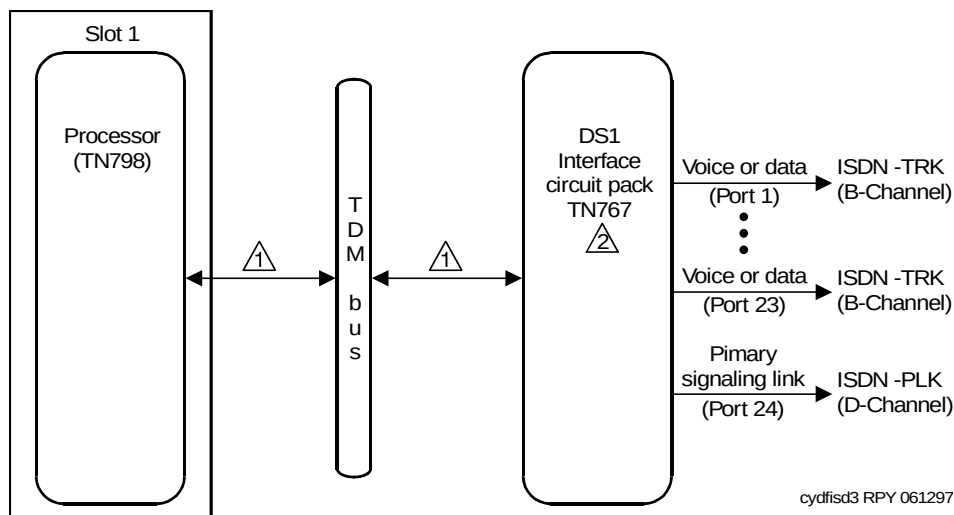
**Figure 3-23. ISDN-PRI Signaling Link Port Interactions (24 Channel - TN767/464C)**

For 24-channel interfaces, the first 23 ports on the circuit pack are used as B-channels. The 24th port may be used as a B-channel or as a D-channel depending on the type of Signaling Group used (see [Figure 3-23](#)).

1. B- and D-channel messages are routed over the TDM Bus. For additional reliability, a duplex D-channel can be administered for a signaling group and located on a different TN464C (or higher) circuit pack.
2. TN767B (or higher) or TN464C (or higher)

The ISDN-PRI Signaling Link Port itself depends on the health of the DS1/UDS1 Interface circuit pack on which it resides. This test will fail if there are problems with either the ISDN-PRI Primary D-channel port or the DS1/UDS1 circuit pack. See [Figure 3-23](#) for DS1 connections, [Figure 3-24](#) for UDS1 connections.

See [Figure 3-23](#) for DS1 connections, [Figure 3-24](#) for UDS1 connections.

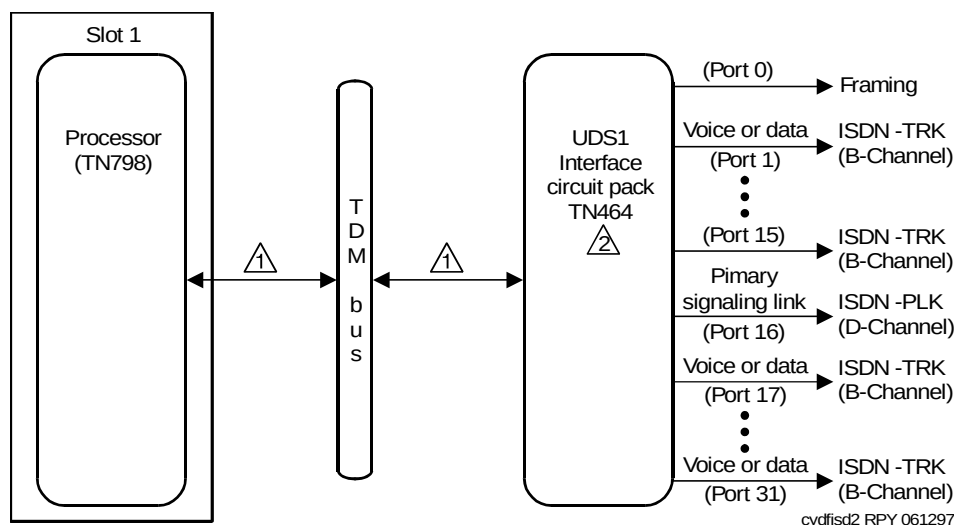
**Figure 3-24. ISDN-PRI Signaling Link Port Interactions (32-Channel - TN464)**

For 32-channel interfaces, ports 1-15 and 17-31 on the circuit pack are used as B-channels. The 16th port may be used as a B-channel or as a D-channel depending on the type of Signaling Group used (see [Figure 3-24](#)).

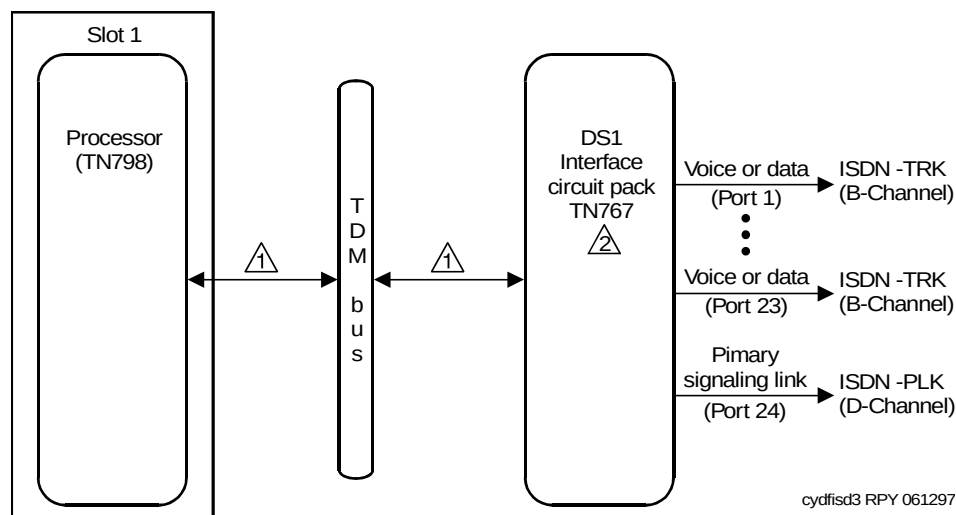
**Figure 3-25. DS1 ISDN Trunk Interactions (24 Channel - TN767/464C)**

On 24-channel interfaces, any of the first 23 ports on the DS1/UDS1 interface circuit pack can be a B-channel. The 24th port may be used as a B-channel or as a D-channel depending on the type of ISDN-PRI Signaling Group (ISDN-SGR) to which it belongs.

1. B- and D-channel messages are routed over the TDM Bus. For additional reliability, a duplex D-channel can be administered for a signaling group and located on a different TN464C (or higher) circuit pack.
2. TN767B (or higher) for DS1; TN464C (or higher) for UDS1

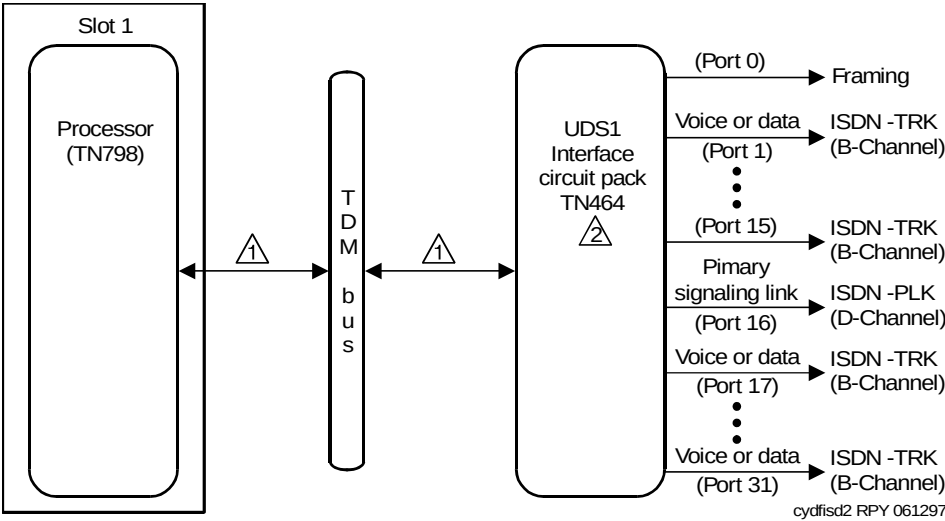
On 32 channel interfaces, any of ports 1-15 and 17-31 on the DS1 interface circuit pack can be a B-channel. The 16th port may be used as a B-channel or as a D-channel depending on the type of ISDN-PRI Signaling Group (ISDN-SGR) to which it belongs. For more details, refer to the ISDN-SGR and DS1-BD/UDS1-BD Maintenance documentation.

1. B- and D-channel messages are routed over the TDM Bus. For additional reliability, a duplex D-channel can be administered for a signaling group and located on a different TN464C (or higher) circuit pack.
2. TN464C or higher

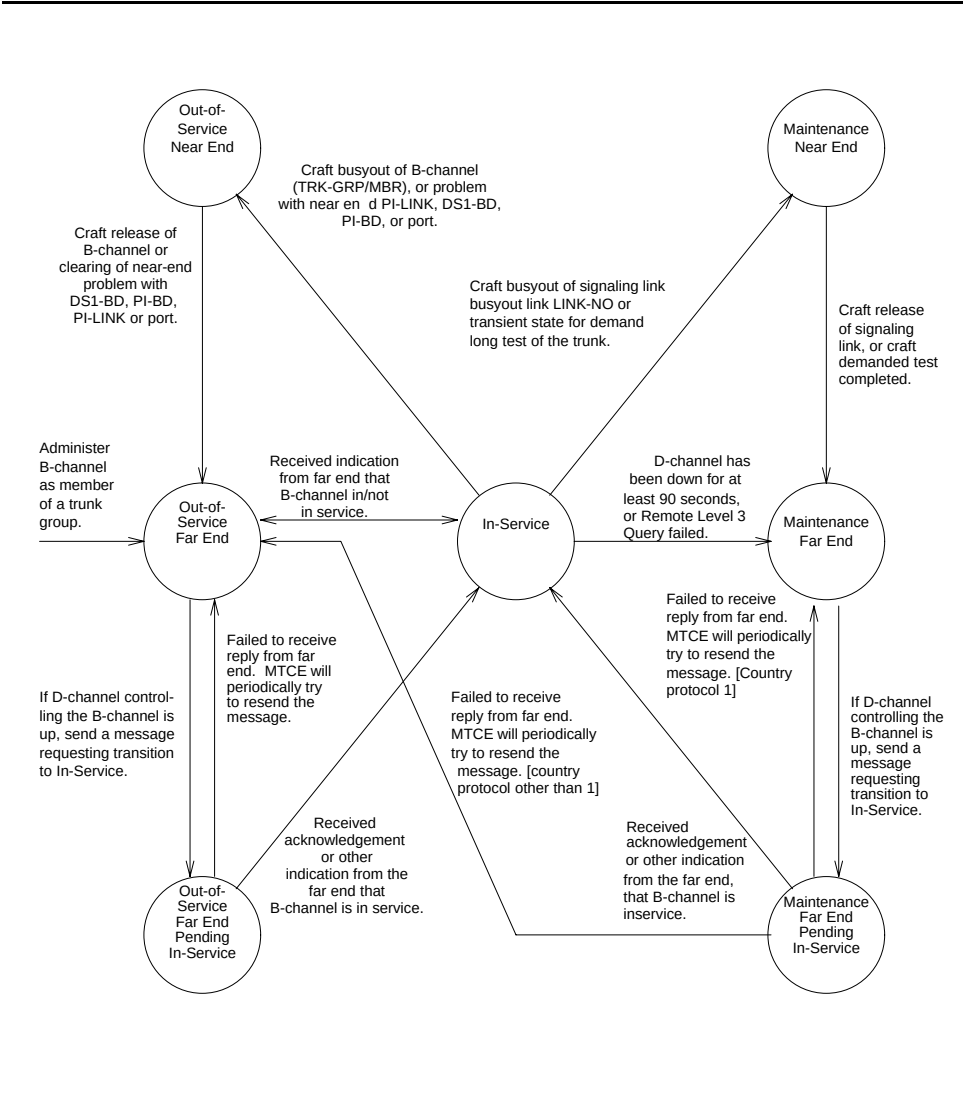
Figure 3-27. Common Progressions in Service States

The following diagram of the DS1 ISDN Trunk service states shows the common progression from one service state to another and the event that caused the change of state.

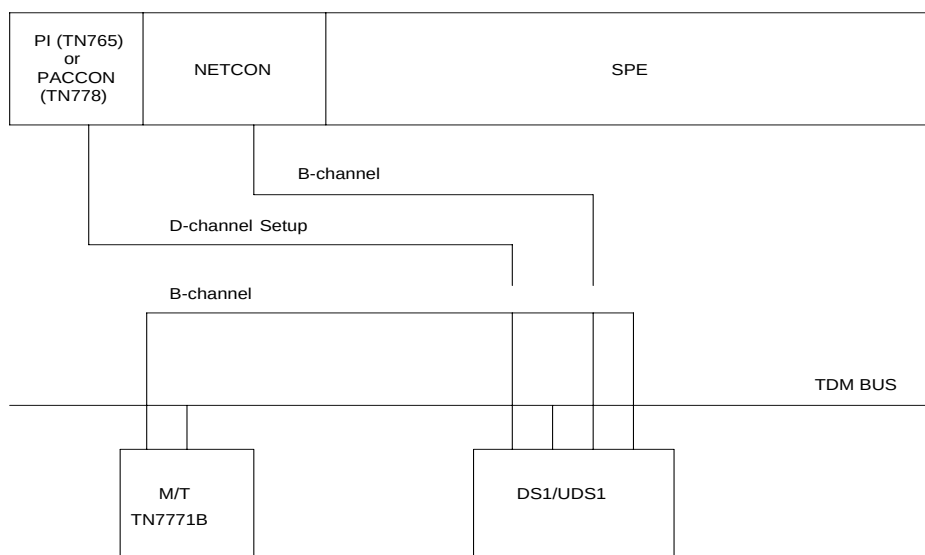
Figure 3-28. ISDN-PRI Outgoing Test Call

In the second method, the test call connection is established over the TDM Bus of the transmit and receive sides of the ISDN-PRI trunk to a digital trunk testing port on the Maintenance/Test circuit pack. The Maintenance/Test Digital Port generates a pseudo bit stream. A pictorial description of the outgoing ISDN-PRI test call connectivity is contained in [Figure 3-28](#).

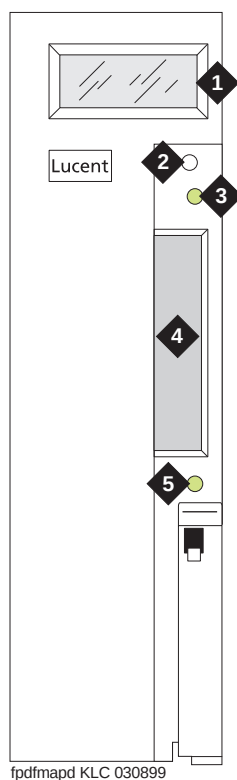
**Figure 3-29. TN802 faceplate**

[Figure 3-29](#) shows the TN802 faceplate.

| Step | Description | Comments |
|---|---|---|
| 4. | Wait | Wait until the yellow Disk-In-Use LED (Note 5 in <a href="#">Figure 3-29</a> ) light is out. |

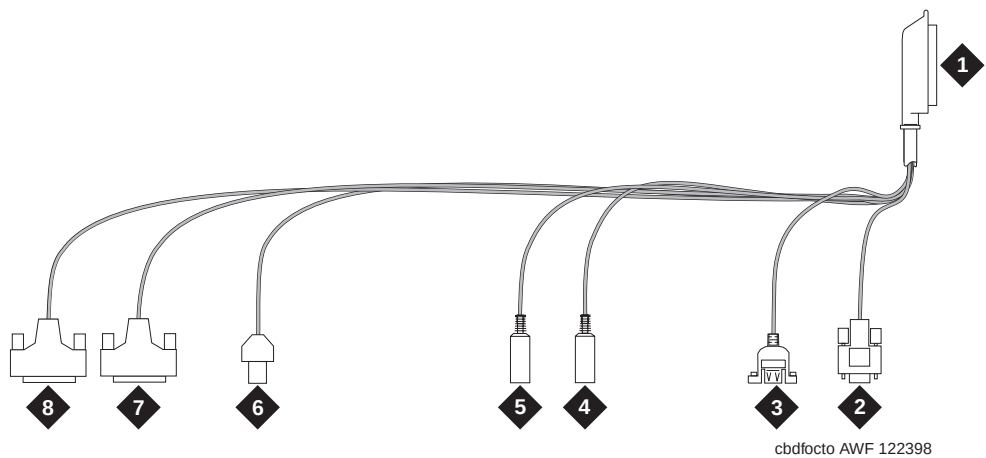
1. To TN802 cabinet backplane
2. VGA monitor
3. USB (Universal Serial Bus)
4. Keyboard
5. Mouse
6. Ethernet
7. 25-pin modem connection
8. 25-pin COM2 connection

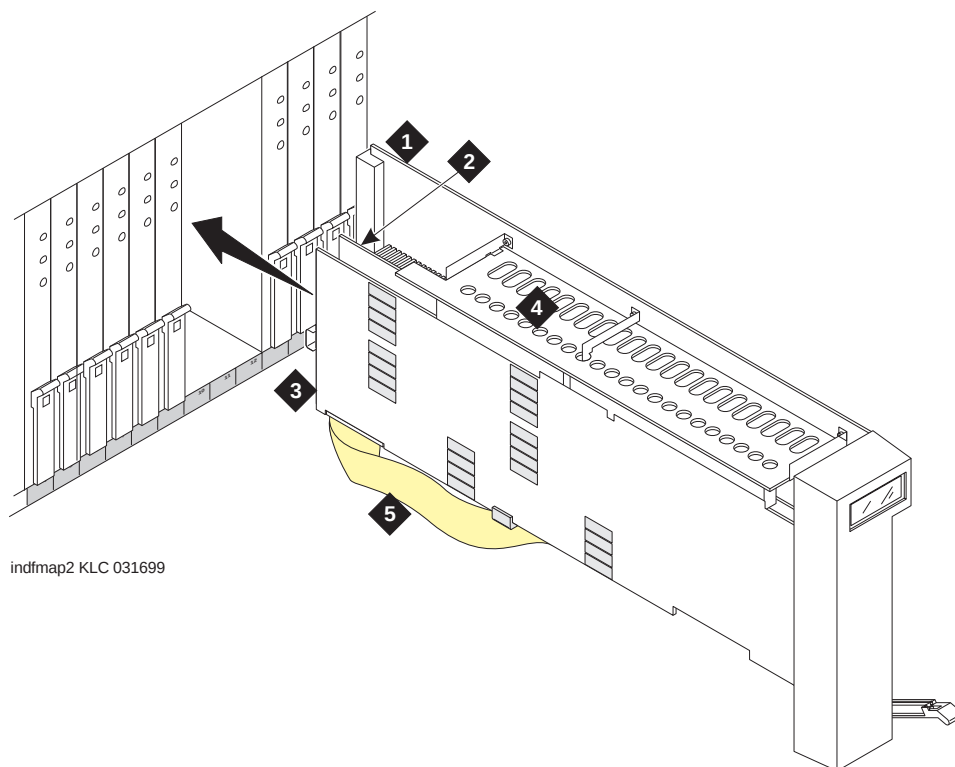
**Figure 3-31. TN802 board assembly**

[Figure 3-31](#) shows the circuit pack with the two additional boards connected through the side plane.

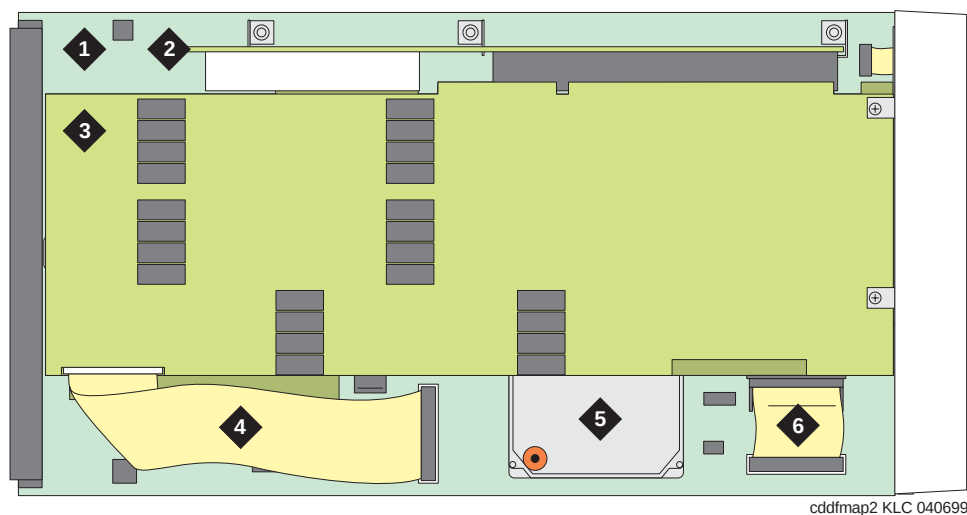
**Figure 3-32. TN802 board assembly and cables (side view)**

[Figure 3-32](#) shows a side view of the three boards and interconnecting cables that make up the TN802.

- a. Verify the IP address
  - b. Check the physical connections to and from the TN802 circuit pack.
  - c. Check the internal cables on the TN802 circuit pack (Notes 4 and 6 in [Figure 3-32](#)).
  - d. Try pinging another device on the same subnet.
  - e. Try pinging the gateway to the rest of the network from the subnet.
  - f. Try pinging a device not on the local subnet but on the network or another subnet.
5. When finished, at the command prompt type **exit** and press Enter.

- a. Check that the internal cables on the TN802 circuit pack (Notes 4 and 6 in [Figure 3-32](#)) have not worked loose.
  - b. Otherwise, replace the circuit pack.
3. At the command prompt, type **ping 10.32.64.97** (the internal IP trunk server address) and press Enter.

- a. Check that the internal cables on the TN802 circuit pack (Notes 4 and 6 in [Figure 3-32](#)) have not worked loose.
  - b. Otherwise, replace the circuit pack.
4. At the command prompt, type **ping 10.32.64.96** (the IP address of the internal Motorola MPC860 processor) and press Enter.

- a. Check that the internal cables on the TN802 circuit pack (Notes 4 and 6 in [Figure 3-32](#)) have not worked loose.
  - b. Otherwise, replace the circuit pack.
5. Ping the gateway: at the command prompt, type **ping XX.XXX.XXX.XXX** (the IP address of the gateway) and press Enter.
6. When finished, at the command prompt type **exit** and press Enter.

The TN802 hard drive (Note 5 in [Figure 3-32](#)) is field-replaceable.

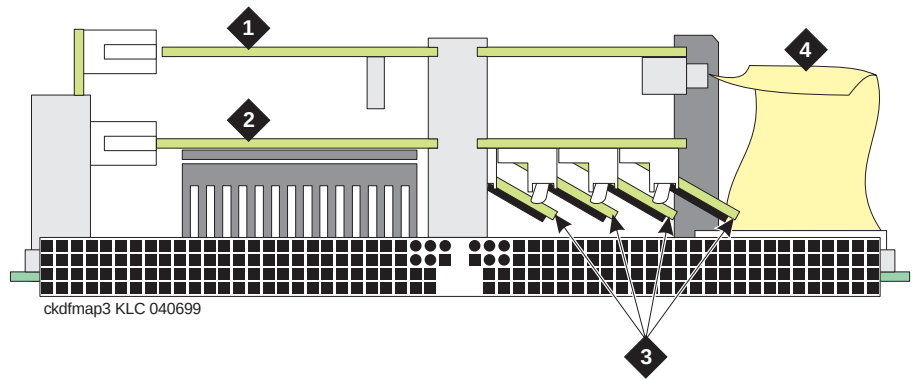
**Figure 3-33. TN802 board assembly and cables (end view)**

[Figure 3-33](#) shows the end view of the thee boards and interconnecting cables on the TN802.

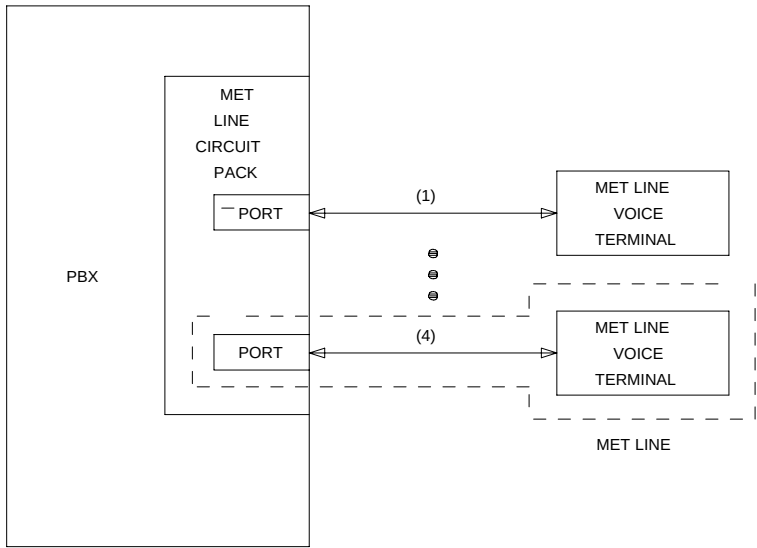
Figure 3-34. MET Line Interactions

The TN735 MET Line circuit pack supports four of these METsets. Each MET set uses three pairs of wires: an analog voice pair, a transmit pair, and a receive pair. Power is sent over the transmit and receive pairs. The MET Line circuit pack supports all 10-, 20-, and 30-button sets.

MET Line interactions are shown in [Figure 3-34](#).

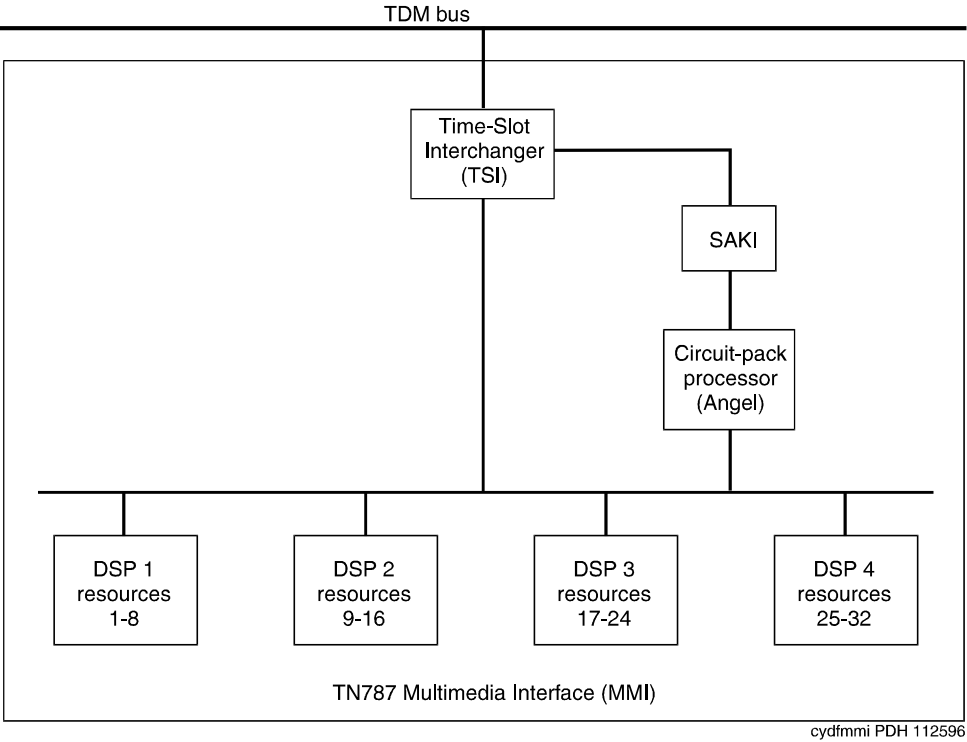
Figure 3-36. TN787 Multimedia Interface (MMI) Circuit Pack

All 8 resources that the circuit pack controls may be placed out of service by the failure of one of these DSPs.

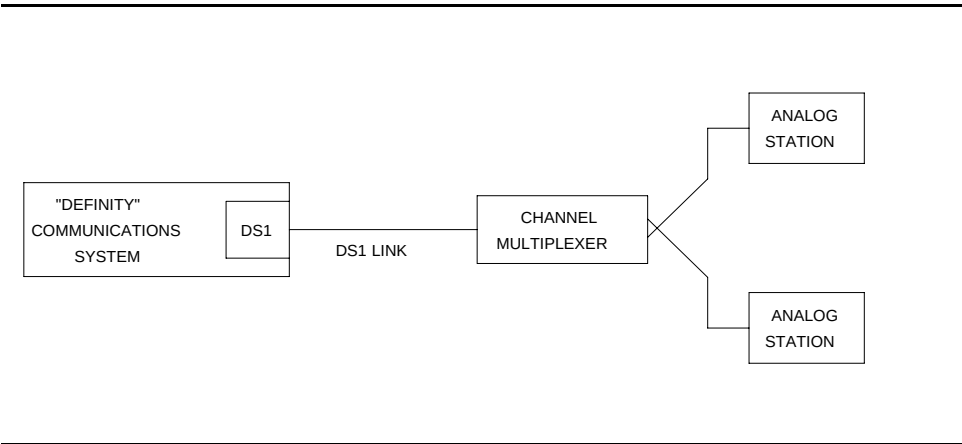
Figure 3-37. DS1 OPS Line Interactions

An analog Off-Premises Station (OPS) can be connected to the system through a DS1 link. A TN767 DS1 Interface circuit pack supports up to 24 DS1OPSs. Since the DS1OPS is an analog telephone set, a channel multiplexer is necessary as the remote DS1 endpoint that converts the digital signal of a DS1 port to the OPS Line and vice versa. See [Figure 3-37](#) for details.

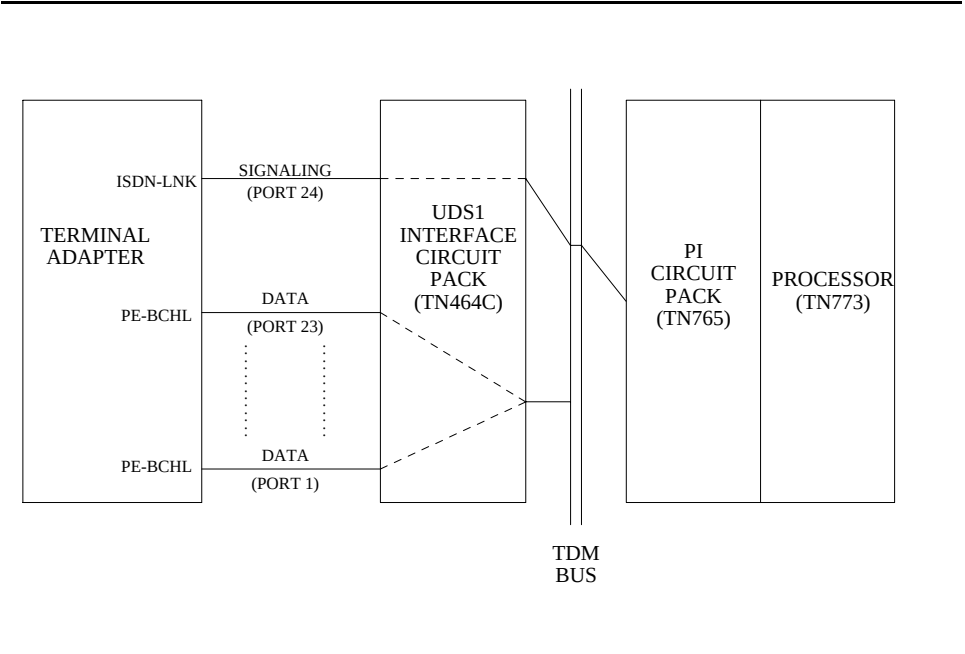
Figure 3-38. PRI Endpoint Port Interactions [INTEL]

A PRI Endpoint Port is a port on a UDS1 interface circuit pack. Therefore, this port depends on the health of the UDS1 interface circuit pack for proper operation (see [Figure 3-38](#)). As noted earlier, a PRI Endpoint Port B-channel also depends on an ISDN-PRI Signaling Link Port D-channel (ISDN-LNK) to carry the signaling traffic. If there is a problem with the ISDN-PRI Signaling Link Port, the PRI Endpoint Port is affected. The ISDN-PRI Signaling Link Port, in turn, depends on the PKT-INT (Packet Interface).

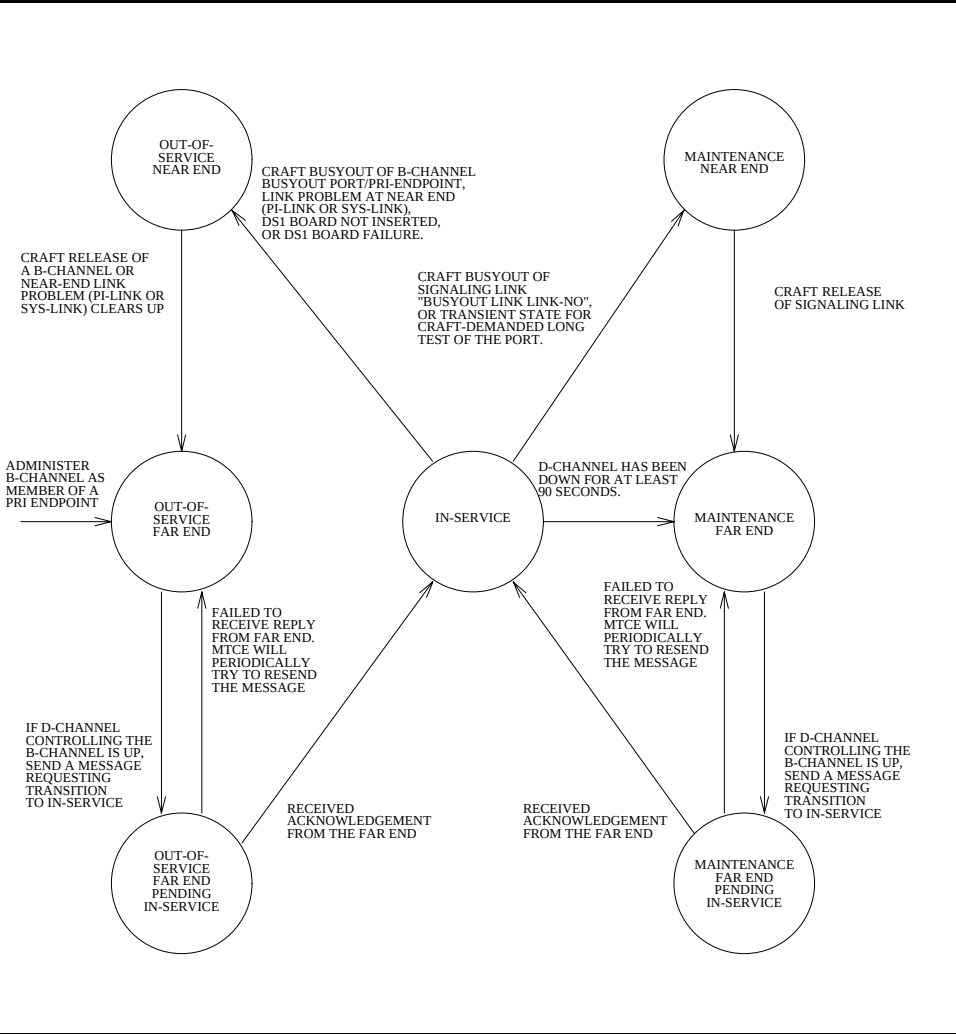
Figure 3-39. Common Progressions in Service States

The following diagram of the PRI Endpoint Port service states shows the common progression from one service state to another and the event that caused the change of state.

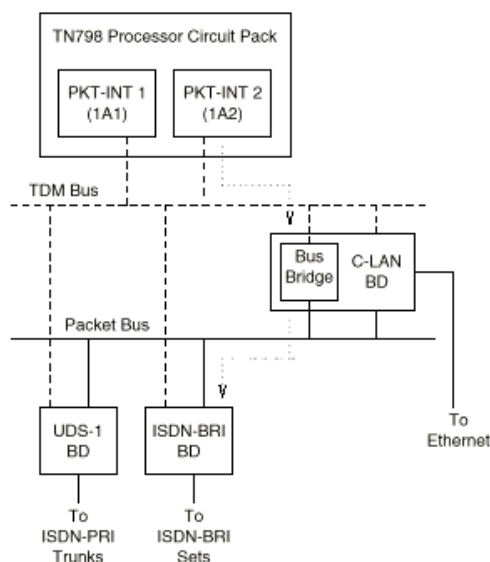
**Figure 3-40. PKT-INT Connections**

PKT-INT 2 is enabled only when the following conditions are met:

- The system contains at least one TN799 C-LAN circuit pack, and
- The *Packet Intf2?* field on the Maintenance-Related System Parameters form is set to "y".

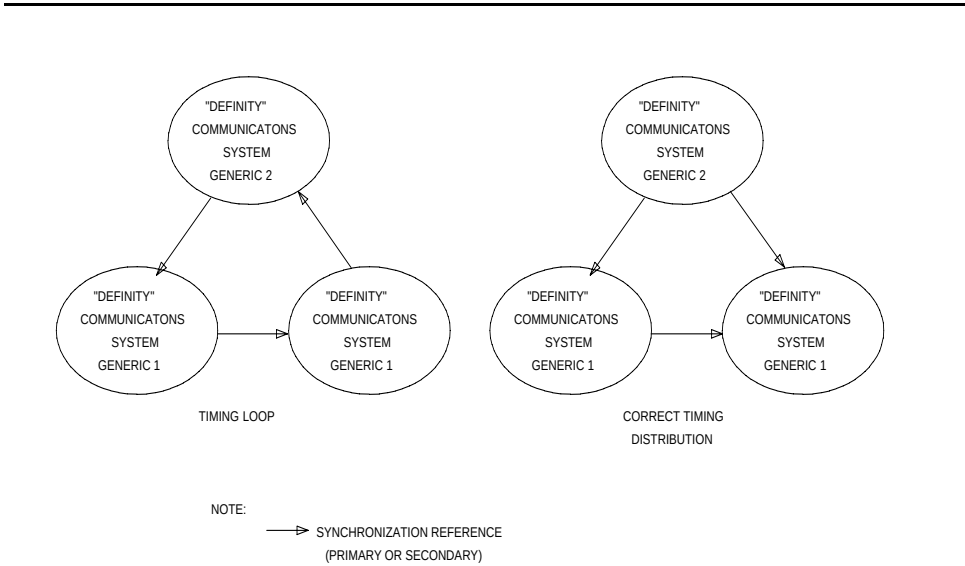
Figure 3-41. Synchronization Timing Loop

The system synchronization planner must avoid creating a *timing loop* when administering the primary and secondary synchronization references in a system. A timing loop exists whenever a system receives timing from another system whose timing reference is directly or indirectly derived from itself. Timing loops can lead to loss of digital data between systems that are exchanging data with any system within the loop. An invalid timing signal is also generated by any system within the loop, thus propagating the invalid timing signal to any system(s) using a system within the loop as a synchronization reference. [Figure 3-41](#) shows a timing loop and a correct distribution of timing between the systems.

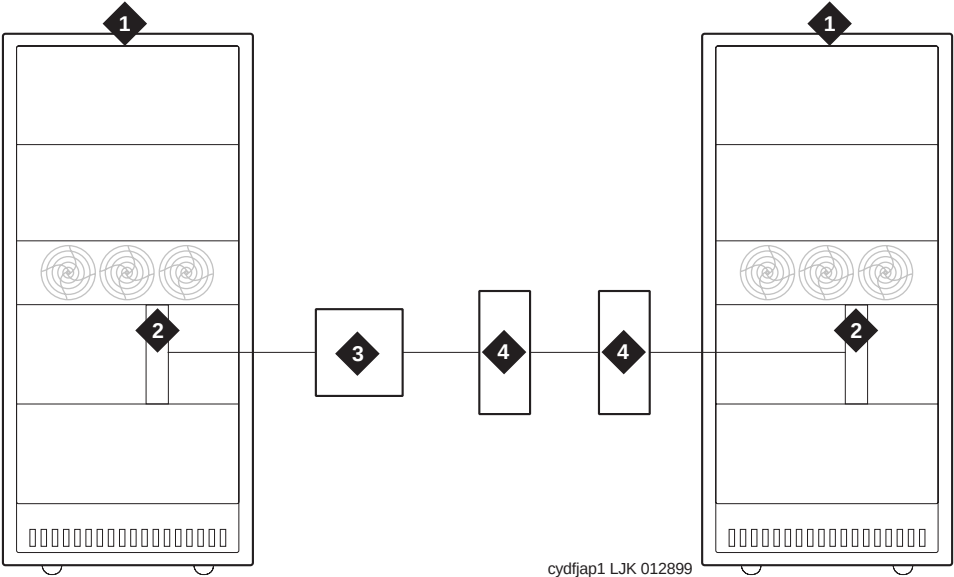
[Figure 3-45](#) shows the hardware connections for public network access in Japan. The upgrade procedure requires removing the JRC (Japan Radio Corporation) external converter in [Figure 3-45](#).

Figure 3-45. Japanese TTC public network connections

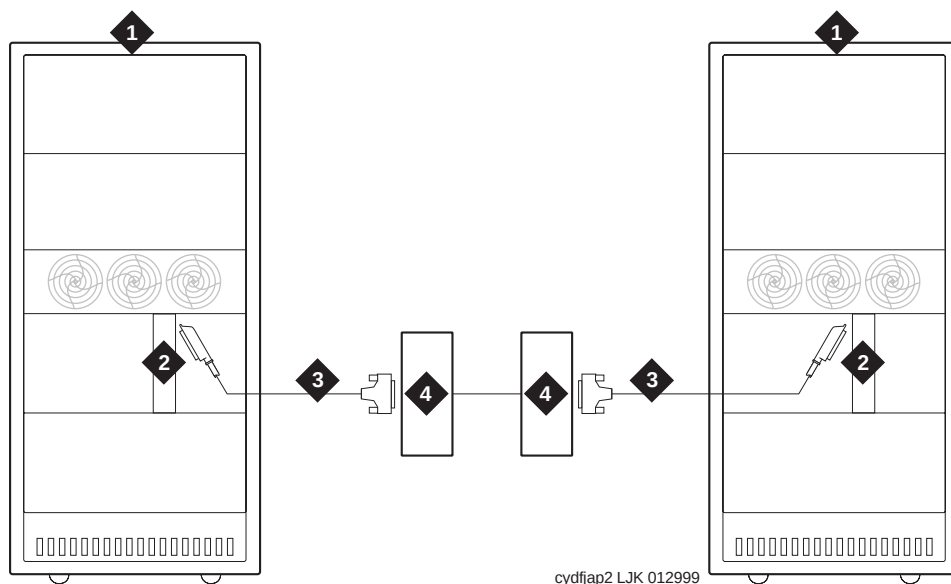
[Figure 3-46](#) shows the hardware connections for private network access using the TN2242 circuit pack.

1. DEFINITY Release 7
2. TN2242 2Mbit Japan trunk circuit pack
3. H600-513 cable assembly cable. (See ["H600-513 cable pinout"](#)).
4. TDM facilities

**Figure 3-46. TN2242 Japan trunk TTC private network connections**

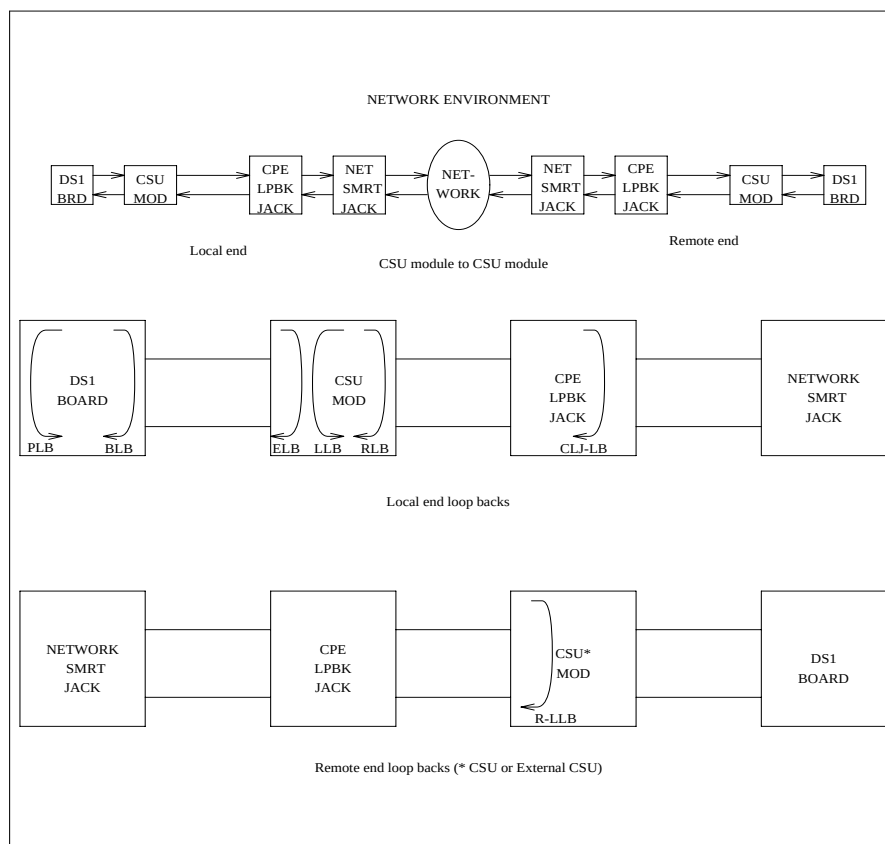
The TN464F and 120A1 CSU Module support on-demand loopback tests that assist in the detection of faults between the TN464F circuit pack and the CSU Module, between the Integrated CSU and the optional Customer Premises Loopback Jack, or between the Integrated CSU and remote CSU. These loopback tests are explained in detail later in this UDS1-BD section, but [Figure 3-47](#) gives a high level overview of the loopback points.

**Figure 3-47. High Level Overview Of Loopback Points**

The following list of acronym definitions are for the [Figure 3-47](#):
