**DEFINITY®**

# **Enterprise Communications Server**

Release 8.2

Maintenance for R8.2csi

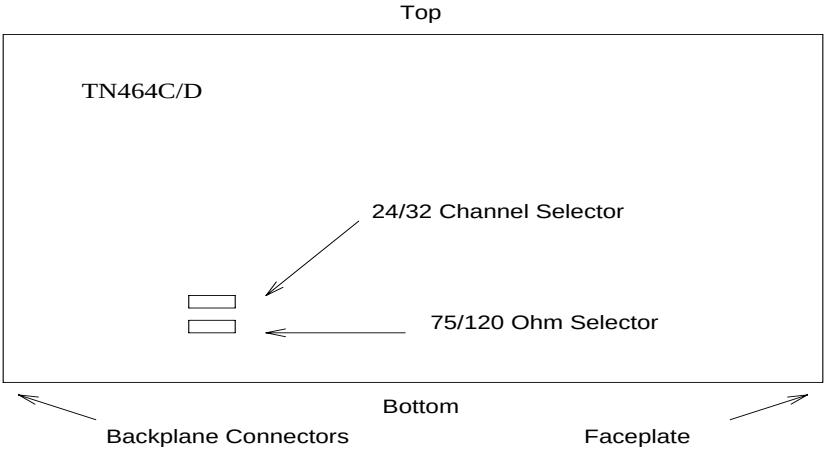
Two option jumpers located on the side of the TN464C/D circuit pack must be installed correctly. The figures on the following page shows how to configure the circuit pack for 24-channel or 32-channel DS1, and for 75\*W (coaxial) or 120\*W trunk connections. The channel selection must match the parameters administered on the corresponding DS1 Circuit Pack Form. (US applications use 24 Channels.)

Figure 3-48. TN464C/D DS1 Option Jumpers

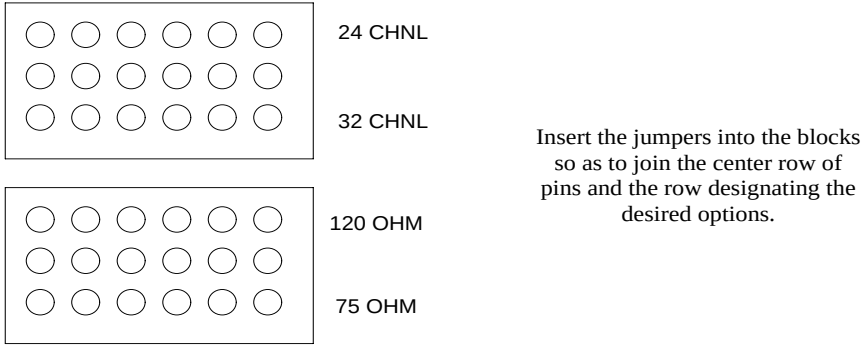
Figure 3-49. TN464C/D DS1 Option Jumpers (Continued)

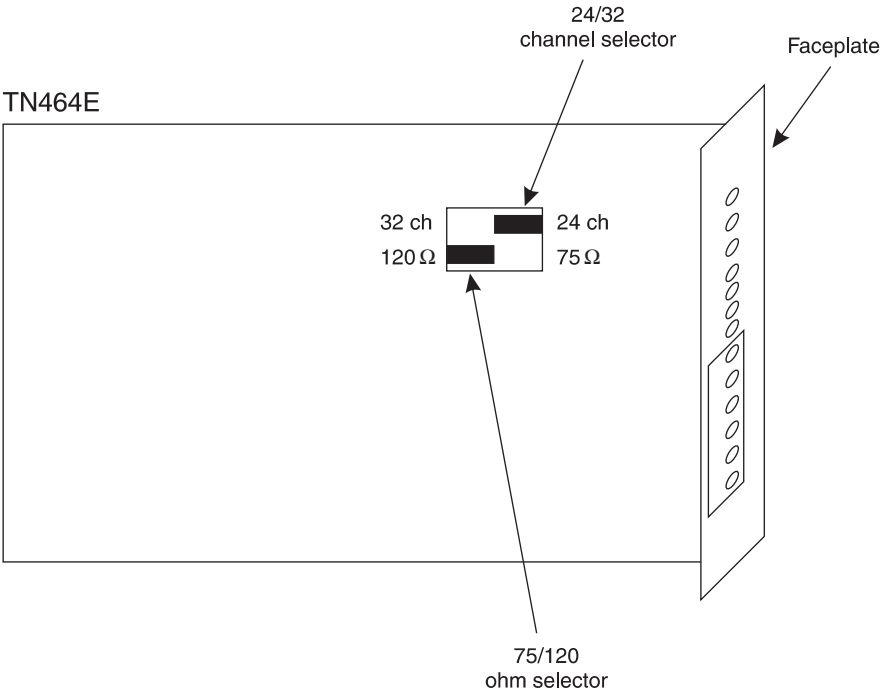
The option switch located on the component side of the TN464E/F circuit pack must be set correctly. [Figure 3-50](#) shows how to configure the circuit pack for 24-channel or 32-channel DS1. The channel selection must match the parameters administered on the corresponding DS1 Circuit Pack Form. (US applications use 24 Channels.)

Figure 3-50. TN464E/F DS1 Option switches

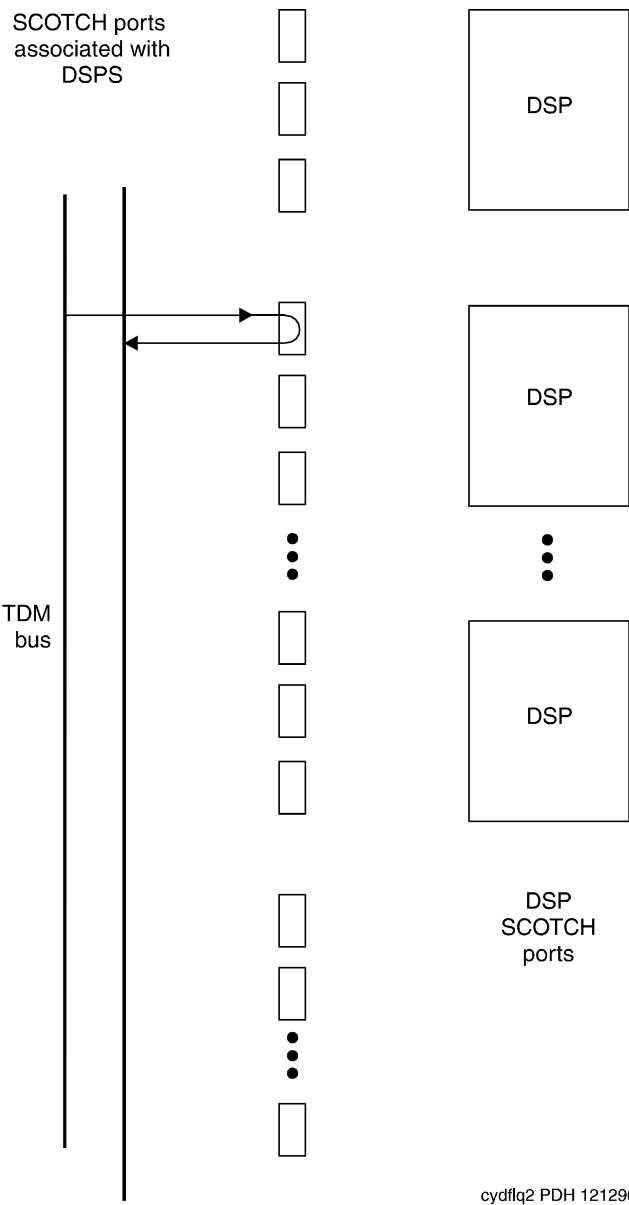
This test verifies the connectivity of a VC DSP Port across the TDM bus. It aborts if calls associated with the port are in progress. Failure of this test indicates an on-board fault associated with the port hardware on the circuit pack. The Loopback Test runs the following tests (refer to [Figure 3-51](#)):

1. A looparound test across the TDM bus.
2. A conference circuit test.

Figure 3-51. VC Circuit Pack DSP Port Local TDM Loopback Test

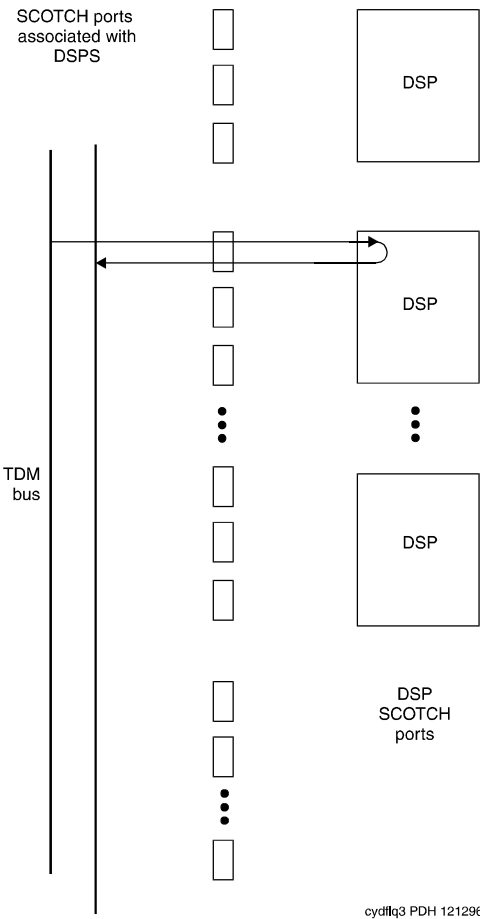
This test verifies the connectivity of a VC-DSPPT across the TDM bus as shown in [Figure 3-52](#). It aborts if calls associated with the port are in progress. Failure of this test indicates an on-board fault associated with the port hardware on the circuit pack.

Figure 3-52. VC Circuit pack DSP Port DSP Looparound Test

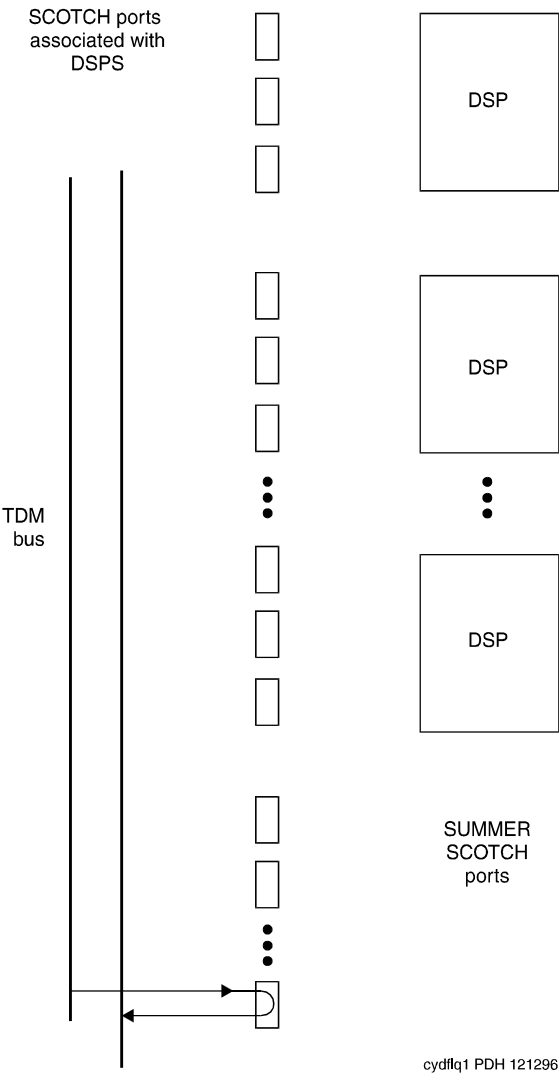
This test verifies the connectivity of a VC Summer Port across the TDM bus. It aborts if calls associated with the port are in progress. Failure of this test indicates an on-board fault associated with the port hardware on the circuit pack. The Loopback Test runs the following tests (refer to [Figure 3-53](#)):

- A Looparound test across the TDM bus.
- A conference circuit test.

Figure 3-53. VC Circuit Pack Summer Port Loopback Test
