Maintenance of the Avaya G350 Media Gateway

555-245-105
Issue 4
January 2005

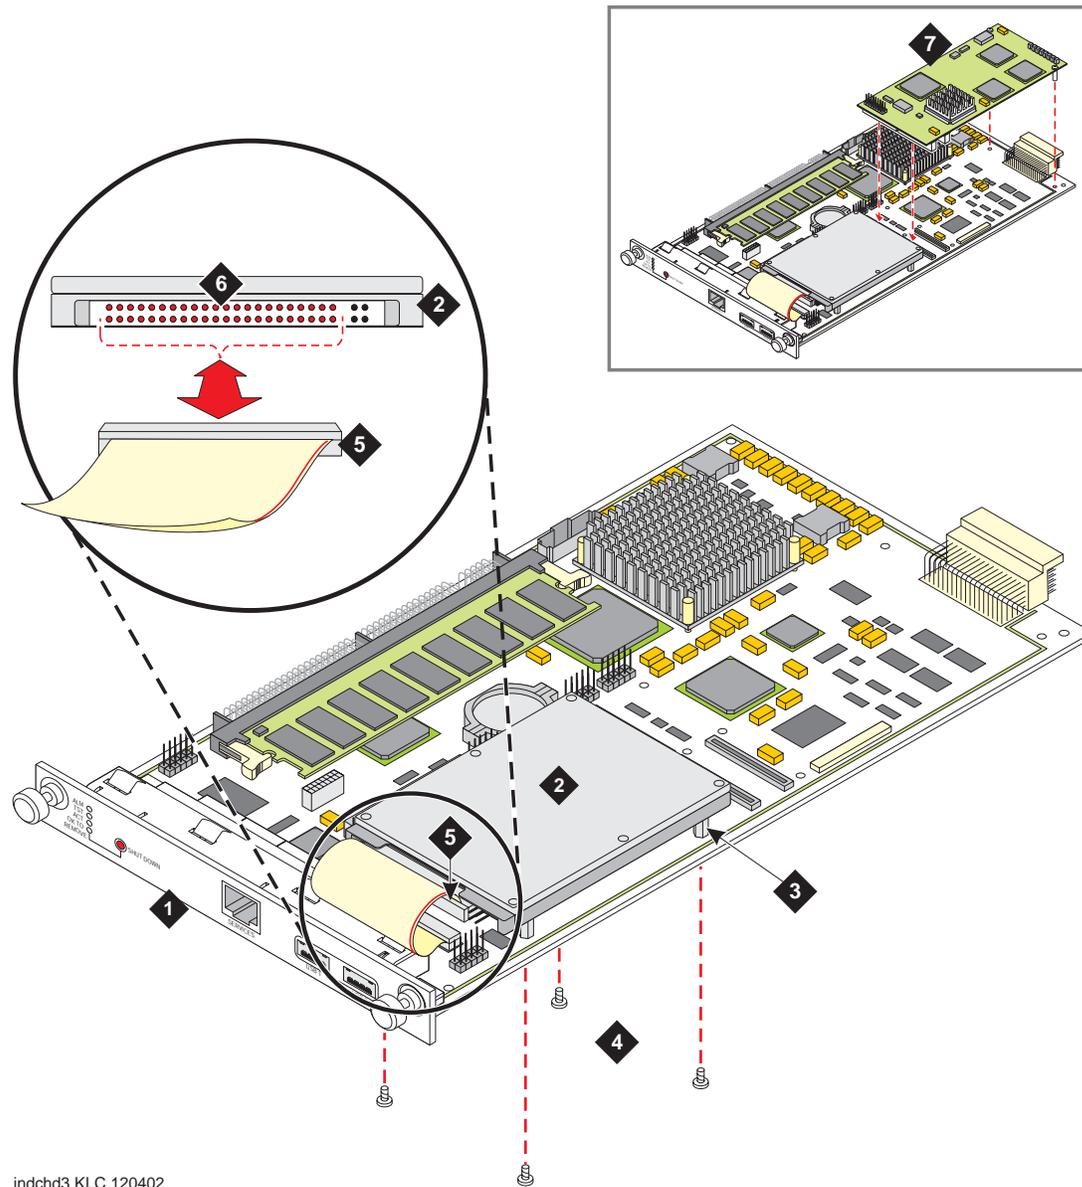
Figure 1: S8300 Hard Drive Replacement

In Step 4, be careful not to bend the pins on the hard drive. Leave the four jumper pins to the right of the ribbon cable open and unconnected, as shown in [Figure 1: S8300 Hard Drive Replacement](#) on page 34.

4. Connect the open end of the hard drive ribbon cable (which is attached to the S8300 board) to the hard drive, as shown in [Figure 1: S8300 Hard Drive Replacement](#) on page 34. Connect pin number one to the end of the ribbon connector marked with the red stripe.
5. Place the hard drive on the S8300 board with the standoffs aligned with the screw holes.
6. Hold the S8300 board on its side, with the hard drive in place, and screw the four screws through the bottom of the S8300 board into the hard drive standoffs.

To replace the S8300 hard drive, perform the following steps (refer to [Figure 1: S8300 Hard Drive Replacement](#) on page 34):

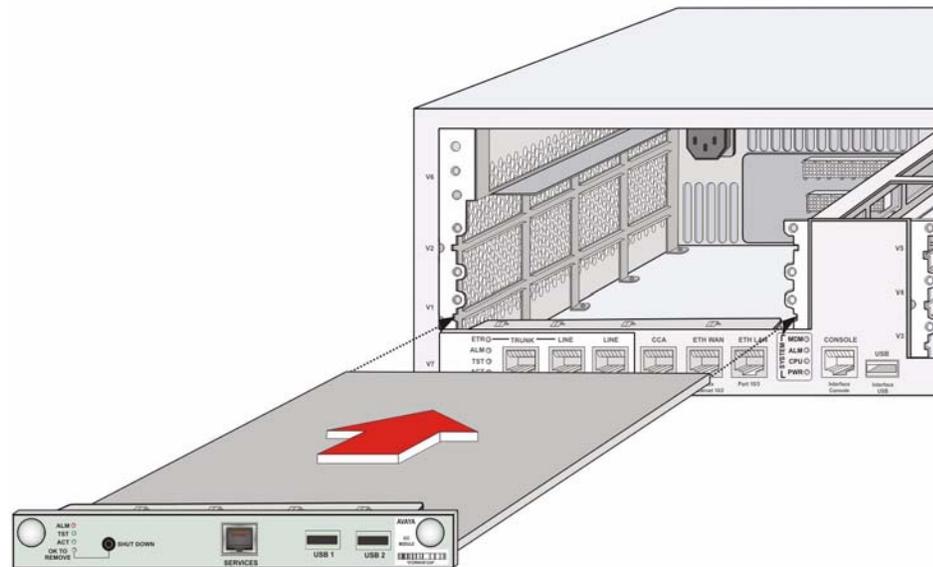
Figure 2: Align the S8300 Media Server/LSP

1. Insert the S8300 into slot v1 of the G350 (refer to [Figure 2: Align the S8300 Media Server/LSP](#) on page 35).
2. With the optional CWY1 and hard drive attached to the S8300 board, insert the S8300 board about 1/3 of the way into the guides (the guides are in slot v1 for the S8300).
3. Push both boards (together) back into the guides, gently and firmly, until the front of each board aligns with the front of the G350.
4. Secure the S8300 faceplate with the thumb screws. Tighten the thumb screws with a screw driver, in the clockwise direction.
5. Replace the plate between slots V1 and V2, labelled "Remove before removing or inserting S8300 module".

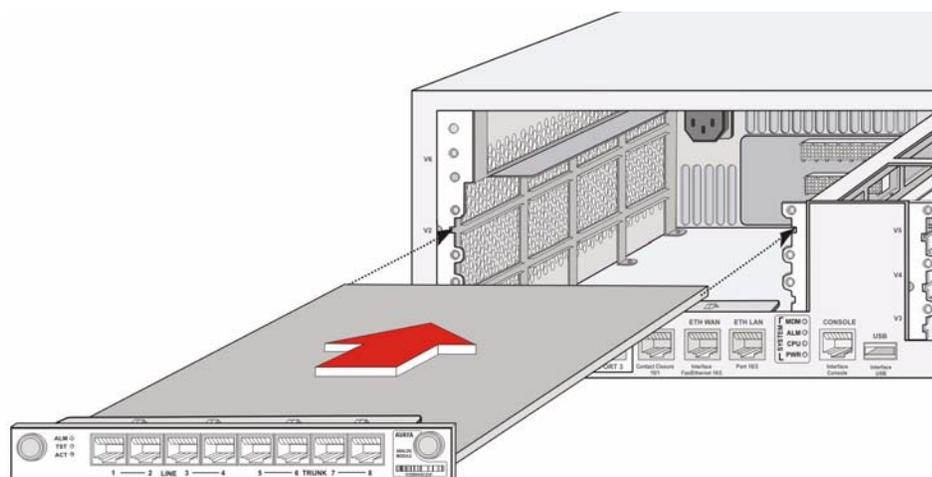
Figure 4: Inserting Media Modules

1. Identify and mark all cables.
2. Undo the cables. Make note of the order in which they are removed.
3. Undo the captive screws and slide out the Media Module currently inserted into the G350.
4. Position the Media Module squarely before the selected slot on the front of the G350 chassis and engage both sides of the module in the interior guides.
5. Slide the module slowly into the chassis, maintaining an even pressure to assure that the module does not become twisted or disengage from the guides ([Figure 4: Inserting Media Modules](#) on page 43).
6. Apply firm pressure to engage the connectors at the back of the chassis.

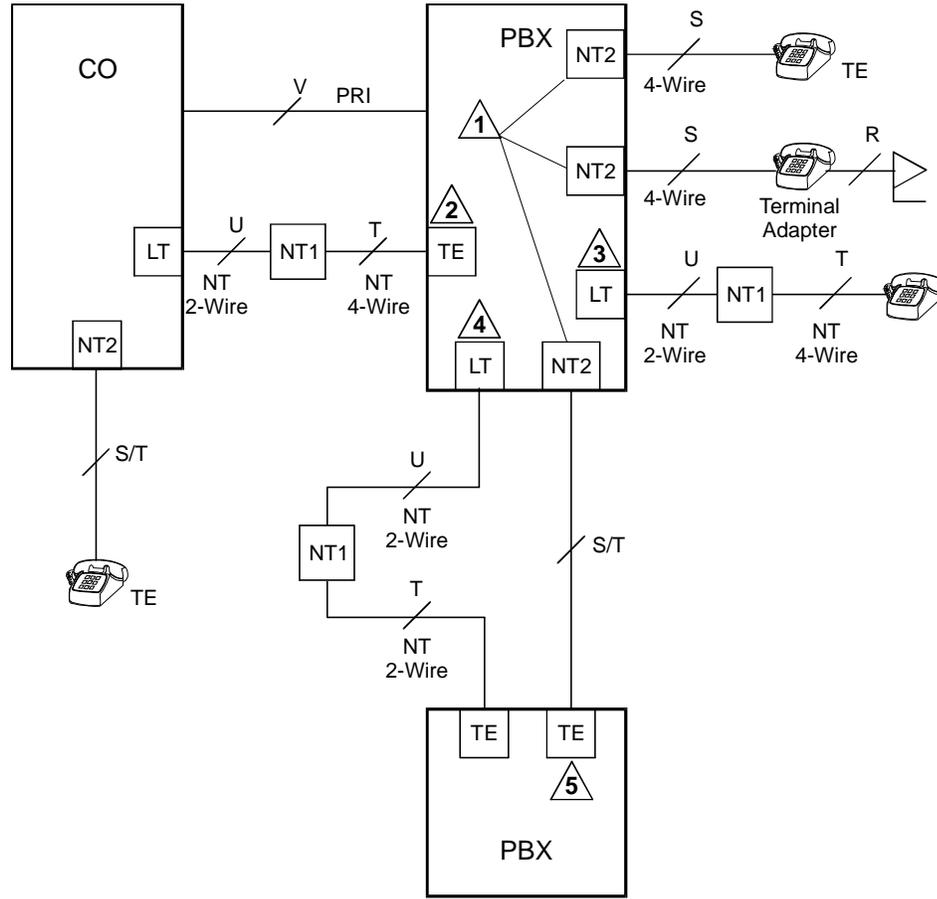
Figure 11: Integrated Trunk-Side BRI, ISDN Interface Reference Points

[Figure 11: Integrated Trunk-Side BRI, ISDN Interface Reference Points](#) on page 190 shows, for a generic integrated trunk-side BRI, the ISDN Interface Reference Points. [Table 101: ISDN Interface Reference Point definitions](#) on page 190 gives definitions for the generic ISDN Interface Reference Points.

ISDN Interface Reference Points

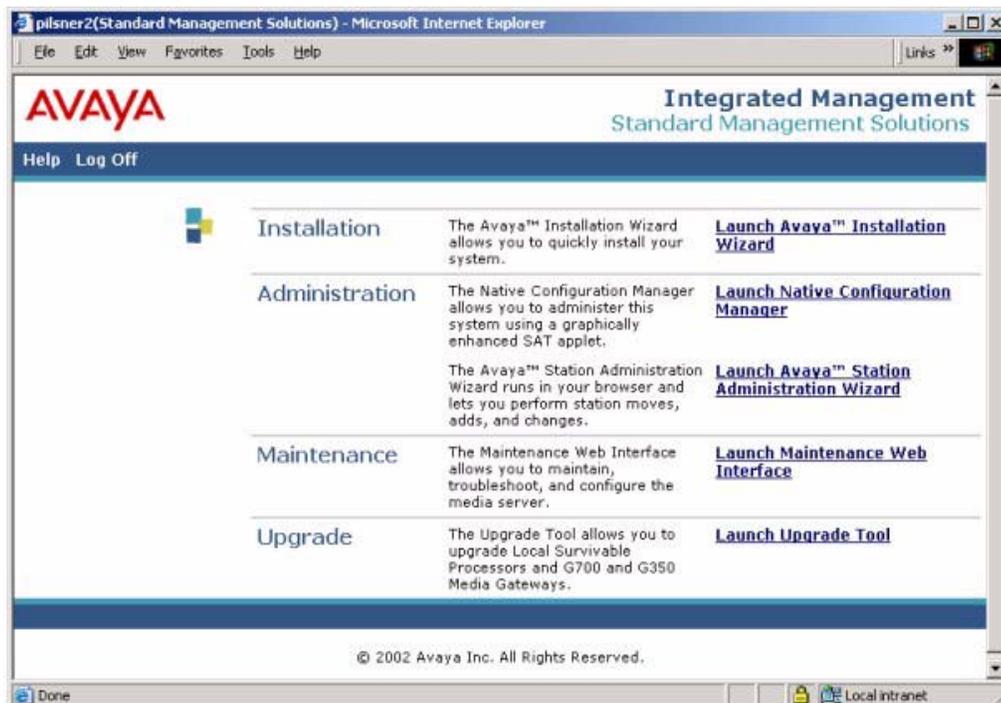
Figure 12: Integrated Management Main Menu

1. Access the Maintenance web pages part of Avaya Integrated Management (AIM) from your laptop, using IP address 192.11.13.5.
2. Logon at the Avaya Integrated Management Logon screen. The main menu for Avaya Integrated Management appears.

3. From the Integrated Management main menu, select Launch Maintenance Web Interface. The Maintenance Web Pages Notice page appears, with a navigation menu at the left.

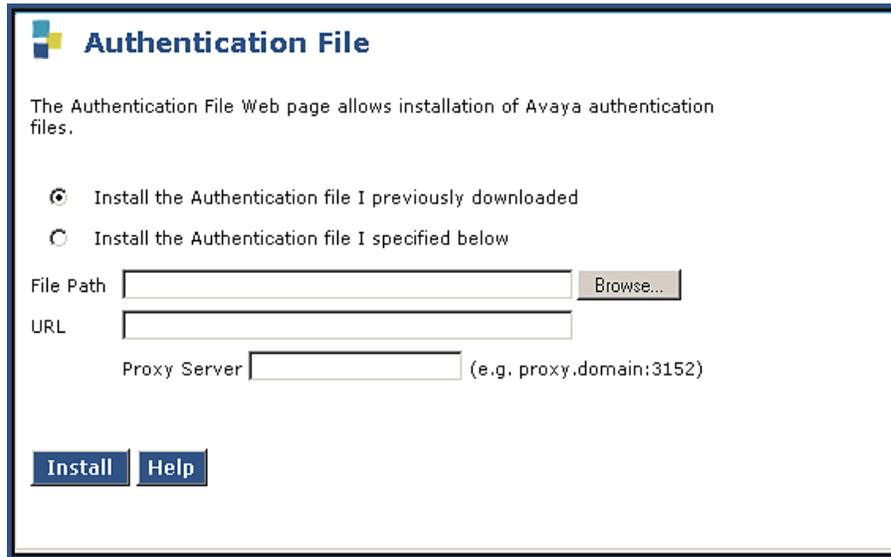
Figure 14: Authentication File Web Page

5. Select **Install the license file specified below**.
6. Browse to the customer's license file (.lic), which you downloaded from the RFA web site.
7. Click **Submit**. A message appears telling you your installation was successful.
8. From the navigation menu, select **Security > Authentication File**. The Authentication File web page appears.

The Authentication File Web page allows installation of Avaya authentication files.

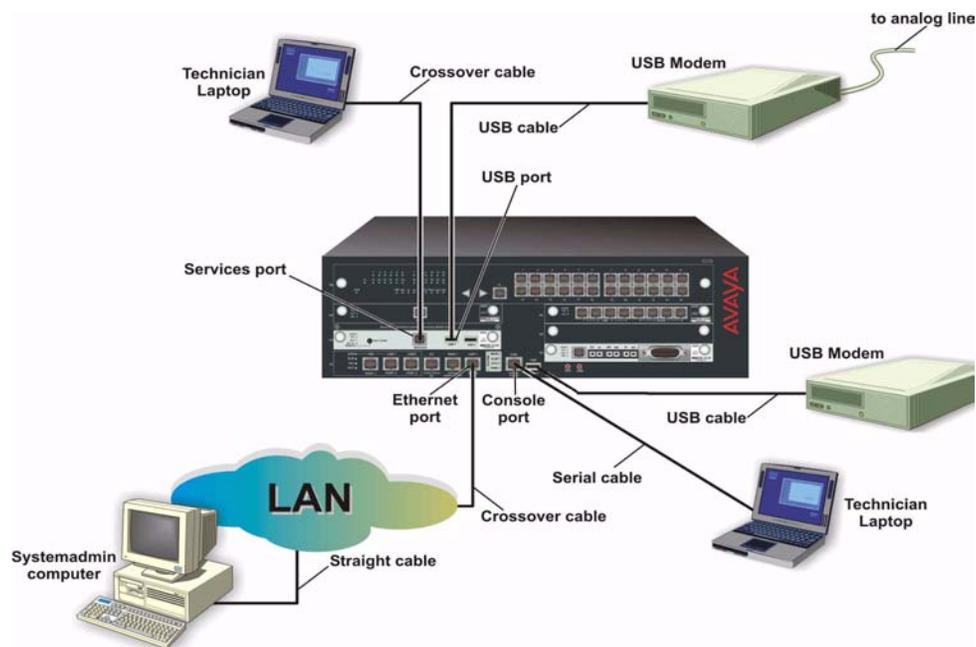
Figure 15: Summary of S8300 and G350 Access Methods and Tasks

There are several methods of connecting to the Avaya G350 Media Gateway and the S8300 Media Server, as shown in [Figure 15: Summary of S8300 and G350 Access Methods and Tasks](#) on page 275. Choose the method and tools appropriate for your maintenance task.

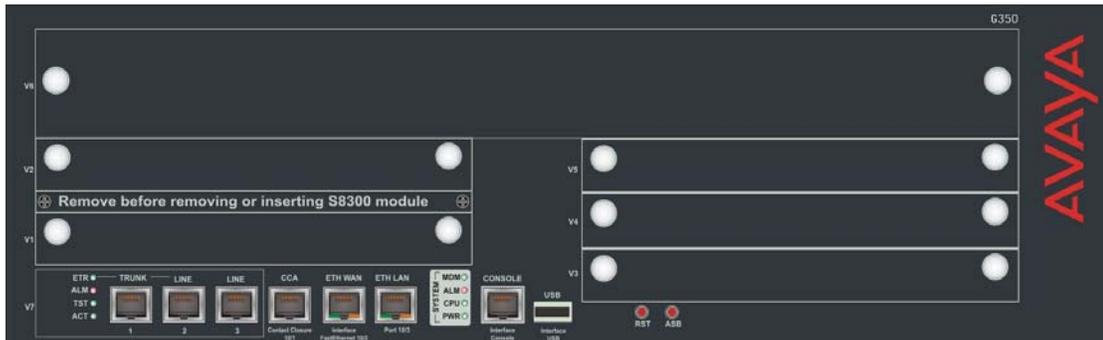
Figure 16: G350 chassis

The following figure shows the G350 chassis:

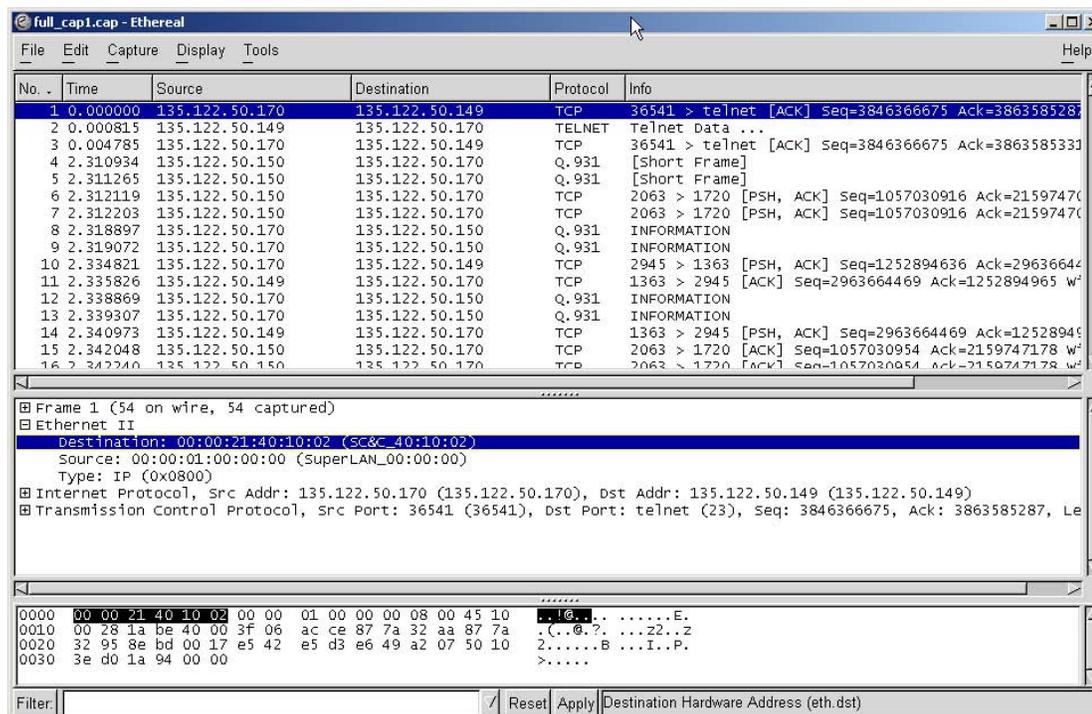
Figure 22: Sample Ethereal screen

The following figure shows a sample Ethereal screen.

The dummy Ethernet headers are allocated according to the original packet type. Dummy Ethernet headers start with 00:00. Therefore if the source or destination address of a packet you are viewing in Ethereal starts with 00:00, this indicates the packet is a non-Ethernet packet. For example, see the highlighted destination address of the packet appearing in the middle pane in [Figure 22](#).

Thus in the example appearing in [Figure 22](#):
