Meridian Mail Options

Maintenance Procedures

Publication number: 555-7011-500
Product release: 10.0
Document release: Standard 1.0
Date: August 1995

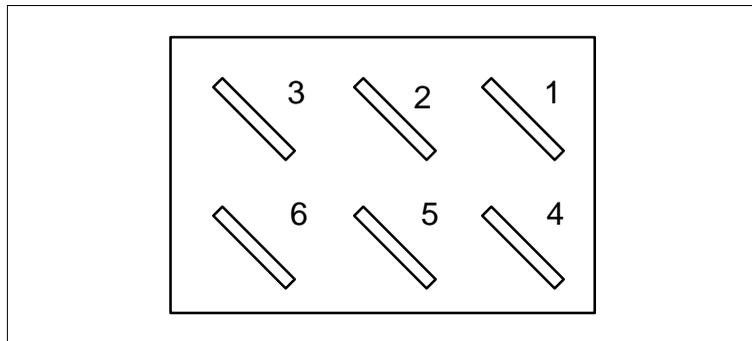
Figure 1-1
Power connector pin outs on fan unit

- 3 Ensure that wire harness is properly connected to the power distribution unit at fan unit power connector.
If connected incorrectly, reconnect wire harness.
- 4 Check power distribution unit.
If a problem is evident, replace the unit.
- 5 Check DC voltage at fan unit.
 - a. Disconnect the power cable from the fan unit.
 - b. Measure the voltage at pins 3 and 4 on the power cable connector (see Figure 1-1).
The measurement should read -52 V DC. If the voltage is correct but the fan isn't running, replace the defective fan unit.

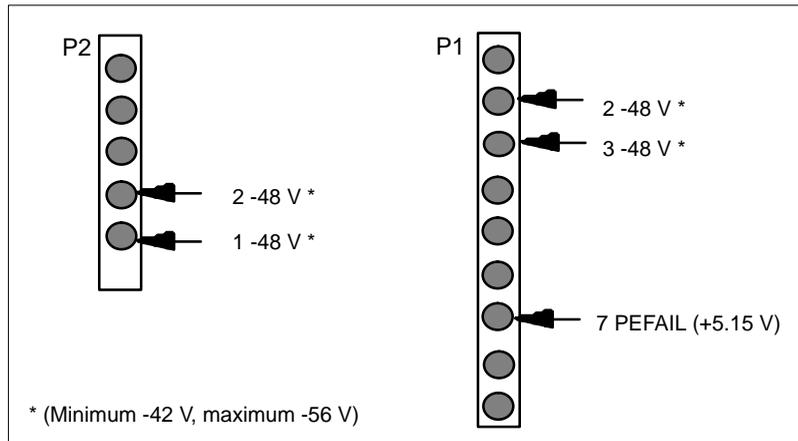
Figure 1-2
Backplane pinouts

Readings should match those shown in Figure 1-2.

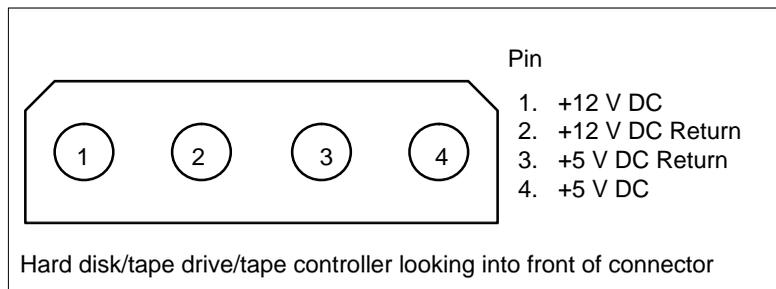
Figure 1-3
DC power connector pinouts

- 2 Check QPC585 power converter and disconnect from disk. Check LEDs. Repeat this procedure for tape drive and controller. Replace the power converter or the unit suspected of causing the problem.
- 3 Power down Meridian Mail and, from the front of the cabinet, remove power connector P3 from the hard disk. Power Meridian Mail back up and measure the voltages at P3 (see Figure 1-3).

If incorrect voltages are measured at hard disk power connector P3, do the following:

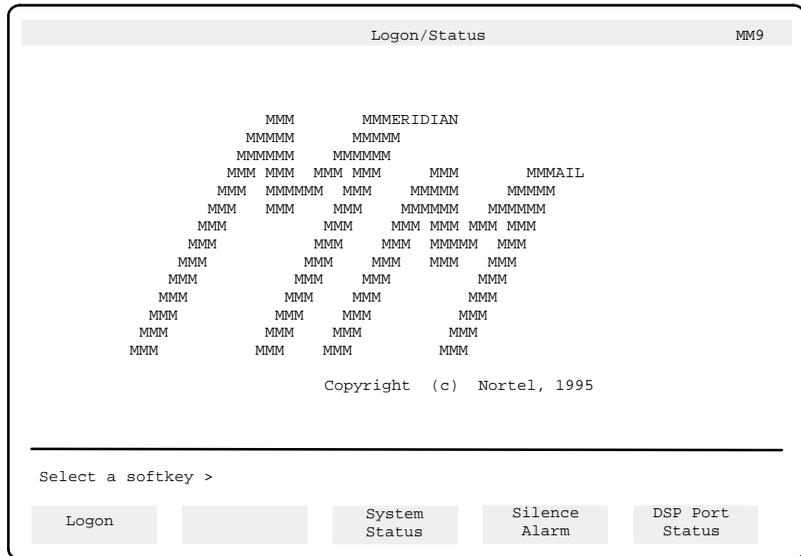
Figure 1-4
The Logon screen

Stage	Key phrases	Comments
9	<pre>PRM: Waiting for Seer Server to register . . . PRM RebootNode: resetting node 2 waittime 0 . . .</pre>	<p>SEER output on the printer should be expected a few seconds after this message.</p> <p>If this is a two-node system, then the non-prime node will be reset here.</p>
10	<pre>PRM Running startup diagnostics . . . PRM: OSP is Up - node 2 . . .</pre>	<p>Diagnostic programs are run</p> <p>On two-node systems, operating system (OS) is loaded on the non-prime node.</p>
11	<pre>PRM: Startup diags finished, starting up system</pre>	<p>Application programs are loaded.</p>
12	<p>The Logon screen comes up as shown in Figure 1-4.</p>	
<p>—end—</p>

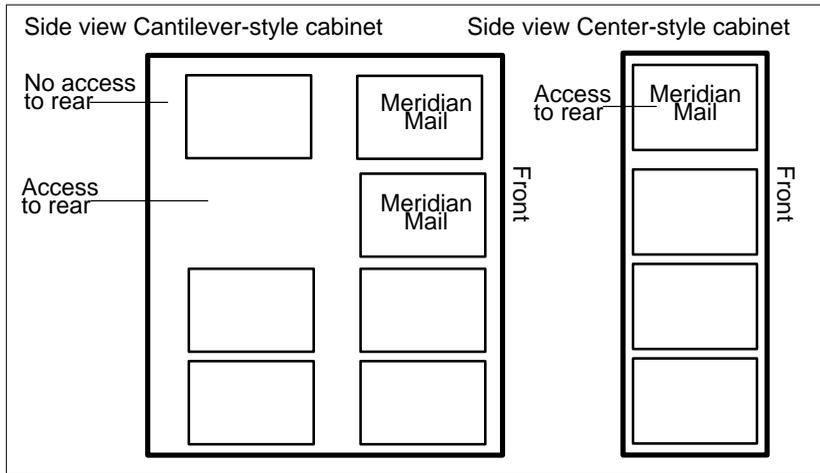
Figure 3-1
Rear access to the Meridian Mail Option shelf

This is only to access the rear of the shelf. If there is no other shelf behind Meridian Mail as in the Center Mount style, then access to the rear is provided without shelf removal. See Figure 3-1.

- 1 Shut off power to the Meridian Mail shelf using the circuit breaker located at the bottom of the Meridian 1 cabinet.
- 2 Select the proper breaker number corresponding to the location of Meridian Mail unit.
(Option only) The main power circuit breaker for the shelf is located on the QBL21 for Cantilever Mount and the QBL10 for Center Mount. See Figure 3-1. These are the power distribution units for Meridian Mail.

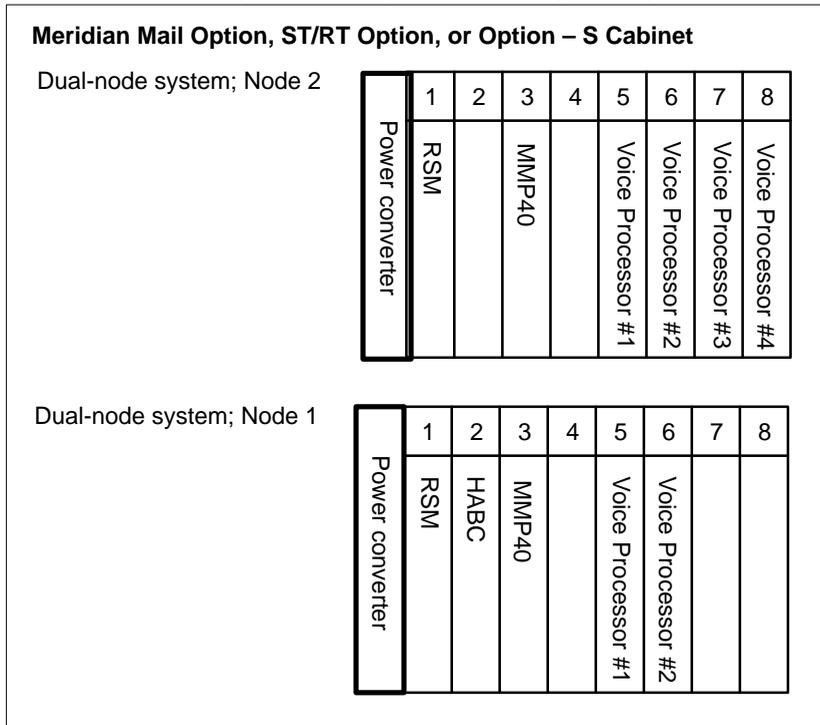
Figure 3-2
Printed Circuit Pack positions—Option, ST/RT Option, Option – S

The PCP slot positions are shown in Figures 3-2 for Option, ST/RT Option, and Option – S cabinet. See *Options Installation Procedures* (NTP 555-7011-210) for PCP switch and jumper settings.

- 3 If there are cables attached to the front of the card to be replaced or checked, disconnect them. Use the card ejectors to remove each PCP.
The designation strip at the bottom rail of the shelf identifies the locations of each pack. Circuit pack locations depend on system size. See Figure 3-2 (Option, ST/RT Option, and Option – S cabinet).
- 4 Verify the switch and jumper settings on the replacement PCP. See *Options Installation Procedures* (NTP 555-7011-210).
- 5 Slide the replacement PCP into the correct slot and fasten the card ejectors. Reattach cables if necessary.
- 6 After ensuring that all cables are properly attached, fasten the cover.

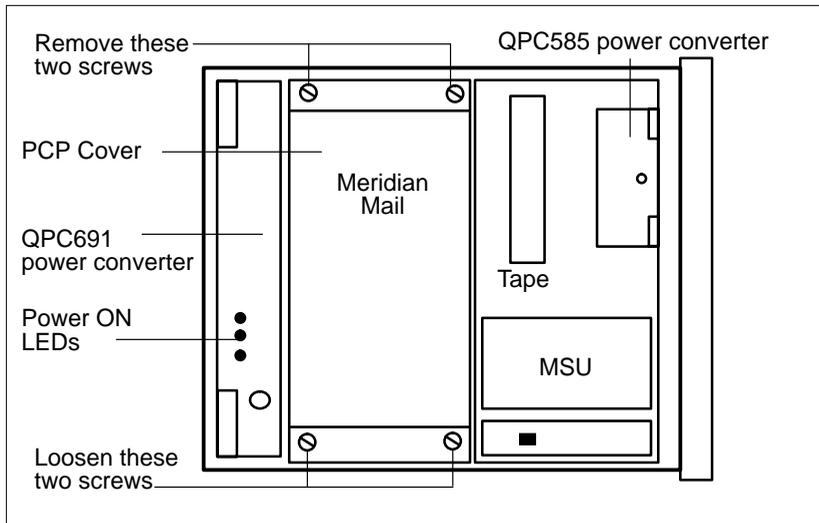
Figure 3-3
PCP cover location (ST/RT Option, Option)

- 3 Locate the power converter to be serviced. The PCPs are powered by the QPC691, and the Mass Storage Unit is powered by the QPC585. (See Figure 3-3.)

- 1 Locate the circuit pack cover on the Meridian Mail shelf (see Figure 3-3).

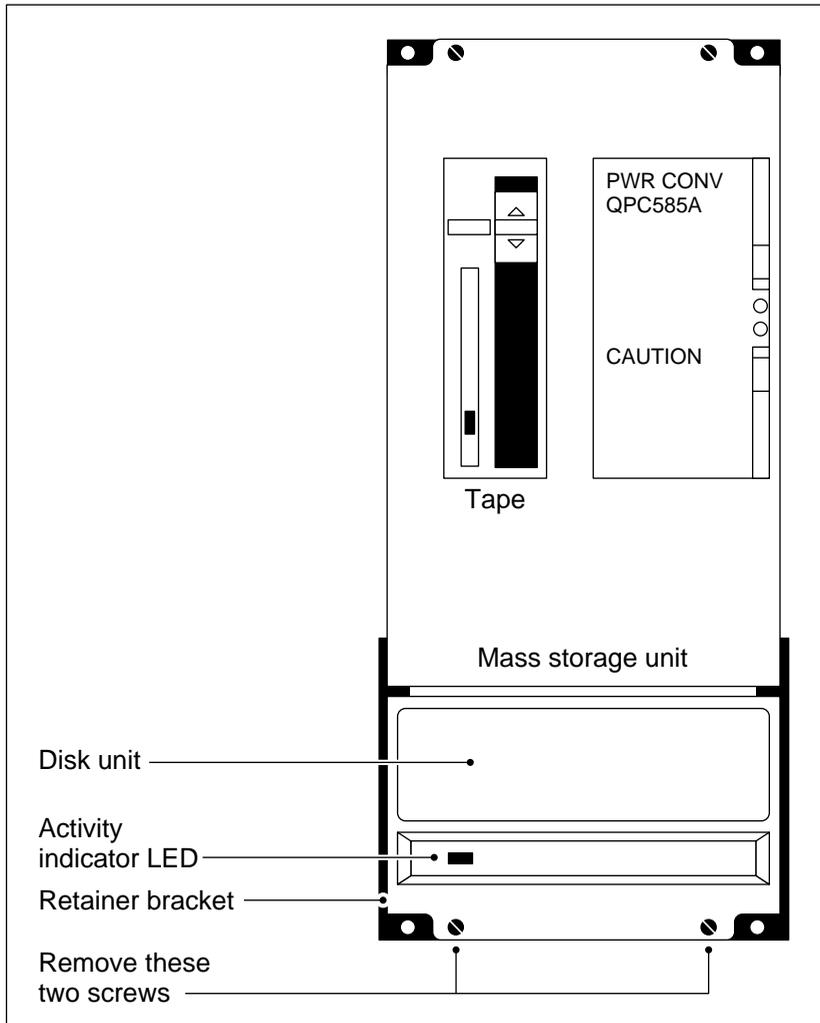
Figure 3-4
Disk unit location

- 1 Locate the opening for the disk unit on the Mass Storage Unit (MSU). See Figure 3-4.
- 2 Remove the disk retainer bracket attached to the bottom of the Mass Storage shelf. Set the two screws and the bracket aside.
- 3 Move to the rear of the shelf/cabinet and locate the Rear MSU access cover (see Figure 3-5)
- 4 Lift the cover away from the rear shield and set it aside.
- 5 Remove the Small Computer Systems Interface (SCSI) data cable and the DC power harness from the disk unit (see Figures 3-6 and 3-9).

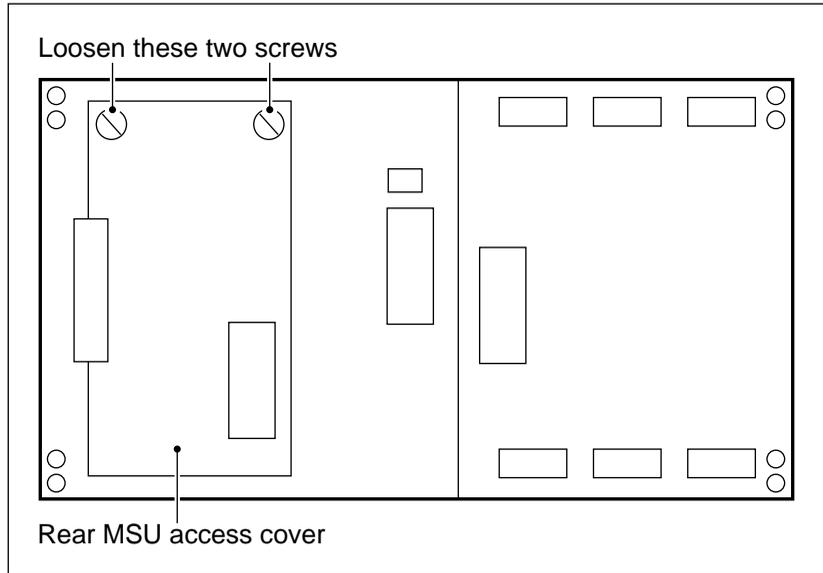
Figure 3-5
Rear Mass Storage Unit cover location

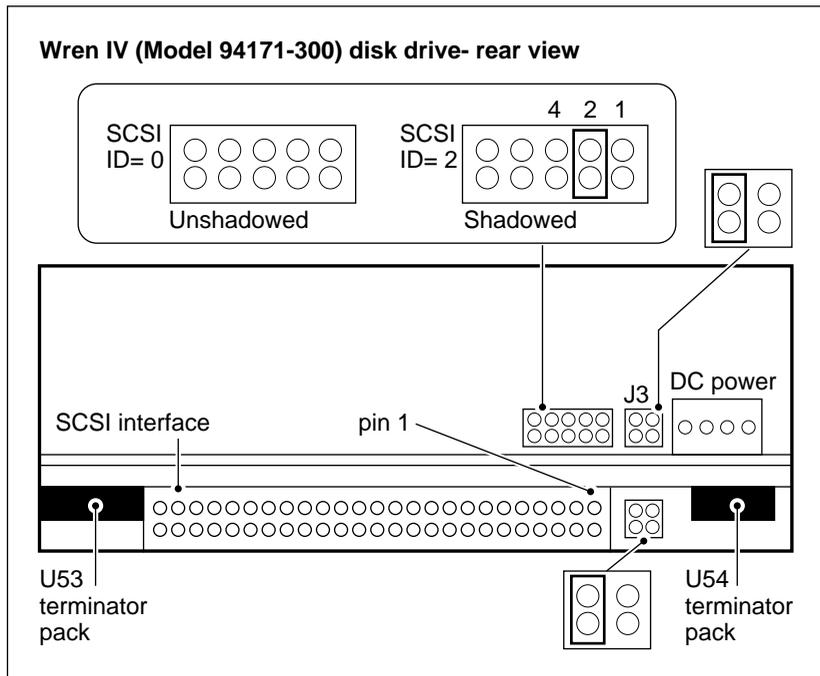
Figure 3-6
300-Mbyte Seagate Wren IV 94171 disk drive connectors and jumper settings

- 1 Check the SCSI cable installation and the jumper settings. Refer to Figures 3-6, 3-9, 3-10, 3-11, 3-12, and 3-13.
- 2 Check the power to disk and tape (+5 V, +12 V, +24 V).
- 3 Replace MMP40 board.
- 4 Replace disk.

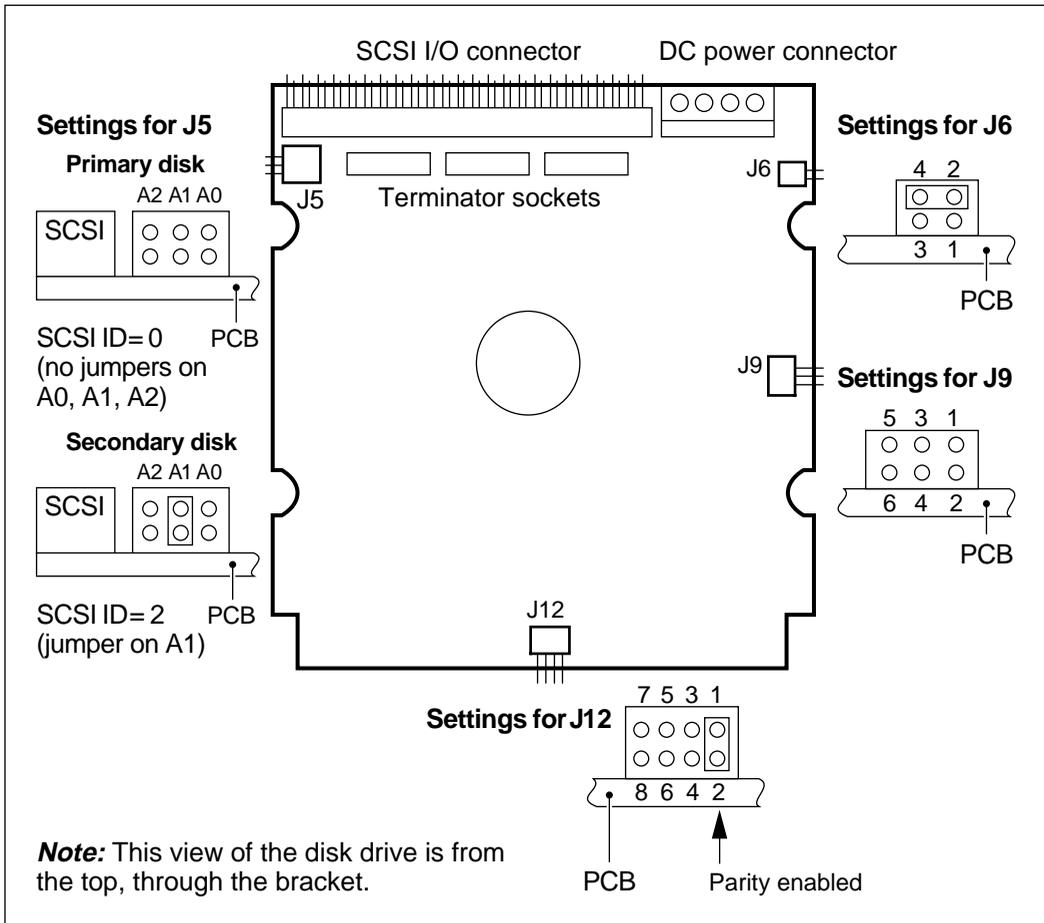
Figure 3-7
300-Mbyte Seagate ST3390N disk drive connectors and jumper settings

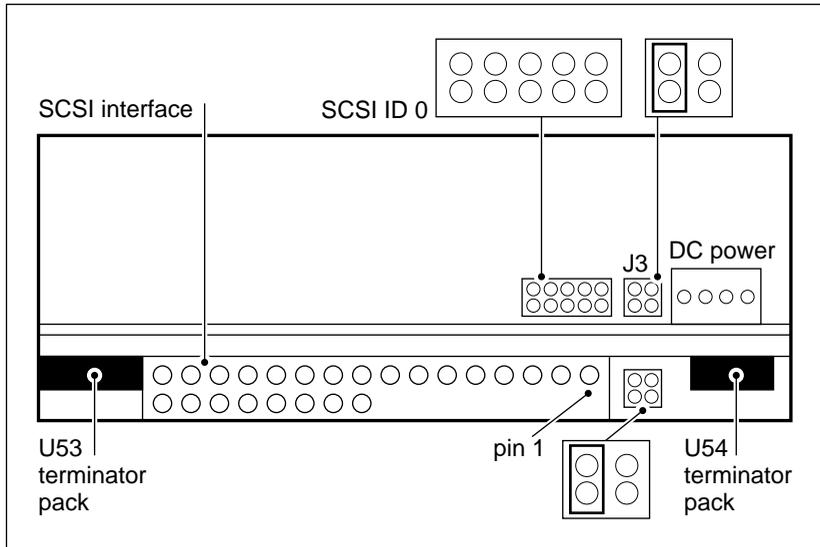
Figure 3-8
300-Mbyte Seagate ST4376N disk drive connectors and jumper settings

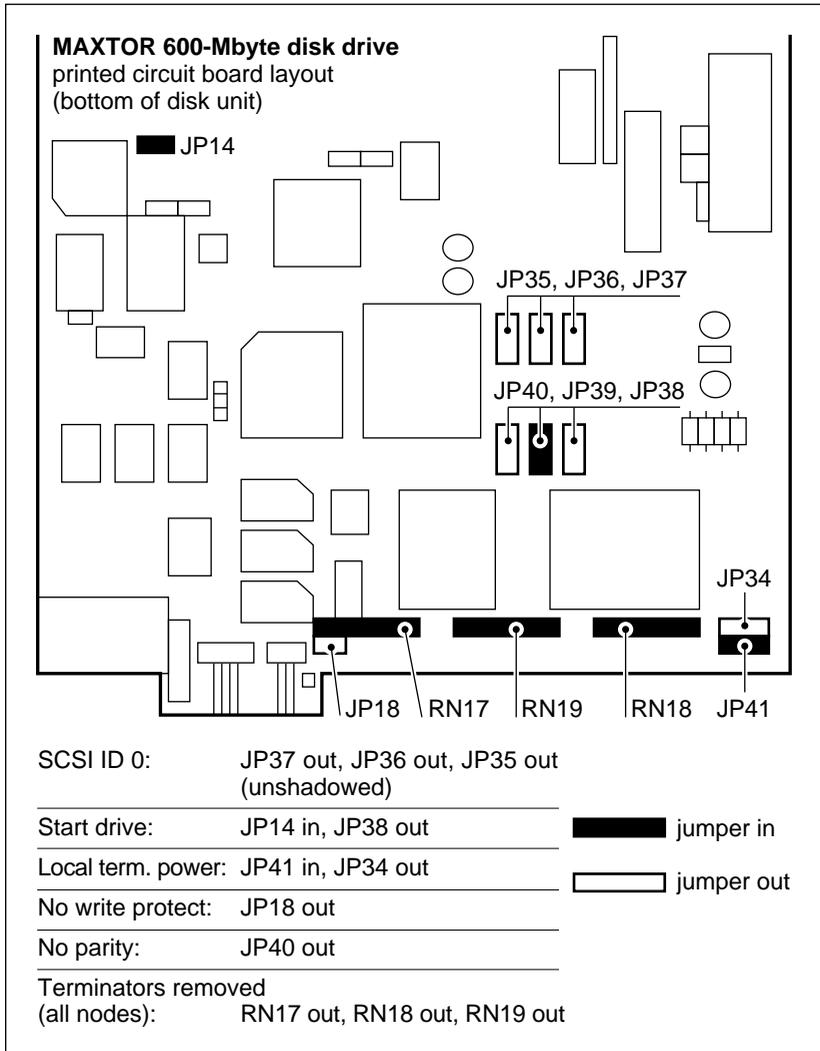
Figure 3-9
600-Mbyte Maxtor disk drive (unshadowed systems only)

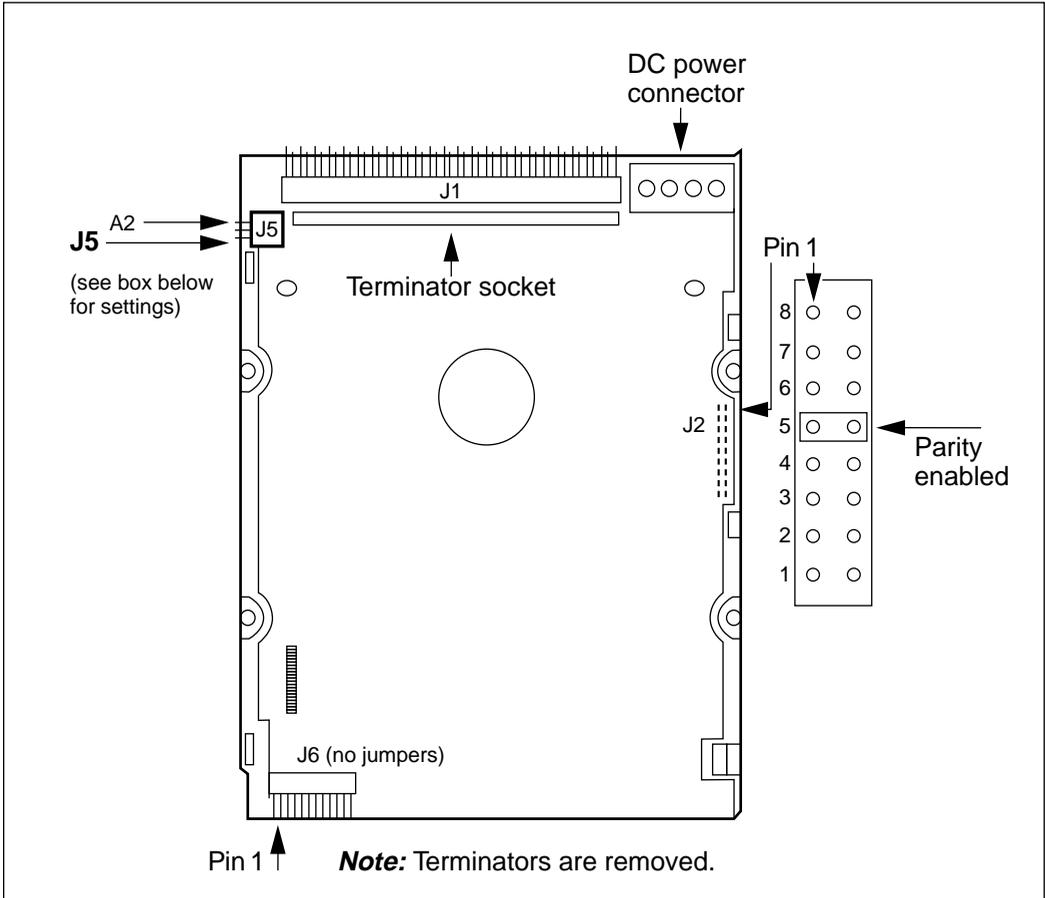
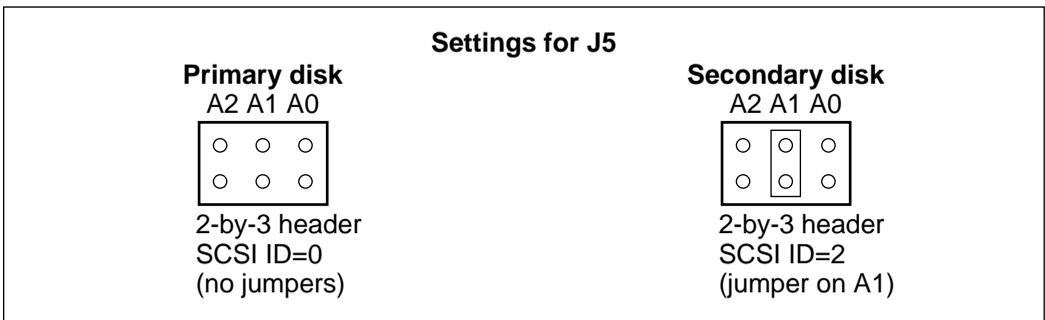
Figure 3-10
1.0-Gbyte Seagate ST11200N or ST31230N disk drive connectors and jumper settings

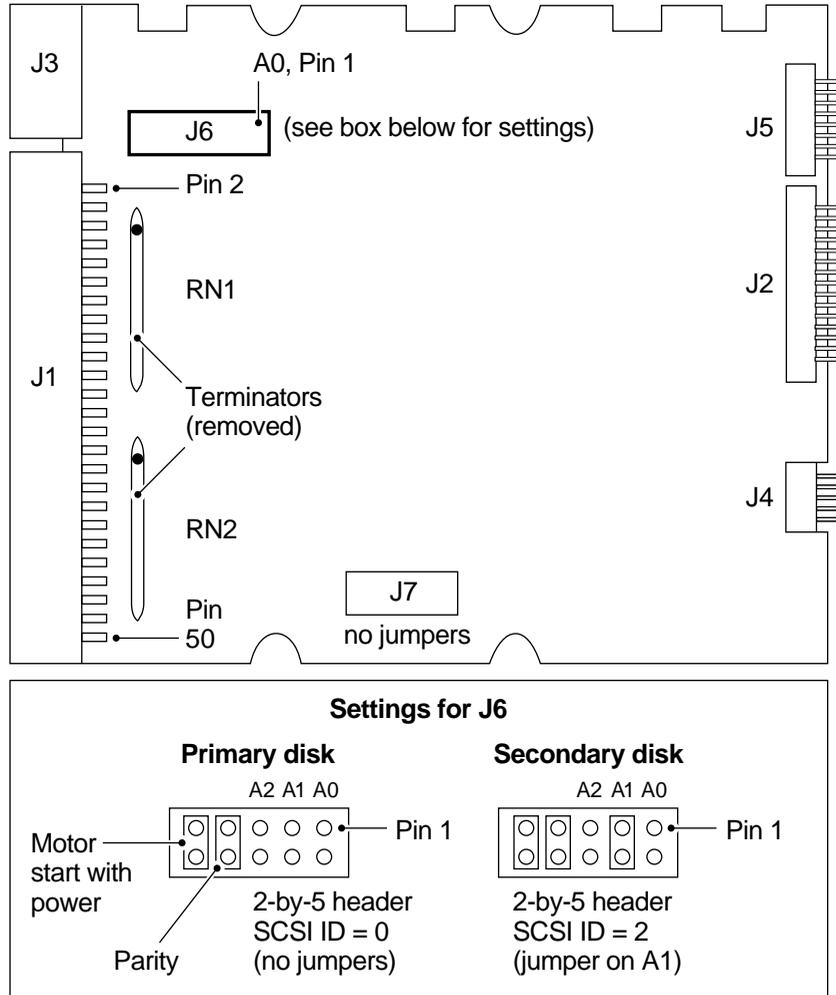
Figure 3-11
1.0-Gbyte Maxtor MXT1240 disk drive connectors and jumper settings

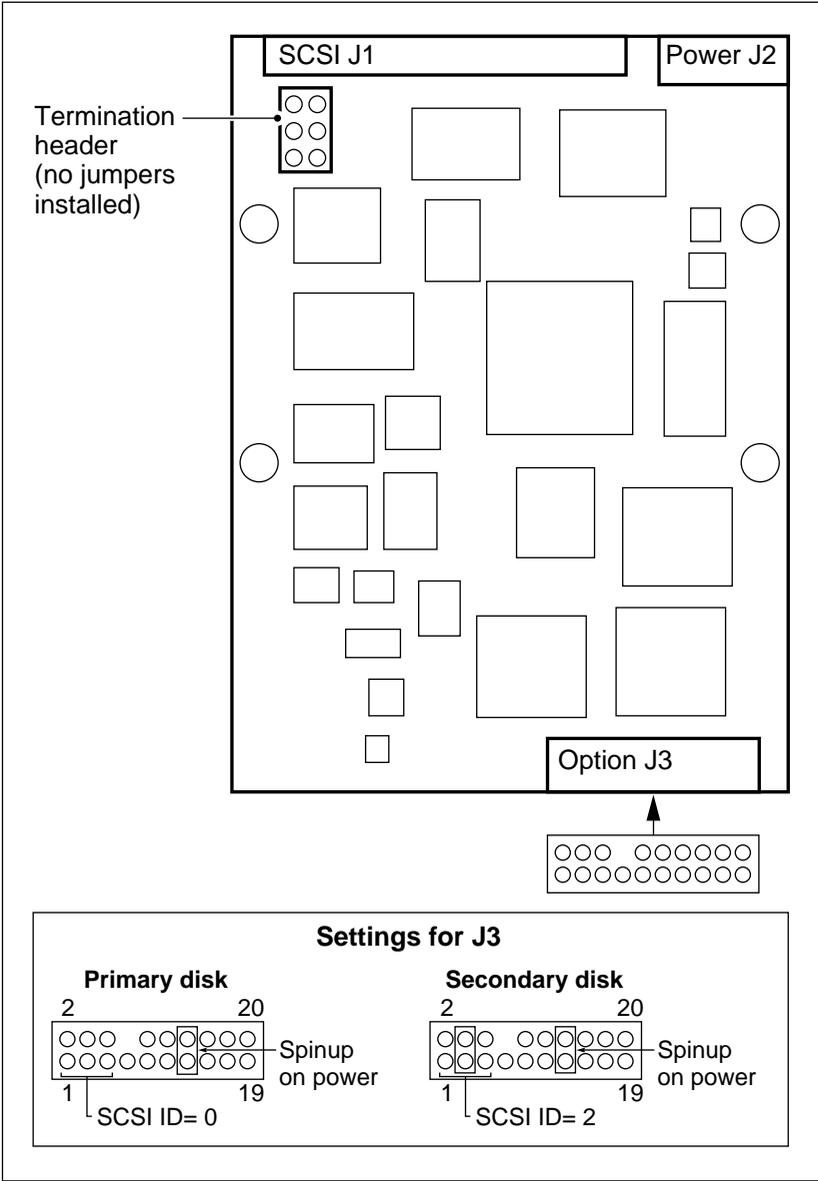
Figure 3-12
DSP3107L disk drive connectors and jumper settings

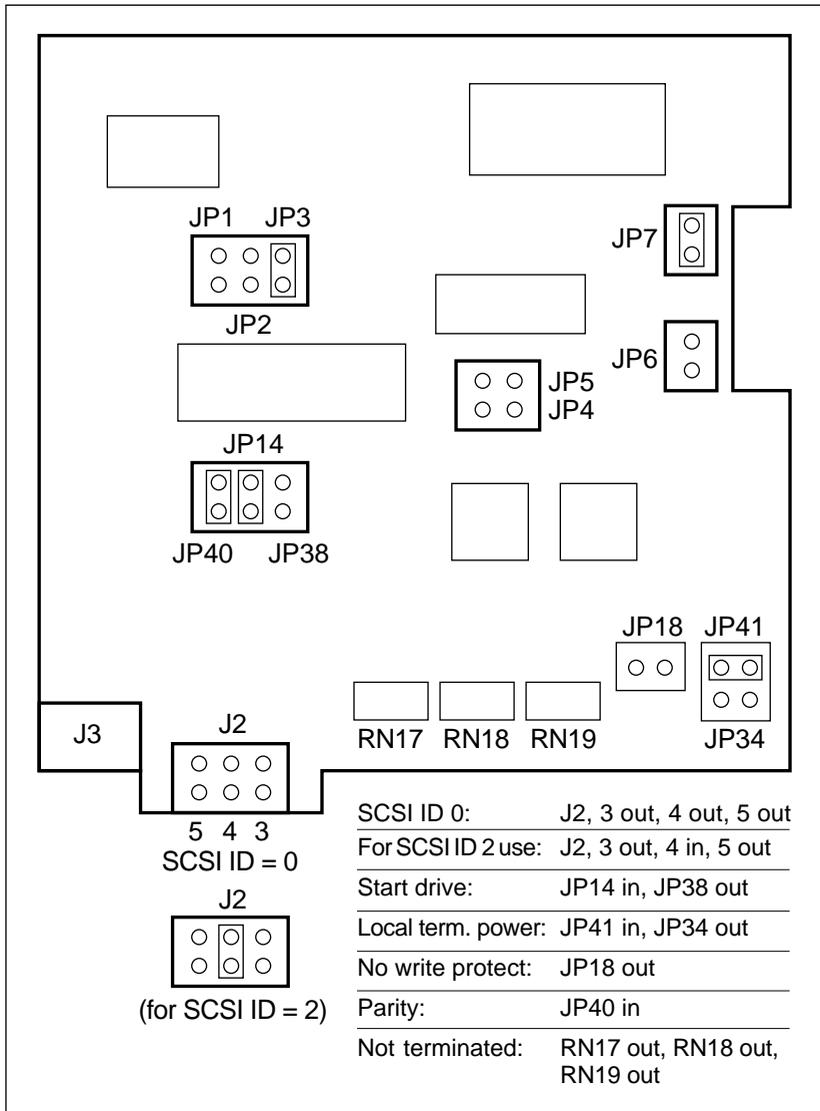
Figure 3-13
Maxtor/Sequel XT8760SH disk drive connectors and jumper settings

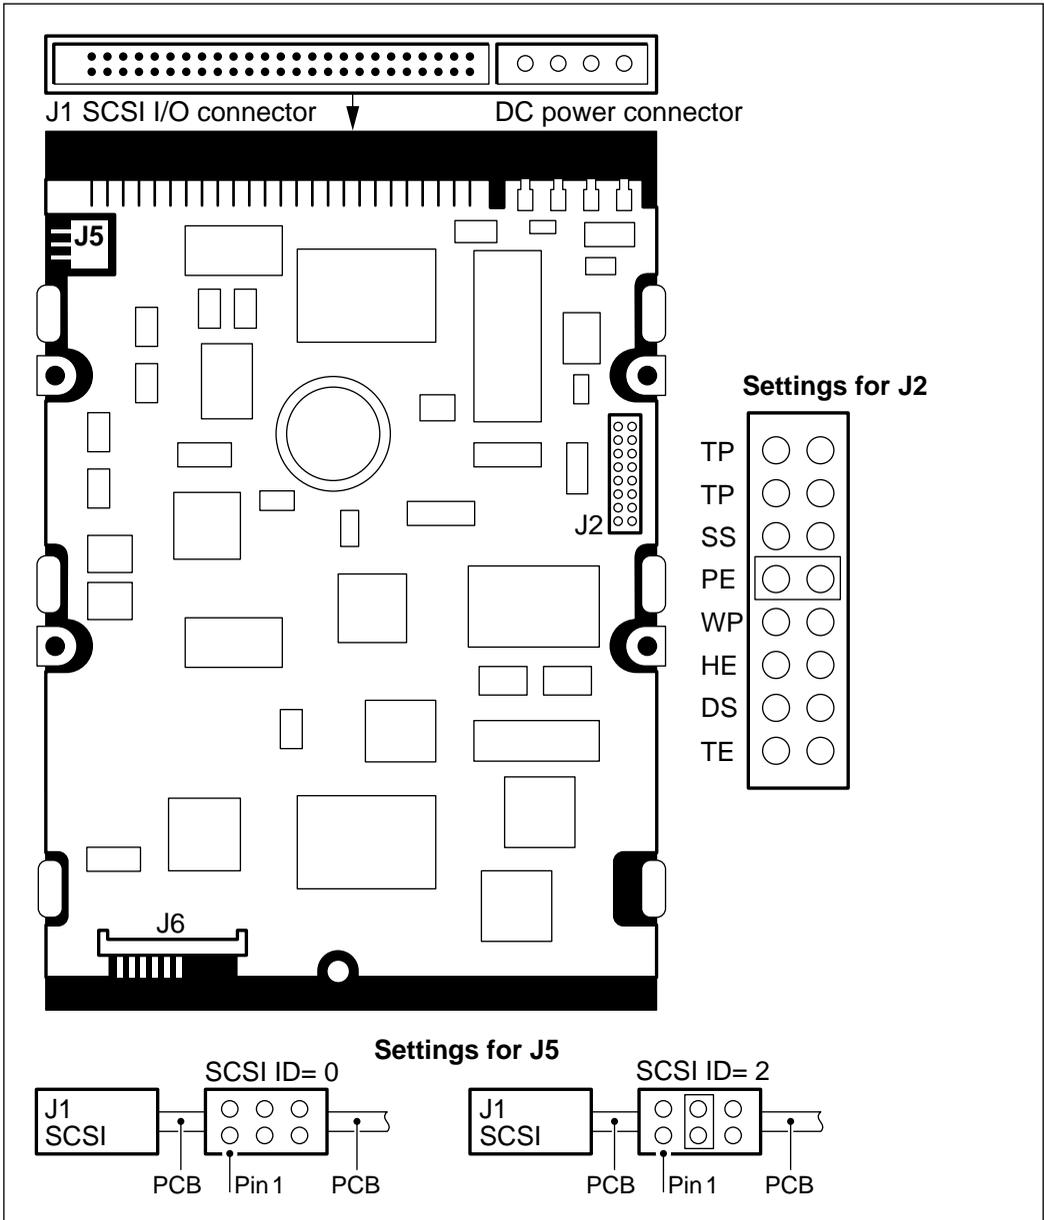
Figure 3-14
Seagate Hawk (ST1120N & ST31230N) disk drive connectors & jumper settings

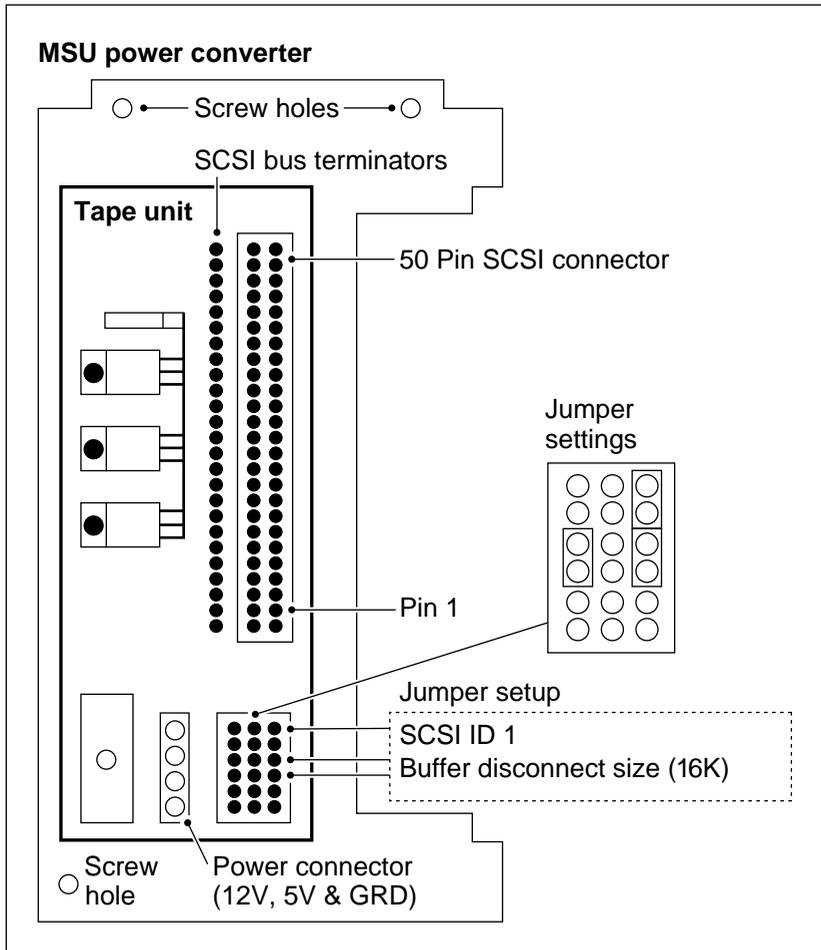
Figure 3-15
Archive mass storage unit

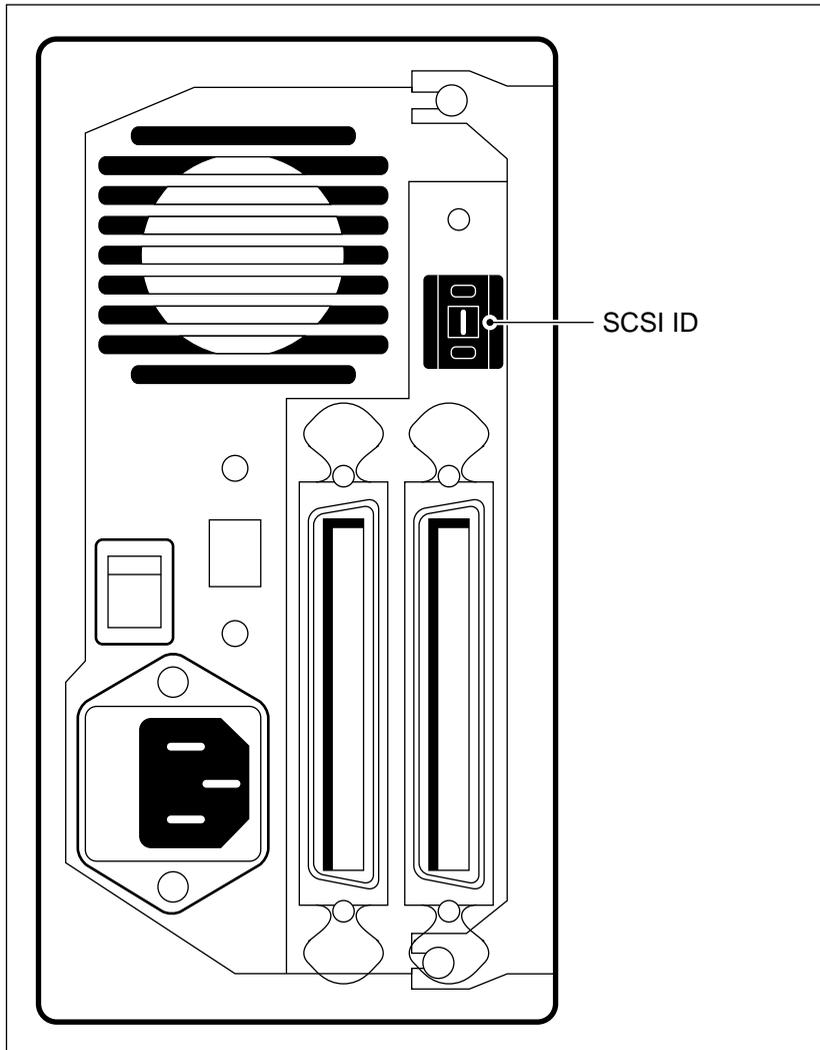
Figure 3-16
Rear of Archive tape drive showing location of SCSI ID

Archive—this is the 3-by-6 header header beside the SCSI connector. See Figure 3-17 and 3-16 for the header location.

Archive—involves removing any jumpers on the header in positions ID1 and ID2 and inserting a jumper on the header in position ID0 (see Figure 3-17 and 3-16).

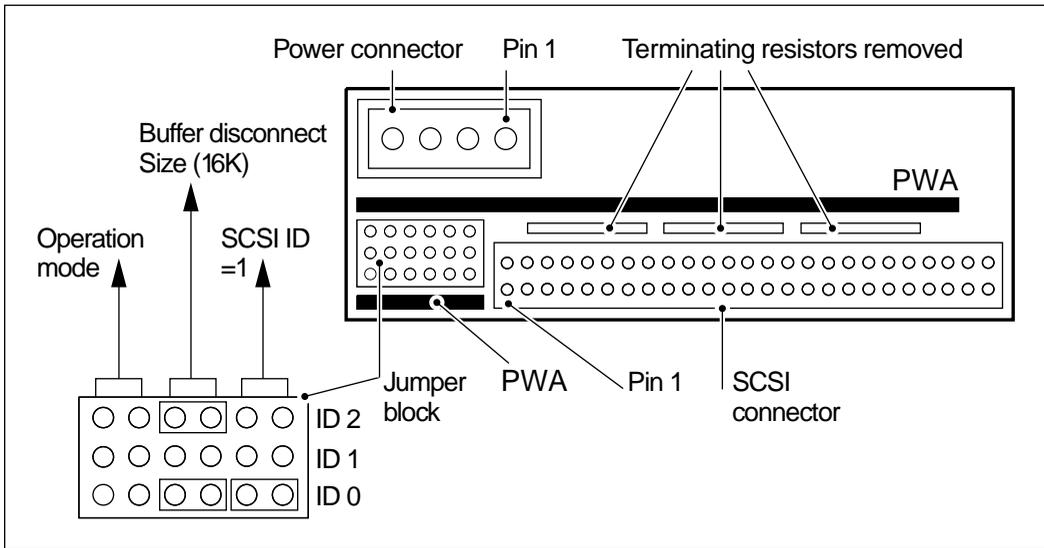
Figure 3-17
Archive tape drive connectors and jumper settings

- 1 Make sure the power is off for the Meridian Mail Option cabinet.
- 2 Check the jumper settings are correct as per Figure 3-17.
- 3 Make sure no SCSI bus terminator is mounted on the tape drive. (See Figure 3-17.)
- 4 Slowly insert the MSU (See Figure 3-17).
- 5 At the rear side, connect the SCSI interface cable with the red stripe in pin #1 and connect the harness cable into the power connector (12V, 5, and ground) of the tape.

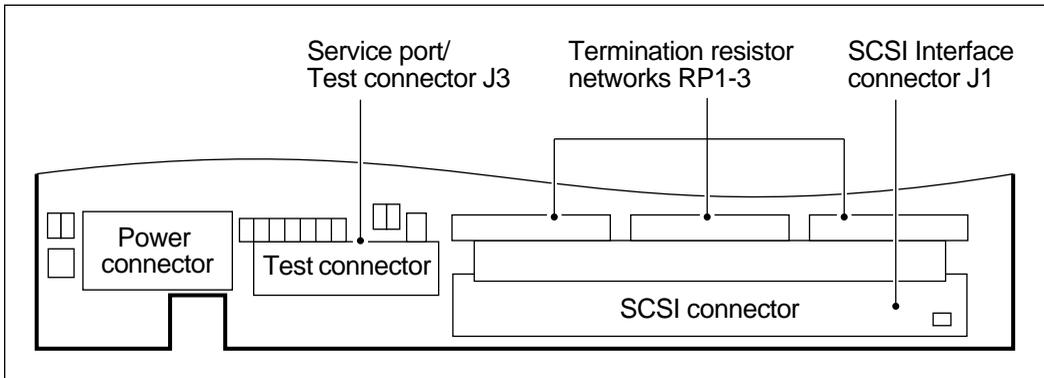
Figure 3-18
Front view of Tandberg tape drive connectors

Tandberg—this is the 2-by-10 header beside the SCSI connector. See Figure 3-19 and 3-18 for the header location.

Tandberg—involves inserting jumpers on the header in position 0 and parity (see Figure 3-19 and 3-18).

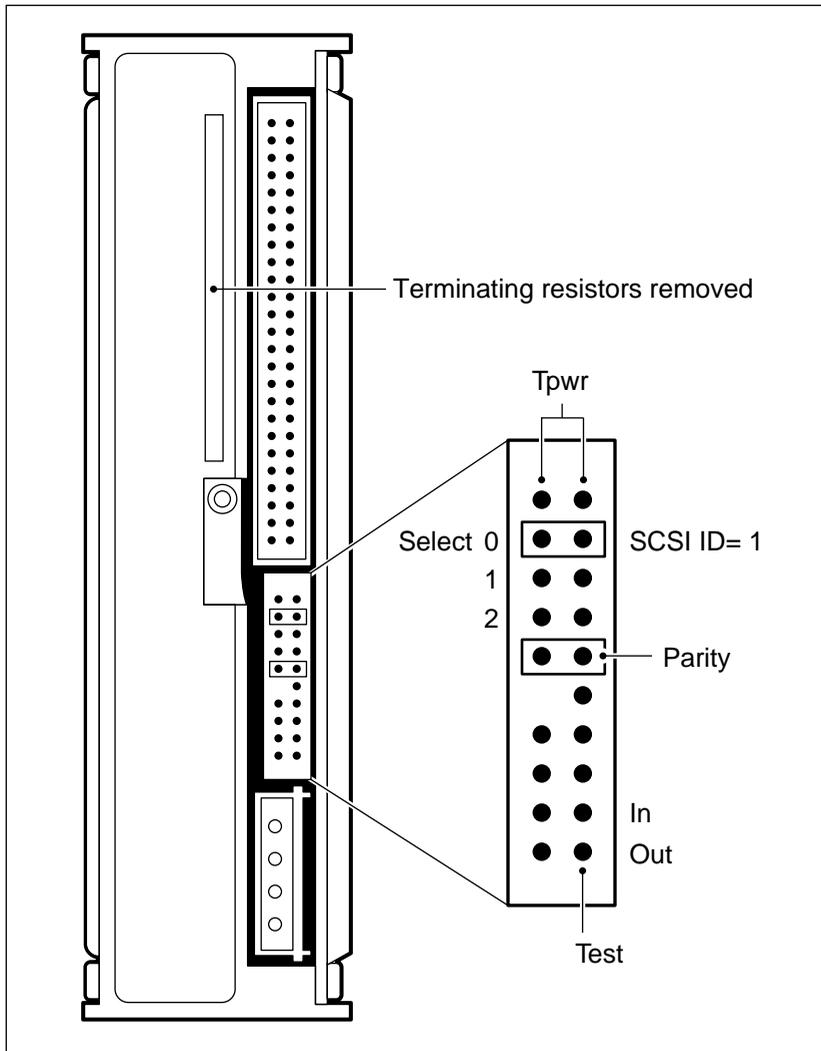
Note: Terminator resistors are removed.

Figure 3-19
Tandberg tape drive connectors and jumper settings

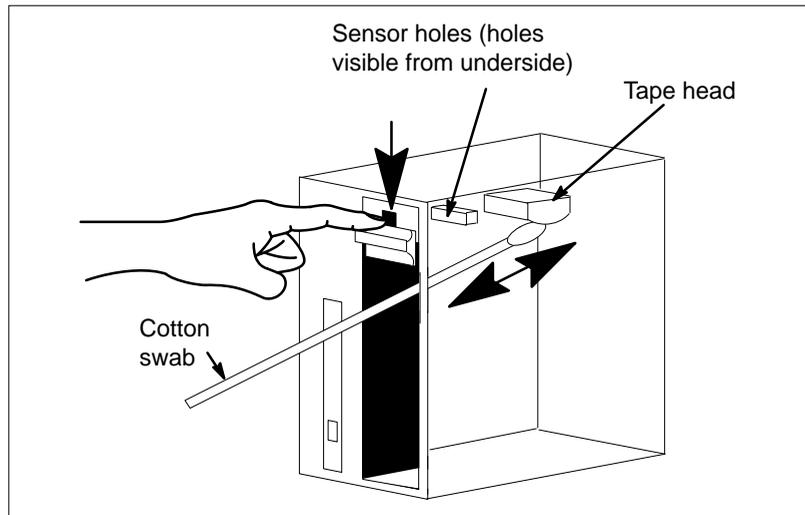
Figure 3-20
Archive tape drive cleaning

- 1 If there is a tape cartridge in the tape drive, remove the cartridge.
- 2 Push the head loading lever down into the load position.
- 3 Carefully blow out dust from the sensor hole and tape cartridge cavity with aerosol air. (Refer to Figure 3-20.)
- 4 Moisten a pad or swab with the head-cleaning fluid until it is saturated but not dripping.

- 5 Carefully wipe the head in the direction that the tape travels. (Refer to Figure 3-20).

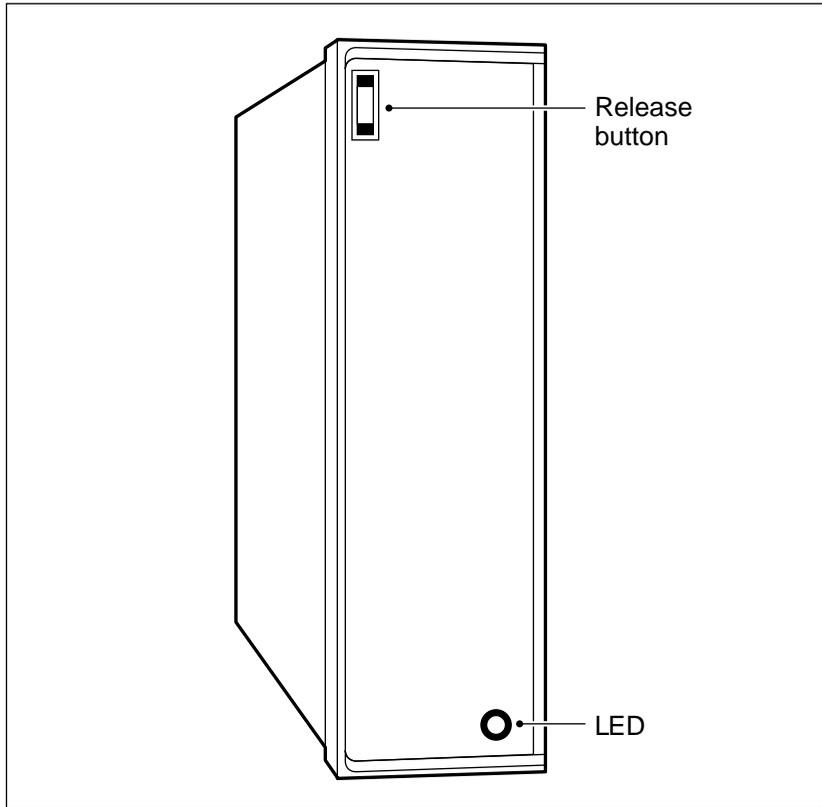
Figure 3-21
Tandberg tape drive

- 1 Press the release button on the tape drive (see Figure 3-21).
The tape drive door will spring open.
- 2 If there is a tape cartridge in the tape drive, remove the cartridge.
- 3 Prepare the cleaning cartridge as per the manufacturer's instructions.
- 4 Carefully blow out dust from the tape cartridge cavity with aerosol air.
- 5 Insert the cleaning cartridge into the tape drive.
- 6 Close the door to engage the cartridge.
The tape drive will start to spin.
- 7 After a suitable period (that is, several minutes), press the release button to disengage the cartridge.
The door will spring open and the tape drive will stop spinning.
- 8 Remove the cartridge and store it in its original container.
The cleaning cartridge should be stored in its original container and put away until its next use.
- 9 Wait a couple of minute for the tape heads to dry before using the tape drive.

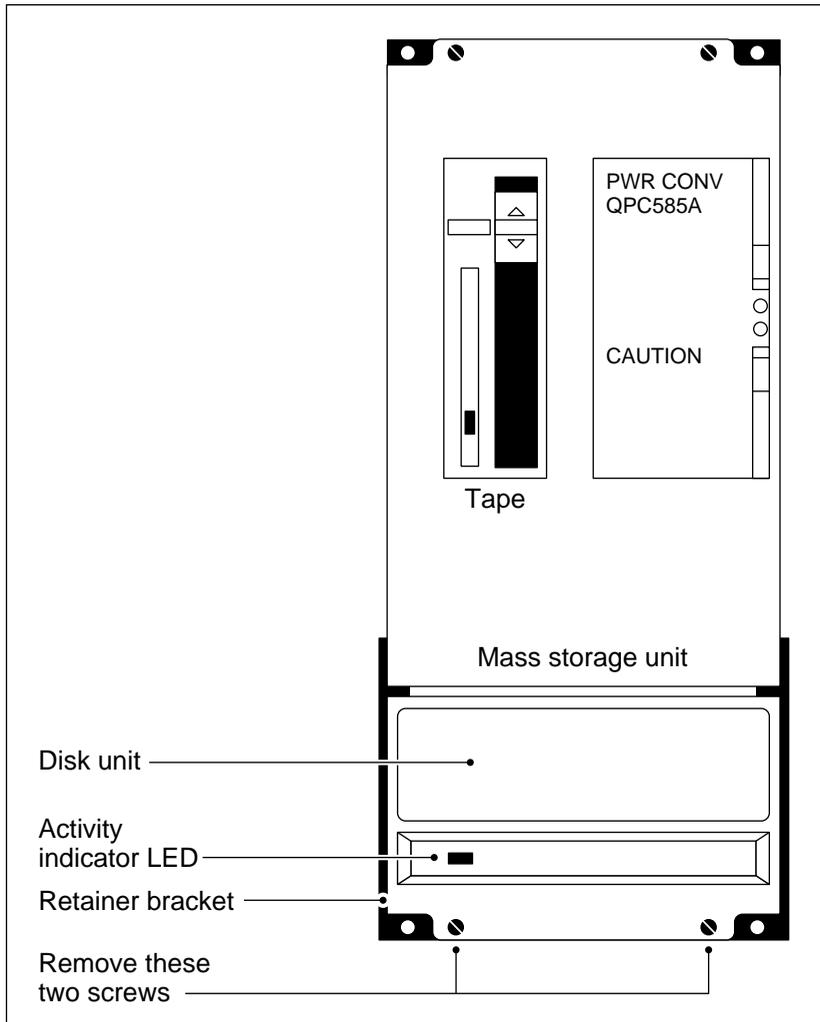
Figure 4-1
Meridian Mail tape shelf

Disk and tape drives are fed by a QPC585A DC power converter and may behave erratically when there are power problems. Using Figure 4-1, ensure that the LED on the panel of the converter remains solidly lit.
