Meridian Mail Options

Maintenance Procedures

Publication number: 555-7011-500
Product release: 10.0
Document release: Standard 1.0
Date: August 1995

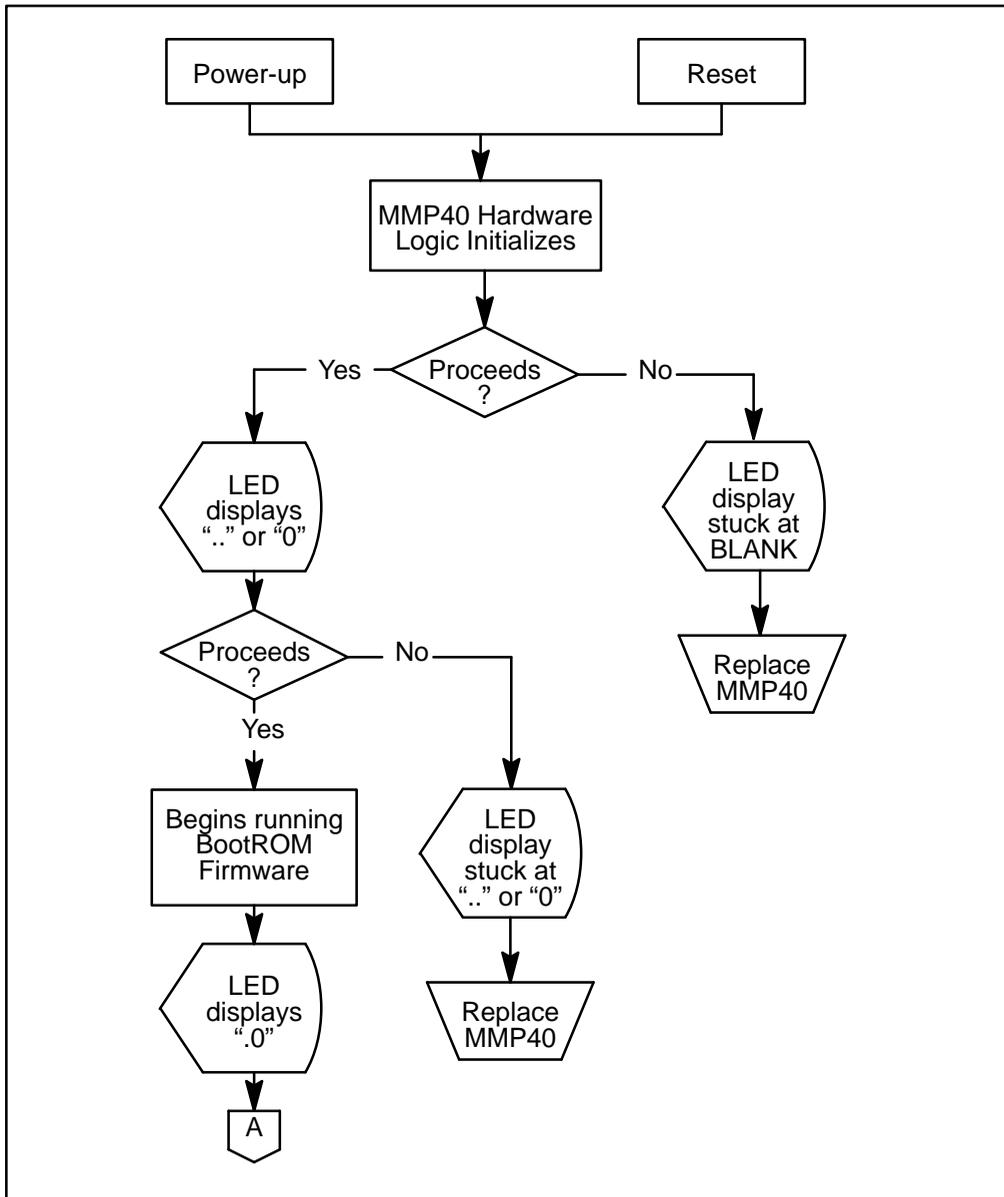
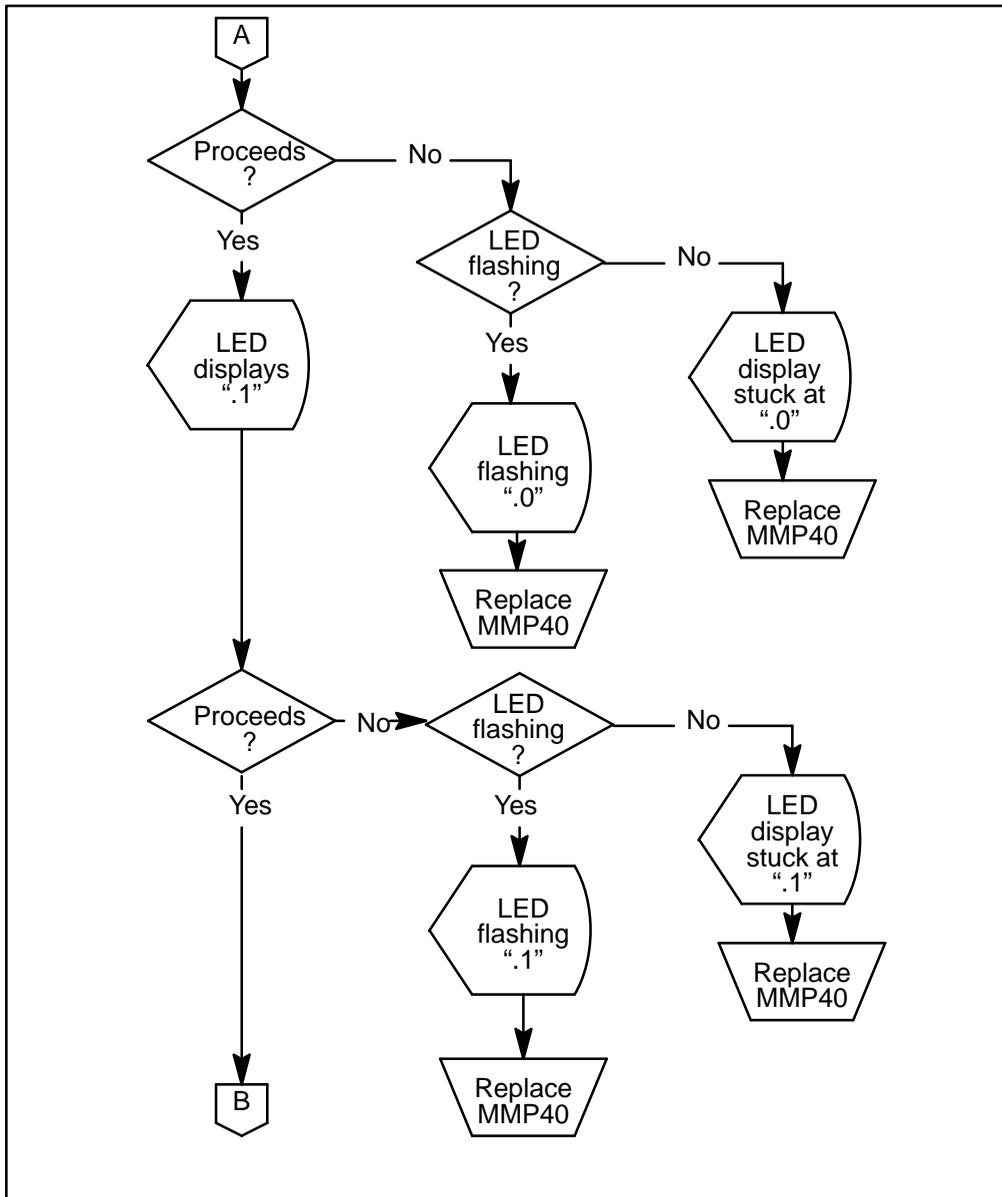
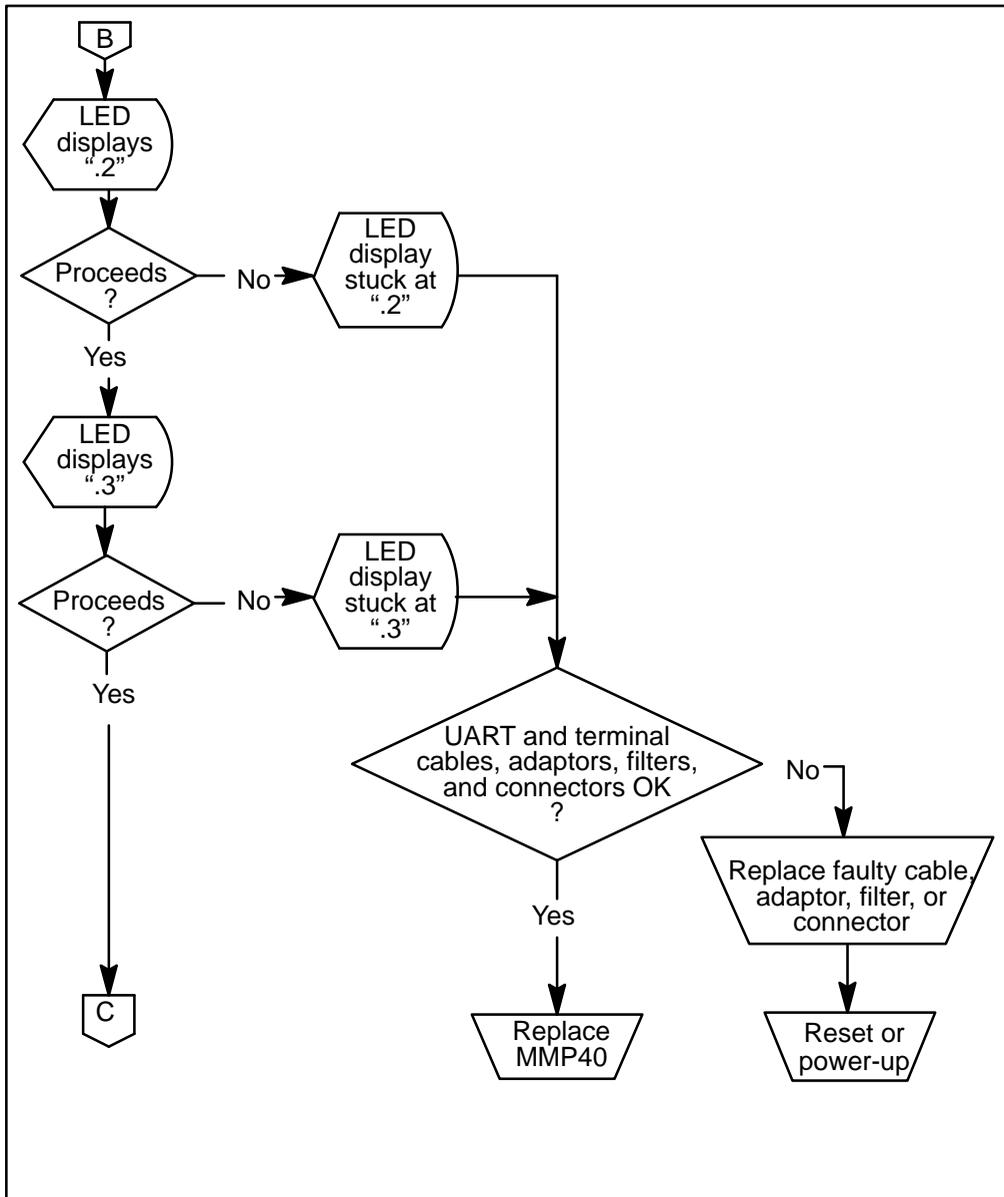
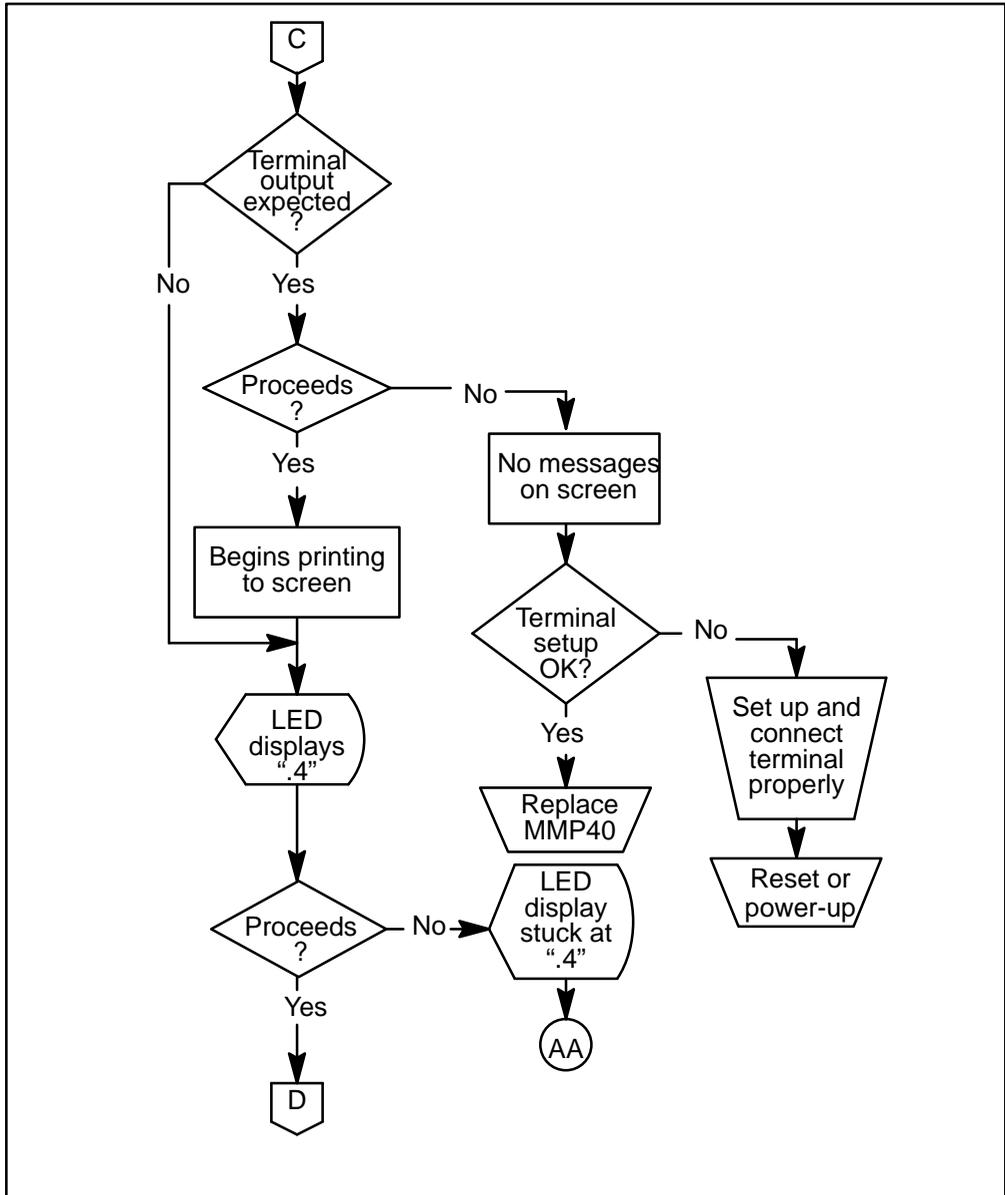
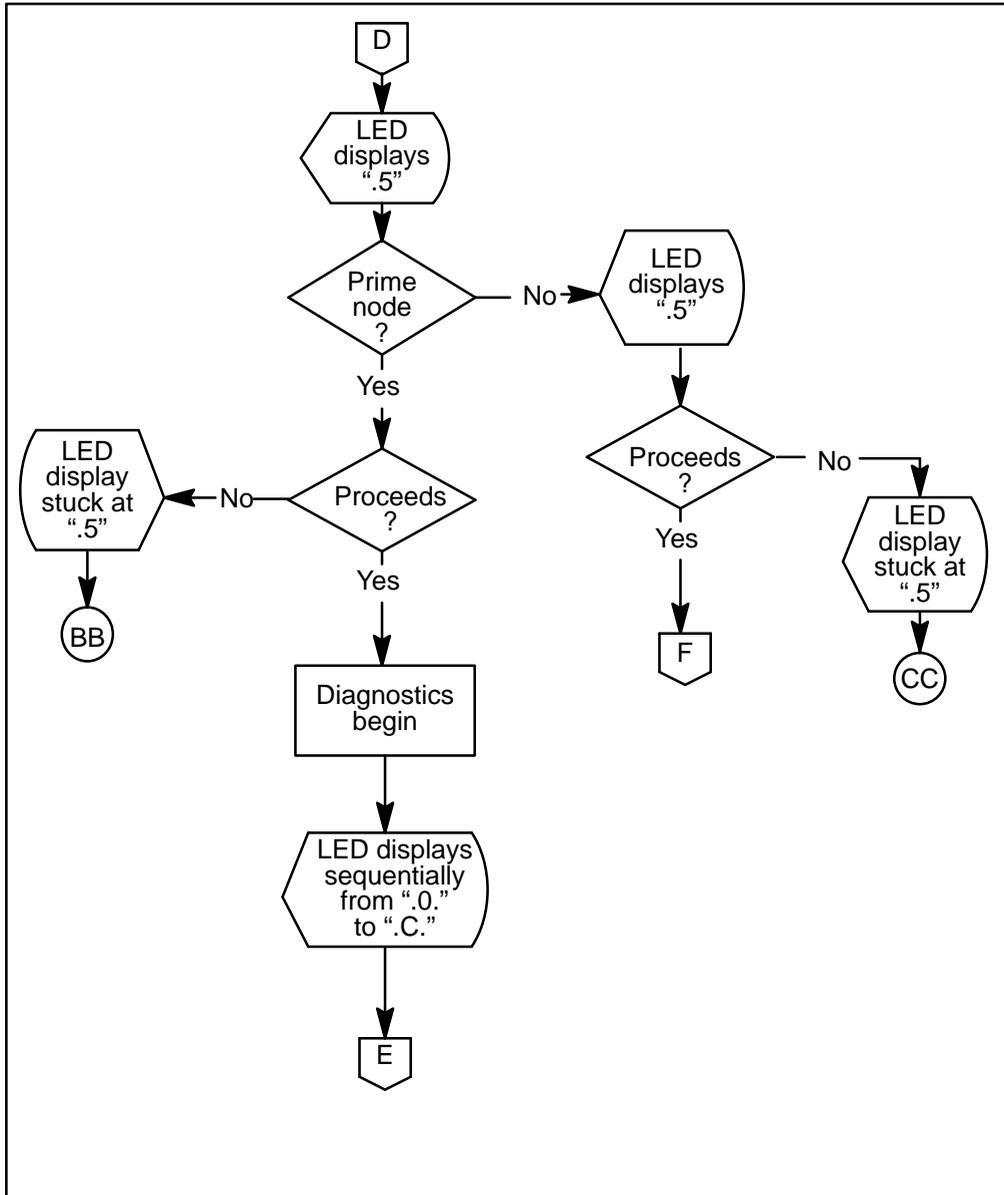
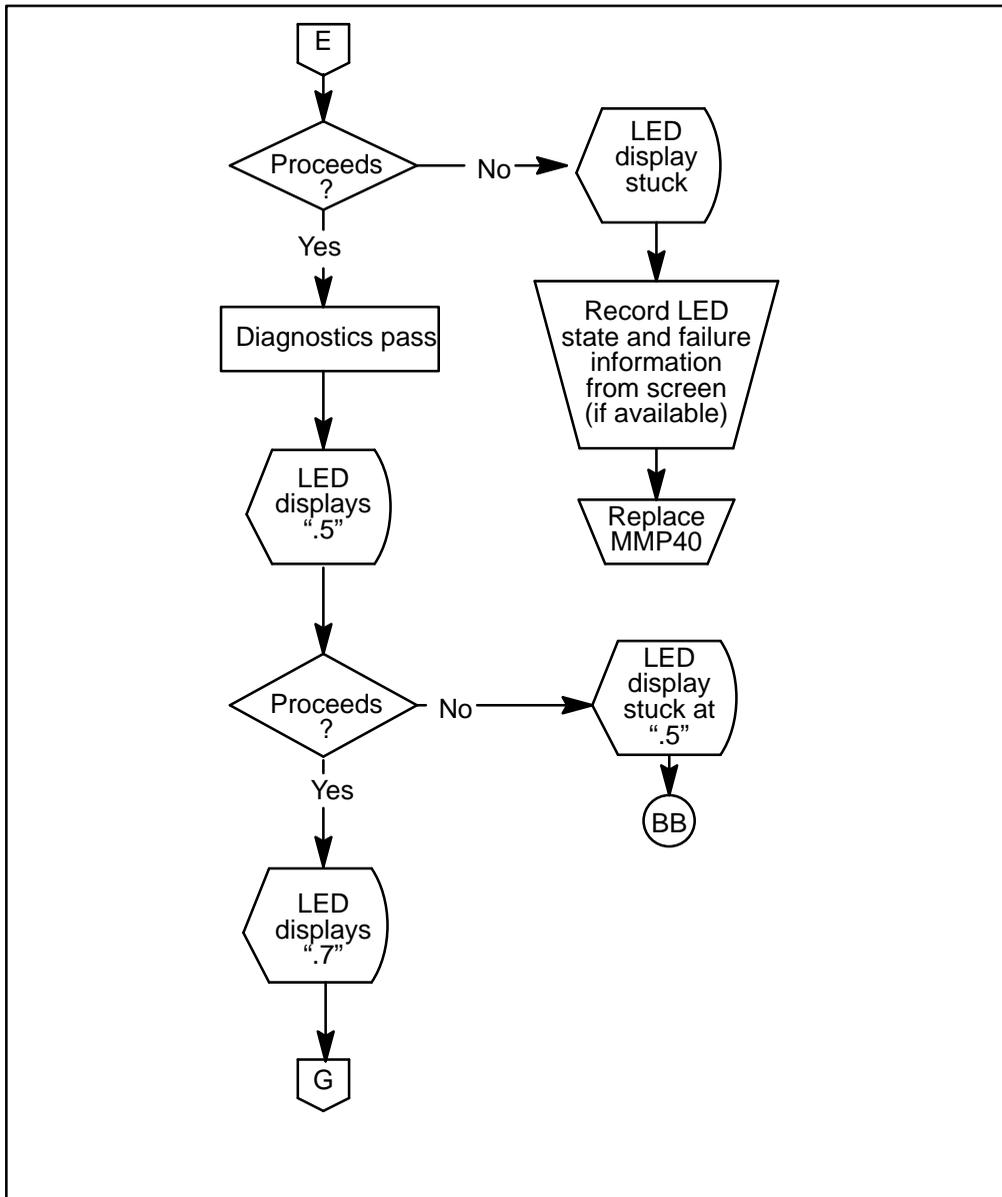
Figure 6-1
MMP40 troubleshooting flowcharts

The following charts can be used to determine causes and solutions for potential problems for the MMP40 card. Start from the first chart, and follow through the others until you have localized the problem. When directed to the double-letter options (AA, BB, CC, and so on), refer to the tables following the flowcharts.
