KEYBOARD DISABLE LOCK FEATURE FOR "DATASPEED\*" 40/4  
 ATTACHED KEYBOARD DISPLAY

1. GENERAL

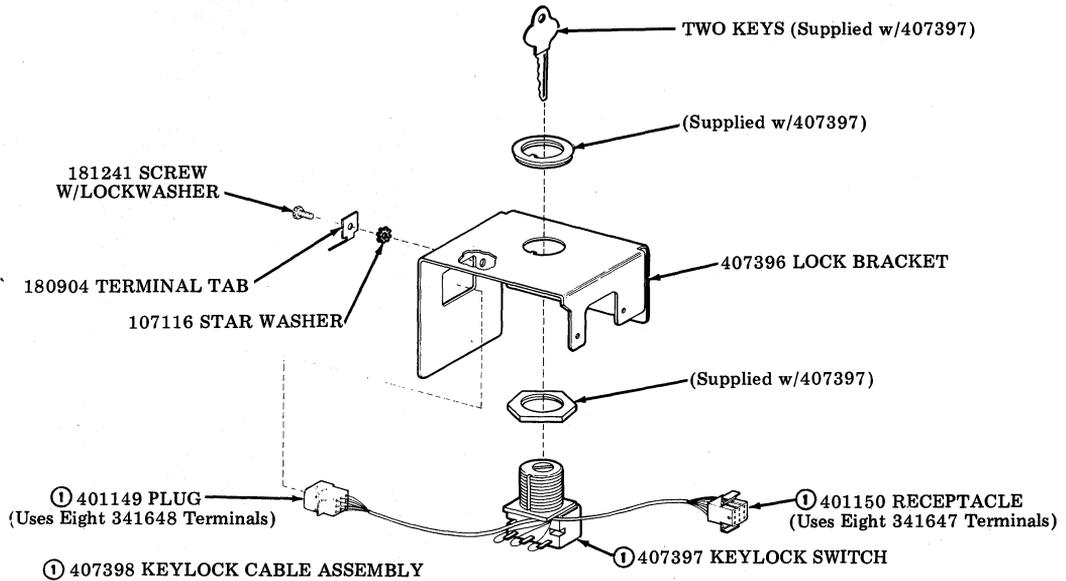
1.05 The 407399 keylock switch assembly consists of:

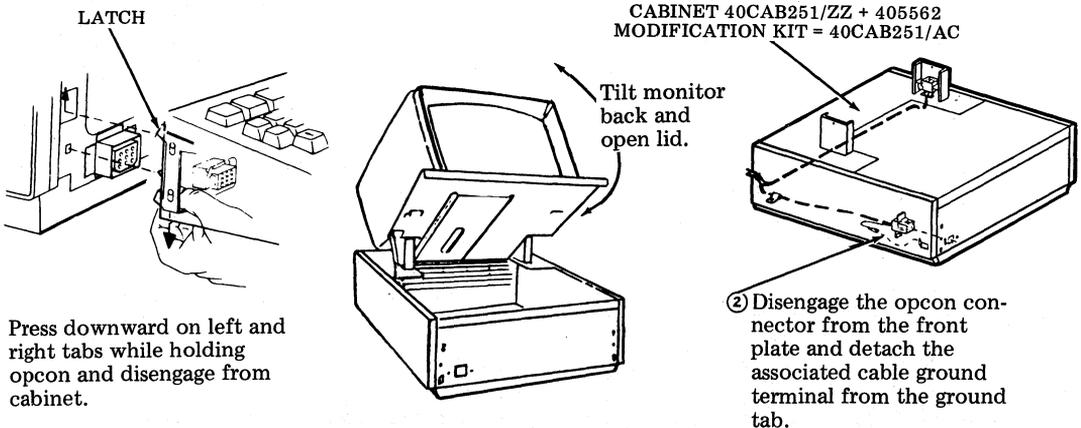
- ① Remove opcon from set and move monitor out of the way

Press downward on left and right tabs while holding opcon and disengage from cabinet.

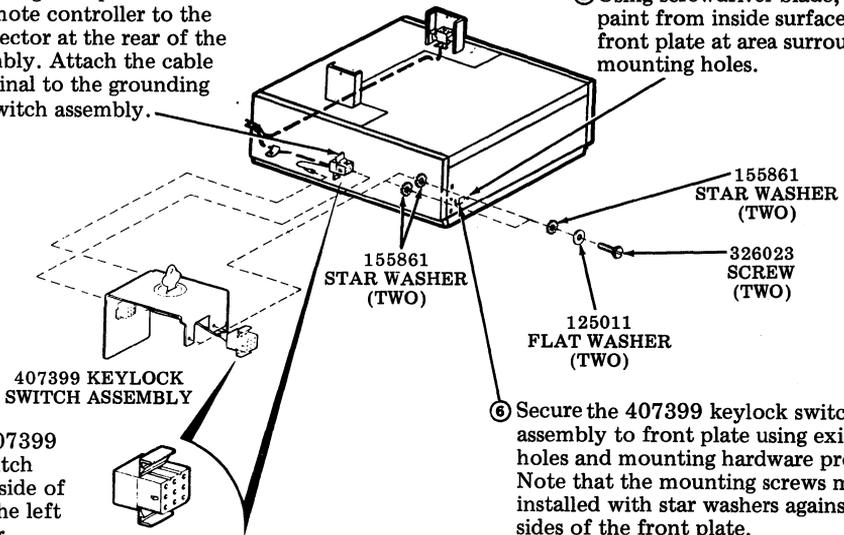
③ Using screwdriver blade, remove paint from inside surface of front plate at area surrounding mounting holes.

④ Place the 407399 keylock switch assembly inside of cabinet at the left front corner

⑥ Secure the 407399 keylock switch assembly to front plate using existing holes and mounting hardware provided. Note that the mounting screws must be installed with star washers against both sides of the front plate.

*Warning: Orient connectors as shown.*

⑤ Orient the switch assembly unmounted connector as shown and snap connector into the cabinet front plate.

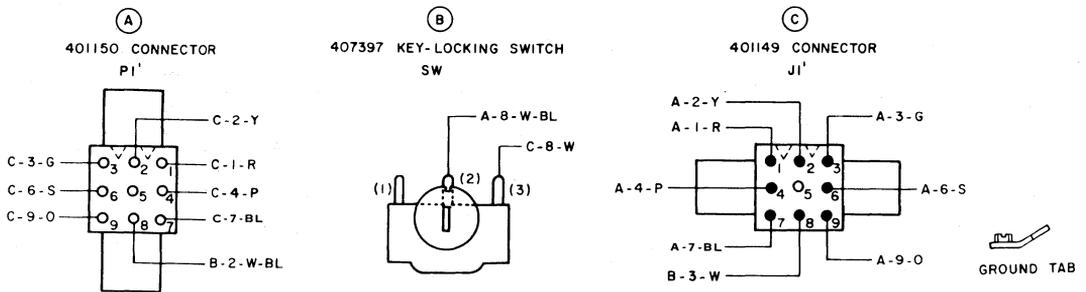
3.04 ACTUAL WIRING DIAGRAM OF KEYLOCK SWITCH ASSEMBLY

All wires 24 AWG. Terminals enclosed in parentheses are for reference and not marked on component. Connectors shown from wired side.

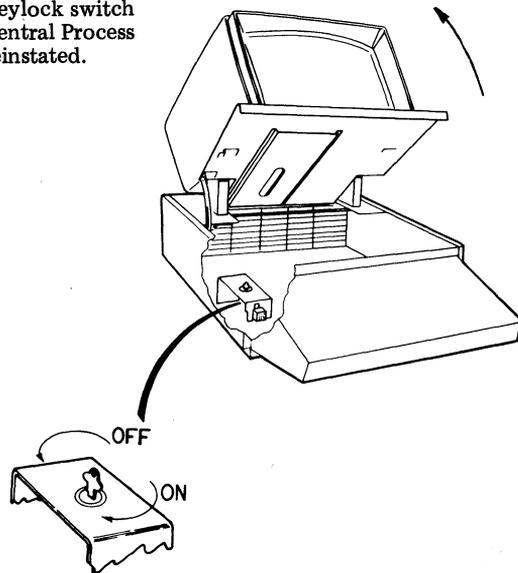
The security lock feature will allow the attendant to disable the associated operator console in the Synchronous 40/4 attached keyboard/display device. A keylock switch located inside the cabinet can disable the operator console by rotating key counterclockwise. To reinstall or restore power to the operator console, the attendant is required to (1) rotate keylock switch clockwise (2) make a call to the CPU (Central Process Unit) and request that the terminal be reinstated.

Tilt monitor back and open lid.

Key is removable in the counterclockwise (off) position only.
