INTUITY™ Messaging Solutions

Release 4

Alarms and Log Messages

585-310-566
Comcode 108328048
Issue 3
July 1998

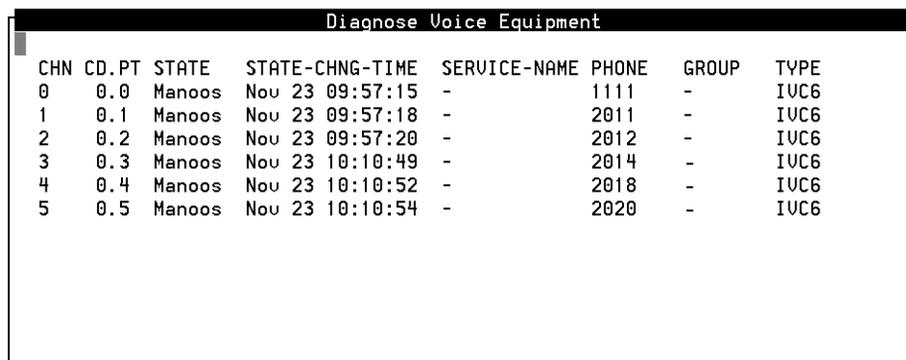
The screenshot shows a window titled "Diagnose Voice Equipment" with a table of data. The table has columns for CHN, CD, PT, STATE, STATE-CHNG-TIME, SERVICE-NAME, PHONE, GROUP, and TYPE. The data is as follows:

CHN	CD	PT	STATE	STATE-CHNG-TIME	SERVICE-NAME	PHONE	GROUP	TYPE
0	0.0		Manoos	Nov 23 09:57:15	-	1111	-	IVC6
1	0.1		Manoos	Nov 23 09:57:18	-	2011	-	IVC6
2	0.2		Manoos	Nov 23 09:57:20	-	2012	-	IVC6
3	0.3		Manoos	Nov 23 10:10:49	-	2014	-	IVC6
4	0.4		Manoos	Nov 23 10:10:52	-	2018	-	IVC6
5	0.5		Manoos	Nov 23 10:10:54	-	2020	-	IVC6

Figure 1. Example of a Lucent INTUITY Window

- The Lucent INTUITY system displays *windows*, *screens*, and *menus*. Windows show and request system information (Figure 1 and Figure 2, respectively). Screens request that you enter a command at the `enter command: prompt` (Figure 3). Input is either a value or other specific information you must input through a field (Figure 2) or a command you must enter from the `enter command: prompt` (Figure 3). “Menus” (Figure 4) present options from which you can choose to view another menu, or a screen or window.

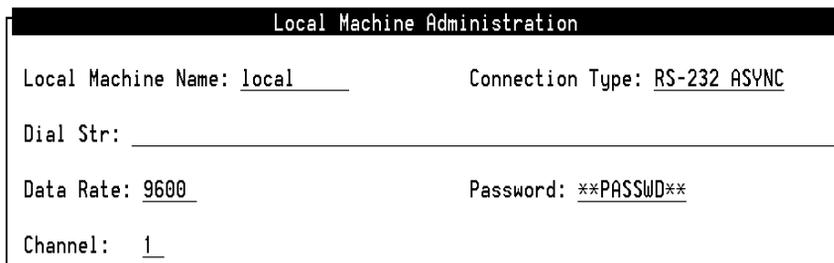
The screenshot shows a window titled "Local Machine Administration" with several configuration fields:

- Local Machine Name: local
- Connection Type: RS-232 ASYNC
- Dial Str: _____
- Data Rate: 9600
- Password: **PASSWORD**
- Channel: 1

Figure 2. Example of a Lucent INTUITY Window

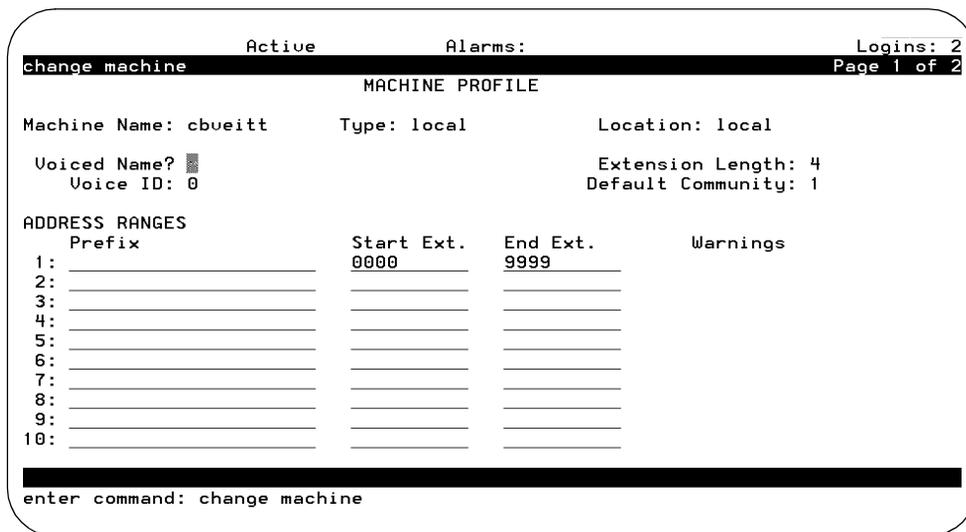
Figure 3. Example of a Lucent INTUITY Screen with a Command Line

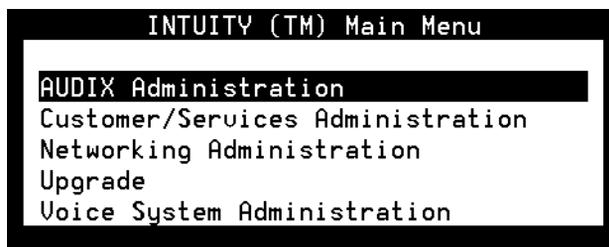
Figure 1-1. Lucent INTUITY Main Menu

1. Start at the Lucent INTUITY main menu ([Figure 1-1](#)).

1. Start at the Lucent INTUITY main menu ([Figure 1-1](#)) and select AUDIX Administration.

1. Start at the Lucent INTUITY main menu ([Figure 1-1](#)) and select

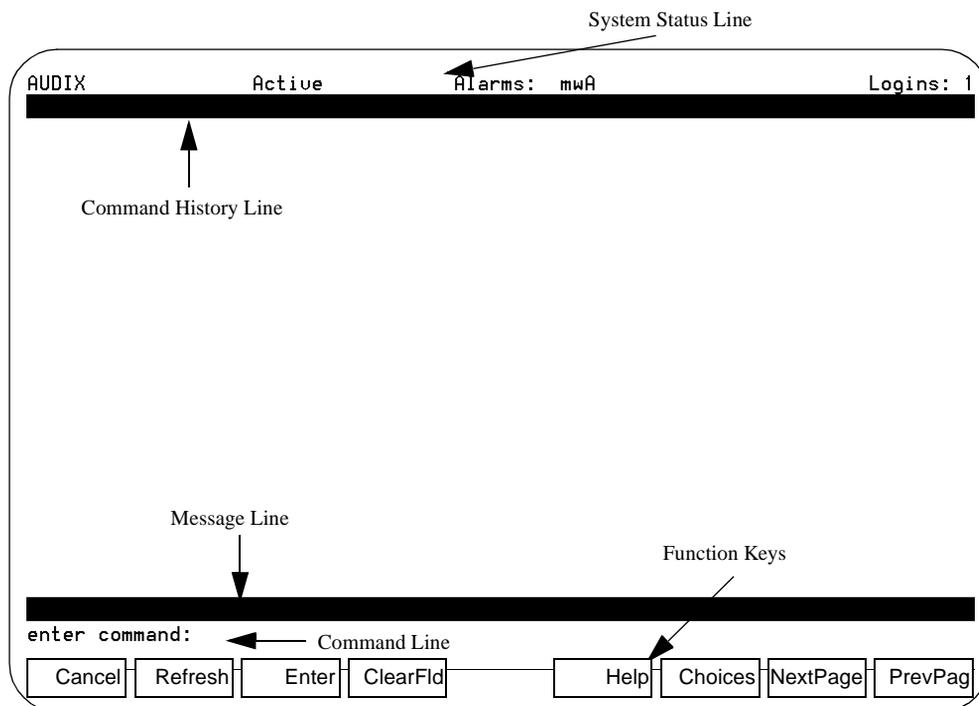
Figure 1-2. AUDIX Administration Screen Layout (Blank Screen)

3. Check the Alarms field: . This field is located at the center top of the INTUITY AUDIX screen in the System Status Line.

The system displays the INTUITY AUDIX administration screen ([Figure 1-2](#)).

The system displays the INTUITY AUDIX Administration screen ([Figure 1-2](#)).

The system displays the AUDIX Administration screen ([Figure 1-2](#)).

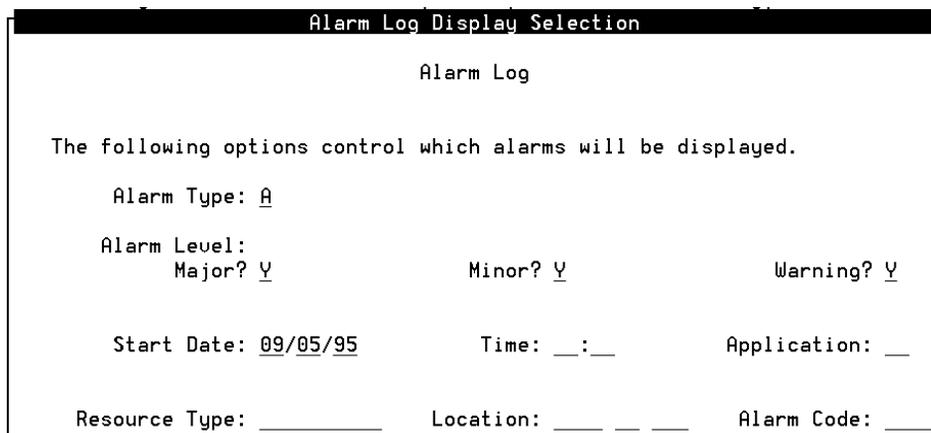
The system displays the Alarm Log Display Selection screen ([Figure 1-5](#)).

Figure 1-5. Alarm Display Selection Window

When you ask the system to display the Alarm Log, the system presents the Alarm Log Display Selection screen ([Figure 1-5](#)). This screen allows you to choose what to display. The selection criteria on the Alarm Log Display Selection screen corresponds to the fields in the Alarm Log.

The Resource Type field of the Alarm Log Display Selection screen ([Figure 1-5](#)) allows you to display only those alarms with a particular alarmed resource type. For example, to see only the alarms related to performing backups, type **BACKUP** in the Resource Type field.

The `Location` field of the Alarm Log Display Selection screen ([Figure 1-5](#)) allows you to display only those alarms for a particular piece of hardware in a location. For example, to see only the alarms related to the IVC6 card #3, type **TR ca 2** in the `Location` field.

The `Major?`, `Minor?`, and `Warning?` fields of the Alarm Log Display Selection screen ([Figure 1-5](#)) allow you to display only those alarms with a particular alarm level. For example, to see only the major alarms, type **y** in the `Major?` field, **n** in `Minor?` field, and **n** in the `Warning?` field.

If the problem can be pinpointed to an approximate time period, it may be desirable to narrow the scope of possible causes by using the `Start Date` and `Time` display selection fields ([Figure 1-5](#)).

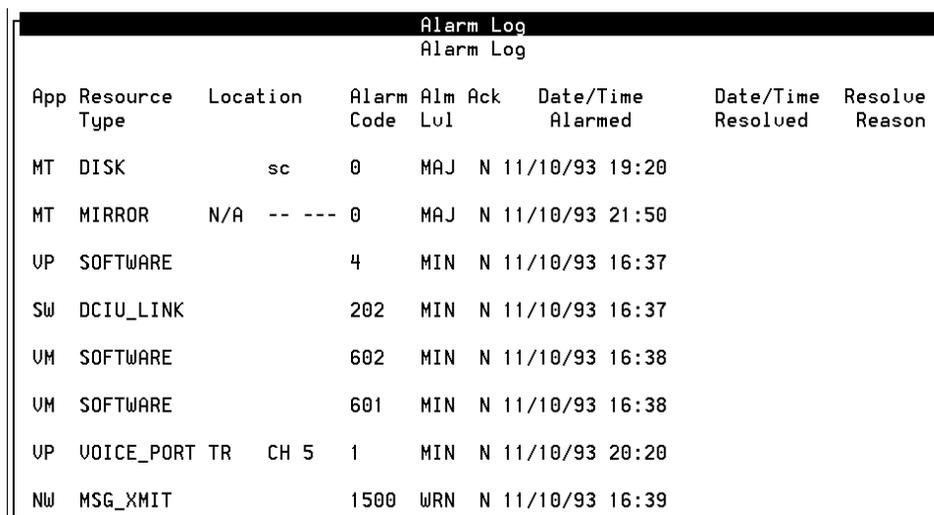
The system displays the Alarm Log screen ([Figure 1-6](#)).

Alarm Log								
Alarm Log								
App	Resource	Location	Alarm	Alm	Ack	Date/Time	Date/Time	Resolve
	Type		Code	Lvl		Alarmed	Resolved	Reason
MT	DISK	sc	0	MAJ	N	11/10/93 19:20		
MT	MIRROR	N/A -- ---	0	MAJ	N	11/10/93 21:50		
UP	SOFTWARE		4	MIN	N	11/10/93 16:37		
SW	DCIU_LINK		202	MIN	N	11/10/93 16:37		
UM	SOFTWARE		602	MIN	N	11/10/93 16:38		
UM	SOFTWARE		601	MIN	N	11/10/93 16:38		
UP	VOICE_PORT TR	CH 5	1	MIN	N	11/10/93 20:20		
NW	MSG_XMIT		1500	WRN	N	11/10/93 16:39

Figure 1-6. Alarm Log Screen

The system displays the Alarm Log screen ([Figure 1-6](#)).

Each alarm occupies a single line in the display. Each entry is described in terms of eight fields in the log ([Figure 1-6](#)). Each field description in this section includes a list of possible values and Alarm Log display selections.
