Intuity™ Messaging Solutions

Release 4

Alarm and Log Messages

585-310-566
Issue 5
February 2000

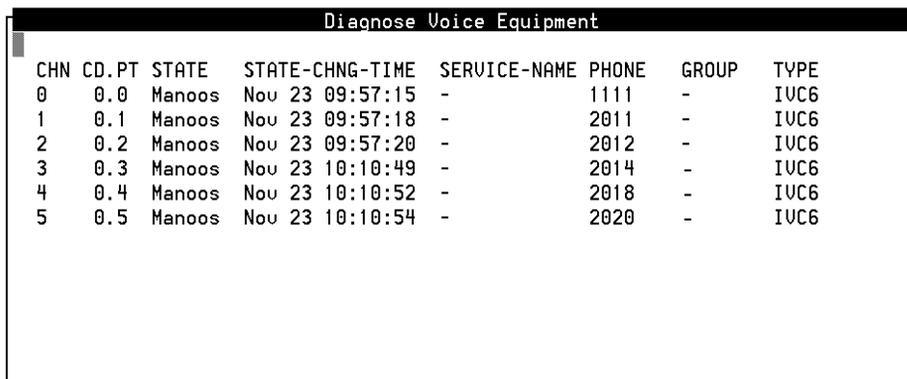
Figure 1. Example of a Lucent INTUITY Window

The screenshot shows a window titled "Diagnose Voice Equipment" with a table of data. The table has columns for CHN, CD, PT, STATE, STATE-CHNG-TIME, SERVICE-NAME, PHONE, GROUP, and TYPE. The data rows are as follows:

CHN	CD	PT	STATE	STATE-CHNG-TIME	SERVICE-NAME	PHONE	GROUP	TYPE
0	0.0		Manoos	Nov 23 09:57:15	-	1111	-	IVC6
1	0.1		Manoos	Nov 23 09:57:18	-	2011	-	IVC6
2	0.2		Manoos	Nov 23 09:57:20	-	2012	-	IVC6
3	0.3		Manoos	Nov 23 10:10:49	-	2014	-	IVC6
4	0.4		Manoos	Nov 23 10:10:52	-	2018	-	IVC6
5	0.5		Manoos	Nov 23 10:10:54	-	2020	-	IVC6

- The Lucent INTUITY system displays *windows*, *screens*, and *menus*. Windows show and request system information (Figure 1 and Figure 2, respectively). Screens request that you enter a command at the `enter command: prompt` (Figure 3). Input is either a value or other specific information you must input through a field (Figure 2) or a command you must enter from the `enter command: prompt` (Figure 3). “Menus” (Figure 4) present options from which you can choose to view another menu, or a screen or window.

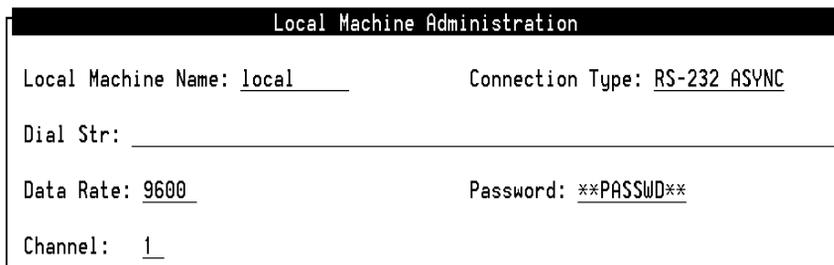
Figure 2. Example of a Lucent INTUITY Window

The screenshot shows a window titled "Local Machine Administration" with several configuration fields:

- Local Machine Name: local
- Connection Type: RS-232 ASYNC
- Dial Str: _____
- Data Rate: 9600
- Password: **PASSWD**
- Channel: 1

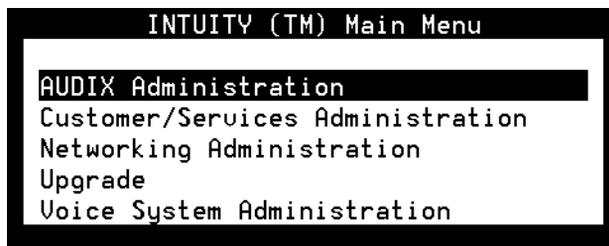
Figure 1-1. Lucent INTUITY Main Menu

1. Start at the Lucent INTUITY main menu ([Figure 1-1](#)).

1. Start at the Lucent INTUITY main menu ([Figure 1-1](#)) and select AUDIX Administration.

1. Start at the Lucent INTUITY main menu ([Figure 1-1](#)) and select

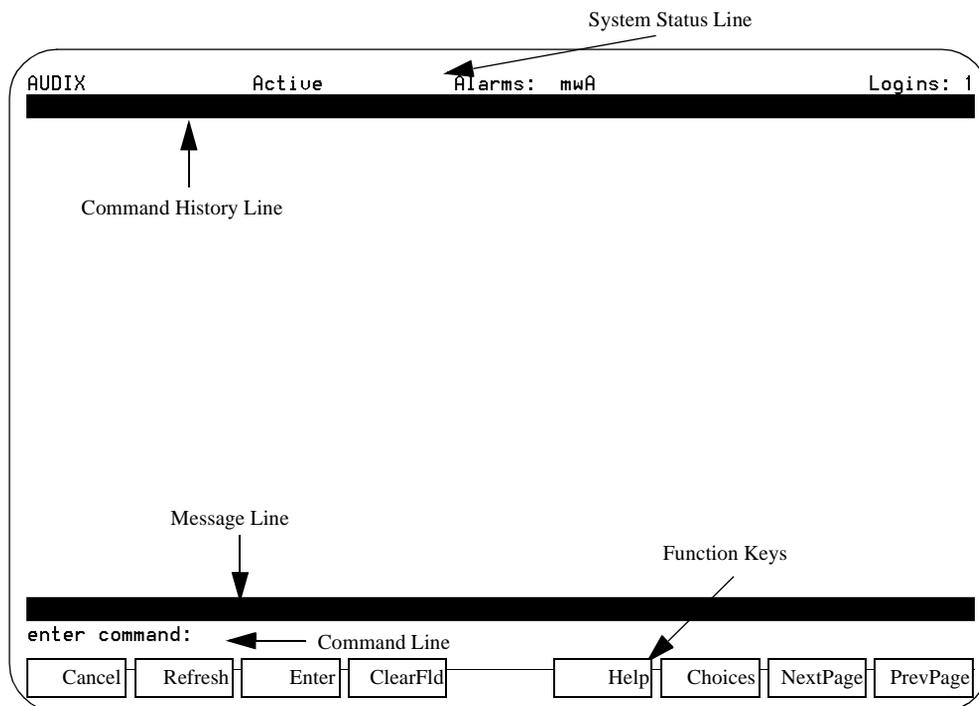
Figure 1-2. AUDIX Administration Screen Layout (Blank Screen)

The system displays the INTUITY AUDIX administration screen ([Figure 1-2](#)).

3. Check the `Alarms` field: . This field is located at the center top of the INTUITY AUDIX screen in the System Status Line.

The system displays the INTUITY AUDIX Administration screen ([Figure 1-2](#)).

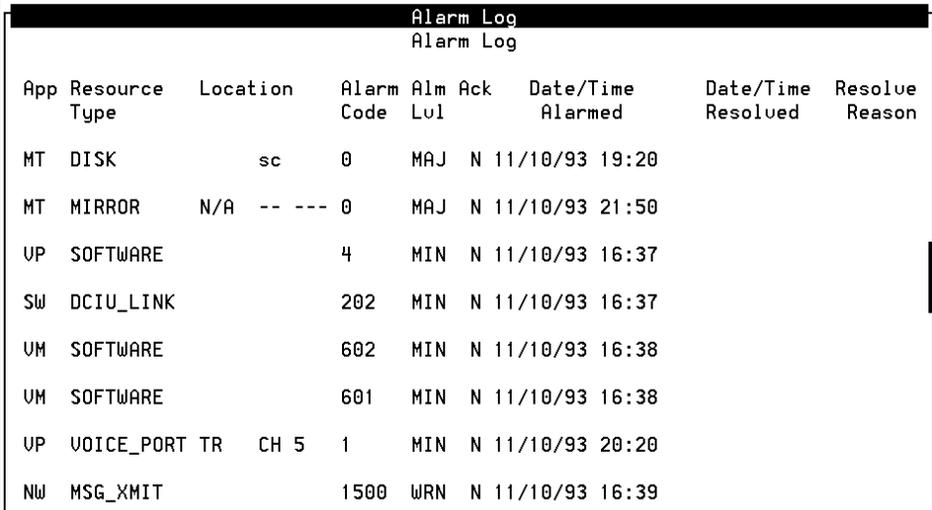
Figure 1-6. Alarm Log Screen

The system displays the Alarm Log screen ([Figure 1-6](#)).

Alarm Log								
Alarm Log								
App	Resource Type	Location	Alarm Code	Alm Lvl	Ack	Date/Time Alarmed	Date/Time Resolved	Resolve Reason
MT	DISK	sc	0	MAJ	N	11/10/93 19:20		
MT	MIRROR	N/A	-- ---	0	MAJ	N 11/10/93 21:50		
UP	SOFTWARE		4	MIN	N	11/10/93 16:37		
SW	DCIU_LINK		202	MIN	N	11/10/93 16:37		
UM	SOFTWARE		602	MIN	N	11/10/93 16:38		
UM	SOFTWARE		601	MIN	N	11/10/93 16:38		
UP	VOICE_PORT TR	CH 5	1	MIN	N	11/10/93 20:20		
NW	MSG_XMIT		1500	WRN	N	11/10/93 16:39

The system displays the Alarm Log screen ([Figure 1-6](#)).

Each alarm occupies a single line in the display. Each entry is described in terms of eight fields in the log ([Figure 1-6](#)). Each field description in this section includes a list of possible values and Alarm Log display selections.
