10B DATA LINE CONCENTRATOR MAINTENANCE

1. GENERAL

- 1.01** This section covers the procedures to be followed when a trouble condition in the Data Line Concentrator System has been isolated to the 10B Data Line Concentrator, as described in the section entitled Data Line Concentrator System—Maintenance (591-810-300). In the following text, the word "module" will refer to a functional unit such as a data mounting equipped with its associated circuit packs.

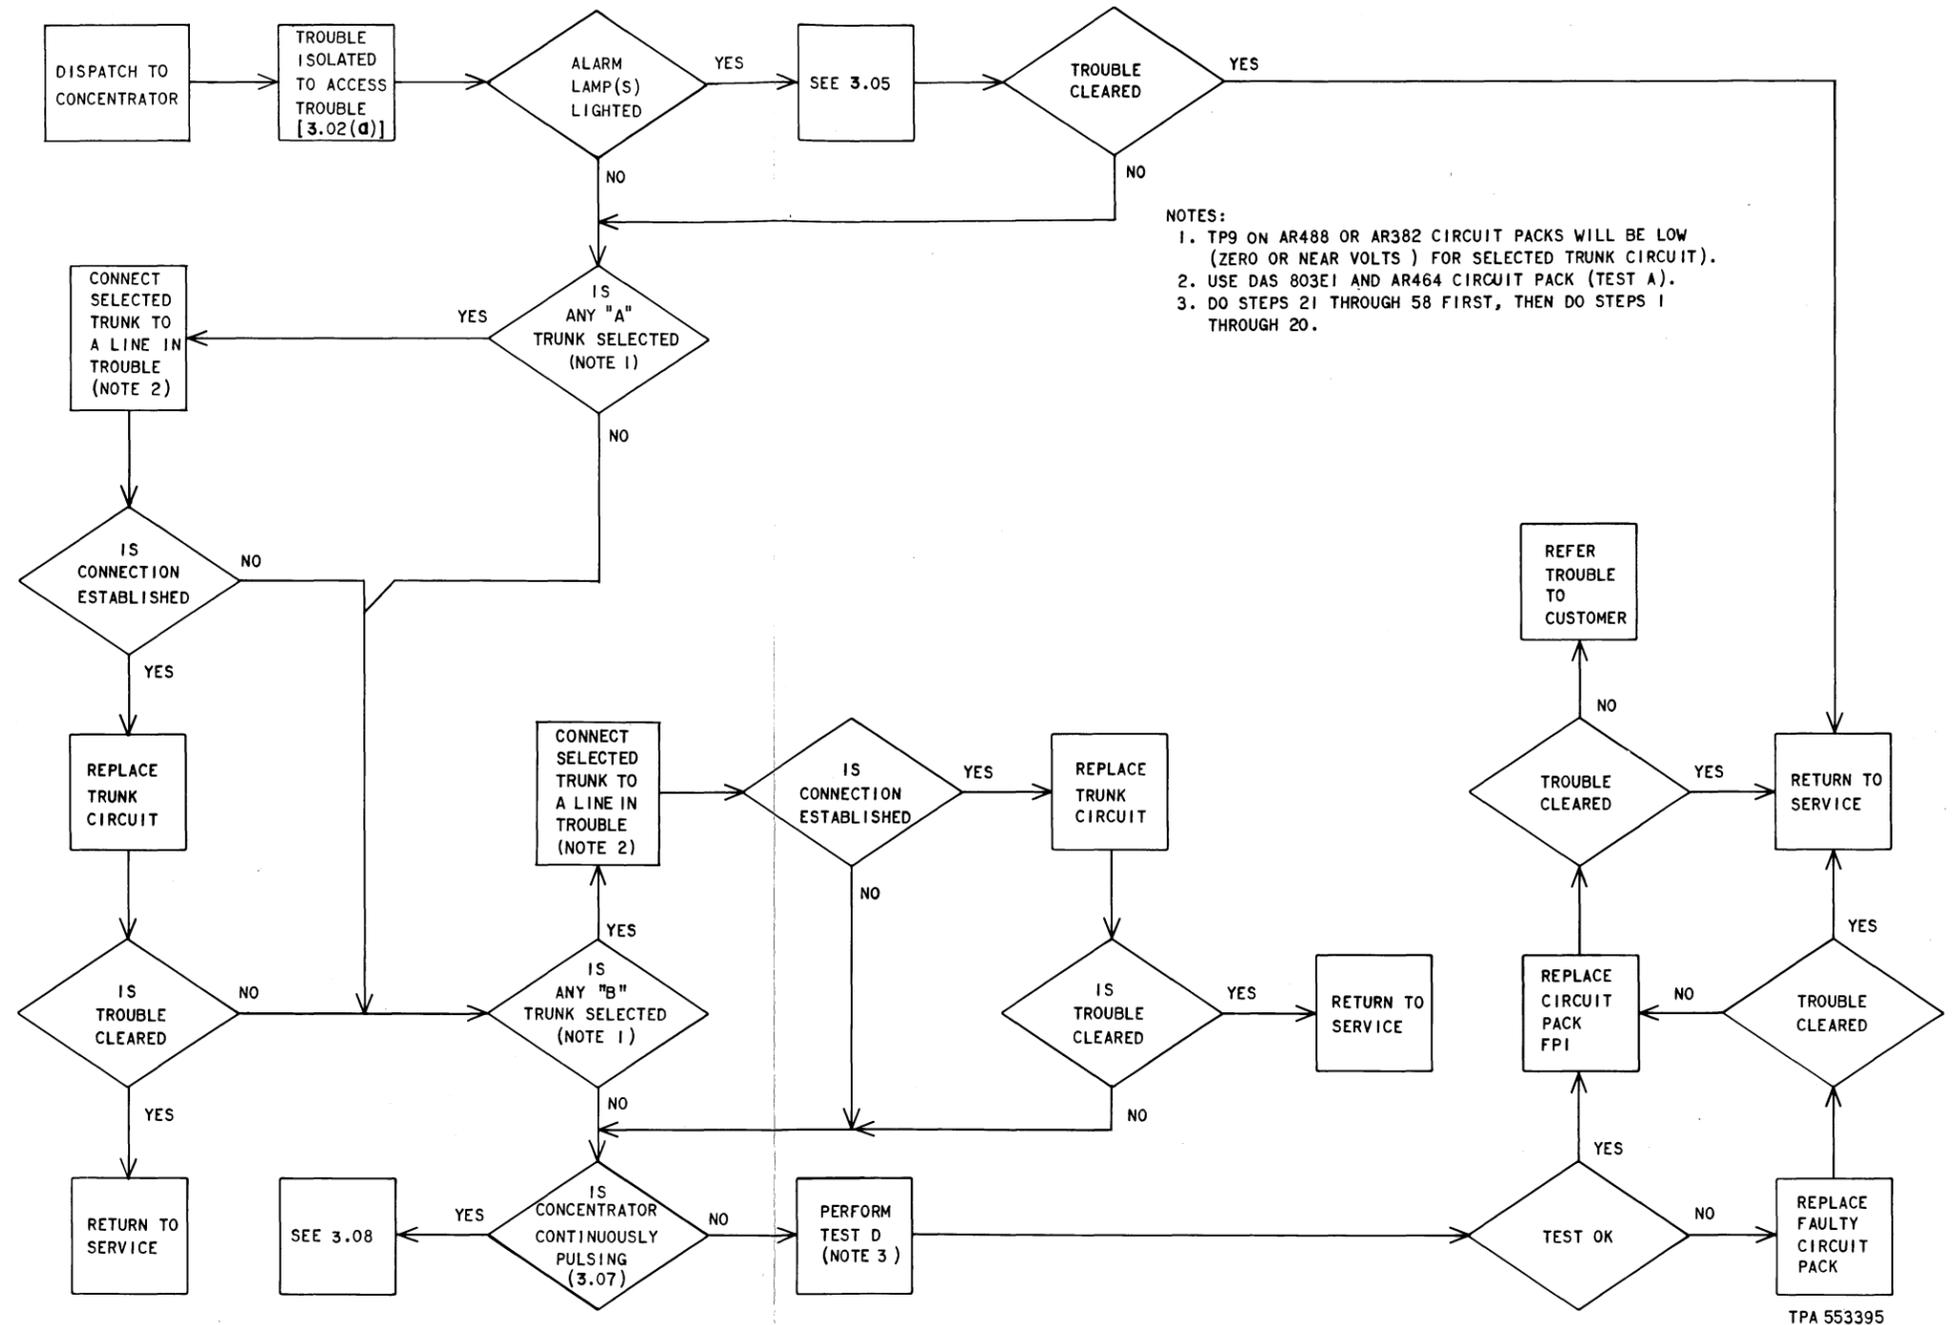
Fig. 1—Troubleshooting Flowchart for Access Troubles [3.02 (a)]

(a) Access troubles (Fig. 1)—

3.03 Once a trouble has been localized to a particular area, it is recommended that all power supplies, fuses, and connector cables be checked first. Then the troubleshooting flowcharts (Fig. 1, 2, 3, and 4) are to be used for an organized trouble investigation with a minimum amount of time spent in locating the cause of trouble.

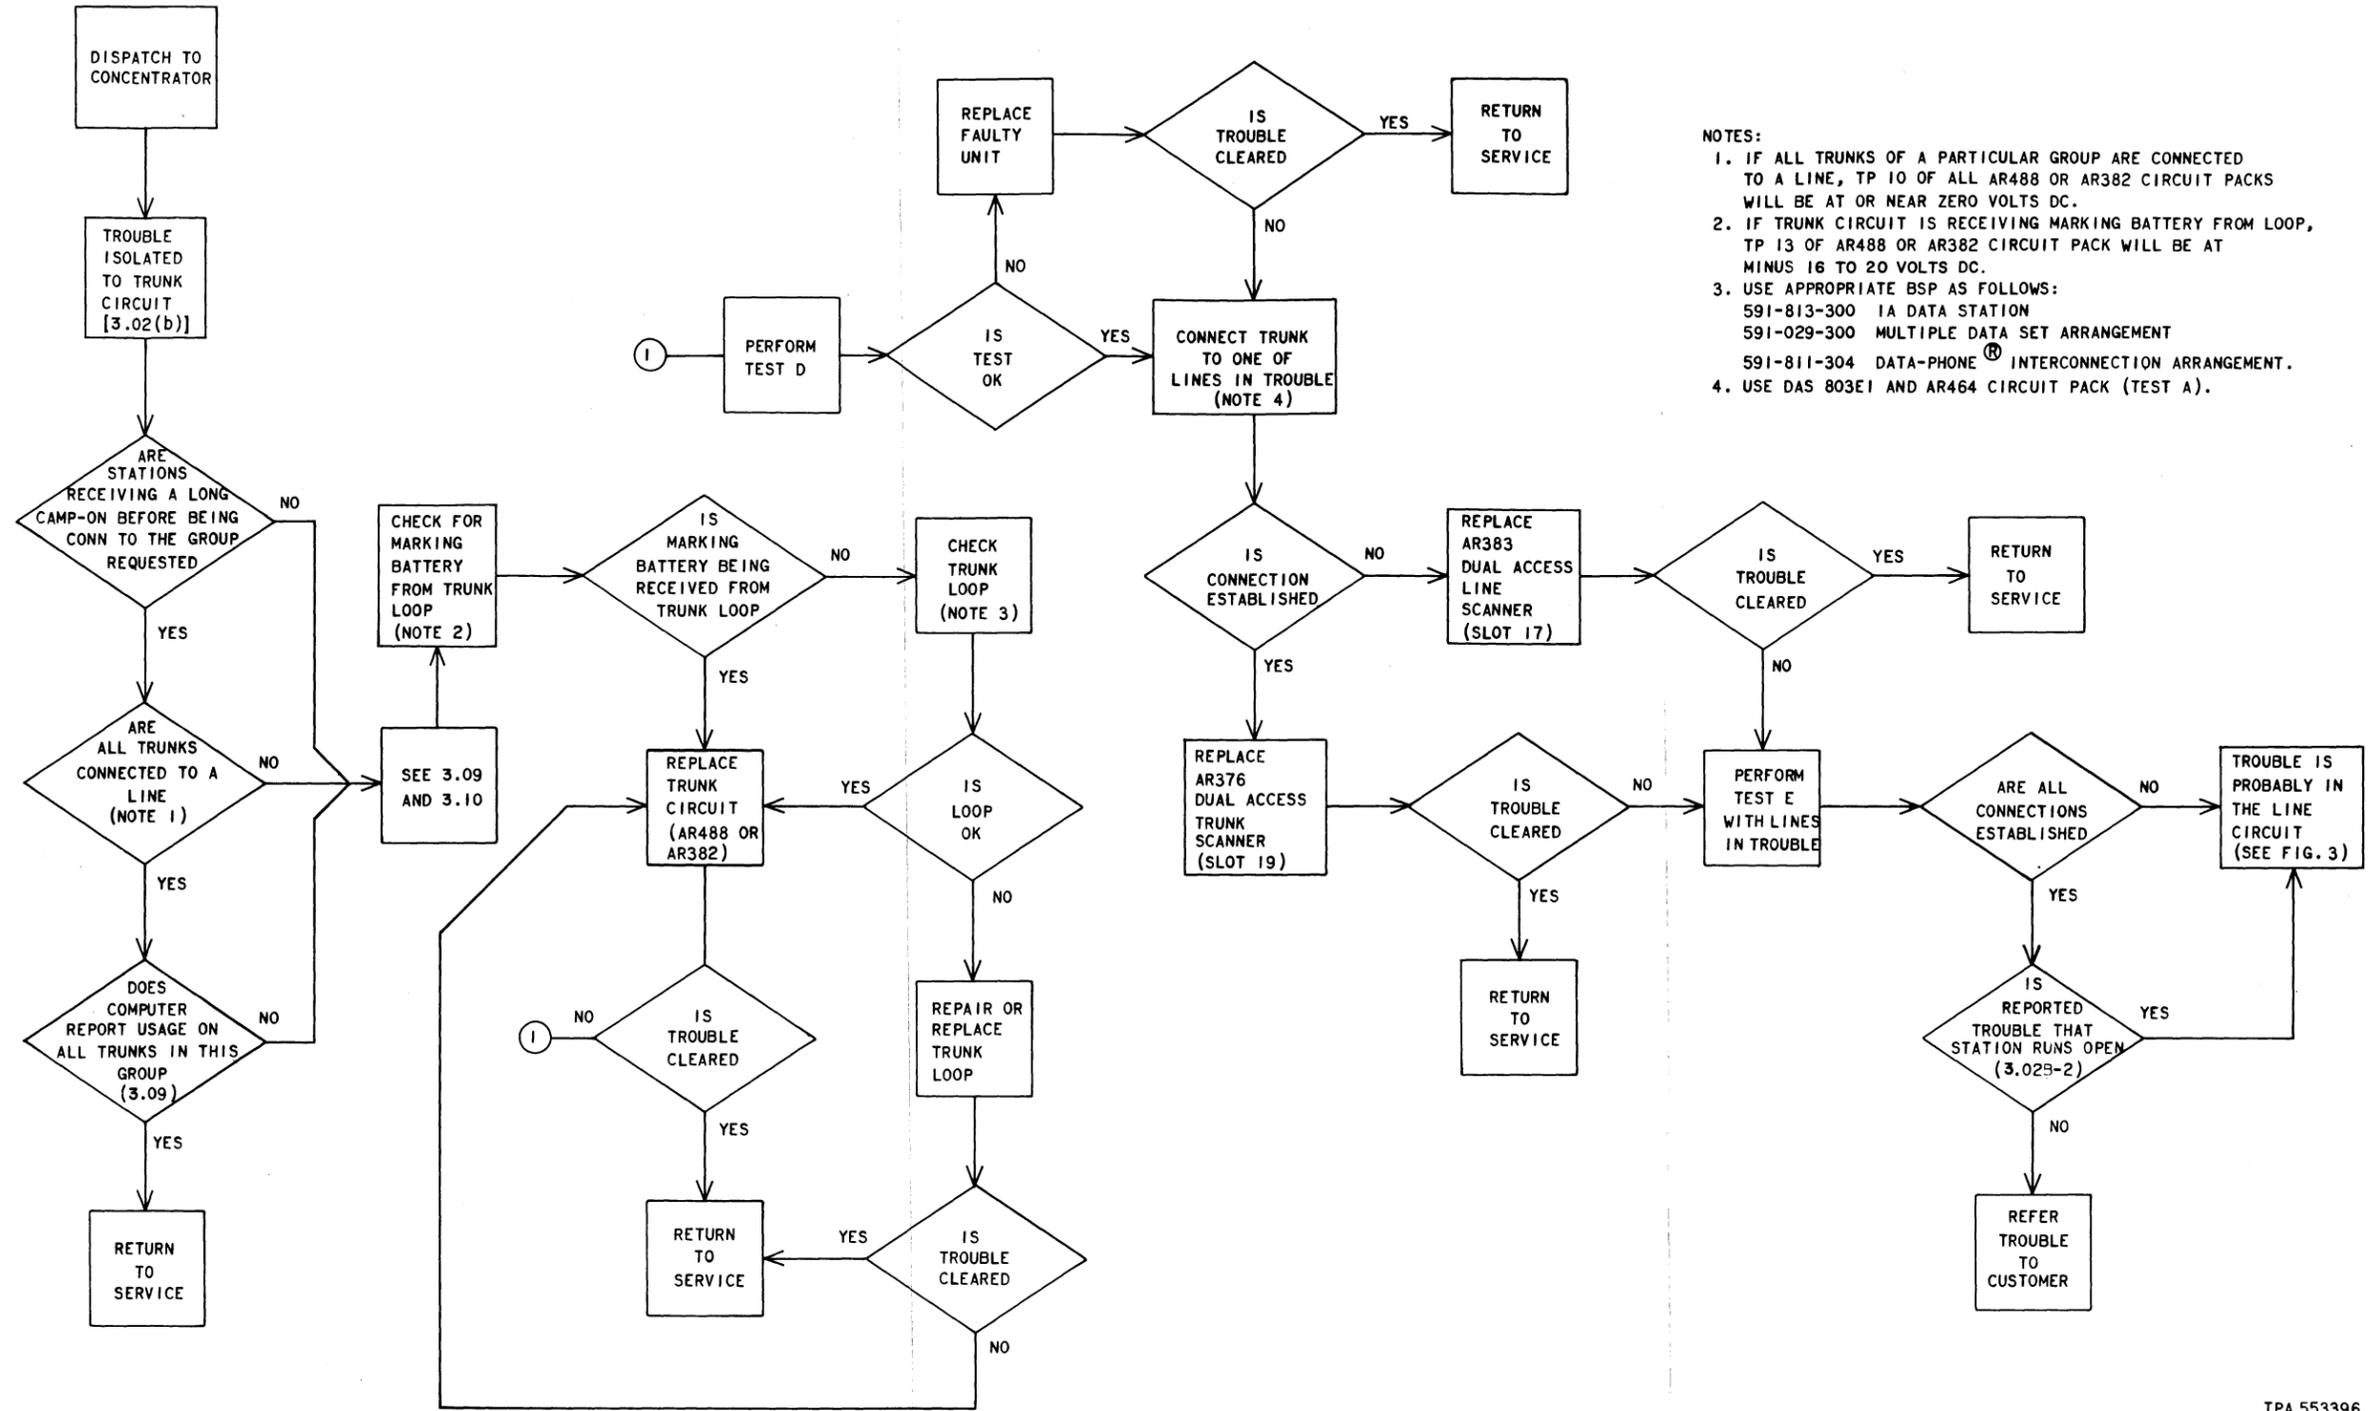
- NOTES:
1. IF ALL TRUNKS OF A PARTICULAR GROUP ARE CONNECTED TO A LINE, TP 10 OF ALL AR488 OR AR382 CIRCUIT PACKS WILL BE AT OR NEAR ZERO VOLTS DC.
 2. IF TRUNK CIRCUIT IS RECEIVING MARKING BATTERY FROM LOOP, TP 13 OF AR488 OR AR382 CIRCUIT PACK WILL BE AT MINUS 16 TO 20 VOLTS DC.
 3. USE APPROPRIATE BSP AS FOLLOWS:
 591-813-300 1A DATA STATION
 591-029-300 MULTIPLE DATA SET ARRANGEMENT
 591-811-304 DATA-PHONE INTERCONNECTION ARRANGEMENT.
 4. USE DAS 803E1 AND AR464 CIRCUIT PACK (TEST A).

Fig. 2—Troubleshooting Flowchart for Trunk Circuit [3.02 (b)]

(b) Trunk circuit troubles (Fig. 2)—

If either (a) or (b) is evident, troubleshooting should be continued with the low usage or short holding time trunk(s) as described in Fig. 2.

- (5) Troubleshooting should be continued as described in Fig. 2 with any trunk circuit(s) found to have a much shorter holding time than the others in the group or appear to be used less often than the others in that group.

- (5) Repeat (4) until all trunk circuits have been reinstalled or replaced. Troubleshooting should be continued as described in Fig. 2 with any trunk circuit which does not become used or which has an extremely short holding time.

- (5) If any trunk circuits are found to which a connection cannot be made, use the manual test set to connect the TTY line to that trunk circuit.
 - (6) Turn on the TTY. If the TTY runs open, it is not seeing a proper termination from the trunk loop and troubleshooting should be continued as described in Fig. 2 with all trunks with which this happens.

- (10) Repeat (3) for approximately 5 minutes. If some of the trunks still do not get used, continue troubleshooting these trunks as described in Fig. 2.

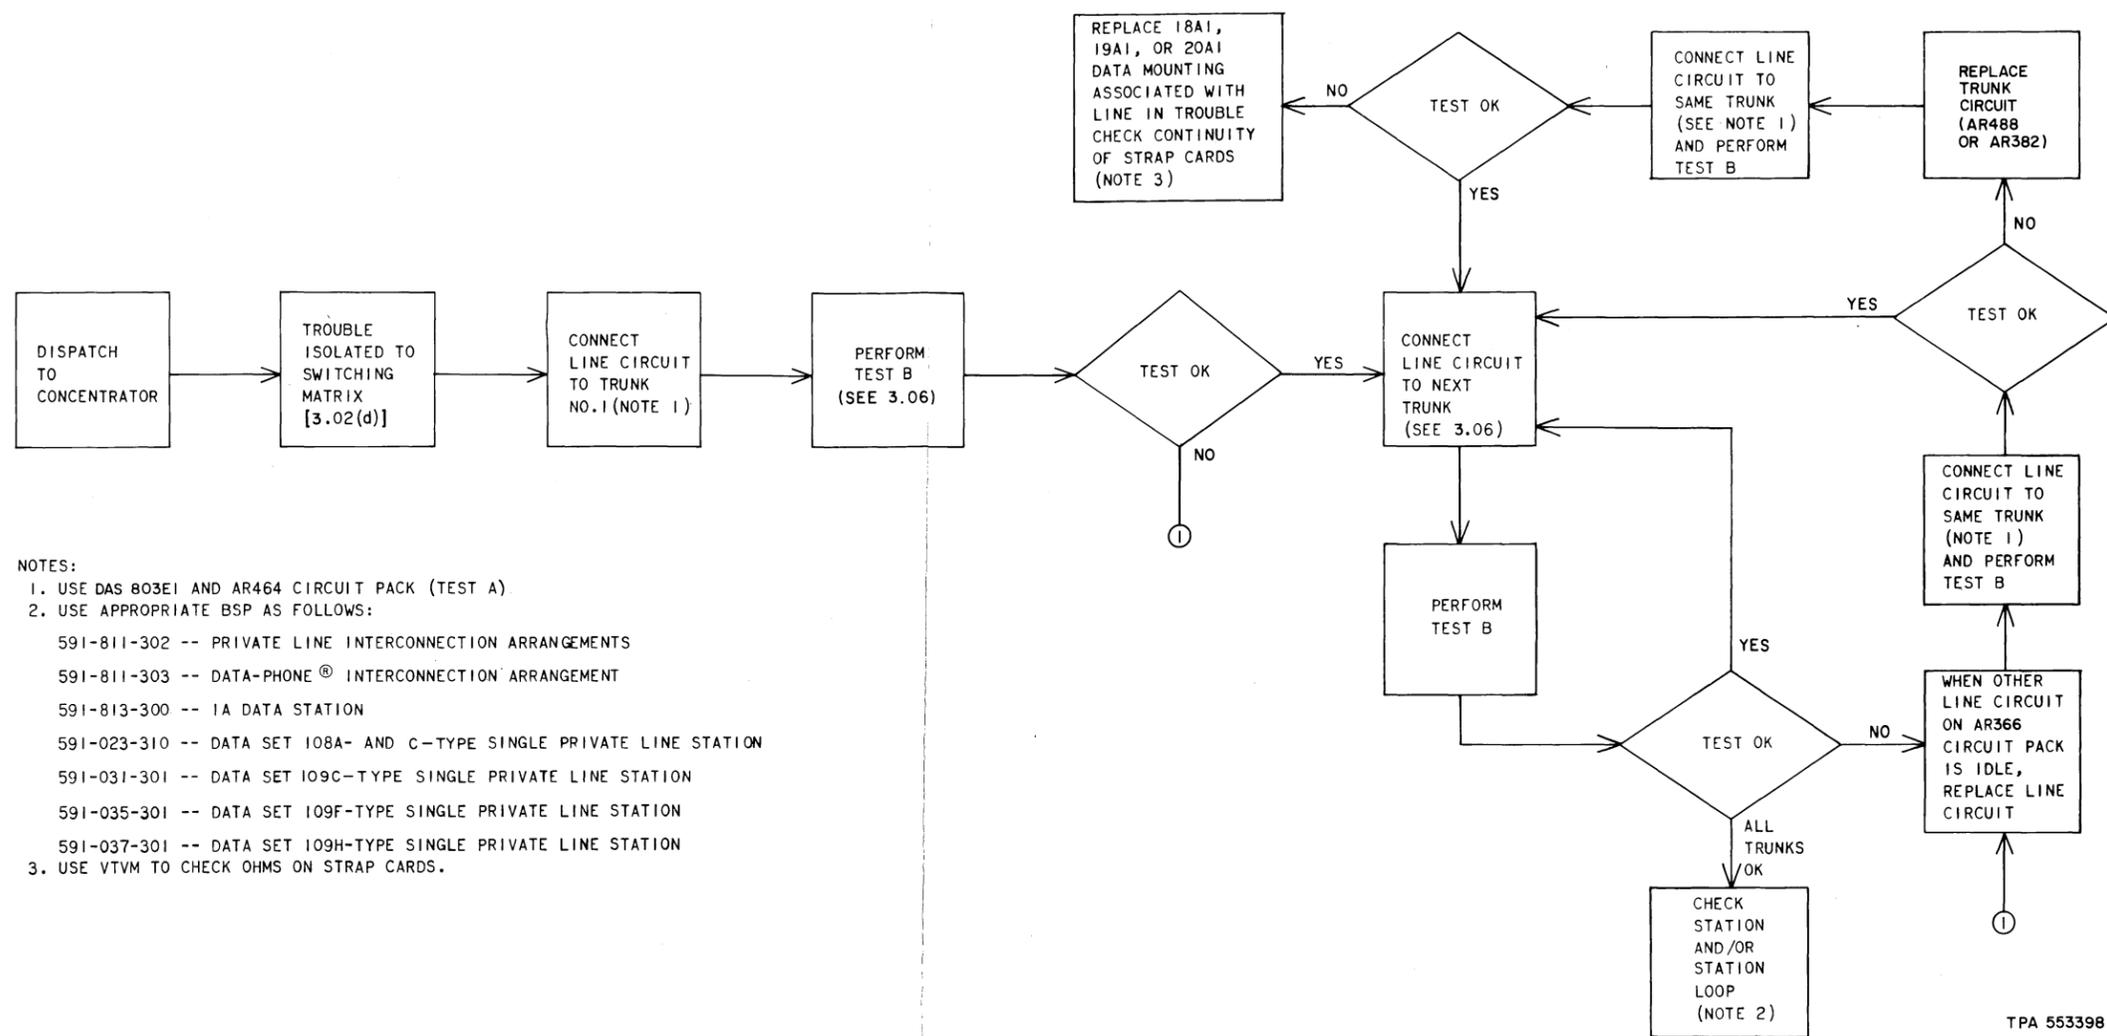
Fig. 4—Troubleshooting Flowchart for Switching Matrix [3.02 (d)]

(d) Switching matrix network troubles (Fig. 4)—
