ELECTRONIC SECRETARY® MODEL AO-3
MECHANICAL CHECKS

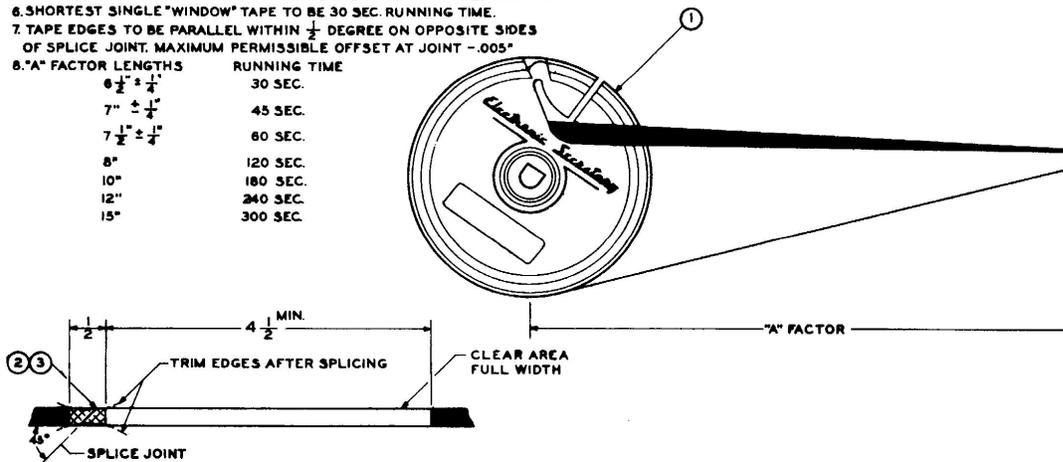
Figure 2. Tape Slack.

2. CLEAR AREA OF TAPE TO BE FREE FROM OXIDE, LUBRICANT, OR SOLVENT RESIDUE. NO SOLVENT DAMAGE PERMITTED TO OXIDE OR LUBRICANT ON UNTREATED AREAS OF TAPE.

8. "A" FACTOR LENGTHS
- | "A" FACTOR LENGTHS | RUNNING TIME |

3.03 When in the mechanism, the tape should move freely around the pillars and heads. Assure that the tape does not bind in the cartridge and that there is sufficient tape slack consistent with running time (refer to figure 2). Tape tension arm (refer to figure 5) should move freely.
