REPAIR OF INSULATION
 WIRING AND CABLING

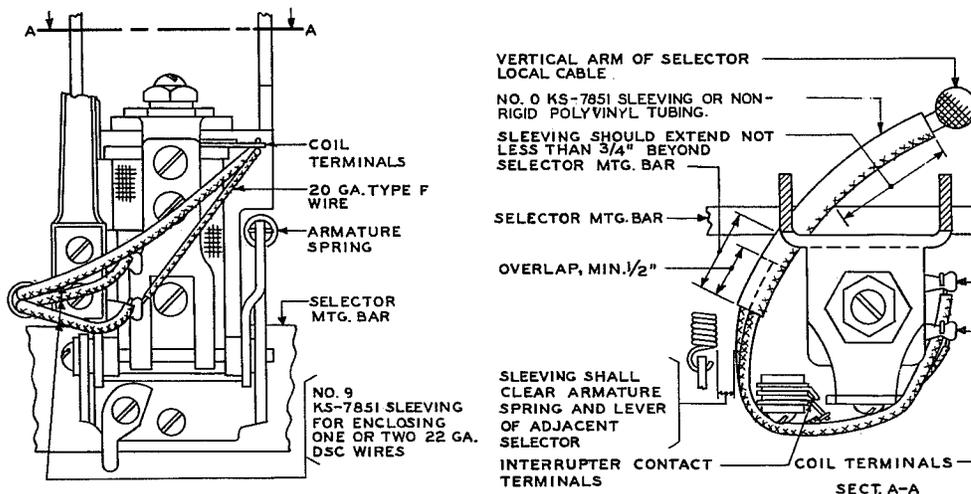
Fig. 1 - Protection of DSC Leads to Coil and Interrupter Spring Contacts of 200- and 206-type Selectors

- (b) On wiring to 200- and 206-type selectors or similar cases where the wiring lies in contact with metalwork and the insulation is badly frayed or the protective tape has become dried out to the extent that it does not adequately protect the wiring, the leads should be sleeved with varnish impregnated sleeving per KS-7851. The leads should be sleeved individually using No. 9 sleeving, except where more than one connects to the same terminal in which case these leads should be enclosed in one sleeve, using No. 9 or larger sleeving as required. Where the wiring is sewed, stitches should be removed as required to permit redressing the sleeved leads as necessary to present the best maintenance conditions. Larger sleeving should be used where necessary to enclose a form for protection against metalwork. Fig. 1 shows the recommended method of sleeving wiring to 200- and 206-type selectors in which case the No. 9 sleeving should be used to enclose one or two leads to a particular terminal and No. 0 to enclose the local cable. Where the insulation is only slightly frayed and the wiring, including the protective tape, is otherwise in good condition, cellulose acetate lacquer should be used to recondition the wiring.
