RINGER — D TYPE

MAINTENANCE

1.01 This section contains requirements and procedures for maintenance of the D1A ringer.

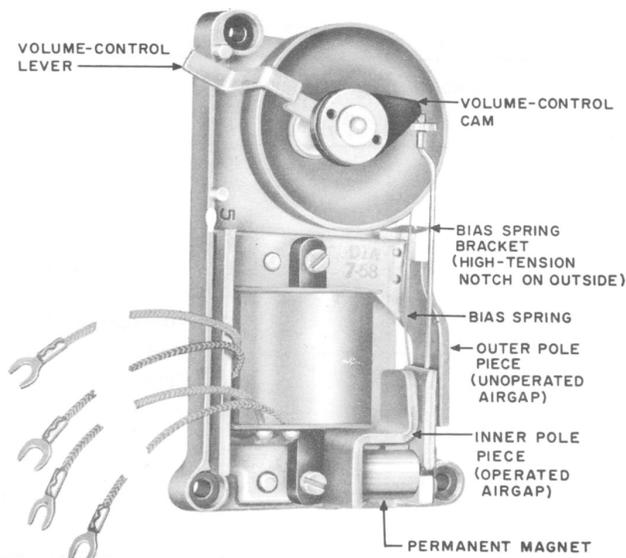
Fig. 1 — D1A Ringer

3.01 With bias spring in low-tension position, the armature should restore to nonoperate side of airgap when operated manually.

3.02 Clearance between clapper and gong should be minimum 1/64 inch.

3.03 Volume-control lever should operate smoothly over entire range.

3.00 MECHANICAL REQUIREMENTS, Fig. 1

Correct bias spring tension has been set at the factory. Do not bend bias spring. Do not use tools when relocating bias spring.

4.01 The ringer is shipped with the bias spring in the high (outside) notch. Table A indicates the proper position of the bias spring for the various classes of service.
