BELL SYSTEM PRACTICES
Outside Plant Construction
and Maintenance

SECTION G73.141.1
Issue 1, November, 1952
AT&T Co Standard

PRESSURE TESTING

TERMINALS

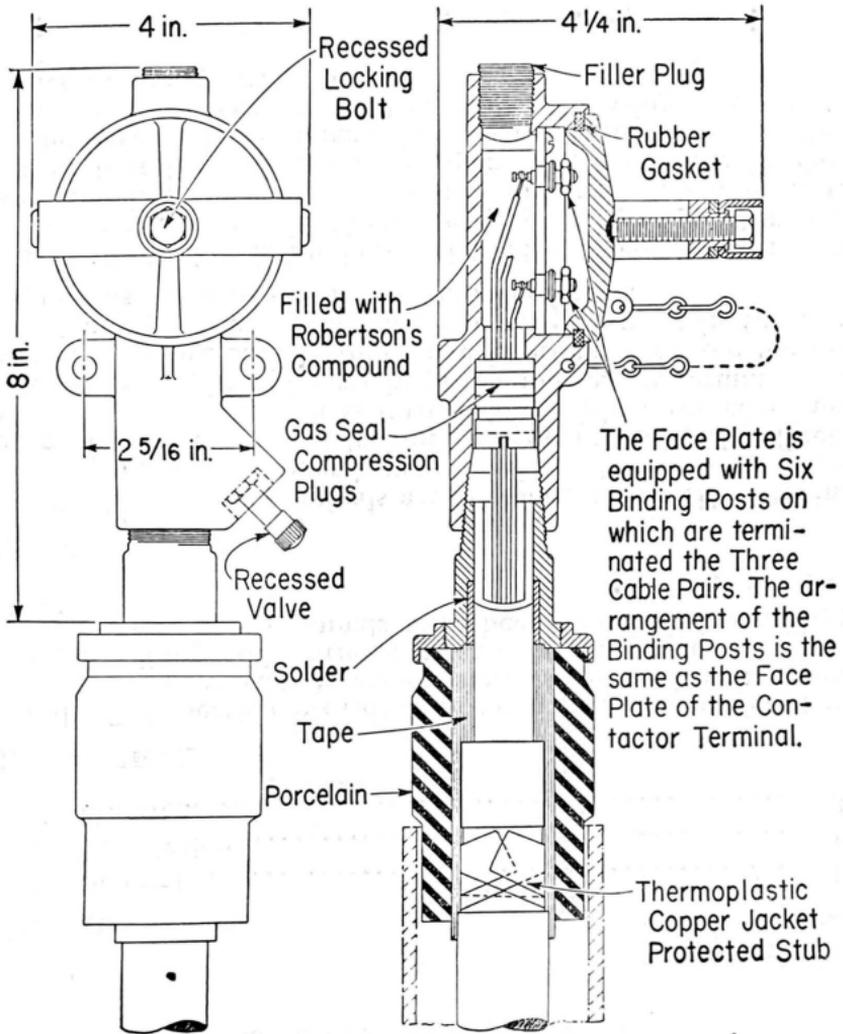
Y Cable Terminal

2.02 Following is an illustration of a 3-pair terminal supplied as the Y Cable Terminal. Older type terminals were supplied under an ES drawing and were similar in design except that they were not equipped with a ceramic insulator at the base of the terminal. Also, in the earliest type of these terminals the cover was held in place by a wing screw at the center of the cover.

2.01 The 3-pair terminals are equipped with a circular binding post chamber having a solid gasketed cover secured by a yoke and recessed locking bolt operated by a C Socket Wrench. When the bolt is turned down tightly the cover provides a watertight and gastight protection for the terminal compartment. A pressure testing valve is provided on the housing. The binding posts on the faceplate are arranged in the same manner as those in the T Contactor-Terminal.

3.01 The wires which connect to the faceplate of these terminals pass through a rubber compression seal which prevents the free passage of gas at cable pressure from the rear of the housing to the terminal plate. When the terminal cover is removed there may be evidence of gas pressure in the space between the terminal plate and the cover. This is due, generally, to very slow seepage of gas through the rubber used in the seal. Unless there is evidence of continued leakage as indicated by a hiss or by soap test, no attempt should be made to eliminate this source of pressure build up under the cover.

3.02 If continued leakage through the faceplate is found by soap test it is an indication of failure of the rubber compression seal in the terminal. It is not practicable to repair this type of defect in the field. If the leak is small it generally is not necessary to correct the condition. However, if the leak is large enough to affect the pressure gradient when the cover of the terminal is removed, consideration should be given to either constructing a gas pressure plug in the stub of the terminal or replacing the terminal.
