SKETCH OF CARD TRANSLATOR OPERATION

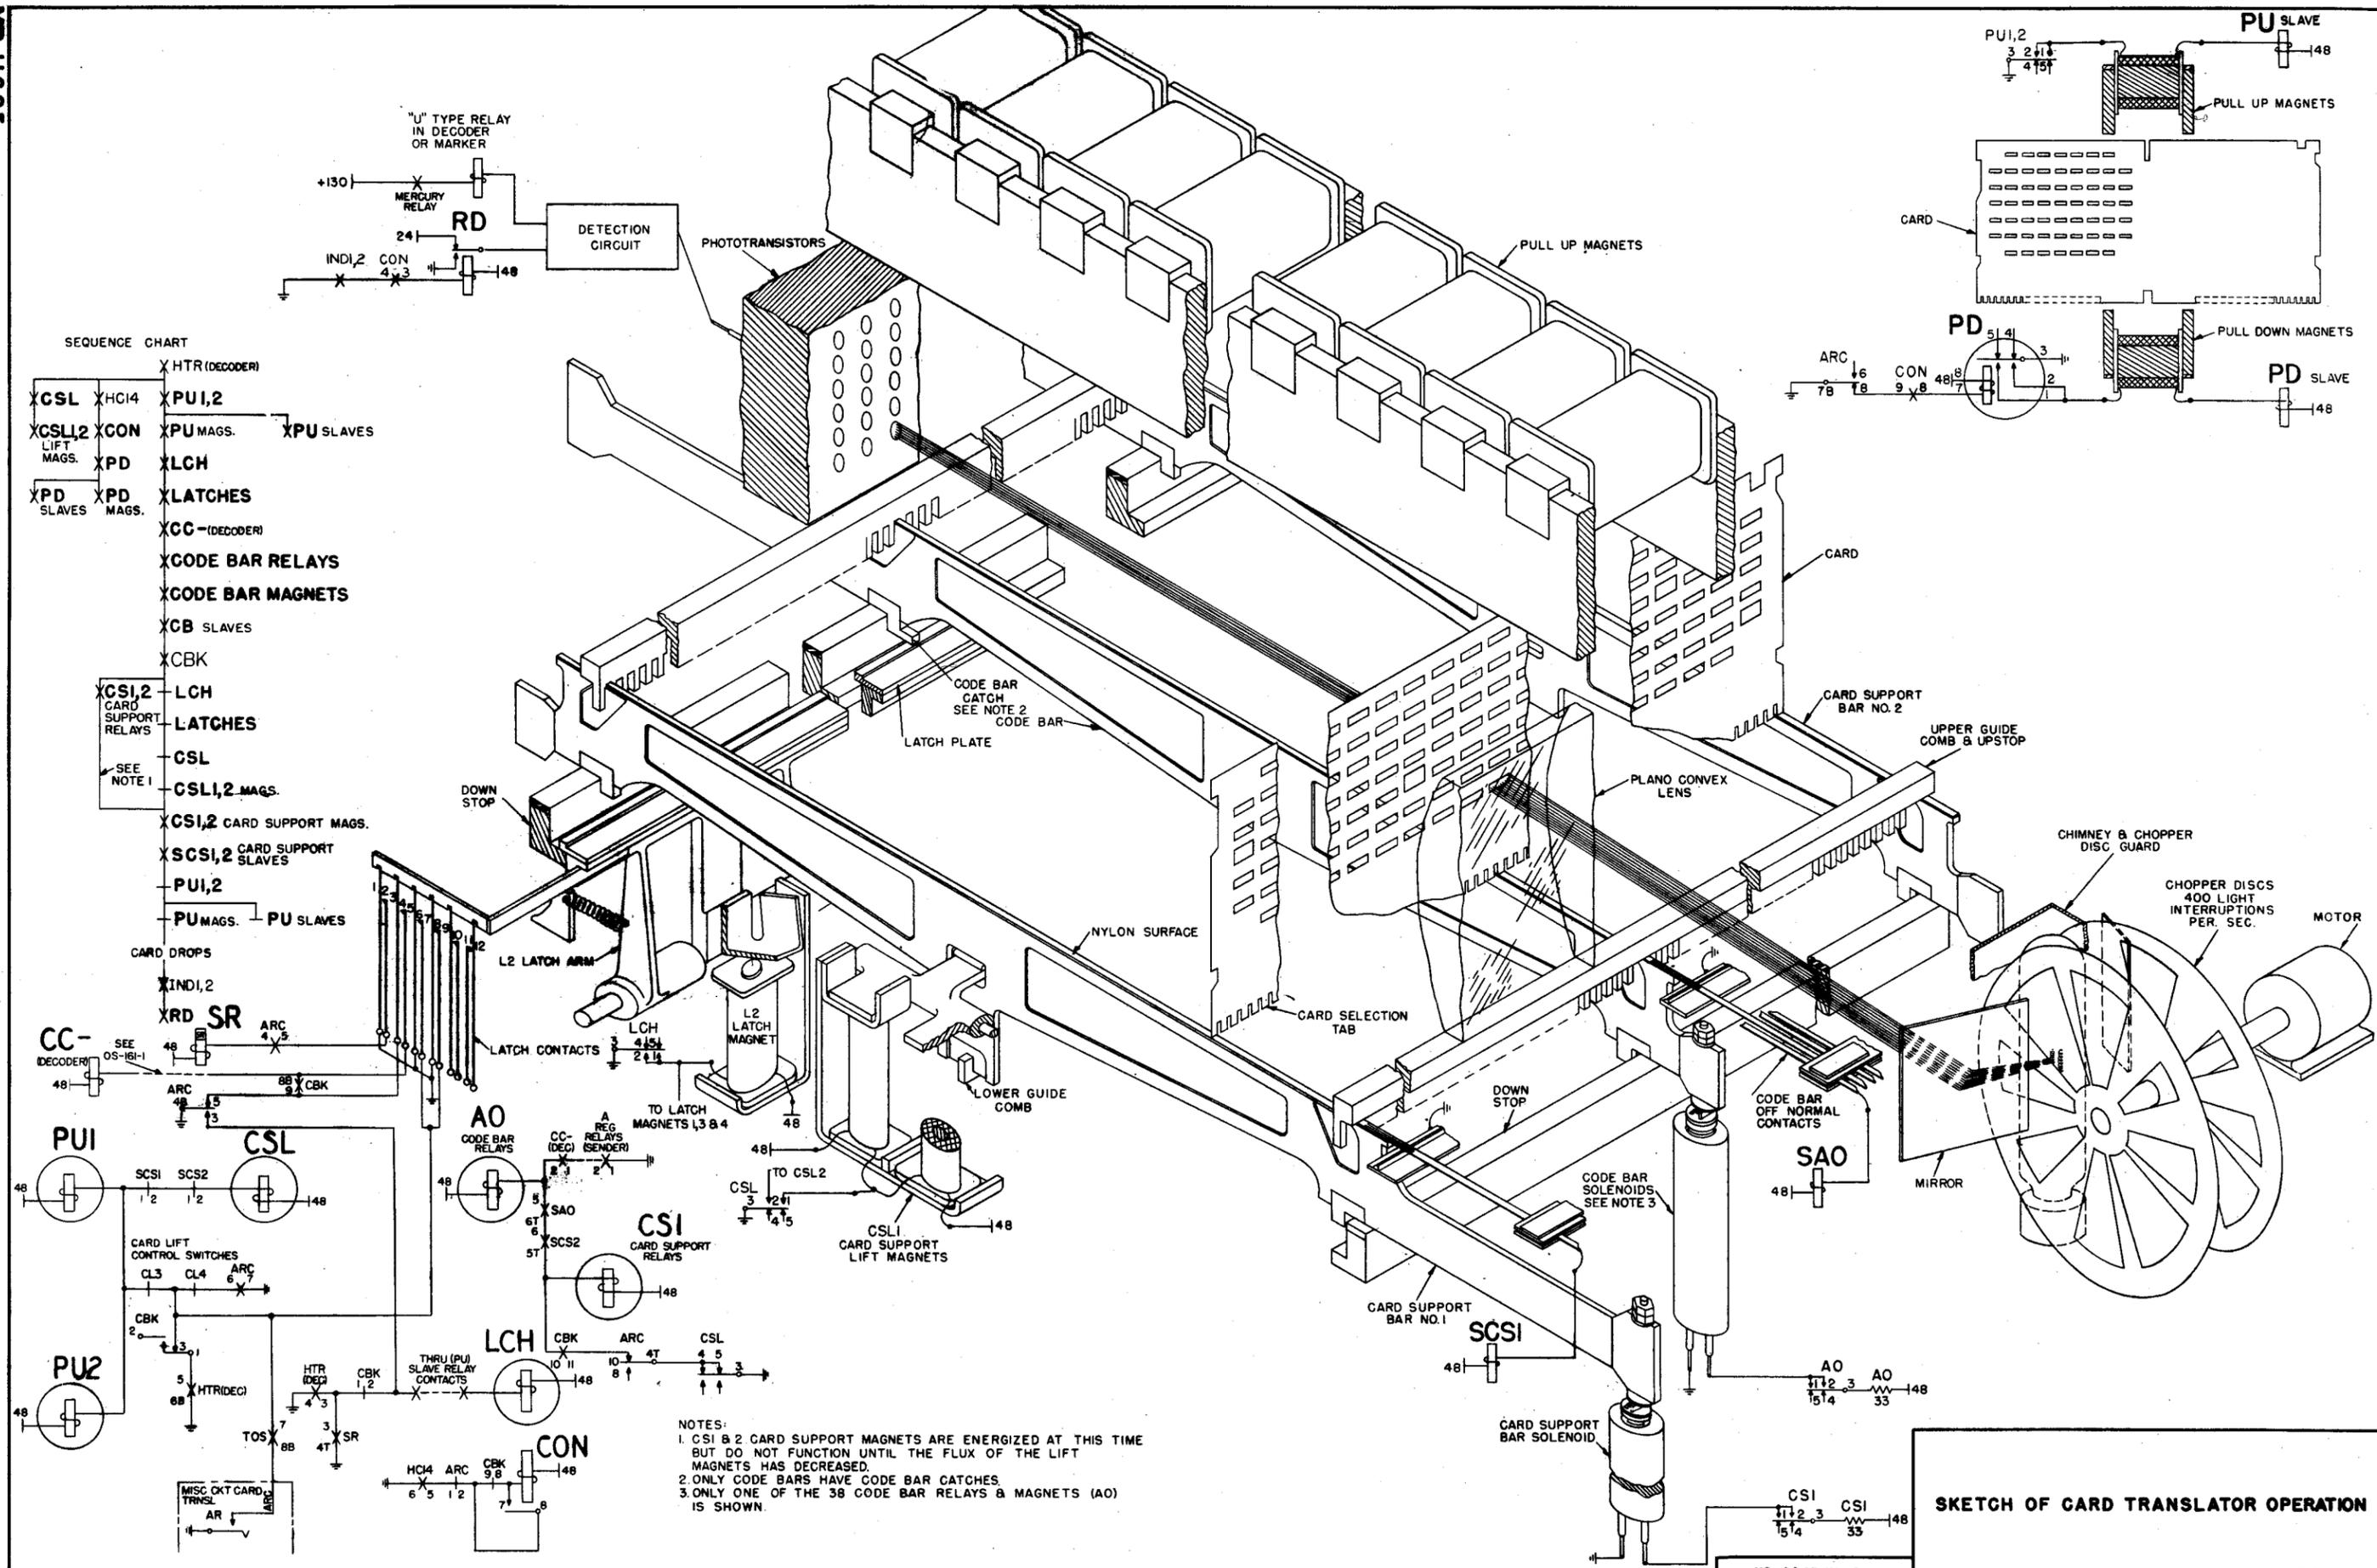
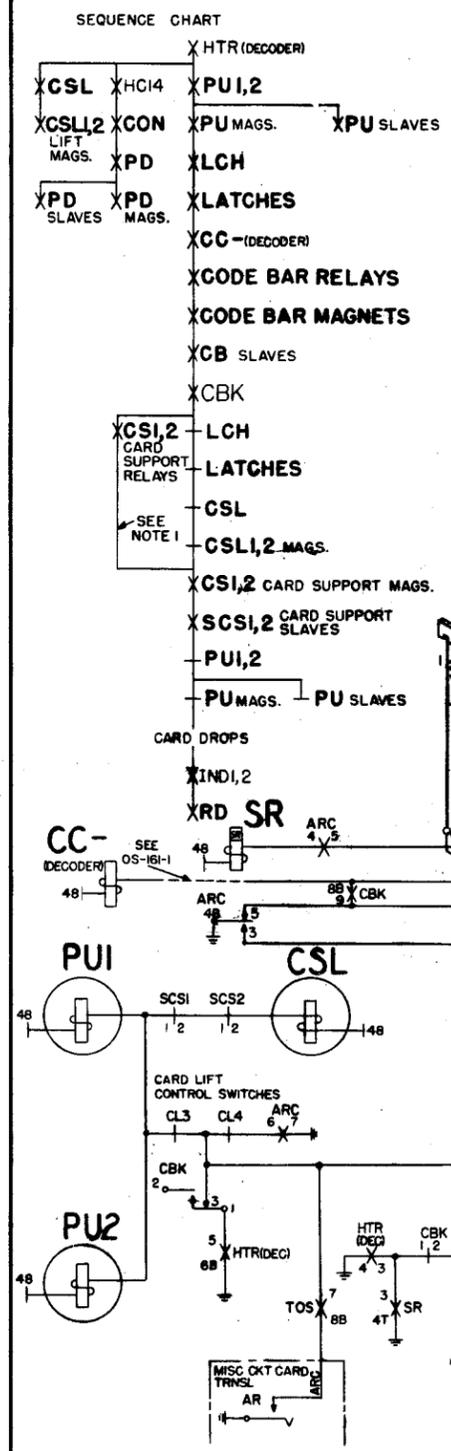
NOTES:
 1. CSI & 2 CARD SUPPORT MAGNETS ARE ENERGIZED AT THIS TIME BUT DO NOT FUNCTION UNTIL THE FLUX OF THE LIFT MAGNETS HAS DECREASED.
 2. ONLY CODE BARS HAVE CODE BAR CATCHES
 3. ONLY ONE OF THE 38 CODE BAR RELAYS & MAGNETS (AO) IS SHOWN.
