Upgrading the MG 9000

This document contains upgrade and downgrade information and procedures for the MG 9000 cards and the MG 9000 Manager.

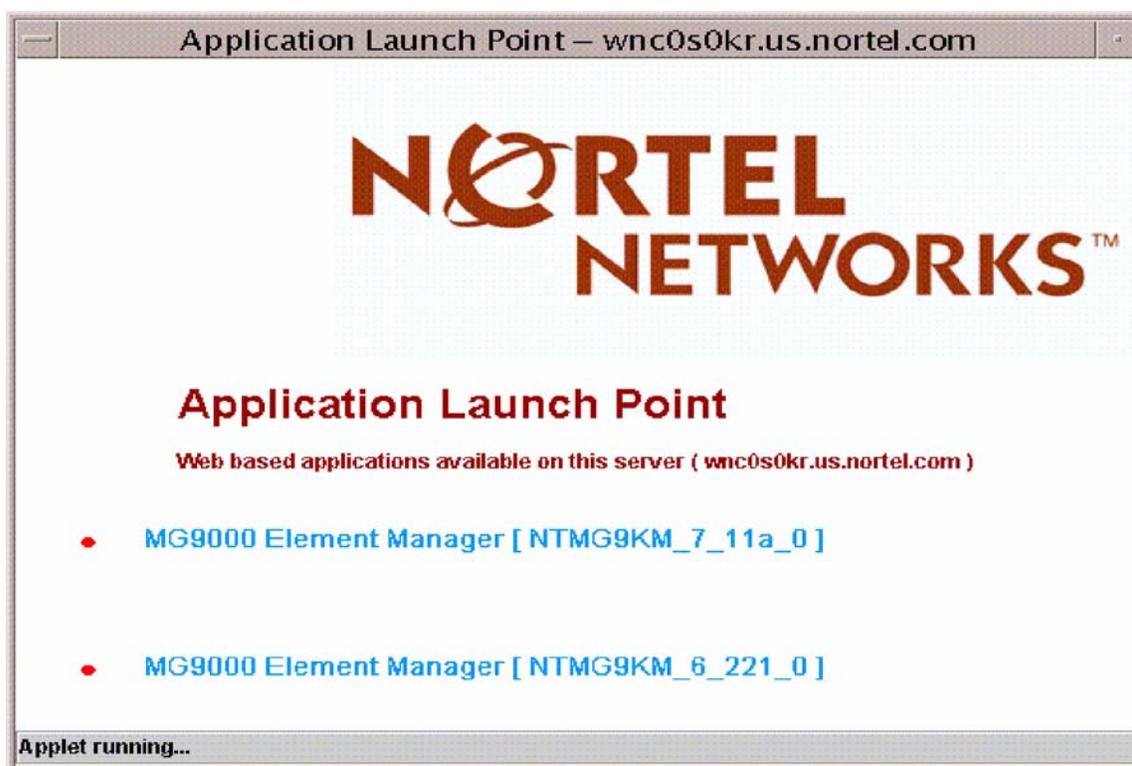
The Application Launch Point window appears containing two links, one for SN06.x and one for SN07. Click on the SN07 “MG9000 Element Manager” link. The following figure shows the Application Launch Point with the SN06.x and SN07 MG 9000 Manager links. Enter the username and password in the login when prompted.

Note: The top link that appears in the launch point window is for the SN07 client, the bottom link is for the SN06 client.

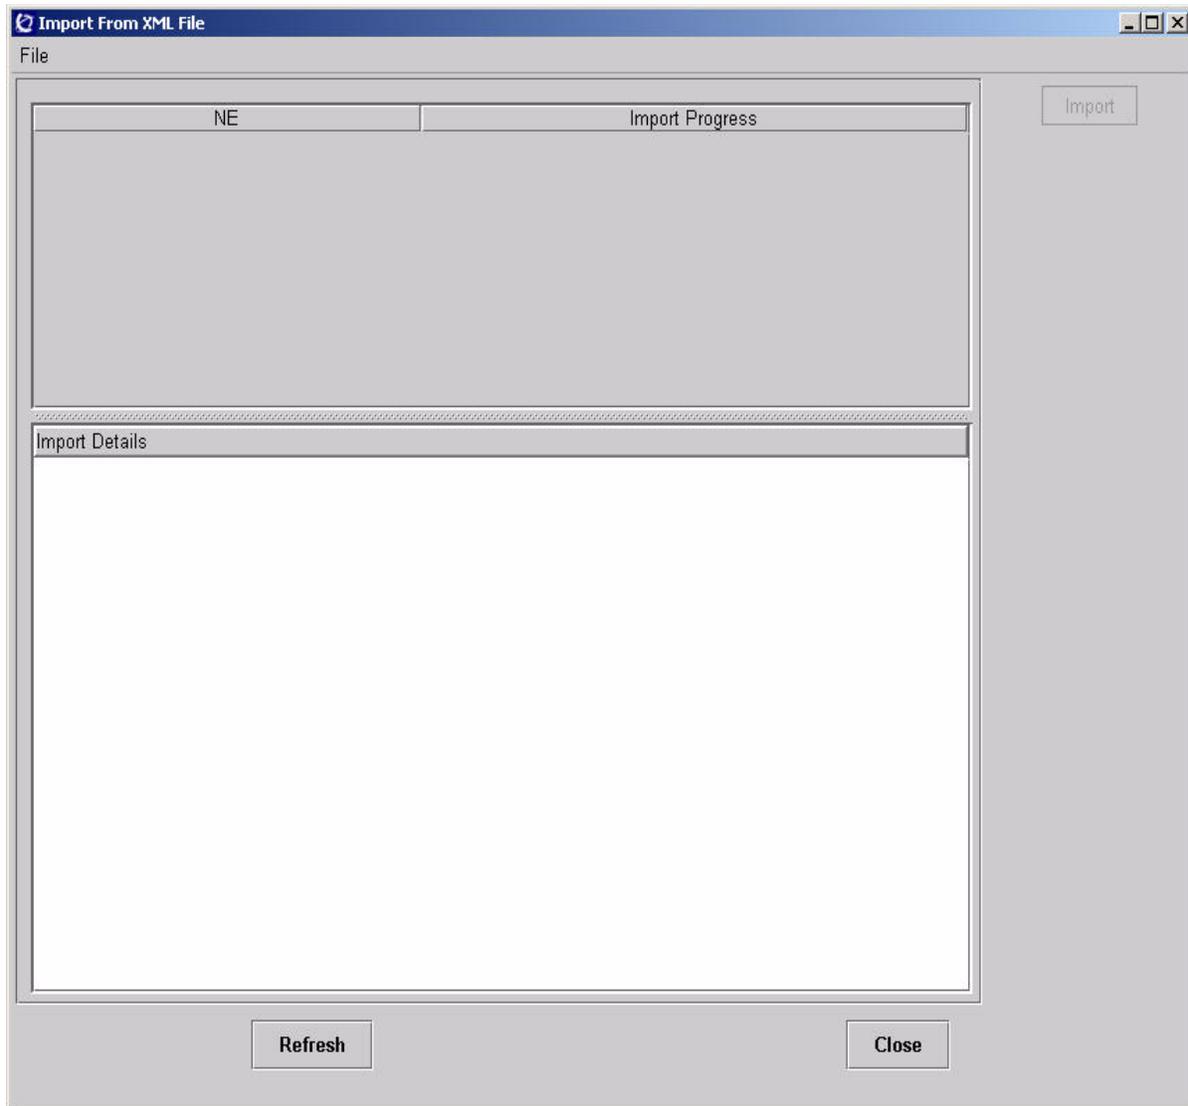
- 1 From the Subnet View, select MG9000->ImportNE from the menu bar. The Import from XML file window appears. The following figure shows the Import from XML file window.

- 2 When upgrading from SN06 to SN07, click on the NE with path named `/data/mg9kem/persistdata/xml/SN06/ <ne_number>`.
When upgrading from SN06.2 to SN07, click on the NE with path named `/data/mg9kem/persistdata/xml/SN06_2/ <ne_number>`.
- 3 Click Import. The progress will be displayed in the Import details pane. Close the window. The Import NE will cause a discovery and an audit to run. Observe the NE icon in the Subnet View appears with a discovery arrow. When the discovery arrow disappears, the Import is complete.
- 4 This procedure is complete.

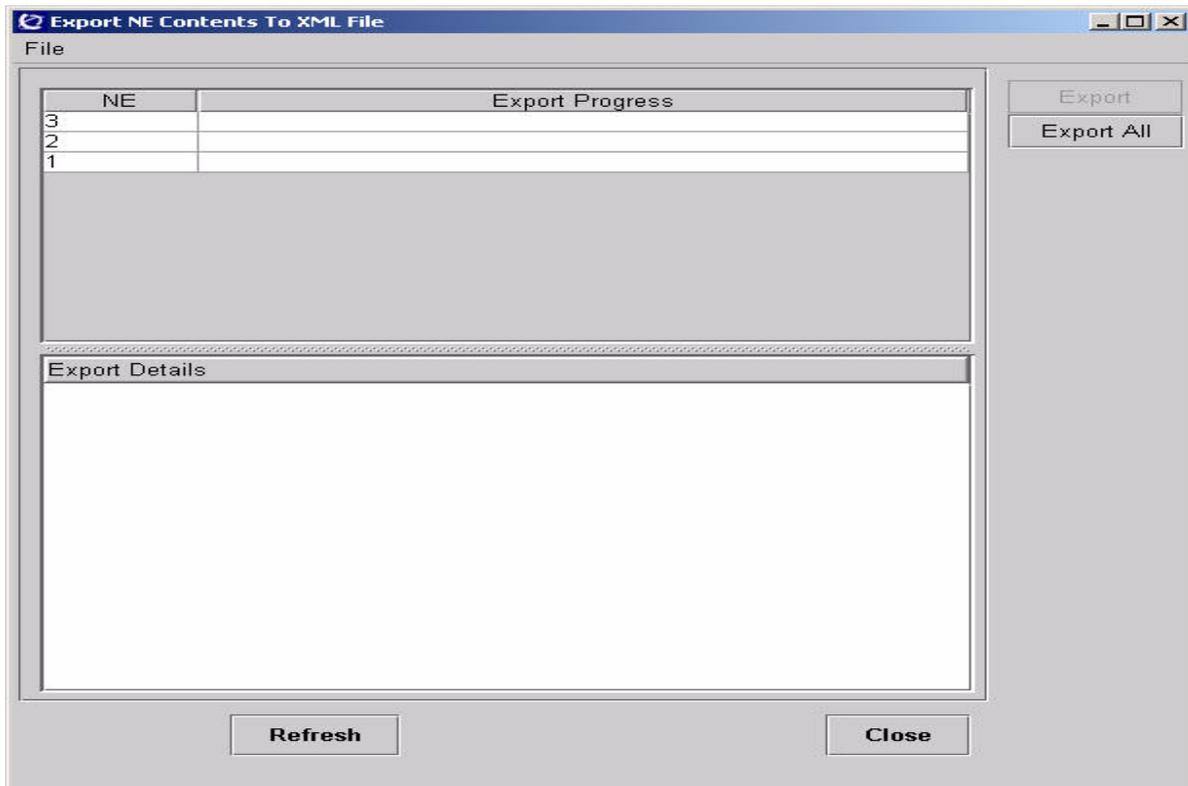
NE Export to XML file window

- 2 Click on the NE, click on Export, then wait for the message “Completed XML Export” appears in the window indicating the export action is complete before closing the window.
Note: Use the Export All button when performing an export in support of an MR release upgrade.
- 3 This procedure is complete.

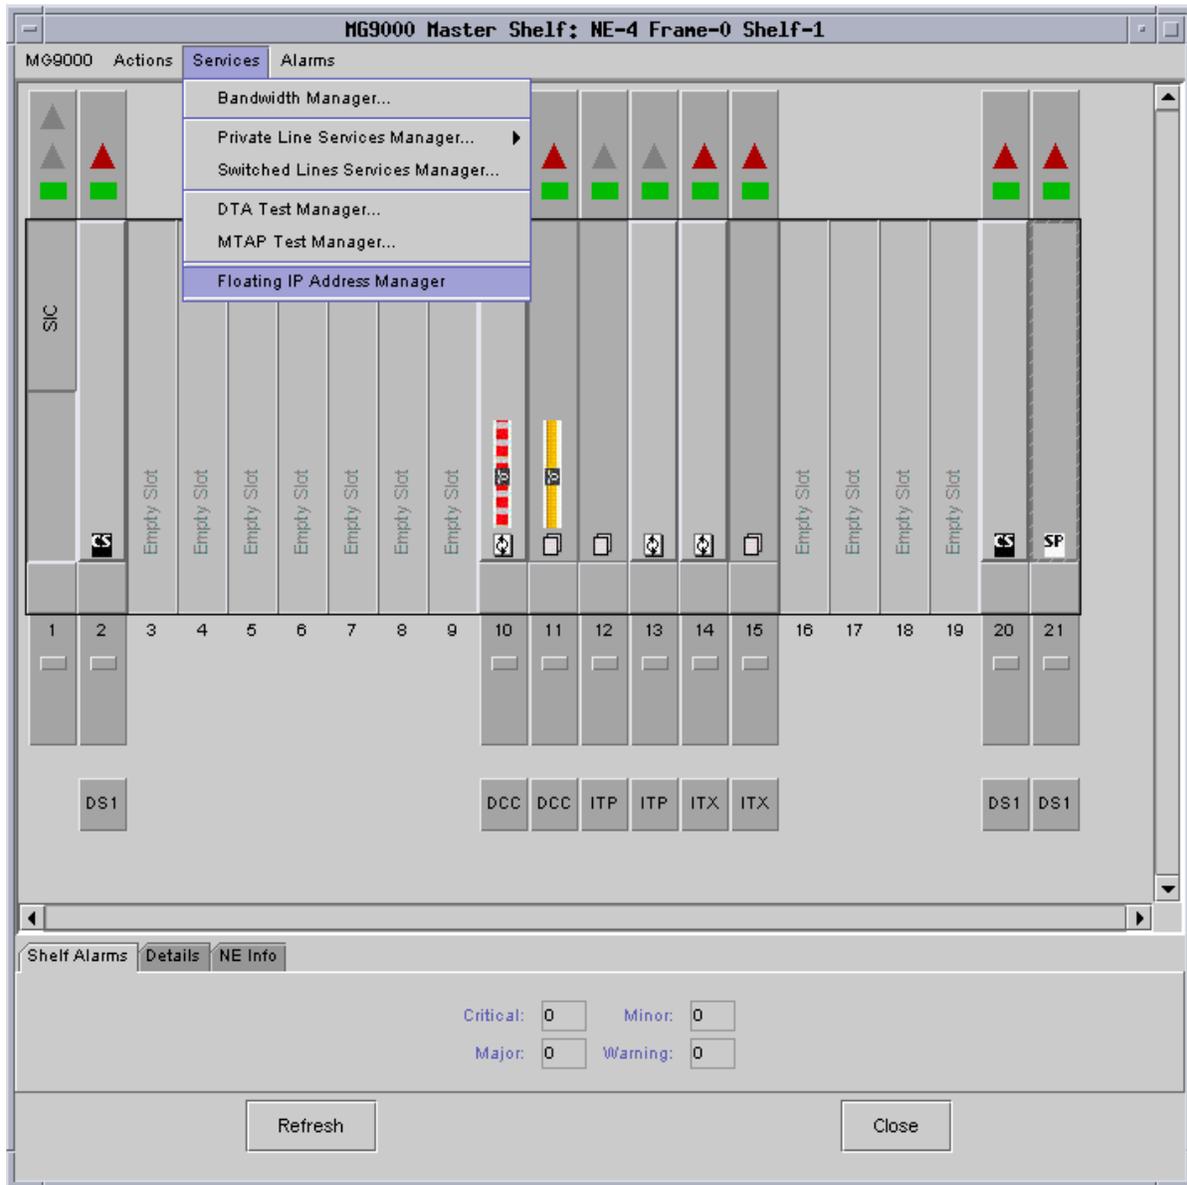
### Floating IP Address Manager accessed from Shelf View

- 2 To provision a floating IP address in the MG 9000 Manager if necessary, perform the following steps:
  - a From any Frame, Shelf, or Card view select the menu Services. From within Services select Floating IP Address Manager, as shown in the following figure.

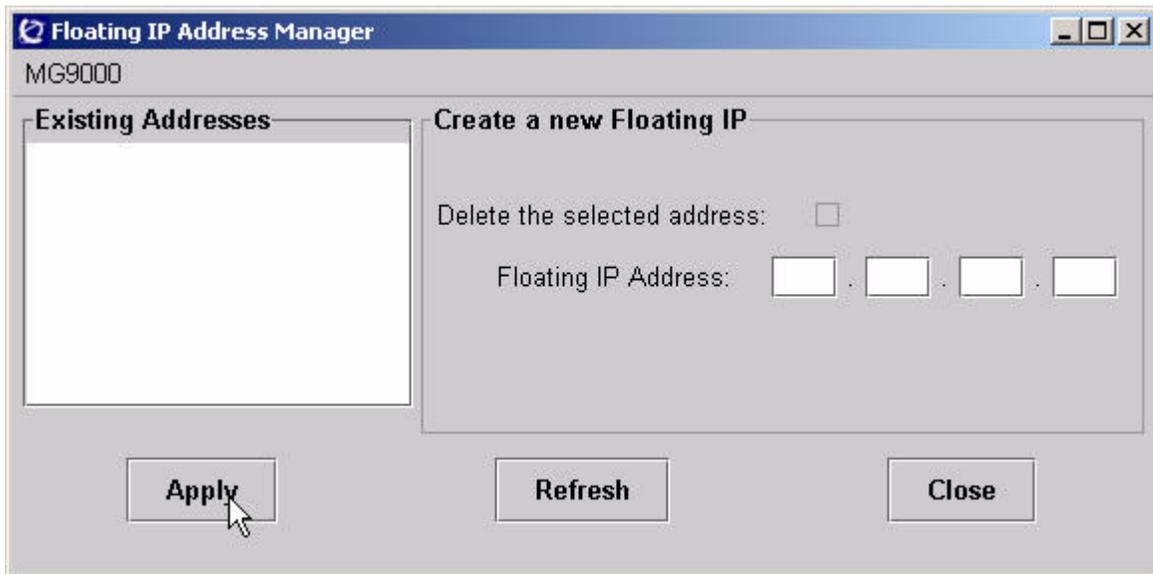
### Floating IP Address Manager View

- b** Enter the IP address in the Floating IP Address Manager and select Apply. The address will be displayed under existing IP addresses. When finished, select Close.

- c** If the floating IP address must be replaced, delete the entry first. To delete an entry select the entry, select the Delete check box, then press Apply. When finished select Close.
  - d** If the floating IP address is correct, select Close.
- 3** This procedure is complete. If this is part of an upgrade, return to the upgrade checklist to continue with the upgrade process.

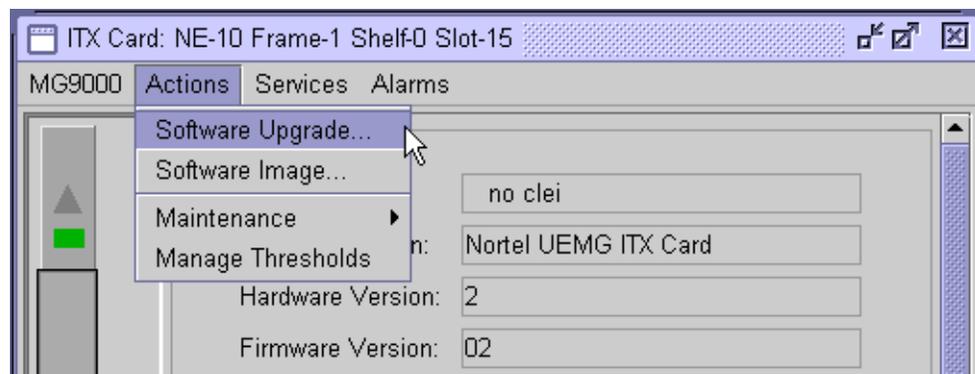
### Software upgrade accessed from Card View

The following figure shows accessing Software Upgrade from the Actions pull-down menu from the Card View

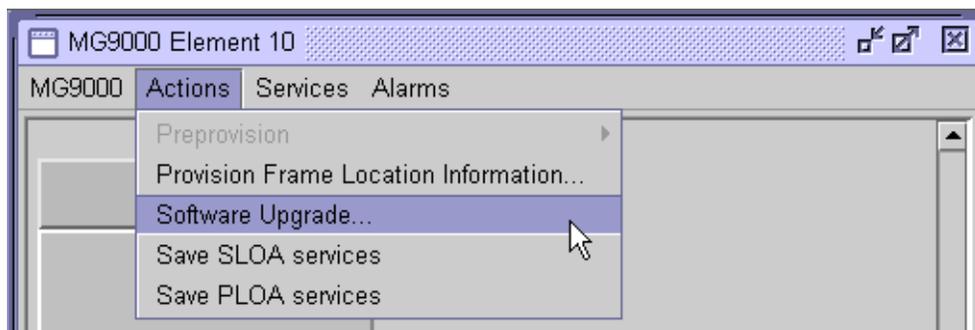
### Software upgrade accessed from Frame View

The following figure shows accessing Software upgrade from the Actions pull-down menu from the Frame View.

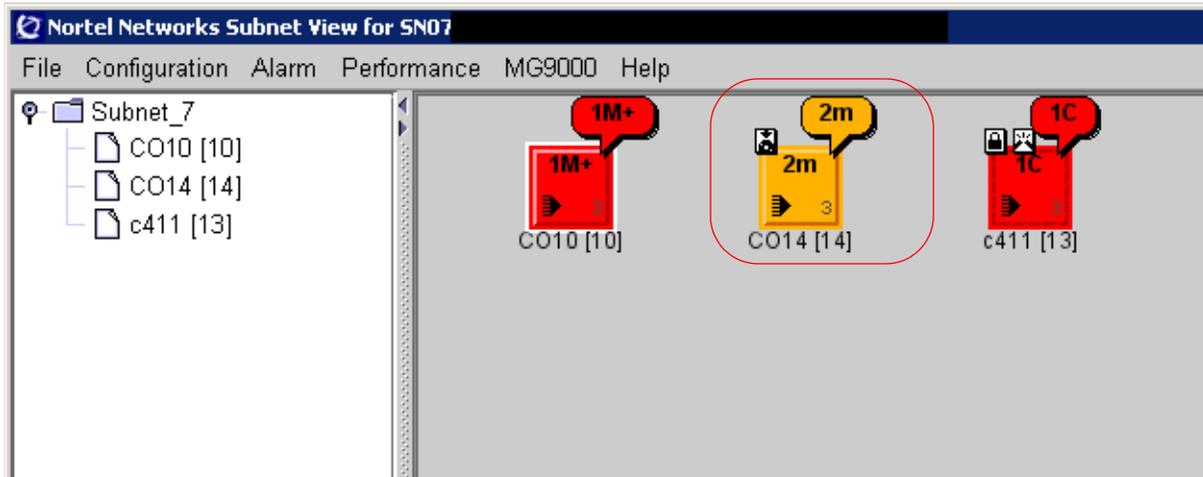
## Subnet View showing download icon

The following figure shows the Subnet View with the download icon on top of the MG 9000 on which a software download is in progress. The download icon also appears at the card and shelf views. The icon remains until the upgrade is complete or an abort completes.

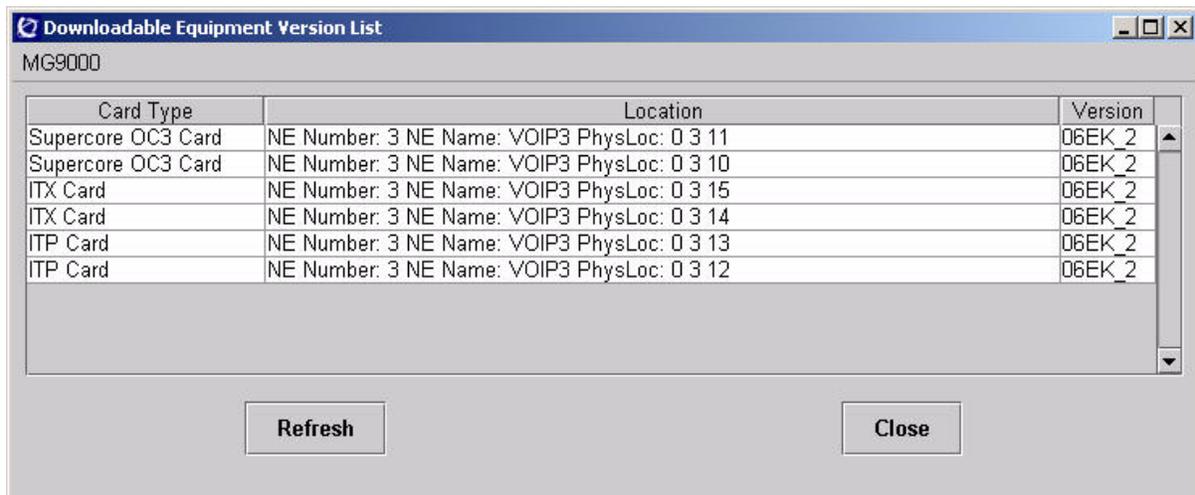
## Version list

The following figure shows the version list that appears in response to selecting the Version List button on the Software Upgrade View. The version list shows all common cards on the selected MG 9000 and the software version of the loads in the card.

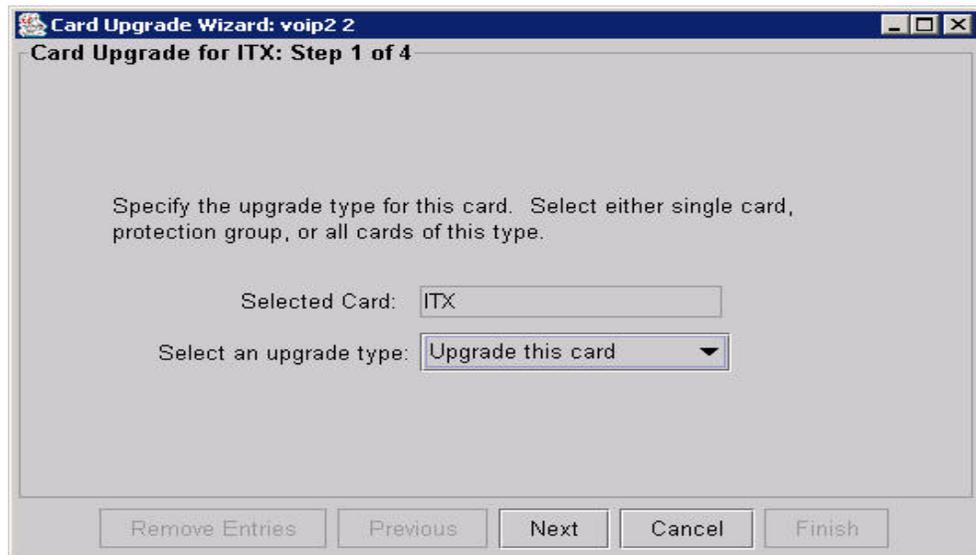
### Card Upgrade Wizard, Step 1

- The first Card Upgrade Wizard step (step 1) allows the user to specify the upgrade type by clicking on the pull down. The following three upgrade types are available:
  - card type - upgrade the individual card from which this panel was launched
  - protection group - upgrade the card from which this panel was launched and its redundant mate (though this option is available in the Card upgrade wizard, it is recommended that upgrades of a protection group be performed using the [MG Upgrade Wizard on page 119.](#))
  - all cards of this type - upgrade all cards of the selected type in the MG 9000 (though this option is available in the Card upgrade

- upgrading of multiple cards instead of a single card with upgrade icon appearing on all cards being upgraded
- Swact occurs without user intervention as part of the upgrade

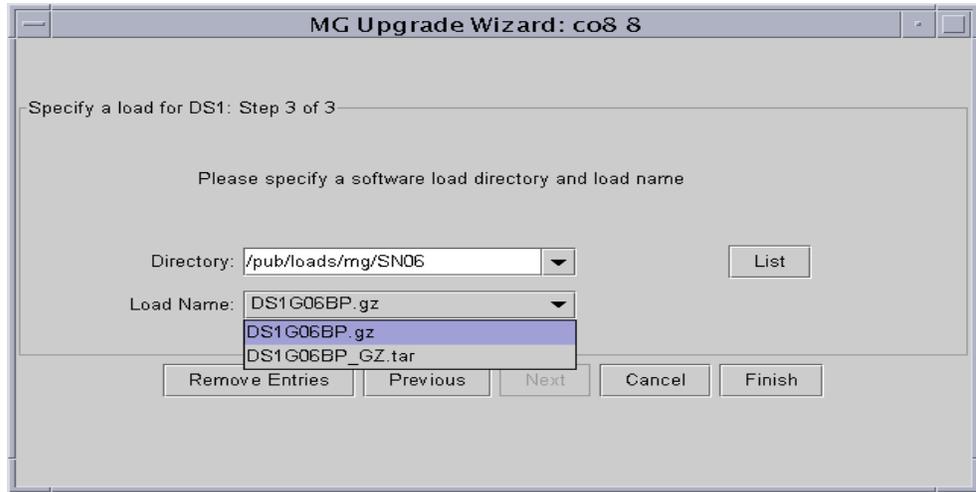
**Card Upgrade Wizard, Step 3, specify a load (SN06.2 version)**

On the SN06.2 or SN07 version of the Step 3, click on the List button to retrieve the files from the SDM and the combo box is populated with MG 9000 patched image (9PI) file names (identified by the .tar extension on the filename). Choose a file from the list. The following figure shows Step 3 of the Card Upgrade Wizard.

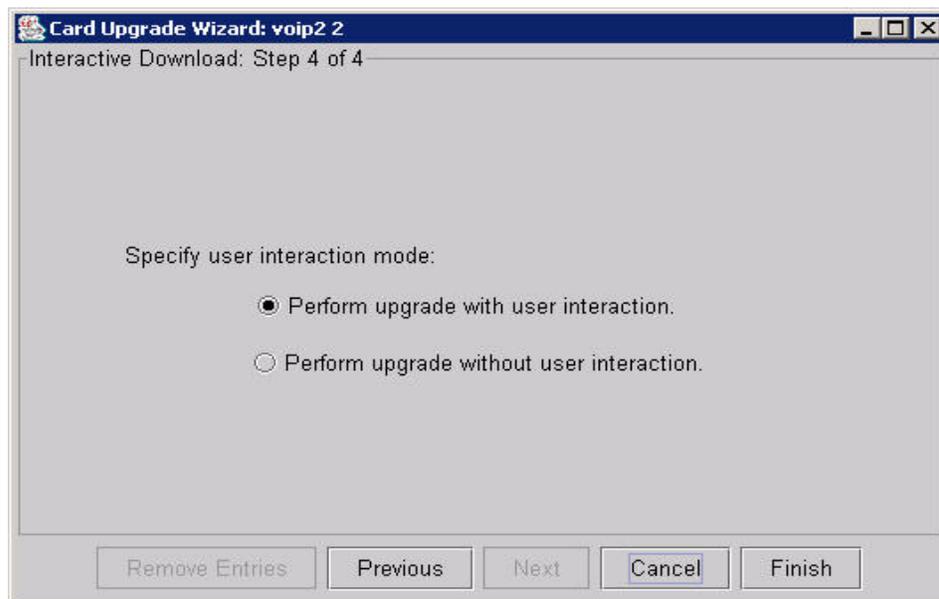
## Card Upgrade Wizard, Step 4, interactive download

- The next panel (step 4) prompts for the user to select between performing the upgrade with user interaction or without user interaction. The following figure shows Step 4 of the MG Upgrade Wizard.

- Perform upgrade without user interaction - It is recommended that this mode is used. When selecting this mode, after the user clicks Finish, the system responds with an Upgrade button on the Software Upgrade View. After the user clicks Upgrade, the system continues with the successful completion of each action, the next action automatically executes without any input needed from the user. The exception to this, is if an error occurs. Then the upgrade stops and the user must click Abort. Error messages will be output. Refer to [Software upgrade errors and problem resolution on page 106](#) for information on responding to errors.

- Perform upgrade with user interaction - When selecting this mode, the system responds with a Download button on the Software Upgrade View. The system then prompts for an Apply followed by an Accept. Like the previously discussed upgrade without user interaction, refer to [Software upgrade errors and problem resolution on page 106](#) for information on responding any errors that may occur.

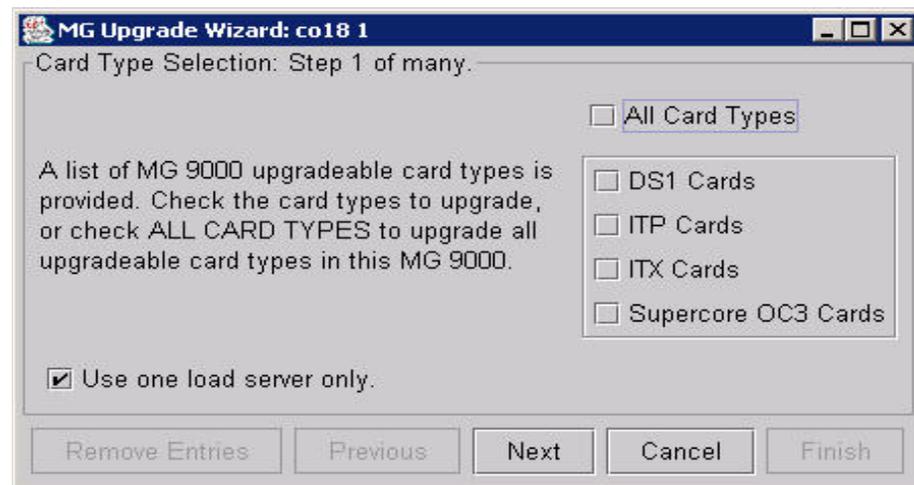
### MG Upgrade Wizard, Step 1, card type selection, multiple cards

- The first MG Upgrade Wizard step (step 1) allows the user to specify All Card Types, one card type, or multiple card types. The MG Upgrade Wizard will upgrade the software in all cards of the selected type. The following figure shows the MG Upgrade Wizard, Card Type Selection, Step 1.

The MG Upgrade Wizard contains a list of card types available to be upgraded on the given MG 9000. One or more than one card types can be selected for upgrade. The user can also select all the card types on a given MG 9000 by selecting All Card Types. The check box “Use one load server only” is provided to specify a single or a different load server for each card type. The default value is to use the same load server for all card types.

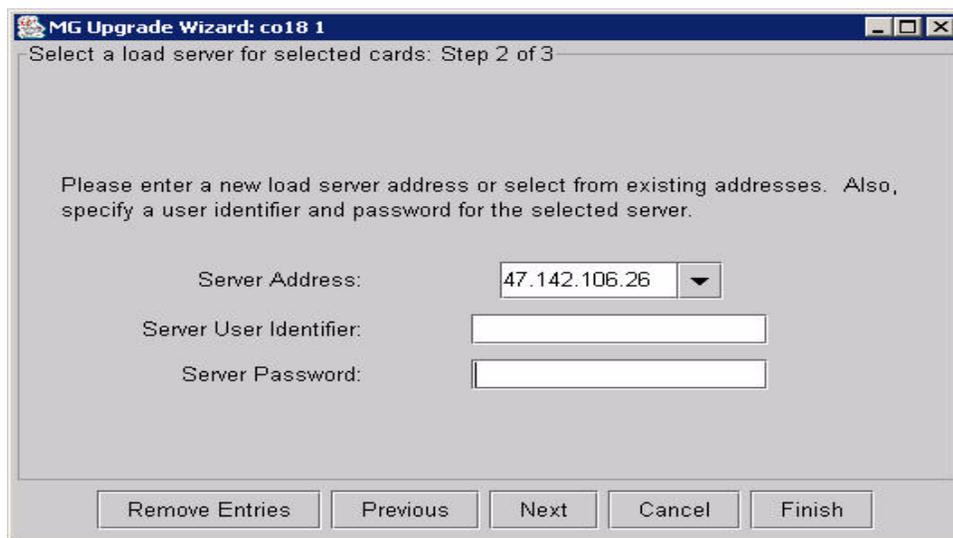
## MG Upgrade Wizard, Step 2, select a load server

- The next MG Upgrade Wizard (step 2) allows the user to enter a load server IP address, a userid and password to be used to access the load server. The last six entries for the server IP address are remembered. The user can select between the last six entries or enter a new one. A user is not allowed to move to the next panel until all the entries on this panel are completed with valid data. The following figure shows the MG Upgrade Wizard, Step 2.

The screenshot shows a Windows-style dialog box titled "MG Upgrade Wizard: co18 1". The subtitle is "Select a load server for selected cards: Step 2 of 3". The main text reads: "Please enter a new load server address or select from existing addresses. Also, specify a user identifier and password for the selected server." Below this text are three input fields: "Server Address:" with a dropdown menu showing "47.142.106.26", "Server User Identifier:" with an empty text box, and "Server Password:" with an empty text box. At the bottom of the dialog are five buttons: "Remove Entries", "Previous", "Next", "Cancel", and "Finish".

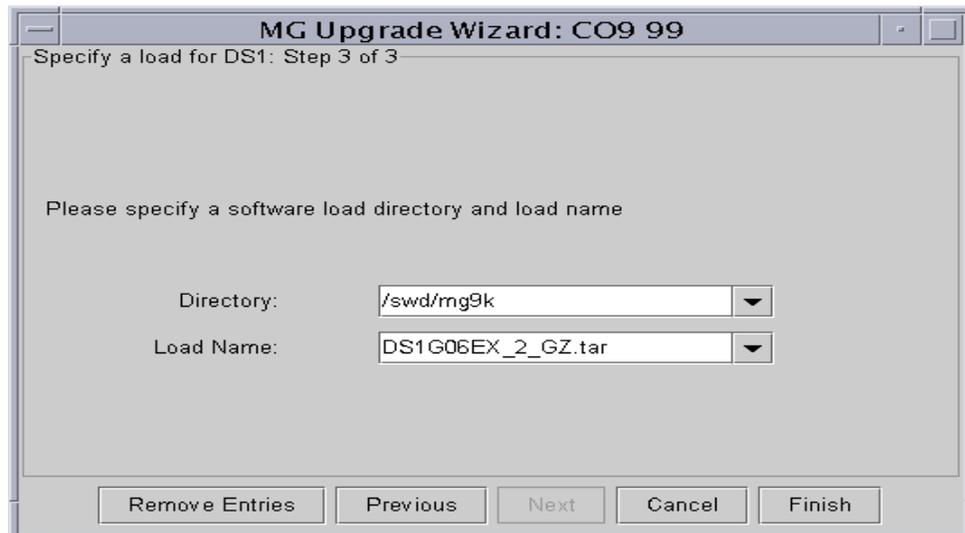
### MG Upgrade Wizard, Step 3, Specify a load (SN06 version)

When upgrading from SN06 to SN07, the SN06 version of Step 3 appears. Enter the load name. The load name is parsed for the version number. A valid string for the load name consists of the card type in uppercase followed by the version.

The screenshot shows a dialog box titled "MG Upgrade Wizard: CO9 99". The main text inside the dialog reads "Specify a load for DS1: Step 3 of 3". Below this, it says "Please specify a software load directory and load name". There are two input fields: "Directory:" with the value "/swd/mg9k" and "Load Name:" with the value "DS1G06EX\_2\_GZ.tar". At the bottom of the dialog, there are five buttons: "Remove Entries", "Previous", "Next", "Cancel", and "Finish".

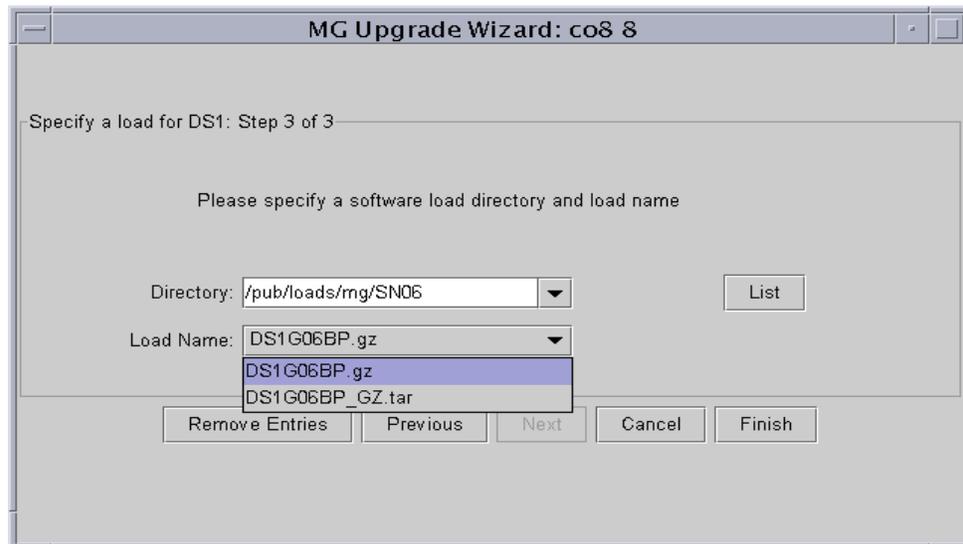
### MG Upgrade Wizard, Step 3, Specify a load (SN06.2 version)

The following figure shows the MG Upgrade Wizard, Step 3, Specify a Load.

On the SN06.2 version of the MG Upgrade Wizard, Step 3, click on the List button to retrieve the files from the SDM and the combo box is populated with 9PI file names (identified by the .tar extension on the filename). Choose a file from the list.

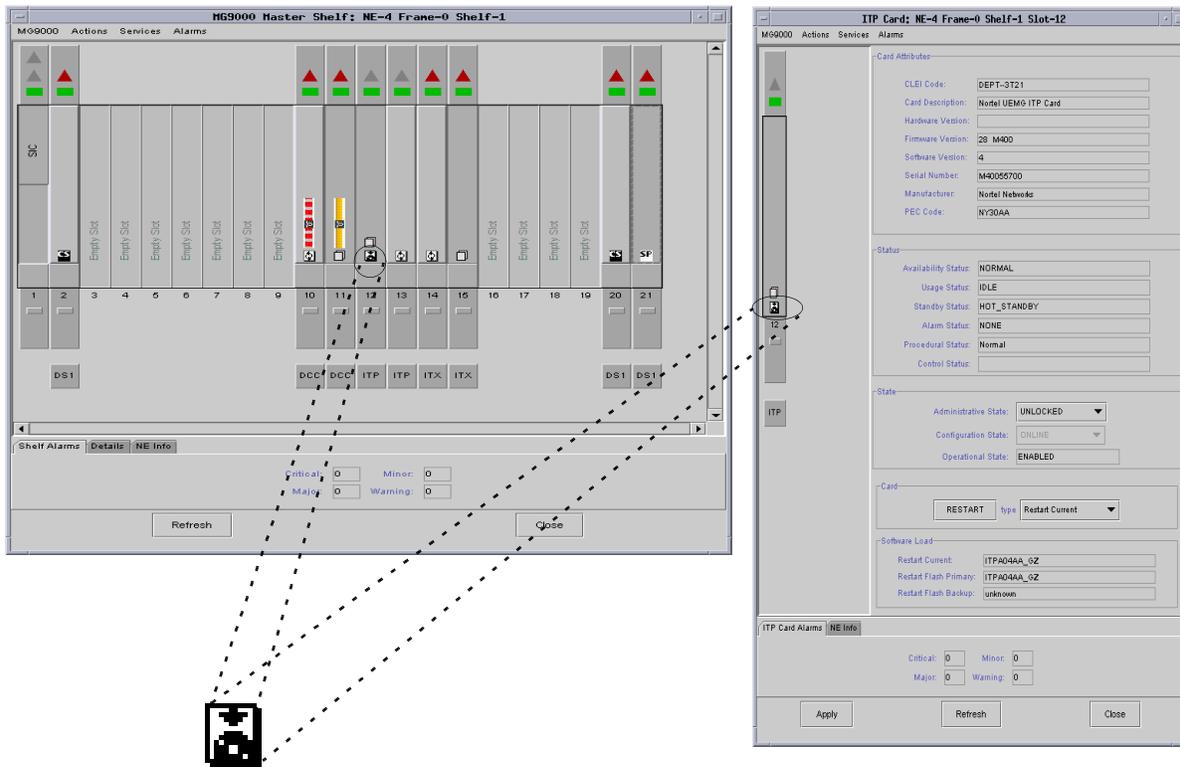
## Shelf View and Card View with download icon

The download icon appears in the Shelf View and the Card View. The icon remains until the upgrade is completed or aborted.

Software download icon

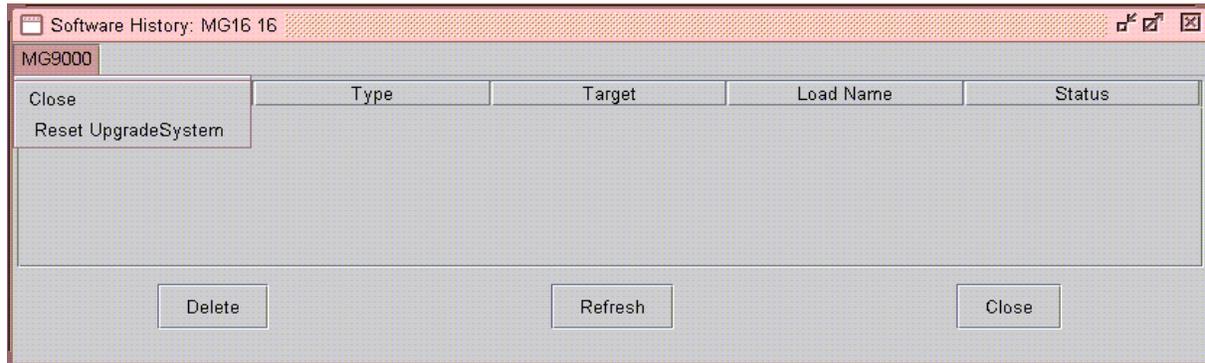
### Reset Upgrade System command

The following figure shows the Reset Upgrade System command.

The Reset Upgrade System command requires emsadm permission and is considered a drastic step. Do not use this command unless directed to do so by Nortel Networks customer support.

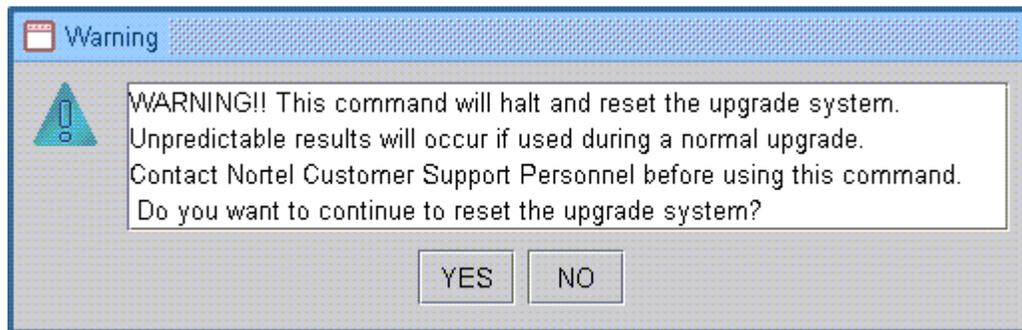
### Reset Upgrade System command warning

The following figure shows the warning message that appears when the Reset Upgrade System command is used.
