Upgrading the STORM

What's new for SN07

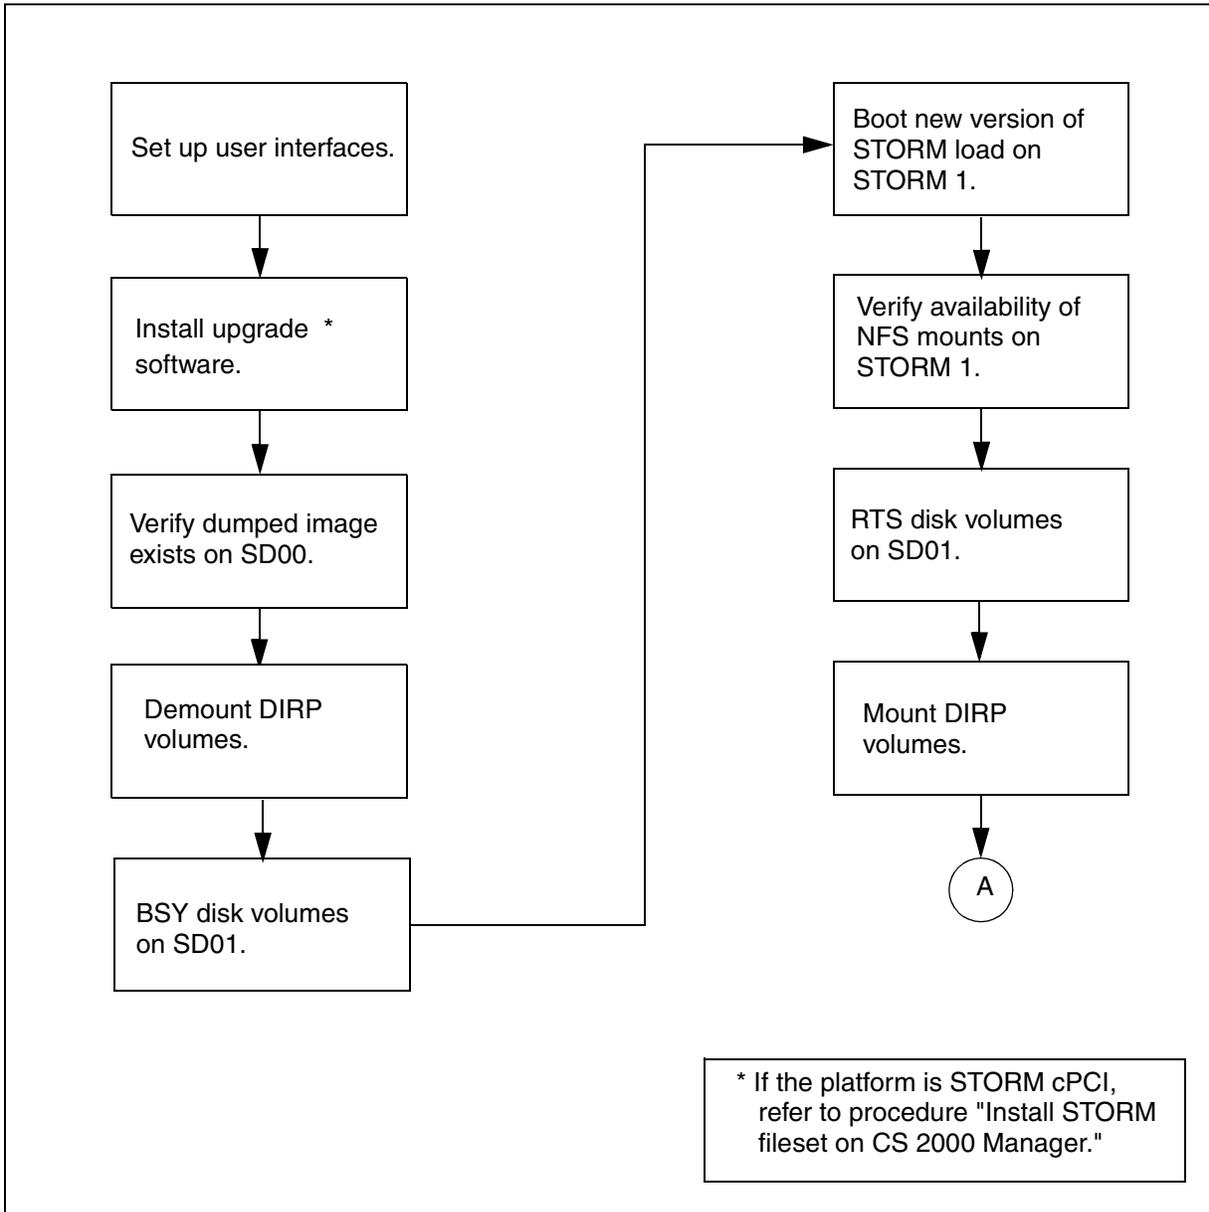
STORM in-service software upgrade overview

The following flowchart shows an overview for performing an in-service maintenance upgrade of STORM software, beginning with the second STORM unit, STORM 1, followed by the first STORM unit, STORM 0.

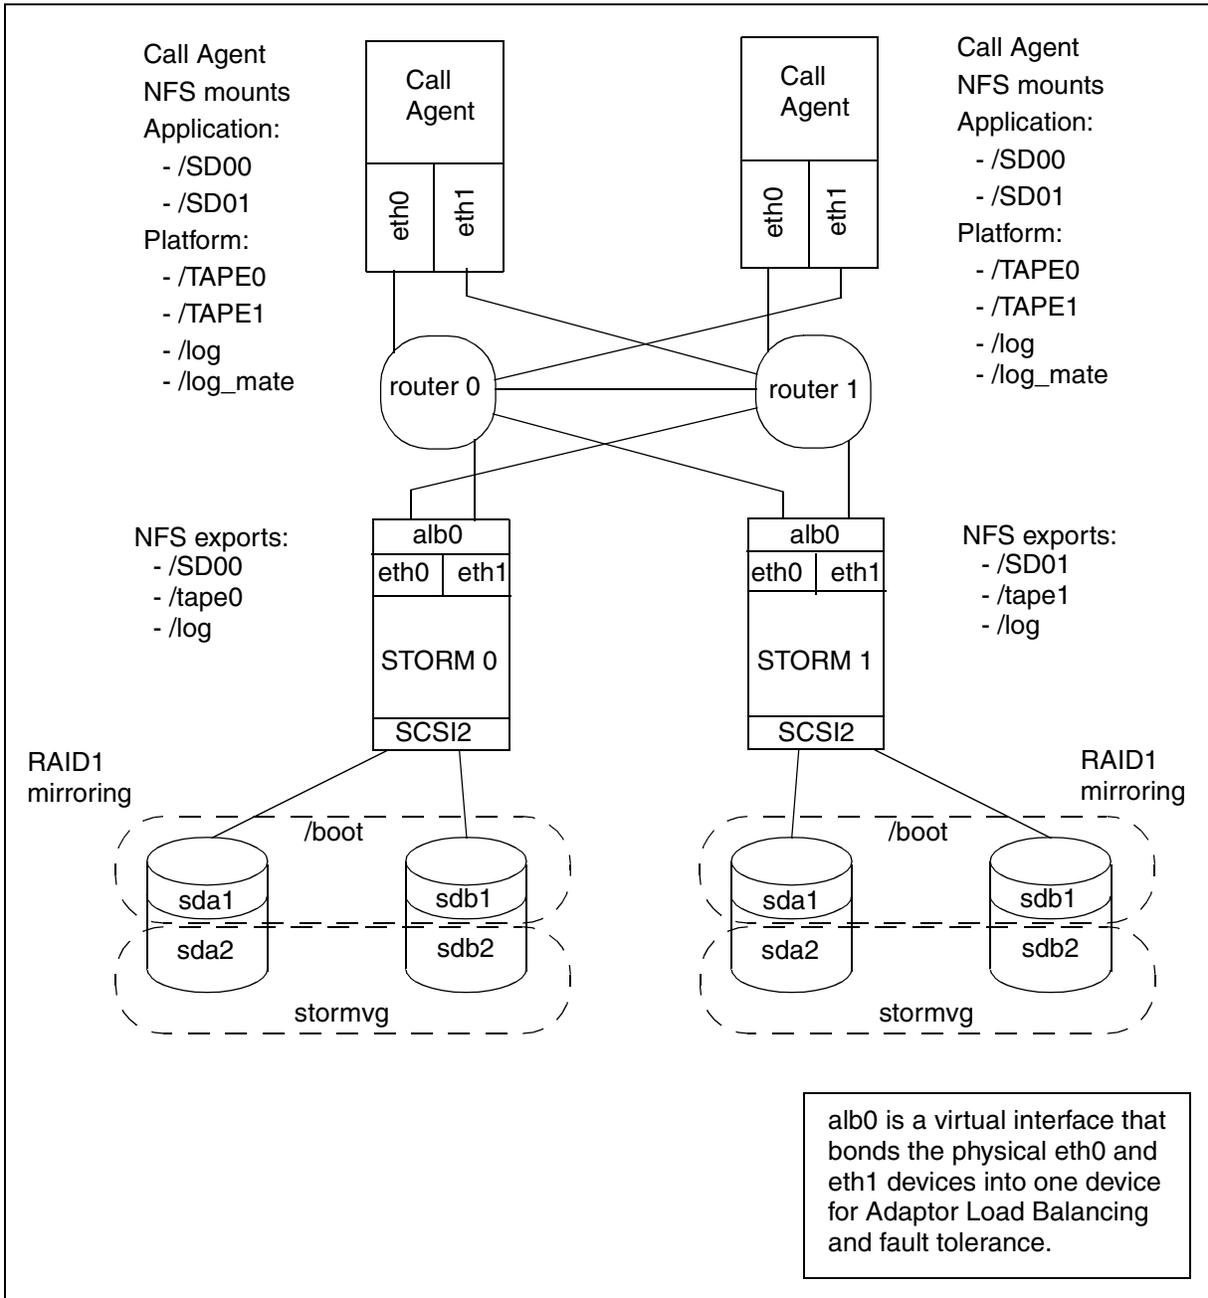
STORM SAM-XTS mounts

The following figures show the structure of the STORM platforms, the exported filesystems, and the Call Agent mount points for those exported filesystems.

Note: This figure does not reflect the mounts to the Universal Signaling Point (USP) - Compact.

Refer to [Mount points](#) for an illustration and information about the STORM exports and Call Agent mount points.

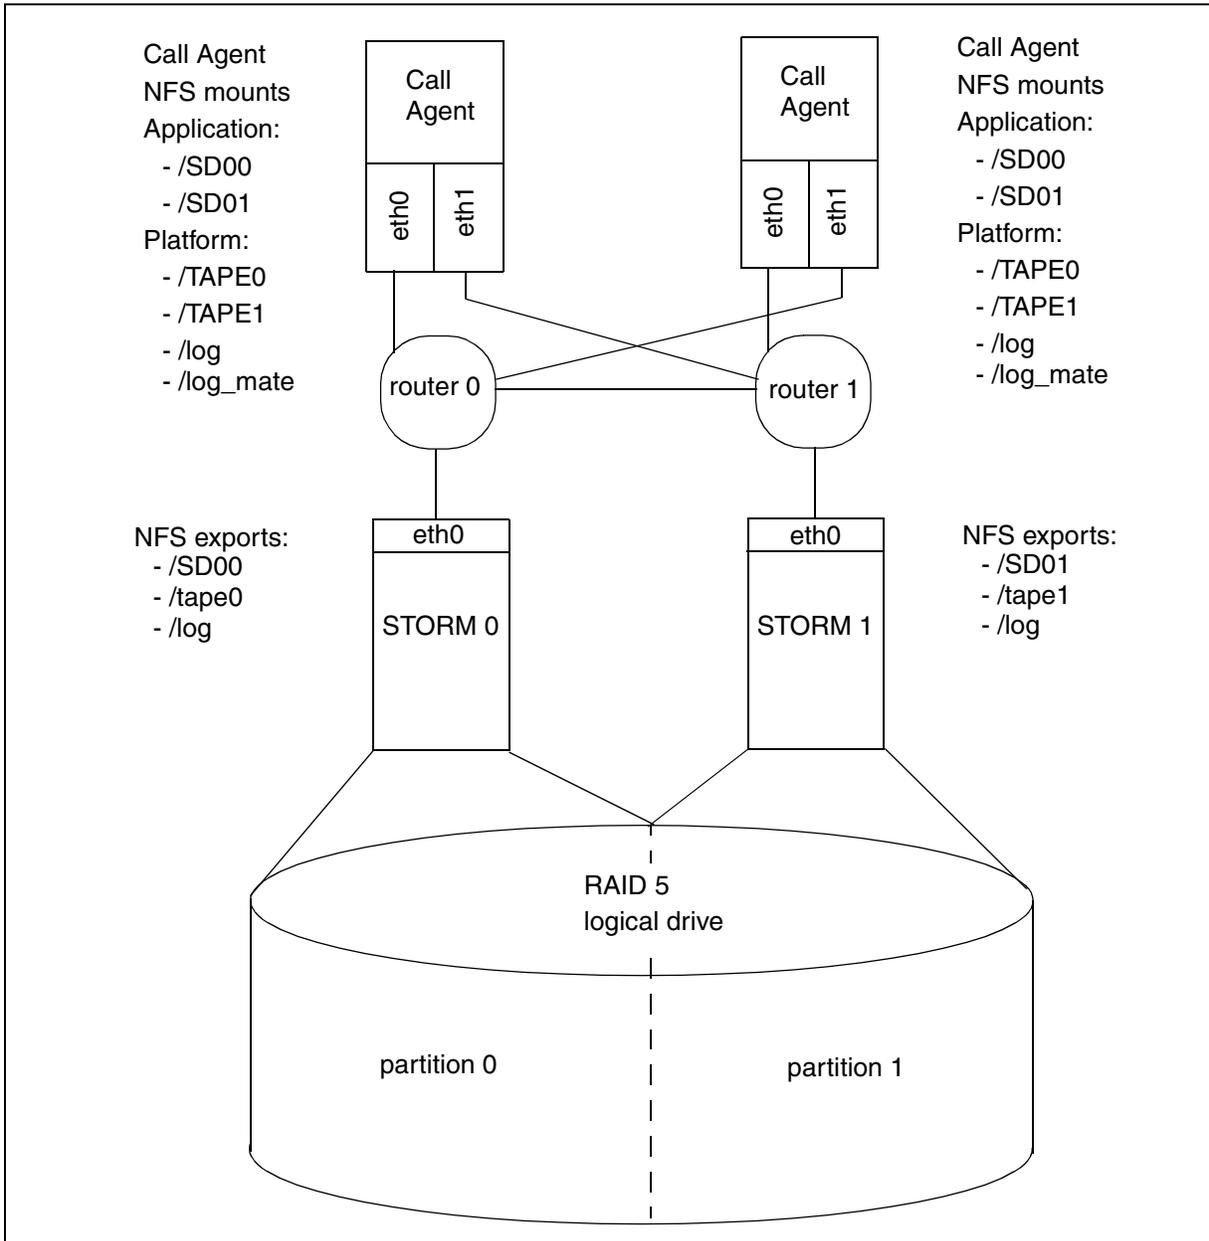
STORM cPCI mounts

Note: This figure does not reflect the mounts to the Universal Signaling Point (USP) - Compact.

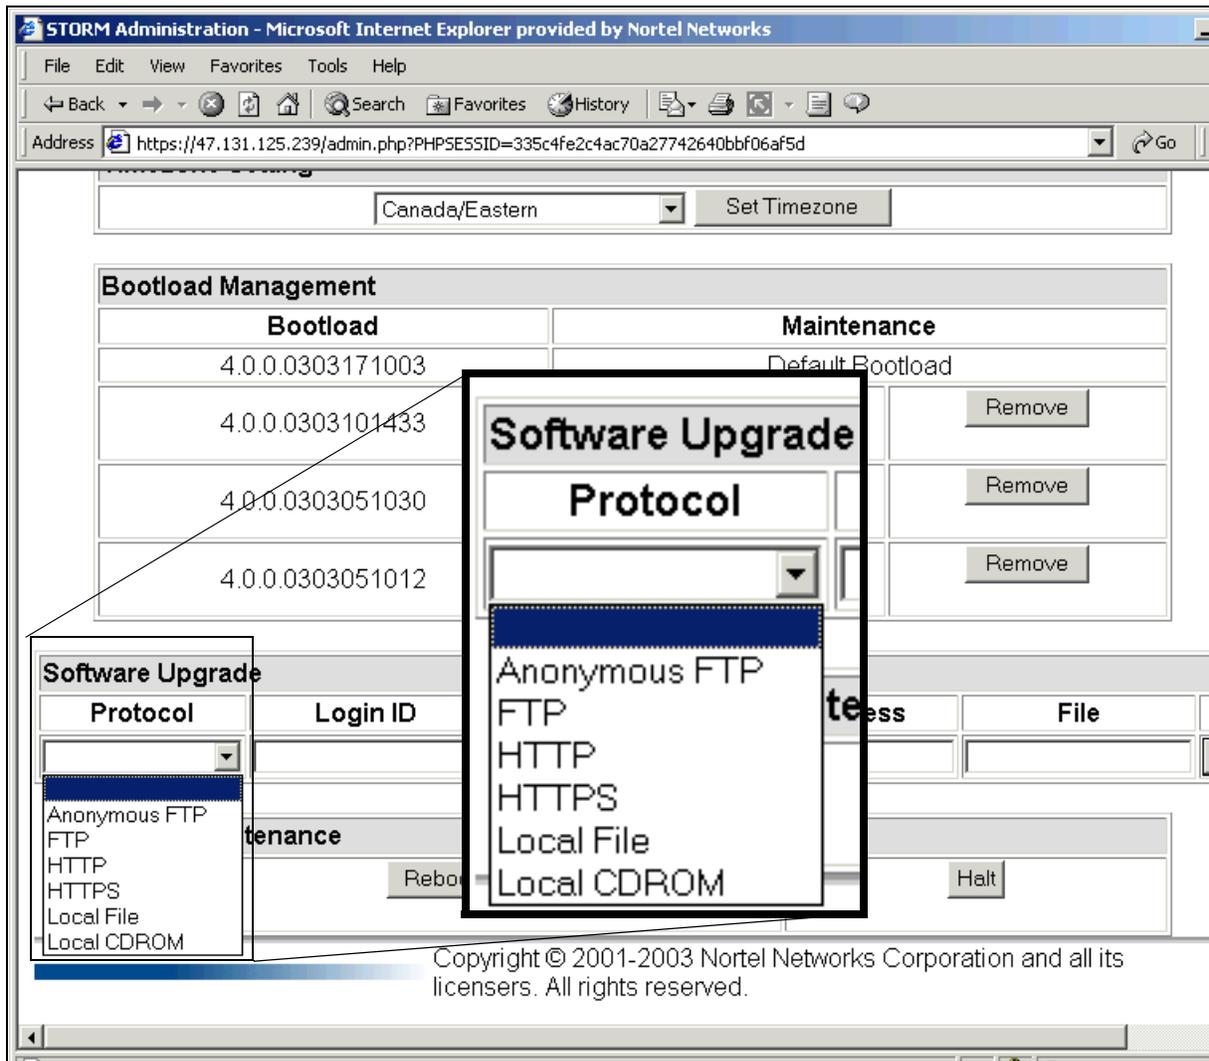
- 1 Select the Admin panel.
- 2 Select the desired access method from the Protocol drop down menu.

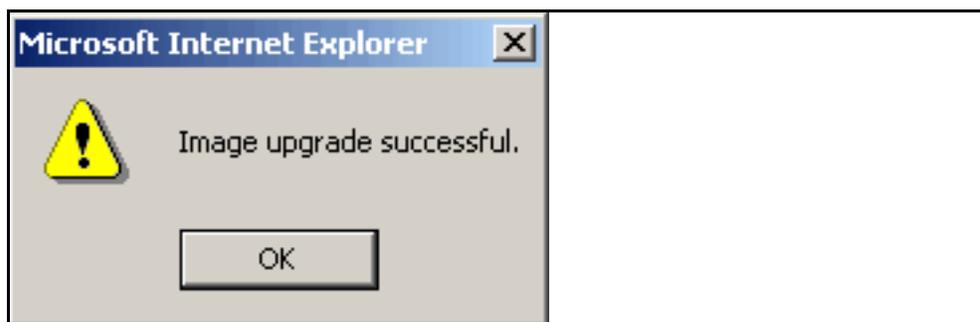
- Verify that the load files were successfully copied by clicking OK on the popup window.

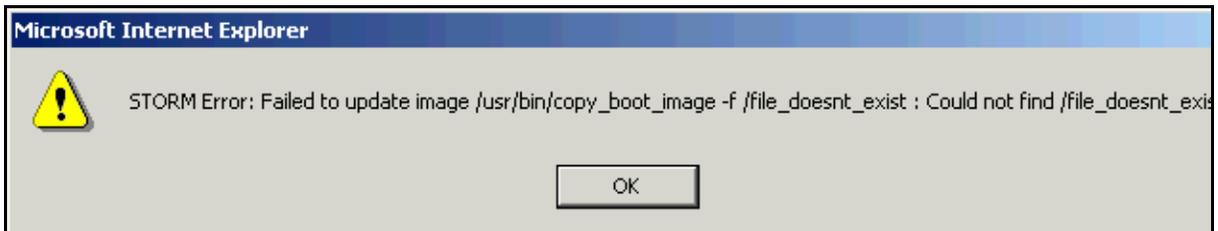
Could not find <filename>

If “Local File” is selected and the path to the file is incorrect, the STORM Manager indicates that it could not find the file.

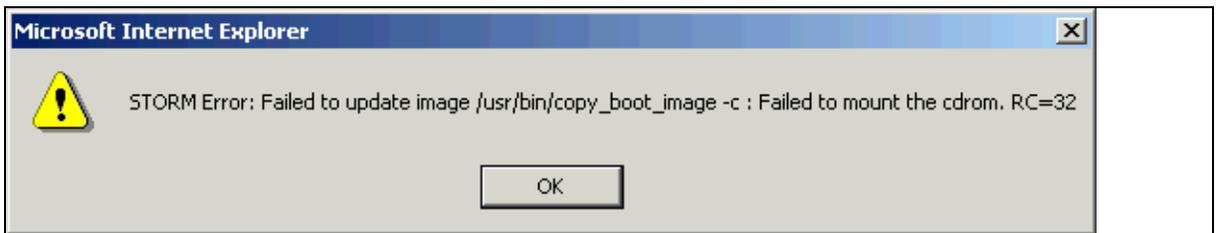
Failed to mount the cdrom

If the CDROM is not placed in the CDROM drive and an attempt is made to upgrade software with the “Local CDROM” option, the following window appears. Verify that the CDROM is in the drive. If the CDROM is inserted, verify that the STORM Manager is connected to the correct STORM unit.

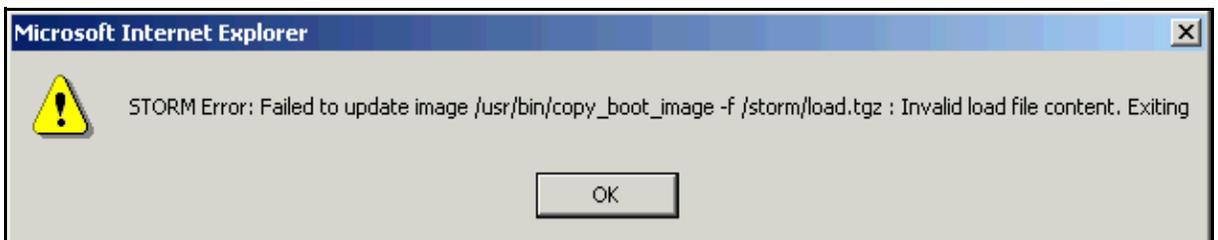
Invalid content

If the bootload is corrupt, the STORM software indicates that the bootload contains invalid content.

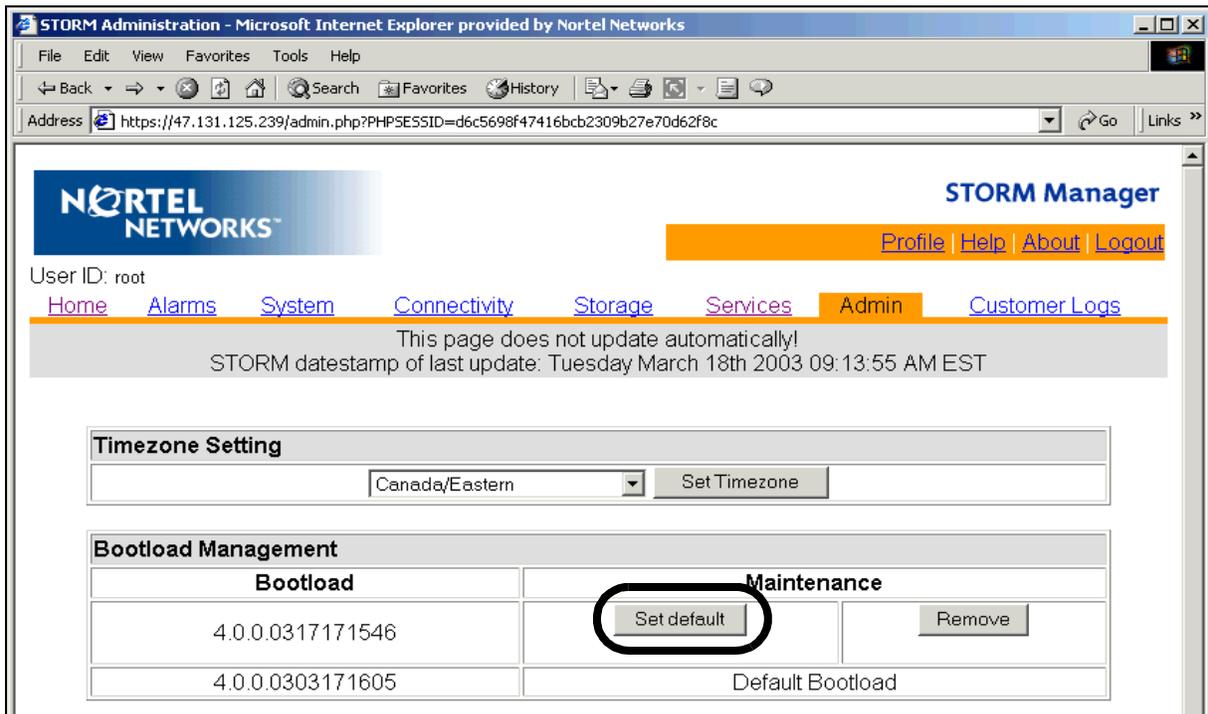
Bootload management

- 3 Ensure that the IP address from [step 2](#) matches the IP address of the STORM unit in the location field of the web browser.
- 4 Change the default bootload to the upgrade software installed in procedure [Install upgrade software on page 16](#) by clicking the Set default button on the Admin page.

The screenshot shows the STORM Administration web interface in Microsoft Internet Explorer. The browser address bar shows the URL: `https://47.131.125.239/admin.php?PHPSESSID=d6c5698f47416cb2309b27e70d62f8c`. The page header includes the Nortel Networks logo and the text "STORM Manager". Below the header, there are navigation links: "Home", "Alarms", "System", "Connectivity", "Storage", "Services", "Admin", and "Customer Logs". The "Admin" link is highlighted. A message states: "This page does not update automatically! STORM timestamp of last update: Tuesday March 18th 2003 09:13:55 AM EST".

The main content area is titled "Timezone Setting" and "Bootload Management". The "Timezone Setting" section has a dropdown menu set to "Canada/Eastern" and a "Set Timezone" button. The "Bootload Management" section is a table with two columns: "Bootload" and "Maintenance".

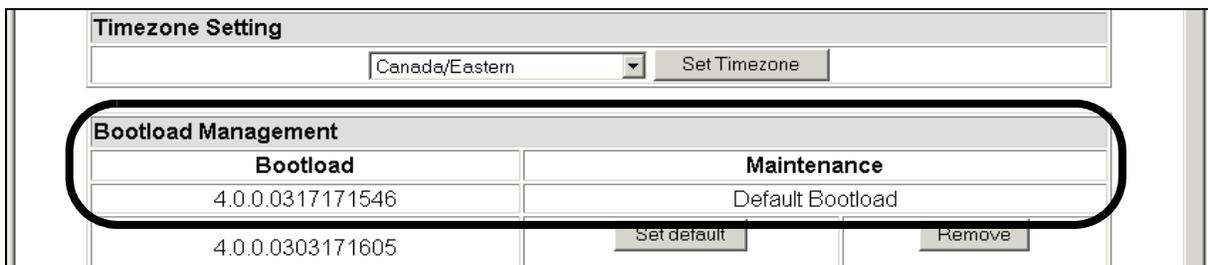
Upgrade bootloader is set

- 5 Verify that the change succeeds by reviewing the Bootload Management section and noticing that the upgrade bootloader is set to the Default Bootload.

This is a close-up view of the "Bootload Management" table from the previous screenshot. The table has two columns: "Bootload" and "Maintenance". The first row shows the bootloader "4.0.0.0317171546" with a "Set default" button and a "Remove" button. The second row shows the bootloader "4.0.0.0303171605" with the text "Default Bootload". The "Set default" button for the first row is circled in black.

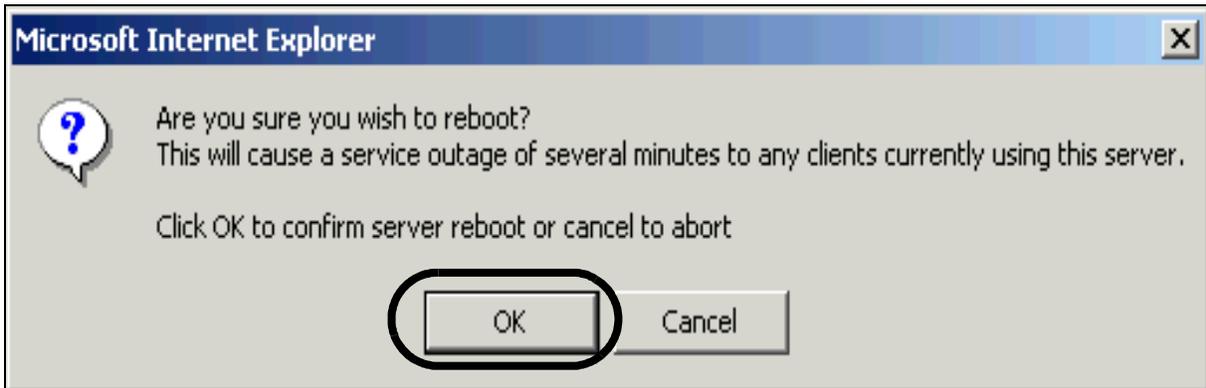
- 7 Confirm the reboot by clicking OK on the popup window.

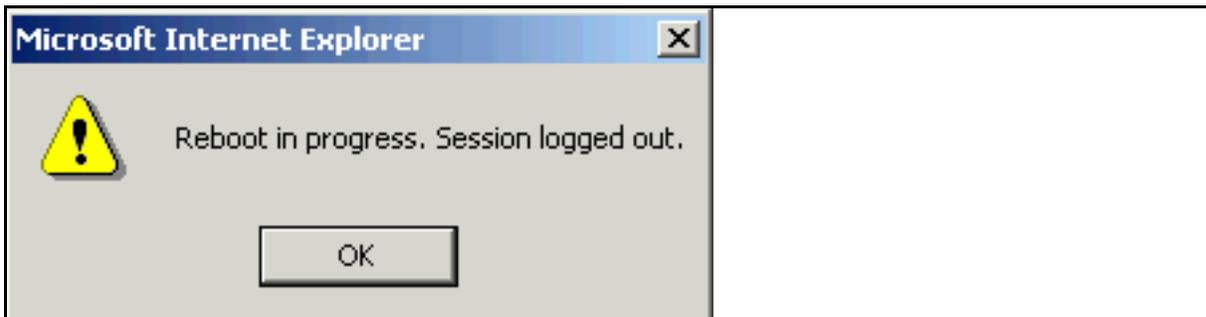
- 8 The STORM Manager ends the session and the STORM unit reboots.

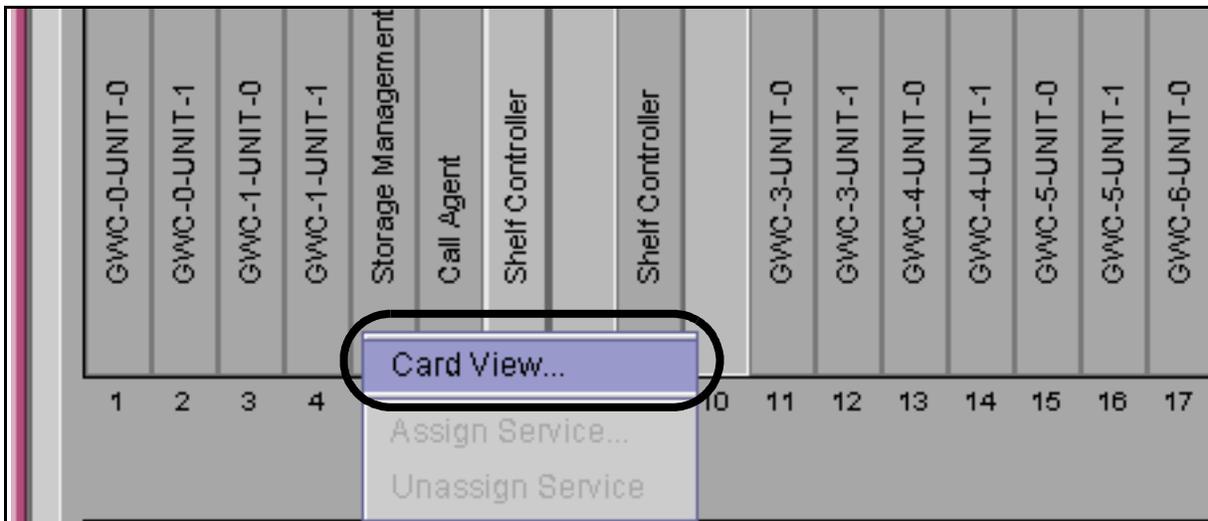
- 3 Right-click the STORM card icon and select Card View from the card context menu to open the Card View window.

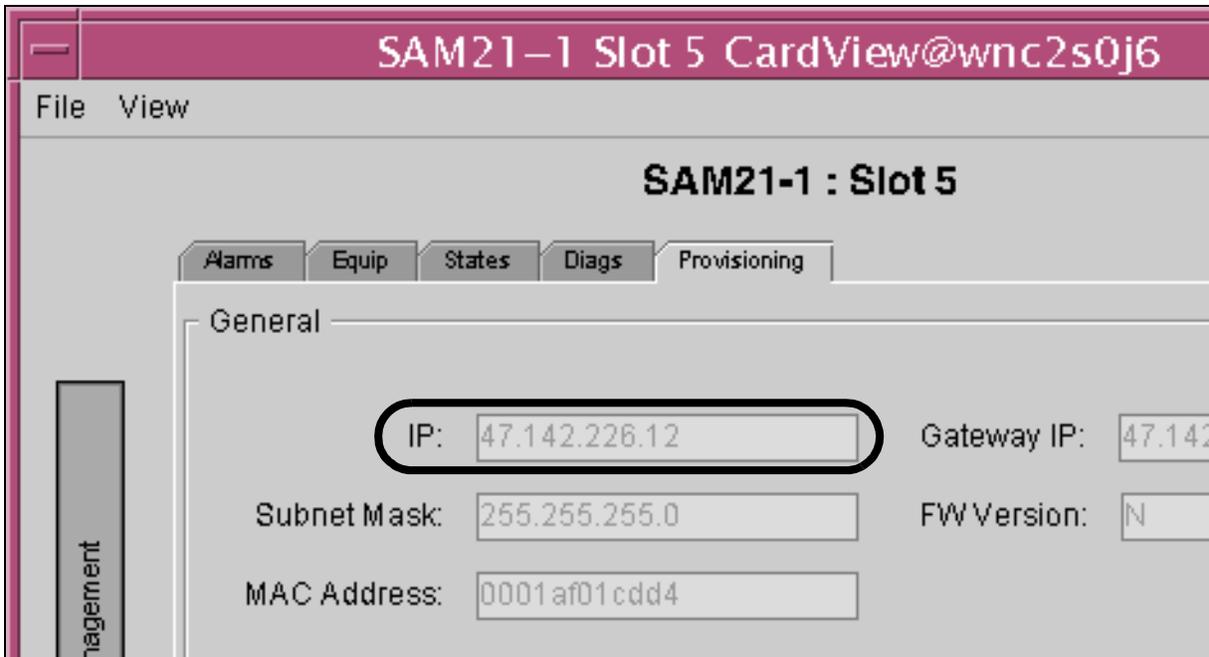
- 4 From the Card View window, select the Provisioning tab and verify that the IP address in the card view matches the IP address from the mount command.

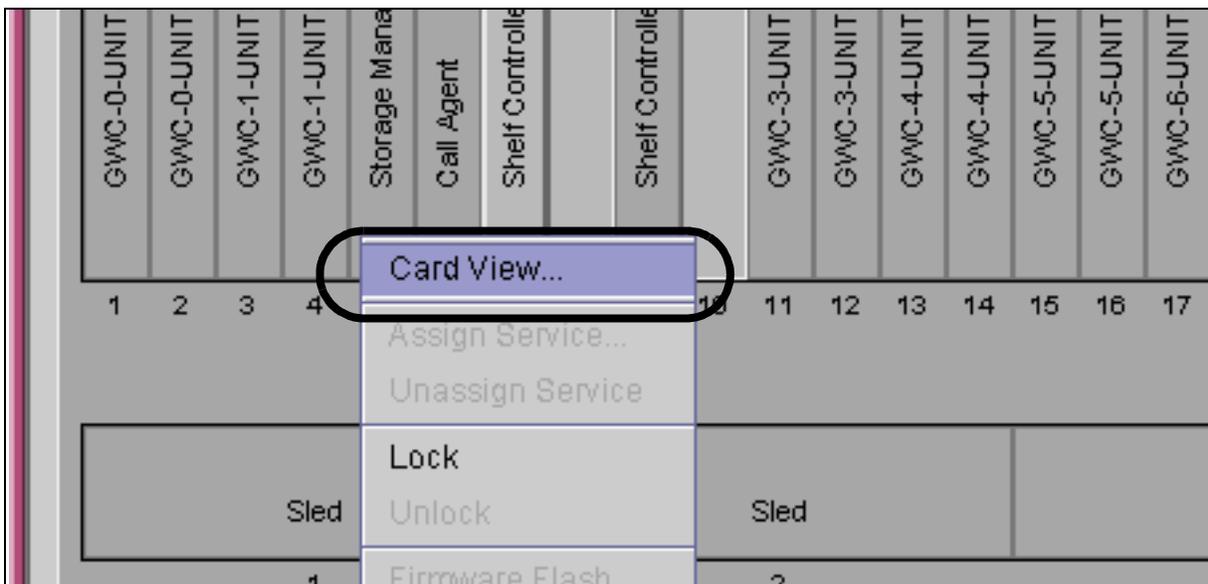
STORM Card View option

- 1 From the Shelf View, right click on the STORM card (Slot 5) and select Card View from the context menu, as the following figure shows.

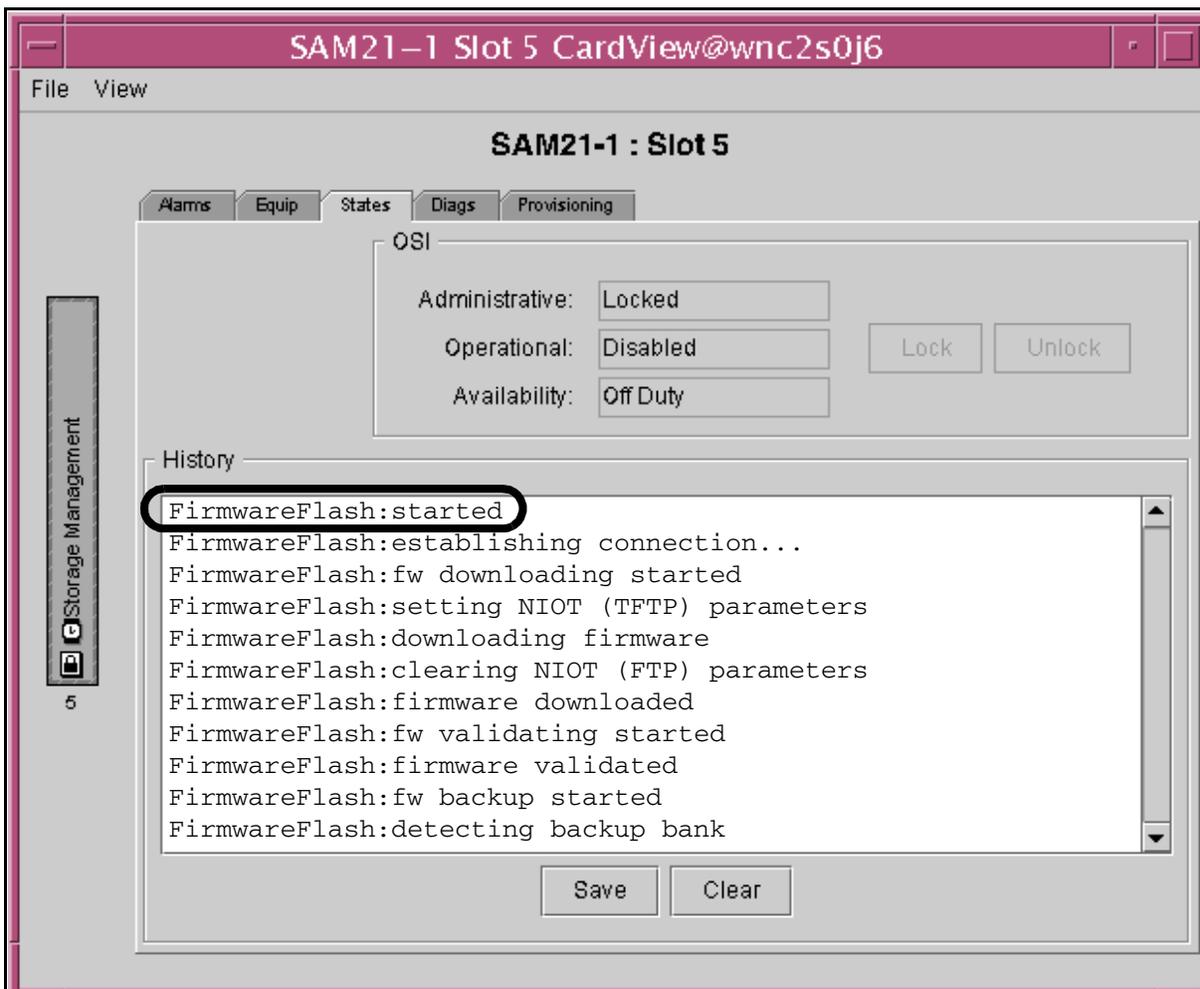
STORM FW Flash in progress

- *an icon representing firmware flash appears in the shelf view*
- *FirmwareFlash progress messages scroll in the History panel in the States window*

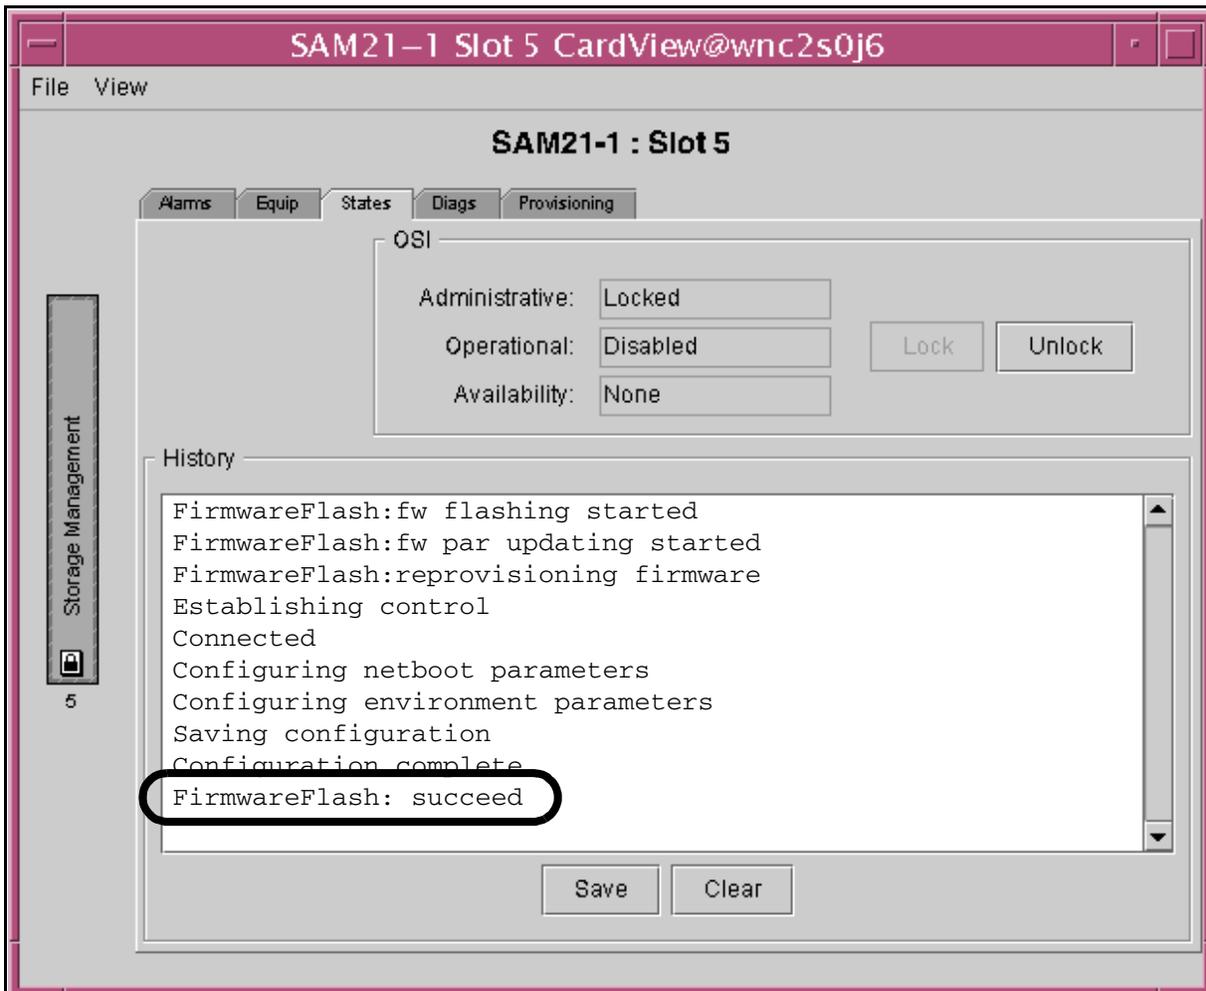
STORM FW Flash completed

The following responses indicate that a firmware flash has completed its execution:

- *the firmware flash icon disappears from the shelf view*
- *the Availability state of the STORM card in the States window displays “locked-disabled-none”*
- *progress message “FirmwareFlash: succeed” displays in the History panel in the States window*

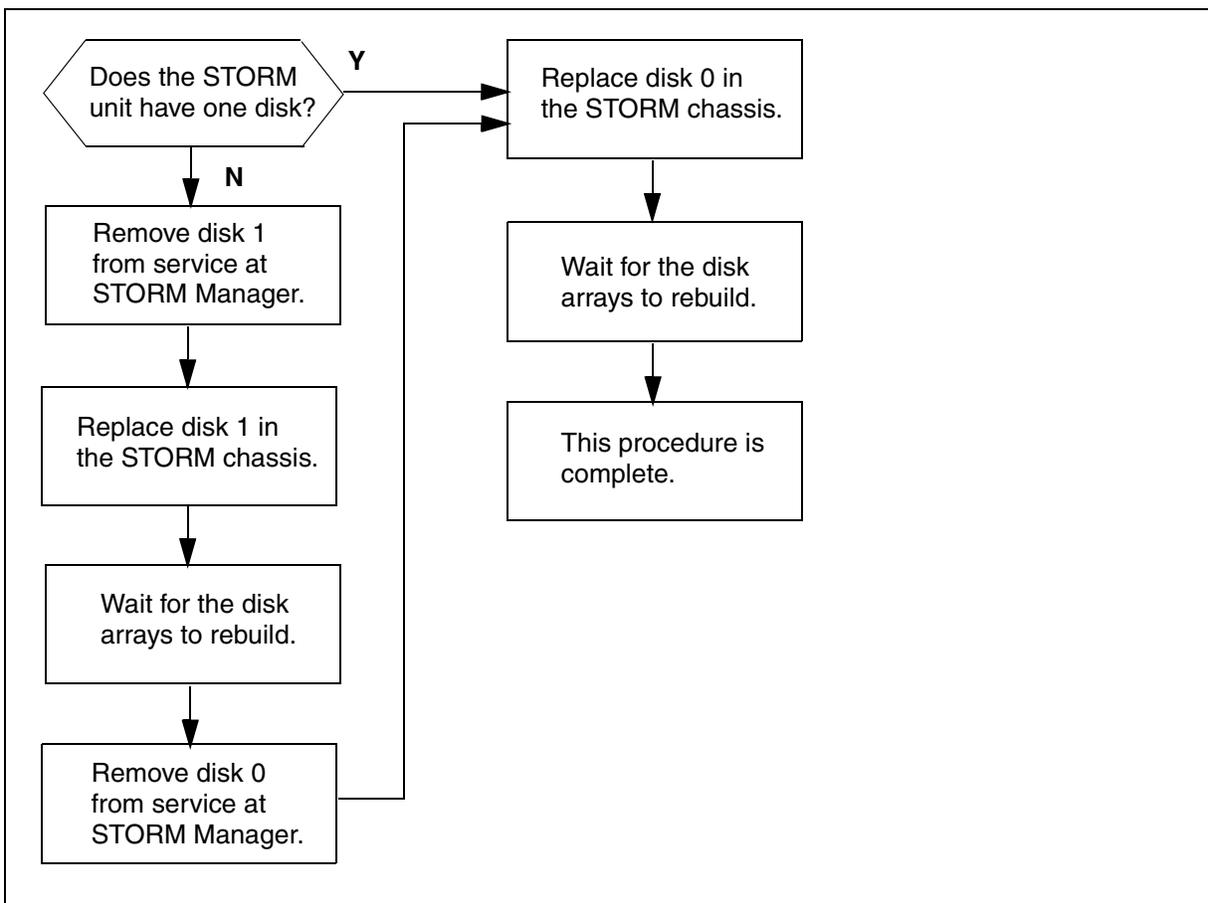
Refer to the following figure for an overview to the required steps.

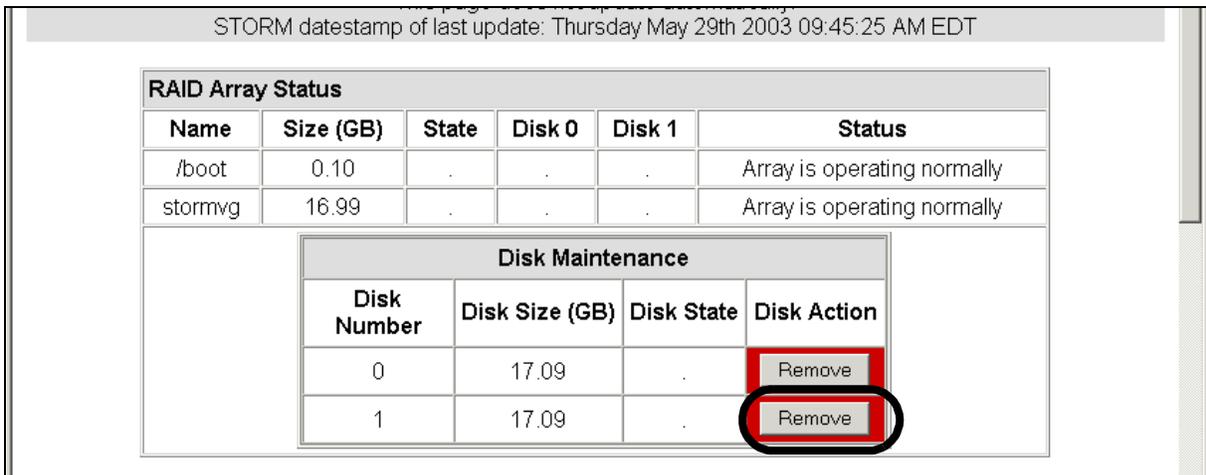
- 2 Remove disk 1 from service by clicking the Remove button for Disk Number 1.
