UAS Fault Management

Fault management activities that are performed to maintain and monitor the Universal Audio Server (UAS) and the Audio Provisioning Server (APS) include:

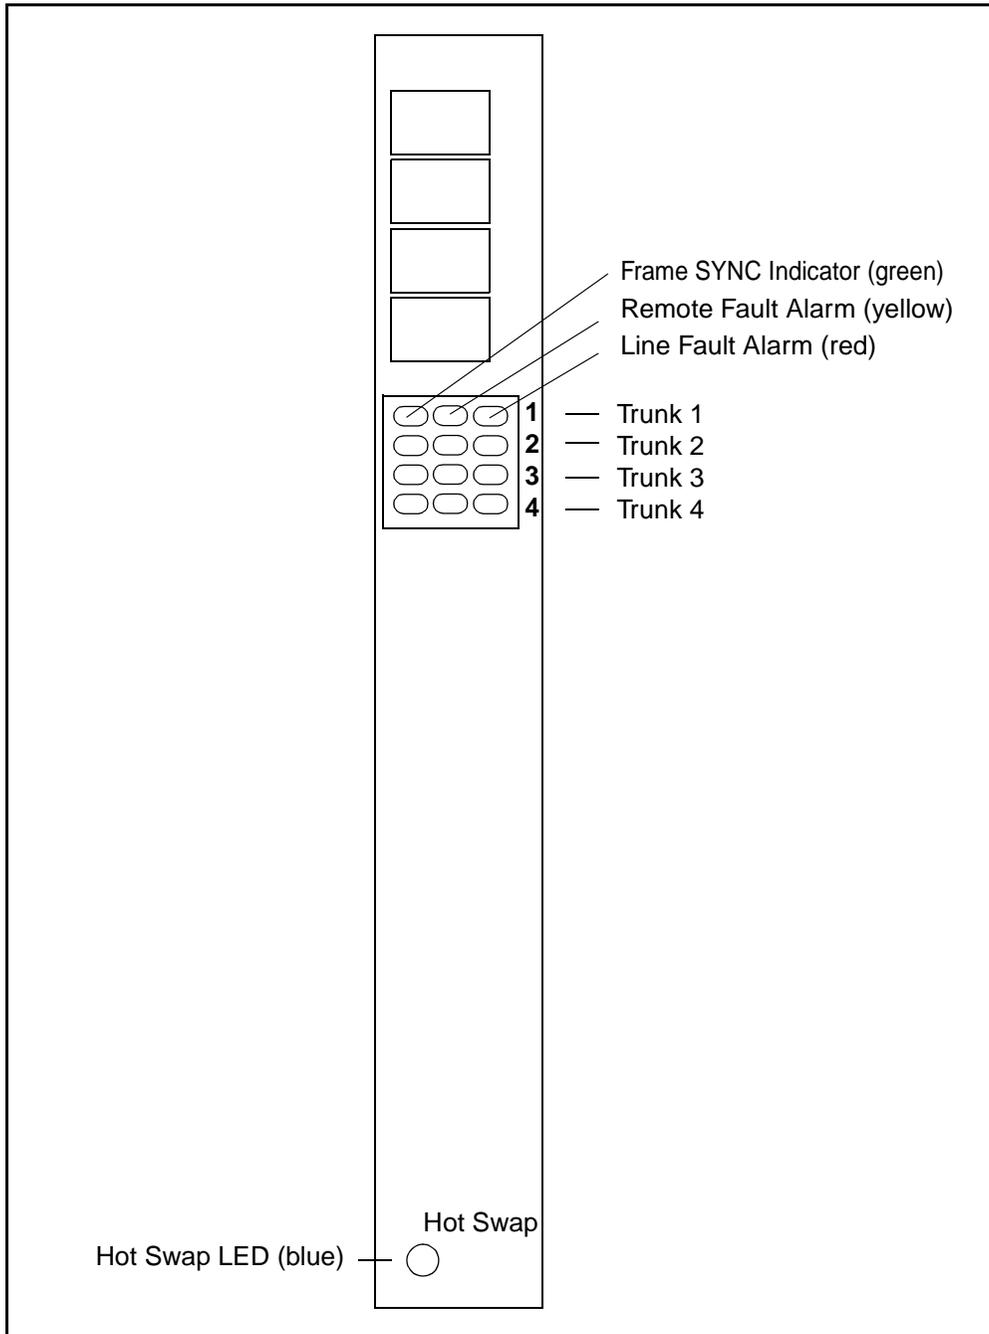
AG4000C front module faceplate

The blue Hot Swap LED, when illuminated, indicates that it is safe to remove the module from the system.

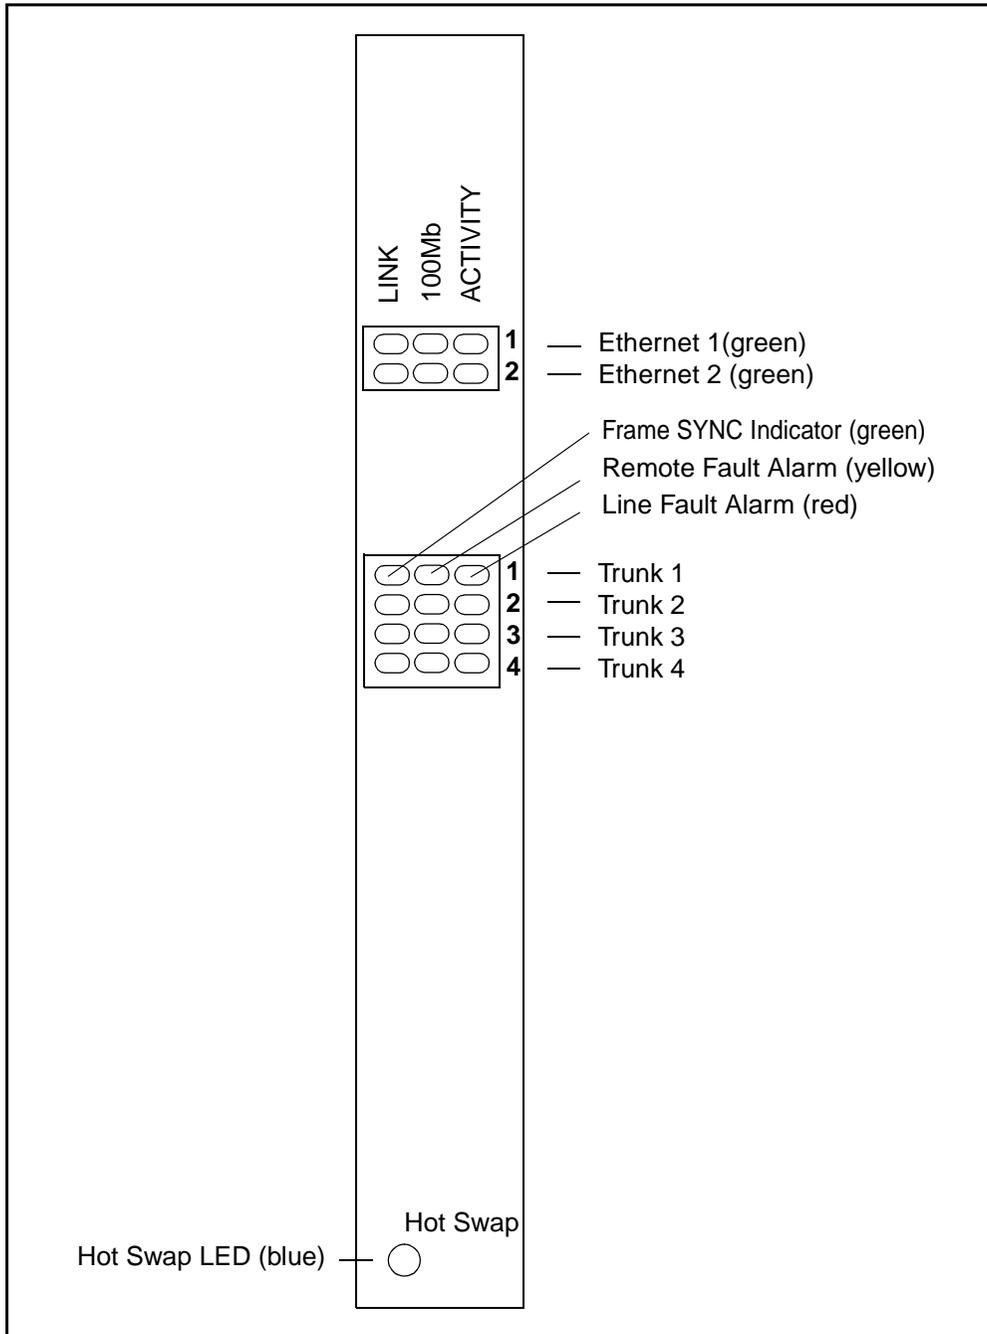
CG6000C front module faceplate

The faceplate of the main (front) CG6000C module, shown in the Figure labeled [CG6000C front module faceplate on page 215](#), has the following indicator LEDs:

- If the module is fully inserted when the backplane is powered up, the blue LED flashes momentarily. This is a normal part of the initialization process.
- After opening the lock latches (during the extraction process), the LED illuminates, indicating that it is safe to remove the module.
- If the LED remains illuminated after insertion of the module and after you have closed the lock latches, the module failed to successfully perform its primary hardware initialization. Although it is safe to remove the module, this condition indicates a problem.
