MG 9000 Fault Management

Fault management strategy

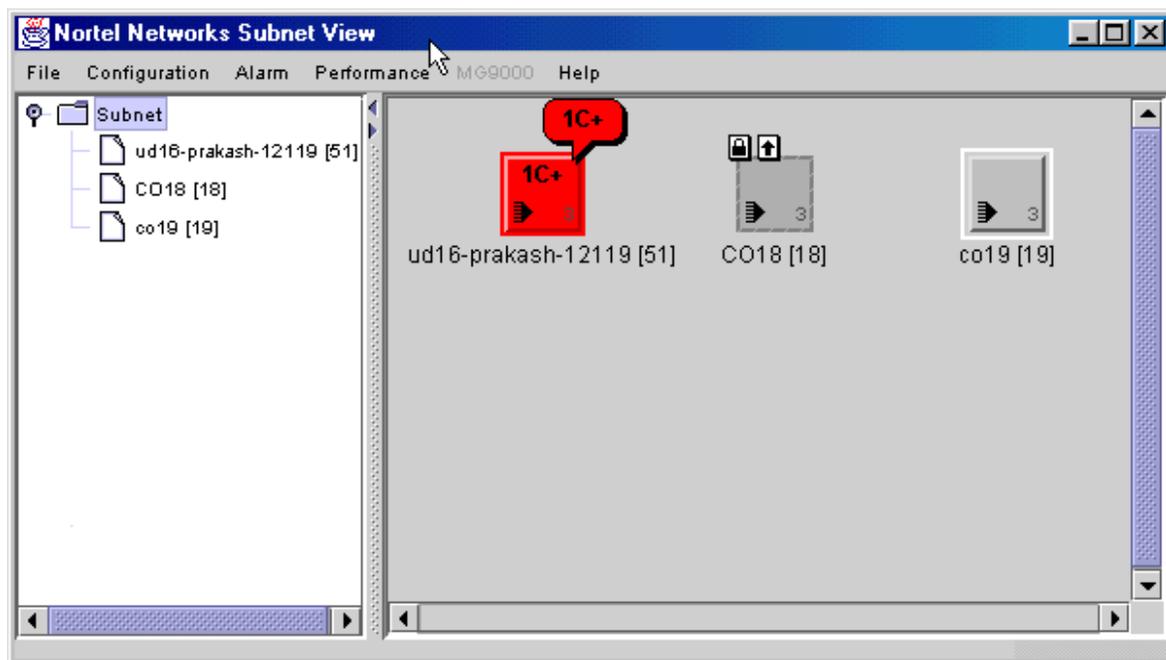
MG 9000 Manager Subnet View

The following figure shows the window-based MG 9000 Manager Subnet View. In this figure, the icon in solid grey without diagonal lines indicates that the MG 9000 is provisioned and discovered. In the Subnet View. A tree view is available in the left side. Each entry or 'NE' in the tree indicates the presence of some entity. The top node (also known as the root NE) indicates the subnet itself, and is named accordingly; its icon shows a folder to indicate it (may) contain other items. As MG 9000s are added to the subnet, they will appear as additional NEs in the tree, connected by a line to the root 'subnet' NE. This indicates a containment relationship that the subnet has over its constituent MG 9000s.

Each MG 9000 NE is shown as a standard 'paper' icon, to indicate there is information available about that particular MG 9000 at this level of the tree. The icon is accompanied by the name of the MG9000, and its network element number appended in square brackets.

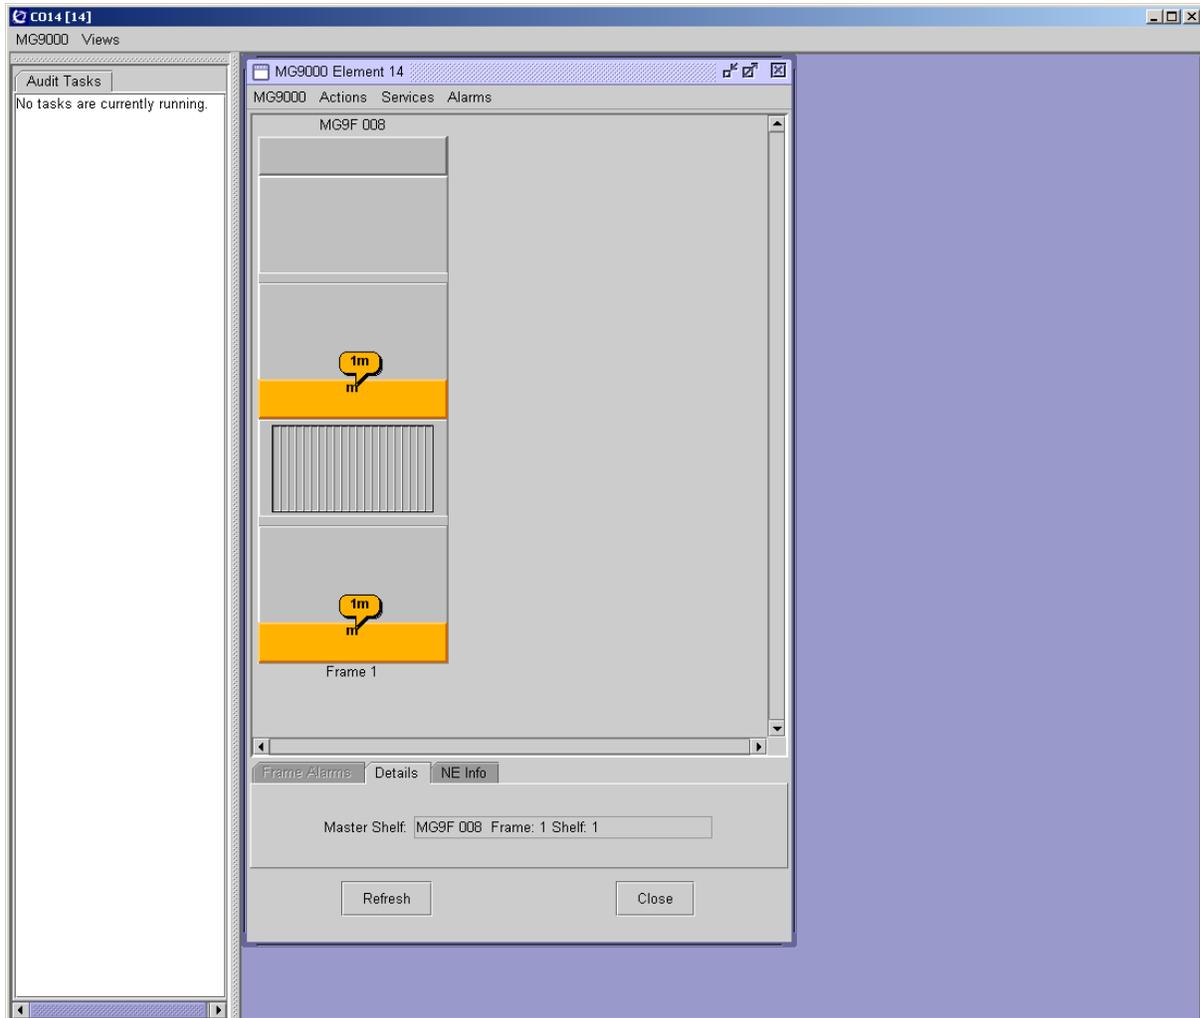
Frame View shown within NE desktop view

the Audit Task tab showing the progress of an audit which is meant as an audit indicator for those tasks that run in the background so the user is aware that an audit is currently in progress for the NE. Throughout this document, the individual GUIs are shown outside the NE desktop view, though in all cases except for the Alarm Browser, the GUIs appear in the NE desktop view.

Each GUI within the NE desktop view can be maximized or minimized within the NE desktop view, similar to how windows can be manipulated in a Windows PC desktop. When the last GUI is closed, the NE desktop view automatically closes.

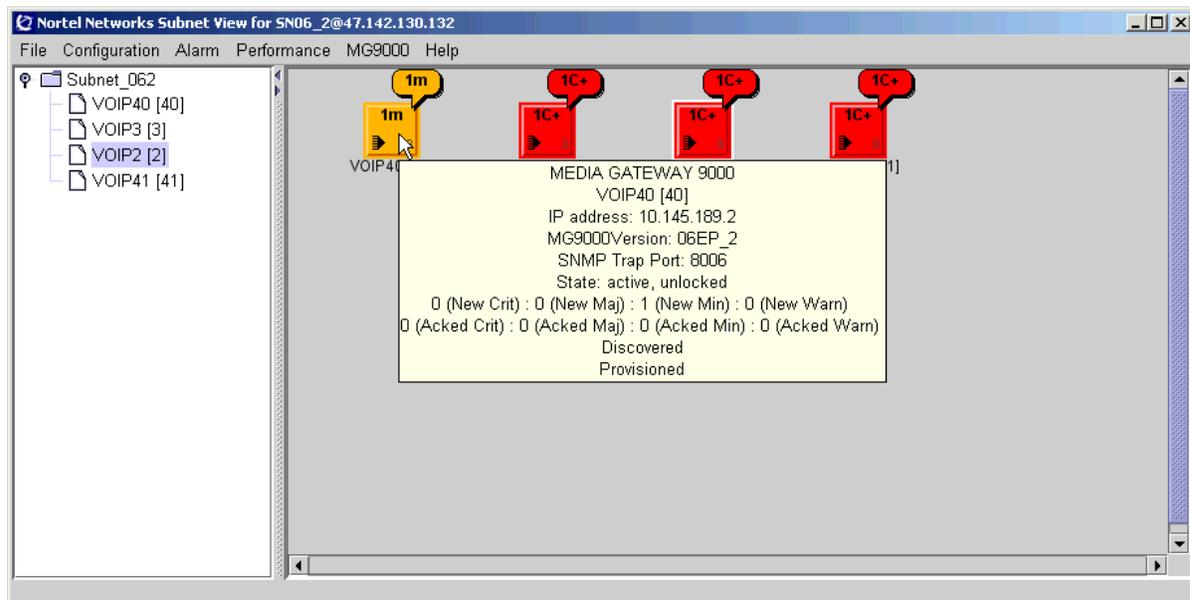
Subnet View showing the information balloon

- network element name and number
- MG 9000 software release
- network element IP address
- SNMP trap port number used
- state of the network element
- total alarms by category and the number of alarms that have been acknowledged

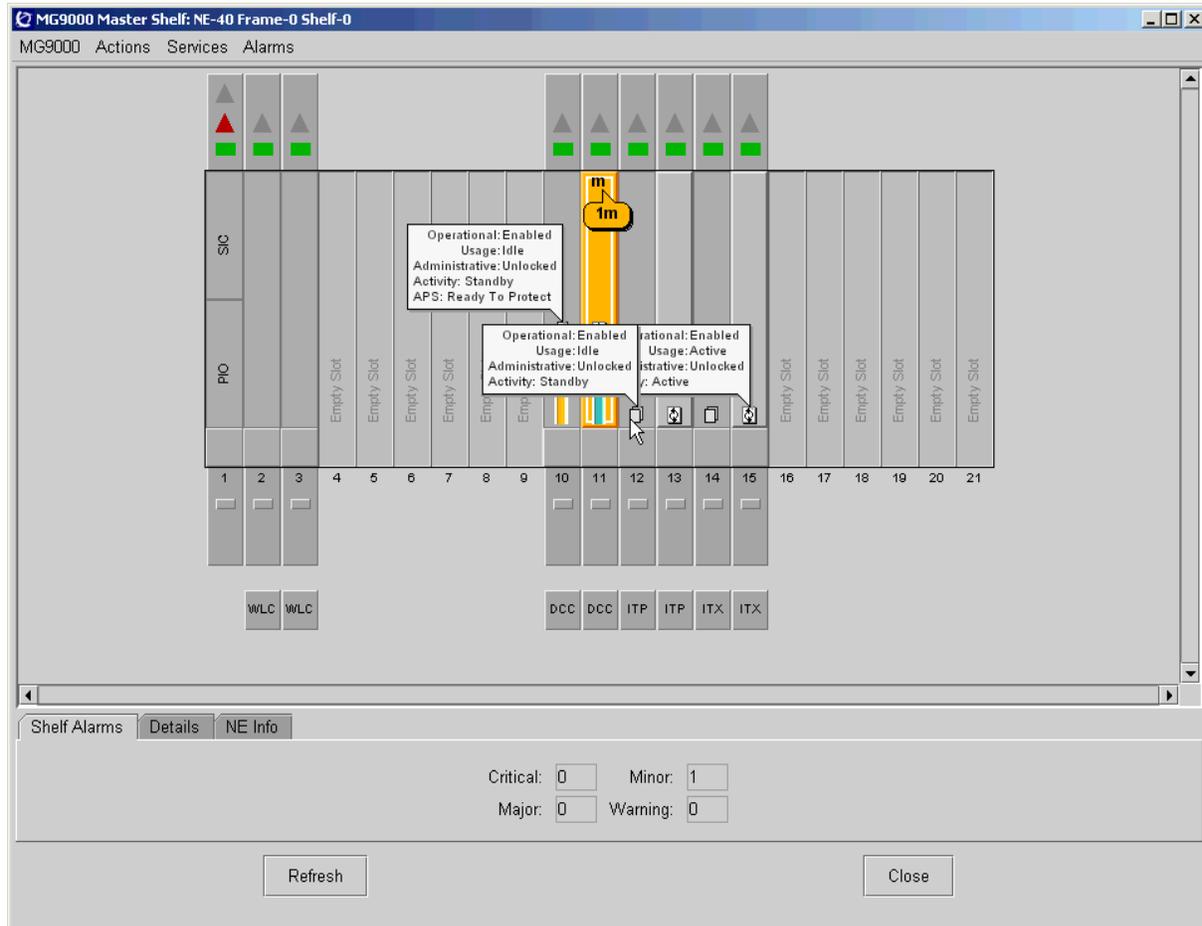
Shelf View with information balloons

In the Shelf View, by placing the cursor over the icon and clicking once on each card, the technician can retrieve information about the state of that card and link. The following figure shows the information balloon. To remove the balloon, click once again on the icon. The following information appears in the balloon:

- operational state
- card status
- card availability

- activity status
- link status

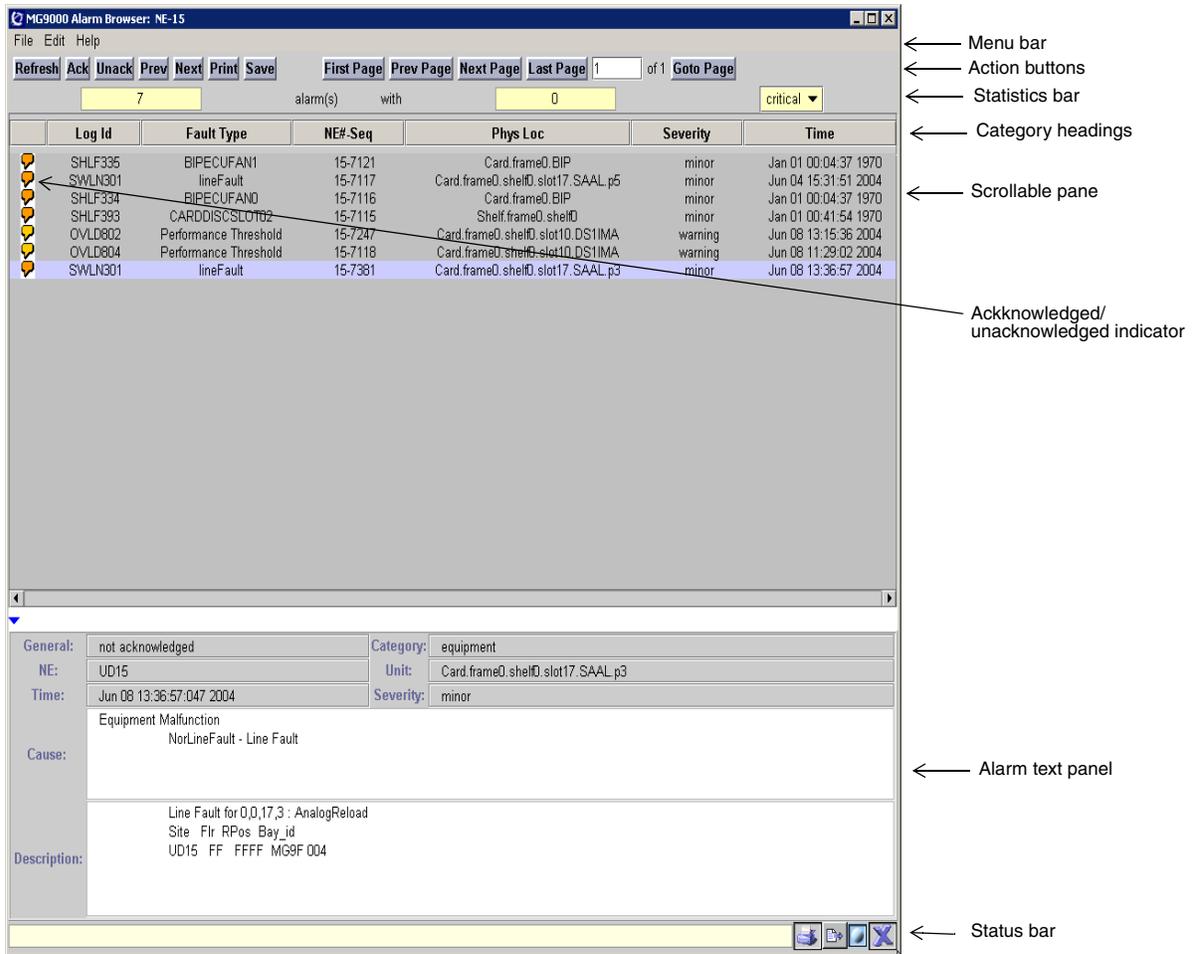
The Alarm Browser screen is used for alarm surveillance. The Alarm Browser screen is accessed from the "Alarm" menu option at the top of all screens. The Alarm Browser consists of multiple sections used to view and manage MG 9000 alarms. Once the alarm browser is open, the browser continues to update as new alarms are added or conditions change.

The following figure shows the Alarm Browser screen.

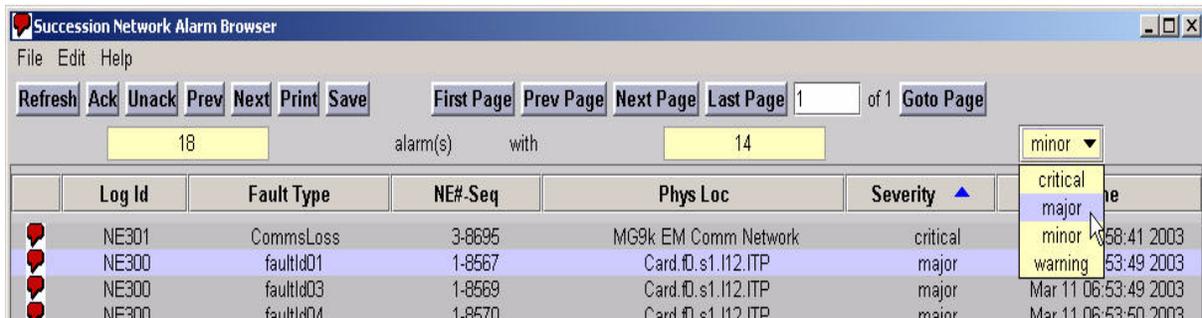
The Statistics Bar summarizes the total number of alarms in the scrollable pane and within that total, the number of a selected alarm type. The selected alarm type isolated in the summary can be selected from any of the available alarm types. For example, the following figure shows a Statistics Bar indicating that the scrollable pane has 20 alarms with one critical alarm. In the figure, the box to change alarm types is open and ready for selection.

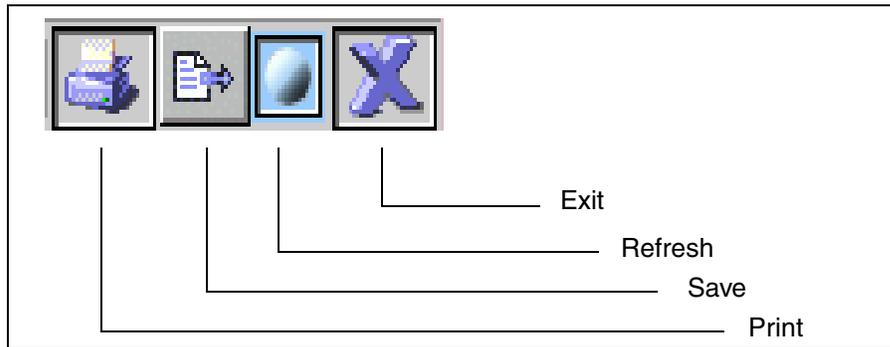
Status Bar icons

The icons on the status bar provide access to some of the features in the File menu. The following figure shows the status bar icons and their functions.

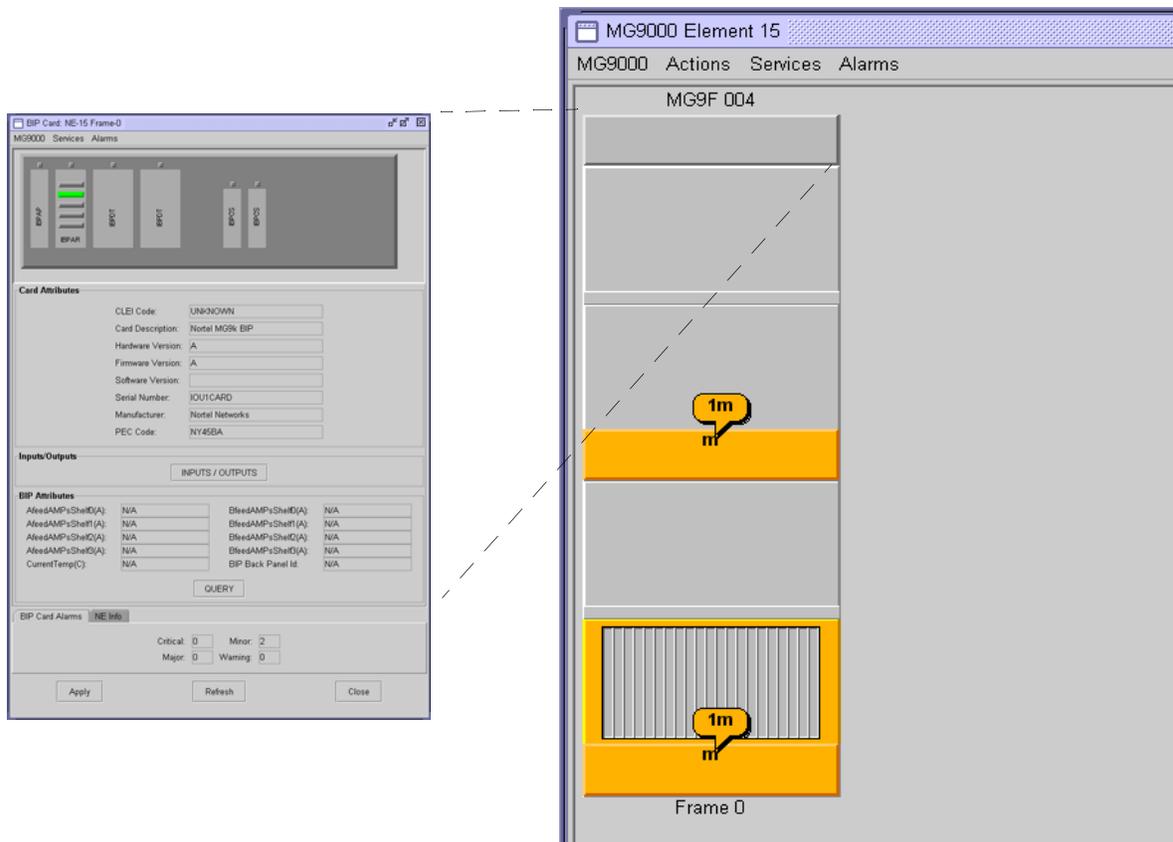
Frame and IBIP card Views

Viewing current frame-level alarms The frame alarm subsystem has a maximum of four links that connect the shelves to the BIP shelf. With these links, the shelves and the BIP shelf perform low-level non-mission critical communication. The BIP shelf receives the fan fail signals and lamp test/alarm cutoff (ACO) signal. The BIP reports the signals to the SIC card.

The following figure shows the Frame View and the IBIP Card View which is accessed by double-clicking on the IBIP within the Frame View.

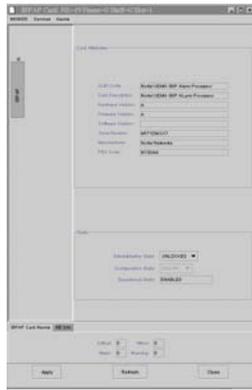
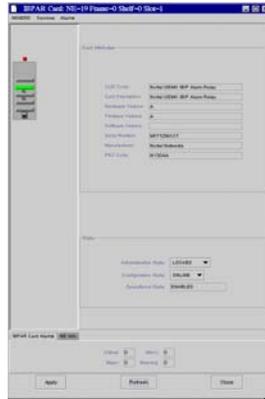
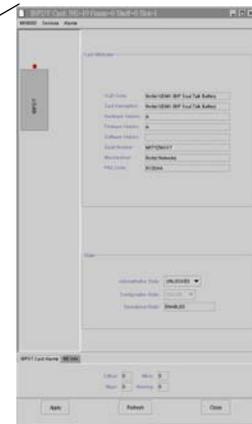
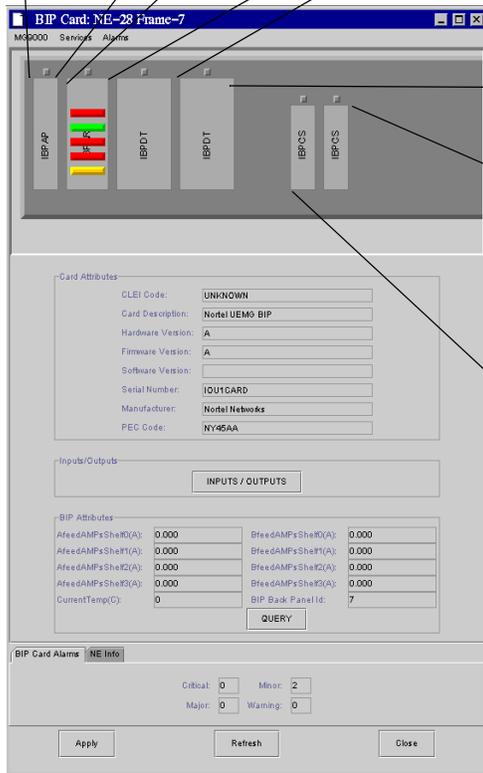
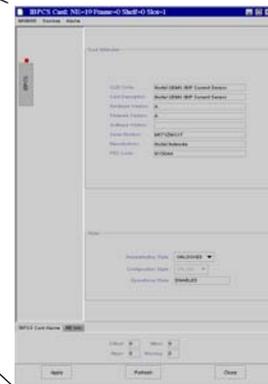
IBIP View and sub-card views

The IBIP architecture has the IBIP as the main card and the following cards as sub-cards of this card:

- Alarm Processor card
- Alarm Relay card
- Dual Talk Battery card
- Current Sensor card

Each sub-card can be opened as a card view when the user double-clicks on the card. The Administrative and Configuration States of these cards can be set to enable replacement. The following figure shows the IBIP and sub-card views.

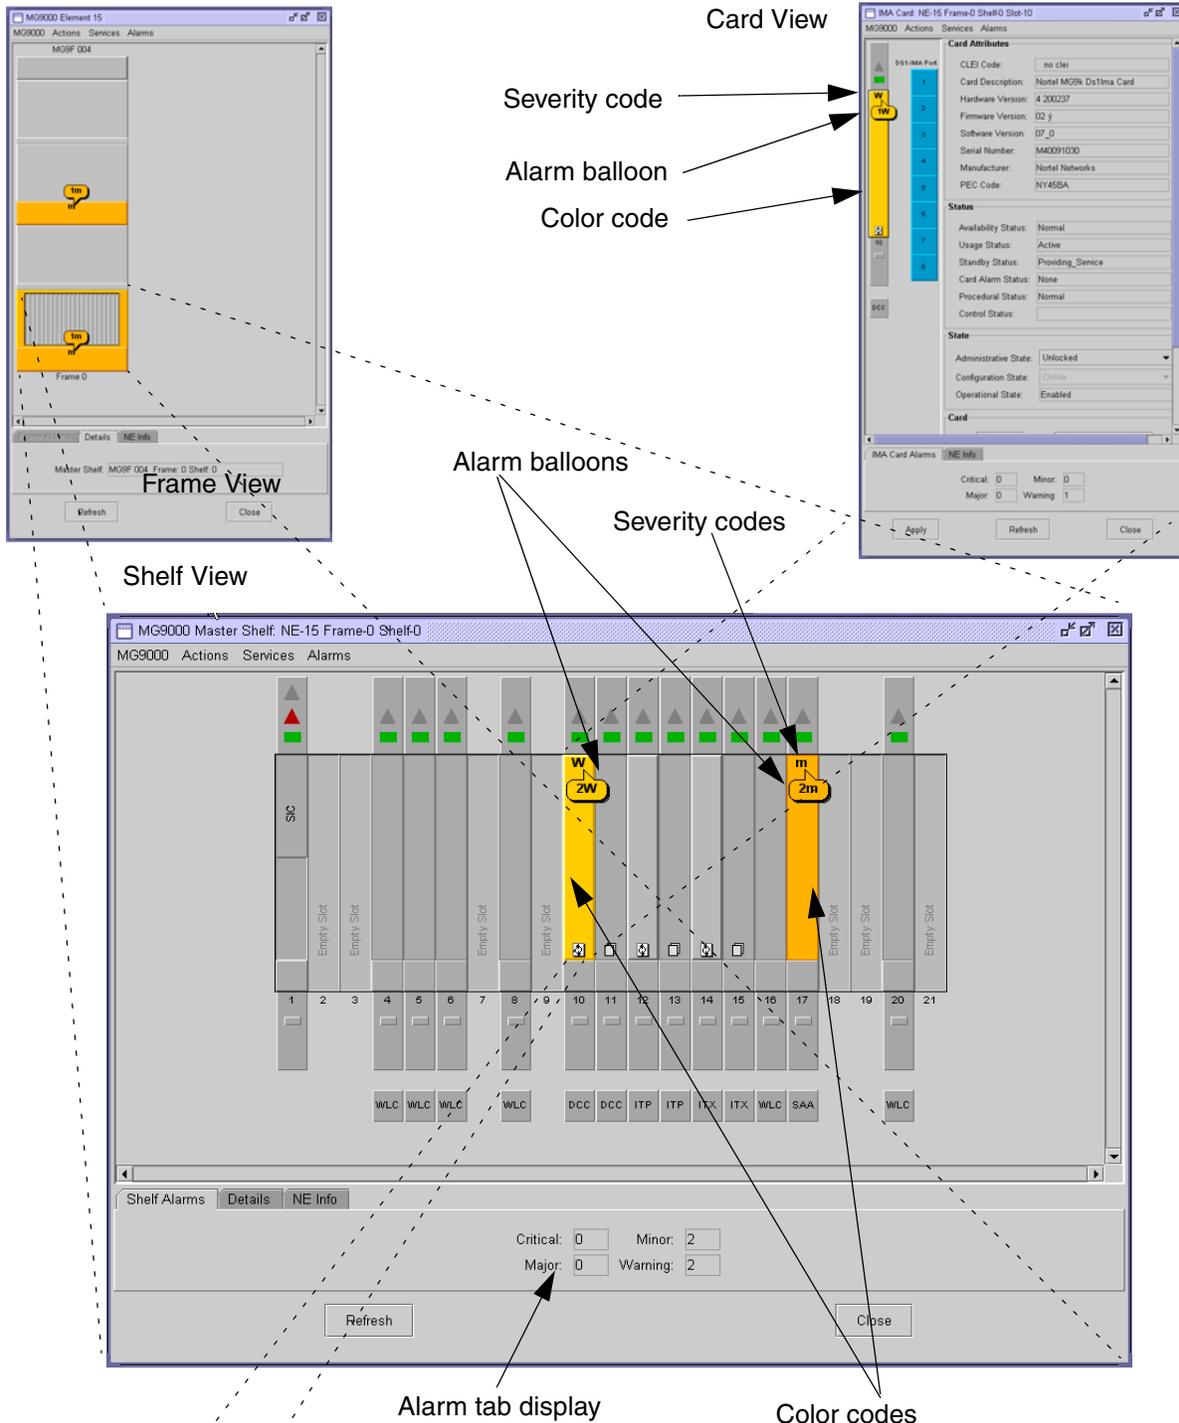
Frame, Shelf, and Card Views showing alarms

Viewing shelf-level alarms The Shelf View which is accessed from the Frame View by double-clicking on the shelf, displays card alarm status through four different methods:

- color code
- alarm balloon
- severity code
- alarm tab

The following figure shows the Shelf View accessed from the Frame View and the shelf level alarms listed previously.

For a list of the operational, state, and status icons used on the shelf and cards, see the [MG 9000 alarm color codes](#) table.

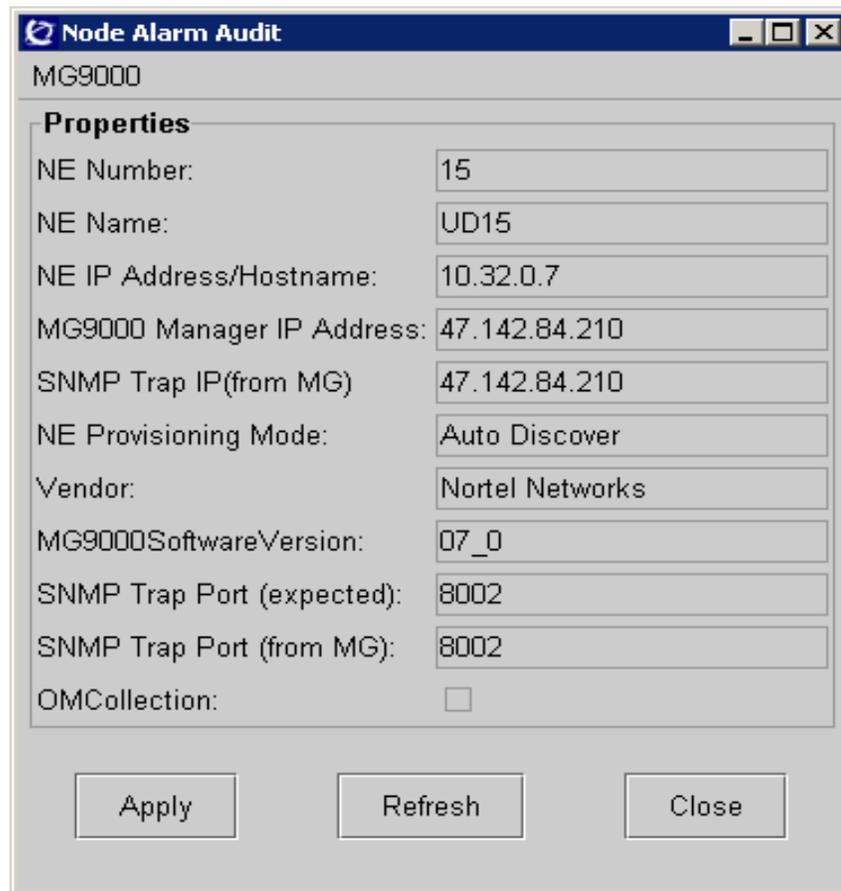
- 1 At the Subnet View, click on the MG 9000 NE on which the Audit alarm is to be performed.
- 2 From the menu bar, select Alarm->Audit alarms. The Node Alarm Audit view appears. The following figure shows the Node Alarm Audit view.

The image shows a dialog box titled "Node Alarm Audit" for a device labeled "MG9000". It contains a "Properties" section with several fields:

NE Number:	15
NE Name:	UD15
NE IP Address/Hostname:	10.32.0.7
MG9000 Manager IP Address:	47.142.84.210
SNMP Trap IP(from MG):	47.142.84.210
NE Provisioning Mode:	Auto Discover
Vendor:	Nortel Networks
MG9000SoftwareVersion:	07_0
SNMP Trap Port (expected):	8002
SNMP Trap Port (from MG):	8002
OMCollection:	<input type="checkbox"/>

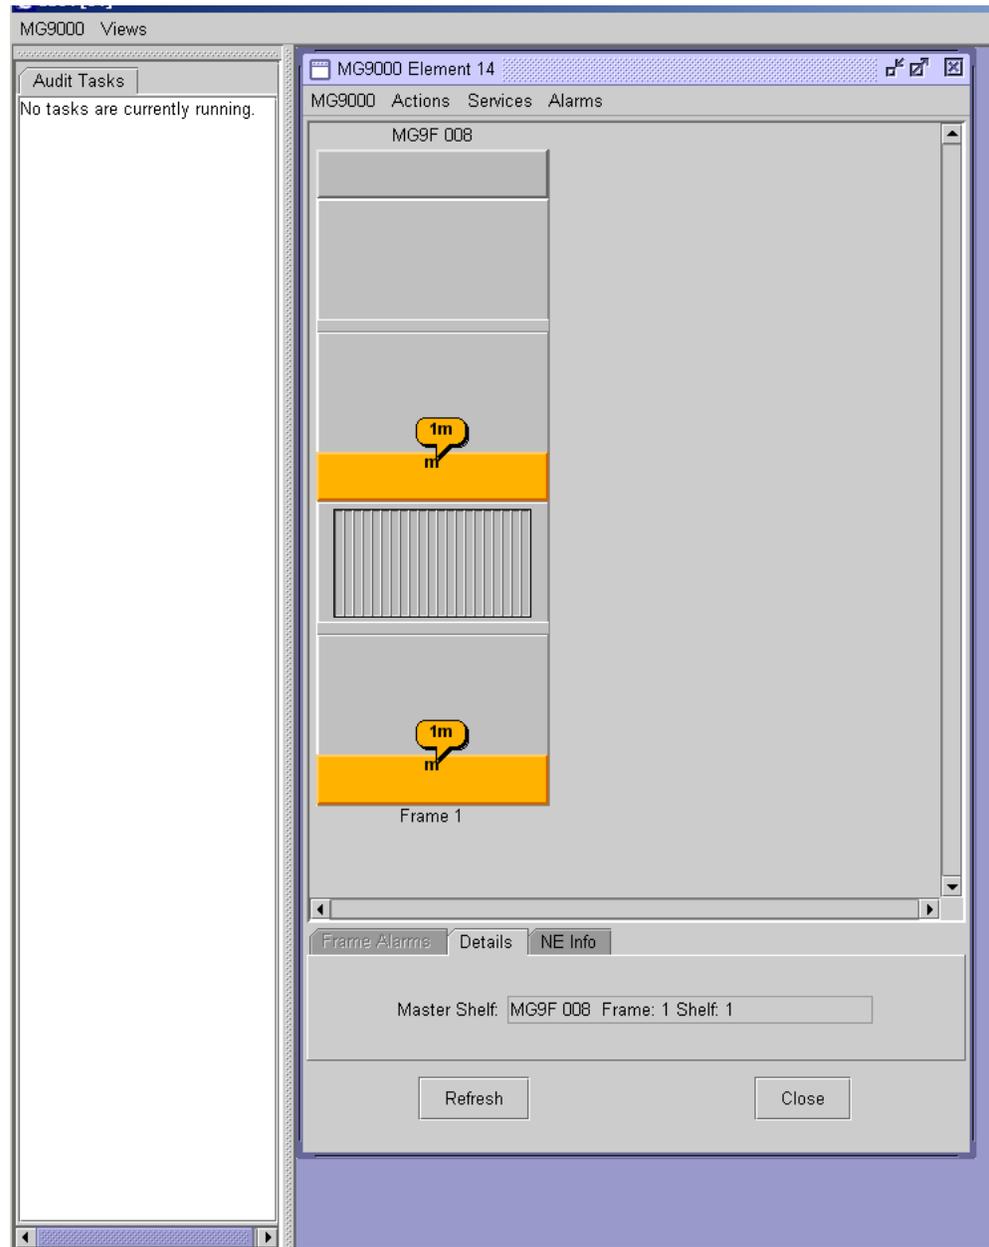
MG 9000 Frame View within the NE desktop view

- 1 At the Subnet View, double-click on the MG 9000 icon in the tree view on the left or on the MG 9000 icon in the MG 9000 Manager view on the right, to select the MG 9000 for which alarm information is to be viewed. The network element (NE) desktop view with the Frame View opens as shown in the following figure.

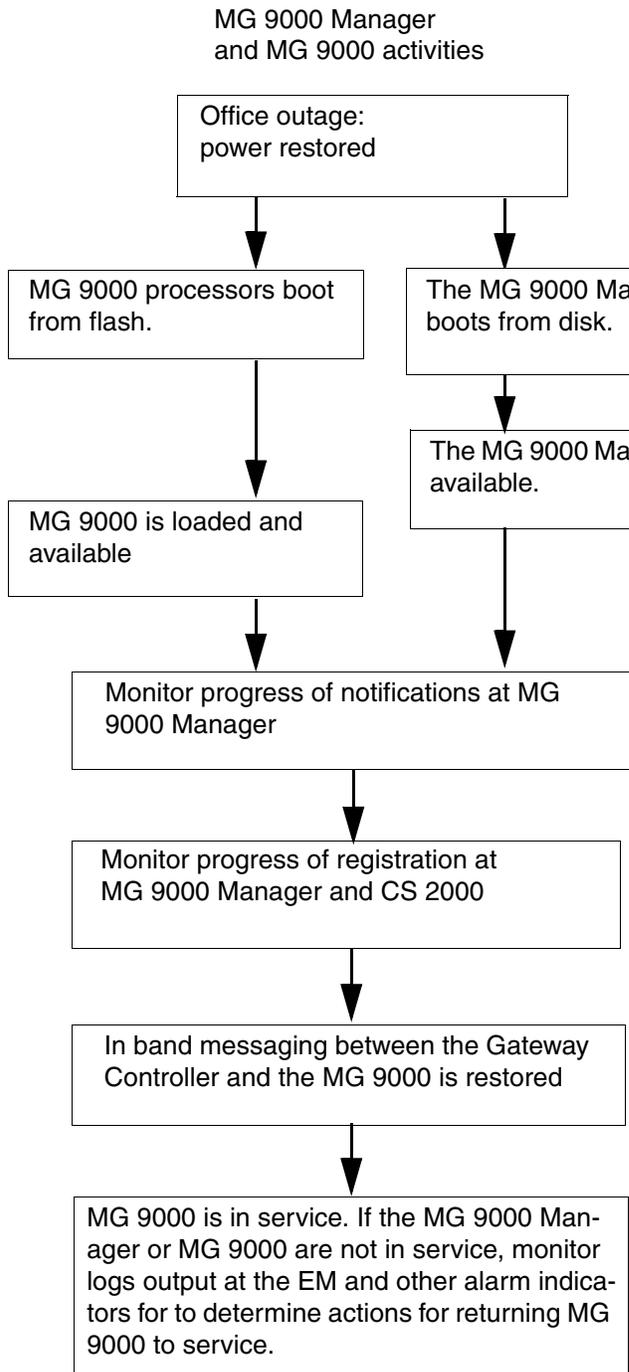
MG 9000 recovery activities

The following flowchart identifies the activities the MG 9000 performs to recover from an outage and the activities operating company personnel observe during recovery.

Activities operating company personnel observe.

Monitor captive office LAN status at Multiservice Switch 8600. Check the individual status of captive office LAN connected equipment at the MG 9000 Manager displays. There will be no communication until the Multiservice Switch 8600s are up.

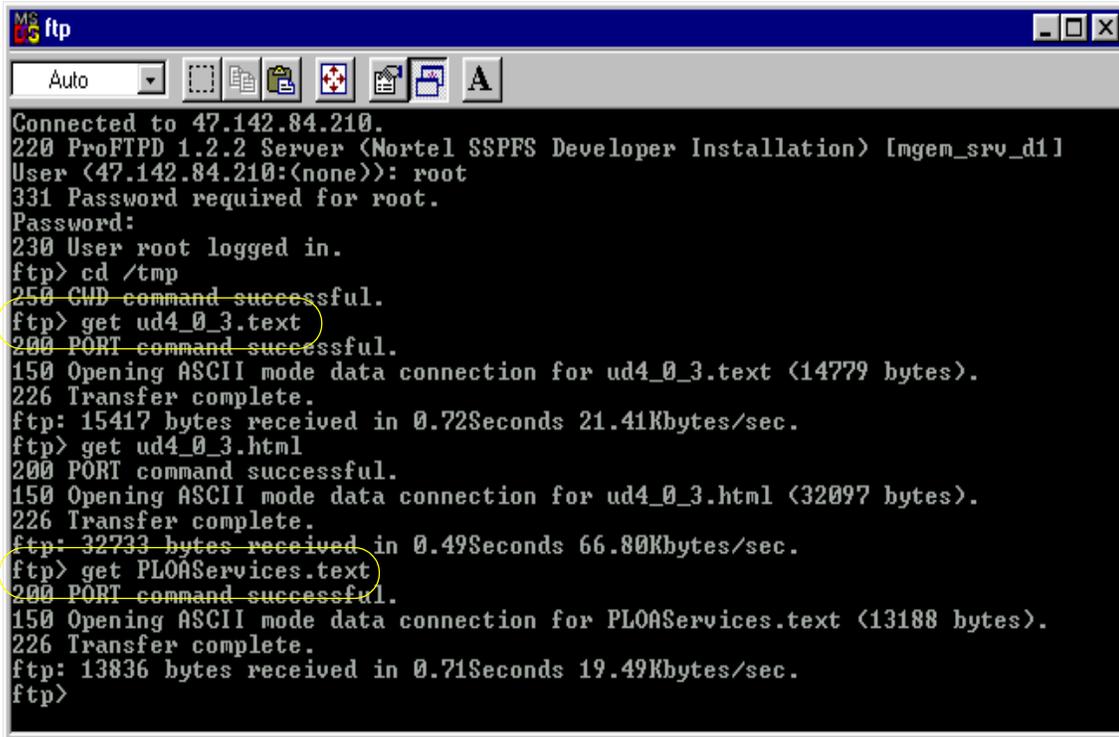
FTP files to secure location

- 6 FTP to the address recorded in step 5 and copy the files in the /tmp directory to a secure location, such as your desktop or permanent server before proceeding.

```
MS ftp
Auto
Connected to 47.142.84.210.
220 ProFTPD 1.2.2 Server (Nortel SSPFS Developer Installation) [mgem_srv_d1]
User (47.142.84.210:(none)): root
331 Password required for root.
Password:
230 User root logged in.
ftp> cd /tmp
250 CWD command successful.
ftp> get ud4_0_3.text
200 PORT command successful.
150 Opening ASCII mode data connection for ud4_0_3.text (14779 bytes).
226 Transfer complete.
ftp: 15417 bytes received in 0.72Seconds 21.41Kbytes/sec.
ftp> get ud4_0_3.html
200 PORT command successful.
150 Opening ASCII mode data connection for ud4_0_3.html (32097 bytes).
226 Transfer complete.
ftp: 32733 bytes received in 0.49Seconds 66.80Kbytes/sec.
ftp> get PLOAServices.text
200 PORT command successful.
150 Opening ASCII mode data connection for PLOAServices.text (13188 bytes).
226 Transfer complete.
ftp: 13836 bytes received in 0.71Seconds 19.49Kbytes/sec.
ftp>
```

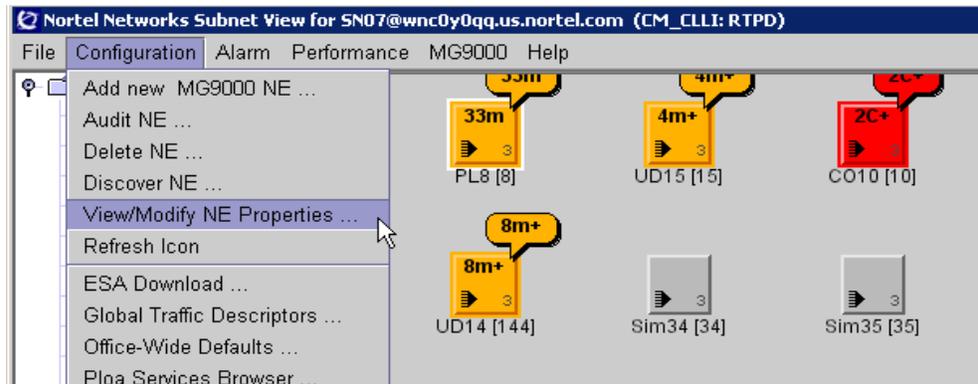
- 4 Obtain the IP address of the MG 9000 Manager server (not the mid-tier or client). At the Subnet View, select Configuration->View/Modify NE Properties from the menu bar.

Subnet View accessing Configuration ->View/Modify NE Properties

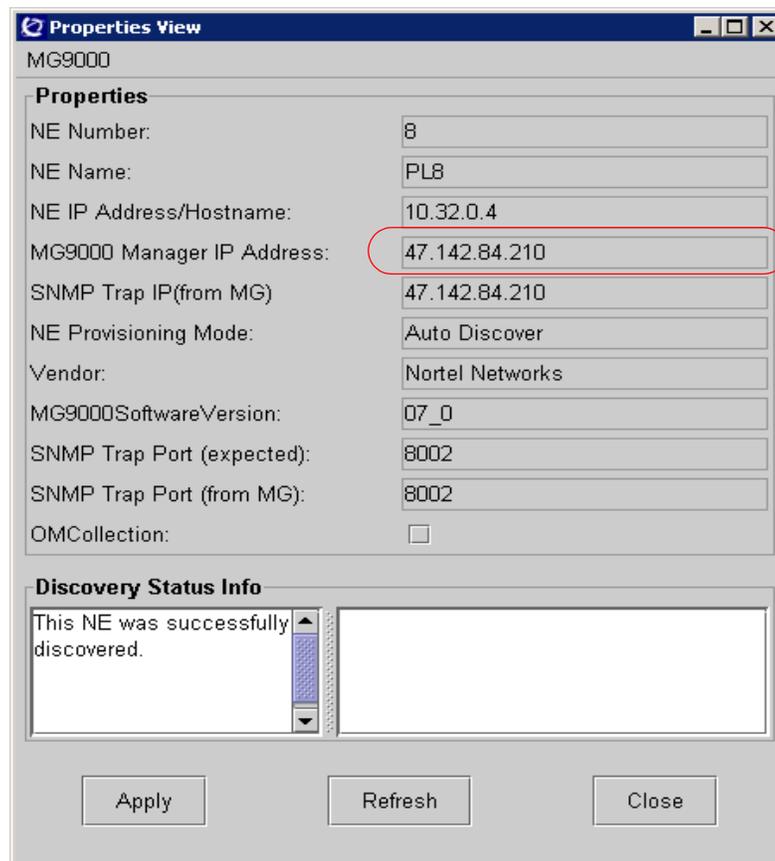
- 5 Record the IP address in the MG 9000 Manager IP Address field.

Properties View

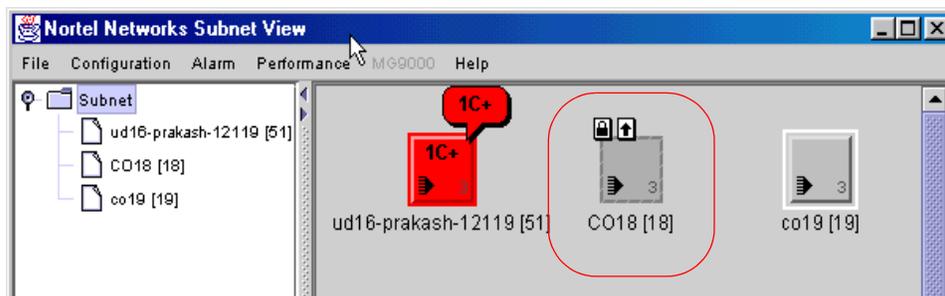
- 9 To continue, click OK and proceed to step [10](#). Otherwise click Cancel and go to step [11](#).
- 10 The MG 9000 responds with a Card State Change trap indicating that the configuration state is set to reinitialize and that the MG 9000 will clear persistence and restart. At the Subnet View, a “bomb” is displayed on the network element icon. After a period of time, the Subnet View is updated to show the up arrow indicating discovery and audit. When the operation is complete, the NE icon will be free of these added indicators. The following figure shows the NE is in discovery.

Subnet View showing degraded network element

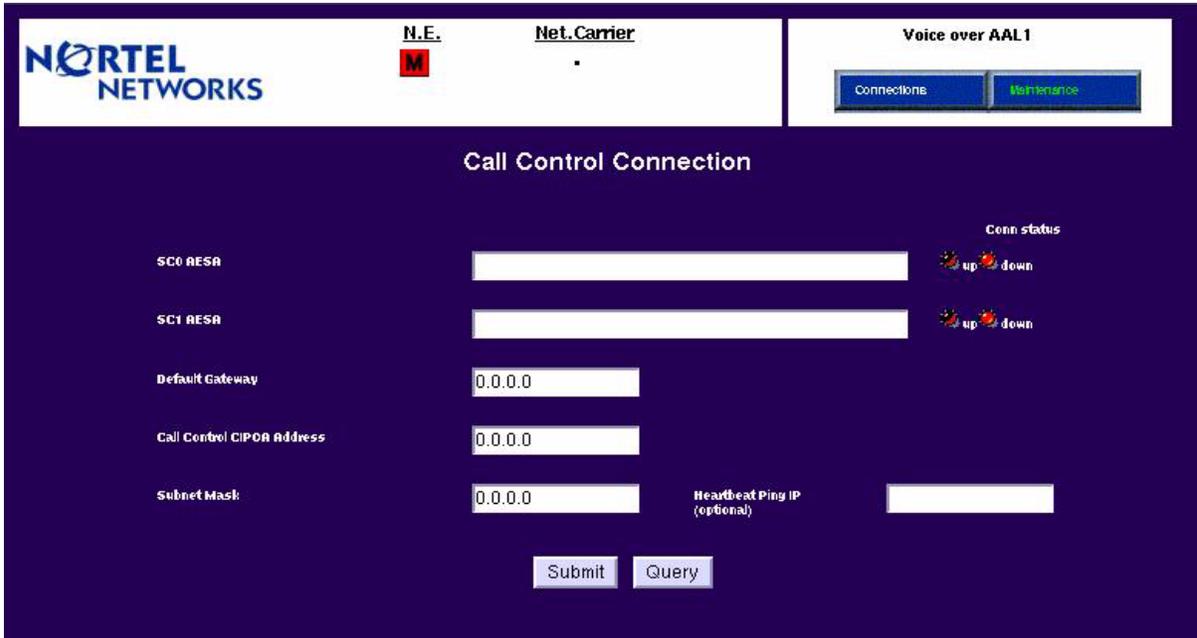
LCI screen showing Call Control Connection for Voice over AAL1

- a Enter or change the Primary AESA to SC0 and/or Secondary AESA to SC1 address.
- b Enter the 'Call Control CIPOA Address'.
- c Enter the optional Heartbeat Ping IP address.

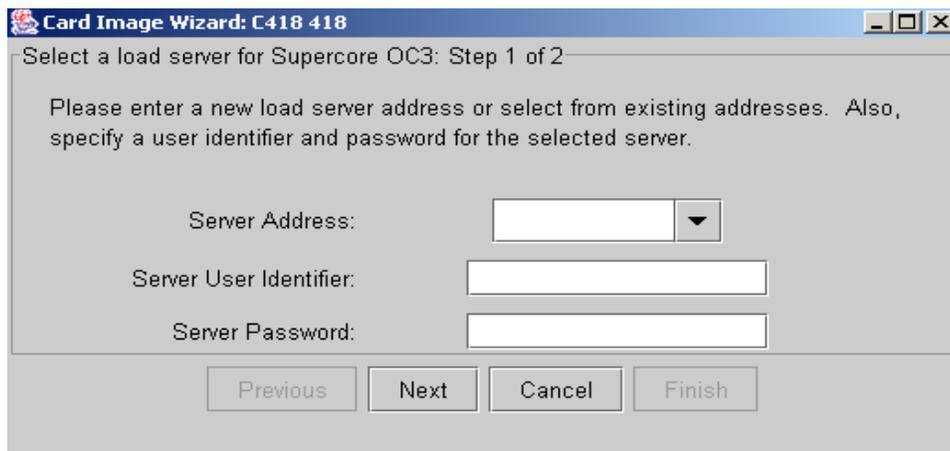
Card Image Wizard, Select a load server: Step 1 of 2

From this wizard, the default server IP address, the server user identifier, and the server password can be changed. After all changes are made click Next. The Card Image Wizard Specify a directory: Step 2 of 2 appears as shown in the following figure.

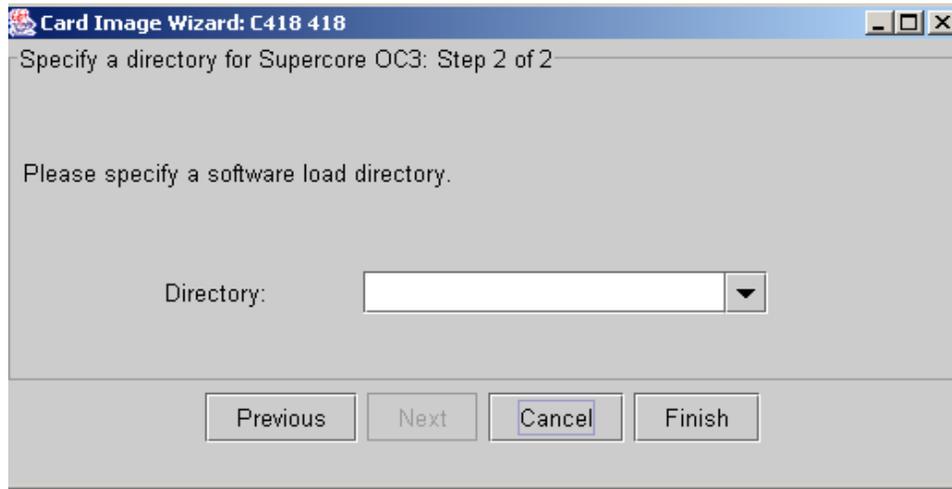
Card Image Wizard, Specify a directory: Step 2 of 2

From this wizard step, the default directory can be changed. Click Finish.

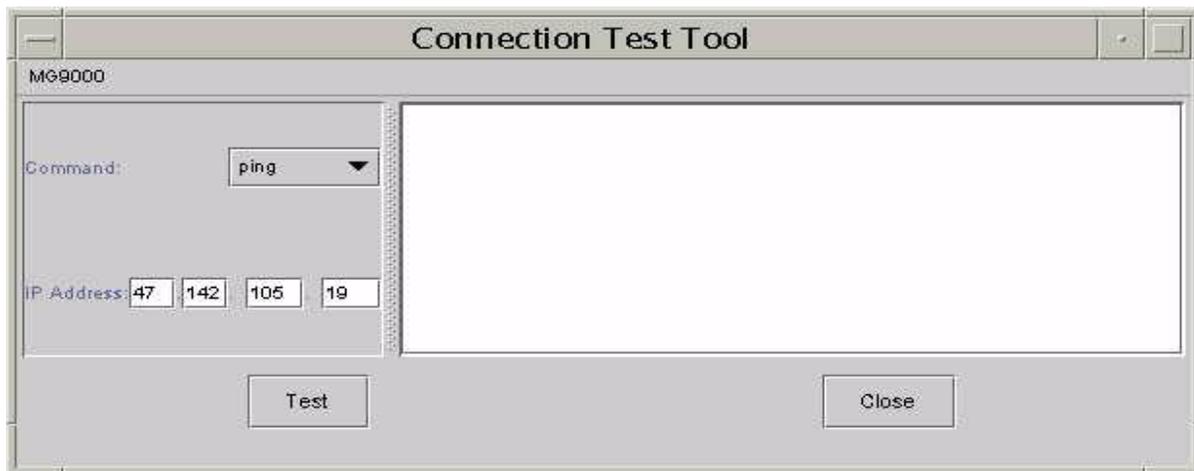
- 2 Select the command to be performed from the pull-down menu. The following figure shows the Connection Test Tool View and the Command pull-down menu.

Connection Test Tool View

- 3 Enter the IP address in the IP Address field.
Note: The MG 9000 cannot be pinged until the MG 9000 has been commissioned with a cold start received by the MG 9000 Manager.
- 4 Click on Test to run the test tool. The results are displayed in the text area on the right.
- 5 This procedure is complete.

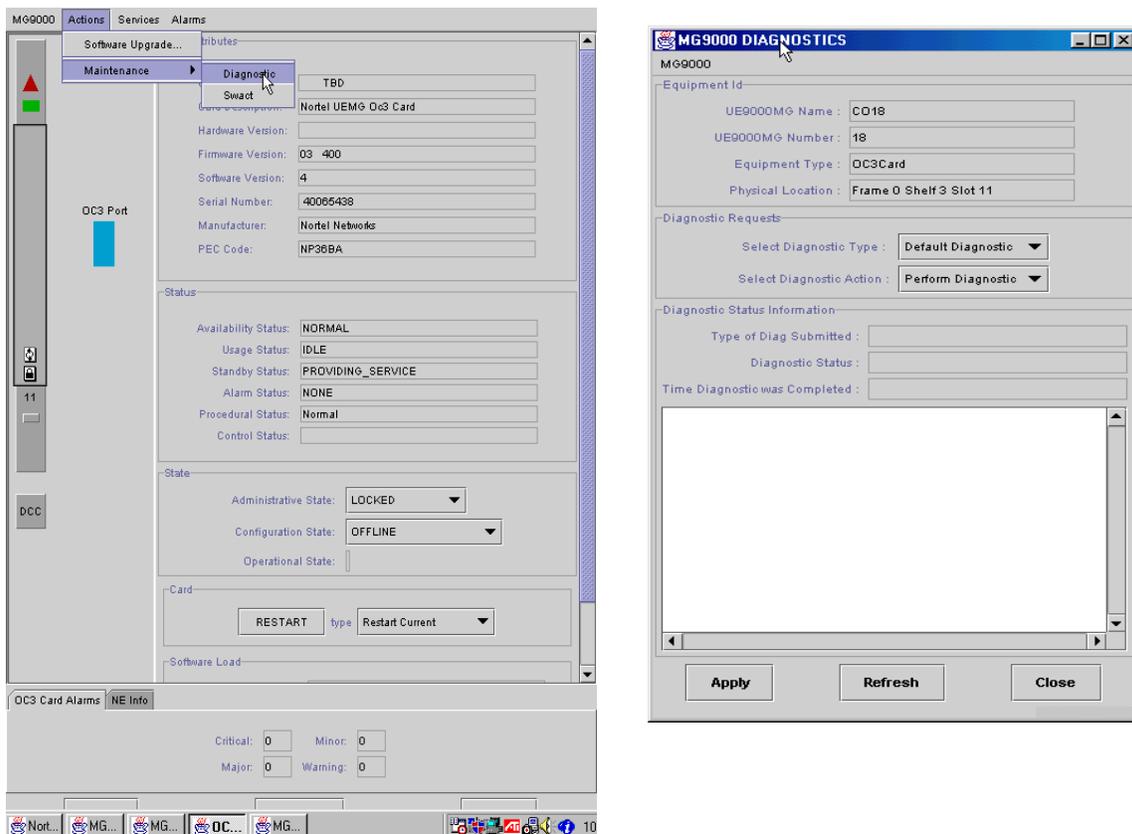
- 1 At the Subnet View, select the MG 9000 on which diagnostics are to be performed. The Frame View appears.
- 2 Double click on the shelf to open the Shelf View.
- 3 Double click on the card on which diagnostics are to be run. The Card View appears.
- 4 Verify that the administrative state of the card is set to unlocked. To Unlock the card, perform the [Unlocking a card](#) procedure.
- 5 From the menu bar on the top left of the Card View, select Actions->Maintenance->Diagnostic as shown in the following figure. The following MG 9000 Diagnostics View appears.

Card View and MG 9000 Diagnostic View

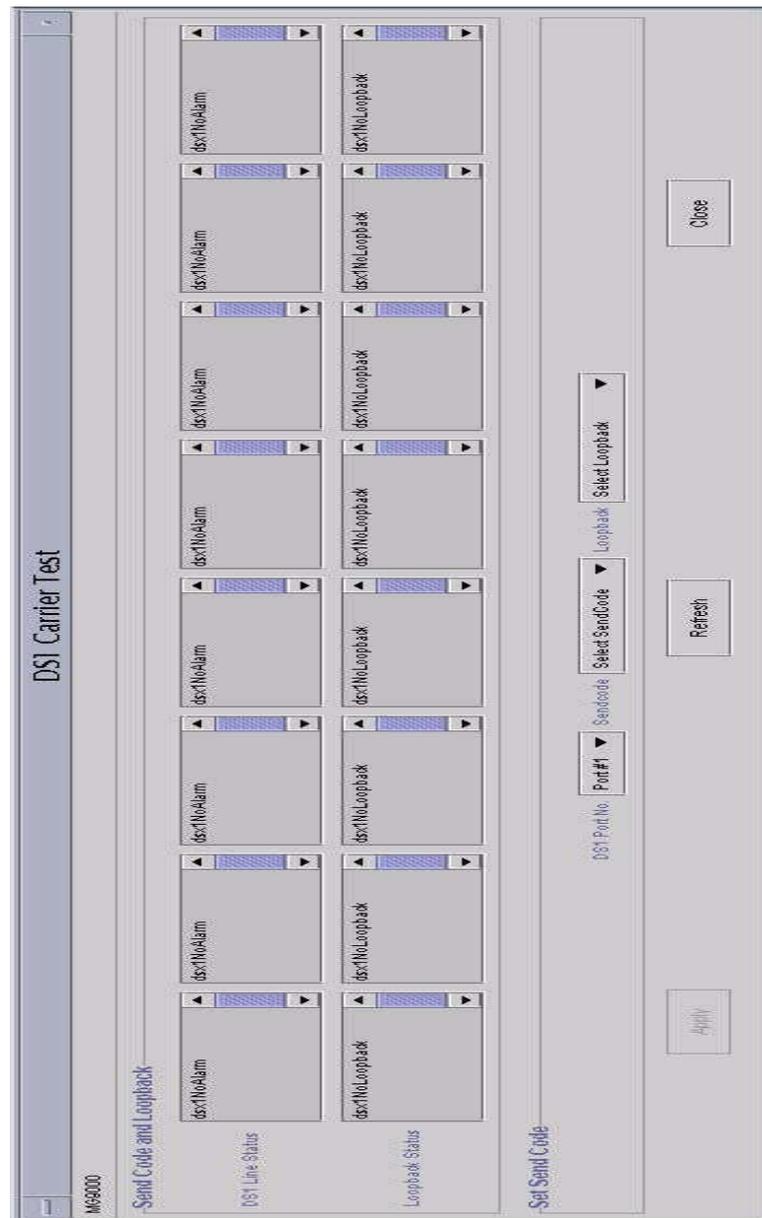
DS1 Carrier Test View

- 9** In the Set Send Code pane, select the DS1 Port No. to be tested, the Send Code and Loopback options.

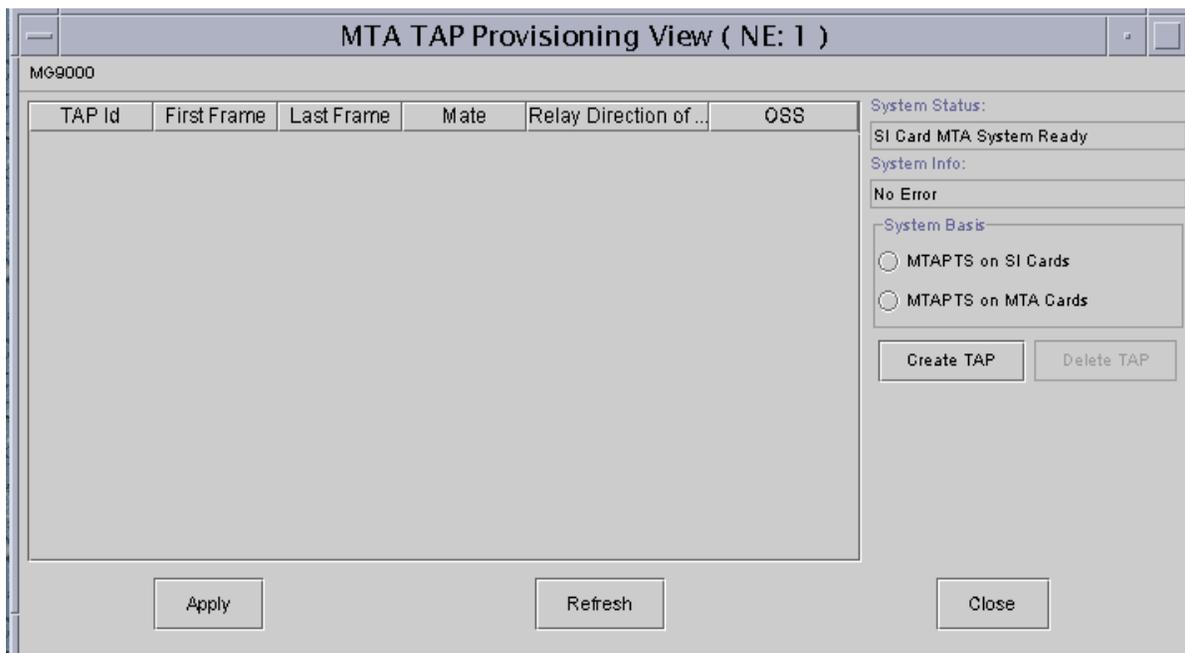
MTA TAP Provisioning View Screen

Field	Explanation
TAP Id	The test access point (TAP).
FirstFrame	The first frame which indicates the beginning of the range of frames for a particular TAP.
LastFrame	The last frame which indicates the end of the range of frames for a particular TAP.
Mate	If the TAP can be used to make up a 4-wire pair, this field contains the mate TAP.

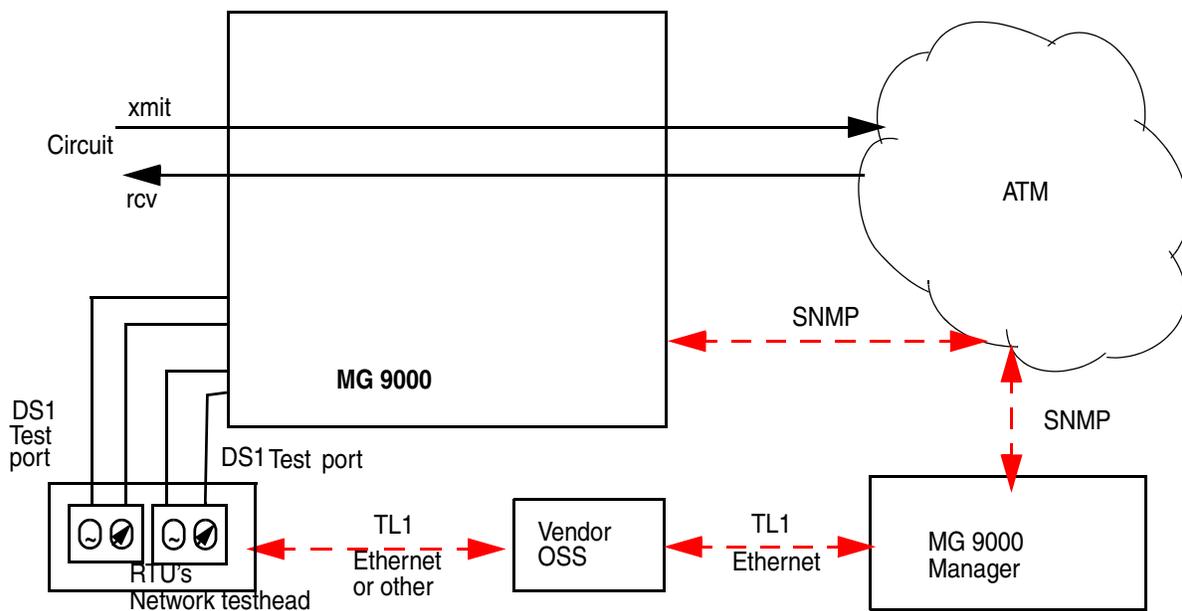
The following figure shows the MG 9000 digital test access using an RTU.

MG 9000 DTA testing

To provide connectivity between the RTU and the MG 9000, DS1 ports on the MG 9000 must be defined as DFADs and/or TADs, and those ports must be connected to the associated ports on the RTU. Provisioning of the DFADs and TADs occur at the SNM.
