MG 9000 Fault Management

Fault management strategy

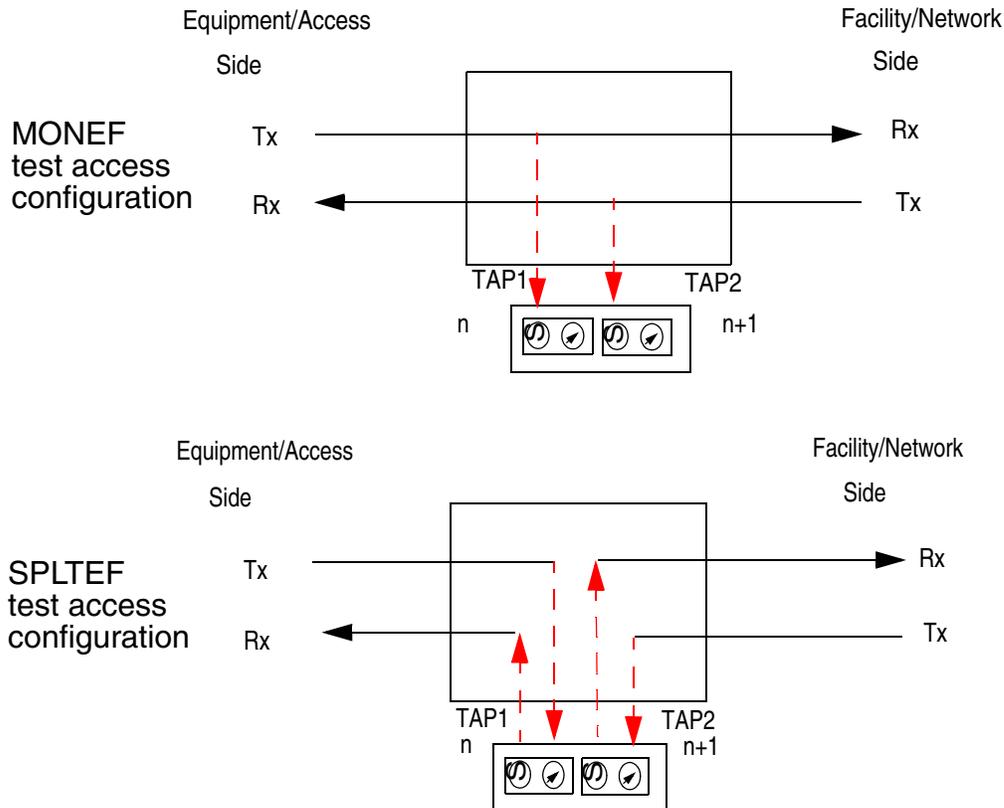
The following figure shows the two DFAD test access modes

DFAD MONEF and SPLTEF test access modes

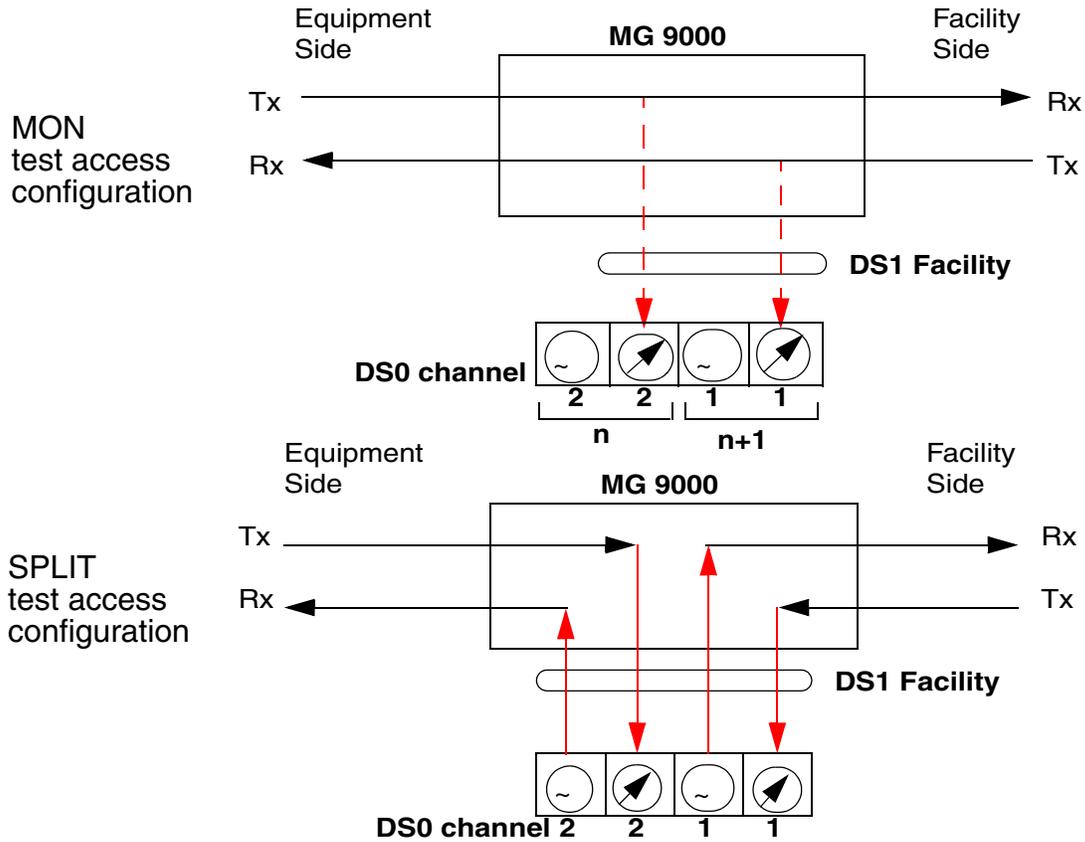
The following figure shows the two TAD test access modes

TAD MONEF and SPLTEF test access modes

TAD When provisioning a TAD, twelve contiguous TAPs are automatically allocated over the DS1. Each TAP is associated with two adjacent channels within the DS1 TAD. The first TAP is associated with channel 1 and channel 2, the second TAP is associated with channel 3 and channel 4. This sequence continues until the twelfth TAP is associated to channel 23 and channel 24. The odd channel of the TAP is used for connections to the facility side of the circuit under test and the even channel number of the TAP is used for connections to the equipment side of the circuit. TAD test access only supports single channel DS0 bundles. TAD employs the following two test access modes.

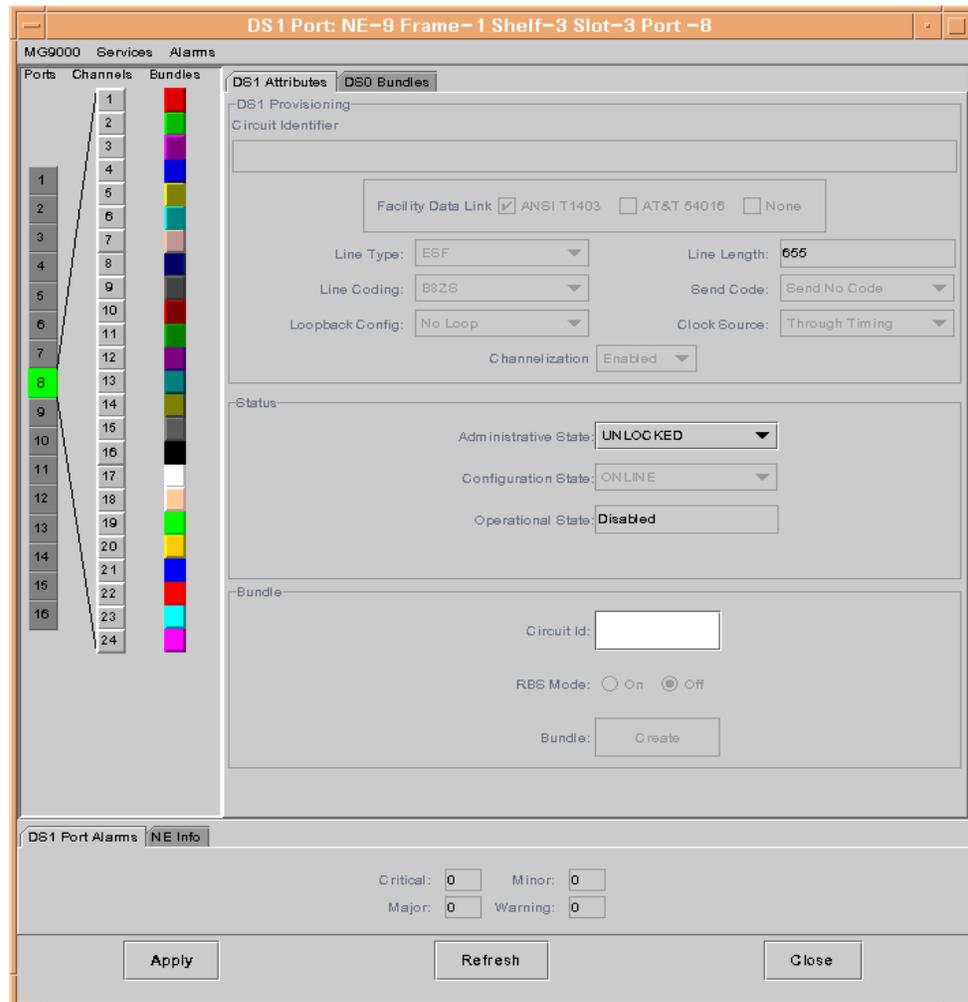
If	Do
the DS1 port is already wired to the test head through the local wiring panel, such as a DSX panel	Step 6
the DS1 port is not wired to the test head	Go to the local wiring panel (such as DSX panel) according to local procedures and wire the DS1 to the test head and return to this step.
- 6 Set the port to On line.
- 7 In the DS1 View, set Channelization to Enabled. At this point the channels in the left side of the DS1 View will turn blue.

DS1 Port View with Channelization Enabled

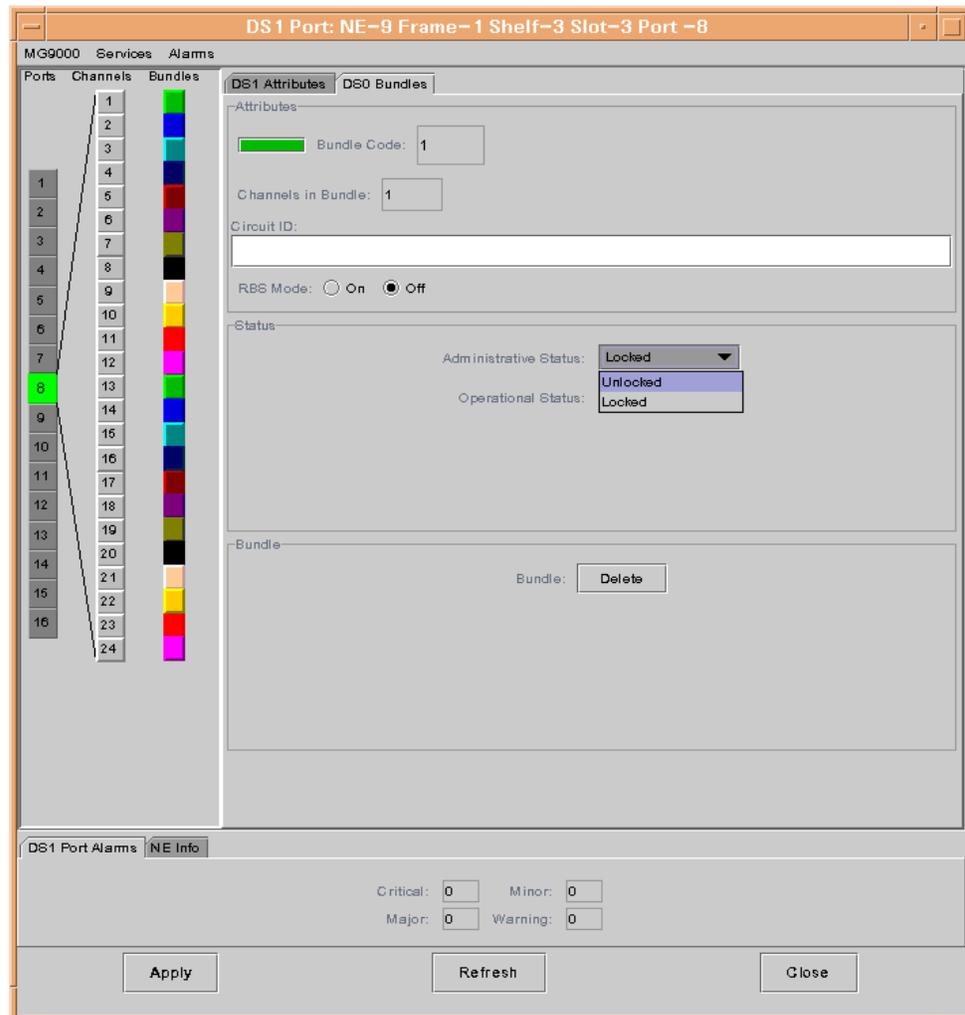
- 8 Unlock the port.
The Operational state becomes Enabled.
- 9 Click on each channel then click on Bundle Create. (Robbed bit signaling [RBS] default = Off.) Repeat this step for all 24 channels in order from 0 to 23.
- 10 Then unlock each bundle by double clicking and changing the Administrative state to Unlocked. Repeat this step for all 24 channels in order from 0 to 23.

DS1 Port View unlocking bundles

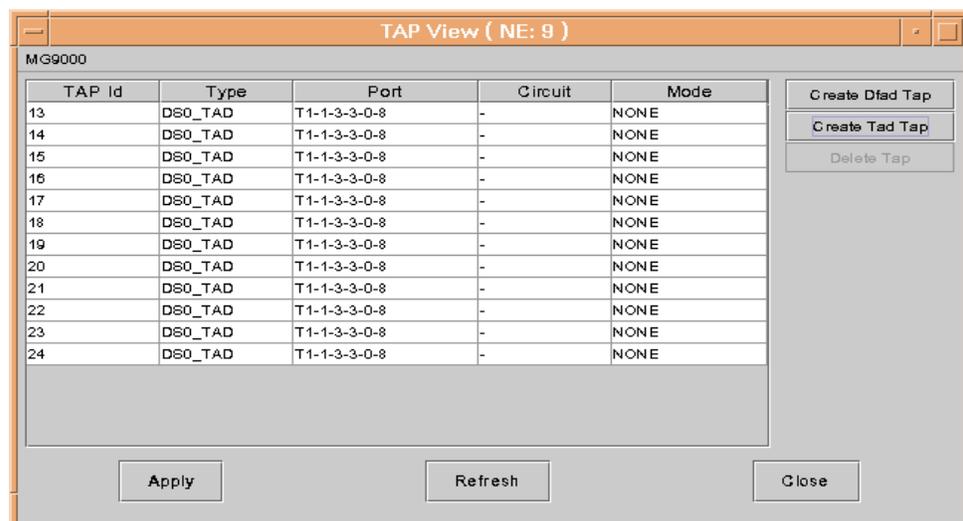
- 13 Click Select. This brings up the NE-1 Selector window.
- 14 Choose the card and port to act as the TAD ports and click OK.
- 15 Enter the TAP ID value according to vendor requirements and local procedures.
- 16 Click OK. The Provisioned DS0 TADs appear in the TAP View window. Click Close.

Provisioned DS0 TADs in TAP View

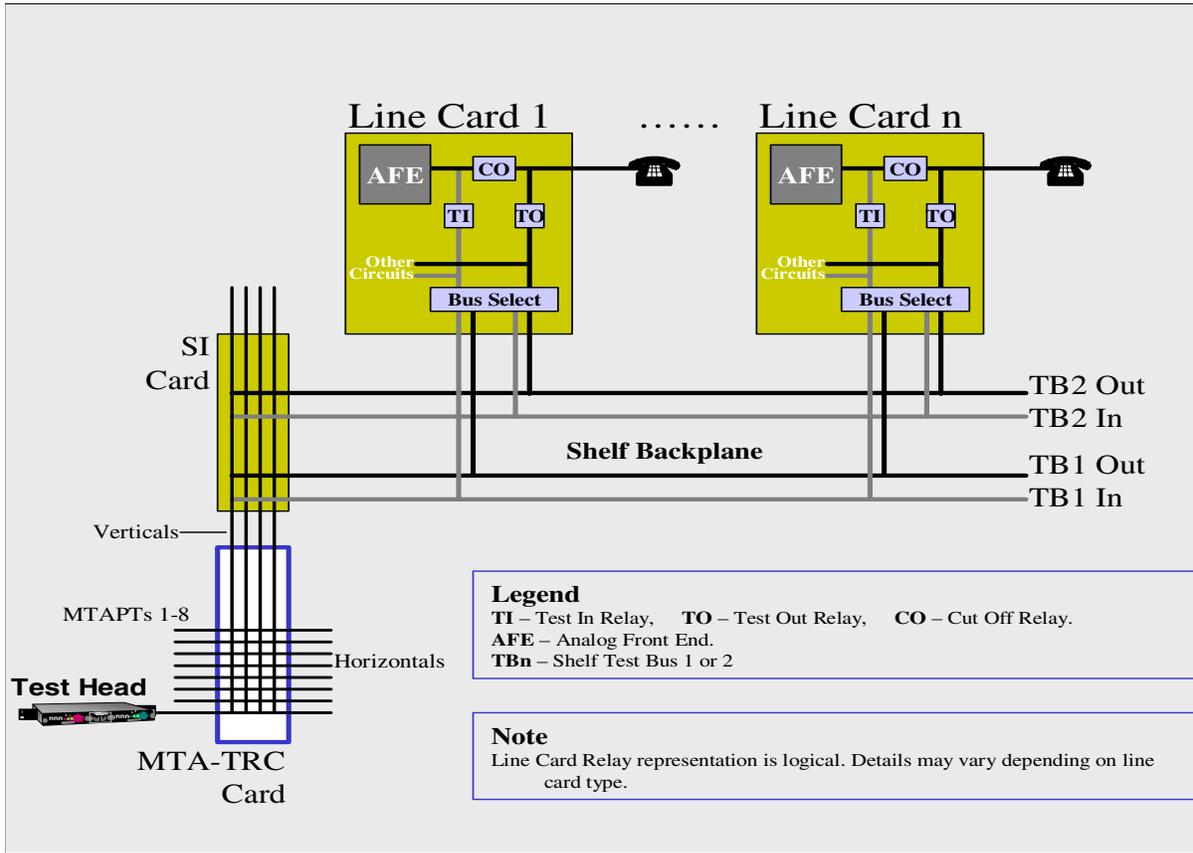
The following figure shows the cut-off (CO) relay in each of the supported line card types.

Cut-off relay on line cards

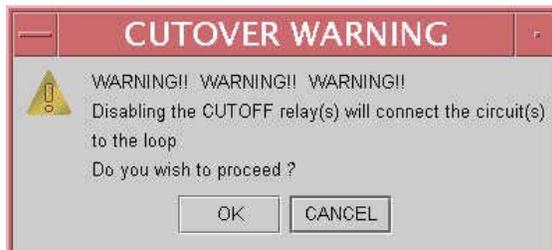
- 8 Click Apply at the bottom of the MG9000 Diagnostics View. A warning message will appear as shown in the following figure.

Warning message - disabling cut-off relay

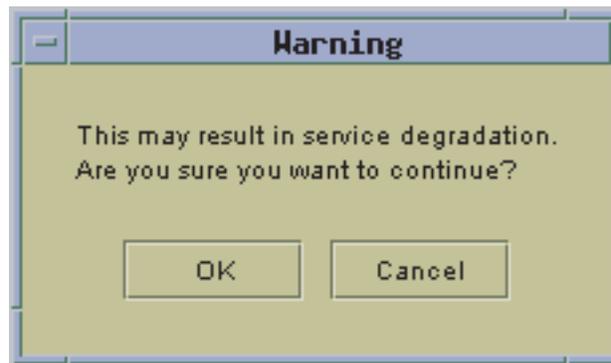
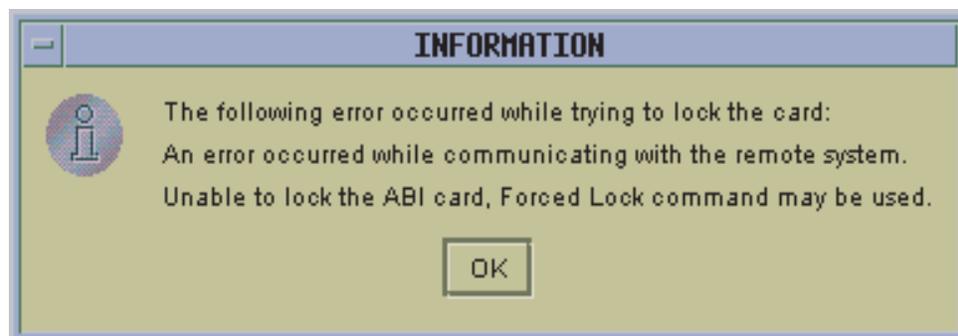
- 5 To switch the activity of the currently active DCC, ITP, or ITX card to be inactive, from the Actions menu at the top of the Card View, select Maintenance->SWACT. Wait for the Standby status to change to Hot_Standby. Go to step [9](#)
- 6 If the card to be locked is a DS1 card, go to step [9](#).
- 7 If the card to be locked is a Master ABI card, perform a Switch Mastership to switch mastership of the ABI card. Go to the [Switching mastership of an ABI card](#) procedure and return to this step. After the Master ABI Service Status is Providing_Service_Slave, go to step [8](#).
- 8 If the card to be locked is a Slave ABI card, a warning message will appear and an informational message will appear warning of service degradation when the Slave ABI card is taken out of service. The warning and information messages are shown next.

To continue with locking the Slave ABI card, use the Force Lock option.

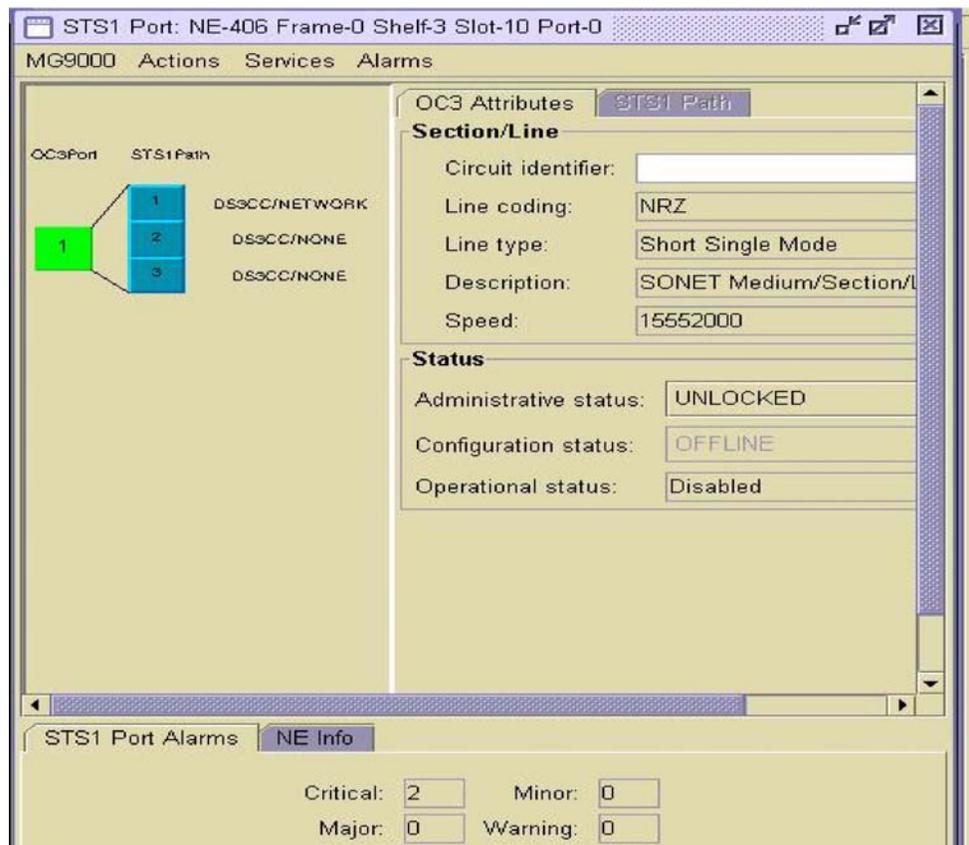
- 6 The following figure shows a channelized carrier and the path icons. Three STS1 path icons are adjacent to the OC3port icon.

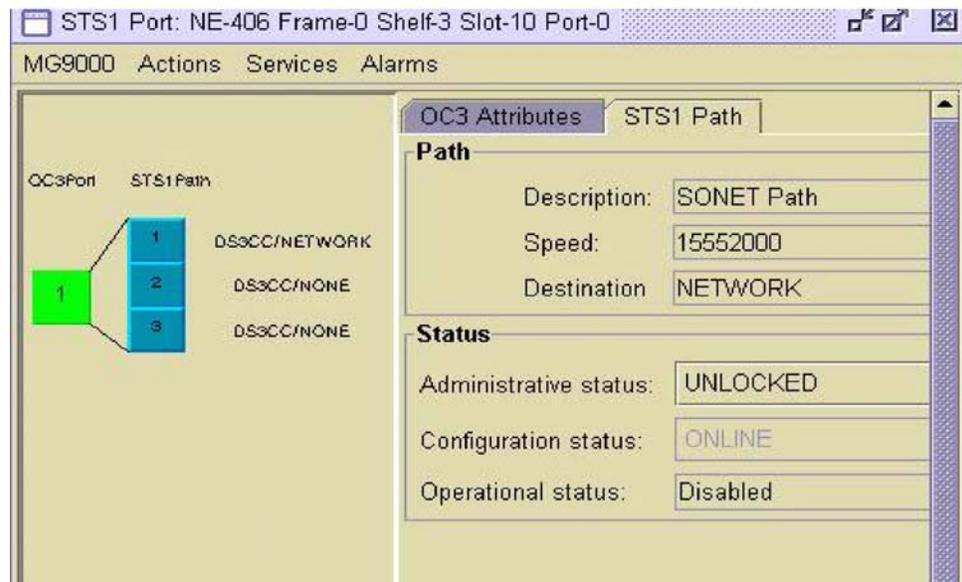
- 7 Double click on an STS1 path to display STS1 path information and its status in the STS1 Path tab on the right side of the port view. The following figure shows the STS1 path description and status information.

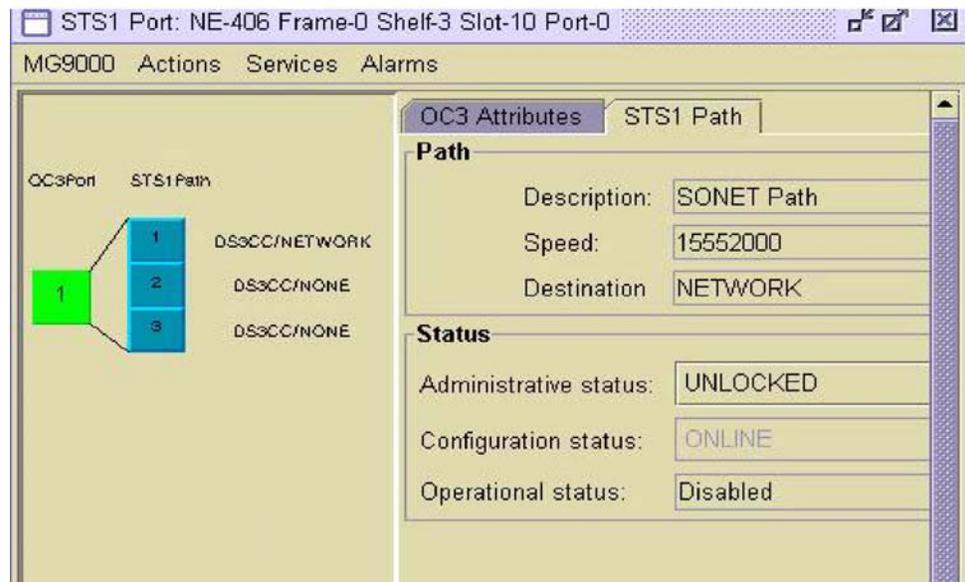
- 7 Double click on an STS1 path to display STS1 path information and its status in the STS1 Path tab on the right side of the port view. The following figure shows the STS1 path description and status information.

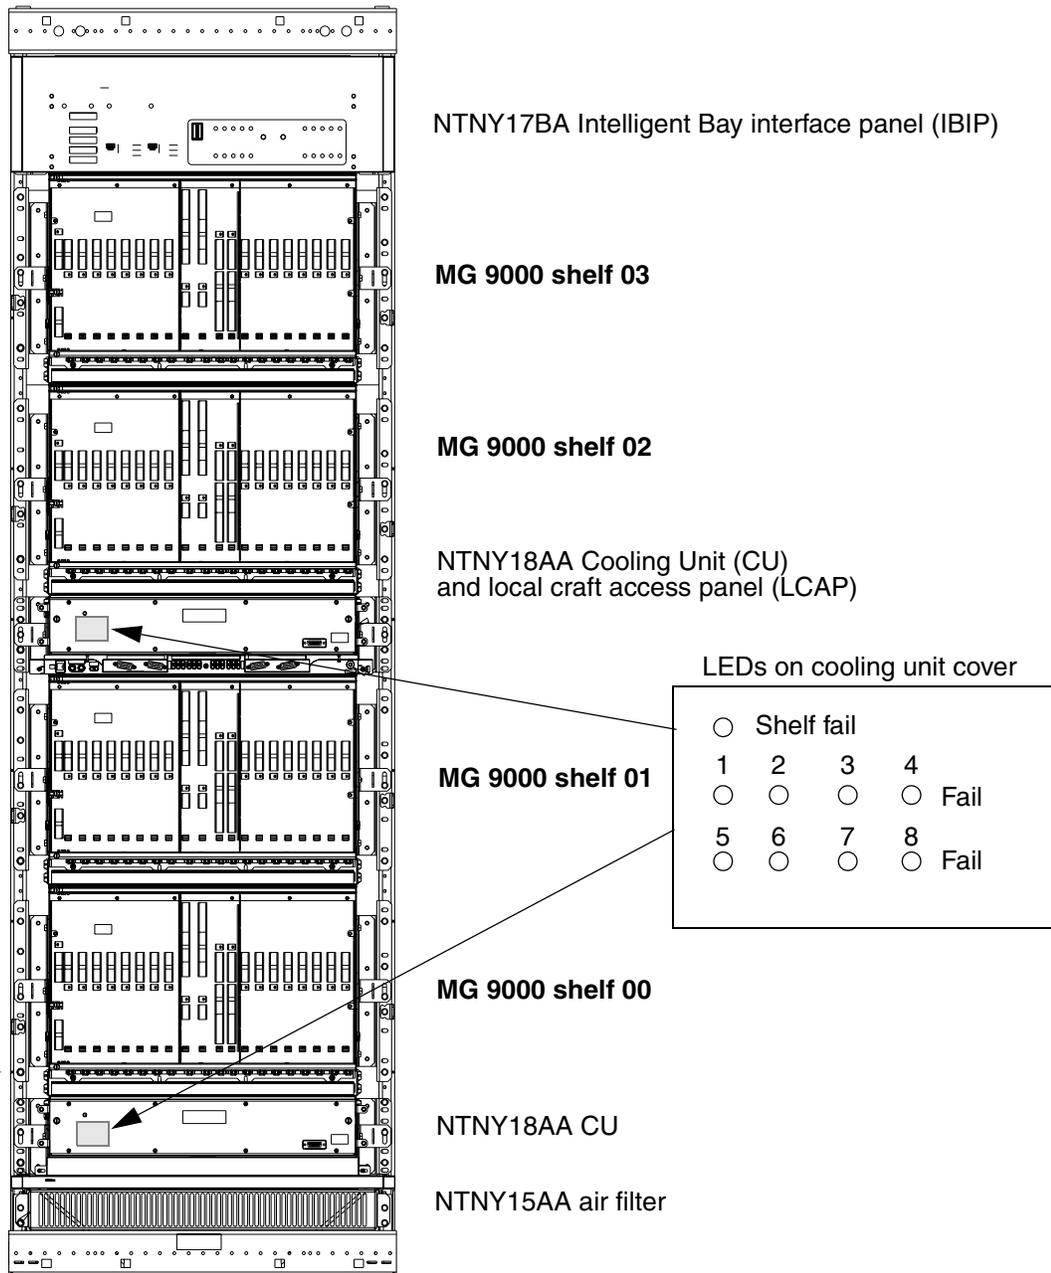
- 5** Remove the screws that hold the cooling unit in place.
- 6** Pull the cooling unit out until it is free of the frame.
- 7** Install the replacement cooling unit into the frame. Replace the screws that were removed in step [5](#) to secure the cooling unit to the frame.
- 8** Replace the fuse modules for the cooling unit that were removed in step [3](#).
- 9** A red LED will light briefly on the face of the cooling unit and then go out, indicating proper connection.
- 10** Check that the LED does not remain lit and that the fans are operating properly by the absence of any lit fan LEDs on the face of the cooling unit. Refer to the following figure to locate the LEDs on the cooling unit.

MG 9000 frame and cooling unit LEDs

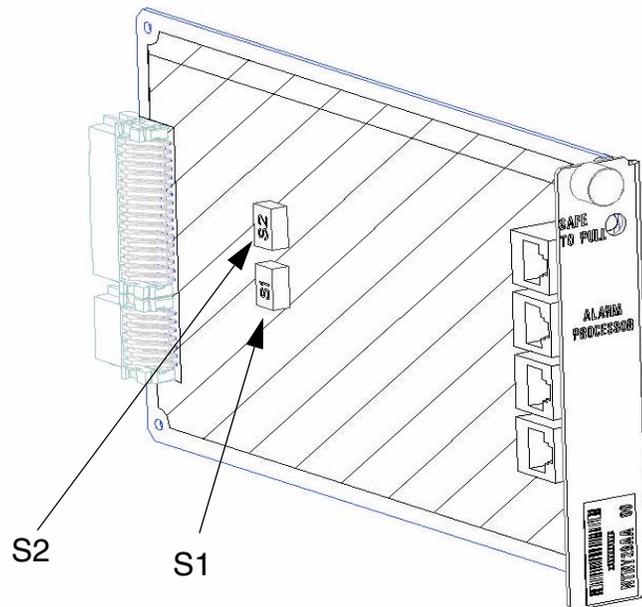
- 8 Remove the IBIP front cover.
- 9 Loosen the hold-down screw on the faceplate of the alarm processor card
- 10 Record the position of the two switch banks (S1 and S2) on the alarm card. Refer to the following figure for switch bank locations.

Alarm processor card switch location

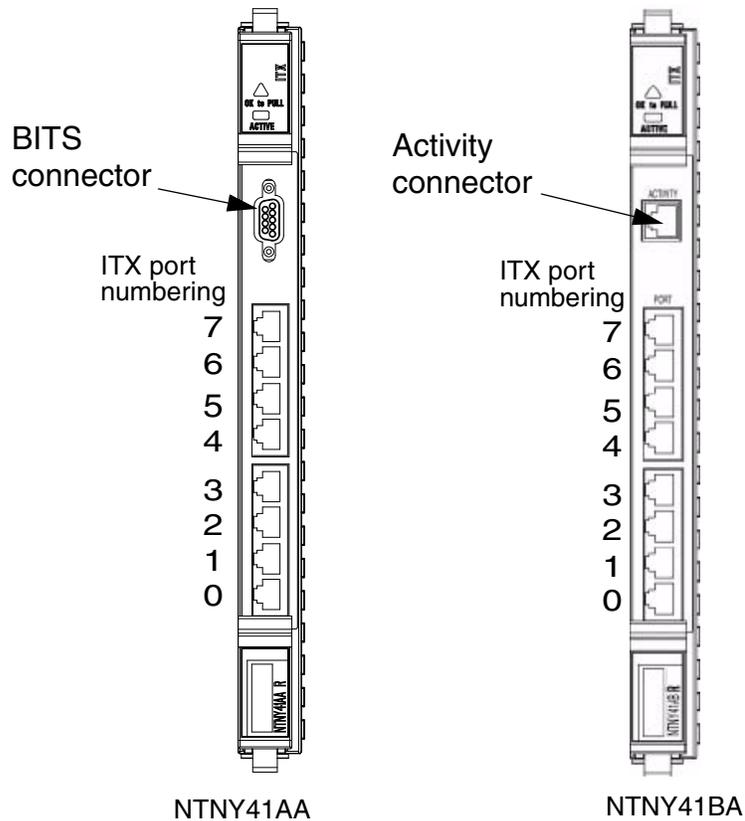
Carefully disconnect the cables from the RJ45 connectors on the faceplate of the ITX card. Label and carefully lay the cables aside. The ports are numbered as shown in the following figure. If there is a BITS cable connected to the DB9 connector on the NTNY41AA card, disconnect it. If an NTNY41BA card is being replaced, disconnect the activity cable.

ITX card port number

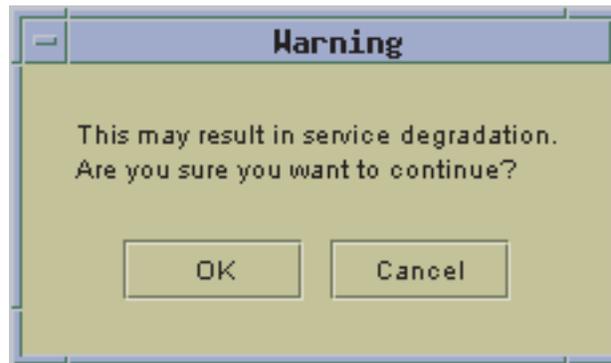
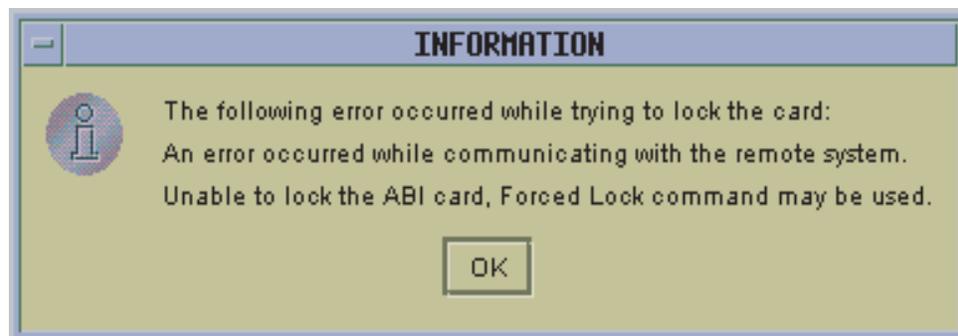
- 6** Identify the ABI card with the alarm condition by observing the alarm balloon.
- 7** To switch the mastership of the Master card to Slave, perform the [Switching mastership of an ABI card](#) procedure
- 8** To lock the ABI card, change the Administrative state by selecting Lock from the administrative state pull-down menu. All service will be terminated on the card. Refer to [Locking a card](#).
- a** When locking the Slave ABI card, a warning message will and an informational message will appear warning of service degradation when the Slave ABI card is taken out of service. The warning and information messages are shown next.

To continue with locking the Slave ABI card, use the Force Lock option.

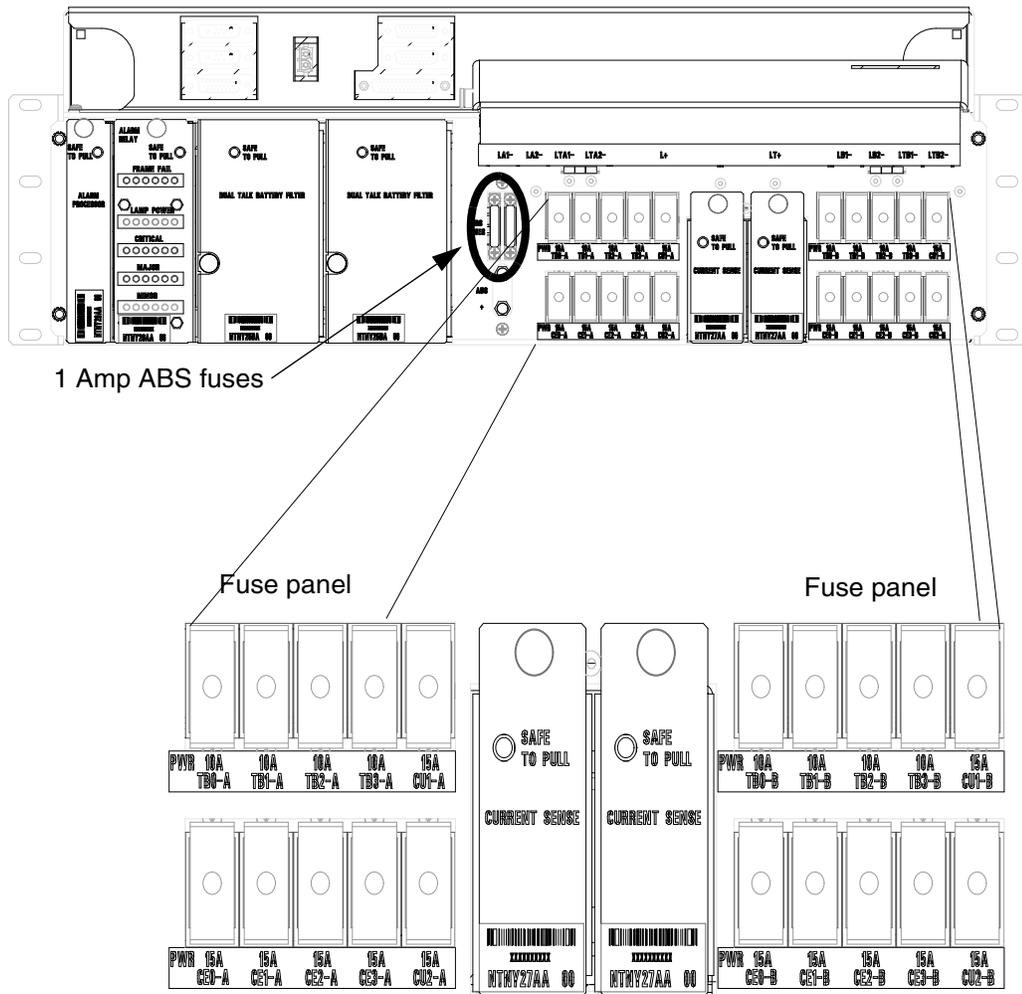
The following figure shows the IBIP and fuse location.

IBIP panel showing the fuse panel and ABS fuses

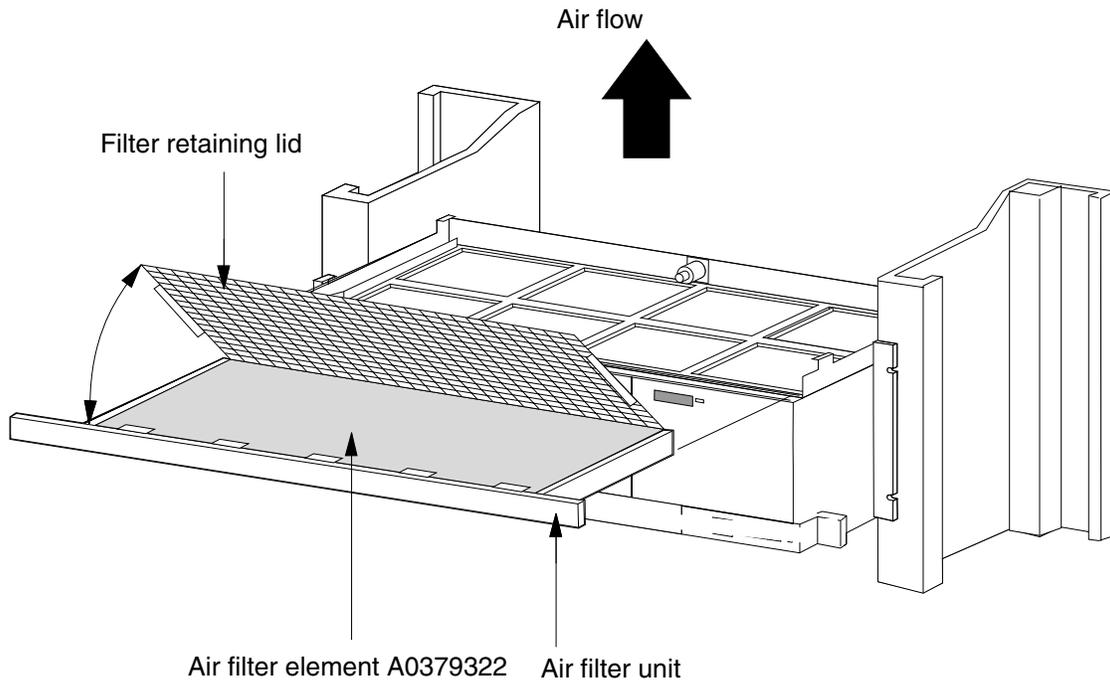
- 4 Close the filter retaining lid, and reinsert the air filter unit into the shelf until it locks into place. Refer to the following figure that shows the filter element in the air filter unit.

Air filter unit and element

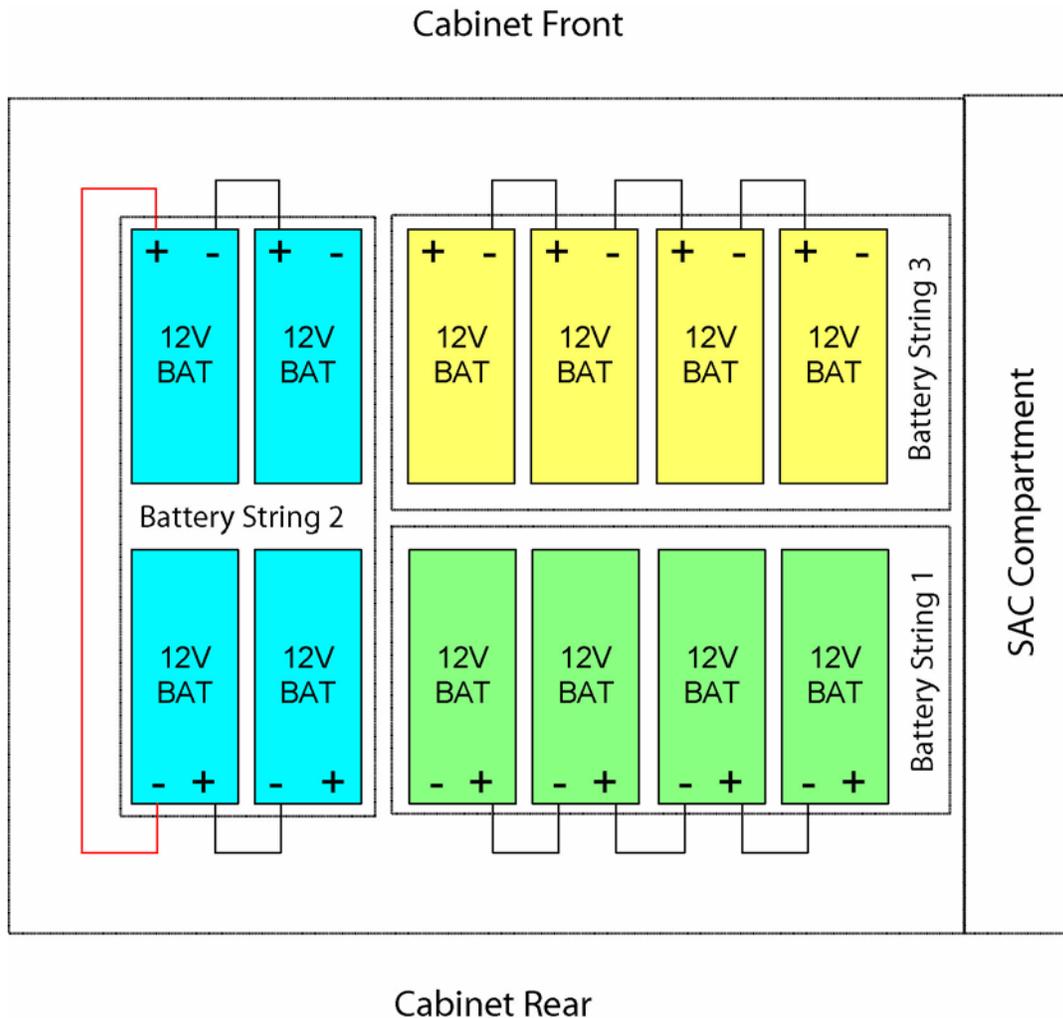
- Inspect battery packs, connections, and floor for moisture or corrosion.
- 4 Identify the affected string(s) to be replaced. Use the following figure to identify the battery strings.

Battery arrangement in the outside plant cabinet

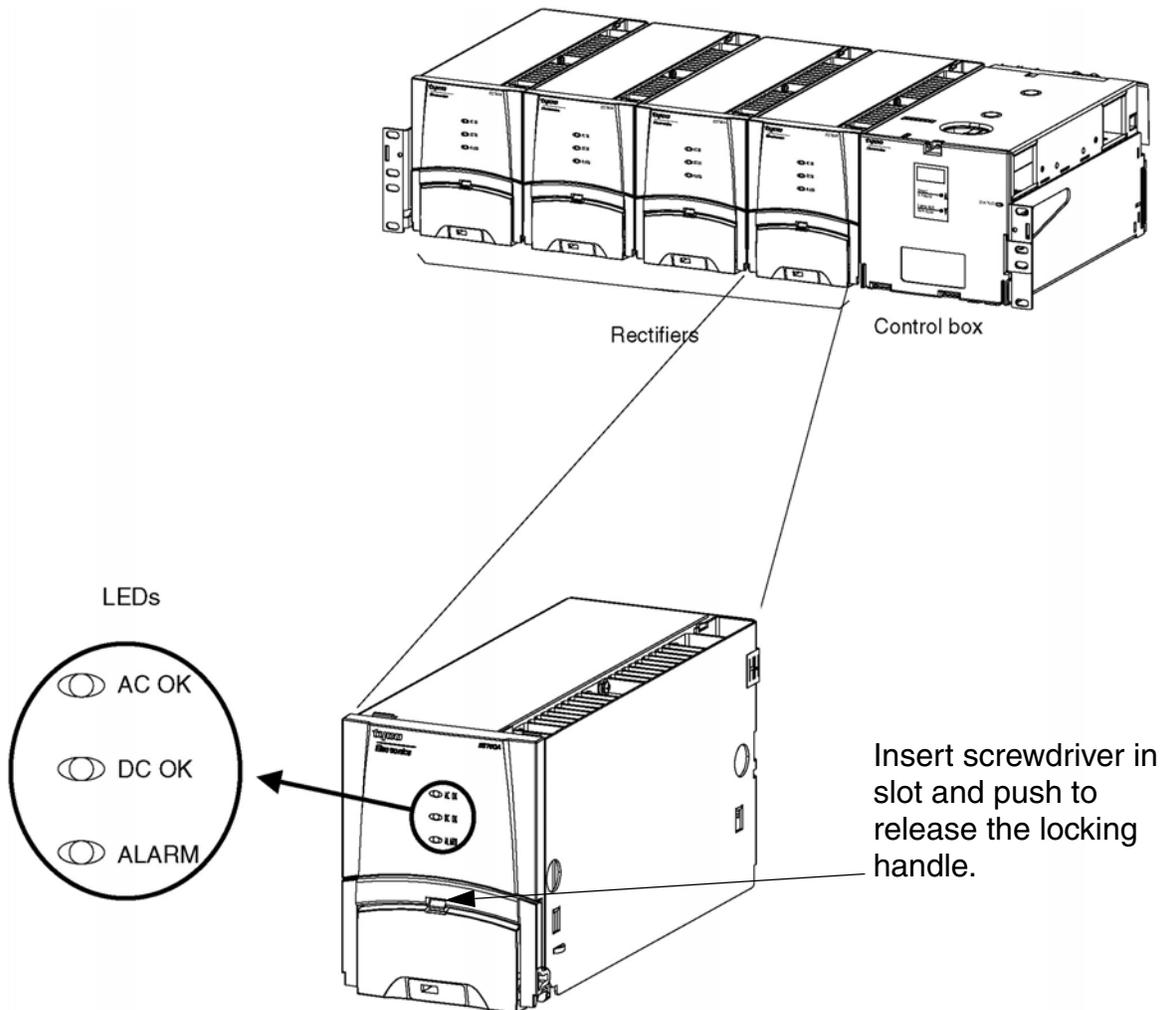
The following figure shows the rectifier shelf, the handle release slot, and alarm LEDs.

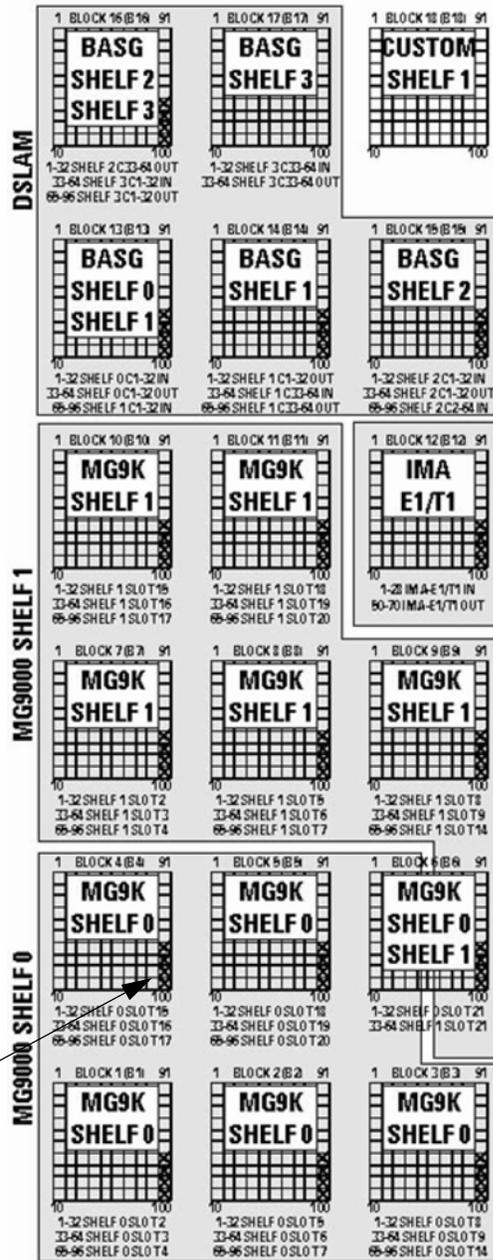
POTS/DSL SURGE PROTECTION LAYOUT DIAGRAM

Optional BASG DSLAM equipment on rear swing frame

"X" indicates spare protection module position. Spares are only located in the first 10 protection modules.

ON PROTECTION BLOCKS 1 THROUGH 10, POSITIONS 97, 98, 99 AND 100 CAN BE USED AS SPARE FUSE HOLDERS

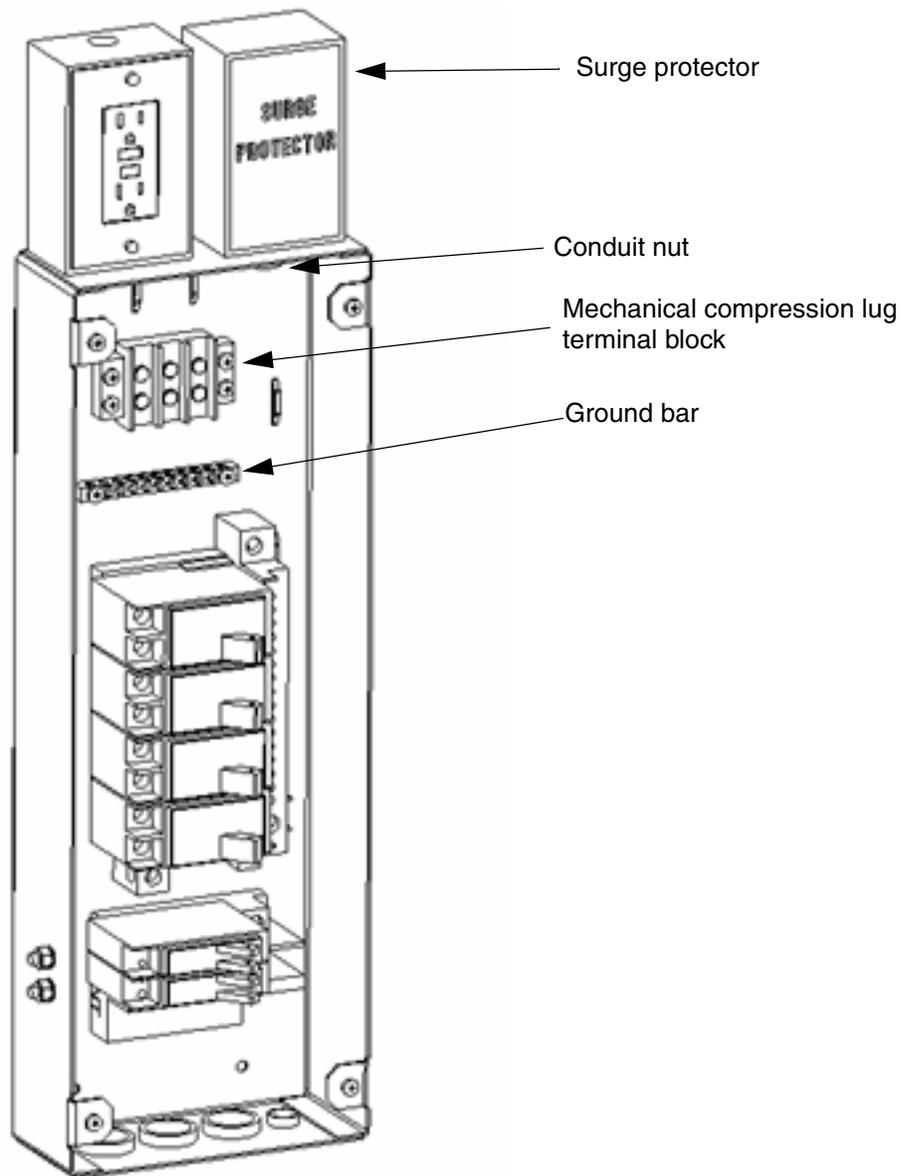
Use the following figure to locate components in this procedure.

ac panel (cover removed) and surge protector

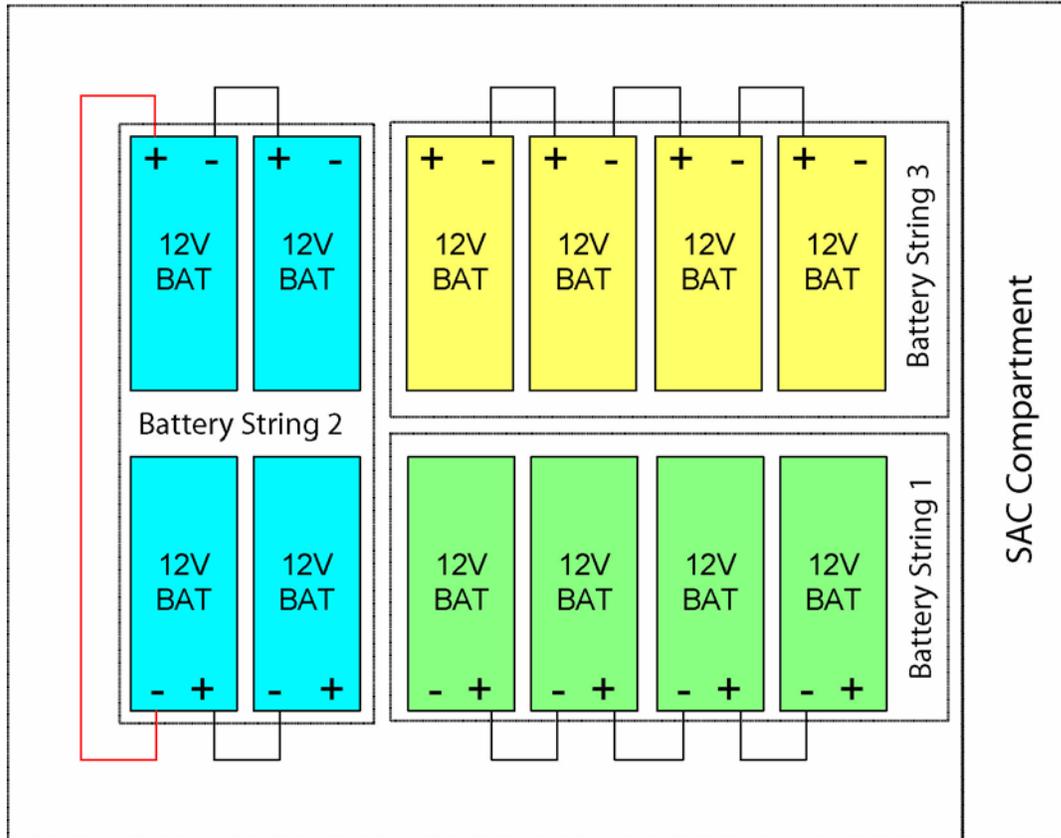
Battery arrangement in the outside plant cabinet

Cabinet Front

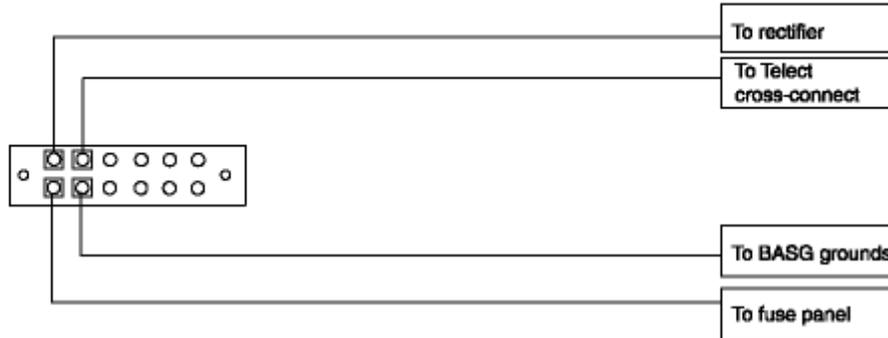
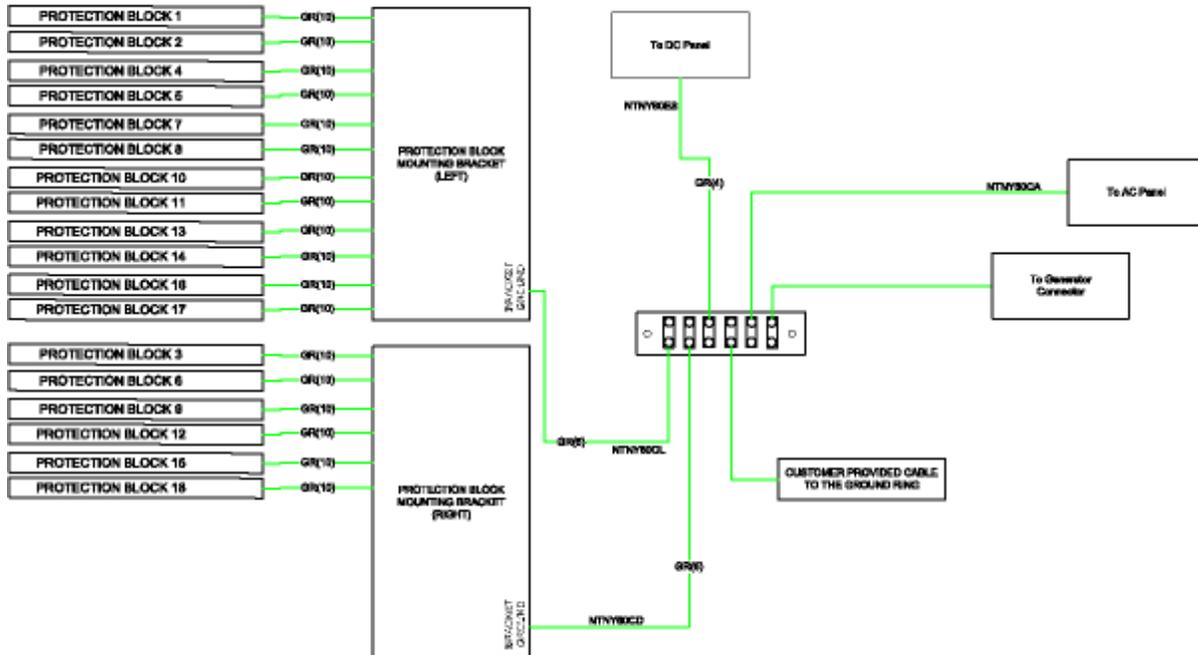
Outside plant cabinet system ground points

Main compartment equipment side

EQUIPMENT CABINET GROUND BAR AND SAC CABINET GROUND BAR ARE CONNECTED USING A COMMON CABINET WALL
