MG 9000 Fault Management

Fault management strategy

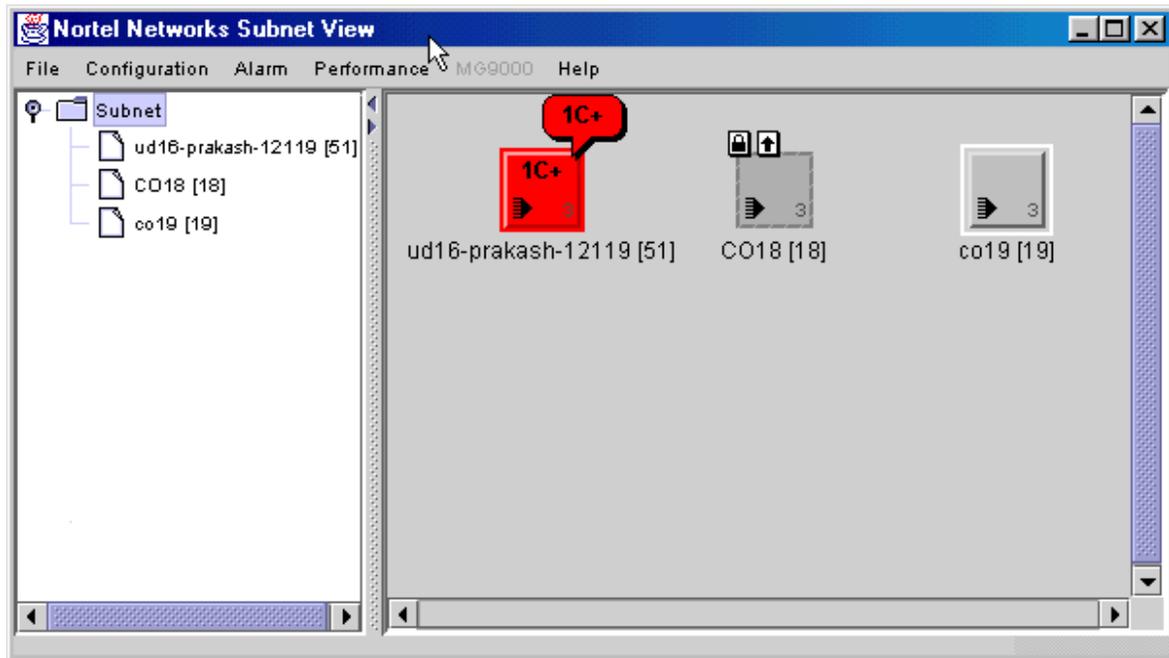
MG 9000 Manager Subnet View

The following figure shows the window-based MG 9000 Manager Subnet View. In this figure, the icon in solid grey without diagonal lines indicates that the MG 9000 is provisioned and discovered. In the Subnet View. A tree view is available in the left side. Each entry or 'NE' in the tree indicates the presence of some entity. The top node (also known as the root NE) indicates the subnet itself, and is named accordingly; its icon shows a folder to indicate it (may) contain other items. As MG 9000s are added to the subnet, they will appear as additional NEs in the tree, connected by a line to the root 'subnet' NE. This indicates a containment relationship that the subnet has over its constituent MG 9000s.

Each MG 9000 NE is shown as a standard 'paper' icon, to indicate there is information available about that particular MG 9000 at this level of the tree. The icon is accompanied by the name of the MG9000, and its network element number appended in square brackets.

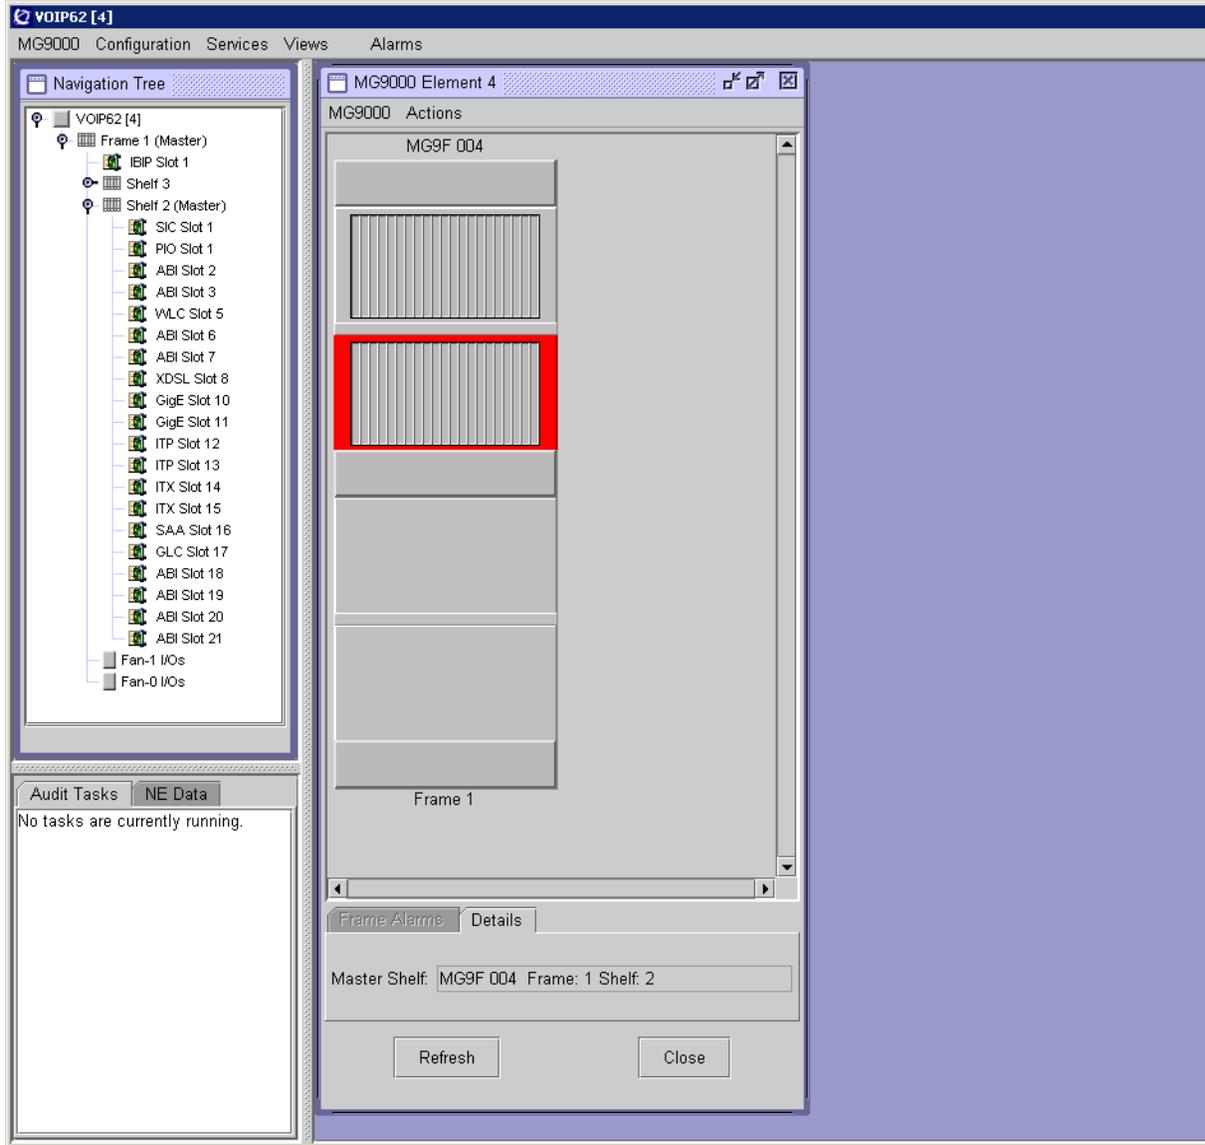
Frame View shown within NE desktop view

The Audit Task tab shows the progress of an NE audit and is meant as an audit indicator for those tasks that run in the background so the user is aware that an NE audit is currently in progress. Throughout this document, the individual GUIs are shown outside the NE desktop view, though in all cases except for the Alarm Browser, the GUIs appear in the NE desktop view.

The menu bar across the top of the NE desktop view consists of the following menu items

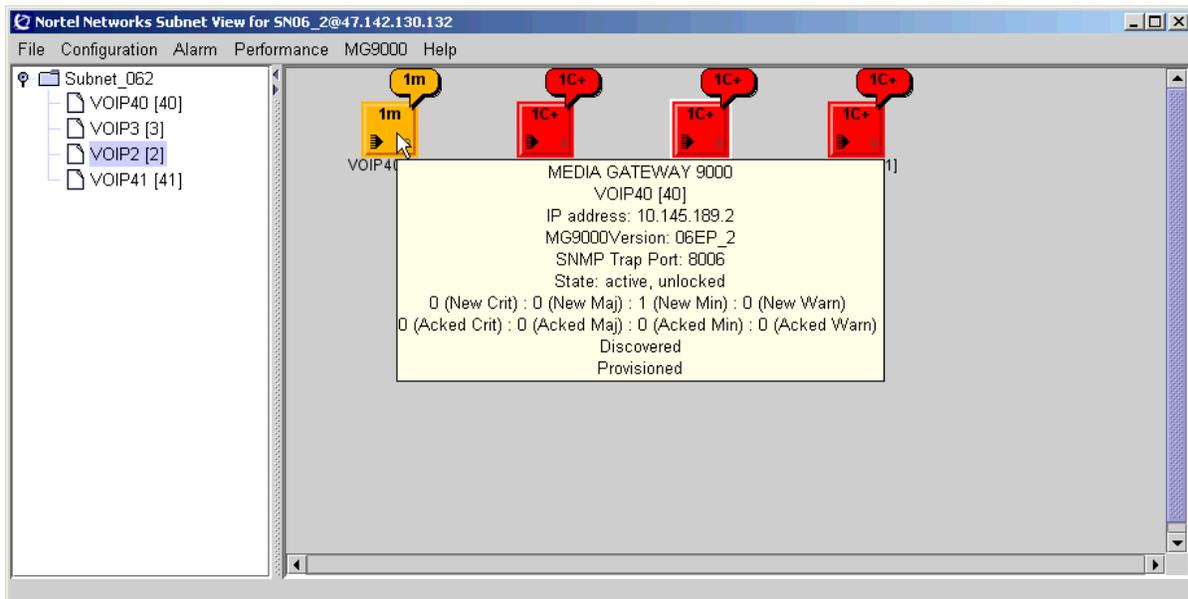
Subnet View showing the information balloon

- network element name and number
- MG 9000 software release
- network element IP address
- SNMP trap port number used
- state of the network element
- total alarms by category and the number of alarms that have been acknowledged

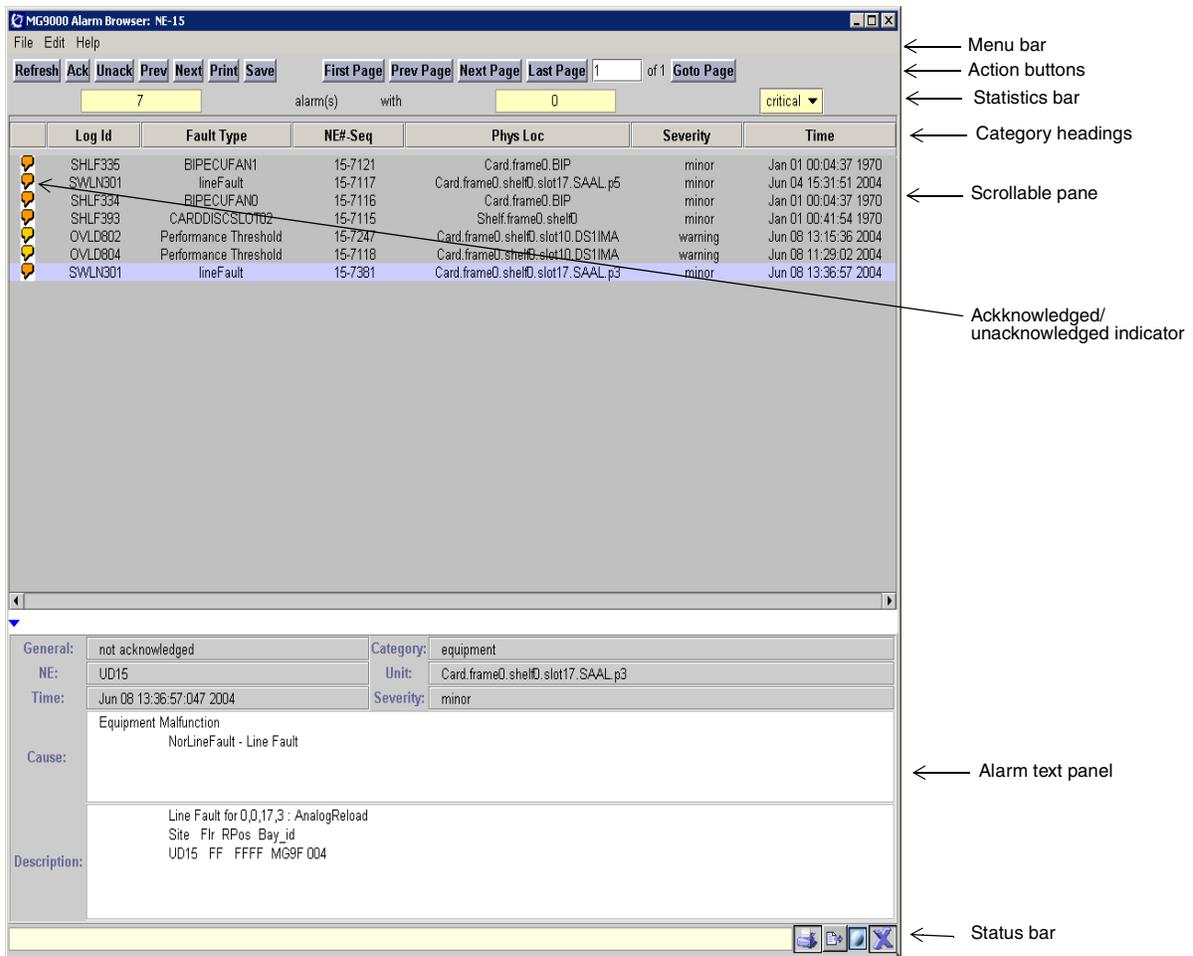
The Alarm Browser screen is used for alarm surveillance. The Alarm Browser screen is accessed from the “Alarm” menu option at the top of all screens. The Alarm Browser consists of multiple sections used to view and manage MG 9000 alarms. Once the alarm browser is open, the browser continues to update as new alarms are added or conditions change.

The following figure shows the Alarm Browser screen.

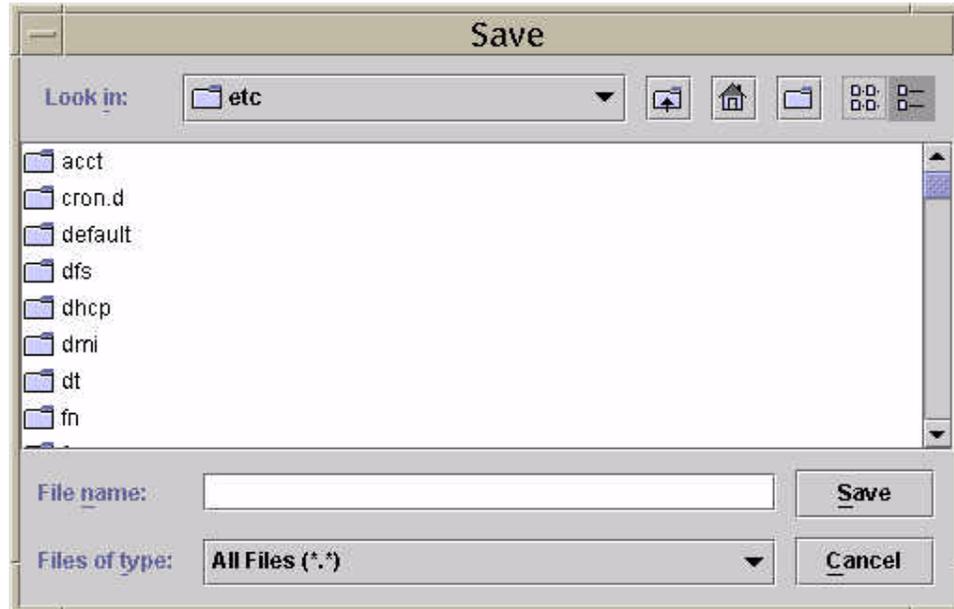
Alarm Browser Save dialog screen

The following figure shows the Save dialog screen.

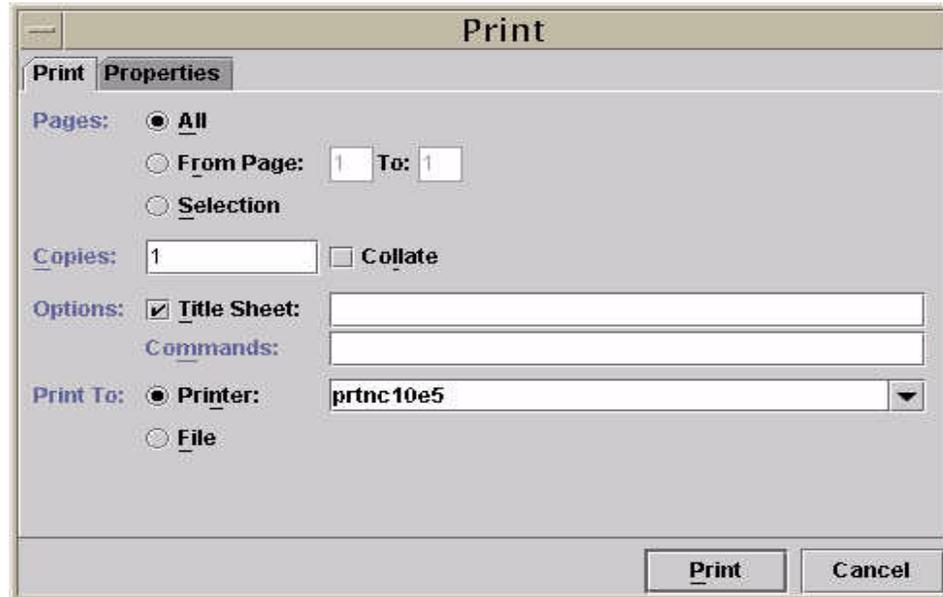
Alarm Browser Print dialog screen

The following figure shows the Print dialog screen.

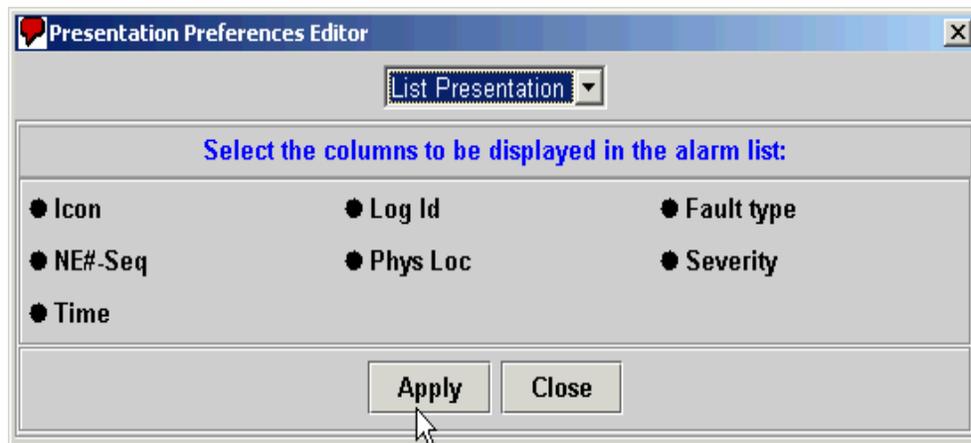
Alarm Browser List Presentation Editor

Click on a radio button next to a category to either select or deselect the category. Click on “Apply” to accept the change.

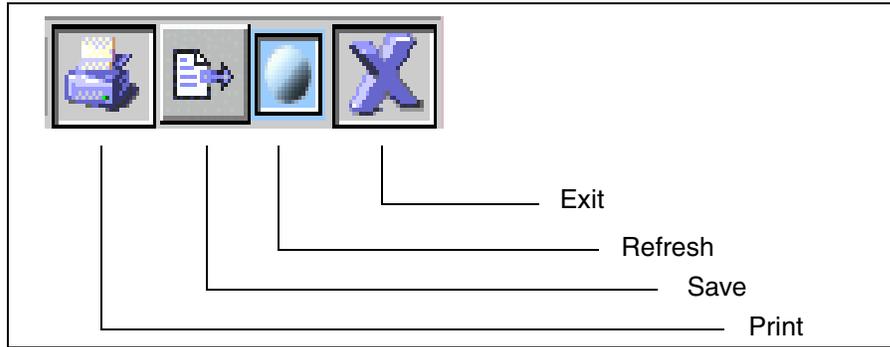
Status Bar icons

The icons on the status bar provide access to some of the features in the File menu. The following figure shows the status bar icons and their functions.

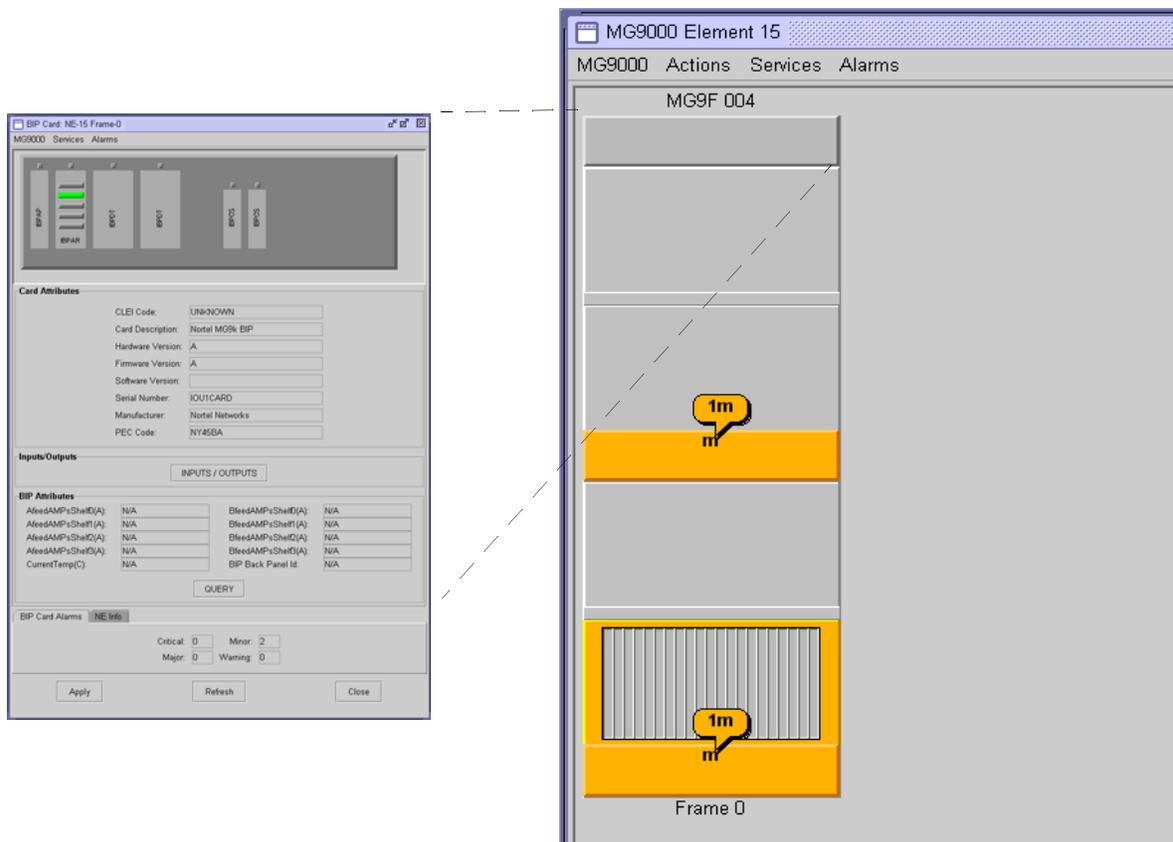
Frame and IBIP card Views

Viewing current frame-level alarms The frame alarm subsystem has a maximum of four links that connect the shelves to the BIP shelf. With these links, the shelves and the BIP shelf perform low-level non-mission critical communication. The BIP shelf receives the fan fail signals and lamp test/alarm cutoff (ACO) signal. The BIP reports the signals to the SIC card.

The following figure shows the Frame View and the IBIP Card View which is accessed by double-clicking on the IBIP within the Frame View.

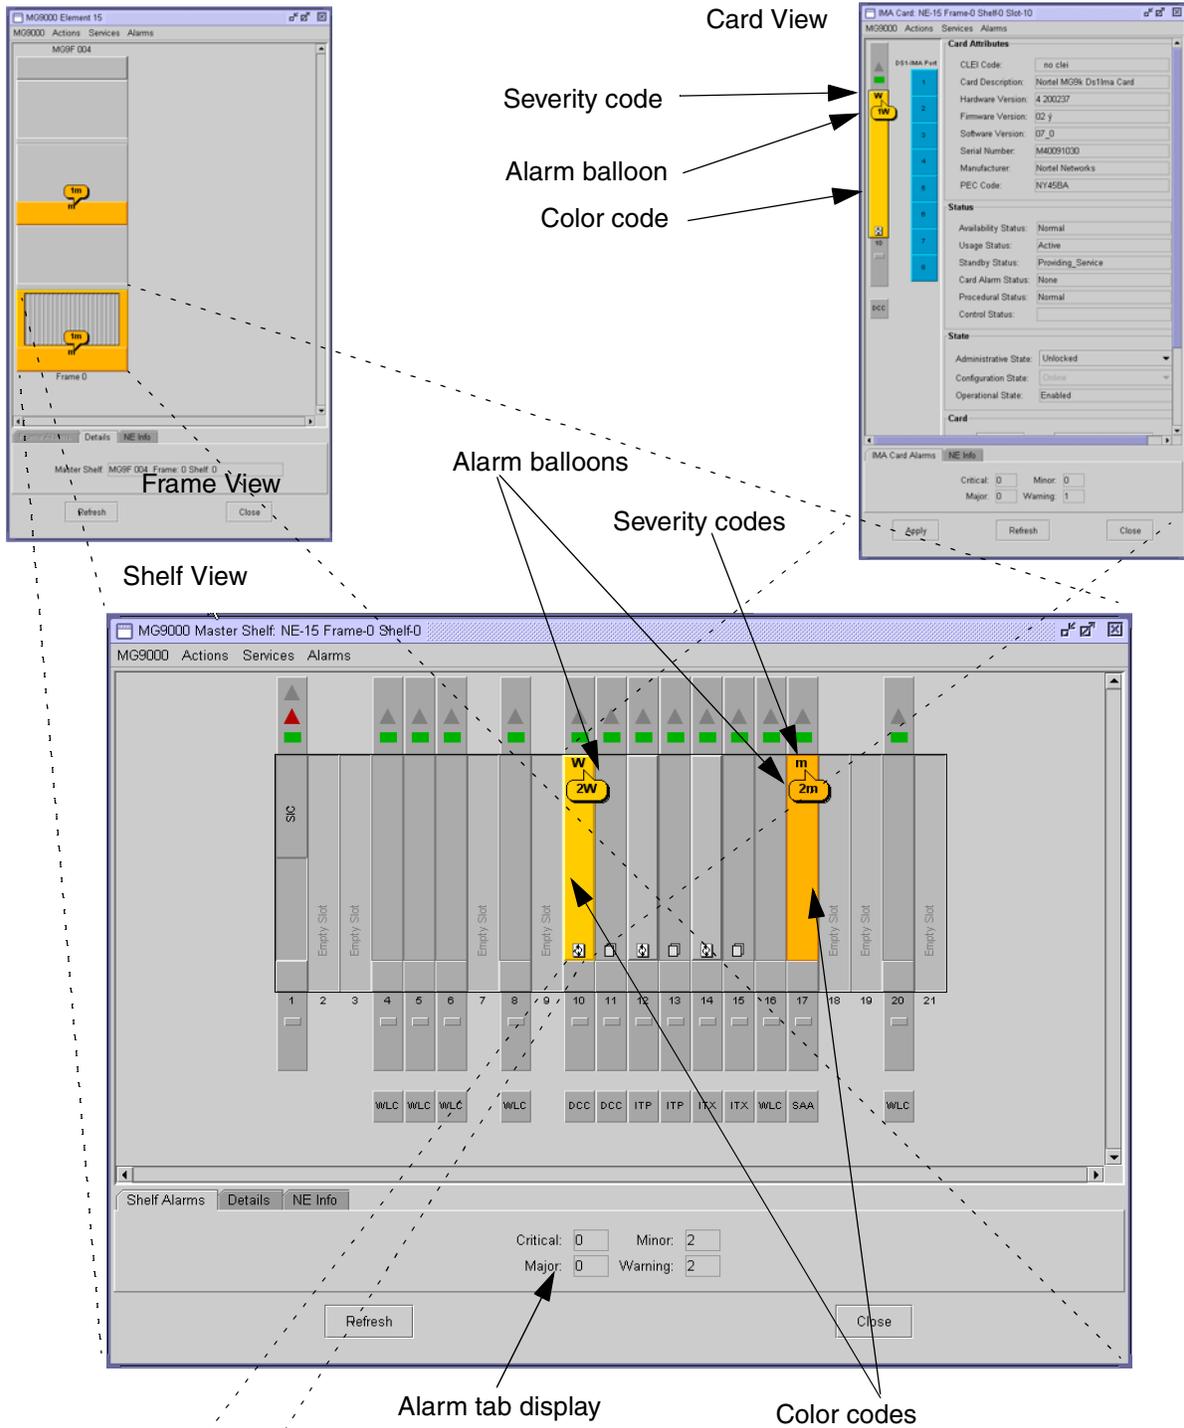
Frame, Shelf, and Card Views showing alarms

Viewing shelf-level alarms The Shelf View which is accessed from the Frame View by double-clicking on the shelf, displays card alarm status through four different methods:

- color code
- alarm balloon
- severity code
- alarm tab

The following figure shows the Shelf View accessed from the Frame View and the shelf level alarms listed previously.

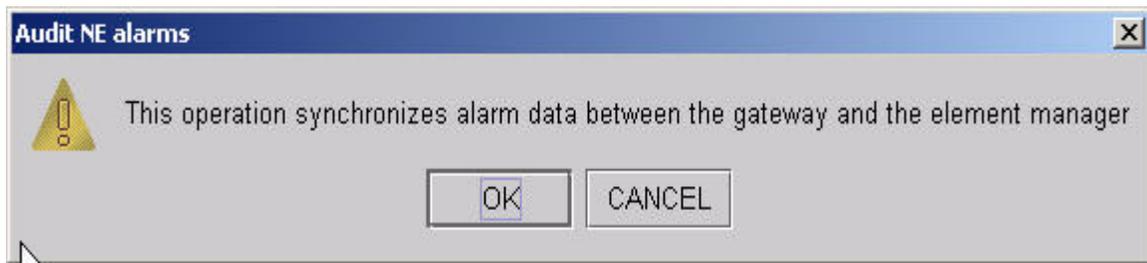
Audit node alarms message

- 3 Click Apply to initiate the Audit Alarms. The following message appears.

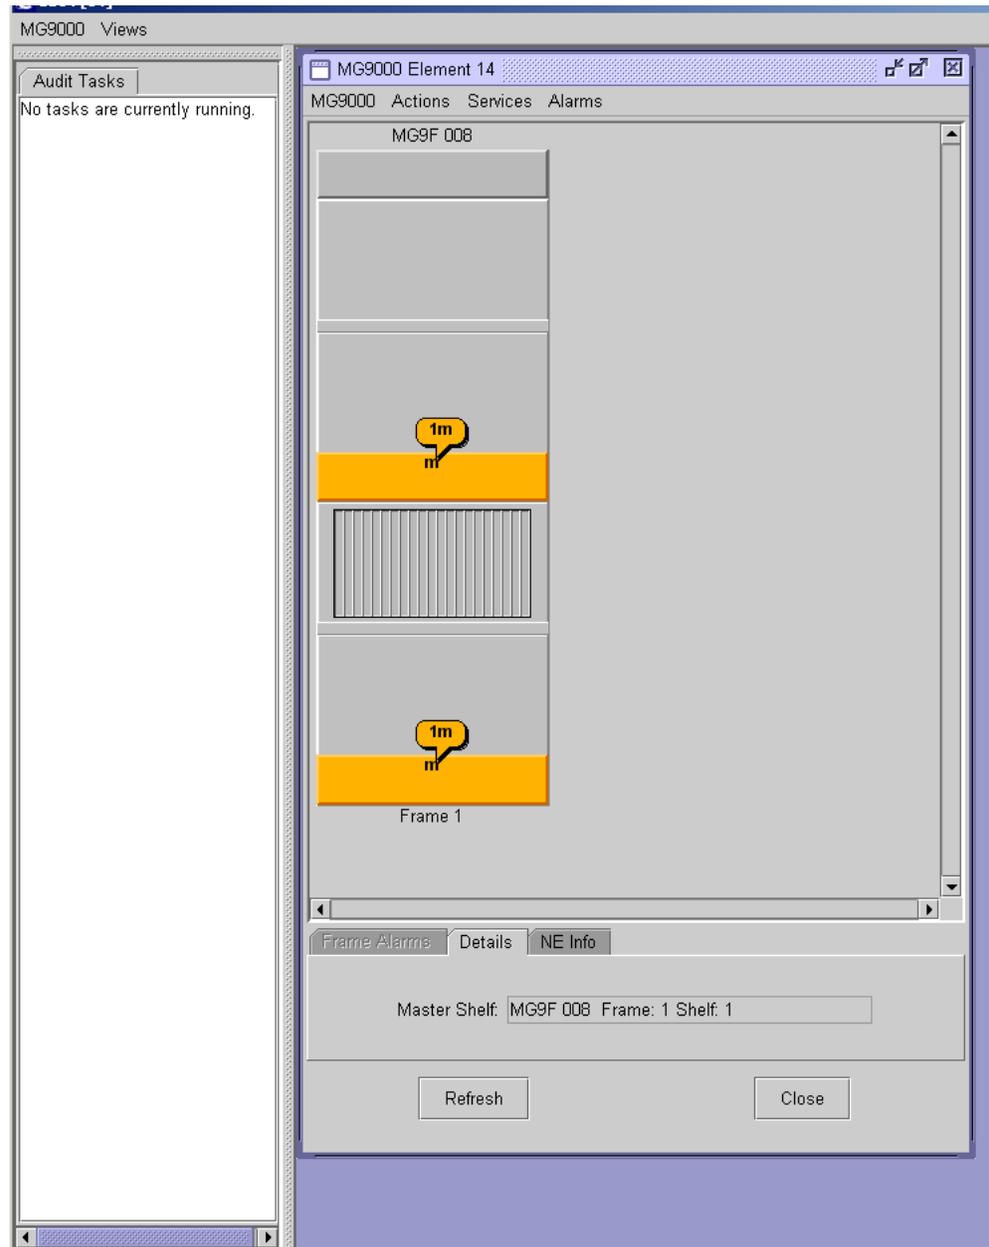
MG 9000 Frame View within the NE desktop view

- 1 At the Subnet View, double-click on the MG 9000 icon in the tree view on the left or on the MG 9000 icon in the MG 9000 Manager view on the right, to select the MG 9000 for which alarm information is to be viewed. The network element (NE) desktop view with the Frame View opens as shown in the following figure.

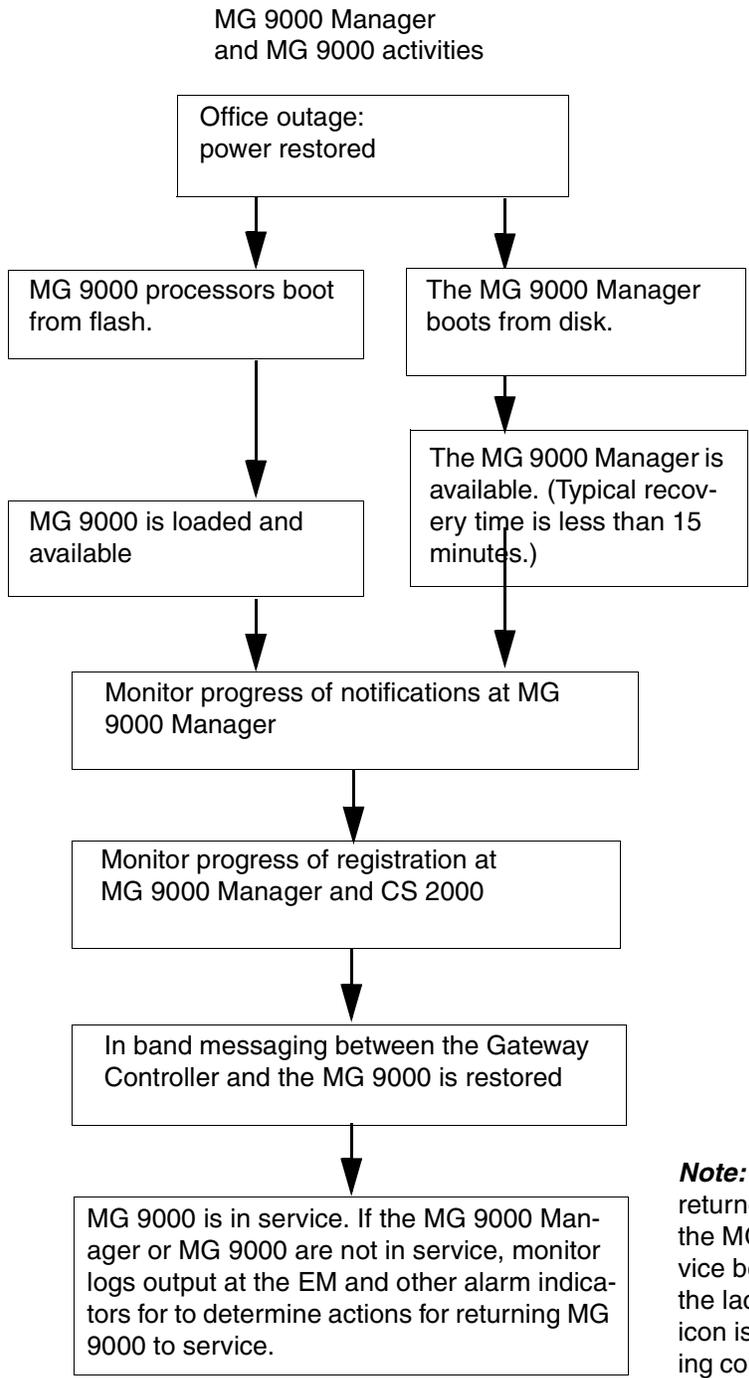
MG 9000 recovery activities

The following flowchart identifies the activities the MG 9000 performs to recover from an outage and the activities operating company personnel observe during recovery.

Activities operating company personnel observe.

Monitor captive office LAN status at Multiservice Switch 8600. Check the individual status of captive office LAN connected equipment at the MG 9000 Manager displays. There will be no communication until the Multiservice Switch 8600s are up.

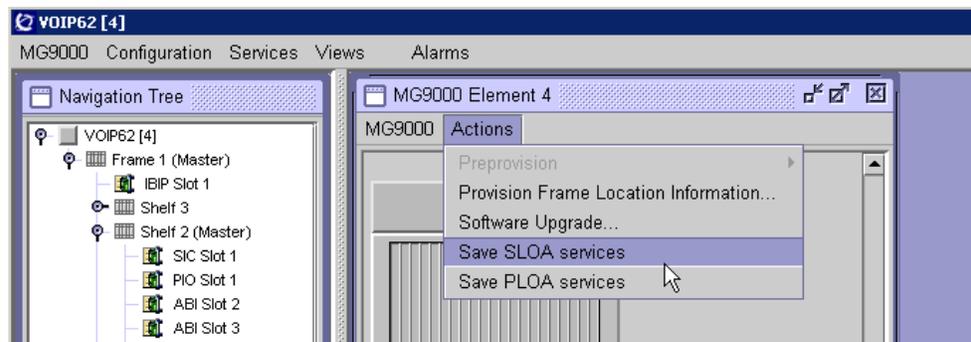
NE desktop view with Frame View

- 1 At the Subnet View of the MG 9000 Manager, double-click on the MG 9000 to be re-commissioned. A warning window indicating that your connection to the gateway is down may appear. This will not block the saving of services information.
- 2 Save a copy of the MG 9000 Manager SLoA provisioning data as follows (this data will be re-entered later):
 - a To Save the SLoA services provisioning data, at the Frame (Element) view, select Actions->Save SLOA services option from the menu bar.

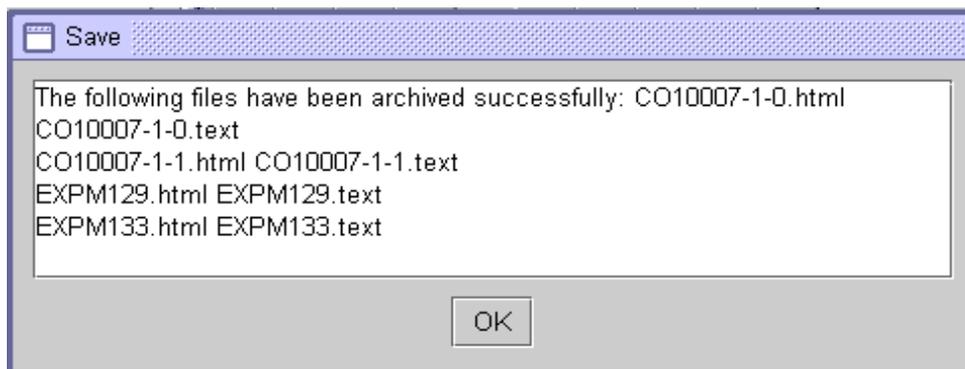
Save acknowledgement message for SLoA

An acknowledgment window appears in response to this request. The acknowledgment window contains the name of the two files (with .html and .text suffixes) where the data was stored on the MG 9000 Manager.

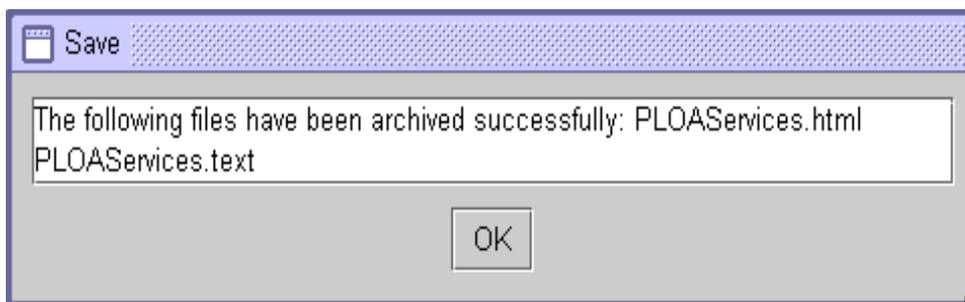
Save acknowledgement message for PLoA

An acknowledgment window appears in response to this request. The acknowledgment window contains the name of the files where your data had been stored on the MG 9000 Manager.
 - b Record the file name provided in the Save acknowledgement window for later use.

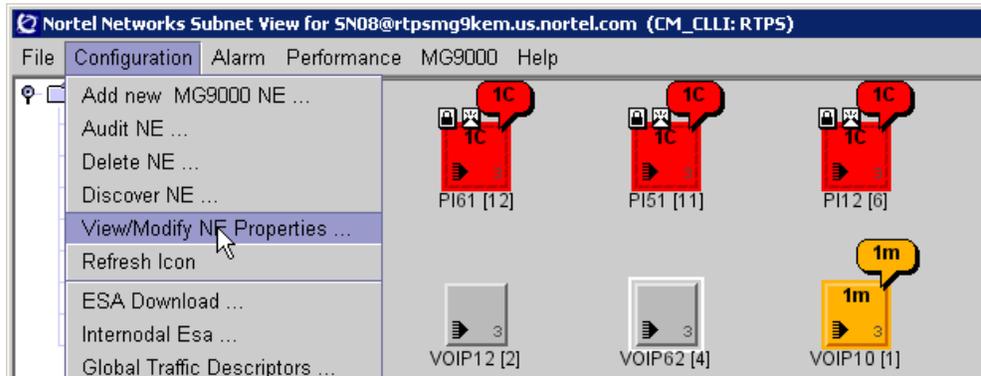
Subnet View accessing Configuration ->View/Modify NE Properties

- 4 Obtain the IP address of the MG 9000 Manager server (not the mid-tier or client). At the Subnet View, select Configuration->View/Modify NE Properties from the menu bar.

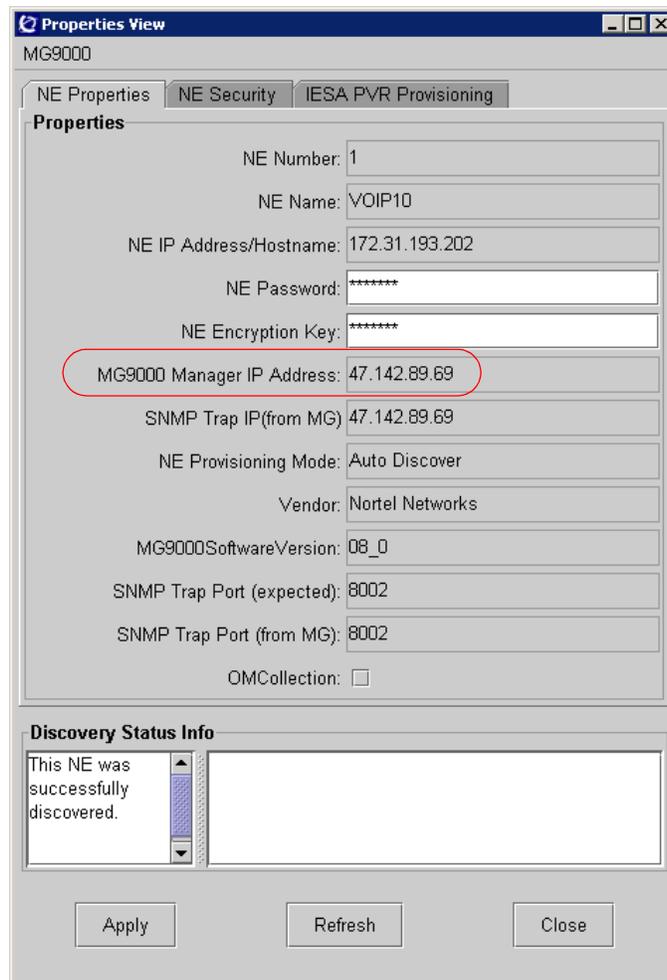
Properties View

- 5 Record the IP address in the MG 9000 Manager IP Address field.

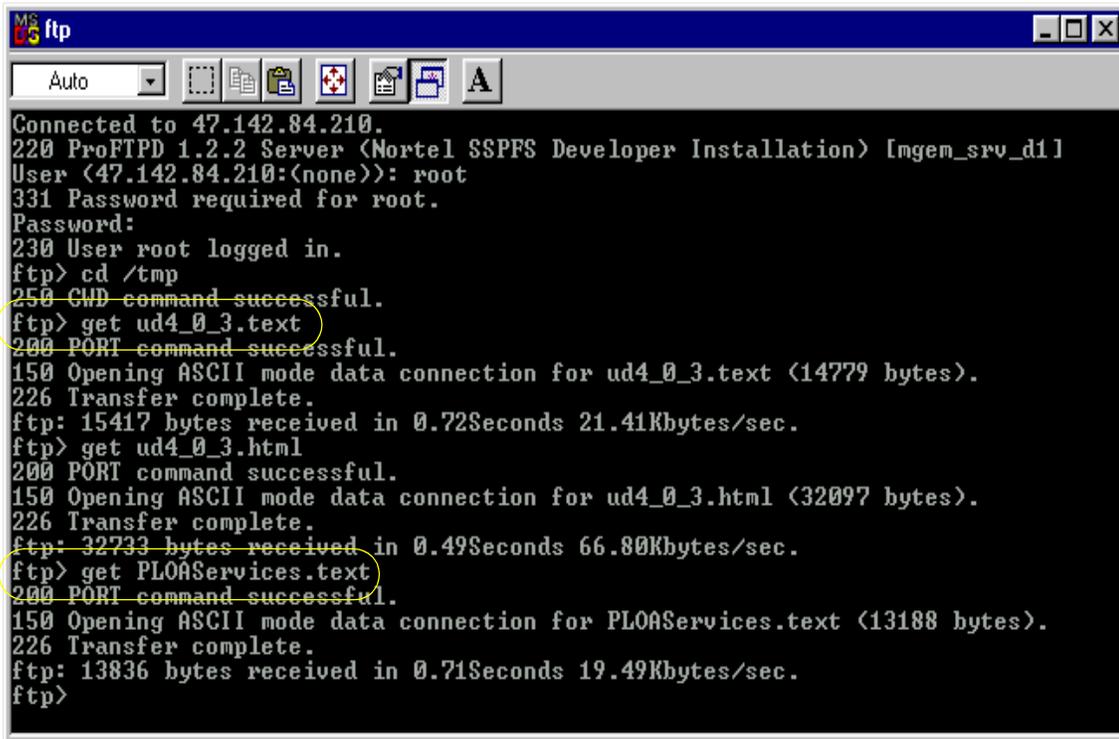
FTP files to secure location

- 6 FTP to the address recorded in step 5 and copy the files in the /tmp directory to a secure location, such as your desktop or permanent server before proceeding.

```
MS ftp
Auto
Connected to 47.142.84.210.
220 ProFTPD 1.2.2 Server (Nortel SSPFS Developer Installation) [mgem_srv_d1]
User (47.142.84.210:(none)): root
331 Password required for root.
Password:
230 User root logged in.
ftp> cd /tmp
250 CWD command successful.
ftp> get ud4_0_3.text
200 PORT command successful.
150 Opening ASCII mode data connection for ud4_0_3.text (14779 bytes).
226 Transfer complete.
ftp: 15417 bytes received in 0.72Seconds 21.41Kbytes/sec.
ftp> get ud4_0_3.html
200 PORT command successful.
150 Opening ASCII mode data connection for ud4_0_3.html (32097 bytes).
226 Transfer complete.
ftp: 32733 bytes received in 0.49Seconds 66.80Kbytes/sec.
ftp> get PLOAServices.text
200 PORT command successful.
150 Opening ASCII mode data connection for PLOAServices.text (13188 bytes).
226 Transfer complete.
ftp: 13836 bytes received in 0.71Seconds 19.49Kbytes/sec.
ftp>
```

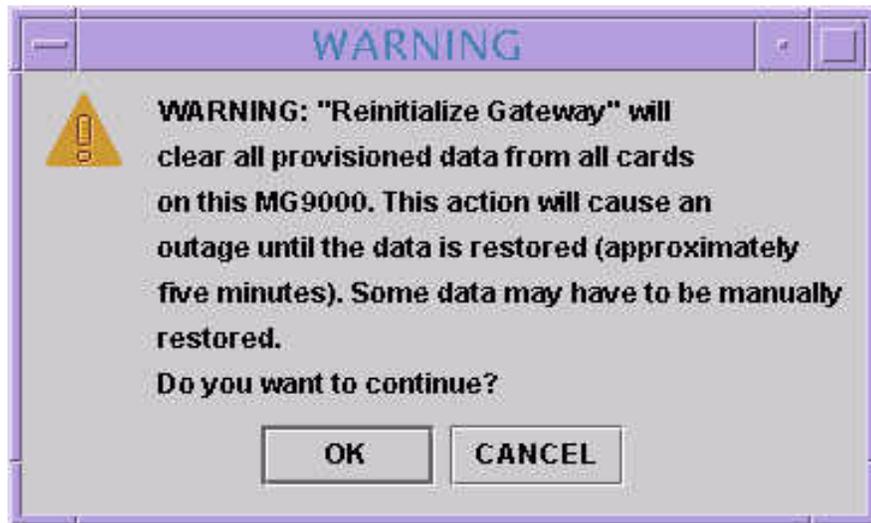
Warning message in response to Reinitialize Gateway

- e After setting the configuration state to “Reinitialize gateway”, a warning message appears requesting a reply before continuing. Select OK.

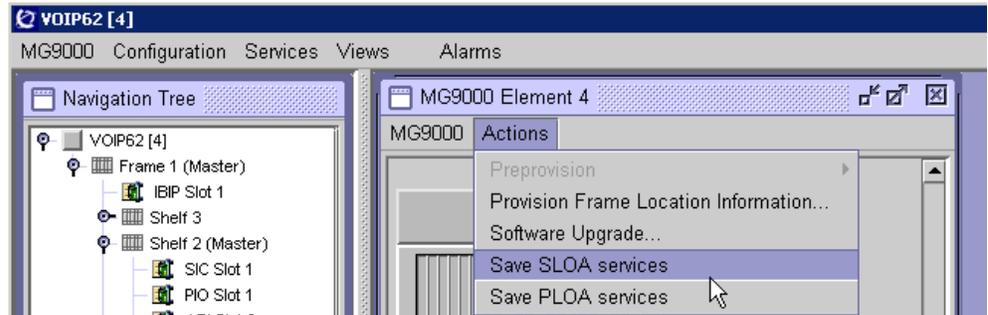
NE desktop view with Frame View

- 1 At the Subnet View of the MG 9000 Manager, select the MG 9000 to be re-commissioned. A warning window indicating that your connection to the gateway is down may appear. This will not block the saving of services information.
- 2 Save a copy of the MG 9000 Manager SLoA provisioning data as follows (you'll be re-entering this data later):
 - a To Save the SLoA services provisioning data, at the Frame (Element) view, select the "Save SLOA services" option from the Actions menu.

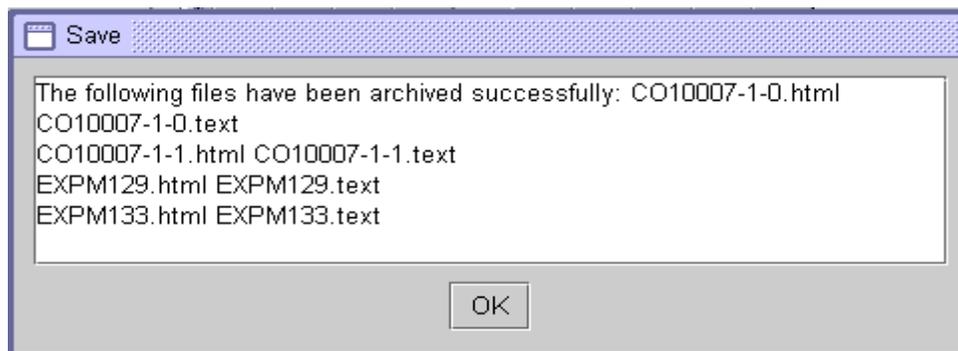
Save acknowledgement message for SLoA

An acknowledgment window appears in response to this request. The acknowledgment window contains the name of the two files (with .html and .text suffixes) where your data had been stored on the MG 9000 Manager.

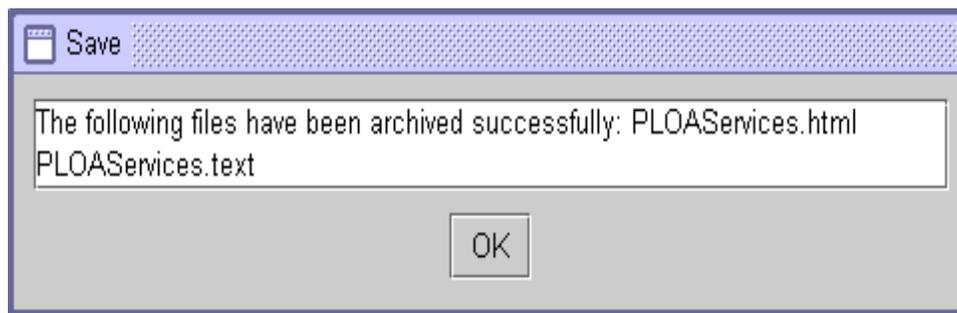
Save acknowledgement message for PLoA

An acknowledgment window appears in response to this request. The acknowledgment window contains the name of the files where your data had been stored on the MG 9000 Manager.
 - b Record the file name provided in the Save acknowledgement window for later use.

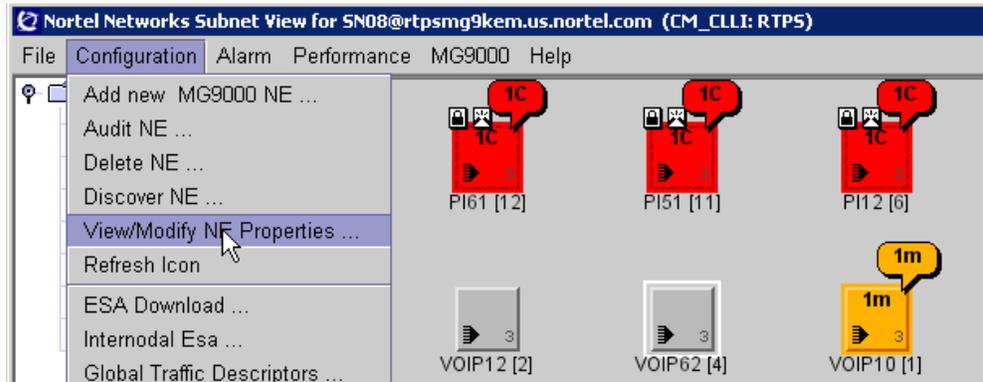
Subnet View accessing Configuration ->View/Modify NE Properties

- 4 Obtain the IP address of the MG 9000 Manager server (not the mid-tier or client). At the Subnet View, select Configuration->View/Modify NE Properties from the menu bar.

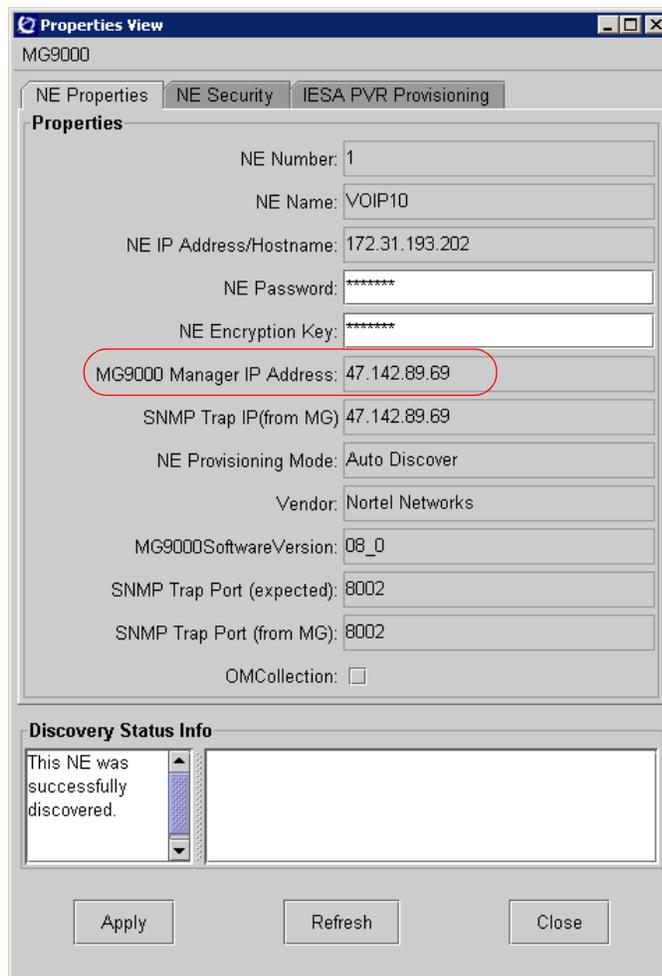
Properties View

- 5 Record the IP address in the MG 9000 Manager IP Address field.

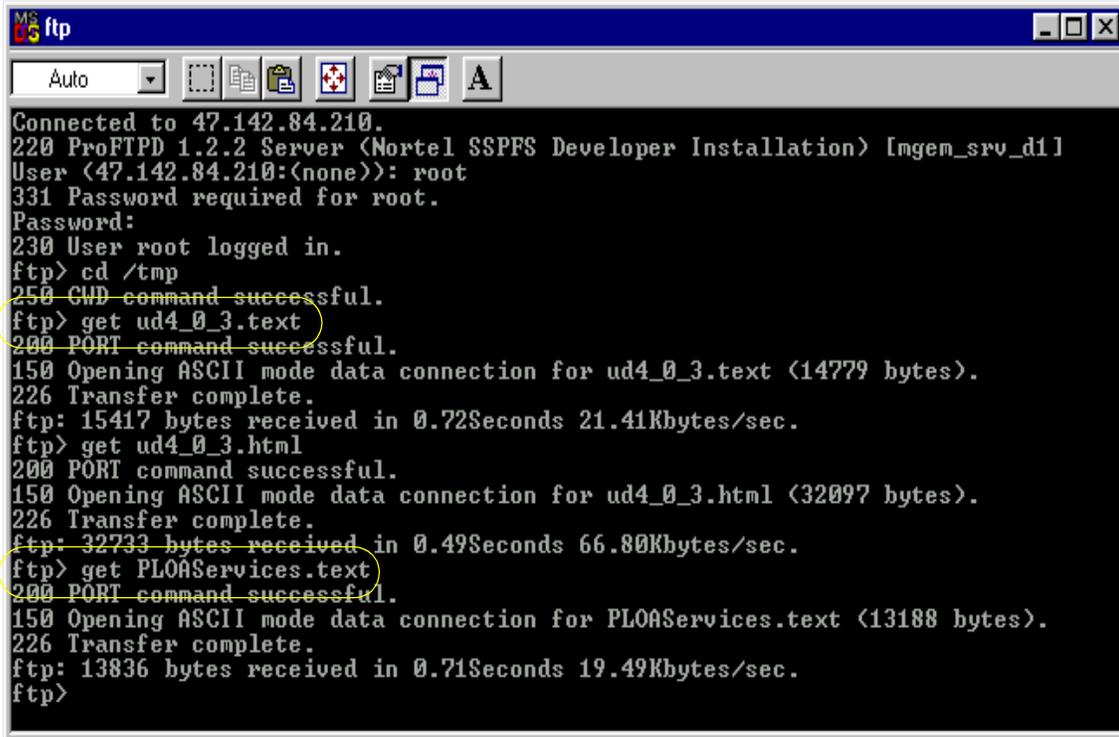
FTP files to secure location

- 6 FTP to the address recorded in step 5 and copy the files in the /tmp directory to a secure location, such as your desktop or permanent server before proceeding.

```
MS-DOS ftp
Auto
Connected to 47.142.84.210.
220 ProFTPD 1.2.2 Server (Nortel SSPFS Developer Installation) [mgem_srv_d1]
User (47.142.84.210:(none)): root
331 Password required for root.
Password:
230 User root logged in.
ftp> cd /tmp
250 CWD command successful.
ftp> get ud4_0_3.text
200 PORT command successful.
150 Opening ASCII mode data connection for ud4_0_3.text (14779 bytes).
226 Transfer complete.
ftp: 15417 bytes received in 0.72Seconds 21.41Kbytes/sec.
ftp> get ud4_0_3.html
200 PORT command successful.
150 Opening ASCII mode data connection for ud4_0_3.html (32097 bytes).
226 Transfer complete.
ftp: 32733 bytes received in 0.49Seconds 66.80Kbytes/sec.
ftp> get PLOAServices.text
200 PORT command successful.
150 Opening ASCII mode data connection for PLOAServices.text (13188 bytes).
226 Transfer complete.
ftp: 13836 bytes received in 0.71Seconds 19.49Kbytes/sec.
ftp>
```

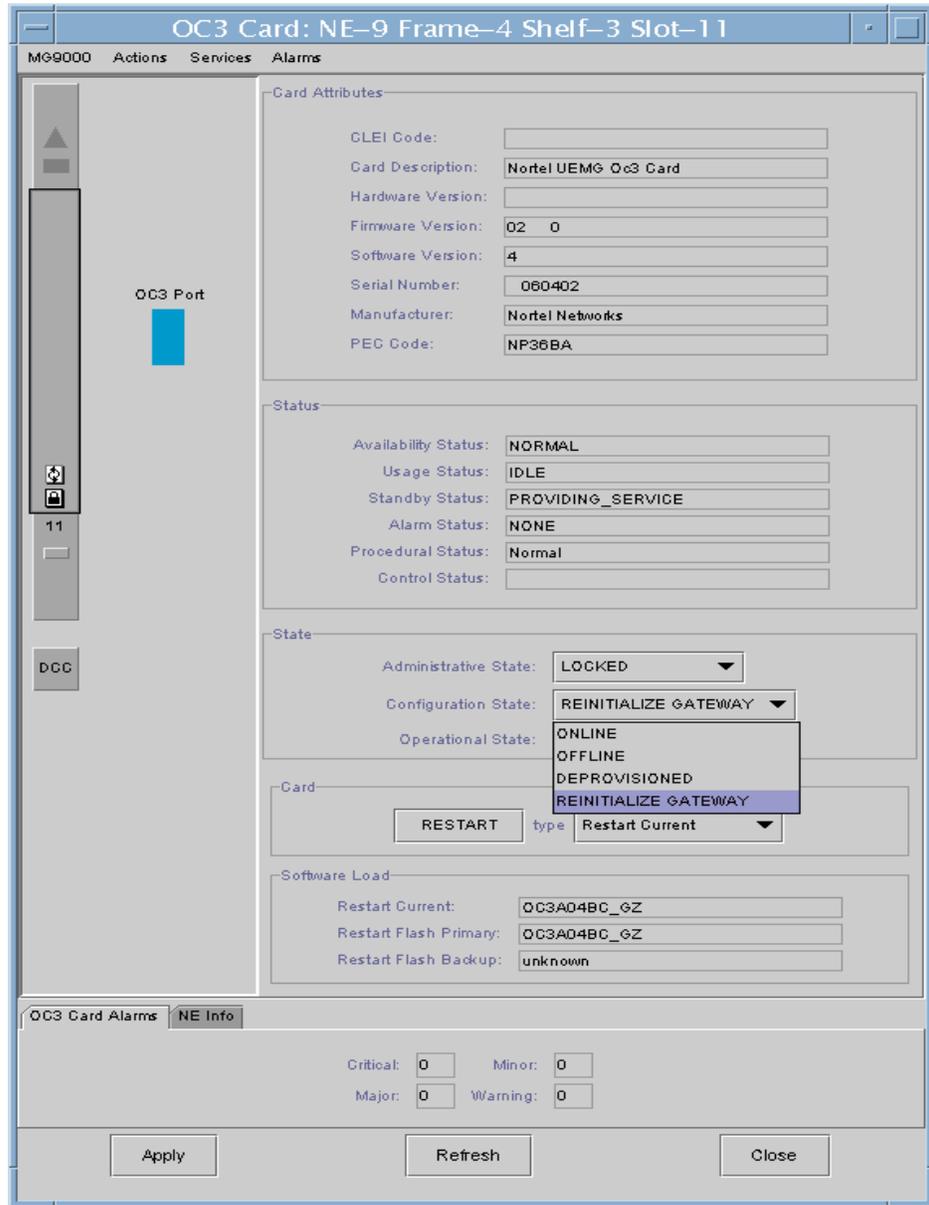
OC-3 Card View

- 2 From the Frame View, double click on the master shelf. The Shelf View appears.
- 3 From the Shelf View, double click on the inactive OC-3/DS1 IMA/GigE card. The OC-3/DS1 IMA/GigE Card View appears.
- 4 Set the Administrative State of the Inactive OC-3/DS1 IMA/GigE card to Forced Locked and respond to the message.
- 5 From the Shelf View, double click on the active OC-3/DS1 IMA/GigE card. The OC-3/DS1 IMA/GigE Card View appears.
- 6 Set the Administrative State of the active OC-3/DS1 IMA/GigE card to Forced Locked and respond to the message.
- 7 In the OC-3/DS1 IMA/GigE Card View, from the Configuration State pull-down menu, select Reinitialize Gateway as shown in the following figure.

- DCC (when the Reinitialize command is run on the DCC cards, the entire MG 9000 is reinitialized, as noted by the naming of the command Reinitialize Gateway as seen at the OC-3/DS1-IMA/GigE Card View)

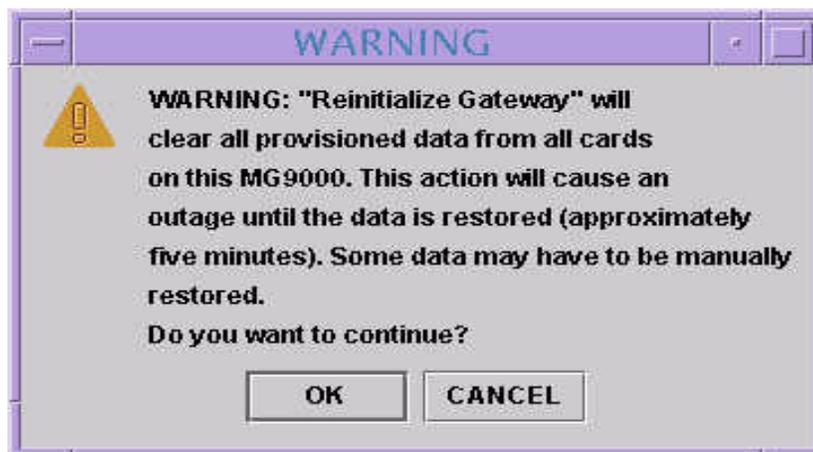
Warning message in response to Reinitialize Gateway command

8 The system responds with the following warning message.

- 9 To continue, click OK and proceed to step [10](#). Otherwise click Cancel and go to step [11](#).
- 10 The MG 9000 responds with a Card State Change trap indicating that the configuration state is set to reinitialize and that the MG 9000 will clear persistence and restart. At the Subnet View, a “bomb” is displayed on the network element icon. After a period of time, the Subnet View is updated to show the up arrow indicating discovery and audit. When the operation is complete, the NE icon will be free of these added indicators. The following figure shows the NE is in discovery.
