MG 9000 Fault Management

Fault management strategy

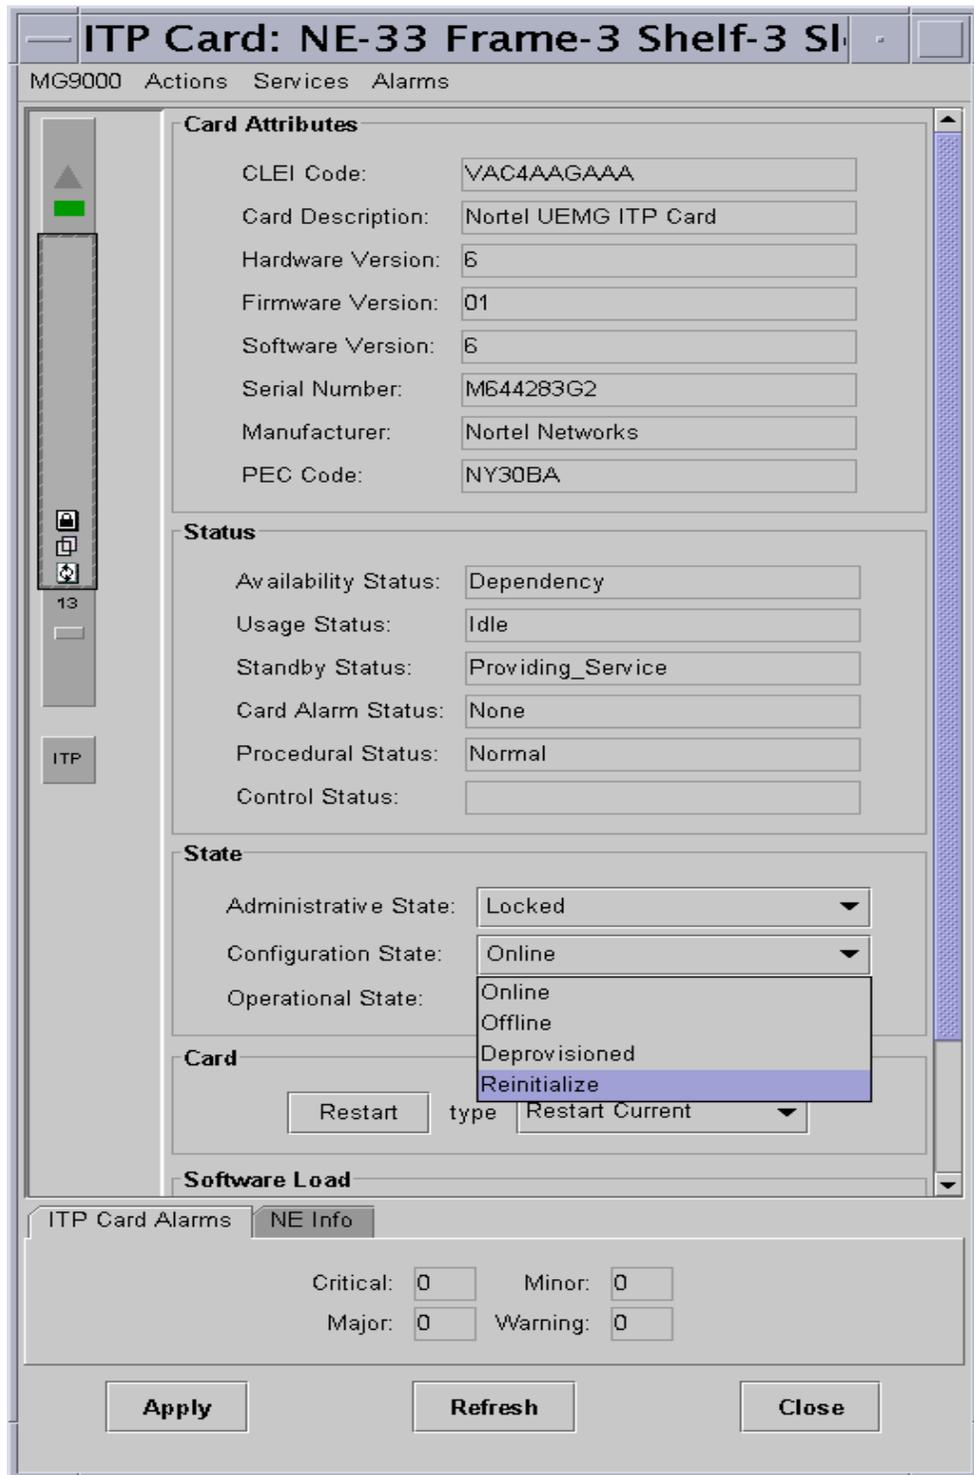
Card View Reinitialize command

In the State pane, set the Configuration State to Reinitialize. The following figure shows the location of the Reinitialize command.

The Reinitialize command is very disruptive to service. Use the Reinitialize command as a last resort when all other attempts have failed, including running the Audit NE command available from the Configuration menu of the Subnet View. The Reinitialize command may interrupt call processing depending on the intelligent card chosen for reinitializing.

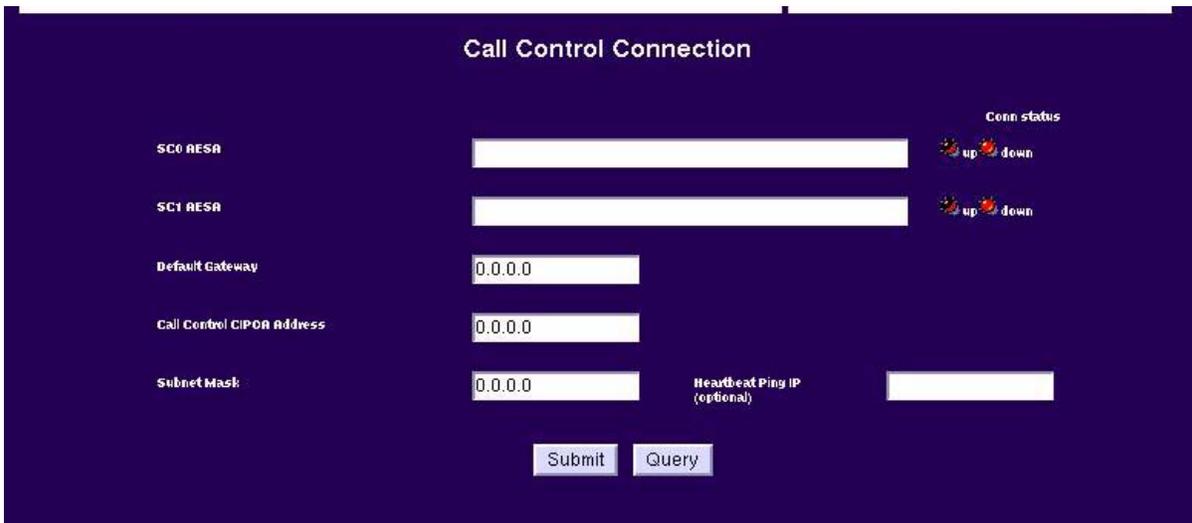
LCI screen showing Call Control Connection for Voice over AAL1

If the MG 9000 connection being provisioned is in a	Do
Voice over AAL1 solution	step 6
Voice over IP solution	step 8
Voice over IP solution with GigE	step 9
- 6 Click on the Connections button and select Call Control Connection from the Menu options. The Call Control Connection LCI screen appears.

- a Enter or change the Primary AESA to SC0 and/or Secondary AESA to SC1 address.
- b Enter the 'Call Control CIPOA Address'.

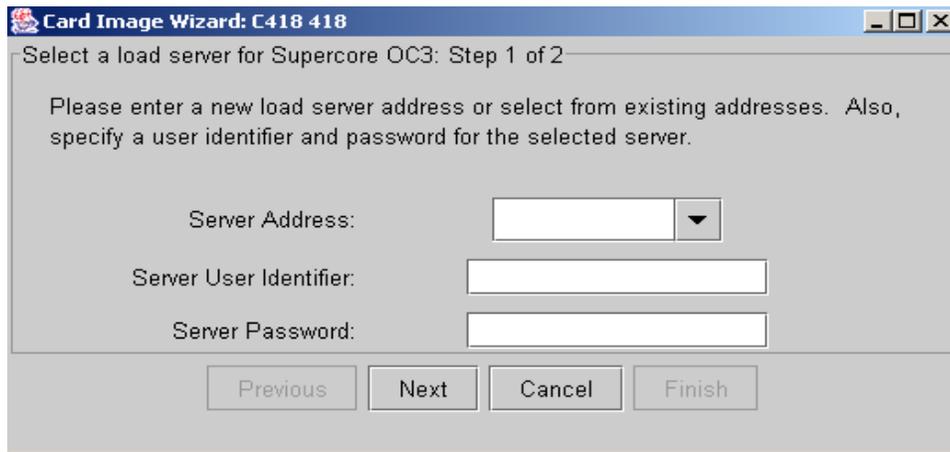
Card Image Wizard, Select a load server: Step 1 of 2

- 6 Click on the Image button to begin the software image of the selected card using the default values provided in the Image Type Data pane.
Go to step [9](#)
- 7 Click on the Configure button. The Card Image Wizard Select a load server: Step 1 of 2 appears as shown in the following figure.

From this wizard, the default server IP address, the server user identifier, and the server password can be changed. After all changes are made click Next. The Card Image Wizard Specify a directory: Step 2 of 2 appears as shown in the following figure.

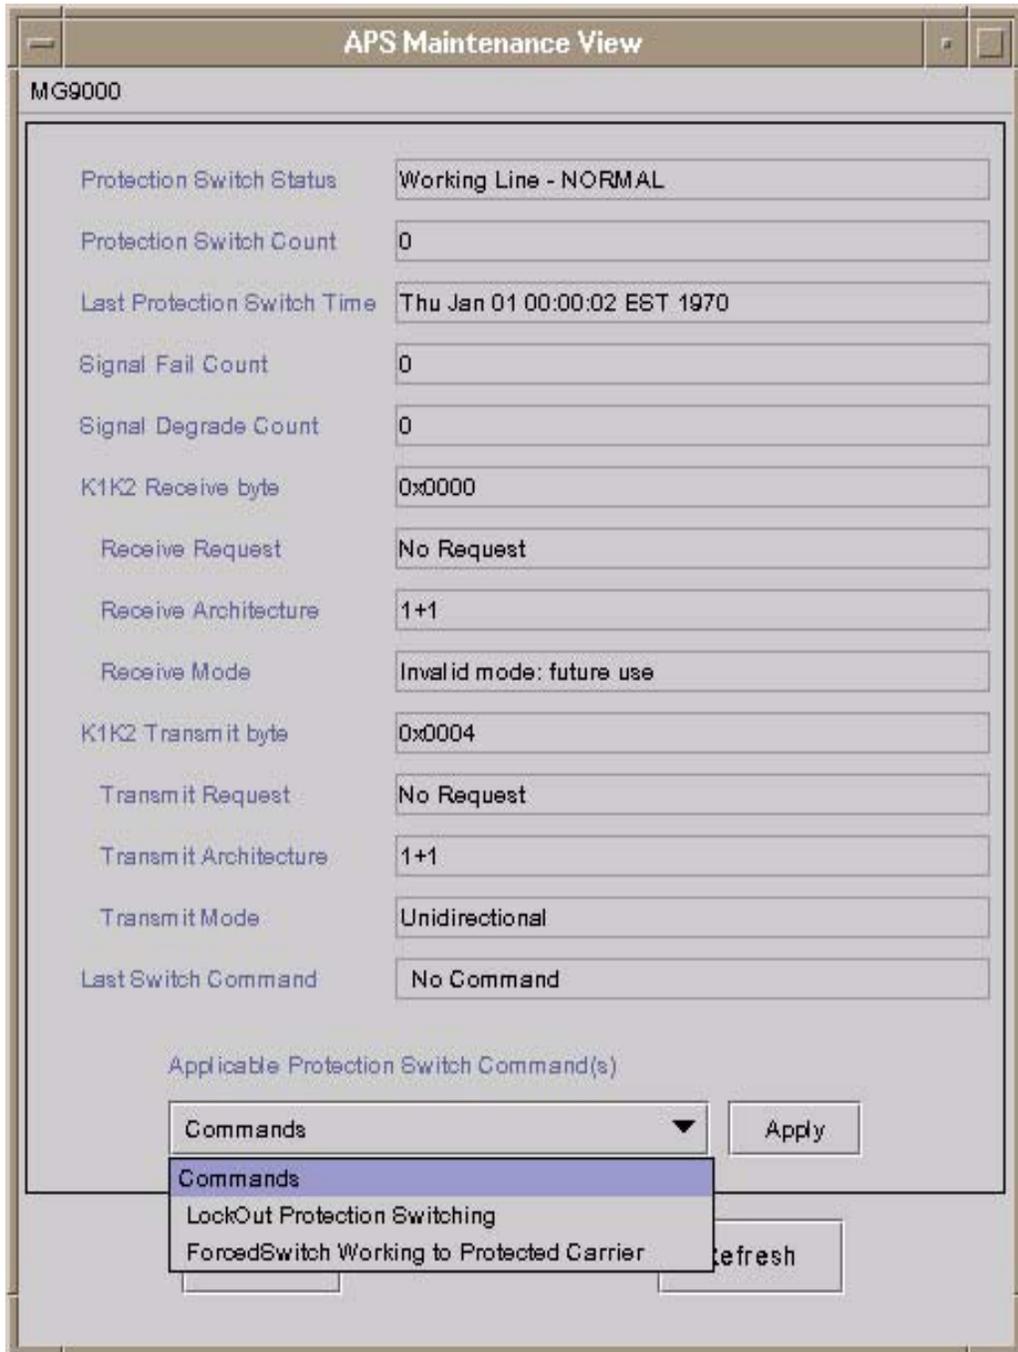
APS Maintenance View with protection switch commands shown

The Protection Switch Commands may only be exercised from the APS Maintenance View launched from the OC-3 port on the active OC-3 card. The APS Maintenance View is shown next.

- 6 Set the OC-3 to the desired state using the Commands pull-down and select Apply.

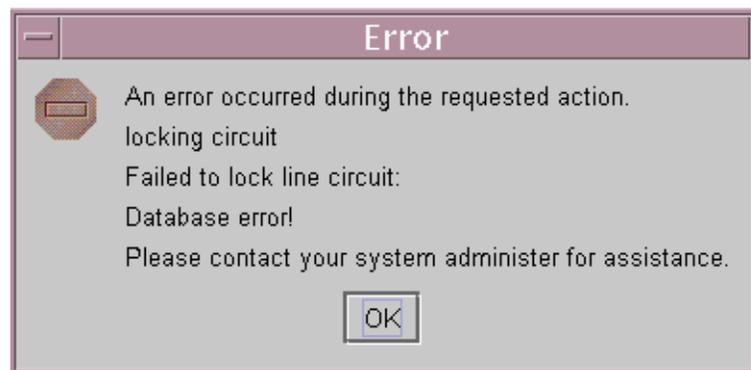
Some data is persisted in the database. If a database error is encountered during MG 9000 Manager actions, an error is displayed to inform the user that the operation has failed due to a database error. Follow the instructions in the message. The following is an example of such an error message.

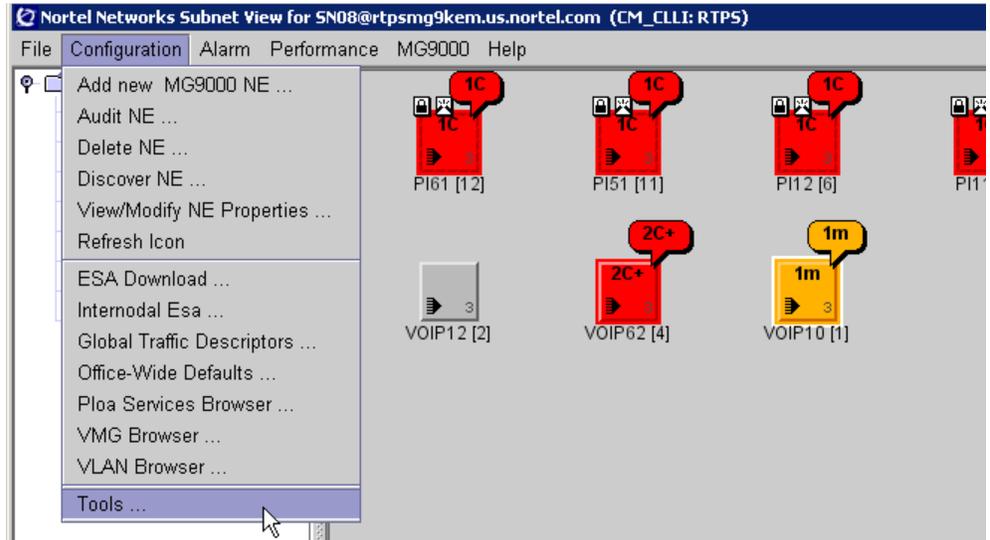
Subnet View showing the Configuration menu

- 1 At the Subnet View, from the Configuration Menu, select Tools...as shown in the following figure.

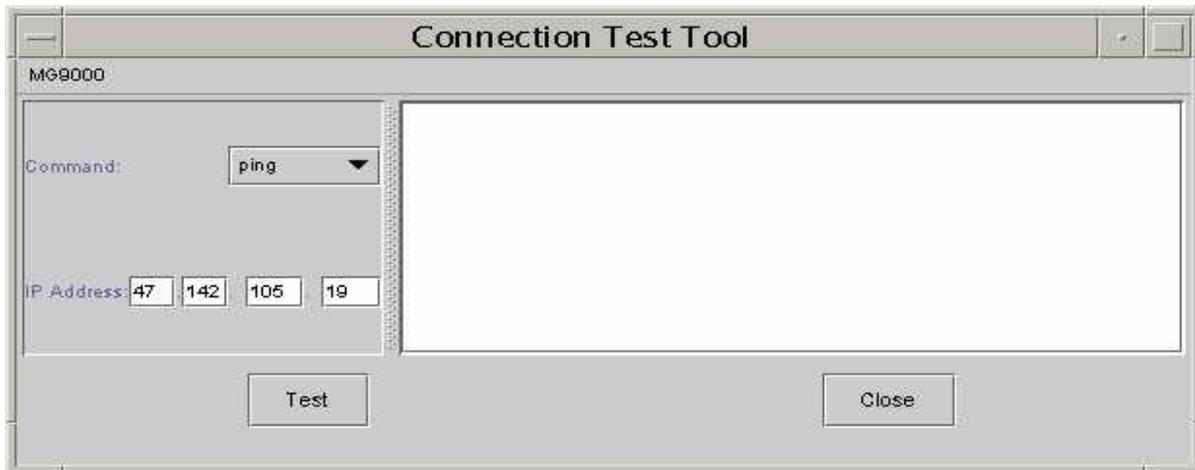
- 2 Select the command to be performed from the pull-down menu. The following figure shows the Connection Test Tool View and the Command pull-down menu.

- 3 Enter the IP address in the IP Address field.
- Note:** The MG 9000 cannot be pinged until the MG 9000 has been commissioned with a cold start received by the MG 9000 Manager.
- 4 Click on Test to run the test tool. The results are displayed in the text area on the right.
- 5 This procedure is complete.

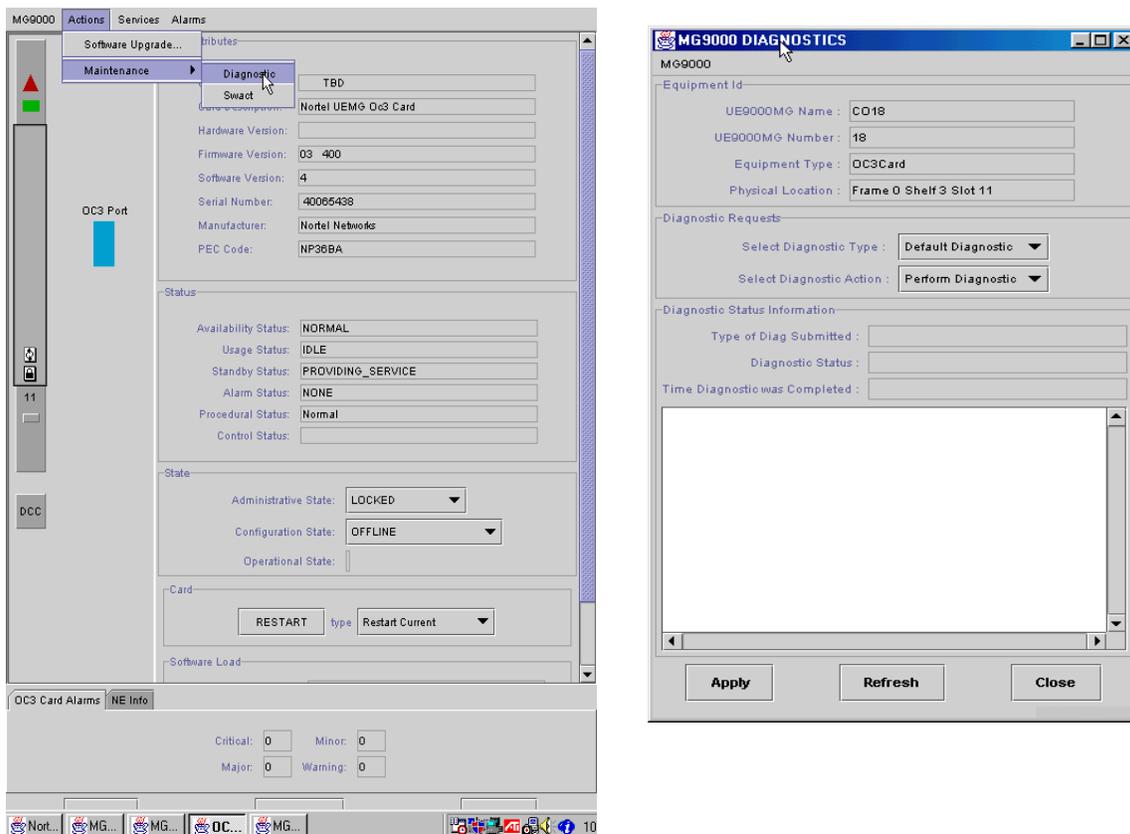
Card View and MG 9000 Diagnostic View

- 1 At the Subnet View, select the MG 9000 on which diagnostics are to be performed. The Frame View appears.
- 2 Double click on the shelf to open the Shelf View.
- 3 Double click on the card on which diagnostics are to be run. The Card View appears.
- 4 Verify that the administrative state of the card is set to unlocked. To Unlock the card, perform the [Unlocking a card](#) procedure.
- 5 From the menu bar on the top left of the Card View, select Actions->Maintenance->Diagnostic as shown in the following figure. The following MG 9000 Diagnostics View appears.

- 6 Select the Default Diagnostic in the Select Diagnostic Type field.

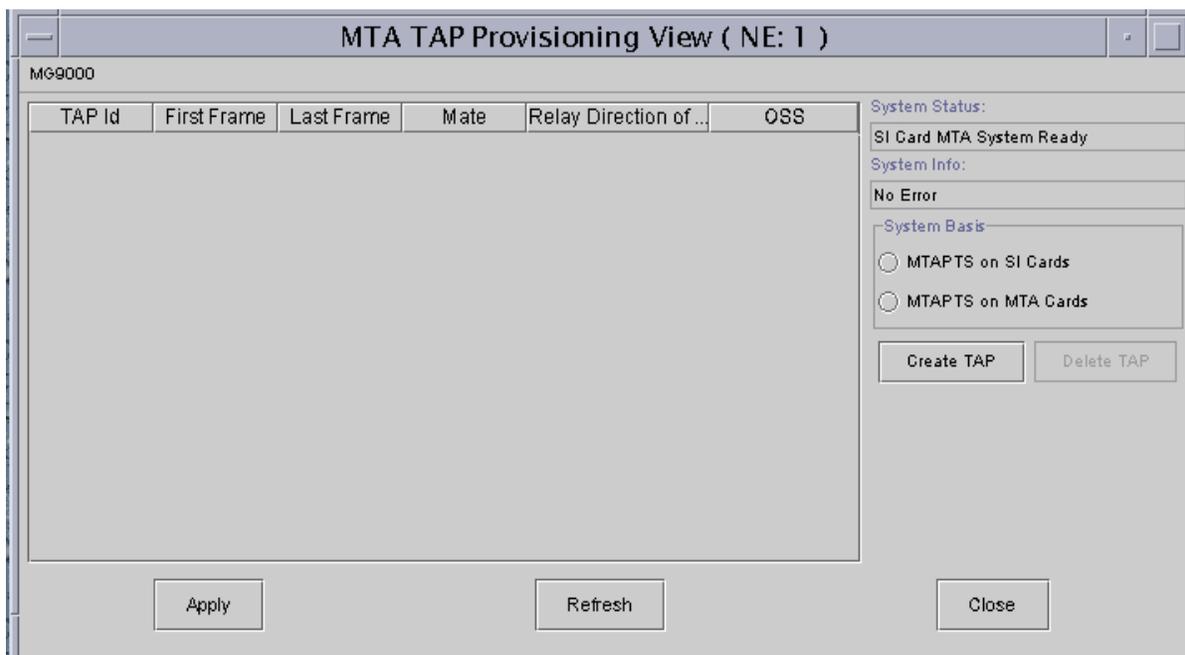
MTA TAP Provisioning View Screen

The following figure shows the MTA TAP Provisioning View screen.

Field	Explanation
TAP Id	The test access point (TAP).
FirstFrame	The first frame which indicates the beginning of the range of frames for a particular TAP.
LastFrame	The last frame which indicates the end of the range of frames for a particular TAP.
Mate	If the TAP can be used to make up a 4-wire pair, this field contains the mate TAP.

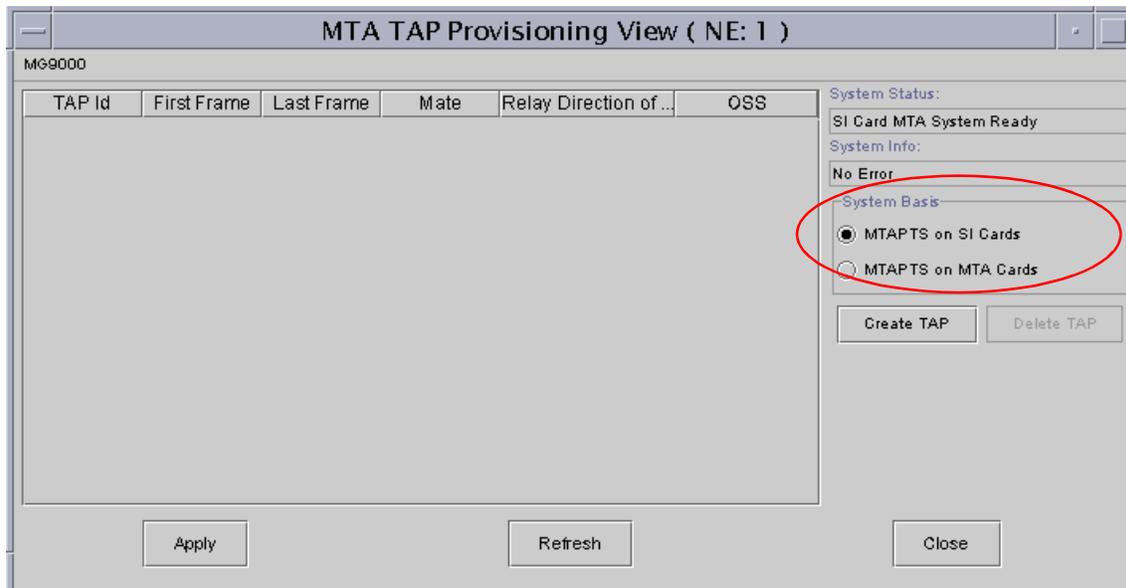
MTA TAP Provisioning View

configuration, meaning an MTA card is provisioned in the MG 9000. If an attempt is made to select MTAPTS on MTA cards and no MTA card is provisioned in the MG 9000, the system responds with a No Support error informing the user that the system does not support MTA card configuration.

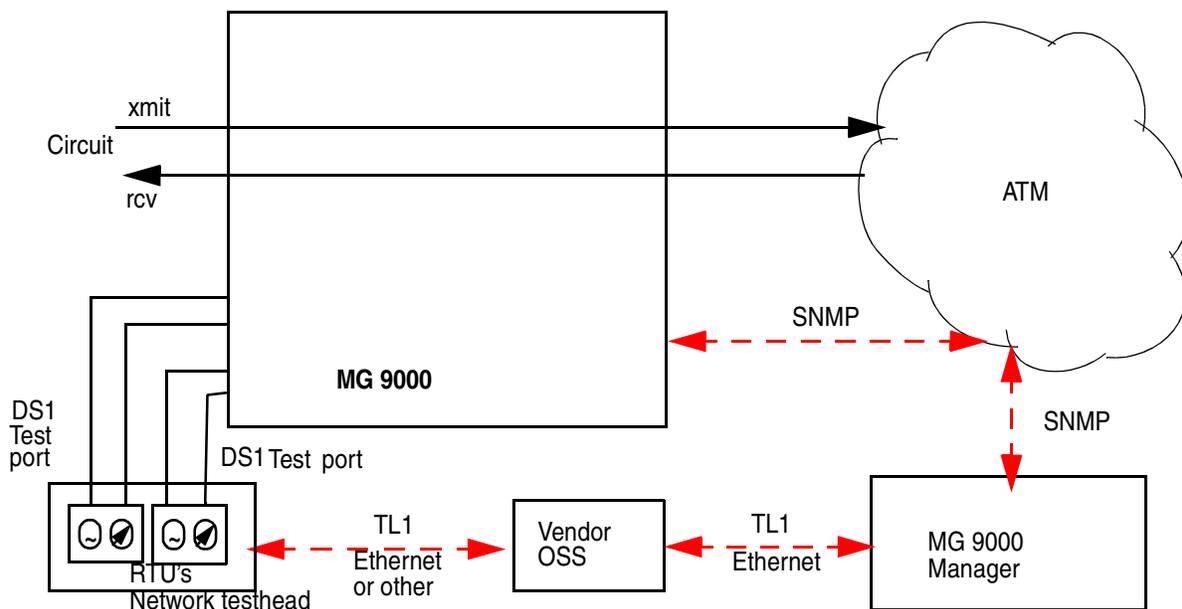
MG 9000 DTA testing

The following figure shows the MG 9000 digital test access using an RTU.

To provide connectivity between the RTU and the MG 9000, DS1 ports on the MG 9000 must be defined as DFADs and/or TADs, and those ports must be connected to the associated ports on the RTU. Provisioning of the DFADs and TADs occur at the SNM.

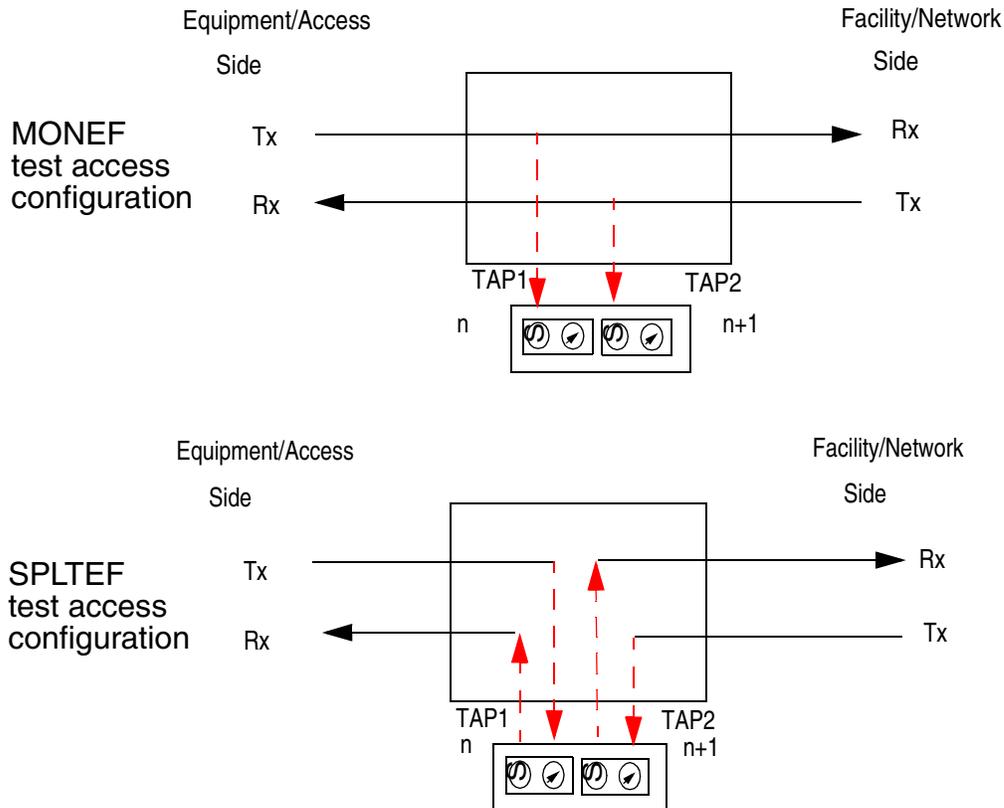
DFAD MONEF and SPLTEF test access modes

The following figure shows the two DFAD test access modes

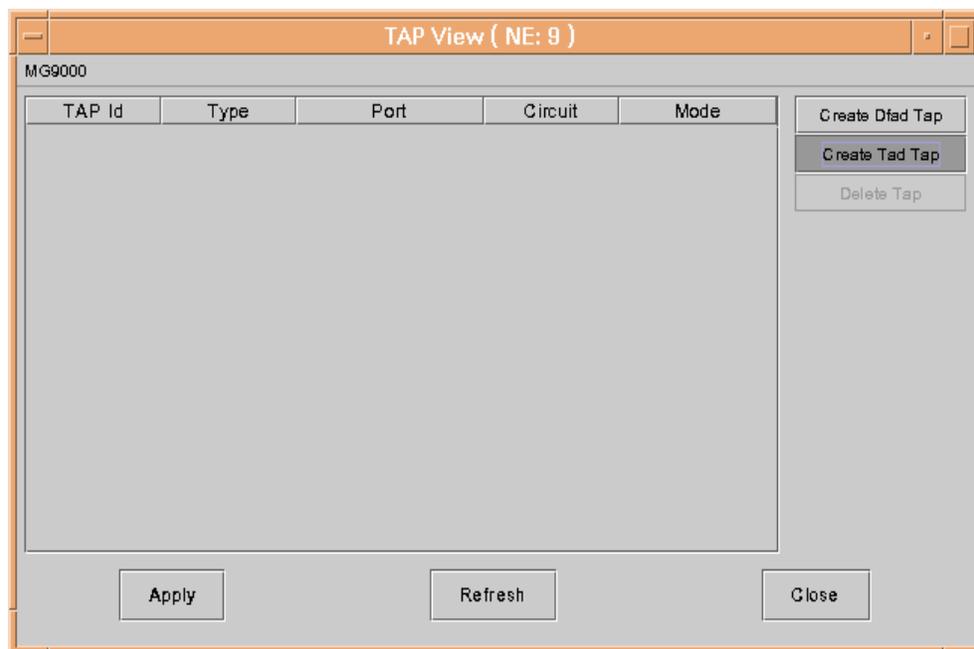
TAP View window

- 7 Select another port on the DS1 card or on another DS1 card in the shelf and repeat steps 1 through 6.
- 8 Go to the Services menu and select the pull down DTA Test Manager menu.
- 9 Select Create Dfad TAP.
A Provision DS1 Dual FAD TAP window appears.

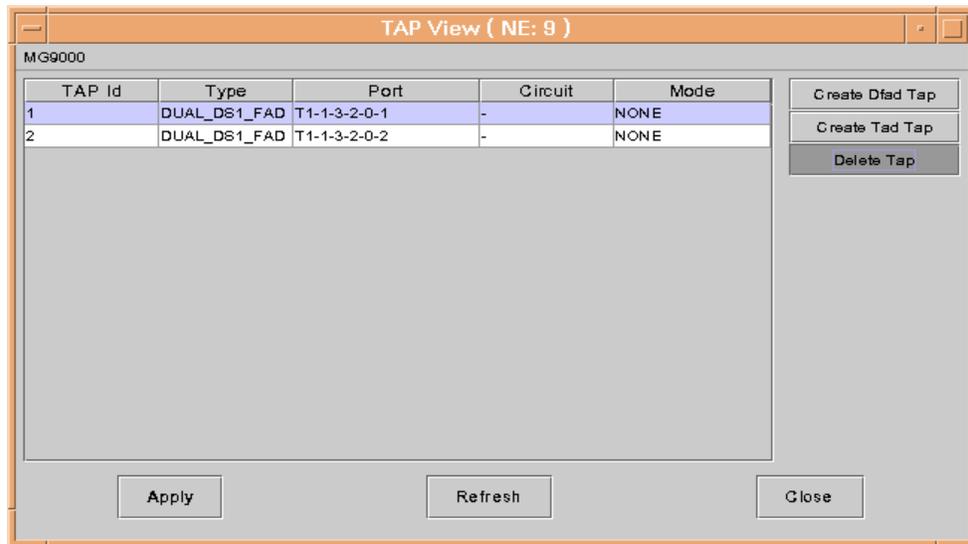
TAP View with Delete TAP selected

- 2 At the TAP View, verify that there is currently no test access (MONEF or SPLTEF) on either TAP of the DFAD to be deleted. Select one row of the DFAD to be deleted. The DFAD entries are adjacent to one another.
- 3 Click Delete TAP. The TAPs are removed.

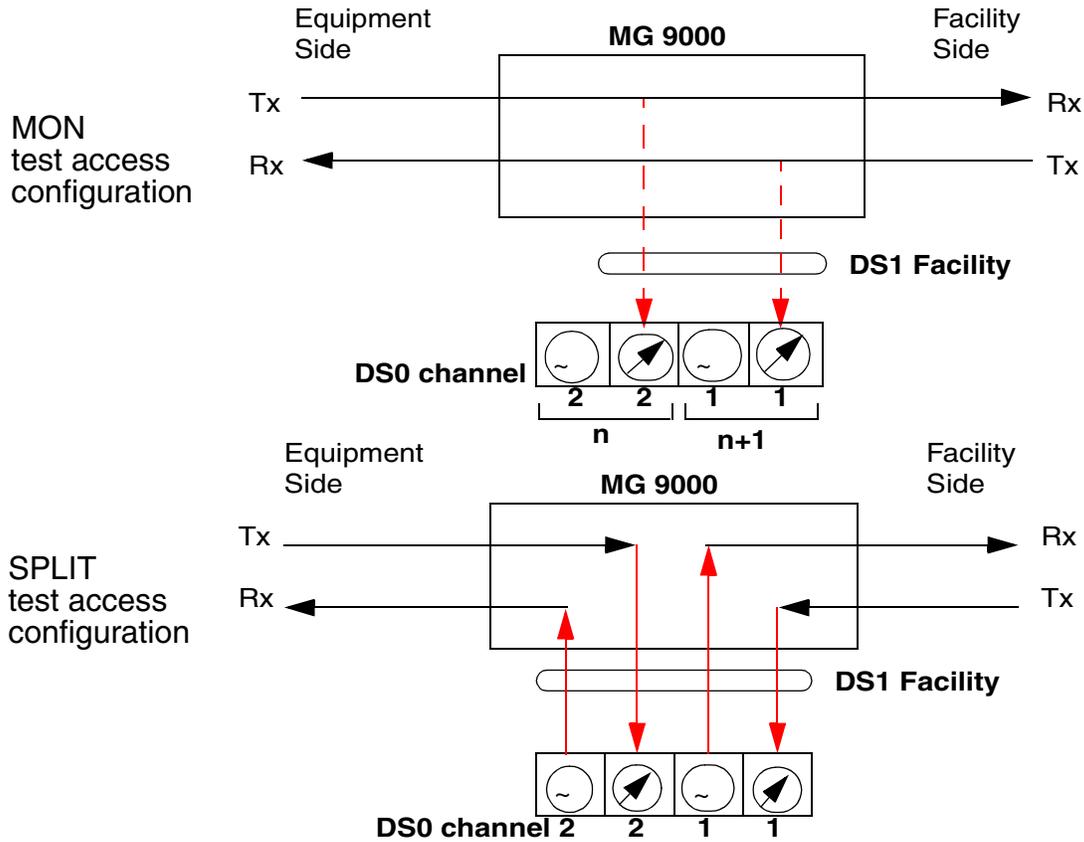
TAD MONEF and SPLTEF test access modes

TAD When provisioning a TAD, twelve contiguous TAPs are automatically allocated over the DS1. Each TAP is associated with two adjacent channels within the DS1 TAD. The first TAP is associated with channel 1 and channel 2, the second TAP is associated with channel 3 and channel 4. This sequence continues until the twelfth TAP is associated to channel 23 and channel 24. The odd channel of the TAP is used for connections to the facility side of the circuit under test and the even channel number of the TAP is used for connections to the equipment side of the circuit. TAD test access only supports single channel DS0 bundles. TAD employs the following two test access modes.

The following figure shows the two TAD test access modes

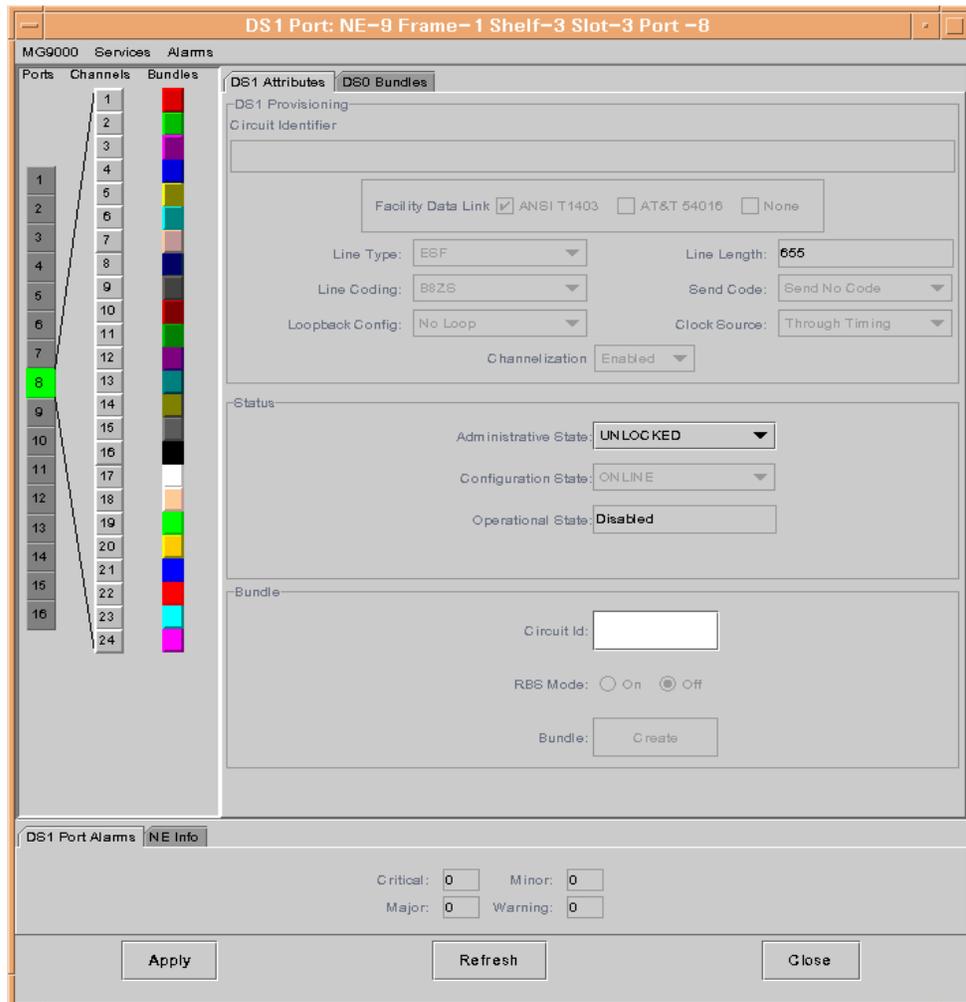
DS1 Port View with Channelization Enabled

- 6 Set the port to On line.
- 7 In the DS1 View, set Channelization to Enabled. At this point the channels in the left side of the DS1 View will turn blue.

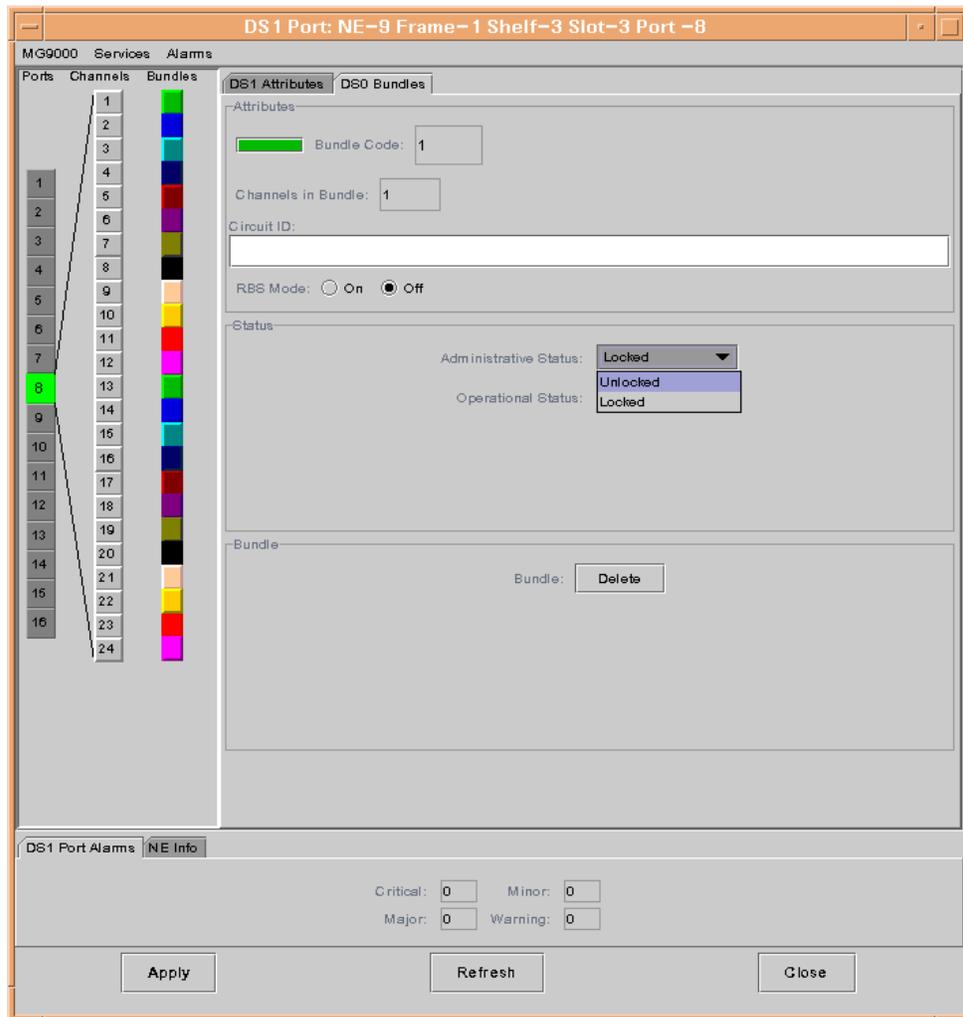
DS1 Port View unlocking bundles

- 8 Unlock the port.
The Operational state becomes Enabled.
- 9 Click on each channel then click on Bundle Create. (Robbed bit signaling [RBS] default = Off.) Repeat this step for all 24 channels in order from 0 to 23.
- 10 Then unlock each bundle by double clicking and changing the Administrative state to Unlocked. Repeat this step for all 24 channels in order from 0 to 23.

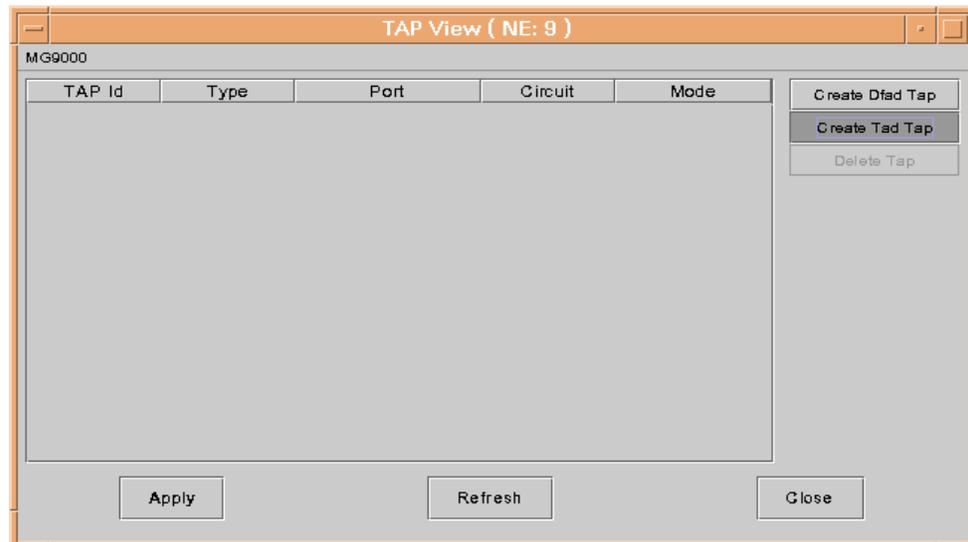
Creating a TAD TAP from the TAP View

- 11 At the Services menu, select DTA Test Manager. This brings up the TAP view.
- 12 Select Create TAD TAP.
A Provision DS0 TAD TAP window appears.

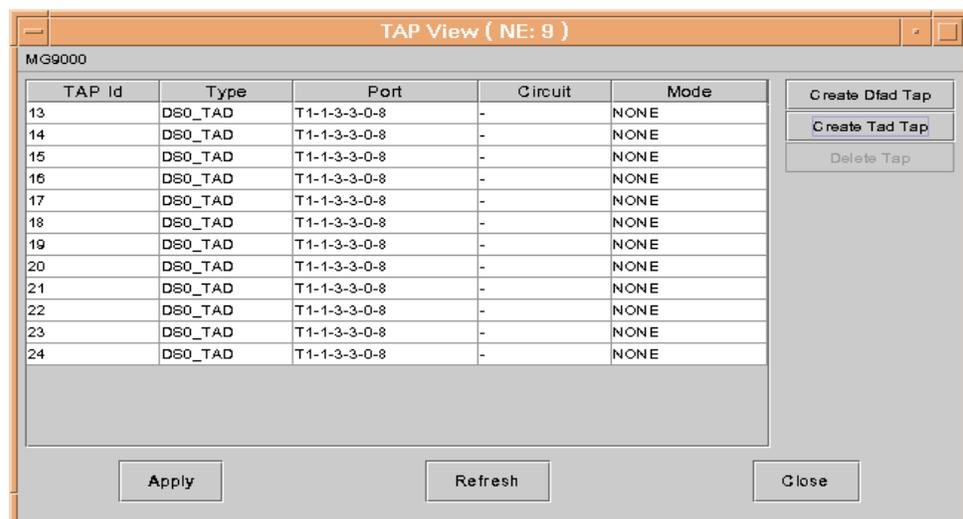
Provisioned DS0 TADs in TAP View

- 13 Click Select. This brings up the NE-1 Selector window.
- 14 Choose the card and port to act as the TAD ports and click OK.
- 15 Enter the TAP ID value according to vendor requirements and local procedures.
- 16 Click OK. The Provisioned DS0 TADs appear in the TAP View window. Click Close.

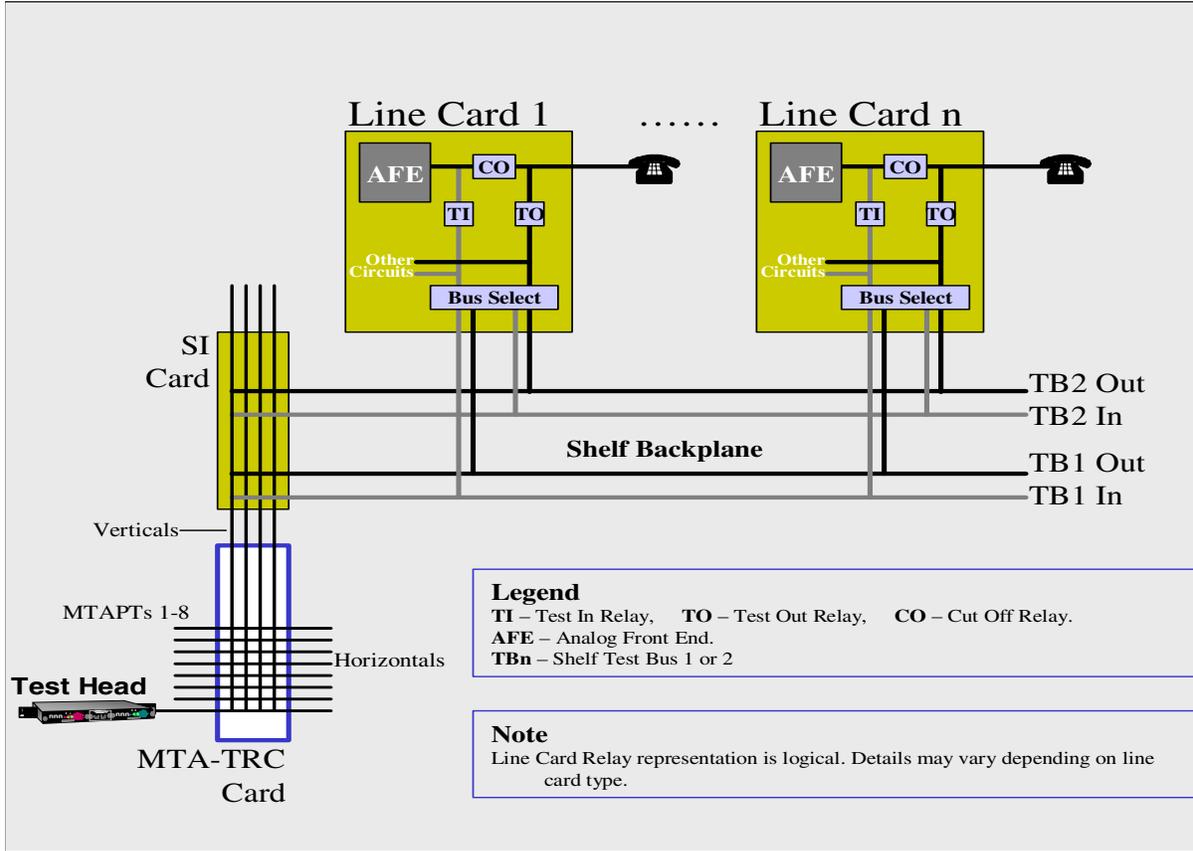
Cut-off relay on line cards

The following figure shows the cut-off (CO) relay in each of the supported line card types.

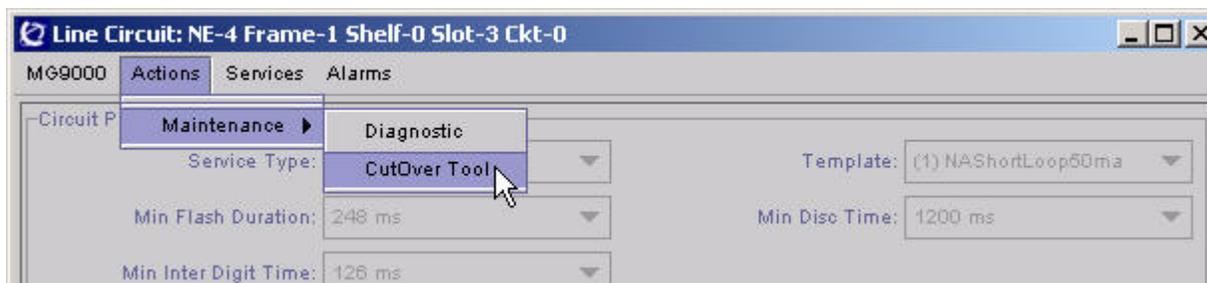
Accessing the CutOver Tool menu

- 1 At the Subnet View, double click the MG 9000 icon on which the cut-off relay is to be activated. The Frame View appears.
- 2 At the Frame View, select the shelf on which the line cut-off relay is to be activated. The Shelf View appears.
- 3 At the Shelf View, select the line card on which the circuit or circuits reside that are to be isolated. The Card View appears.
Note: If the lines in a shelf, frame, or entire network element are to be isolated, select the lowest number slot in the shelf.
- 4 At the Card View, select the line circuit 0. The Circuit View appears.
- 5 From the Actions->Maintenance menu at the top, select CutOver Tool. The following figure shows the menu selection.

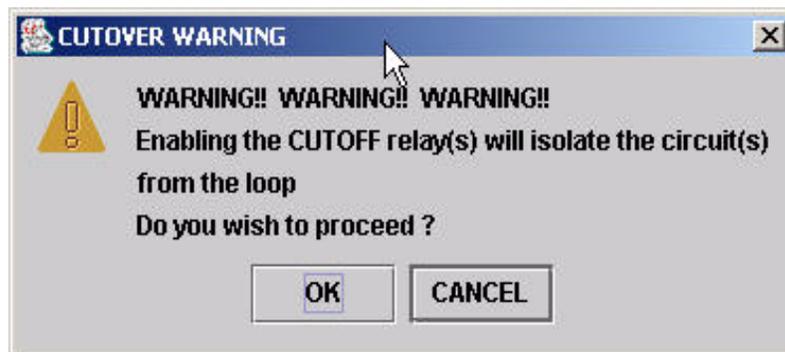
Warning message - enabling cut-off relay

- 7 Select Enable from the Select Maintenance Action pull-down menu.
- 8 Click Apply at the bottom of the MG9000 Diagnostics View. A warning message will appear as shown in the following figure.

- 9 Respond to the warning message by clicking on OK.
The Status Information window reports the status of the operation.
- 10 This procedure is complete.

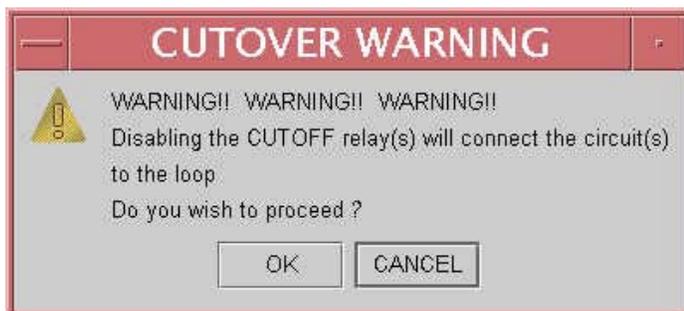
- 8 Click Apply at the bottom of the MG9000 Diagnostics View. A warning message will appear as shown in the following figure.

Warning message - disabling cut-off relay

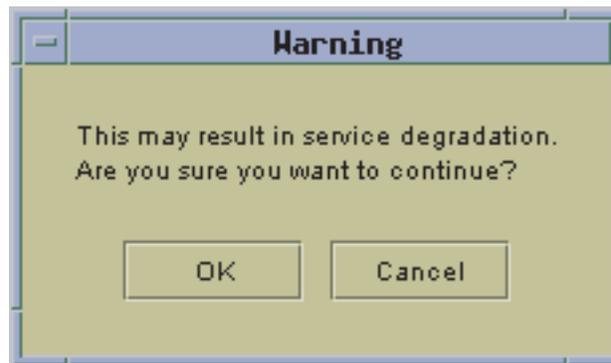
- 5 To switch the activity of the currently active DCC, ITP, or ITX card to be inactive, from the Actions menu at the top of the Card View, select Maintenance->SWACT. Wait for the Standby status to change to Hot_Standby. Go to step [9](#)
- 6 If the card to be locked is a DS1 card, go to step [9](#).
- 7 If the card to be locked is a Master ABI card, perform a Switch Mastership to switch mastership of the ABI card. Go to the [Switching mastership of an ABI card](#) procedure and return to this step. After the Master ABI Service Status is Providing_Service_Slave, go to step [8](#).
- 8 If the card to be locked is a Slave ABI card, a warning message will appear and an informational message will appear warning of service degradation when the Slave ABI card is taken out of service. The warning and information messages are shown next.

To continue with locking the Slave ABI card, use the Force Lock option.

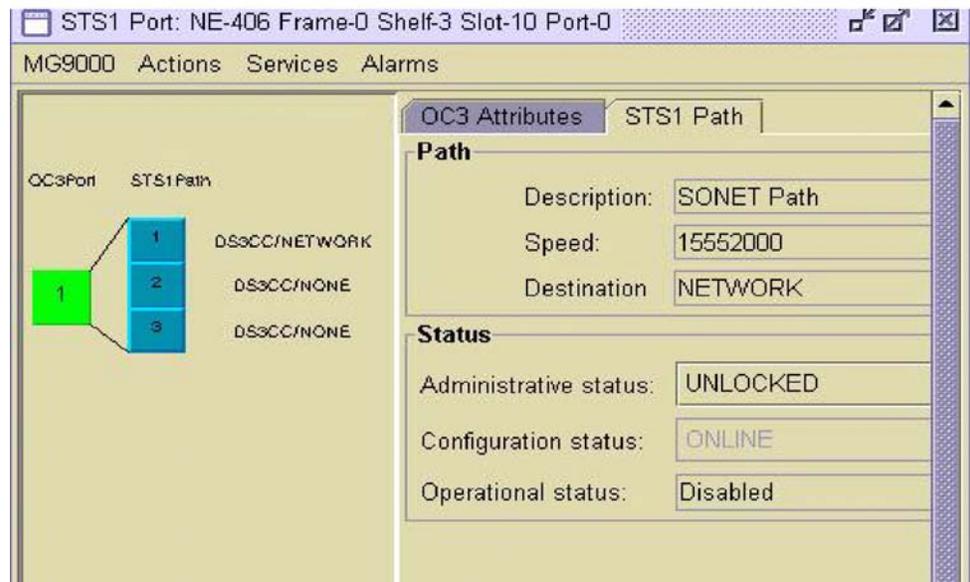
- 7 Double click on an STS1 path to display STS1 path information and its status in the STS1 Path tab on the right side of the port view. The following figure shows the STS1 path description and status information.

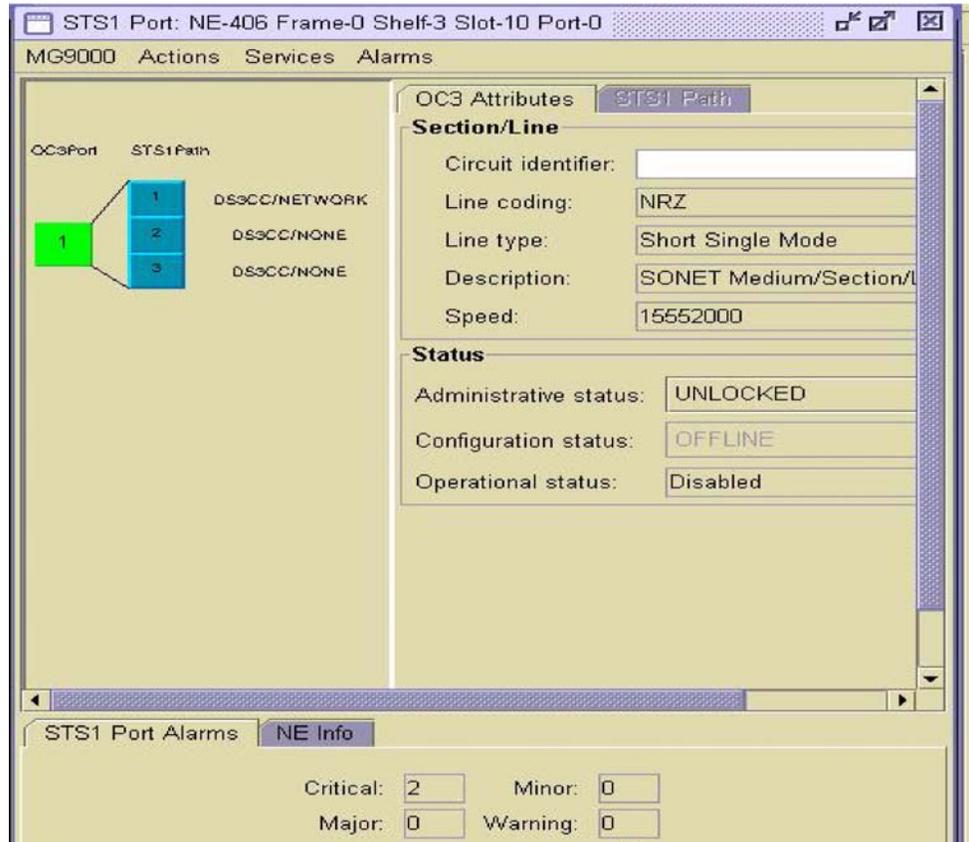
- 6 The following figure shows a channelized carrier and the path icons. Three STS1 path icons are adjacent to the OC3port icon.

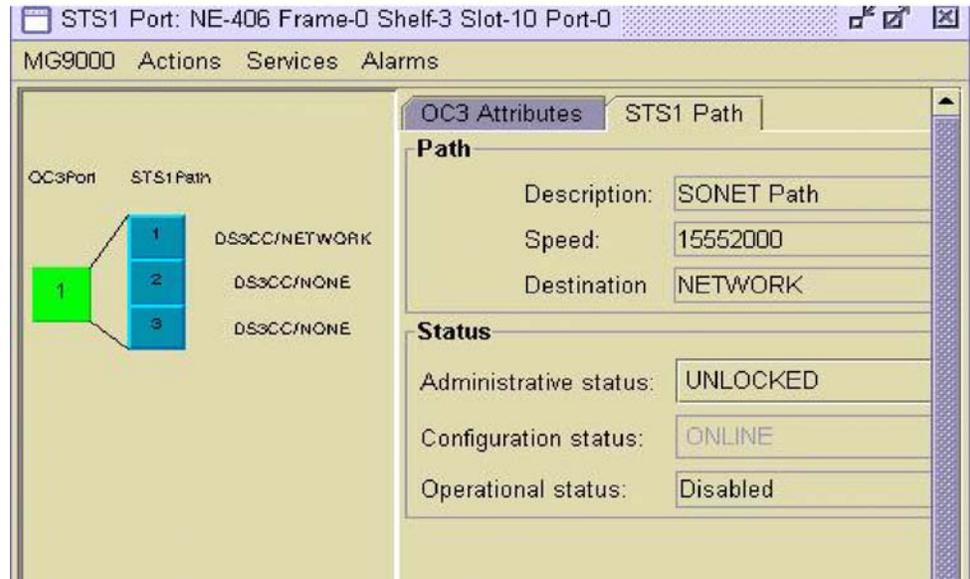
- 7 Double click on an STS1 path to display STS1 path information and its status in the STS1 Path tab on the right side of the port view. The following figure shows the STS1 path description and status information.

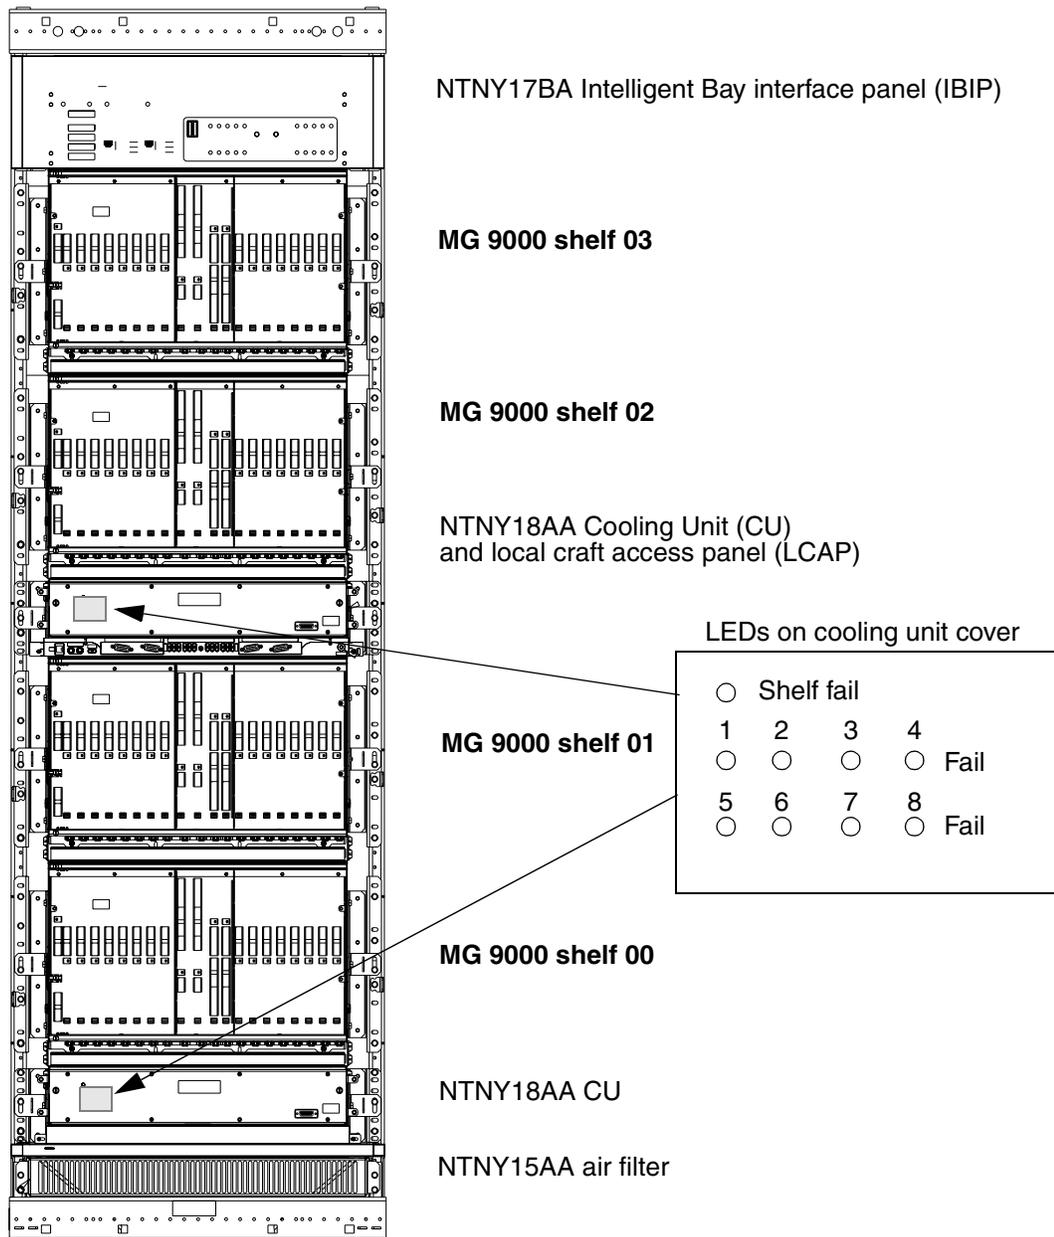
- 5** Remove the screws that hold the cooling unit in place.
- 6** Pull the cooling unit out until it is free of the frame.
- 7** Install the replacement cooling unit into the frame. Replace the screws that were removed in step [5](#) to secure the cooling unit to the frame.
- 8** Replace the fuse modules for the cooling unit that were removed in step [3](#).
- 9** A red LED will light briefly on the face of the cooling unit and then go out, indicating proper connection.
- 10** Check that the LED does not remain lit and that the fans are operating properly by the absence of any lit fan LEDs on the face of the cooling unit. Refer to the following figure to locate the LEDs on the cooling unit.

MG 9000 frame and cooling unit LEDs

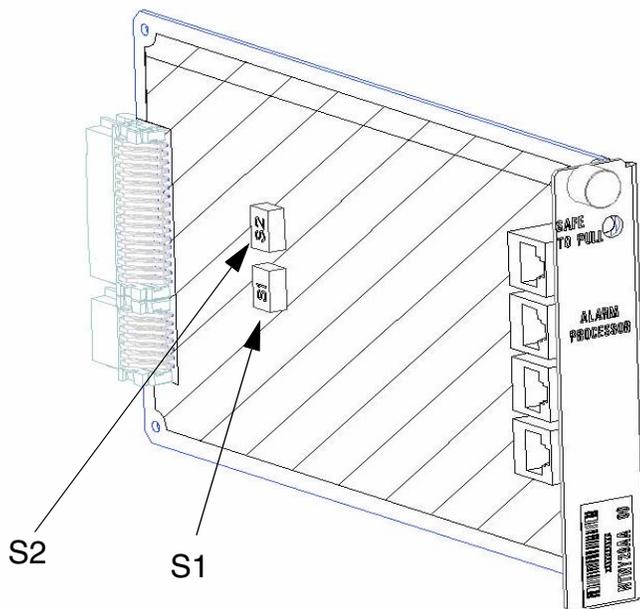
- 8 Remove the IBIP front cover.
- 9 Loosen the hold-down screw on the faceplate of the alarm processor card
- 10 Record the position of the two switch banks (S1 and S2) on the alarm card. Refer to the following figure for switch bank locations.

Alarm processor card switch location
