MG 9000 Fault Management

Fault management strategy

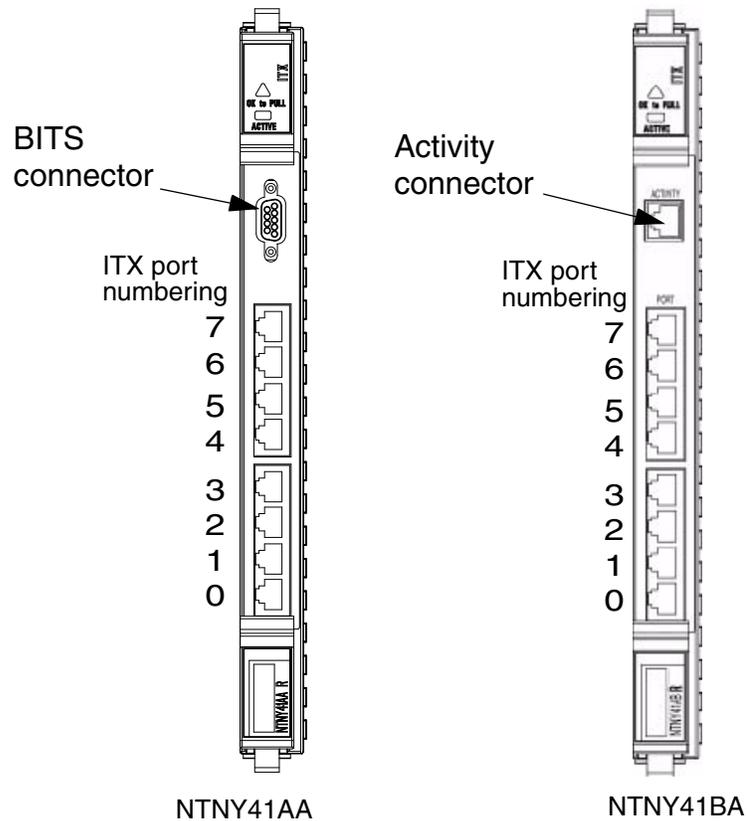
- 11** Carefully disconnect the cables from the RJ45 connectors on the faceplate of the ITX card. Label and carefully lay the cables aside. The ports are numbered as shown in the following figure. If there is a BITS cable connected to the DB9 connector on the NTNY41AA card, disconnect it. If an NTNY41BA card is being replaced, disconnect the activity cable.

ITX card port number

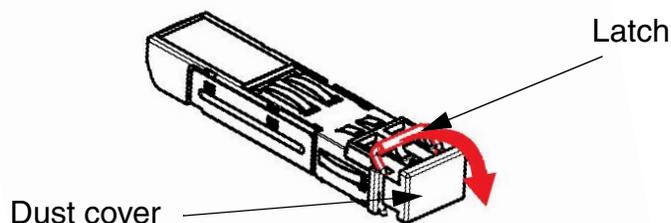
Carefully disconnect the GigE fiber cable from the NTT62 SFP transceiver device. Then using the latch, pull to withdraw the SFP from the faceplate of the GigE DCC card.

NTT62 SFP transceiver device

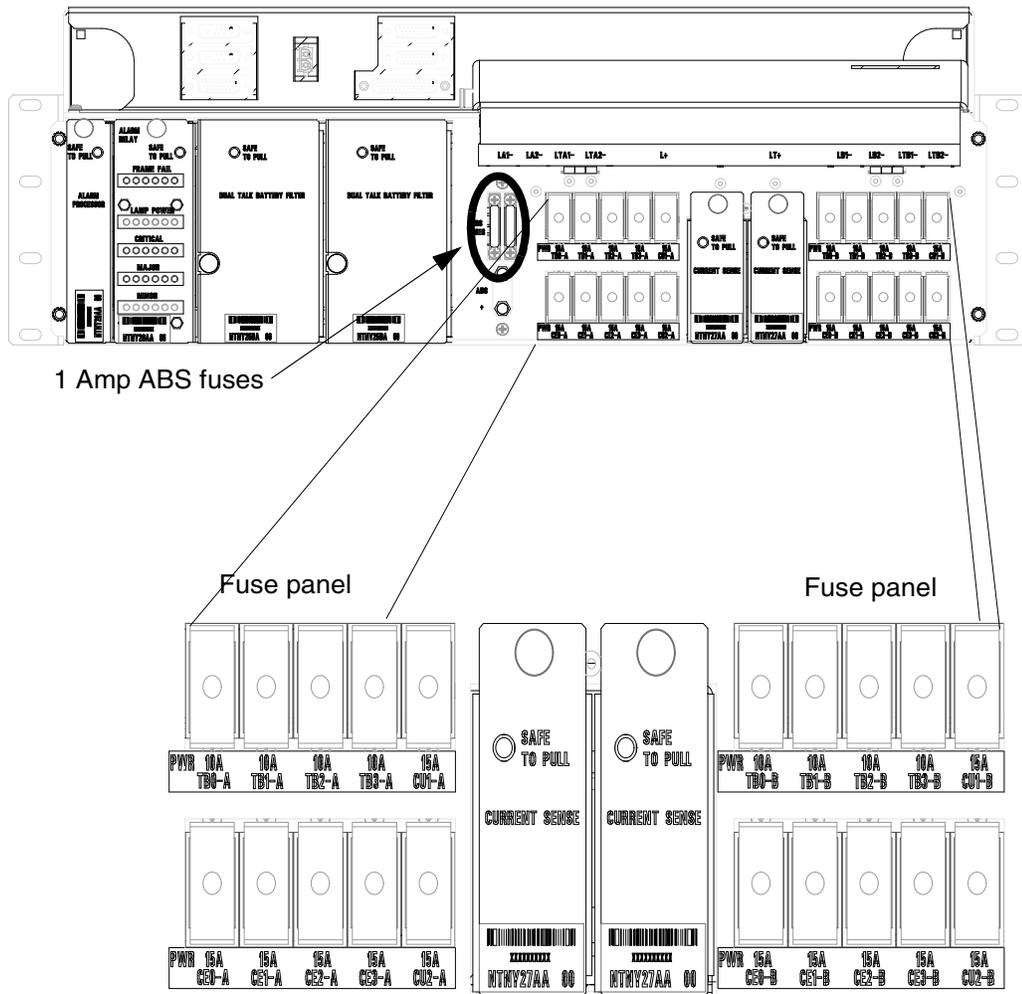
The following figure shows the IBIP and fuse location.

IBIP panel showing the fuse panel and ABS fuses

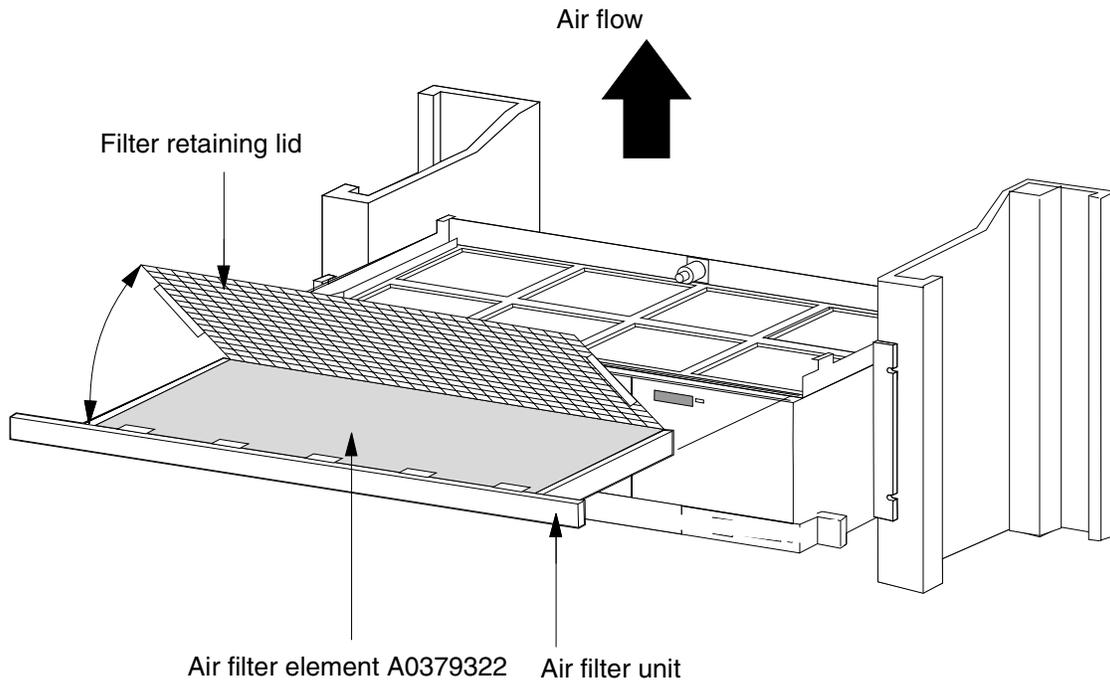
- 4 Close the filter retaining lid, and reinsert the air filter unit into the shelf until it locks into place. Refer to the following figure that shows the filter element in the air filter unit.

Air filter unit and element

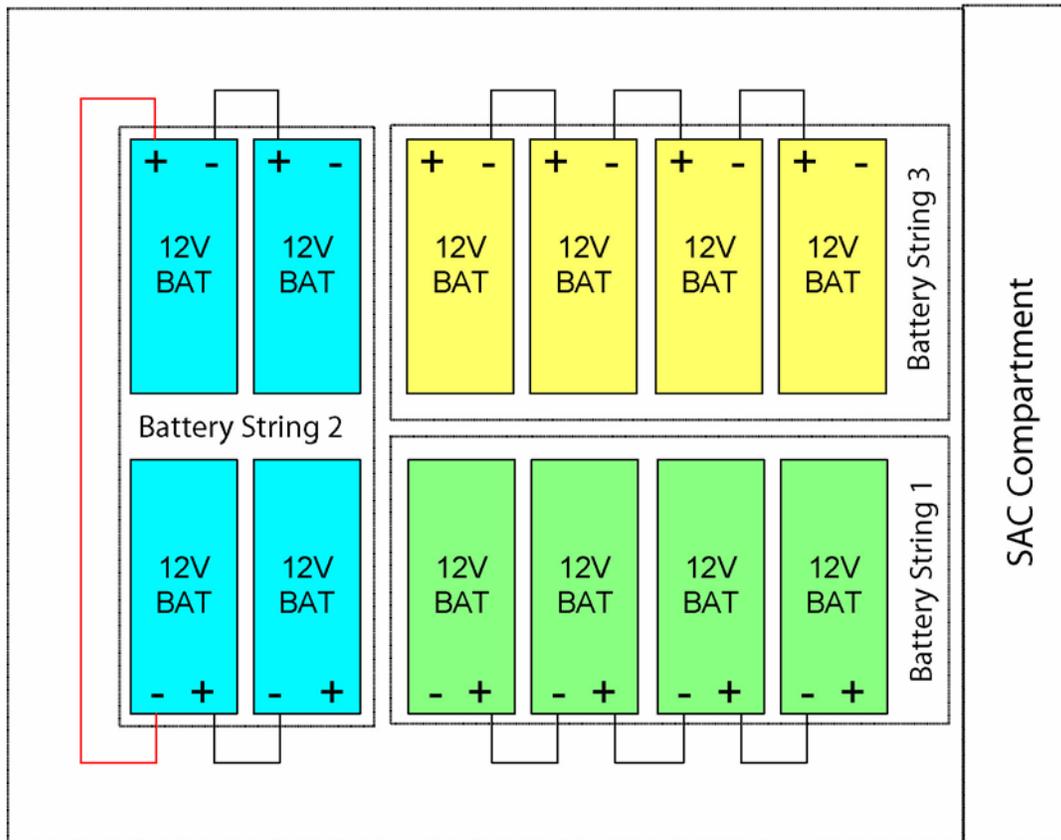
Battery arrangement in the outside plant cabinet

Cabinet Front

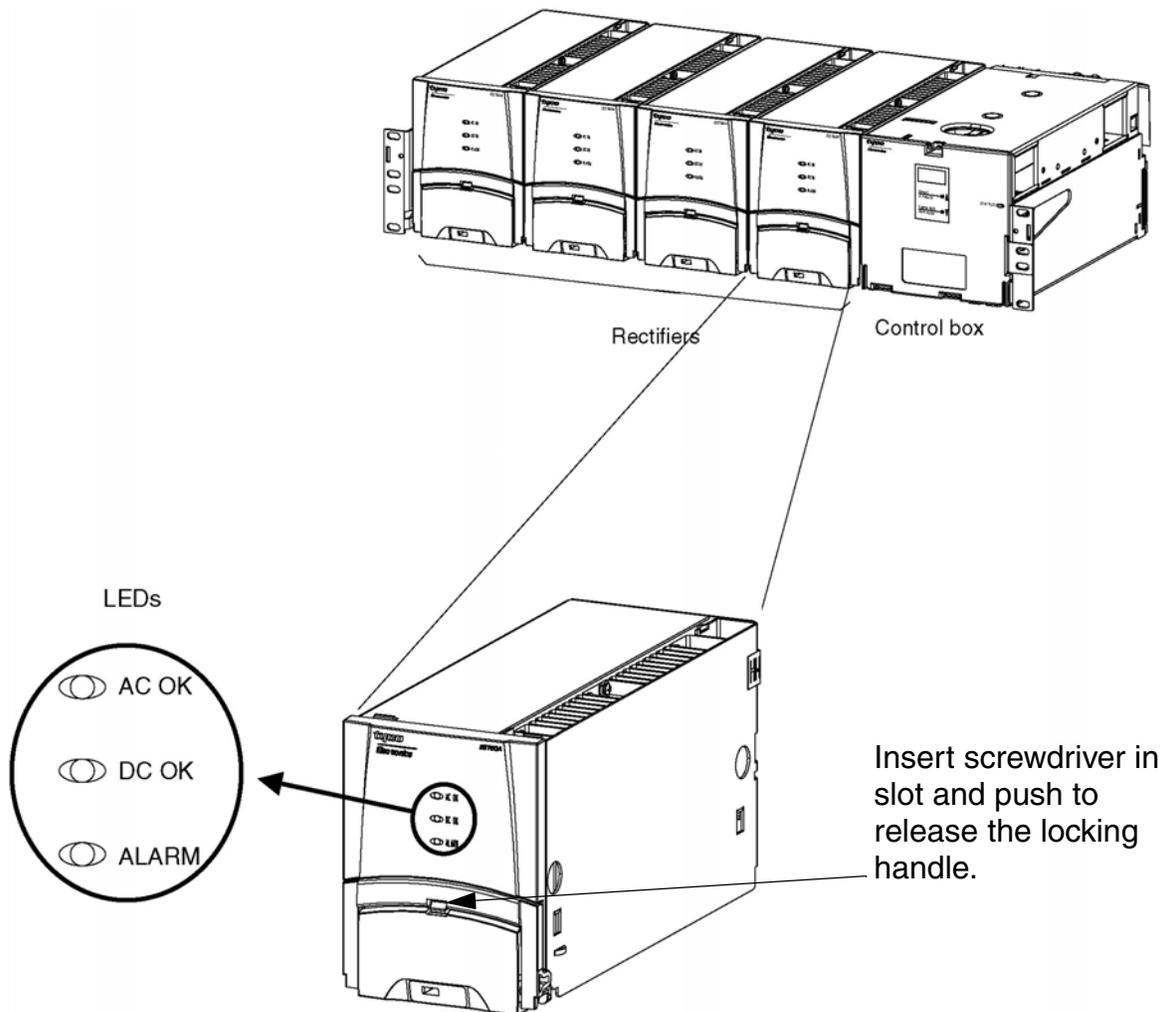
The following figure shows the rectifier shelf, the handle release slot, and alarm LEDs.

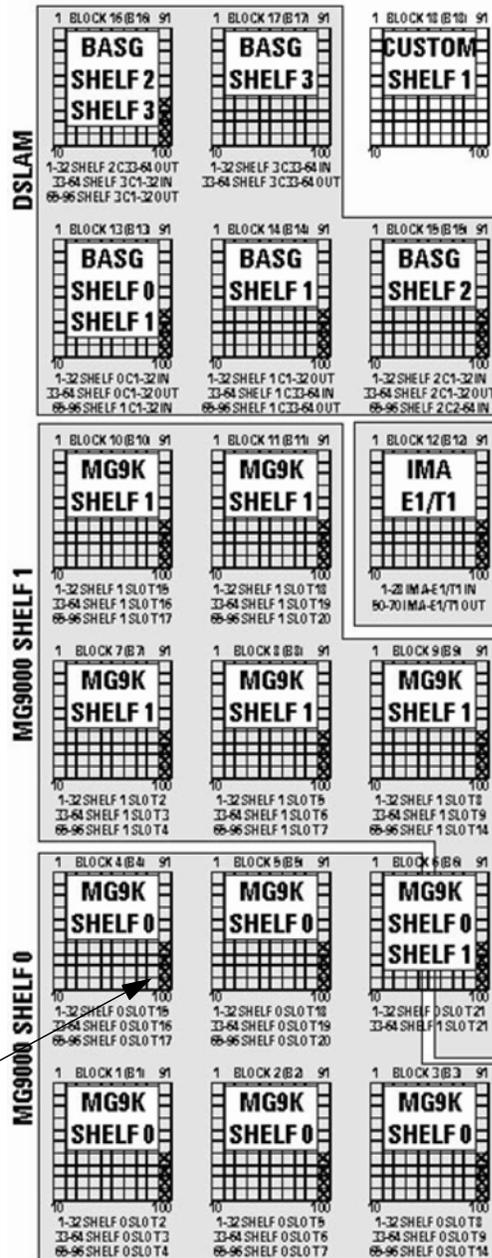
POTS/DSL SURGE PROTECTION LAYOUT DIAGRAM

Optional BASG DSLAM equipment on rear swing frame

"X" indicates spare protection module position. Spares are only located in the first 10 protection modules.

ON PROTECTION BLOCKS 1 THROUGH 10, POSITIONS 97, 98, 99 AND 100 CAN BE USED AS SPARE FUSE HOLDERS

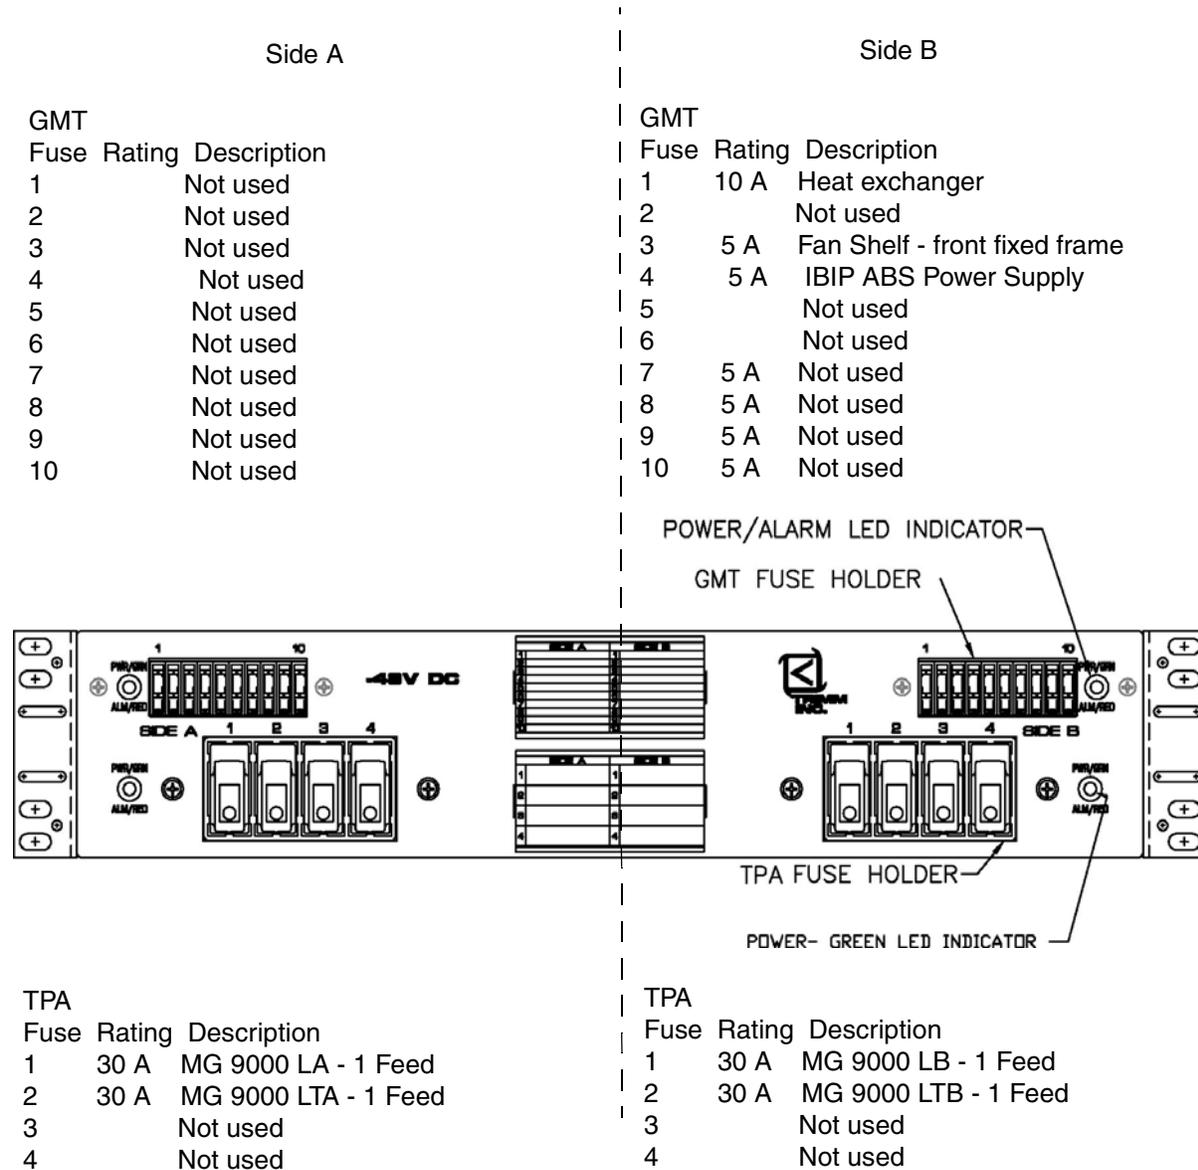
The following figure shows the fuse panel and fuse assignments. The placard in between the two sides identifies fuse assignment.

Fuse panel and fuse assignments

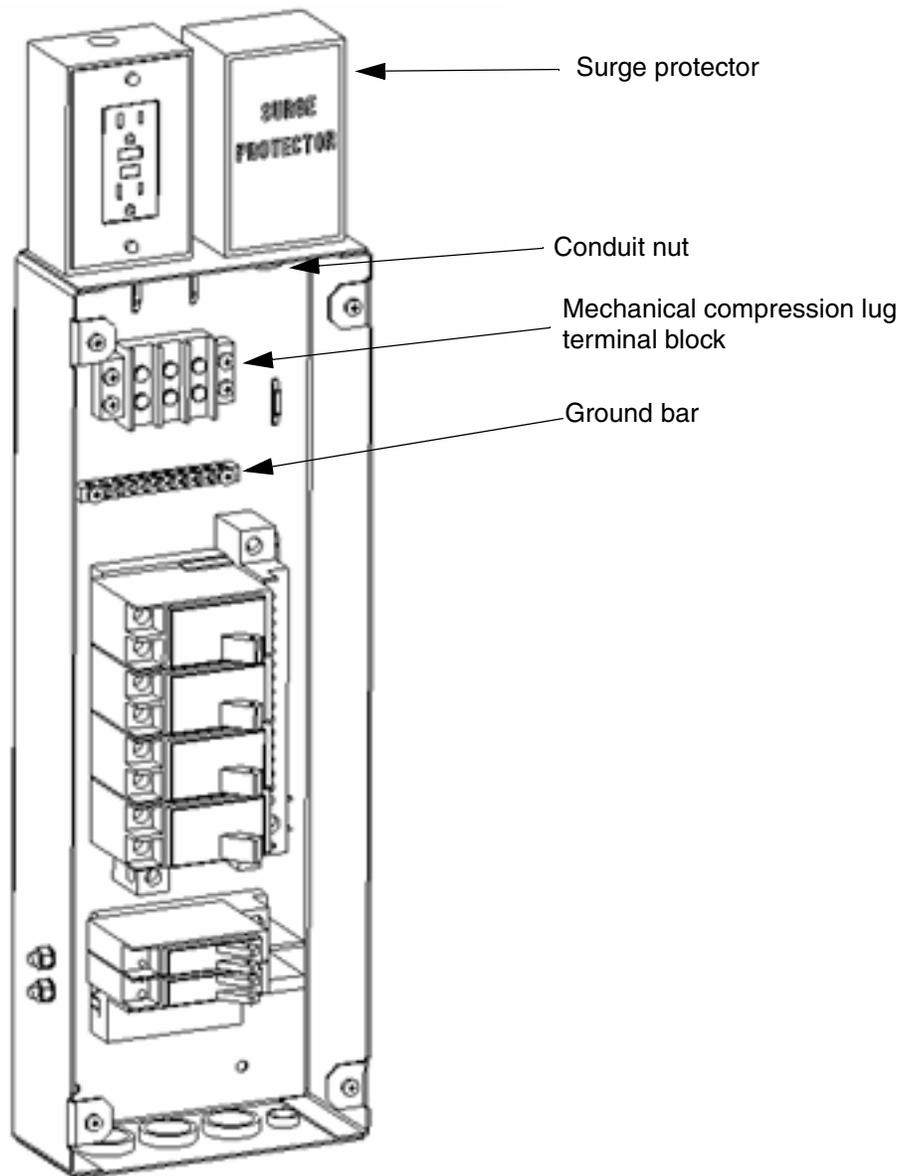
ac panel (cover removed) and surge protector

- 4 Remove the three leads (two hot, one neutral) that run to the surge protector from the mechanical compression lugs on the terminal block at the top of the ac panel. Label the wiring for proper installation.
- 5 Disconnect the surge protector ground wire from the ground bar.
- 6 Pull the wires free and out of the ac panel.

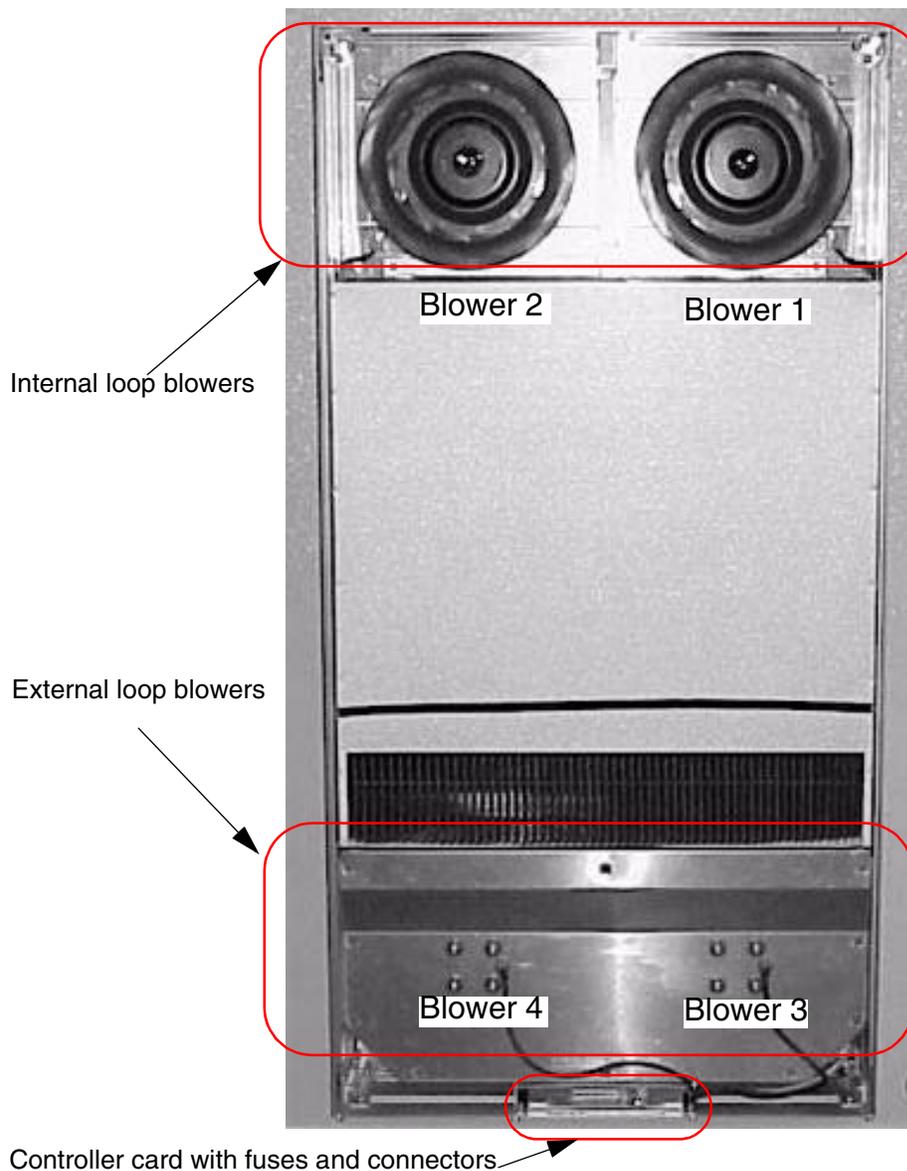
Heat exchanger (shown with cover removed)

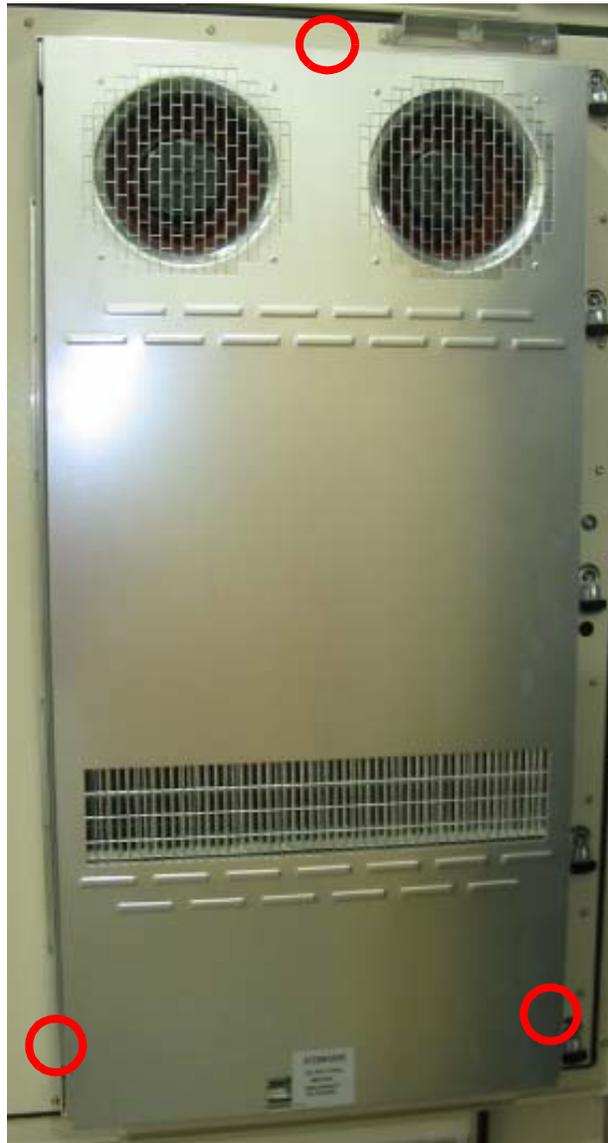
Use the following figure to locate the three screws.

Heat exchanger (identifying location of three cover screws)

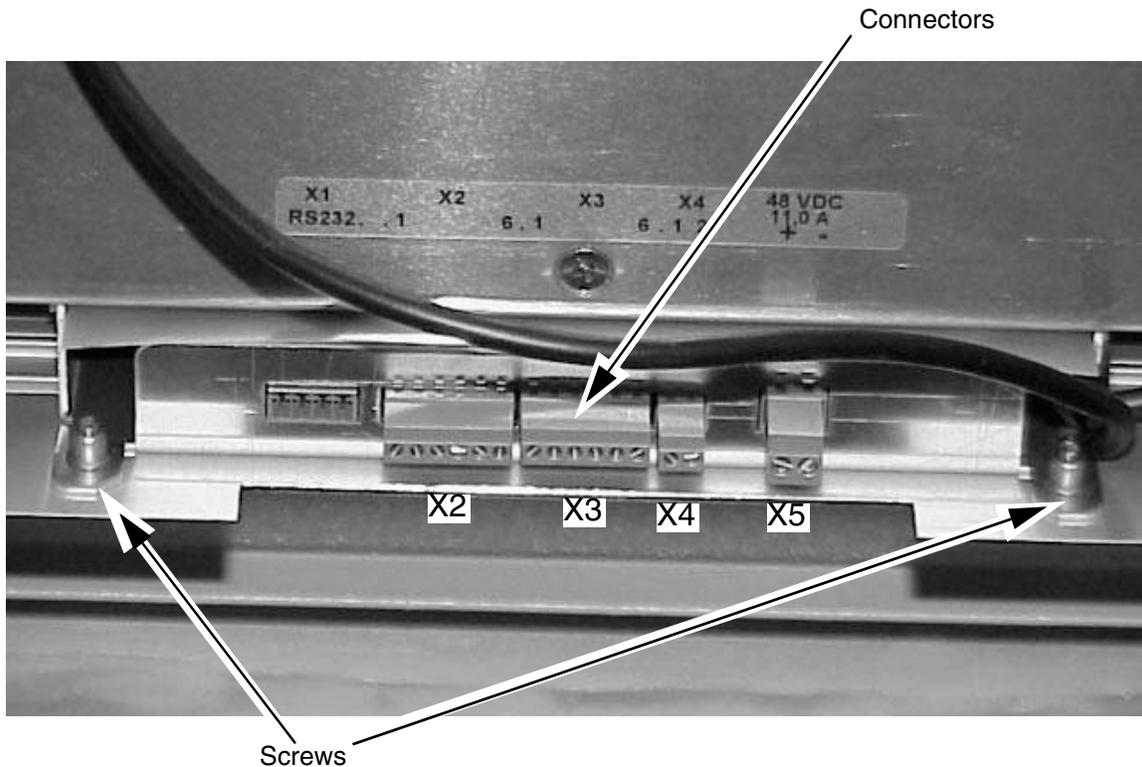
- 5** Unplug connectors X2 through X5 on the controller board at the bottom of the heat exchanger cabinet. The following figure shows the controller card and the orientation of the connectors.

Heat exchanger controller card and connectors

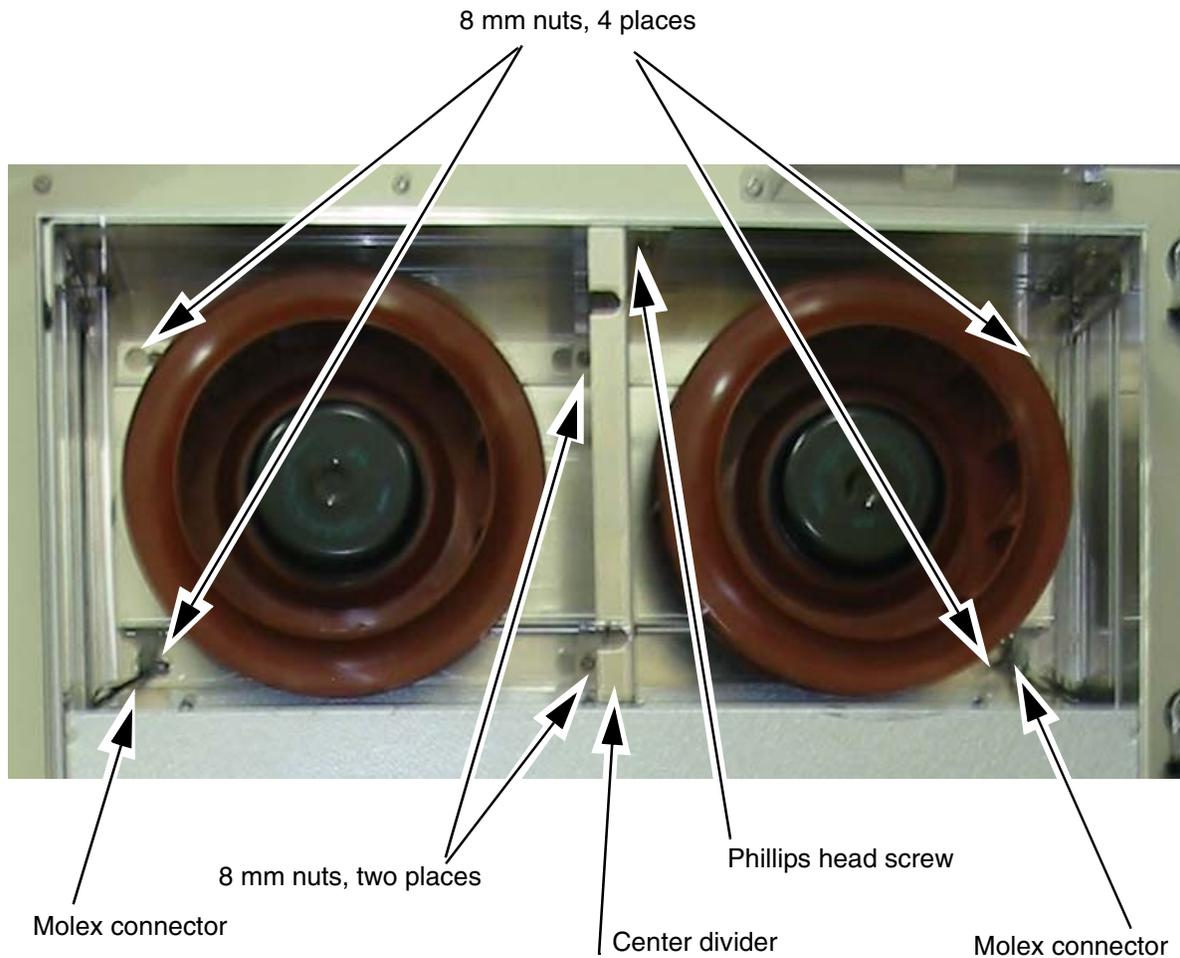
Internal loop blower compartment

- 8** Use an 8 mm nut driver to loosen the two nuts that secure the center divider in the internal loop blower compartment. On the right side of the divider, remove the Phillips head screw that secures the divider to the top of the heat exchanger cabinet. Slide the divider to the left and remove the divider.
- 9** Disconnect the two Molex connectors that supply power to the blowers, one at the bottom of each end of the internal loop blower compartment.
- 10** Use the 8 mm nut driver to loosen the four nuts, two at each end of the panel to which the blowers are mounted.
- 11** Slide the panel to the right and grasp the blower assembly and lift it clear of the cabinet.
- 12** Identify the faulty blower and turn the blower assembly over. Using a T25 Torx screwdriver, loosen and remove the four Torx

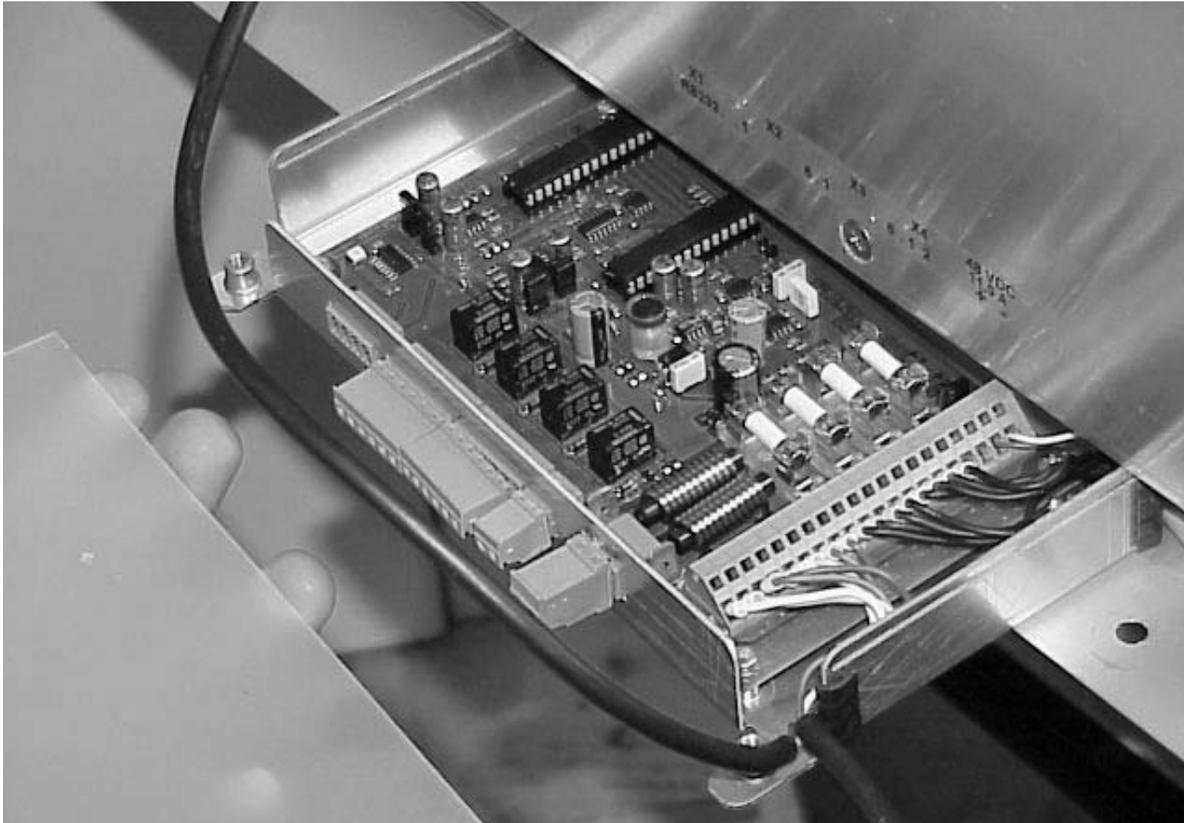
- 20** Withdraw the controller card assembly from the heat exchanger. Gently remove the cover from the top of the assembly. The fuses and blower wiring connector are now exposed. The following figure shows the controller card, fuses, and wiring connector.

Heat exchanger blower controller card

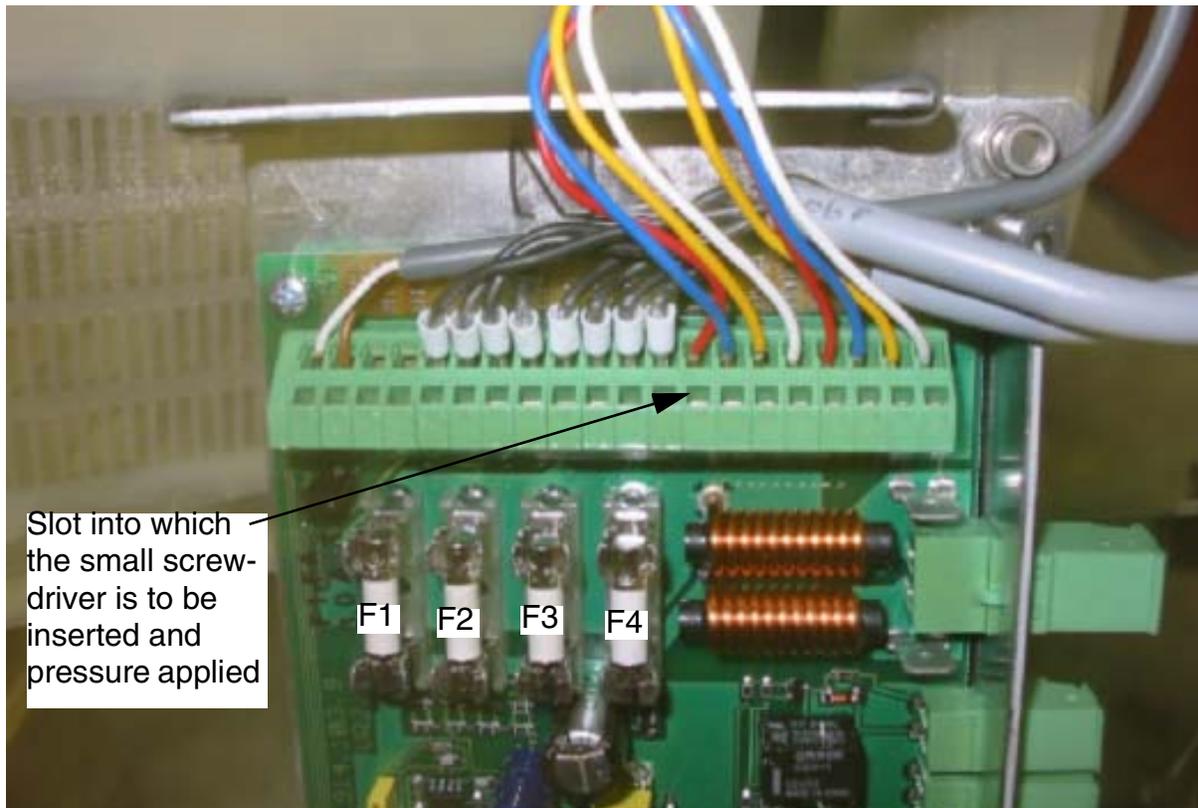
The following figure shows the connector and the slot into which the screwdriver is to be inserted.

Controller card connector wiring and fuse labels

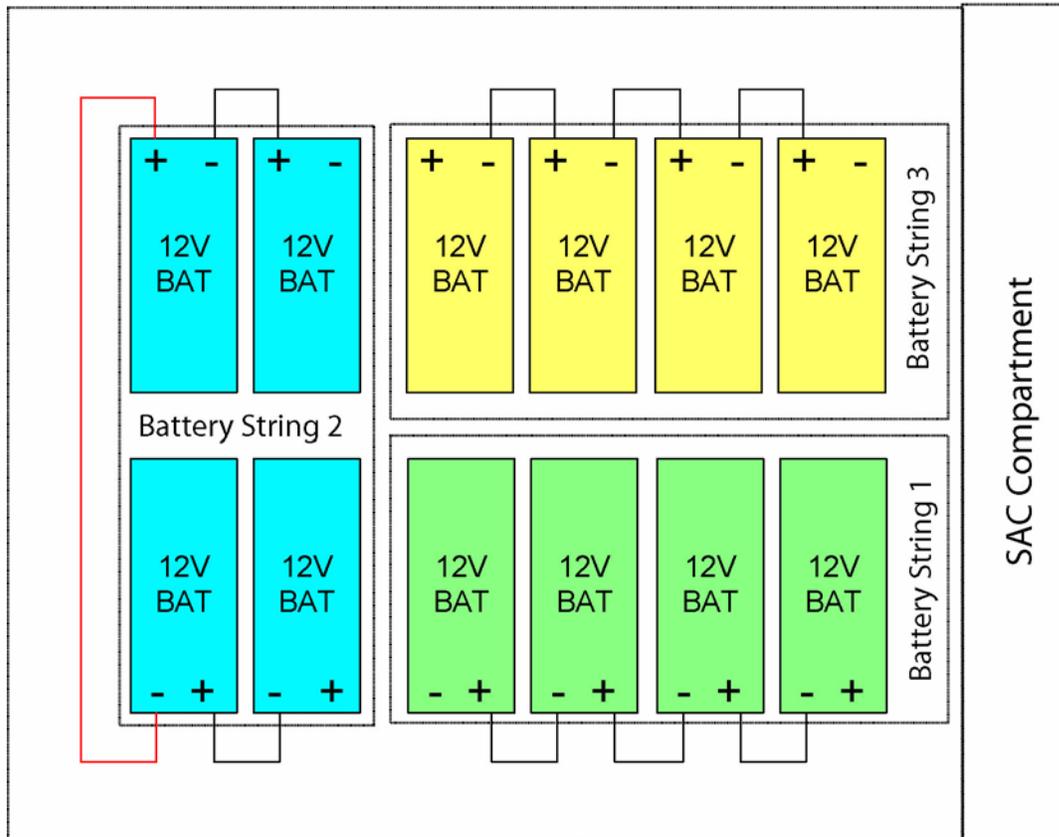
Battery arrangement in the outside plant cabinet

Cabinet Front

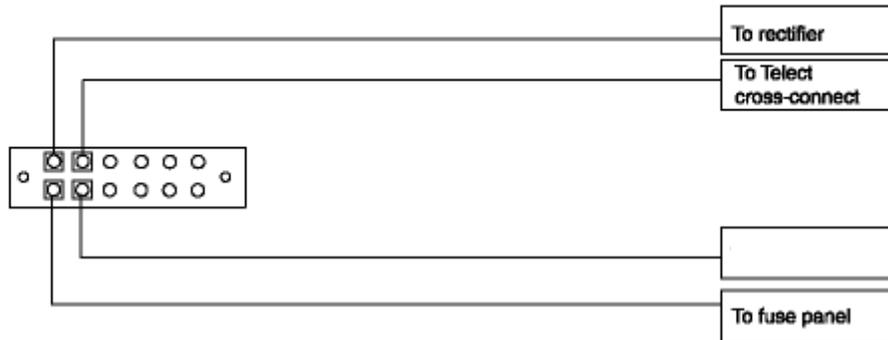
Outside plant cabinet system ground points

Main compartment equipment side

EQUIPMENT CABINET GROUND BAR AND SAC CABINET GROUND BAR ARE CONNECTED USING A COMMON CABINET WALL

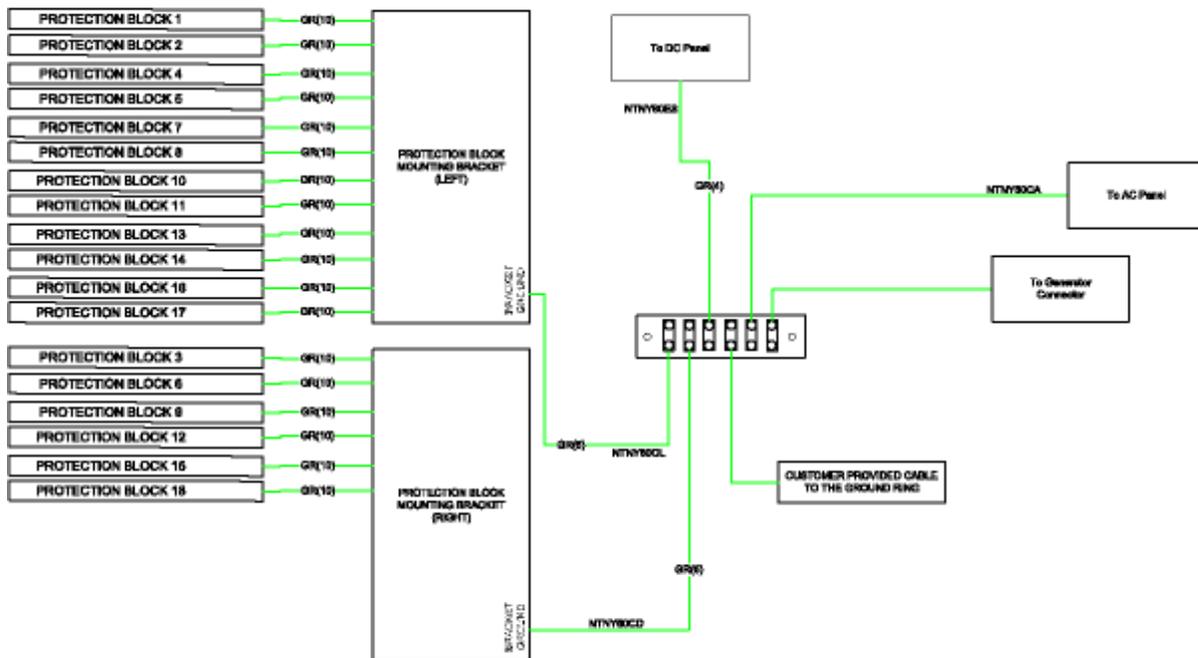
Service access compartment side

- 4 Use local approved methods to measure ground resistance. The resistance for each ground must be ≤ 25 Ohms.
