MG 9000 Fault Management

New in this release

The following sections detail what is new in MG 9000 Fault Management for release (I)SN09FF.

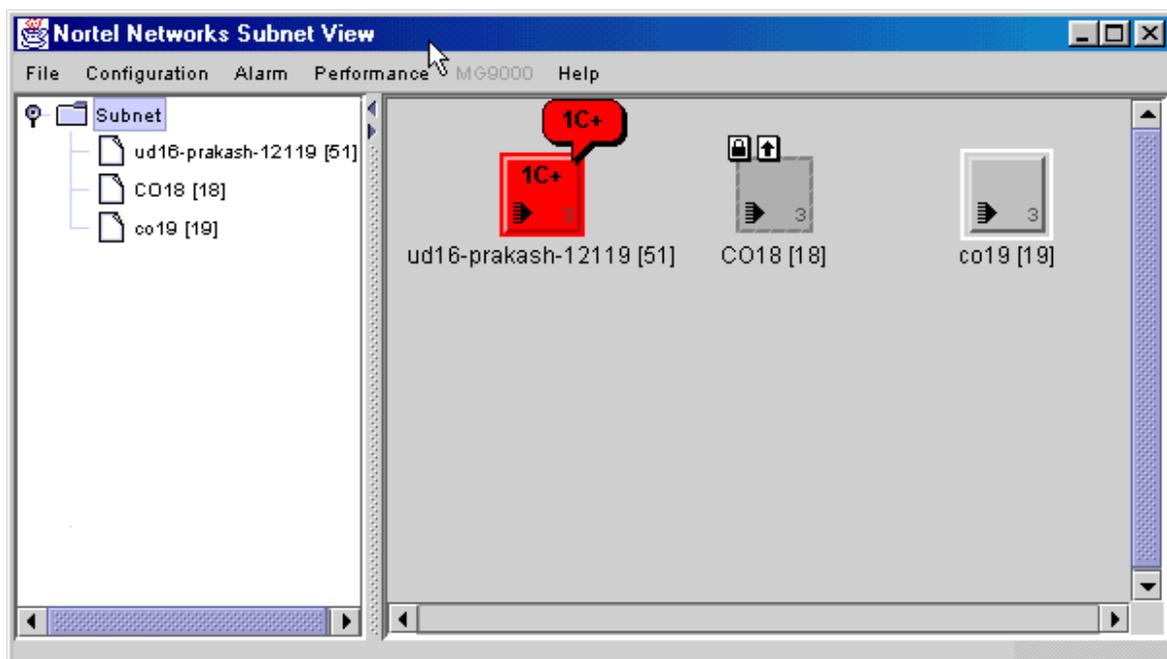
MG 9000 Manager Subnet View

The following figure shows the window-based MG 9000 Manager Subnet View. In this figure, the icon in solid grey without diagonal lines indicates that the MG 9000 is provisioned and discovered. In the Subnet View. A tree view is available in the left side. Each entry or 'NE' in the tree indicates the presence of some entity. The top node (also known as the root NE) indicates the subnet itself, and is named accordingly; its icon shows a folder to indicate it (may) contain other items. As MG 9000s are added to the subnet, they will appear as additional NEs in the tree, connected by a line to the root 'subnet' NE. This indicates a containment relationship that the subnet has over its constituent MG 9000s.

Each MG 9000 NE is shown as a standard 'paper' icon, to indicate there is information available about that particular MG 9000 at this level of the

tree. The icon is accompanied by the name of the MG9000, and its network element number appended in square brackets.

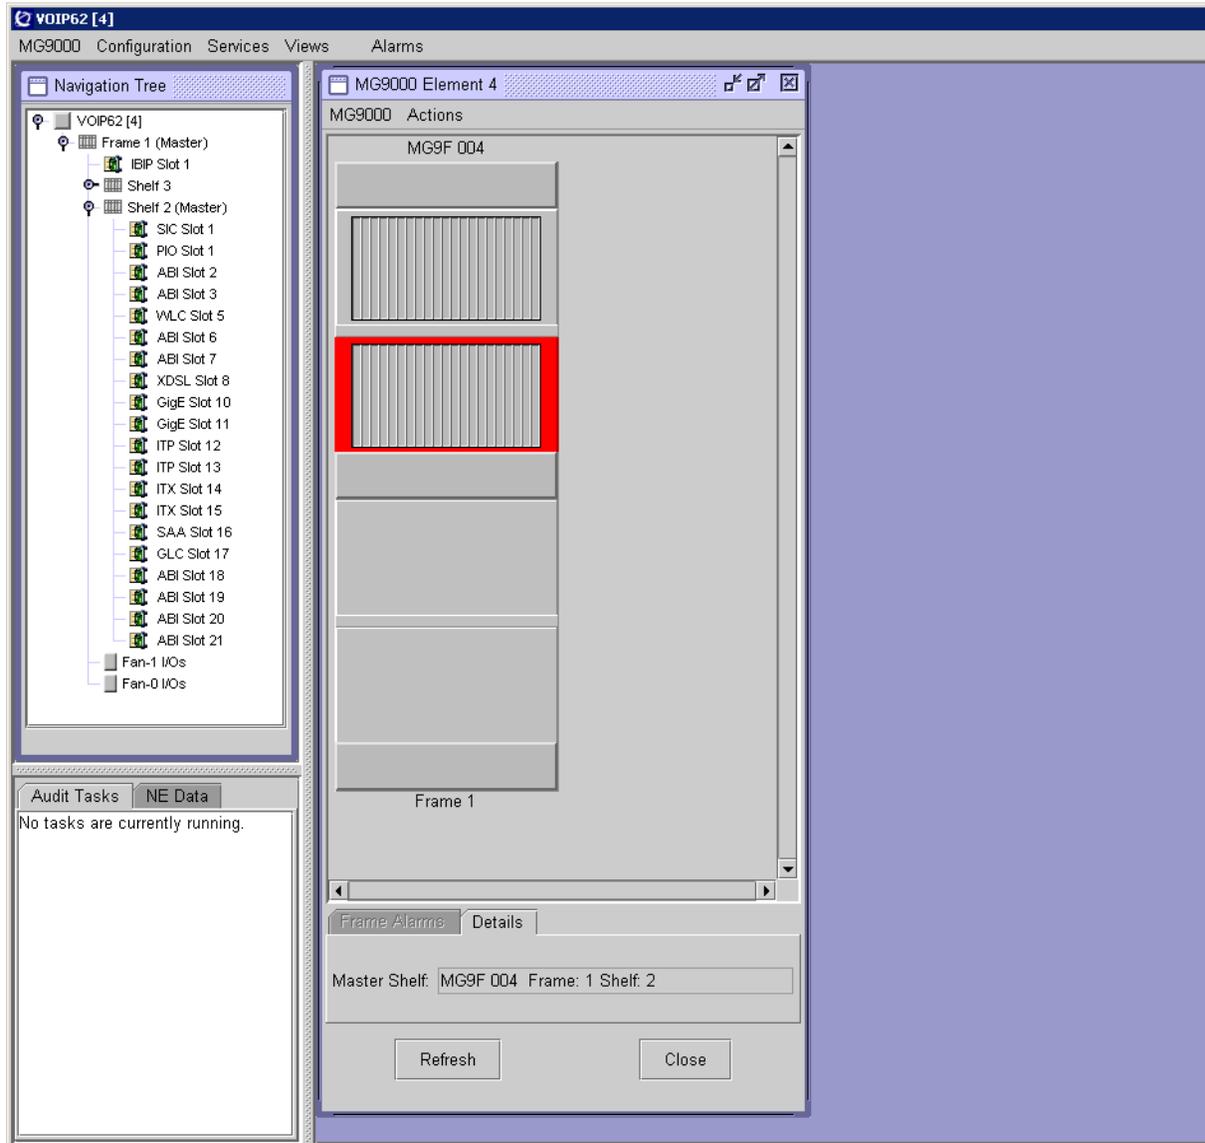
Frame View shown within NE desktop view

The Audit Task tab shows the progress of an NE audit and is meant as an audit indicator for those tasks that run in the background so the user is aware that an NE audit is currently in progress. Throughout this document, the individual GUIs are shown outside the NE desktop view, though in all cases except for the Alarm Browser, the GUIs appear in the NE desktop view.

The menu bar across the top of the NE desktop view consists of the following menu items

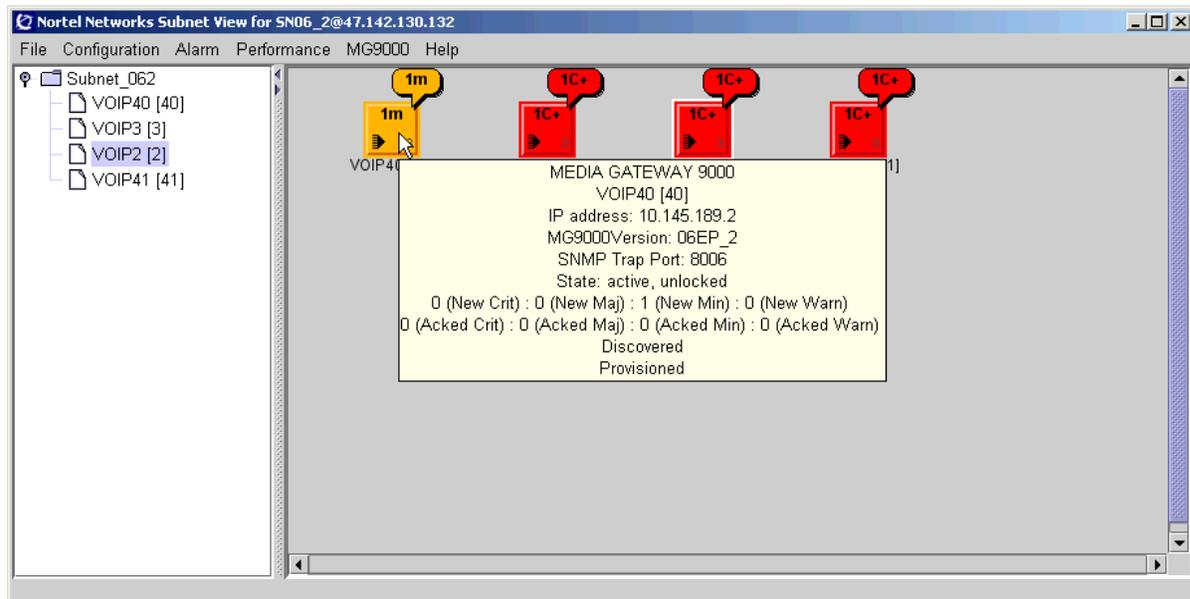
Subnet View showing the information balloon

- network element name and number
- MG 9000 software release
- network element IP address
- SNMP trap port number used
- state of the network element
- total alarms by category and the number of alarms that have been acknowledged

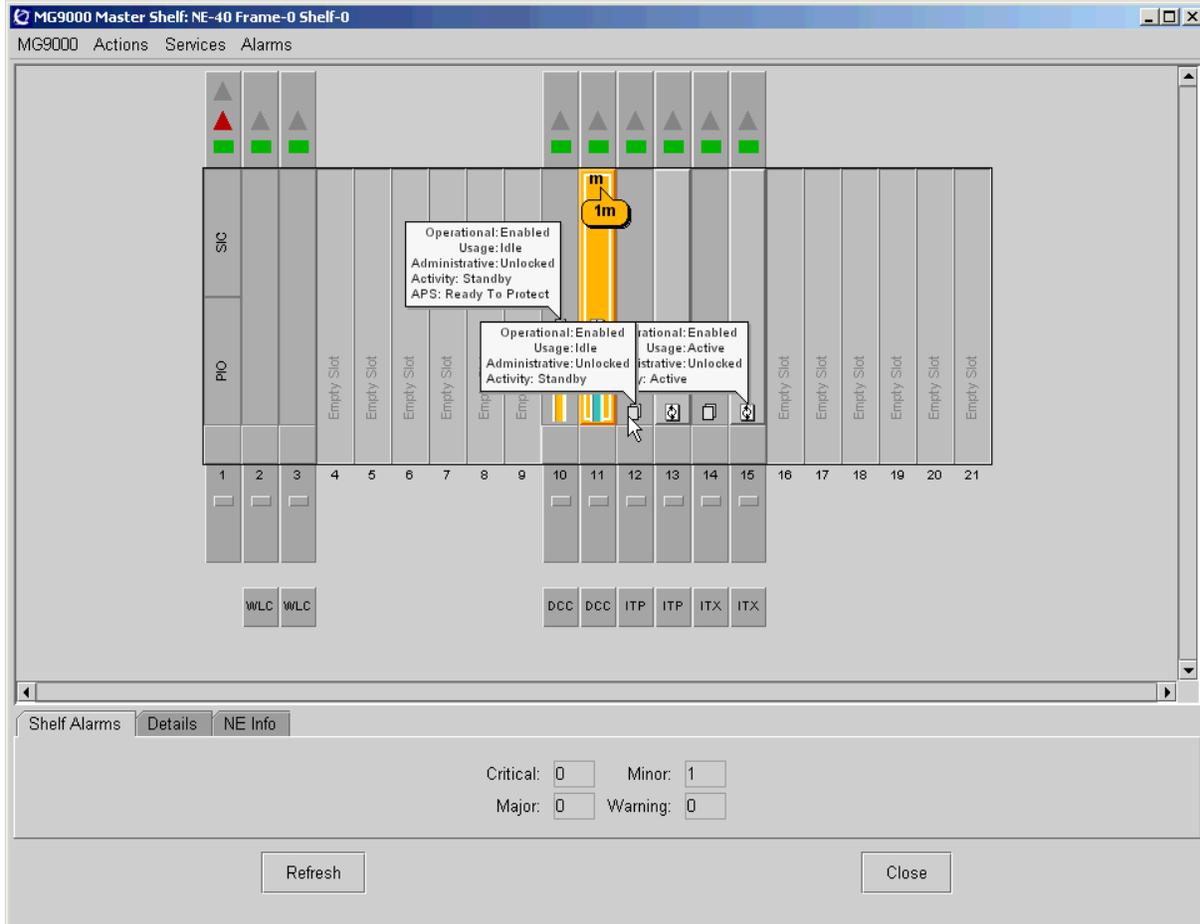
Shelf View with information balloons

In the Shelf View, by placing the cursor over the icon and clicking once on each card, the technician can retrieve information about the state of that card and link. The following figure shows the information balloon. To remove the balloon, click once again on the icon. The following information appears in the balloon:

- operational state
- card status
- card availability
- activity status
- link status

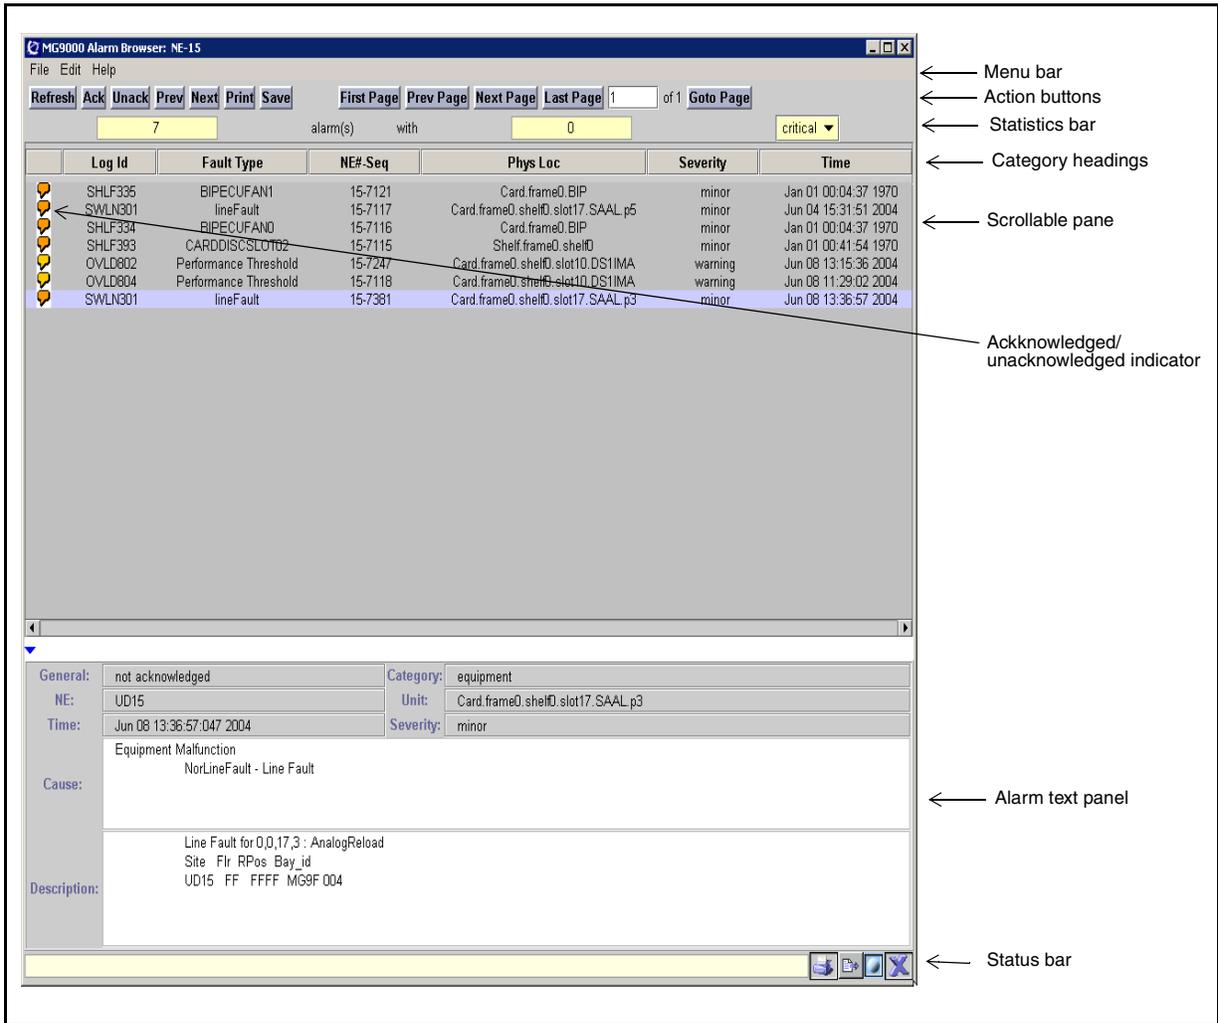
The Alarm Browser screen is used for alarm surveillance. The Alarm Browser screen is accessed from the “Alarm” menu option at the top of all screens. The Alarm Browser consists of multiple sections used to view and manage MG 9000 alarms. Once the alarm browser is open, the browser continues to update as new alarms are added or conditions change.

The following figure shows the Alarm Browser screen.

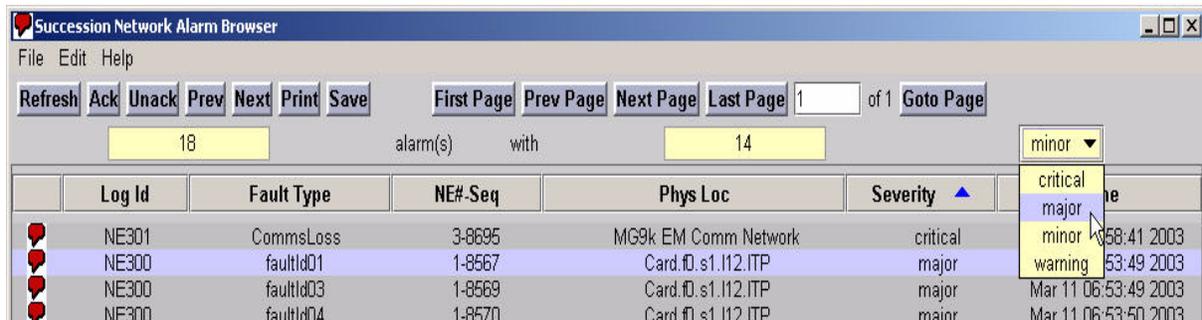
The Statistics Bar summarizes the total number of alarms in the scrollable pane and within that total, the number of a selected alarm type. The selected alarm type isolated in the summary can be selected from any of the available alarm types. For example, the following figure shows a Statistics Bar indicating that the scrollable pane has 20 alarms with one critical alarm. In the figure, the box to change alarm types is open and ready for selection.

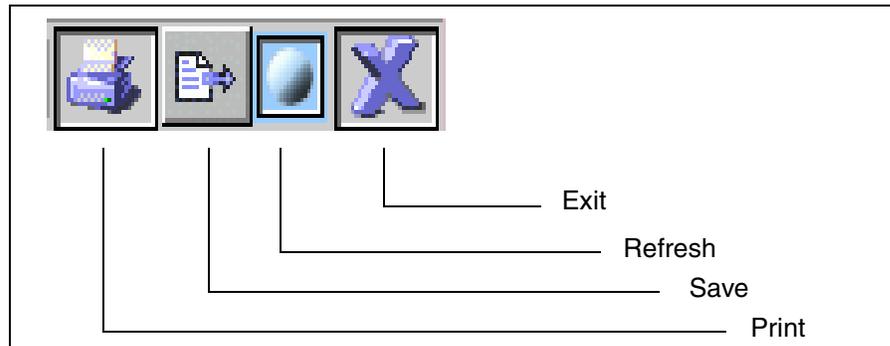
Status Bar icons

The icons on the status bar provide access to some of the features in the File menu. The following figure shows the status bar icons and their functions.

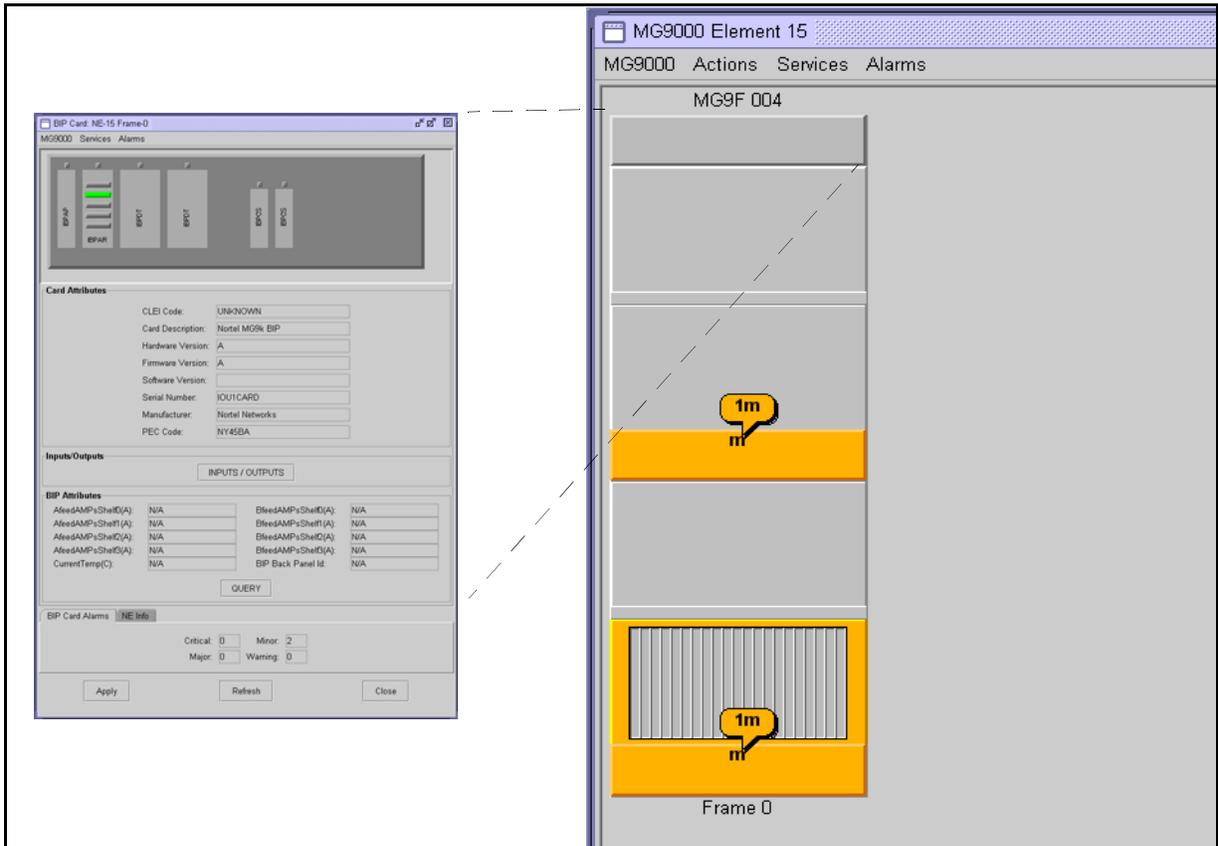
Frame and IBIP card Views

The following figure shows the Frame View and the IBIP Card View which is accessed by double-clicking on the IBIP within the Frame View.

The IBIP architecture has the IBIP as the main card and the following cards as sub-cards of this card:

- Alarm Processor card
- Alarm Relay card
- Dual Talk Battery card
- Current Sensor card

Viewing current frame-level alarms The frame alarm subsystem has a maximum of four links that connect the shelves to the BIP shelf. With these links, the shelves and the BIP shelf perform low-level non-mission critical communication. The BIP shelf receives the fan fail signals and lamp test/alarm cutoff (ACO) signal. The BIP reports the signals to the SIC card.

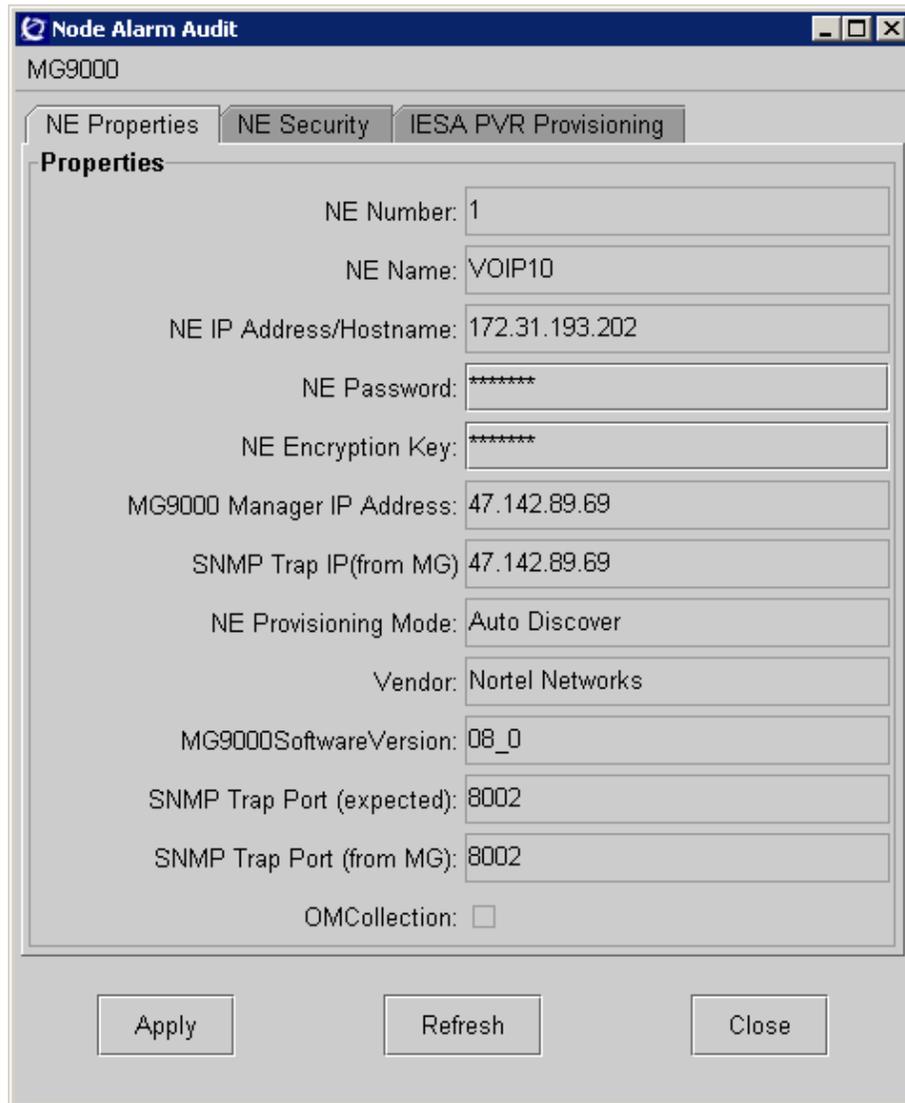
- From the menu bar, select Alarm->Audit NE alarms. The Node Alarm Audit view appears. The command can also be accessed from the NE desktop view for a specific NE. The following figure shows the Node Alarm Audit view.

The screenshot shows a window titled "Node Alarm Audit" with a sub-header "MG9000". It features three tabs: "NE Properties", "NE Security", and "IESA PVR Provisioning". The "NE Properties" tab is active, displaying a "Properties" section with the following fields:

NE Number:	1
NE Name:	VOIP10
NE IP Address/Hostname:	172.31.193.202
NE Password:	*****
NE Encryption Key:	*****
MG9000 Manager IP Address:	47.142.89.69
SNMP Trap IP(from MG):	47.142.89.69
NE Provisioning Mode:	Auto Discover
Vendor:	Nortel Networks
MG9000SoftwareVersion:	08_0
SNMP Trap Port (expected):	8002
SNMP Trap Port (from MG):	8002
OMCollection:	<input type="checkbox"/>

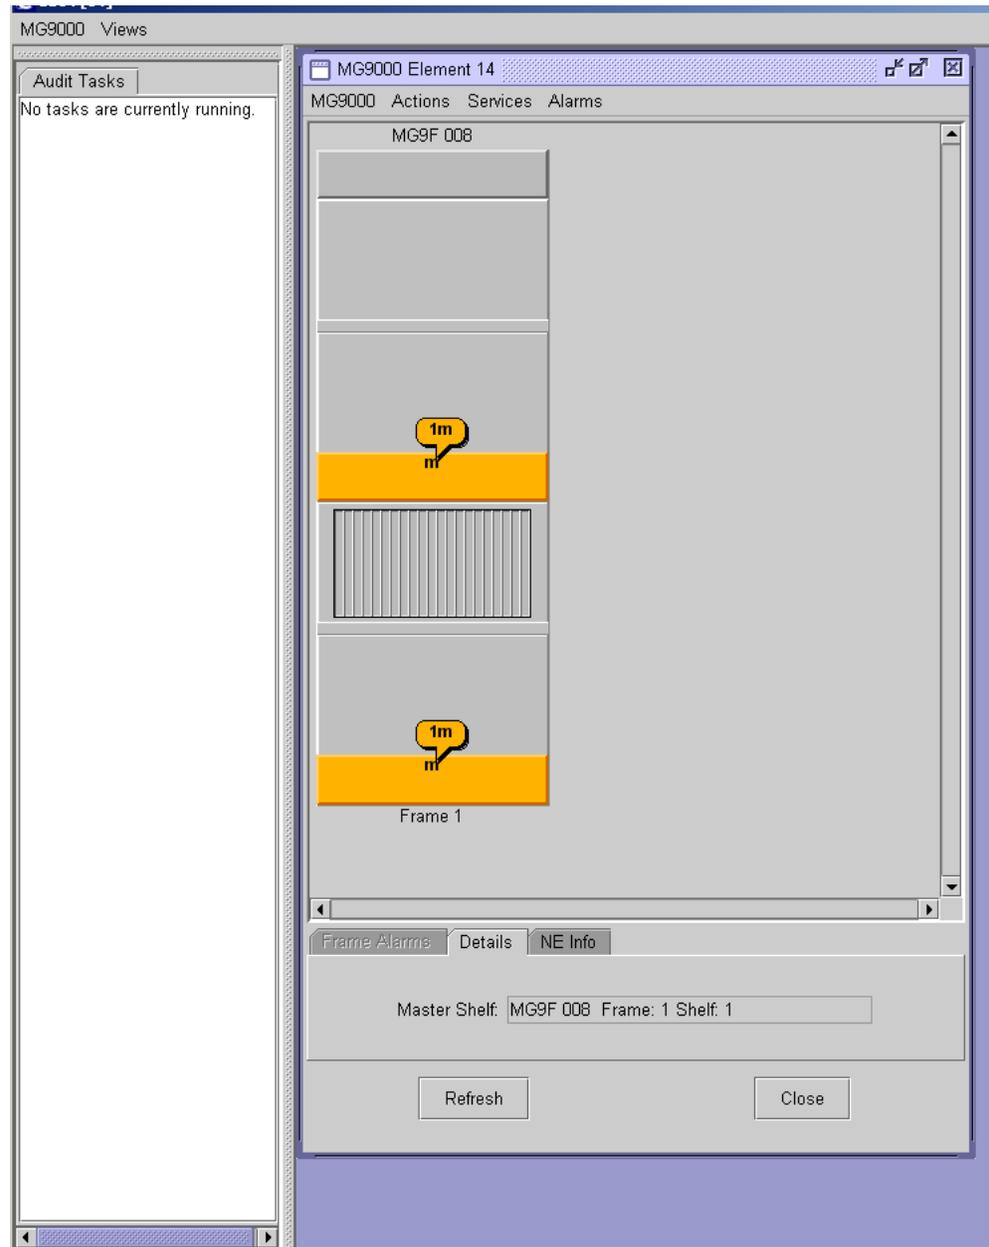
MG 9000 Frame View within the NE desktop view

- 1 At the Subnet View, double-click on the MG 9000 icon in the tree view on the left or on the MG 9000 icon in the MG 9000 Manager view on the right, to select the MG 9000 for which alarm information is to be viewed. The network element (NE) desktop view with the Frame View opens as shown in the following figure.

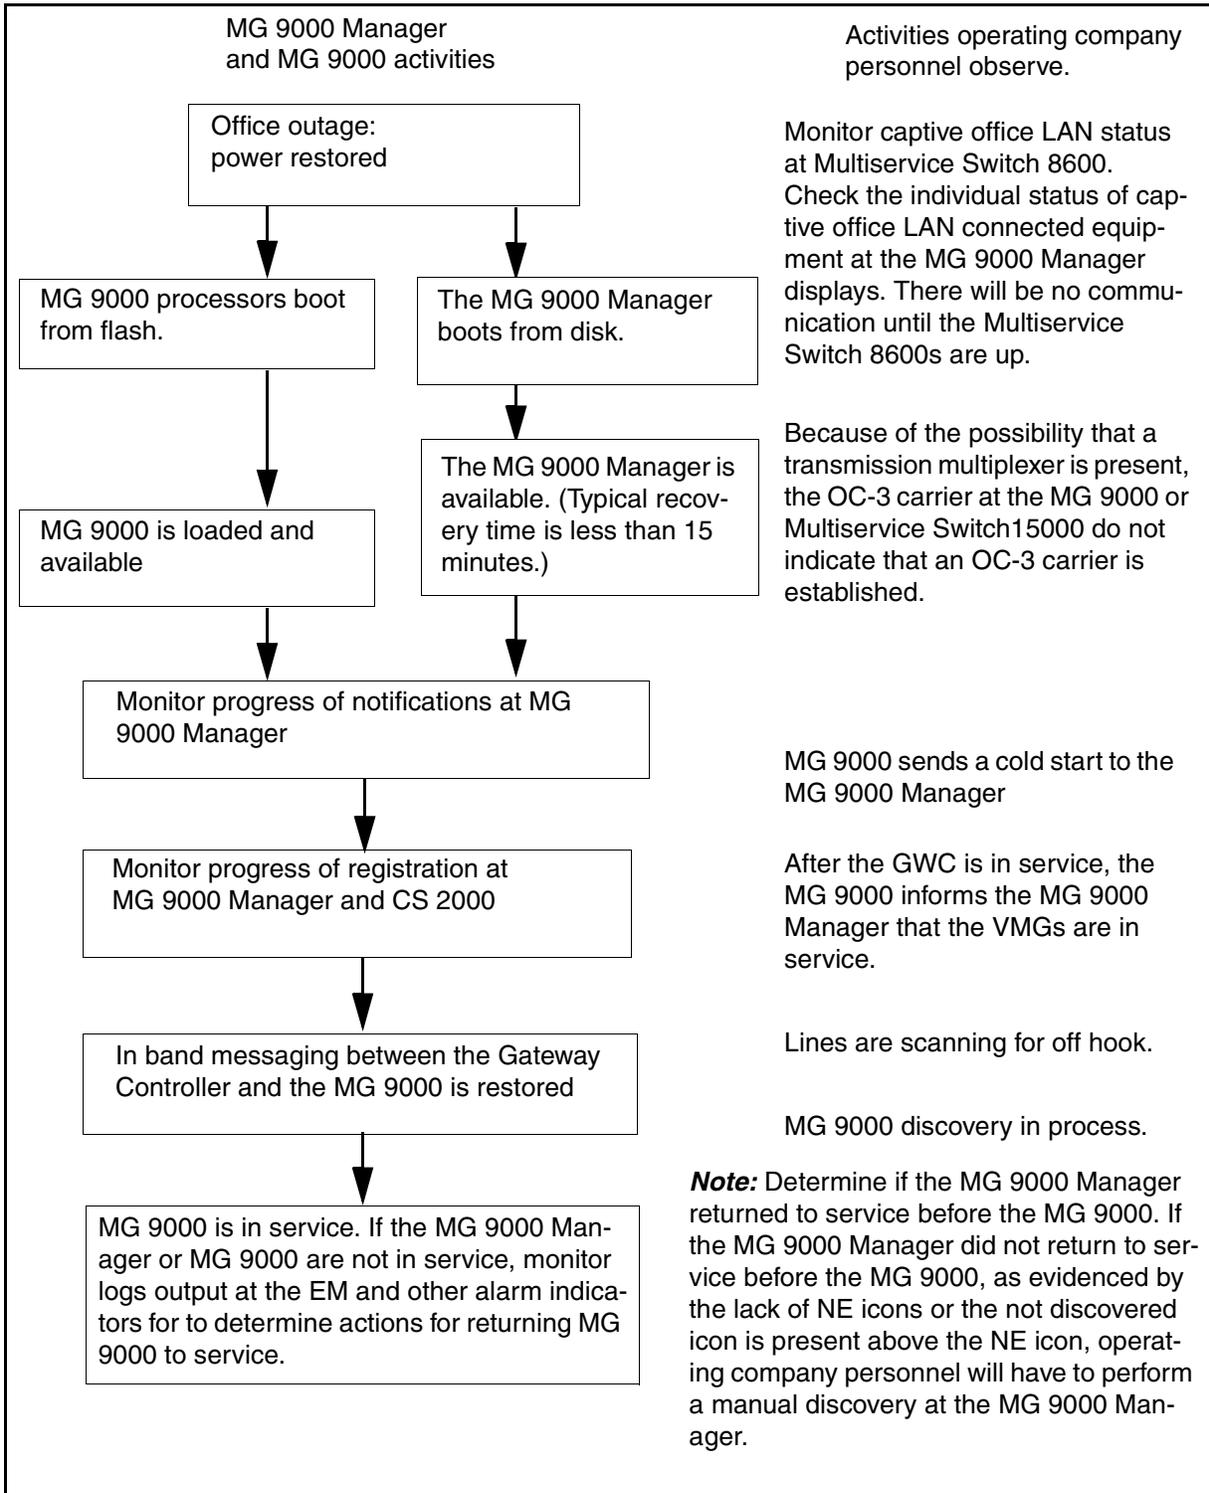
MG 9000 recovery activities

The following flowchart identifies the activities the MG 9000 performs to recover from an outage and the activities operating company personnel observe during recovery.

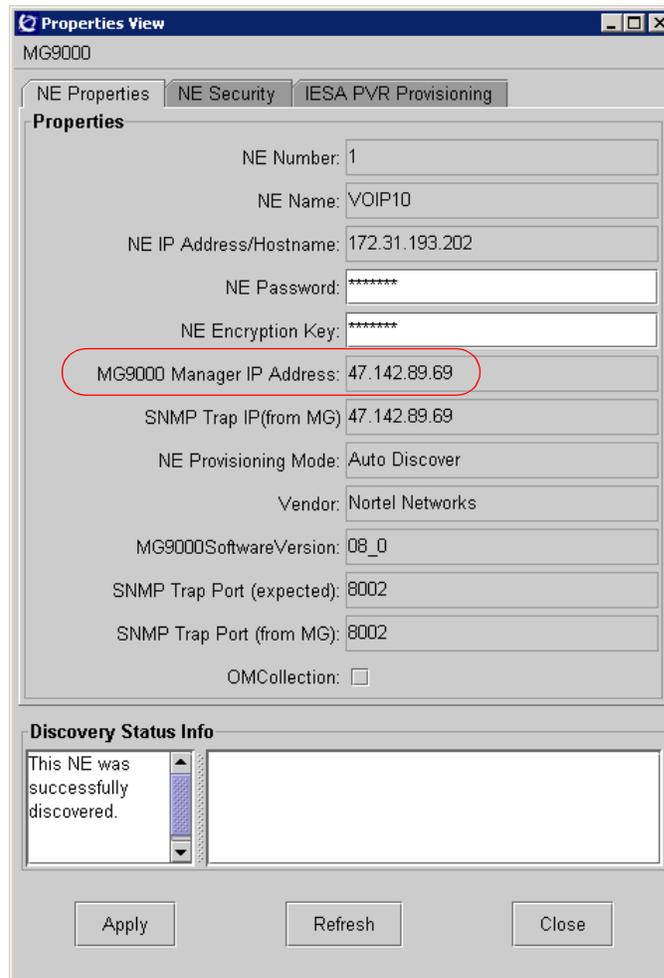
Properties View: an example showing the location of IP Address field

The following figure shows the location of the IP address data (circled in red). The address in the figure is intended as an example; your data depends on your network configuration.

The screenshot shows a window titled "Properties View" for "MG9000". It has three tabs: "NE Properties", "NE Security", and "IESA PVR Provisioning". The "NE Properties" tab is active. The "Properties" section contains the following fields:

NE Number:	1
NE Name:	VOIP10
NE IP Address/Hostname:	172.31.193.202
NE Password:	*****
NE Encryption Key:	*****
MG9000 Manager IP Address:	47.142.89.69
SNMP Trap IP(from MG):	47.142.89.69
NE Provisioning Mode:	Auto Discover
Vendor:	Nortel Networks
MG9000SoftwareVersion:	08_0
SNMP Trap Port (expected):	8002
SNMP Trap Port (from MG):	8002
OMCollection:	<input type="checkbox"/>

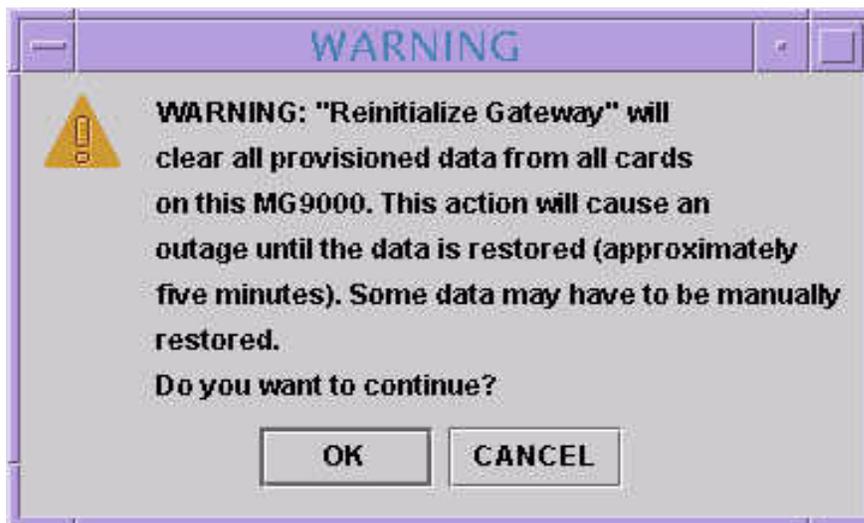
Warning message in response to Reinitialize Gateway

- e After setting the configuration state to “Reinitialize gateway”, a warning message appears requesting a reply before continuing. Select OK.

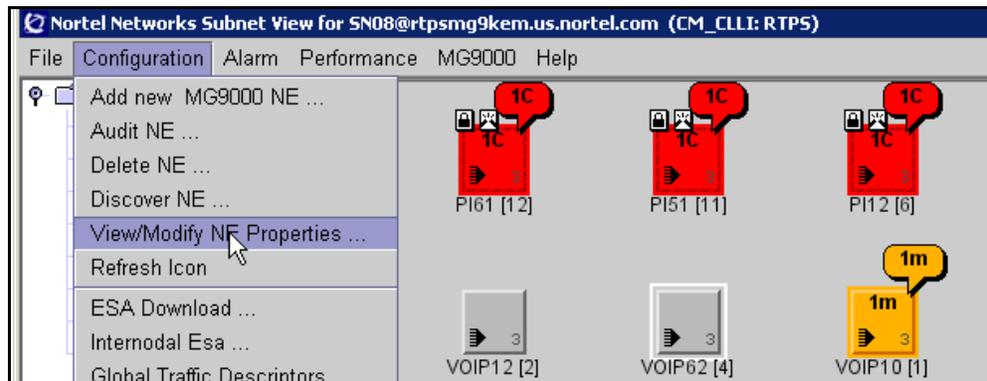
- 6 Obtain the IP address of the MG 9000 Manager server (not the mid-tier or client). At the Subnet View, select Configuration->View/Modify NE Properties from the menu bar.

Subnet View accessing Configuration ->View/Modify NE Properties

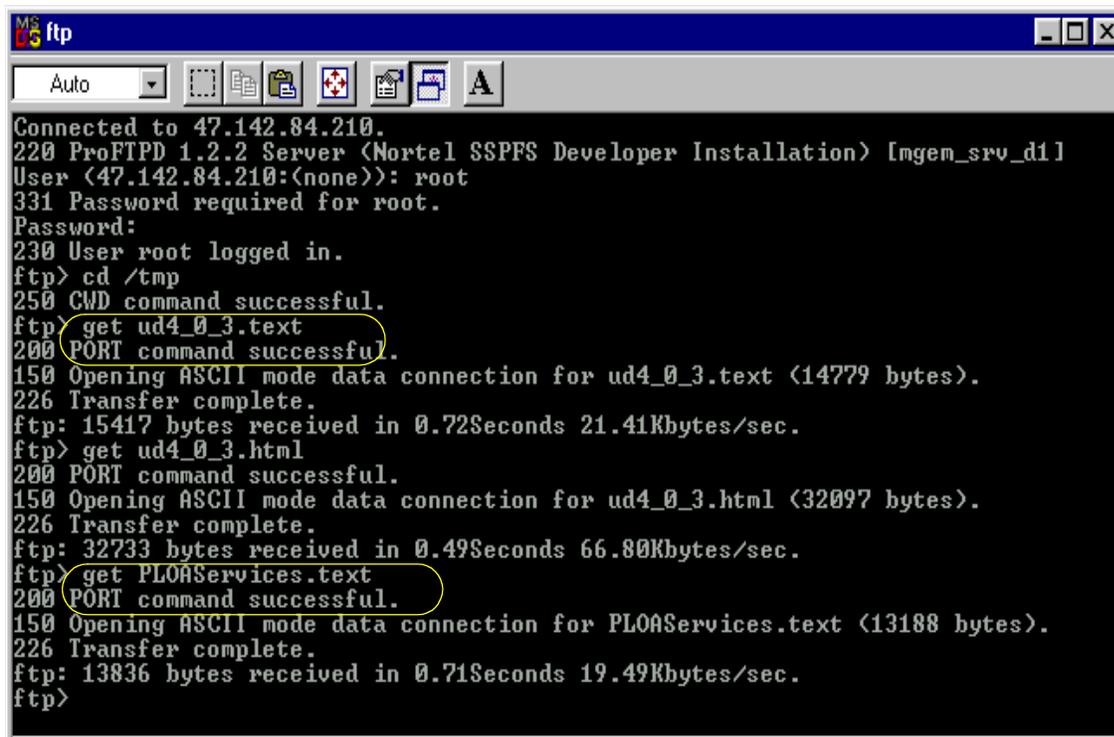
The following figure shows an example of an FTP session. The VMG files have the following format: <VMG name>.txt, where the VMG name is that assigned by your network administrator.

FTP session: an example of a file transfer to a secure location

A screenshot of a Windows-style FTP client window titled 'ftp'. The window has a menu bar with 'Auto' and several icons. The main area displays a text-based FTP session log. The log shows the client connecting to 47.142.84.210, logging in as 'root', and then transferring three files: 'ud4_0_3.text', 'ud4_0_3.html', and 'PLOAServices.text'. Each file transfer is preceded by a 'get' command and followed by status messages indicating the transfer is complete and showing the number of bytes received and the transfer rate. The 'get' commands and the 'PORT command successful' messages are circled in yellow in the original image.

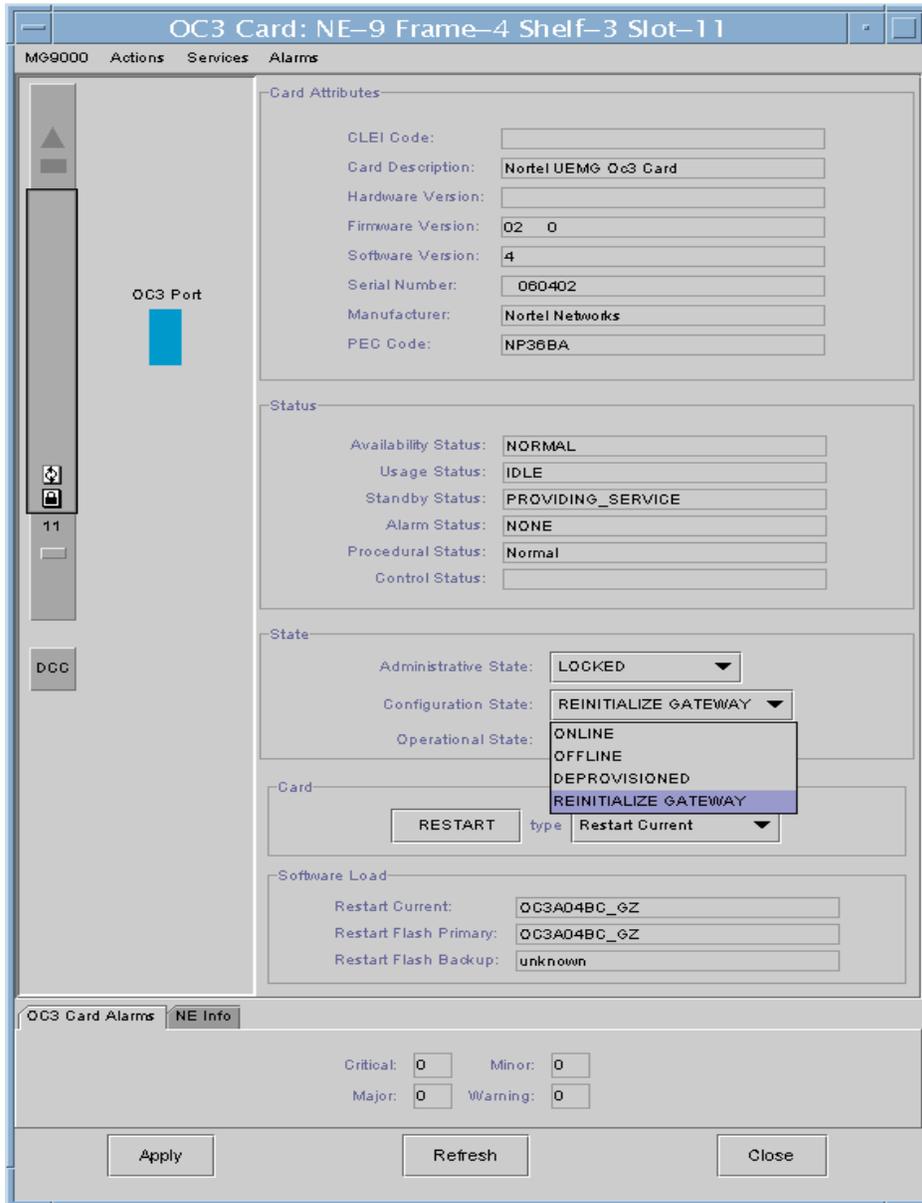
- 2 From the Frame View, double click on the master shelf. The Shelf View appears.
- 3 From the Shelf View, double click on the inactive OC-3/DS1 IMA/GigE card. The OC-3/DS1 IMA/GigE Card View appears.
- 4 Set the Administrative State of the Inactive OC-3/DS1 IMA/GigE card to Forced Locked and respond to the message.
- 5 From the Shelf View, double click on the active OC-3/DS1 IMA/GigE card. The OC-3/DS1 IMA/GigE Card View appears.
- 6 Set the Administrative State of the active OC-3/DS1 IMA/GigE card to Forced Locked and respond to the message.
- 7 In the OC-3/DS1 IMA/GigE Card View, from the Configuration State pull-down menu, select Reinitialize Gateway as shown in the following figure.

OC-3 Card View

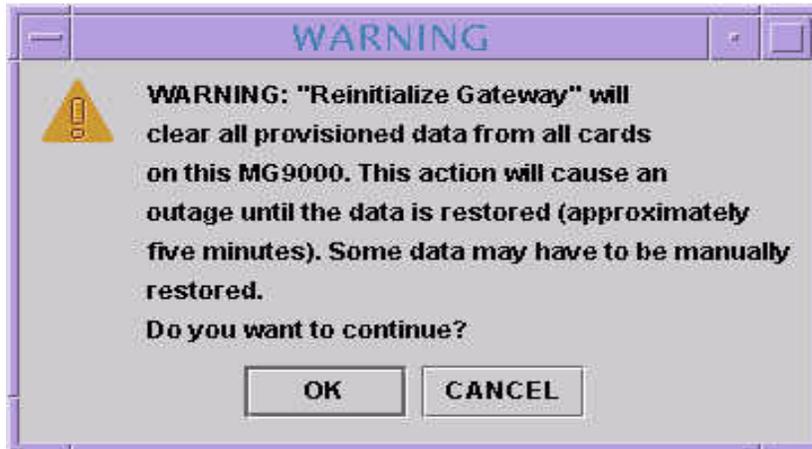
8 The system responds with the following warning message.

Warning message in response to Reinitialize Gateway command

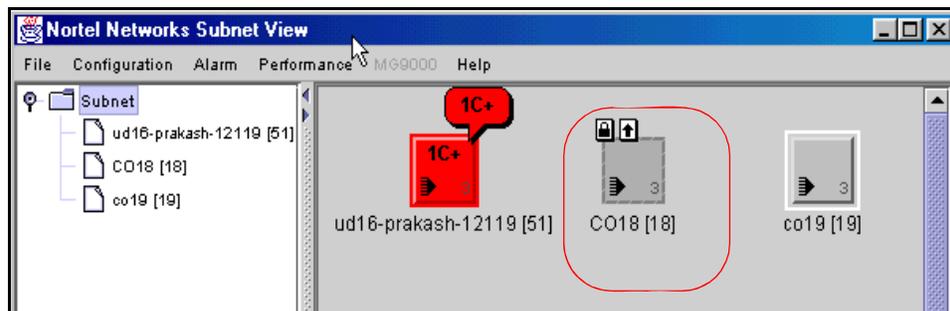
- 9 To continue, click OK and proceed to step [10](#). Otherwise click Cancel and go to step [11](#).
- 10 The MG 9000 responds with a Card State Change trap indicating that the configuration state is set to reinitialize and that the MG 9000 will clear persistence and restart. At the Subnet View, a “bomb” is displayed on the network element icon. After a period of time, the Subnet View is updated to show the up arrow indicating discovery and audit. When the operation is complete, the NE icon will be free of these added indicators. The following figure shows the NE is in discovery.

Subnet View showing degraded network element

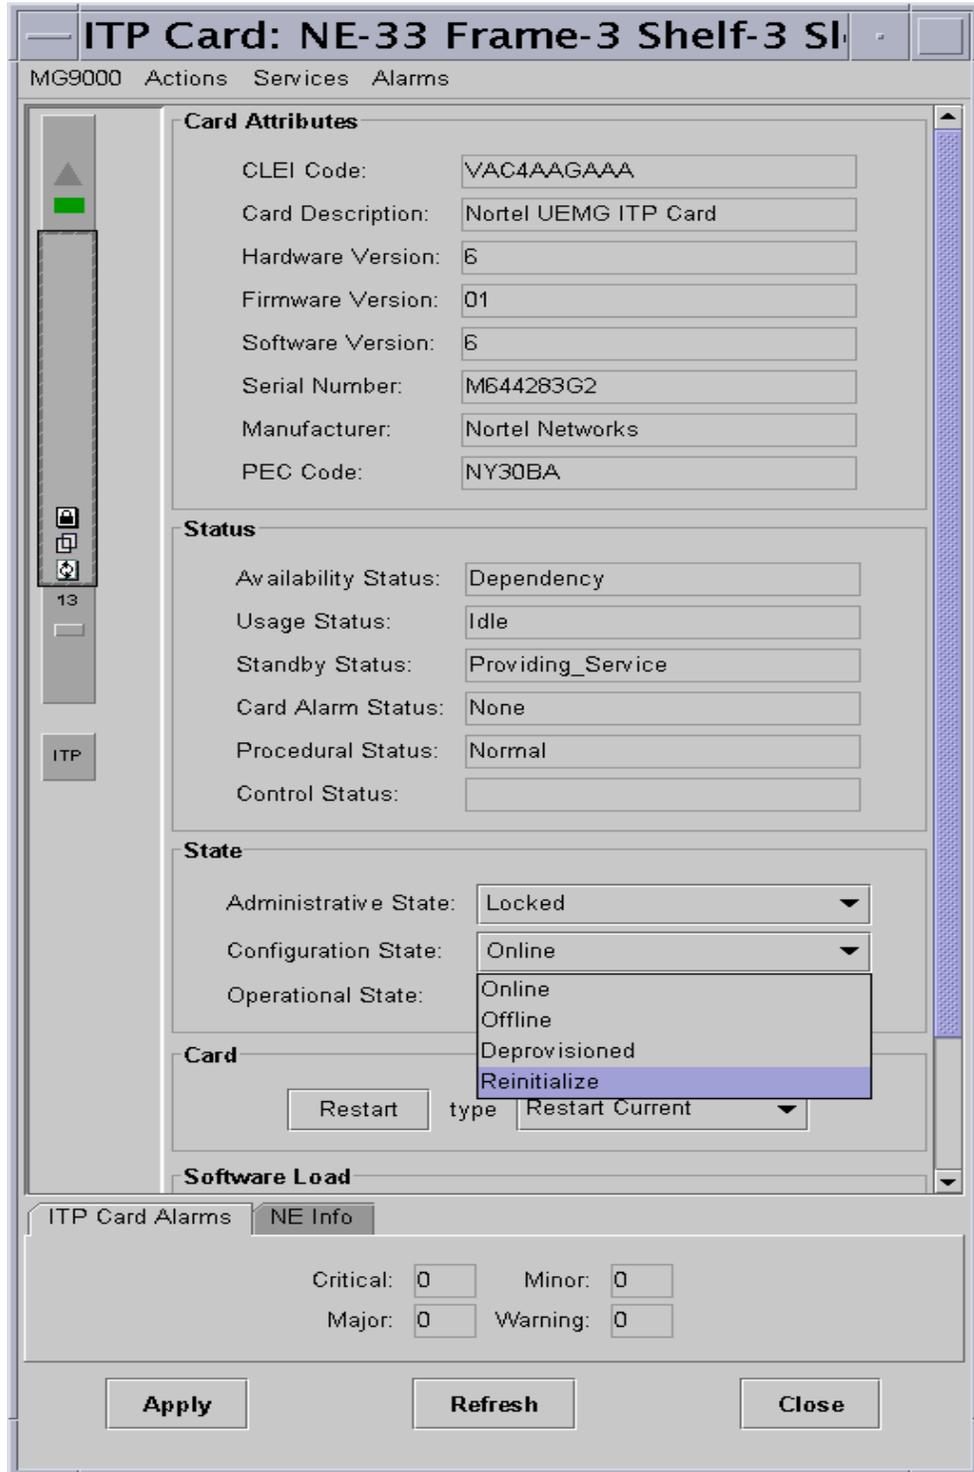
In the State pane, set the Configuration State to Reinitialize. The following figure shows the location of the Reinitialize command.

Card View Reinitialize command

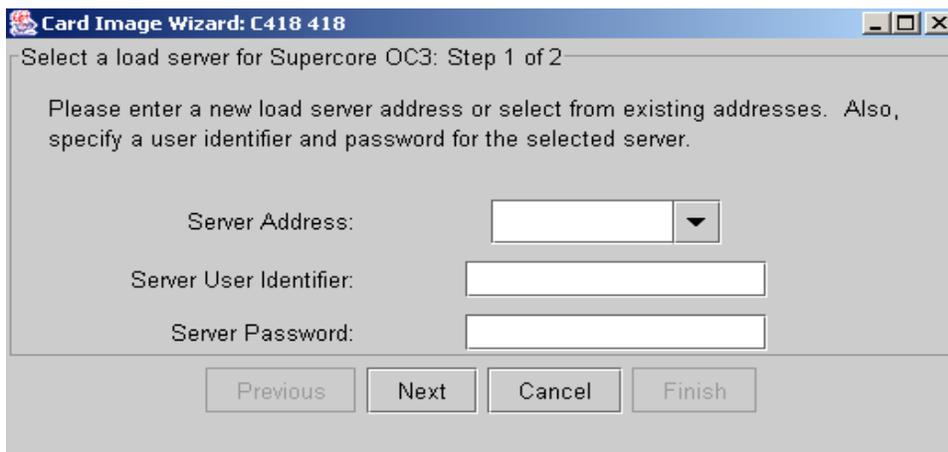
- 6 Click on the Image button to begin the software image of the selected card using the default values provided in the Image Type Data pane.
Go to step [9](#)
- 7 Click on the Configure button. The Card Image Wizard Select a load server: Step 1 of 2 appears as shown in the following figure.

Card Image Wizard, Select a load server: Step 1 of 2

From this wizard, the default server IP address, the server user identifier, and the server password can be changed. After all changes are made click Next. The Card Image Wizard Specify a directory: Step 2 of 2 appears as shown in the following figure.

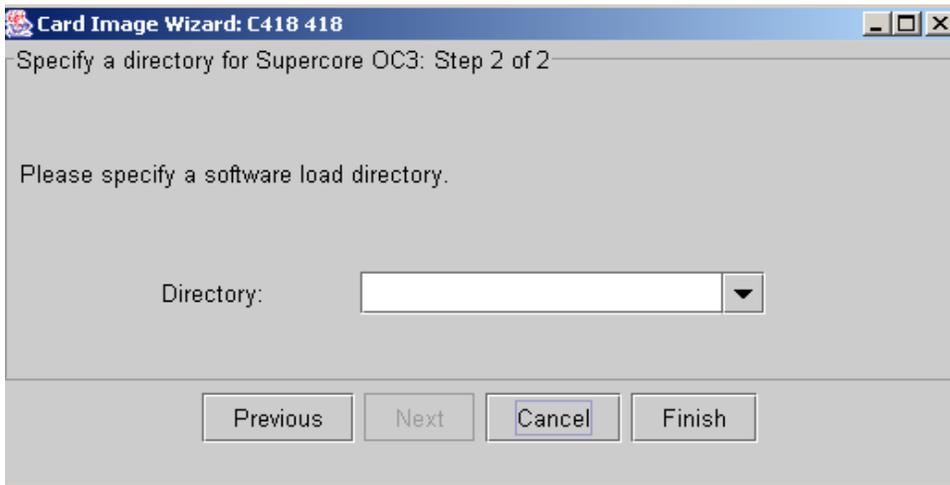
Card Image Wizard, Specify a directory: Step 2 of 2

From this wizard step, the default directory can be changed. Click Finish.

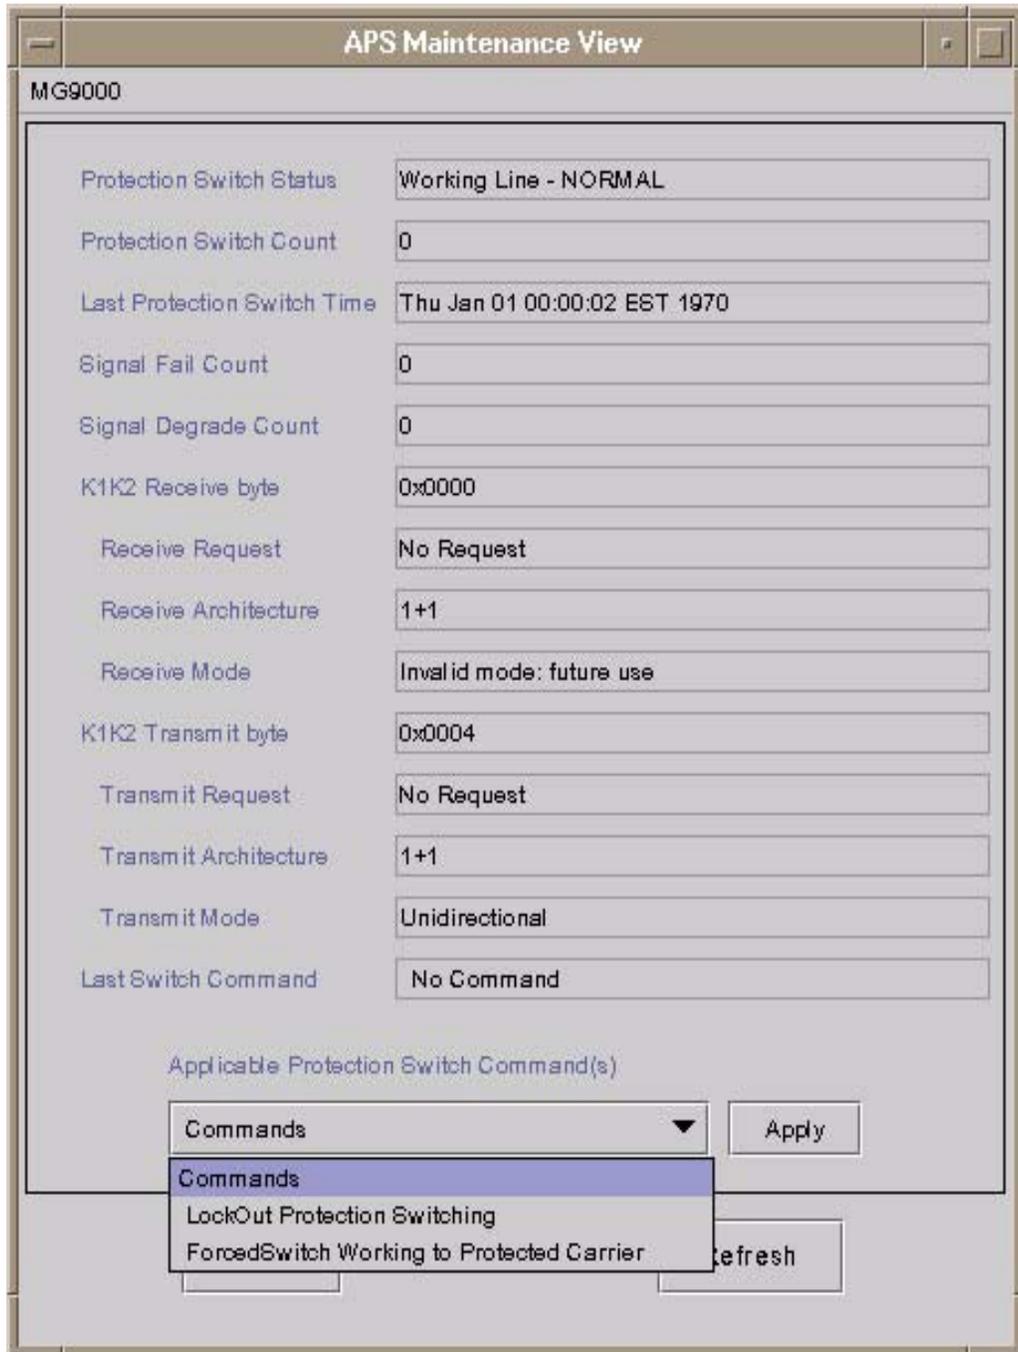
The Protection Switch Commands may only be exercised from the APS Maintenance View launched from the OC-3 port on the active OC-3 card. The APS Maintenance View is shown next.

APS Maintenance View with protection switch commands shown

Note: The list of commands displayed varies according to the state of the carrier. The Commands pull-down is only accessible on the active card.

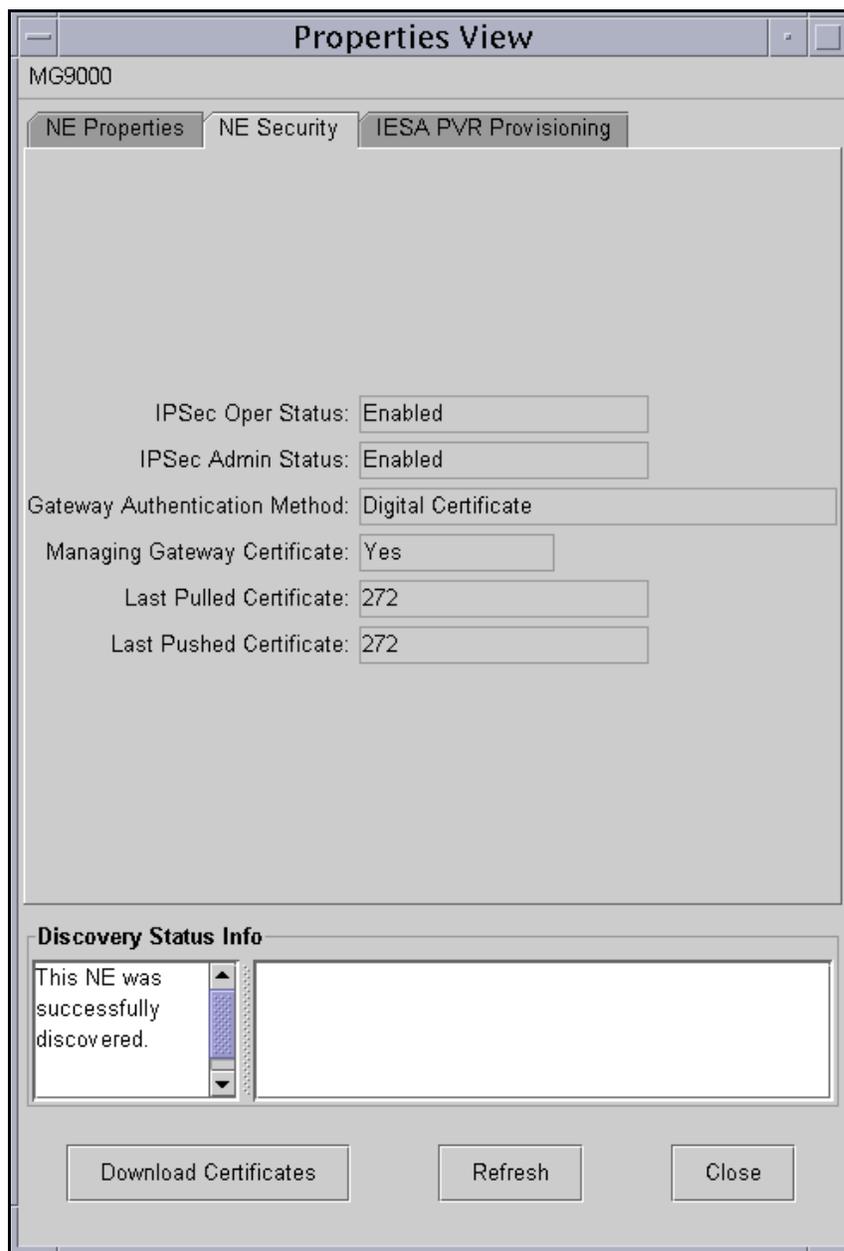
- 1 Choose a NE and select **Configuration > View/Modify NE Properties**. The Properties View appears.
- 2 Click the **NE Security** tab. The **NE Security** view appears:

Properties View showing the NE Security Properties View
