MG 9000 Fault Management

New in this release

The following sections detail what is new in MG 9000 Fault Management for release (I)SN09FF.

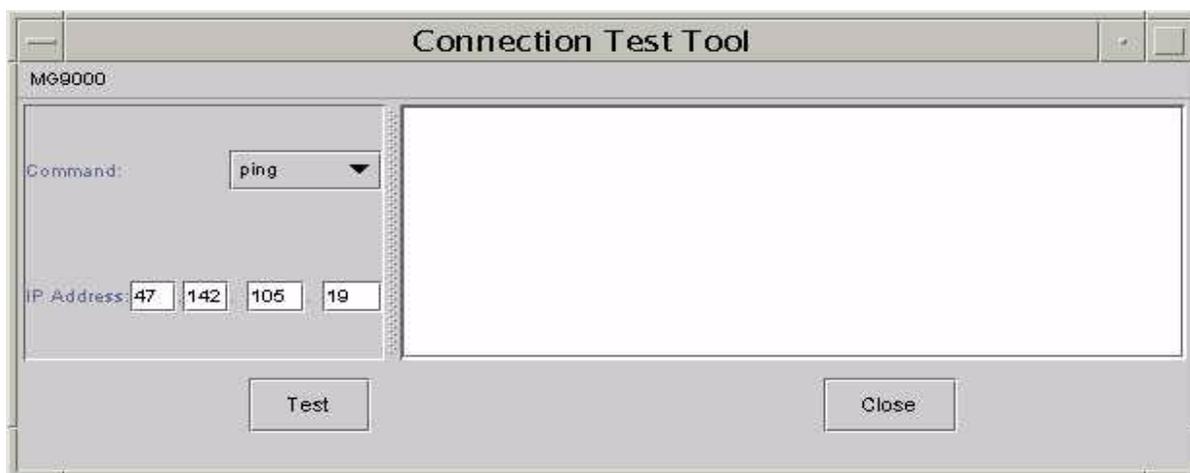
- 2 Select the command to be performed from the pull-down menu. The following figure shows the Connection Test Tool View and the Command pull-down menu.

Connection Test Tool View

- 3 Enter the IP address in the IP Address field.
Note: The MG 9000 cannot be pinged until the MG 9000 has been commissioned with a cold start received by the MG 9000 Manager.
- 4 Click on Test to run the test tool. The results are displayed in the text area on the right.
- 5 This procedure is complete.

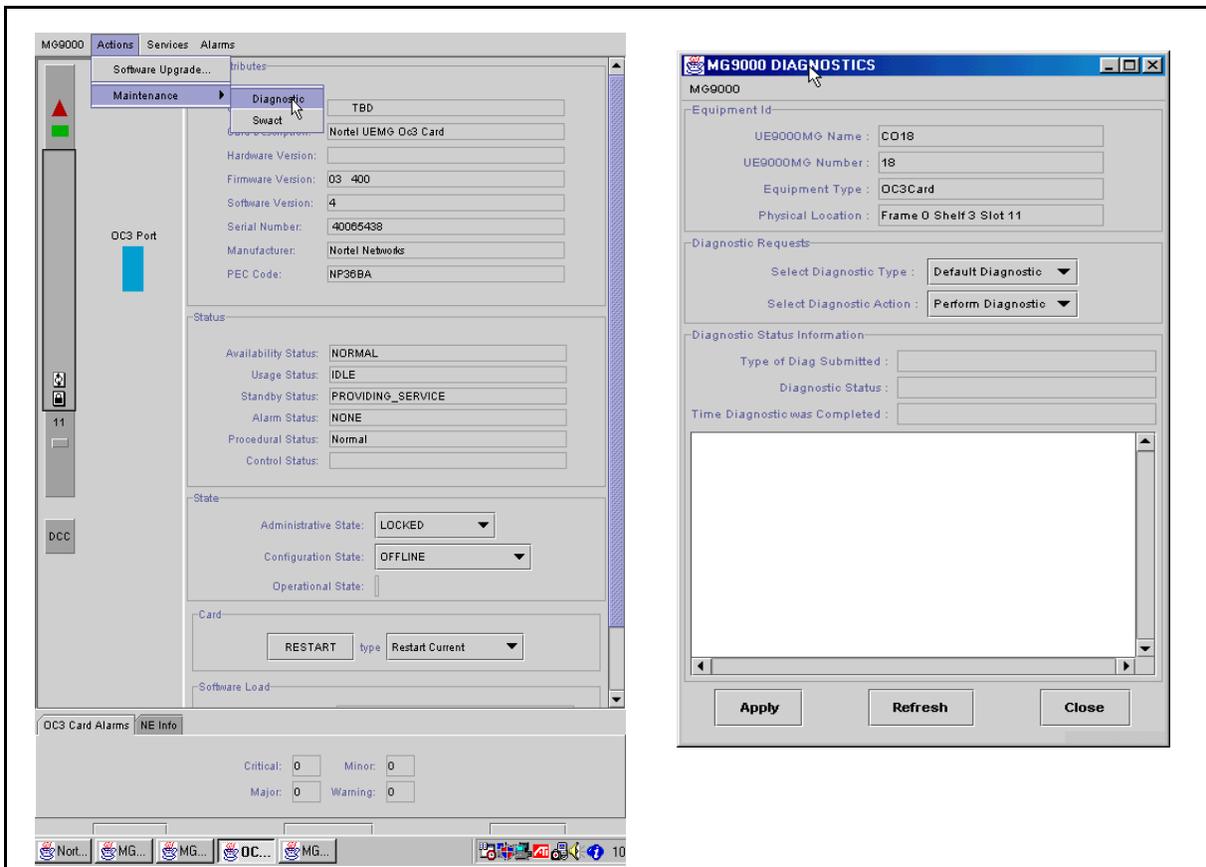
- 1 At the Subnet View, select the MG 9000 on which diagnostics are to be performed. The Frame View appears.
- 2 Double click on the shelf to open the Shelf View.
- 3 Double click on the card on which diagnostics are to be run. The Card View appears.
- 4 Verify that the administrative state of the card is set to unlocked. To Unlock the card, perform the [Unlocking a card](#) procedure.
- 5 From the menu bar on the top left of the Card View, select Actions->Maintenance->Diagnostic as shown in the following figure. The following MG 9000 Diagnostics View appears.

Card View and MG 9000 Diagnostic View

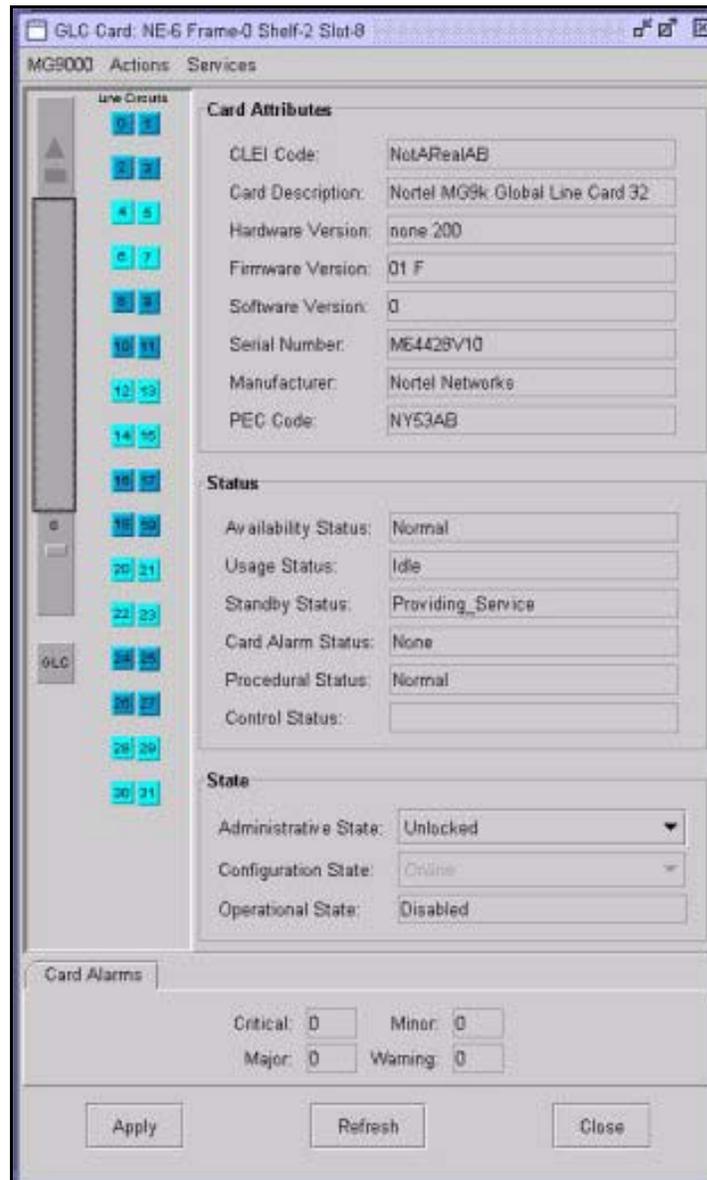
GLC Card View shows the 4 lines circuits associated with a circuit controller by alternating the line circuit graphic color from dark blue to light blue. The following figure shows the GLC Card View and the allocation of circuits to circuit controllers.

GLC Card View showing allocation of circuits to circuit controllers

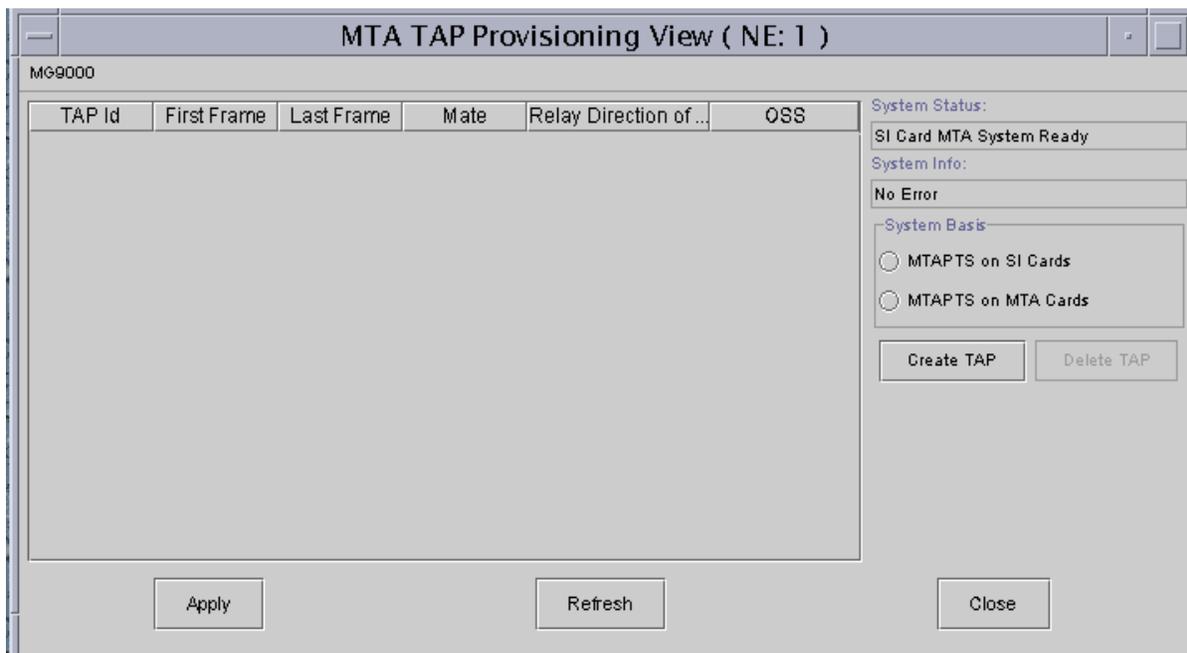
The following figure shows the MTA TAP Provisioning View screen.

MTA TAP Provisioning View Screen

Field	Explanation
TAP Id	The test access point (TAP).
FirstFrame	The first frame which indicates the beginning of the range of frames for a particular TAP.
LastFrame	The last frame which indicates the end of the range of frames for a particular TAP.
Mate	If the TAP can be used to make up a 4-wire pair, this field contains the mate TAP.

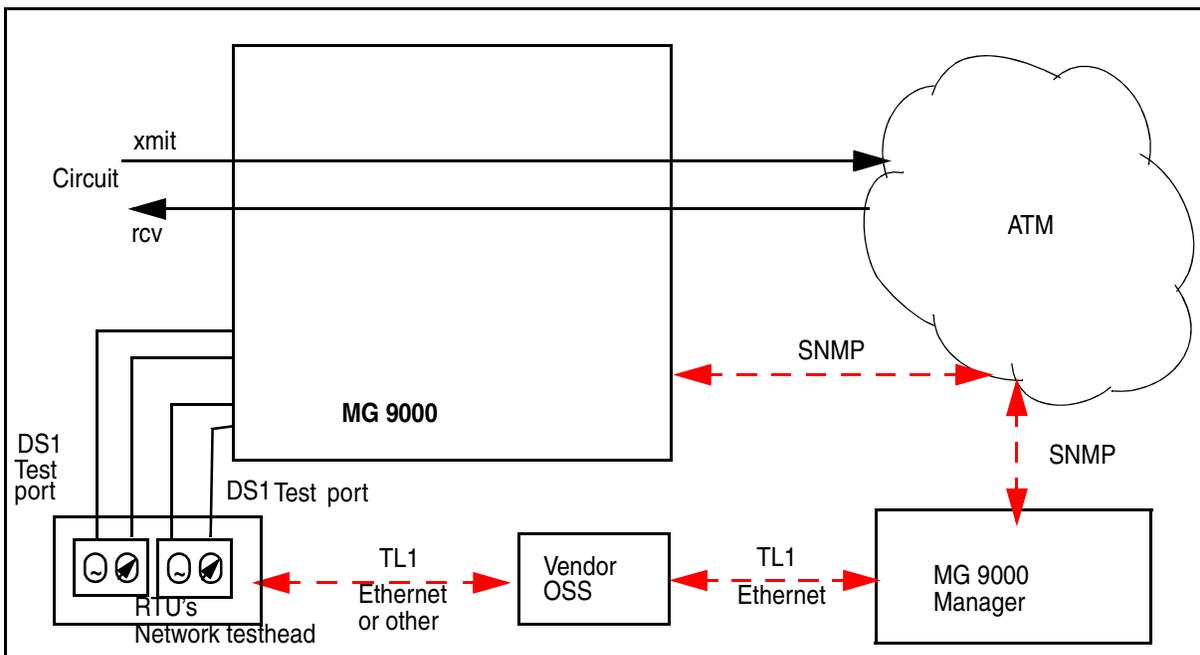
The following figure shows the MG 9000 digital test access using an RTU.

MG 9000 DTA testing

To provide connectivity between the RTU and the MG 9000, DS1 ports on the MG 9000 must be defined as DFADs and/or TADs, and those

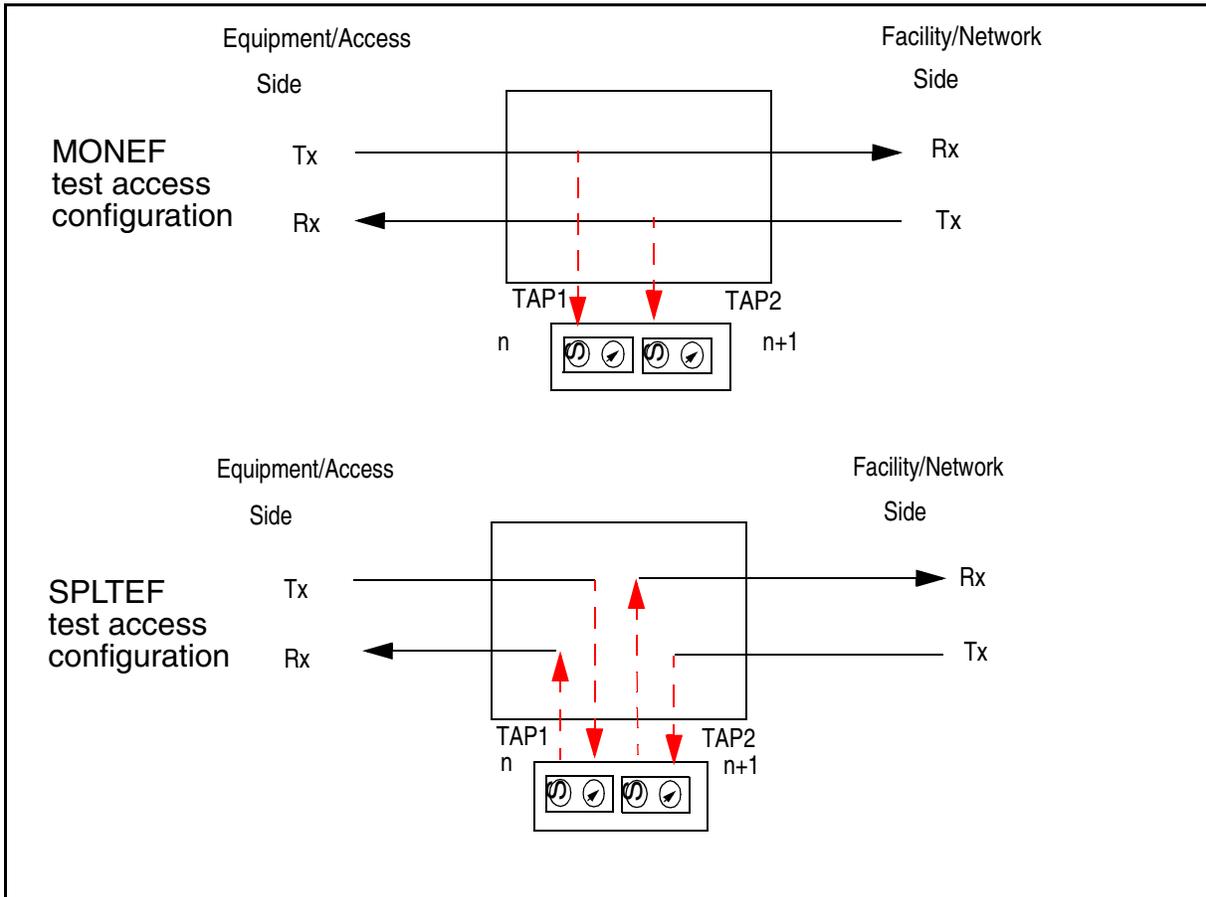
The following figure shows the two DFAD test access modes

DFAD MONEF and SPLTEF test access modes

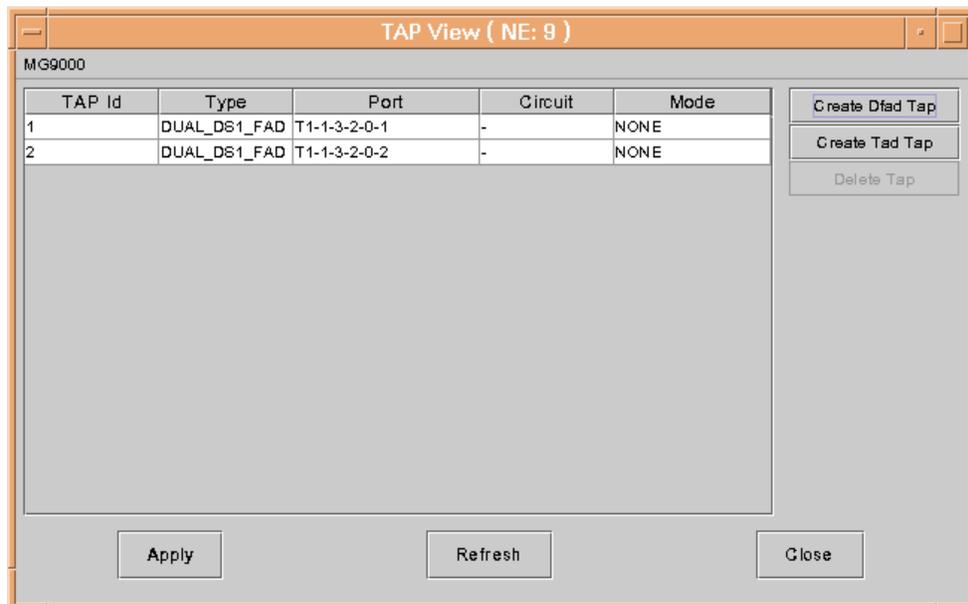
- 10 Click on Equipment Side Port Select button and a NE Selector window appears. To select the card and port, click OK. At this point the card and port information will be entered in the empty field in the Provision DS1 Dual FAD TAP screen.
- 11 Select the facility side port by clicking on the Facility Side port select button.
- 12 The NE Selector window appears. Select the Facility Side card and port by clicking OK. The port information appears in the Facility.
- 13 Select Equip TAP ID, based on the vendor requirements and local procedure.
- 14 Click OK.
- 15 The following window appears with the TAP information filled in.

TAP View with TAP data entered

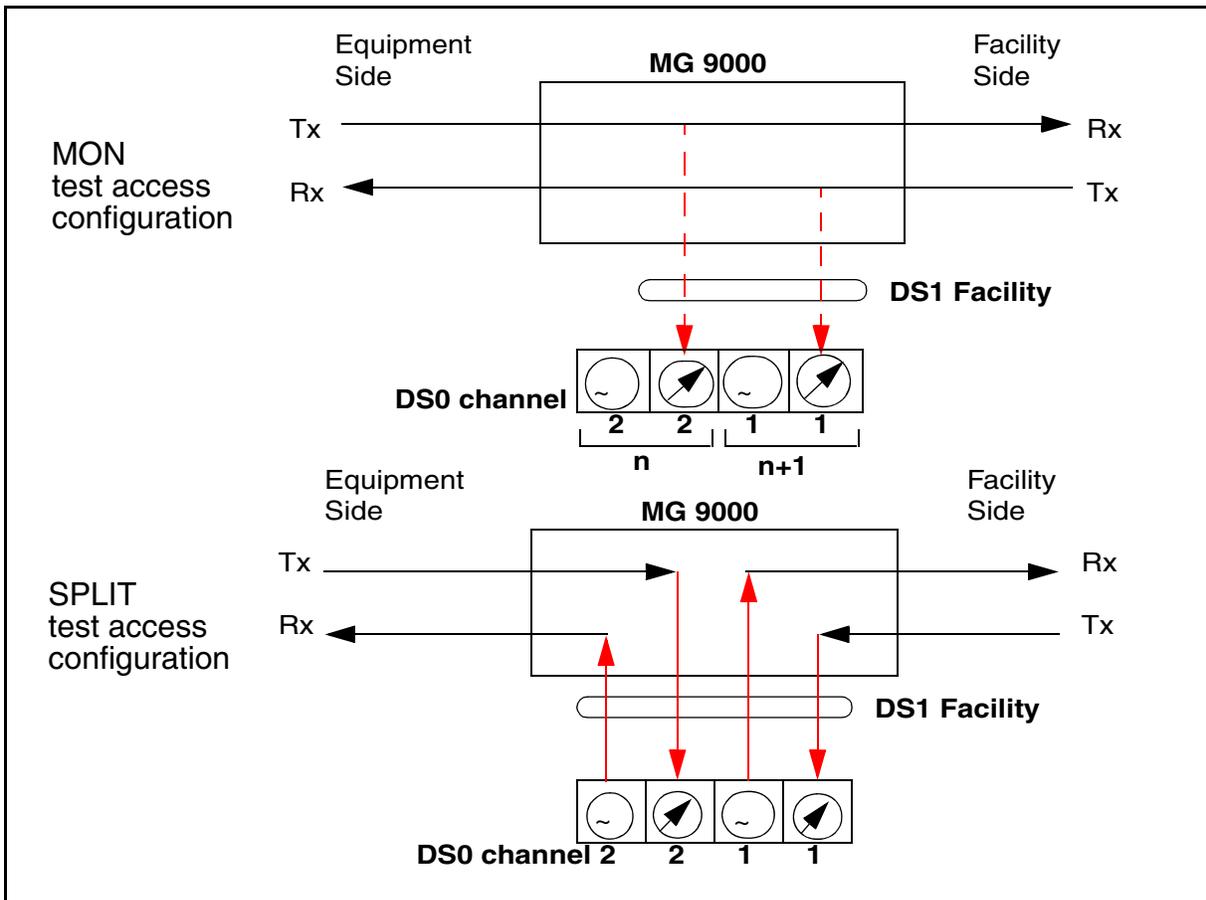
TAD When provisioning a TAD, twelve contiguous TAPs are automatically allocated over the DS1. Each TAP is associated with two adjacent channels within the DS1 TAD. The first TAP is associated with channel 1 and channel 2, the second TAP is associated with channel 3 and channel 4. This sequence continues until the twelfth TAP is associated to channel 23 and channel 24. The odd channel of the TAP is used for connections to the facility side of the circuit under test and the even channel number of the TAP is used for connections to the equipment side of the circuit. TAD test access only supports single channel DS0 bundles. TAD employs the following two test access modes.

The following figure shows the two TAD test access modes

TAD MONEF and SPLTEF test access modes

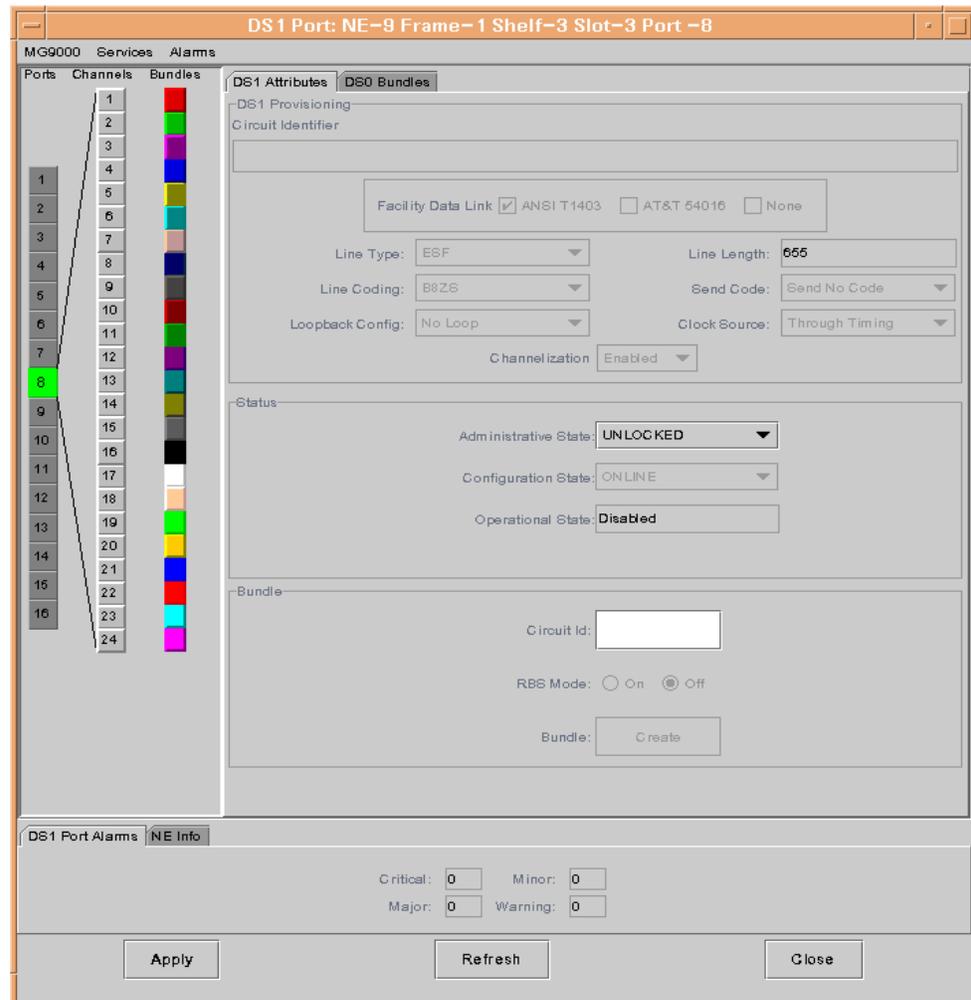
If	Do
the DS1 port is already wired to the test head through the local wiring panel, such as a DSX panel	Step 6
the DS1 port is not wired to the test head	Go to the local wiring panel (such as DSX panel) according to local procedures and wire the DS1 to the test head and return to this step.
- 6 Set the port to On line.
- 7 In the DS1 View, set Channelization to Enabled. At this point the channels in the left side of the DS1 View will turn blue.

DS1 Port View with Channelization Enabled

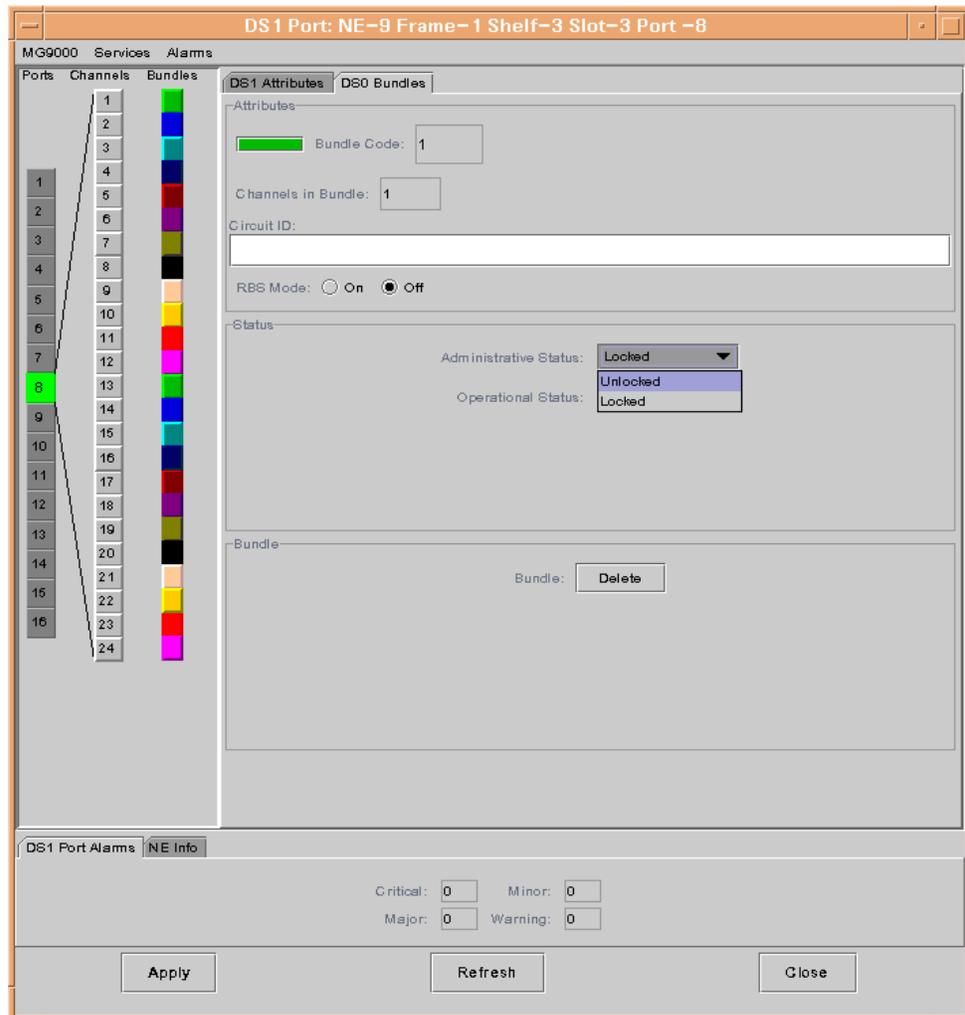
- 8 Unlock the port.
The Operational state becomes Enabled.
- 9 Click on each channel then click on Bundle Create. (Robbed bit signaling [RBS] default = Off.) Repeat this step for all 24 channels in order from 0 to 23.
- 10 Then unlock each bundle by double clicking and changing the Administrative state to Unlocked. Repeat this step for all 24 channels in order from 0 to 23.

DS1 Port View unlocking bundles

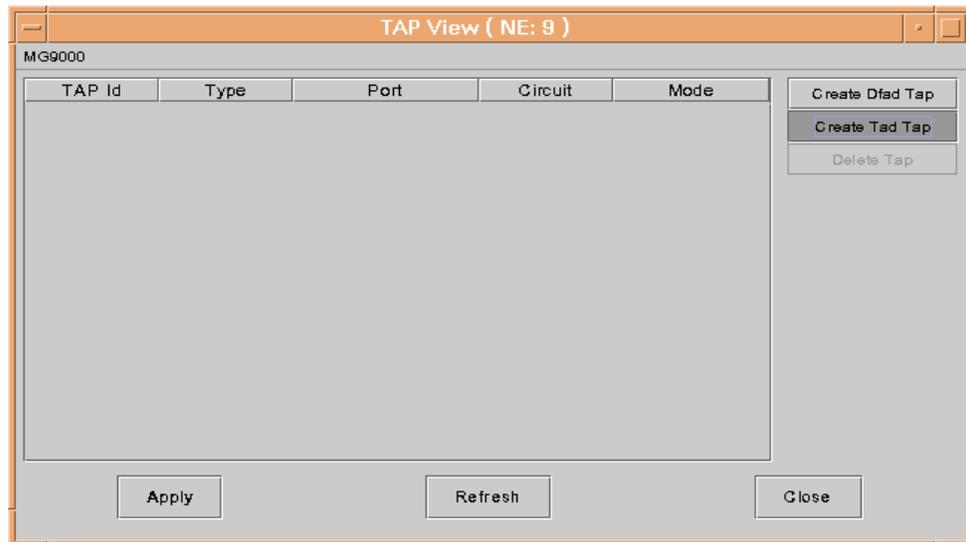
- 11 At the Services menu, select DTA Test Manager. This brings up the TAP view.
- 12 Select Create TAD TAP.
A Provision DS0 TAD TAP window appears.

Creating a TAD TAP from the TAP View

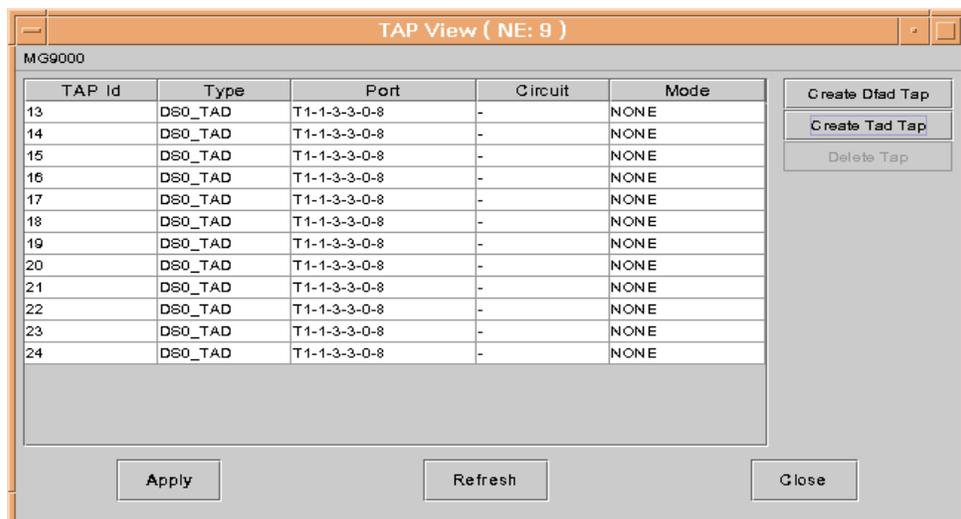
- 13 Click Select. This brings up the NE-1 Selector window.
- 14 Choose the card and port to act as the TAD ports and click OK.
- 15 Enter the TAP ID value according to vendor requirements and local procedures.
- 16 Click OK. The Provisioned DS0 TADs appear in the TAP View window. Click Close.

Provisioned DS0 TADs in TAP View

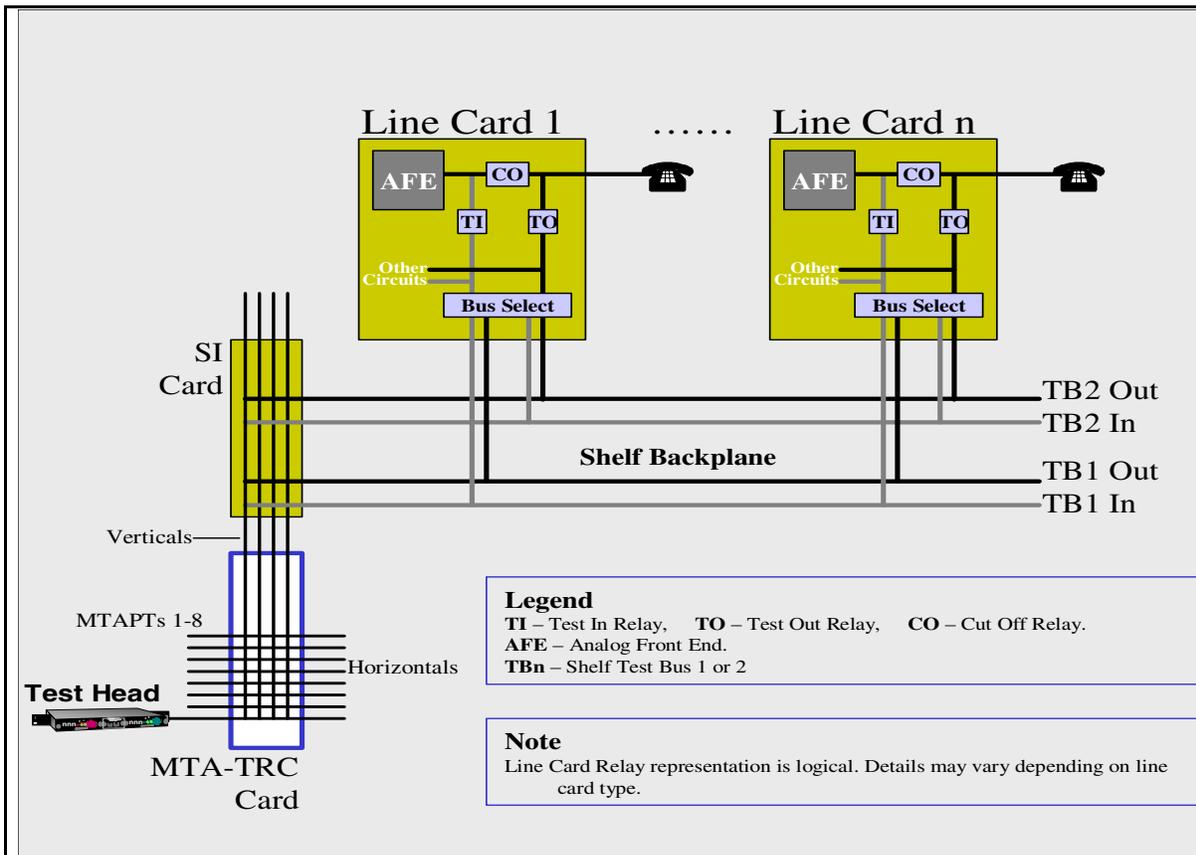
The following figure shows the cut-off (CO) relay in each of the supported line card types.

Cut-off relay on line cards

This procedure provides steps on activating, querying, and deactivating the line cut-off relay. The cut-off relay may be used by technicians to isolate an individual line circuit, or group of circuits, from the external facility to prevent damage to the circuit and as over-voltage protection when it is necessary to test the line circuit with a metallic connection.

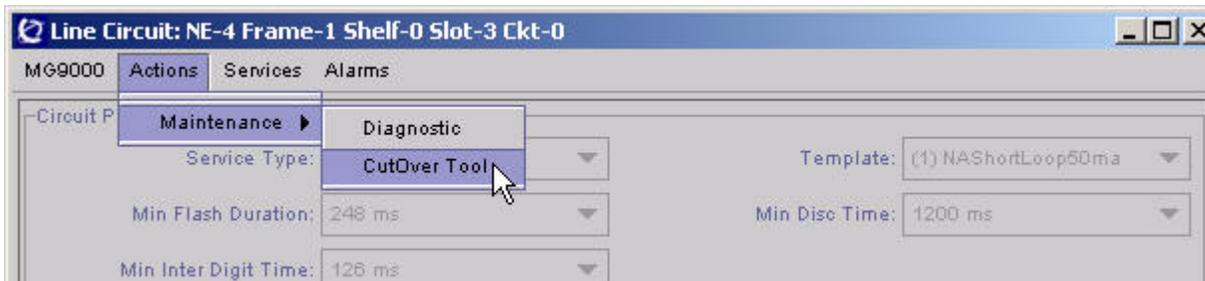
- 1 At the Subnet View, double click the MG 9000 icon on which the cut-off relay is to be activated. The Frame View appears.
- 2 At the Frame View, select the shelf on which the line cut-off relay is to be activated. The Shelf View appears.
- 3 At the Shelf View, select the line card on which the circuit or circuits reside that are to be isolated. The Card View appears.
Note: If the lines in a shelf, frame, or entire network element are to be isolated, select the lowest number slot in the shelf.
- 4 At the Card View, select the line circuit 0. The Circuit View appears.
- 5 From the Actions->Maintenance menu at the top, select CutOver Tool. The following figure shows the menu selection.

Accessing the CutOver Tool menu

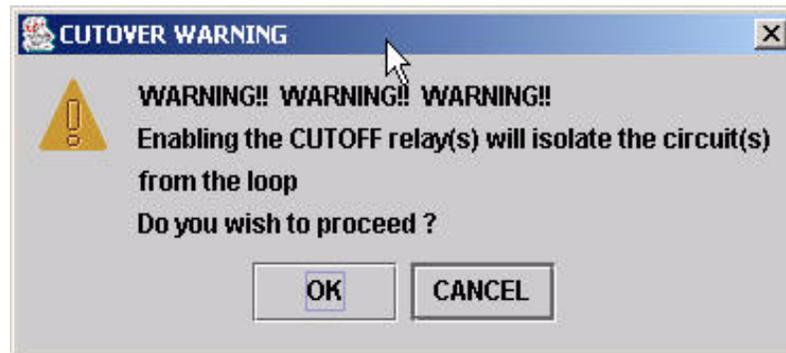
- 7 Select Enable from the Select Maintenance Action pull-down menu.
- 8 Click Apply at the bottom of the MG9000 Diagnostics View. A warning message will appear as shown in the following figure.

Warning message - enabling cut-off relay

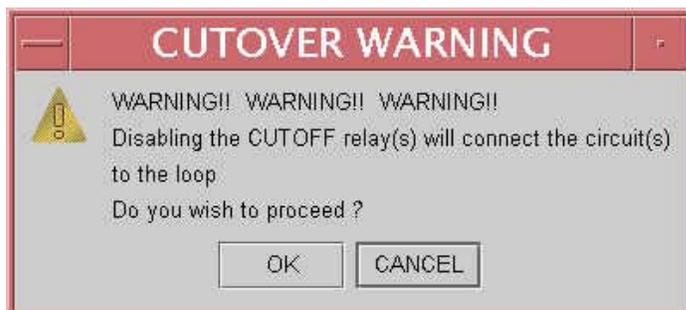
- 8 Click Apply at the bottom of the MG9000 Diagnostics View. A warning message will appear as shown in the following figure.

Warning message - disabling cut-off relay

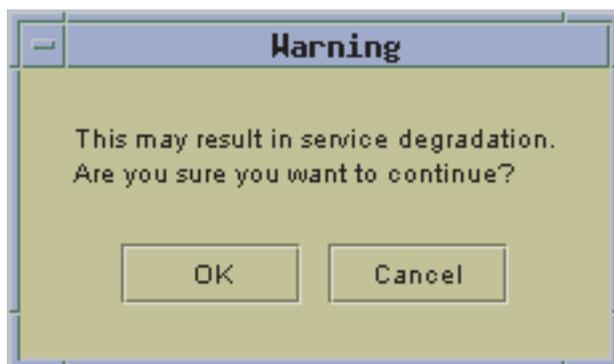
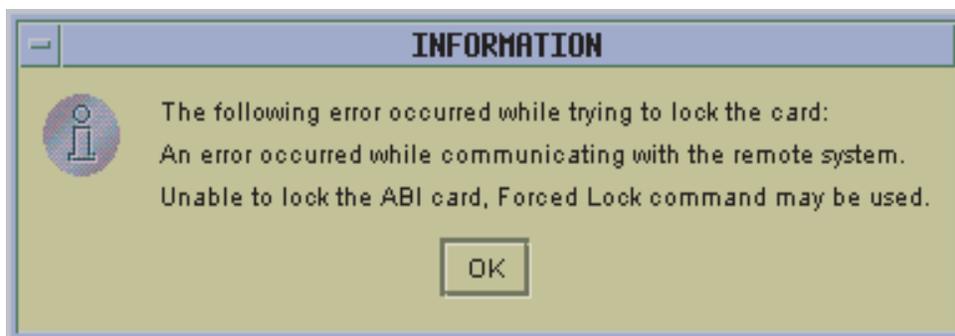
- 5 To switch the activity of the currently active DCC, ITP, or ITX card to be inactive, from the Actions menu at the top of the Card View, select Maintenance->SWACT. Wait for the Standby status to change to Hot_Standby. Go to step [9](#)
- 6 If the card to be locked is a DS1 card, go to step [9](#).
- 7 If the card to be locked is a Master ABI card, perform a Switch Mastership to switch mastership of the ABI card. Go to the [Switching mastership of an ABI card](#) procedure and return to this step. After the Master ABI Service Status is Providing_Service_Slave, go to step [8](#).
- 8 If the card to be locked is a Slave ABI card, a warning message will appear and an informational message will appear warning of service degradation when the Slave ABI card is taken out of service. The warning and information messages are shown next.

To continue with locking the Slave ABI card, use the Force Lock option.

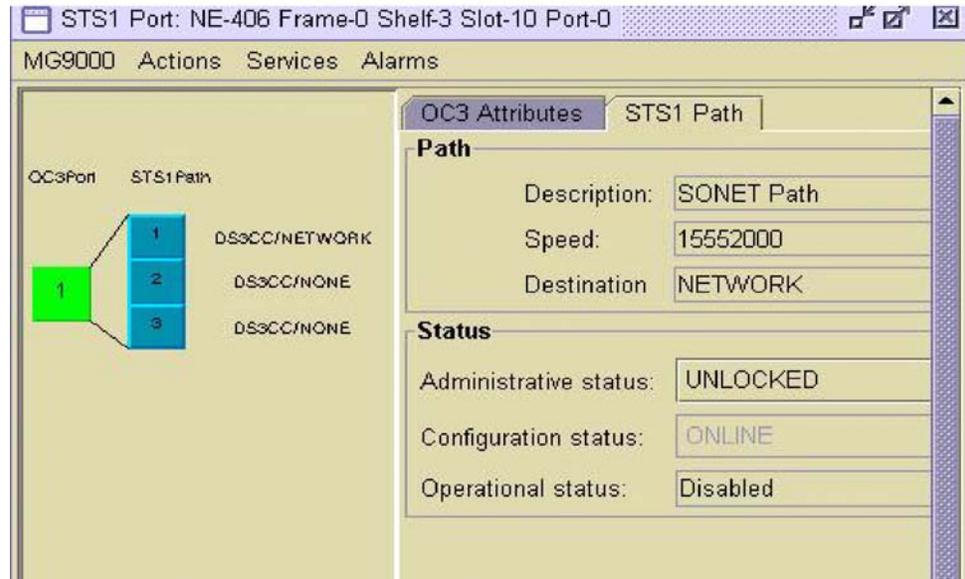
- 7 Double click on an STS1 path to display STS1 path information and its status in the STS1 Path tab on the right side of the port view. The following figure shows the STS1 path description and status information.

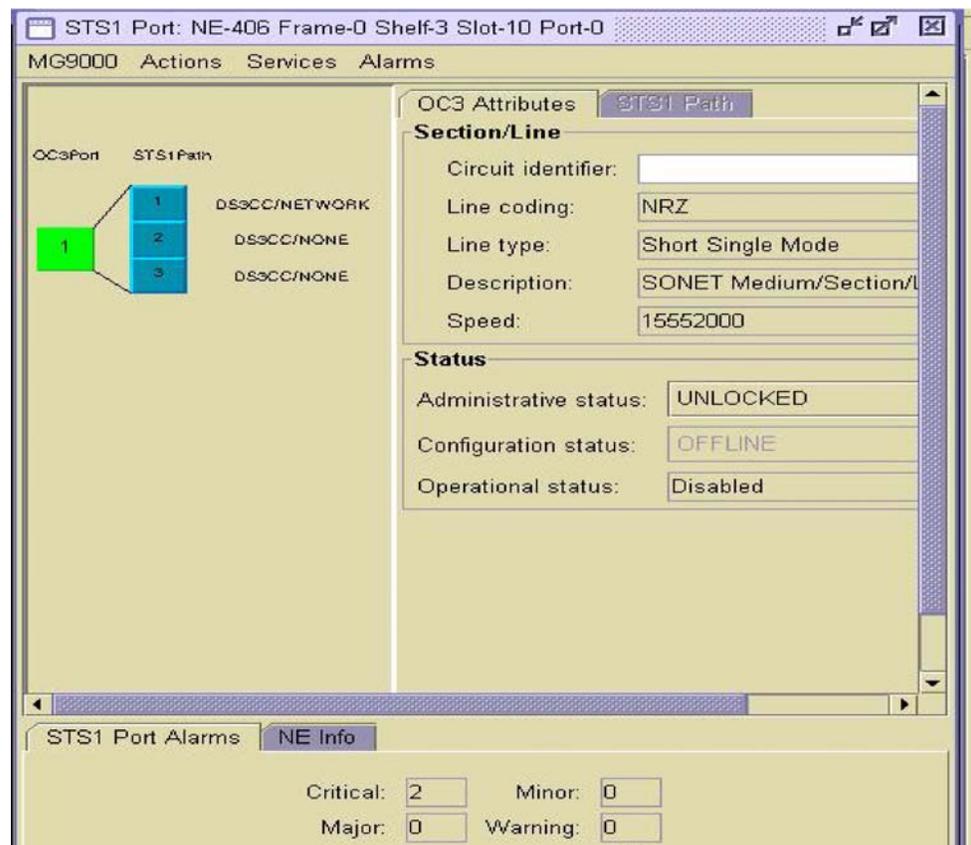
- 6 The following figure shows a channelized carrier and the path icons. Three STS1 path icons are adjacent to the OC3port icon.

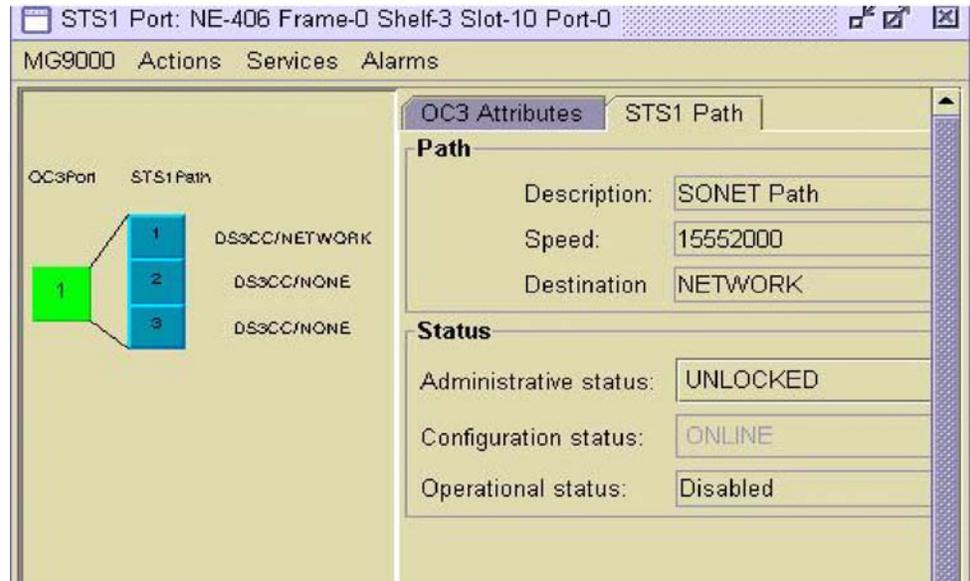
- 7 Double click on an STS1 path to display STS1 path information and its status in the STS1 Path tab on the right side of the port view. The following figure shows the STS1 path description and status information.

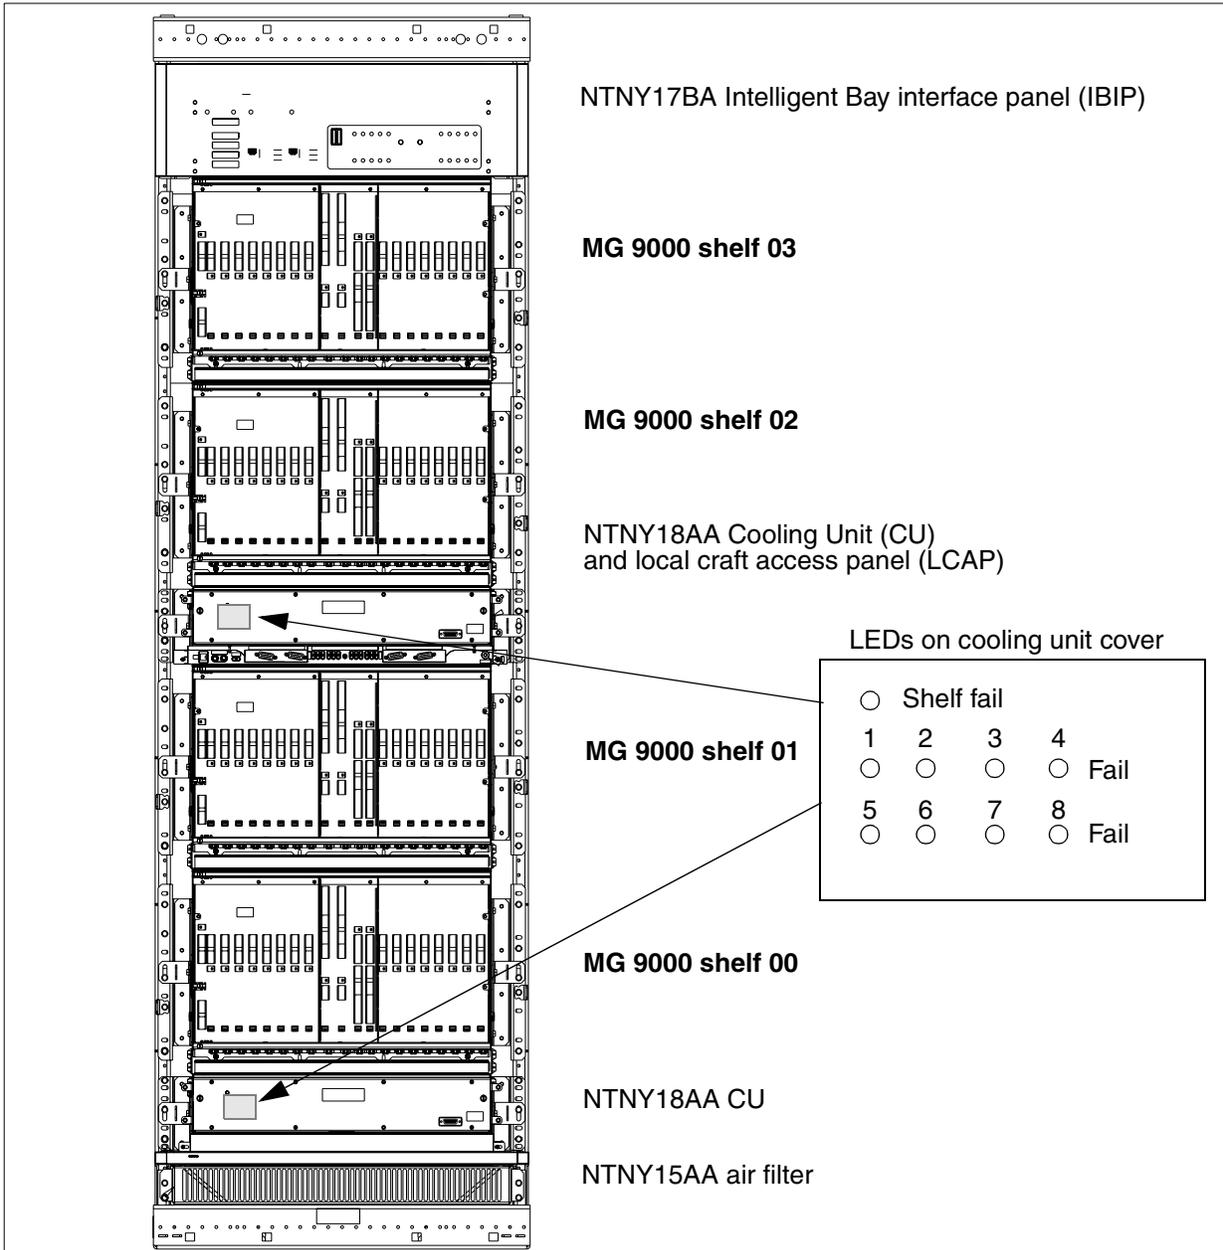
- 5** Remove the screws that hold the cooling unit in place.
- 6** Pull the cooling unit out until it is free of the frame.
- 7** Install the replacement cooling unit into the frame. Replace the screws that were removed in step [5](#) to secure the cooling unit to the frame.
- 8** Replace the fuse modules for the cooling unit that were removed in step [3](#).
- 9** A red LED will light briefly on the face of the cooling unit and then go out, indicating proper connection.
- 10** Check that the LED does not remain lit and that the fans are operating properly by the absence of any lit fan LEDs on the face of the cooling unit. Refer to the following figure to locate the LEDs on the cooling unit.

MG 9000 frame and cooling unit LEDs

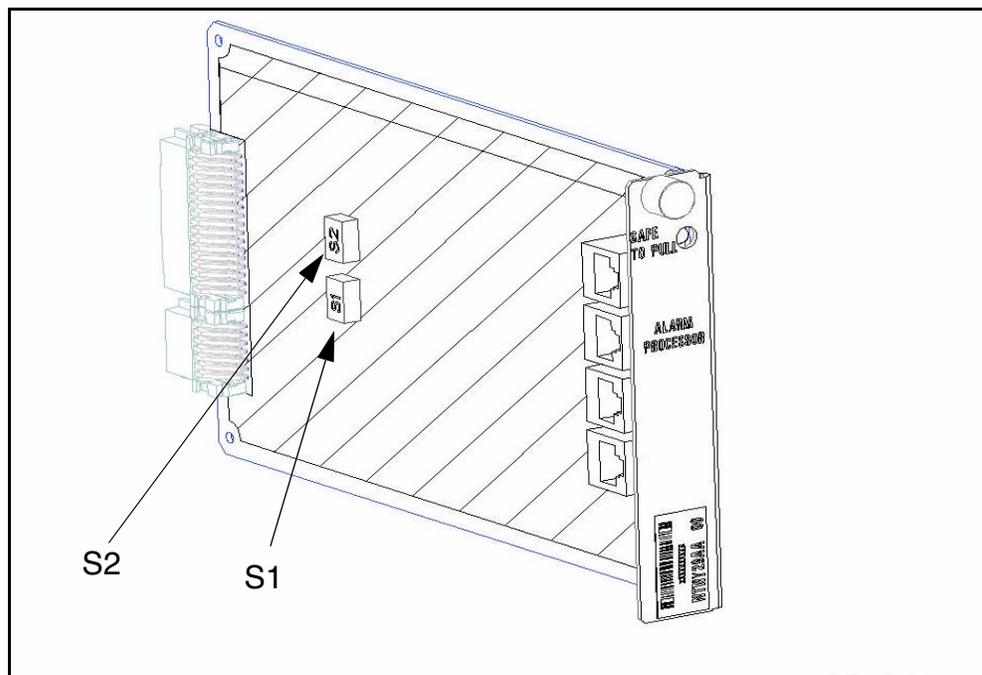
- 8 Remove the IBIP front cover.
- 9 Loosen the hold-down screw on the faceplate of the alarm processor card
- 10 Record the position of the two switch banks (S1 and S2) on the alarm card. Refer to the following figure for switch bank locations.

Alarm processor card switch location

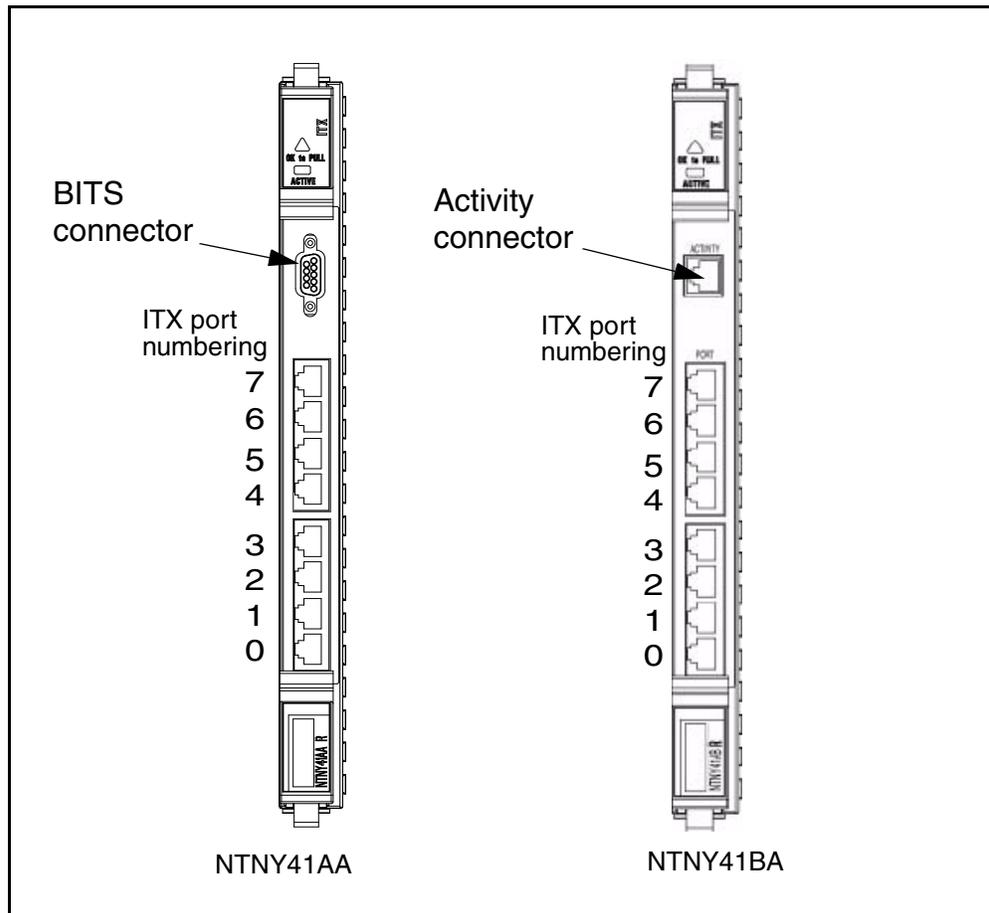
Carefully disconnect the cables from the RJ45 connectors on the faceplate of the ITX card. Label and carefully lay the cables aside. The ports are numbered as shown in the following figure. If there is a BITS cable connected to the DB9 connector on the NTNY41AA card, disconnect it. If an NTNY41BA card is being replaced, disconnect the activity cable.

ITX card port number

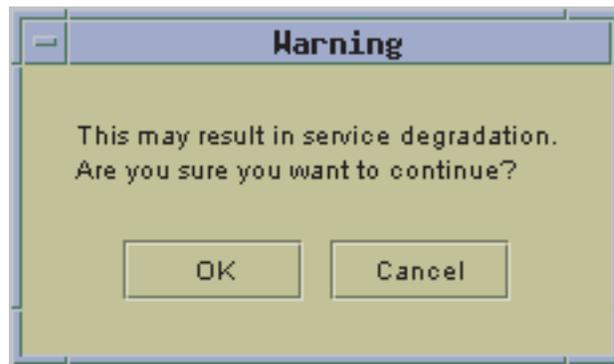
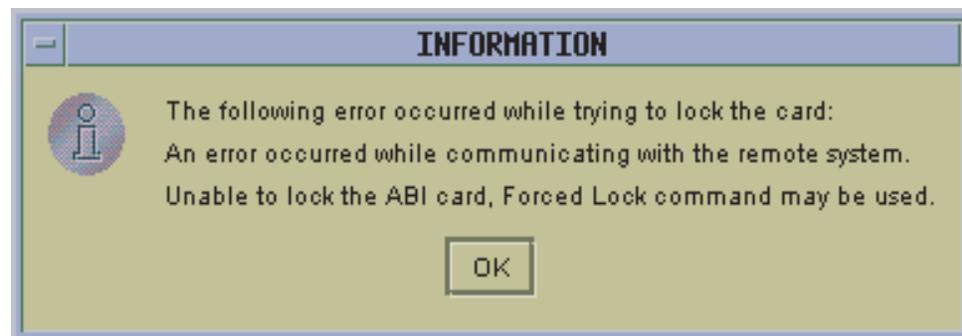
- 6** Identify the ABI card with the alarm condition by observing the alarm balloon.
- 7** To switch the mastership of the Master card to Slave, perform the [Switching mastership of an ABI card](#) procedure
- 8** To lock the ABI card, change the Administrative state by selecting Lock from the administrative state pull-down menu. All service will be terminated on the card. Refer to [Locking a card](#).
- a** When locking the Slave ABI card, a warning message will and an informational message will appear warning of service degradation when the Slave ABI card is taken out of service. The warning and information messages are shown next.

To continue with locking the Slave ABI card, use the Force Lock option.

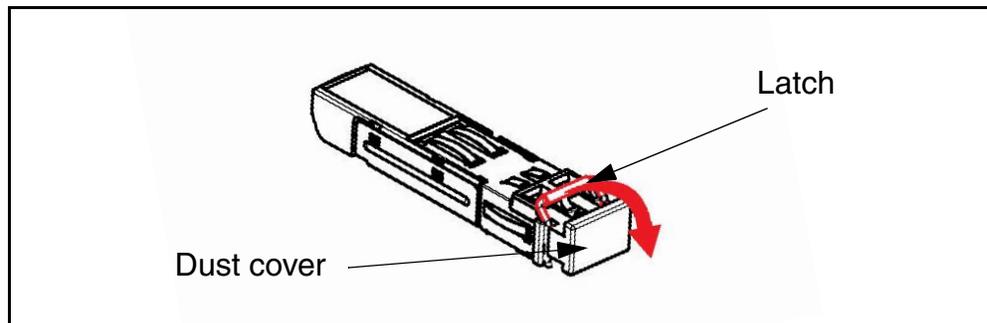
Carefully disconnect the GigE fiber cable from the NTT62 SFP transceiver device. Then using the latch, pull to withdraw the SFP from the faceplate of the GigE DCC card.

NTT62 SFP transceiver device

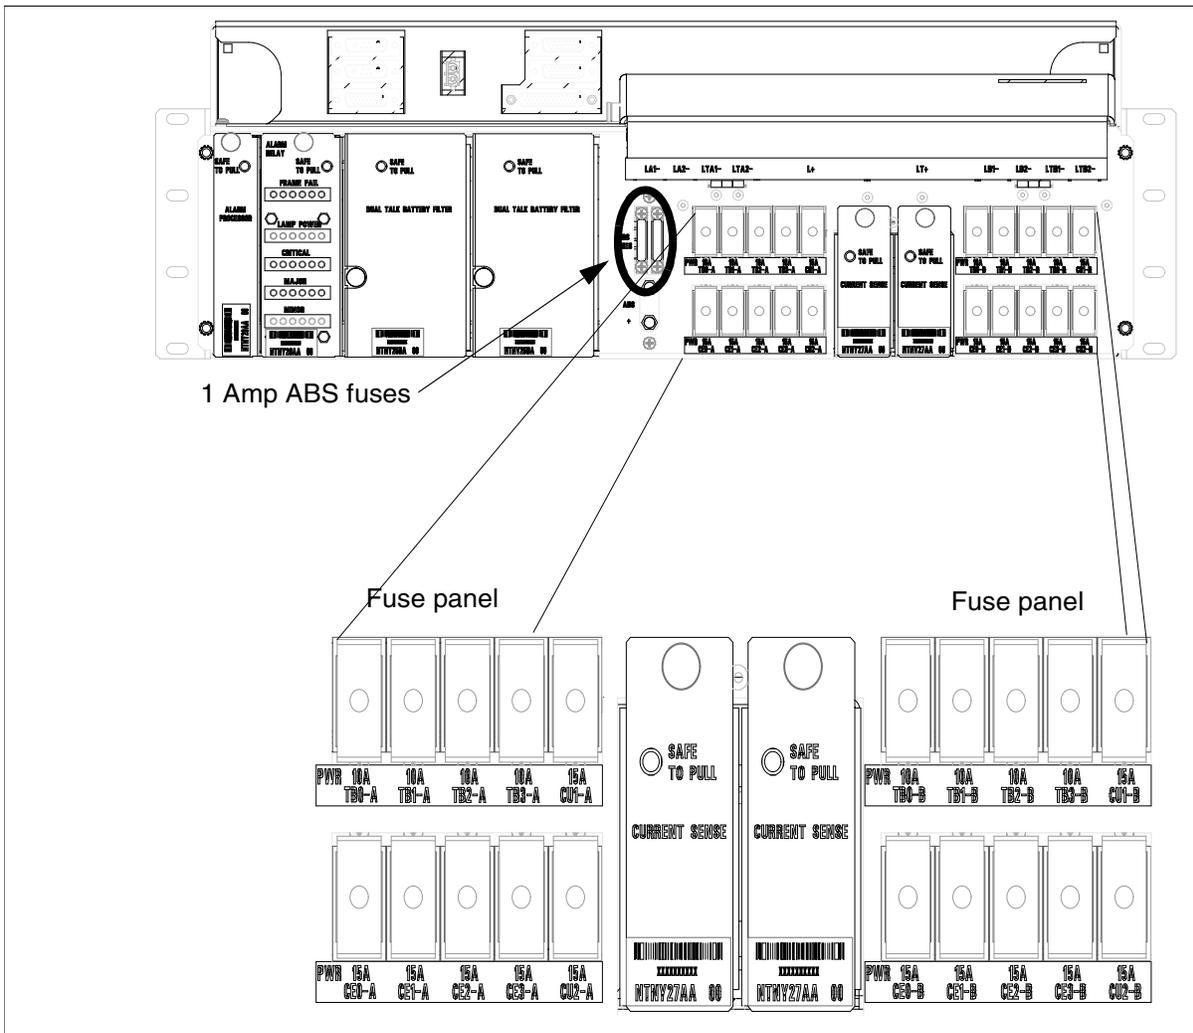
The following figure shows the IBIP and fuse location.

IBIP panel showing the fuse panel and ABS fuses
