MG 9000 Fault Management

New in this release

The following sections detail what is new in MG 9000 Fault Management for release (I)SN09FF.

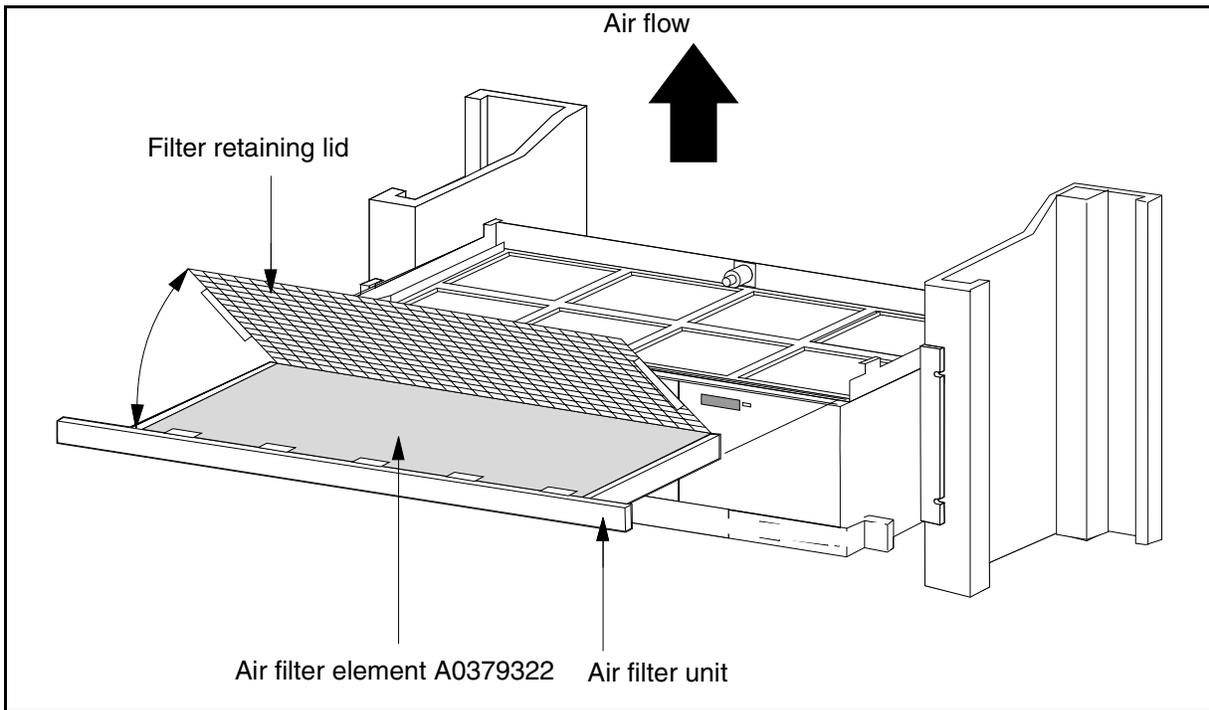
- 4 Close the filter retaining lid, and reinsert the air filter unit into the shelf until it locks into place. Refer to the following figure that shows the filter element in the air filter unit.

Air filter unit and element

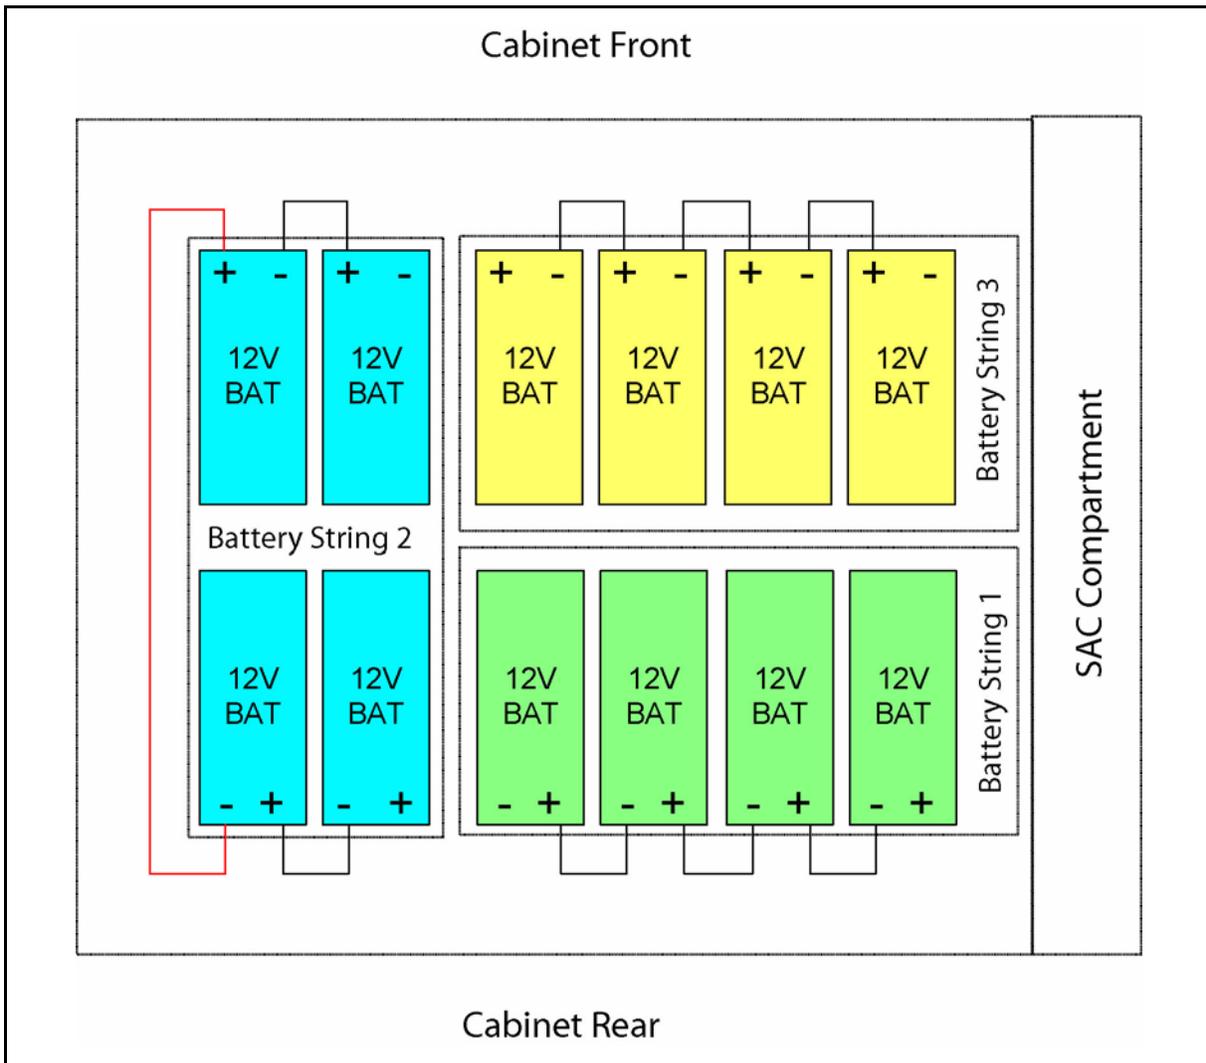
- Inspect battery packs, connections, and floor for moisture or corrosion.
- 4 Identify the affected string(s) to be replaced. Use the following figure to identify the battery strings.

Battery arrangement in the outside plant cabinet

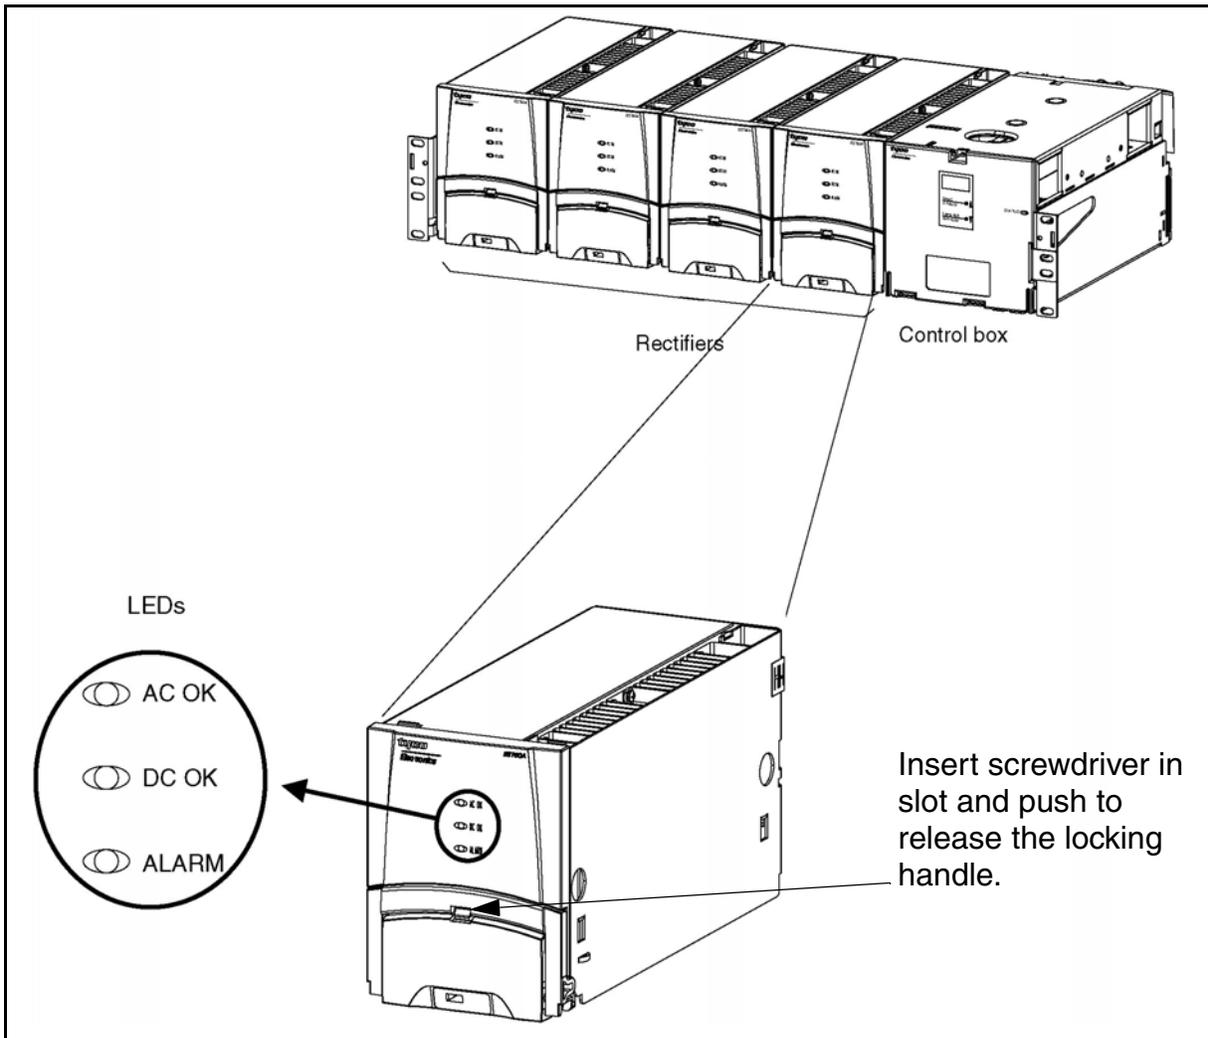
The following figure shows the rectifier shelf, the handle release slot, and alarm LEDs.

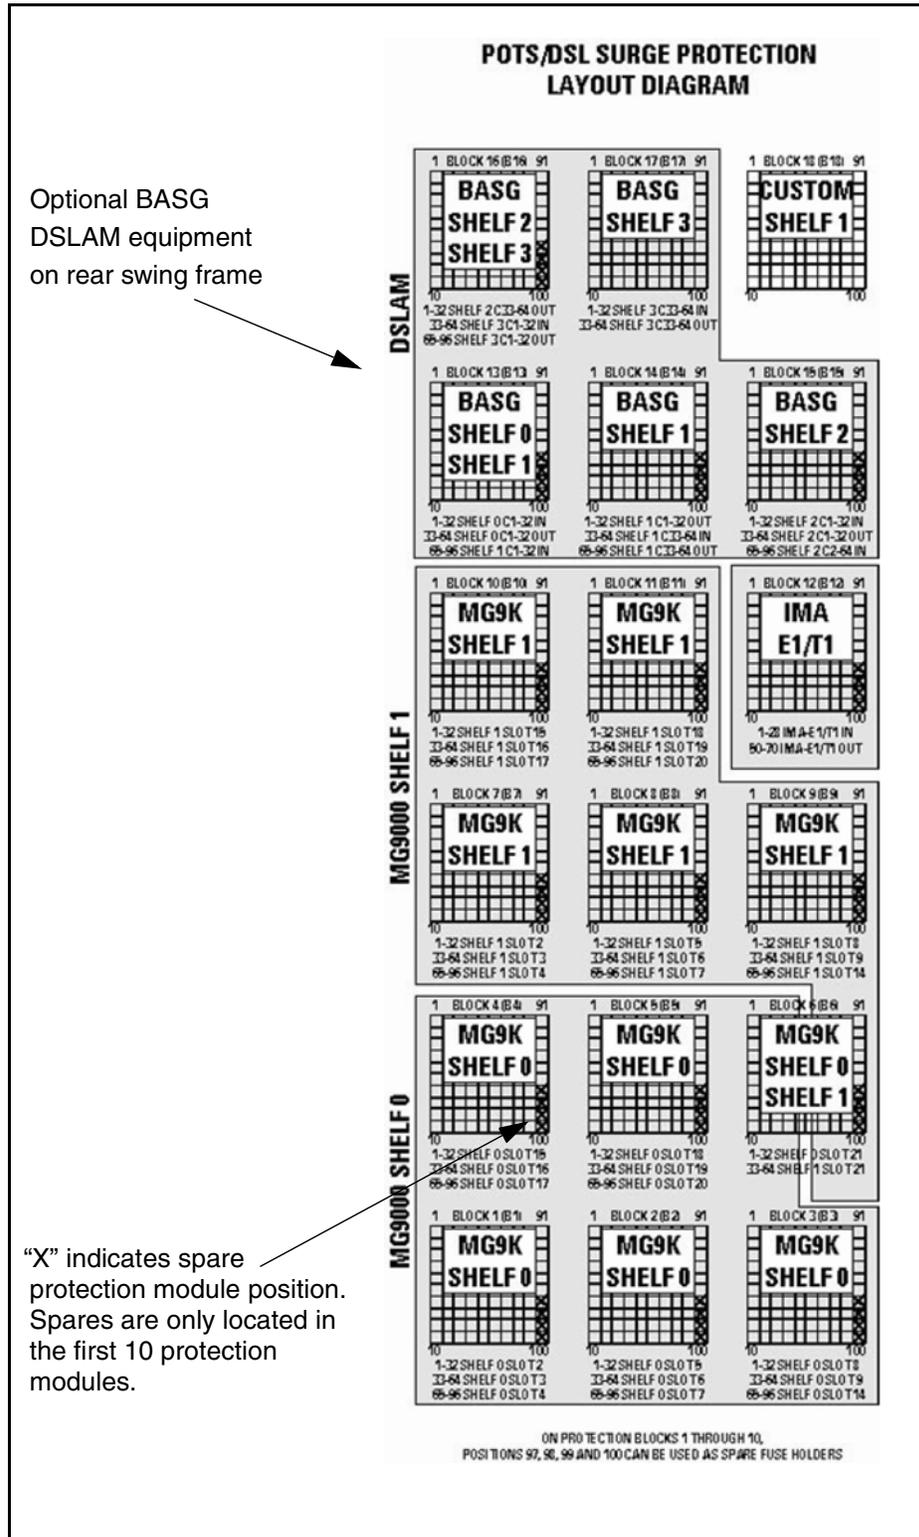
Note: Spare 5-pin protection modules are stored in positions 97-100 on protection blocks 1-10.

Surge protection layout diagram

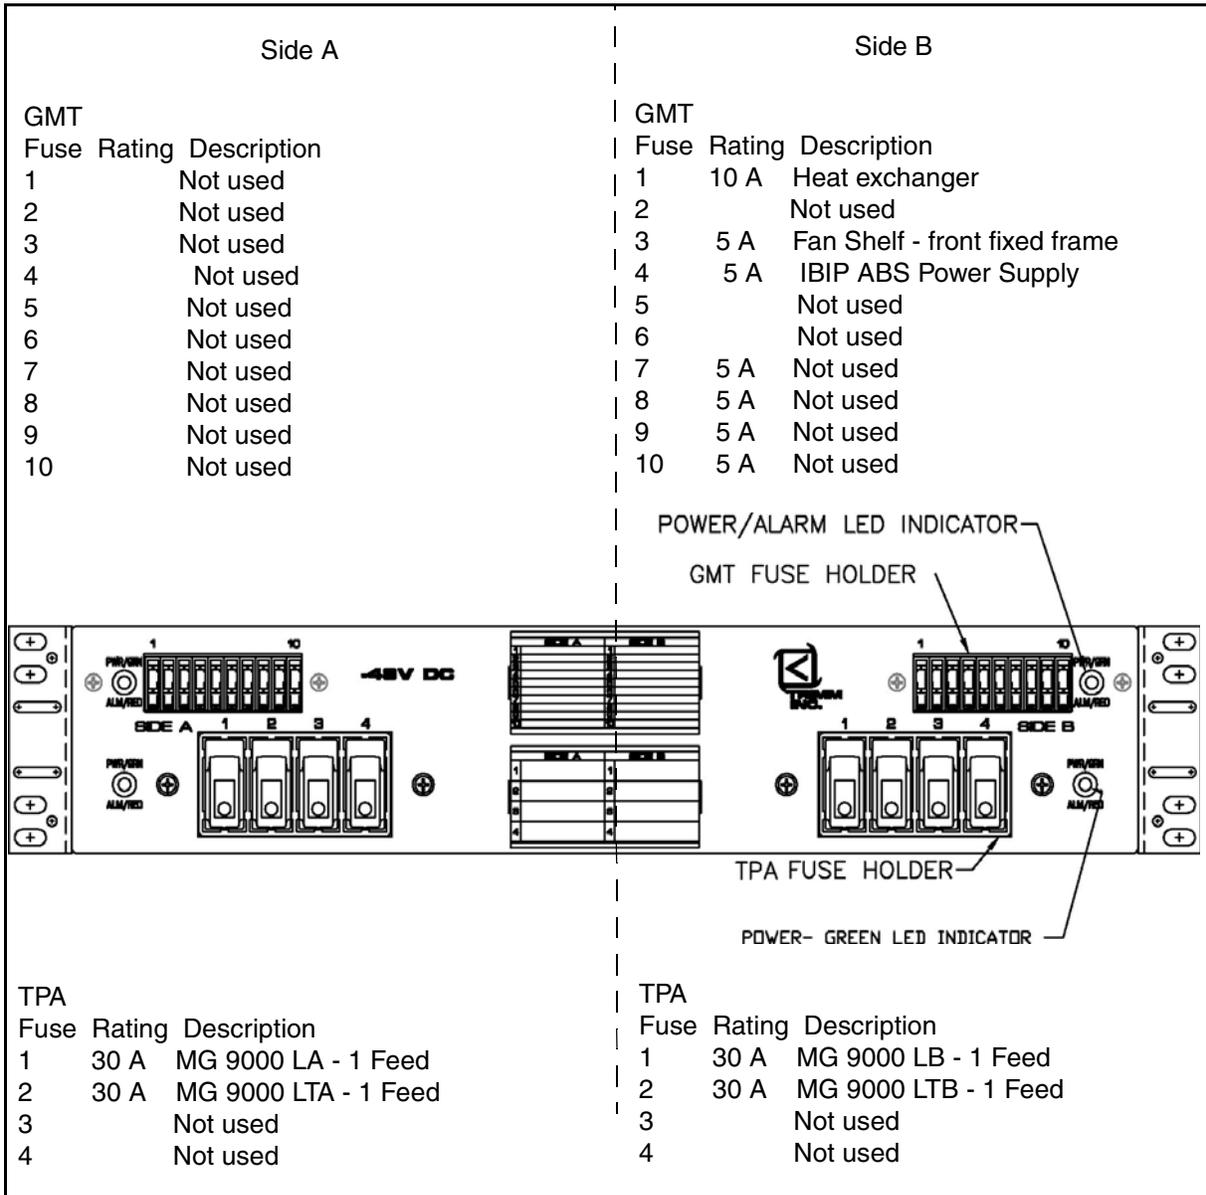
The following figure shows the fuse panel and fuse assignments. The placard in between the two sides identifies fuse assignment.

Fuse panel and fuse assignments

- 3 Replace the fuse with a fuse of the same rating. Spare fuses are located in the spare fuse mounting bracket located to the left side of the equipment bay on the upright. Ensure the TPA fuse is installed correctly, observing the placement of the orientation ring.
- 4 Close the access door and use a 3/8 in. nut driver to turn the door latch and lock the door.
- 5 This procedure is complete.

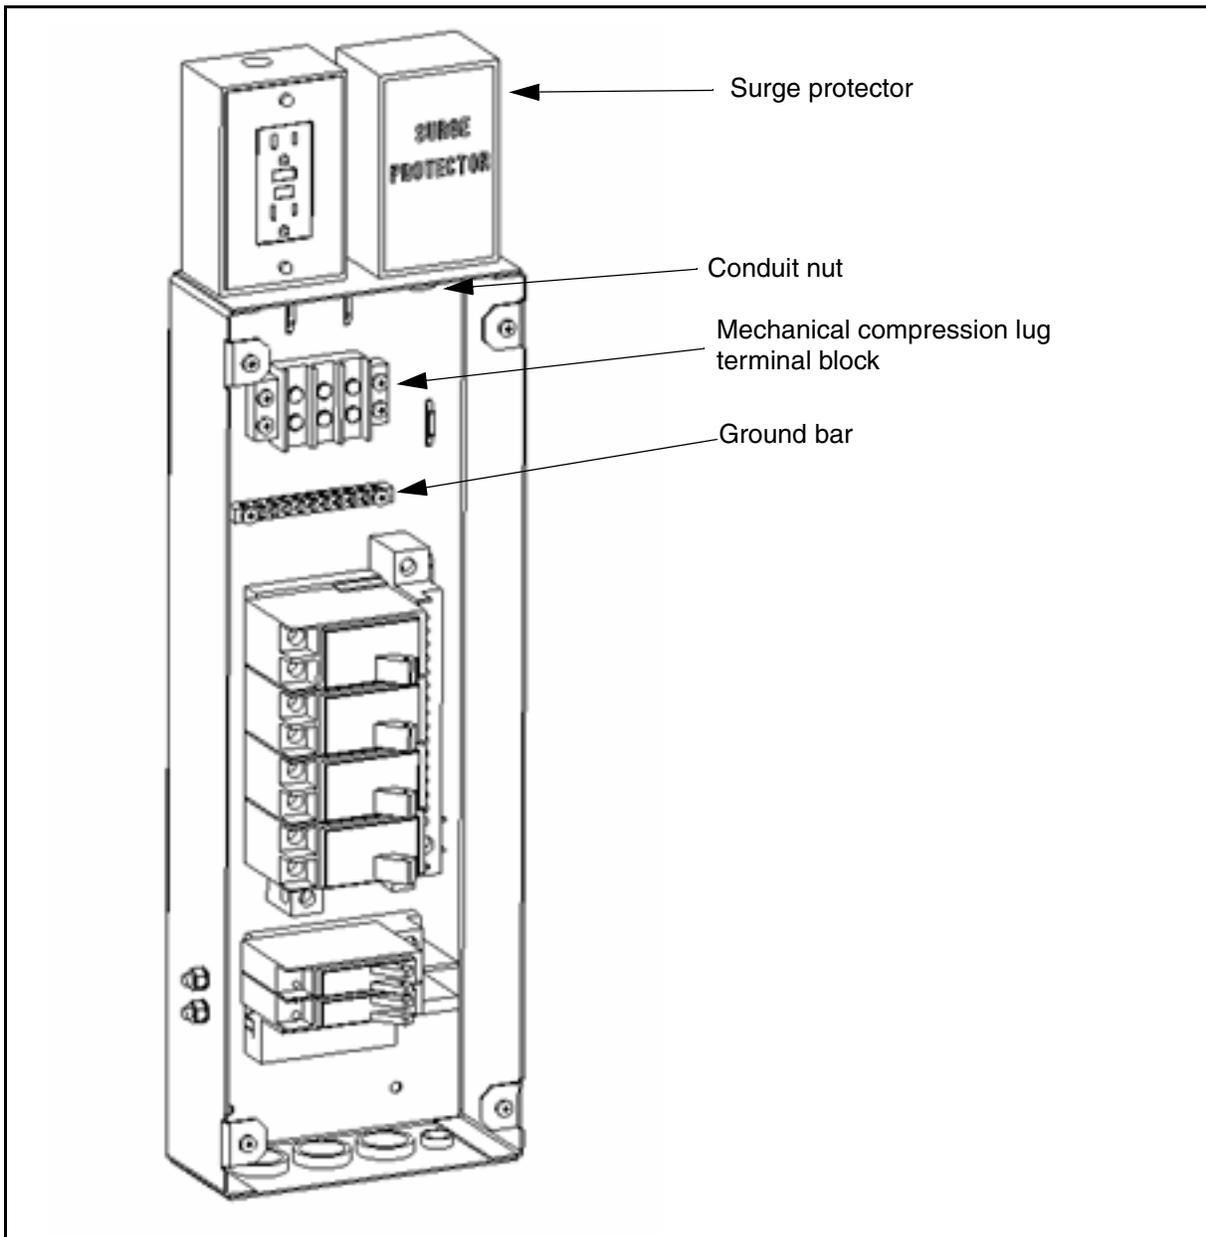
Use the following figure to locate components in this procedure.

ac panel (cover removed) and surge protector

- 4 Remove the three leads (two hot, one neutral) that run to the surge protector from the mechanical compression lugs on the terminal block at the top of the ac panel. Label the wiring for proper installation.
- 5 Disconnect the surge protector ground wire from the ground bar.
- 6 Pull the wires free and out of the ac panel.

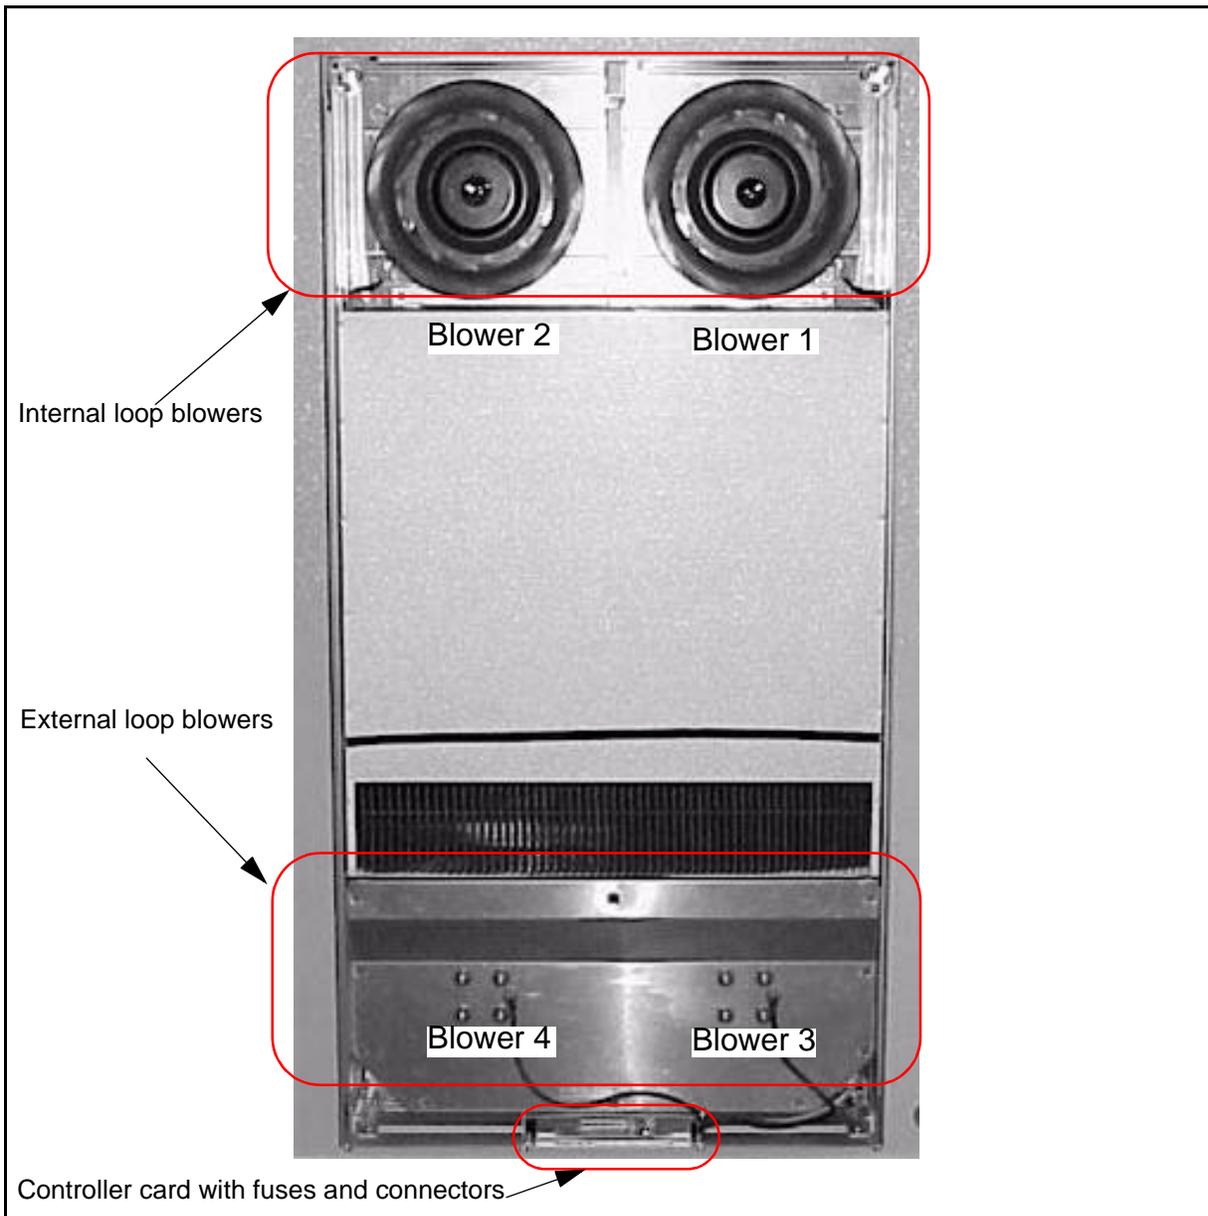
The following figure shows the location of components referred to in this procedure.

Heat exchanger (shown with cover removed)

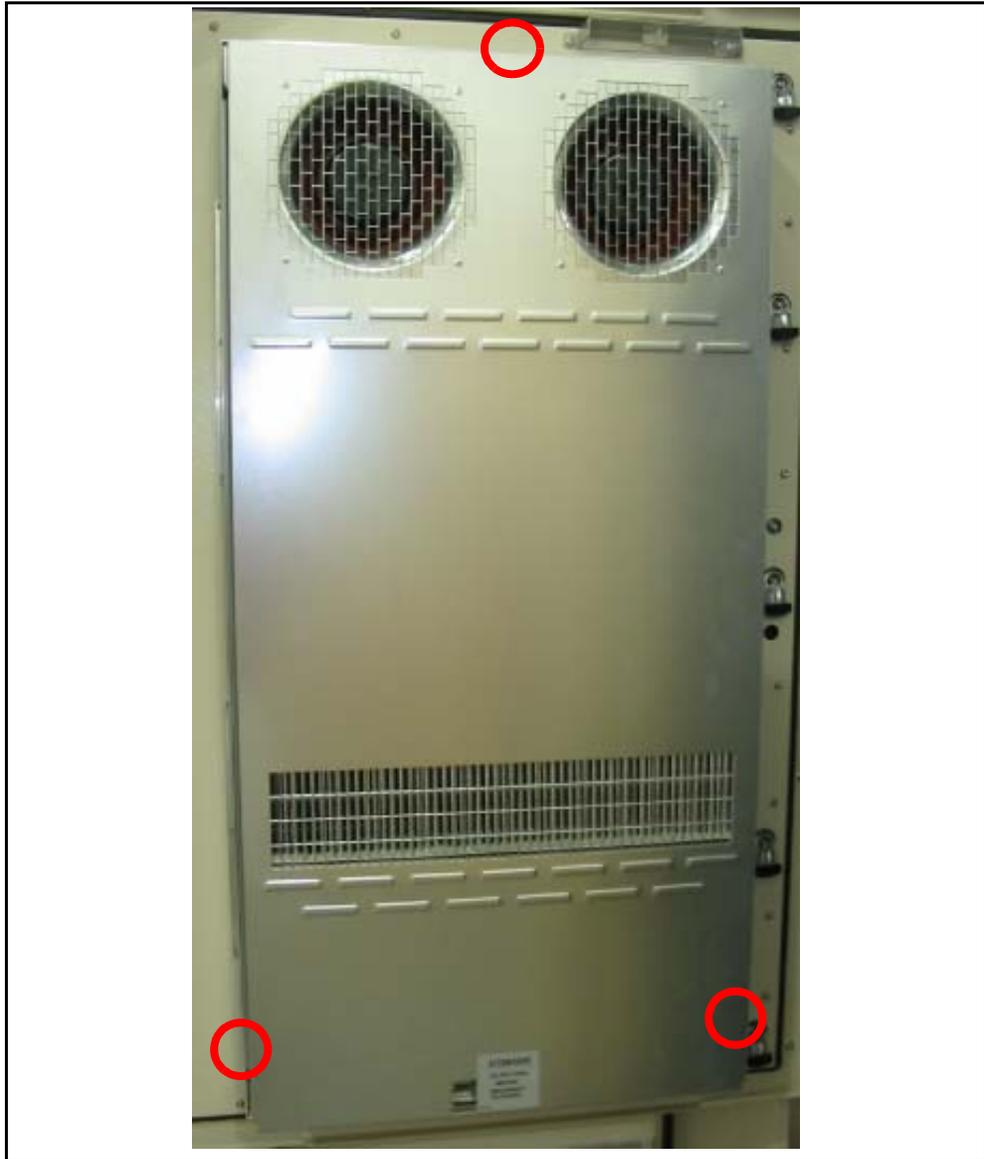
Use the following figure to locate the three screws.

Heat exchanger (identifying location of three cover screws)

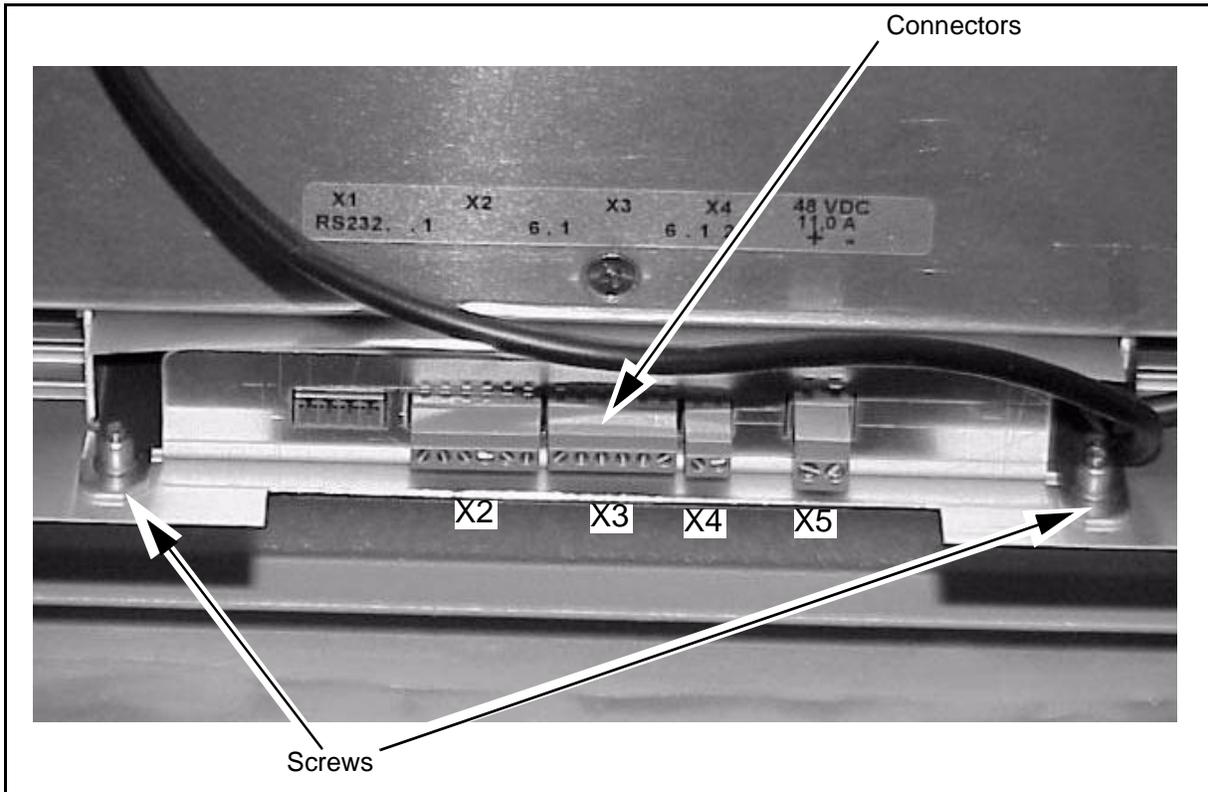
- 5 Unplug connectors X2 through X5 on the controller board at the bottom of the heat exchanger cabinet. The following figure shows the controller card and the orientation of the connectors.

Heat exchanger controller card and connectors

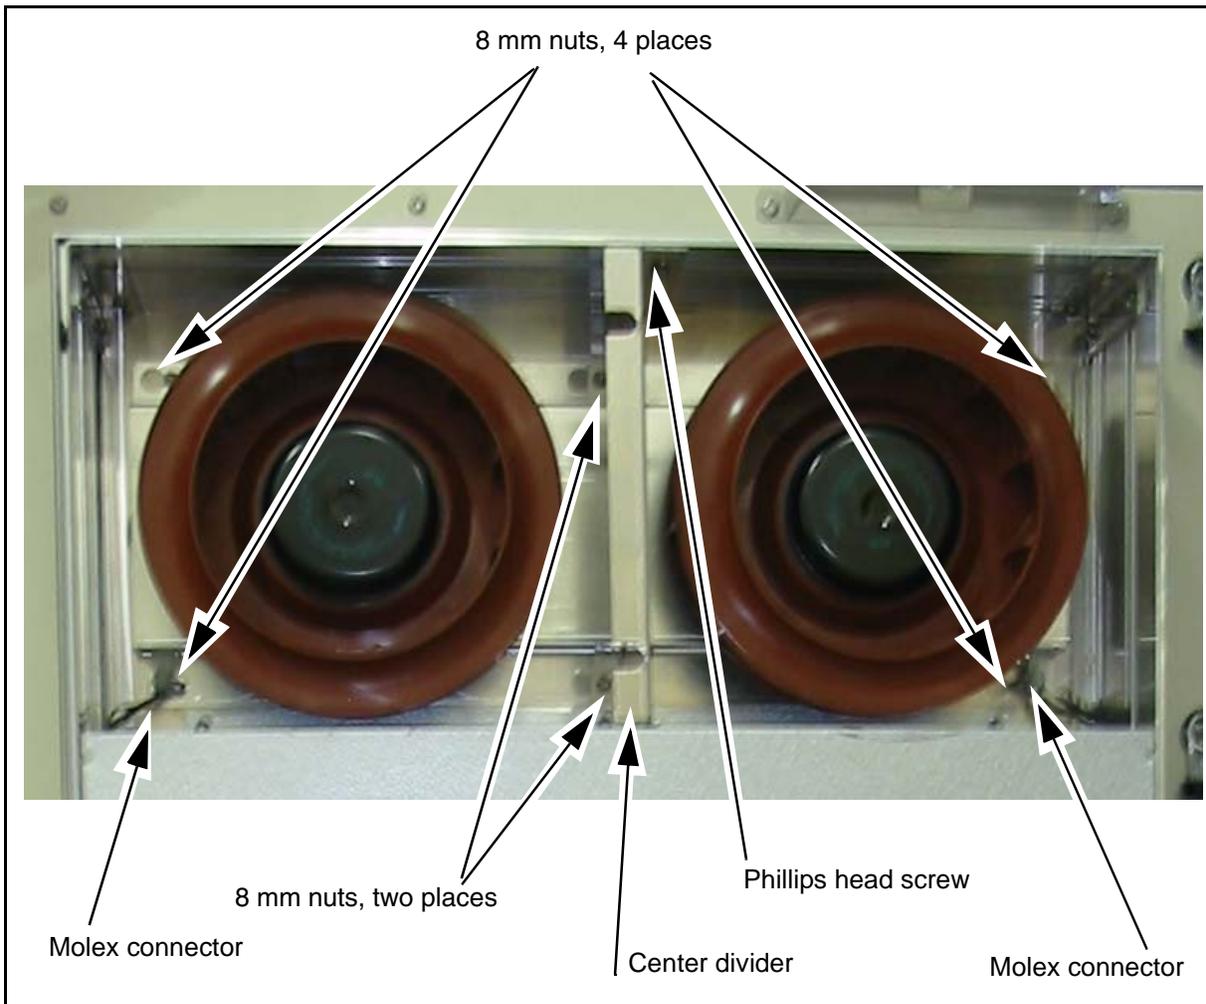
- 7** Use the following figure to identify the components in the steps for replacing an internal loop blower.

Internal loop blower compartment

- 8** Use an 8 mm nut driver to loosen the two nuts that secure the center divider in the internal loop blower compartment. On the right side of the divider, remove the Phillips head screw that secures the divider to the top of the heat exchanger cabinet. Slide the divider to the left and remove the divider.
- 9** Disconnect the two Molex connectors that supply power to the blowers, one at the bottom of each end of the internal loop blower compartment.
- 10** Use the 8 mm nut driver to loosen the four nuts, two at each end of the panel to which the blowers are mounted.
- 11** Slide the panel to the right and grasp the blower assembly and lift it clear of the cabinet.
- 12** Identify the faulty blower and turn the blower assembly over. Using a T25 Torx screwdriver, loosen and remove the four Torx

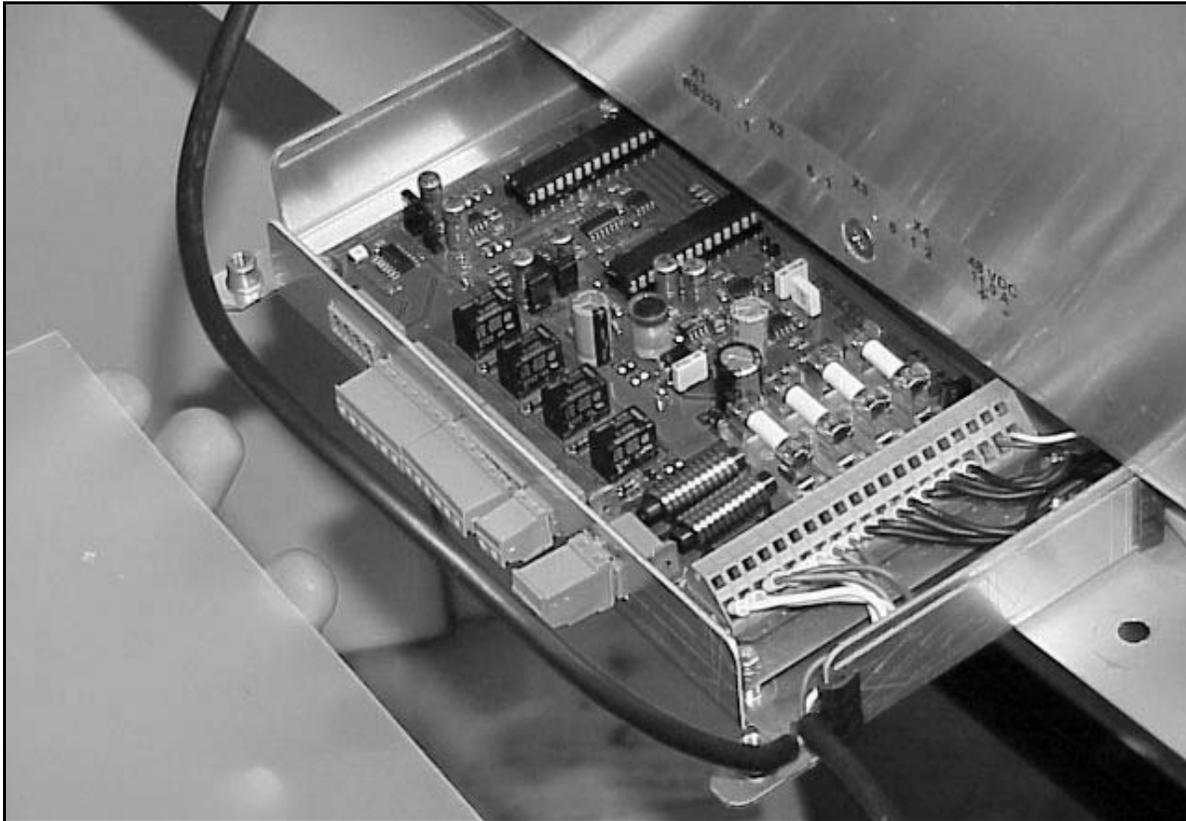
- 20** Withdraw the controller card assembly from the heat exchanger. Gently remove the cover from the top of the assembly. The fuses and blower wiring connector are now exposed. The following figure shows the controller card, fuses, and wiring connector.

Heat exchanger blower controller card

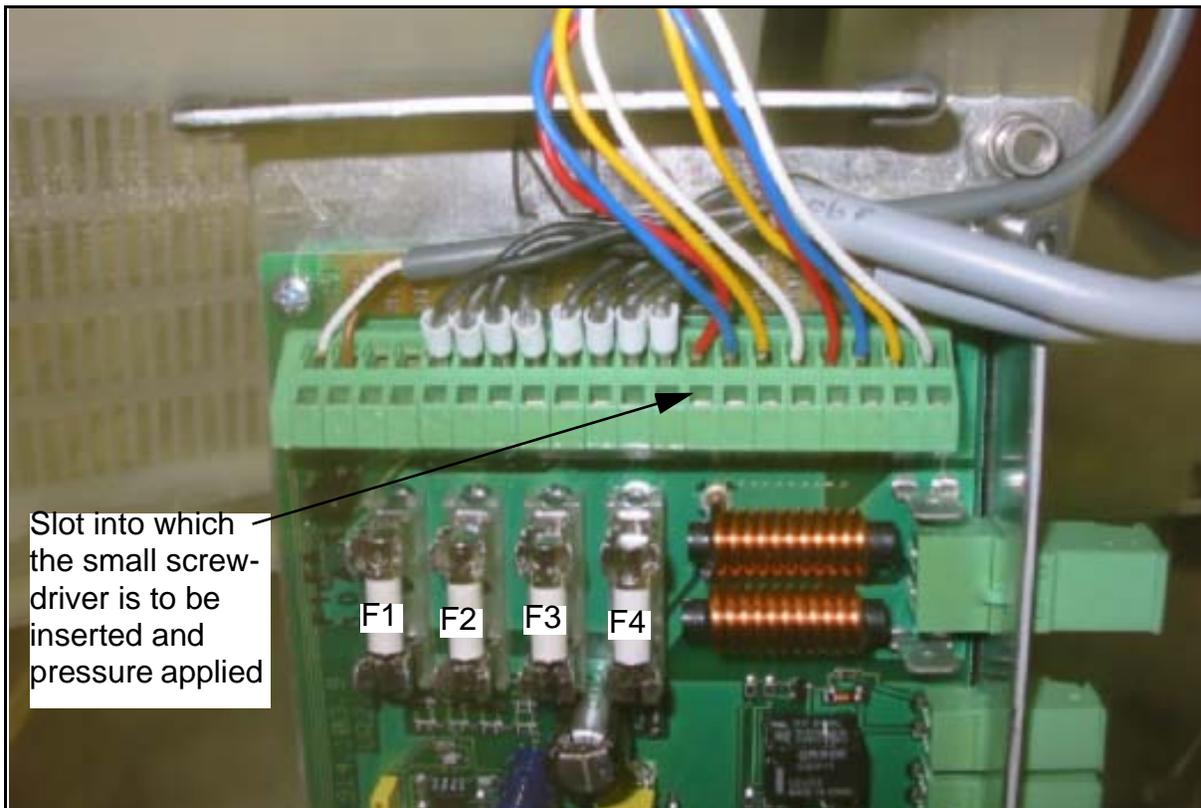
The following figure shows the connector and the slot into which the screwdriver is to be inserted.

Controller card connector wiring and fuse labels

- 28** Replace the blown fuse that supplies the affected blower on the controller card with the correct fuse (part number N0019048). The fuses are labeled in figure [Controller card connector wiring and fuse labels on page 458](#). The blowers are numbered as shown in figure [Heat exchanger \(shown with cover removed\) on page 451](#). The relationship of fuse to blower is as follows:

- Fuse F1 - Blower 1 on top right
 - Fuse F2- Blower 2 on top left
 - Fuse F3 - Blower 3 on bottom right
 - Fuse F4- Blower 4 on bottom left
- 29** Gently replace the controller card cover onto the top of the assembly. Insert the controller card assembly into the heat exchanger.

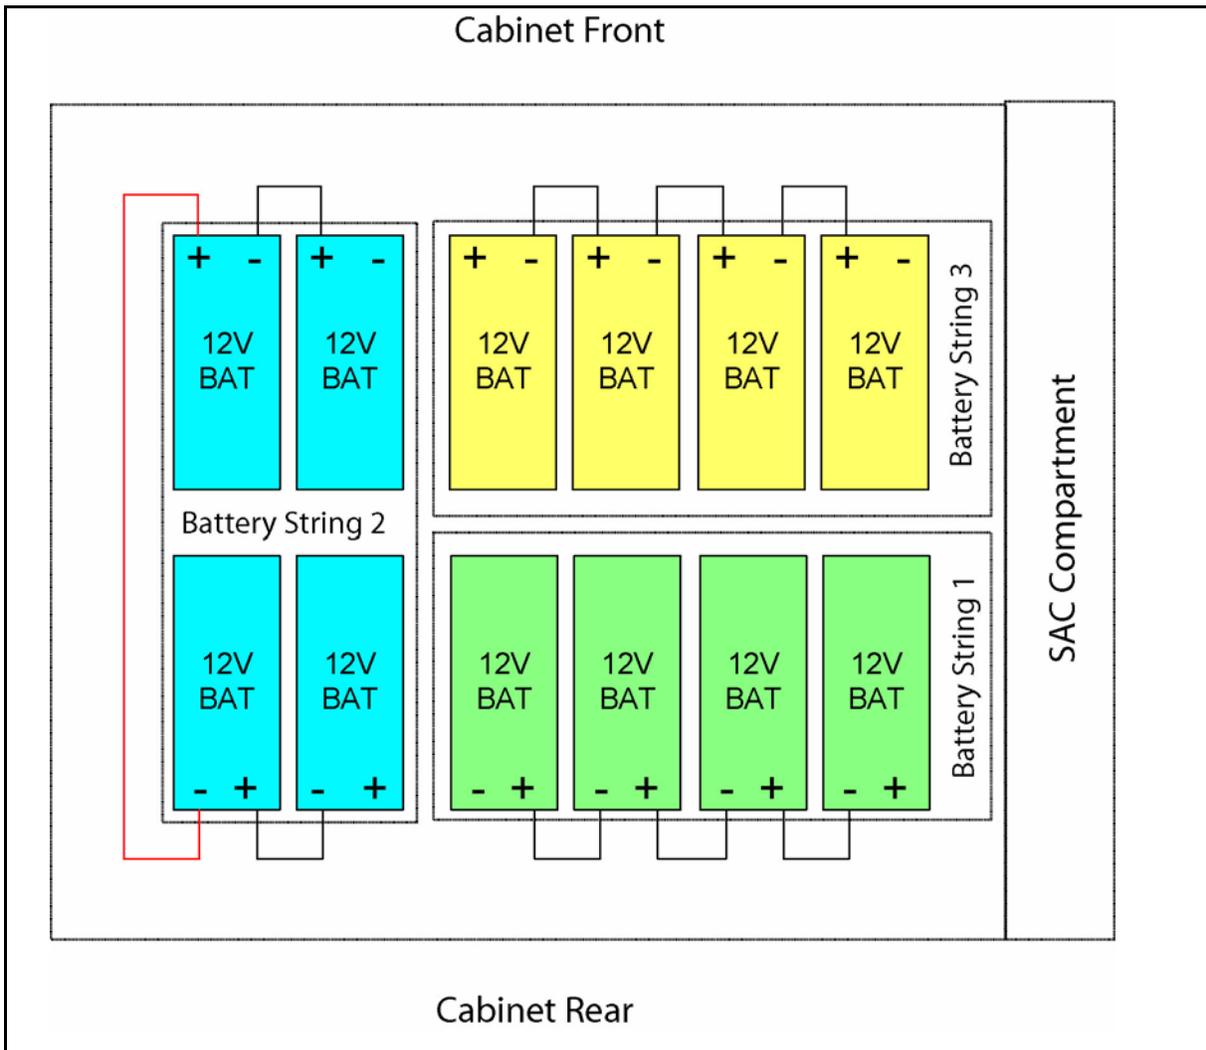
- 5 Identify the affected string(s). Use the following figure to identify the battery strings.

Battery arrangement in the outside plant cabinet

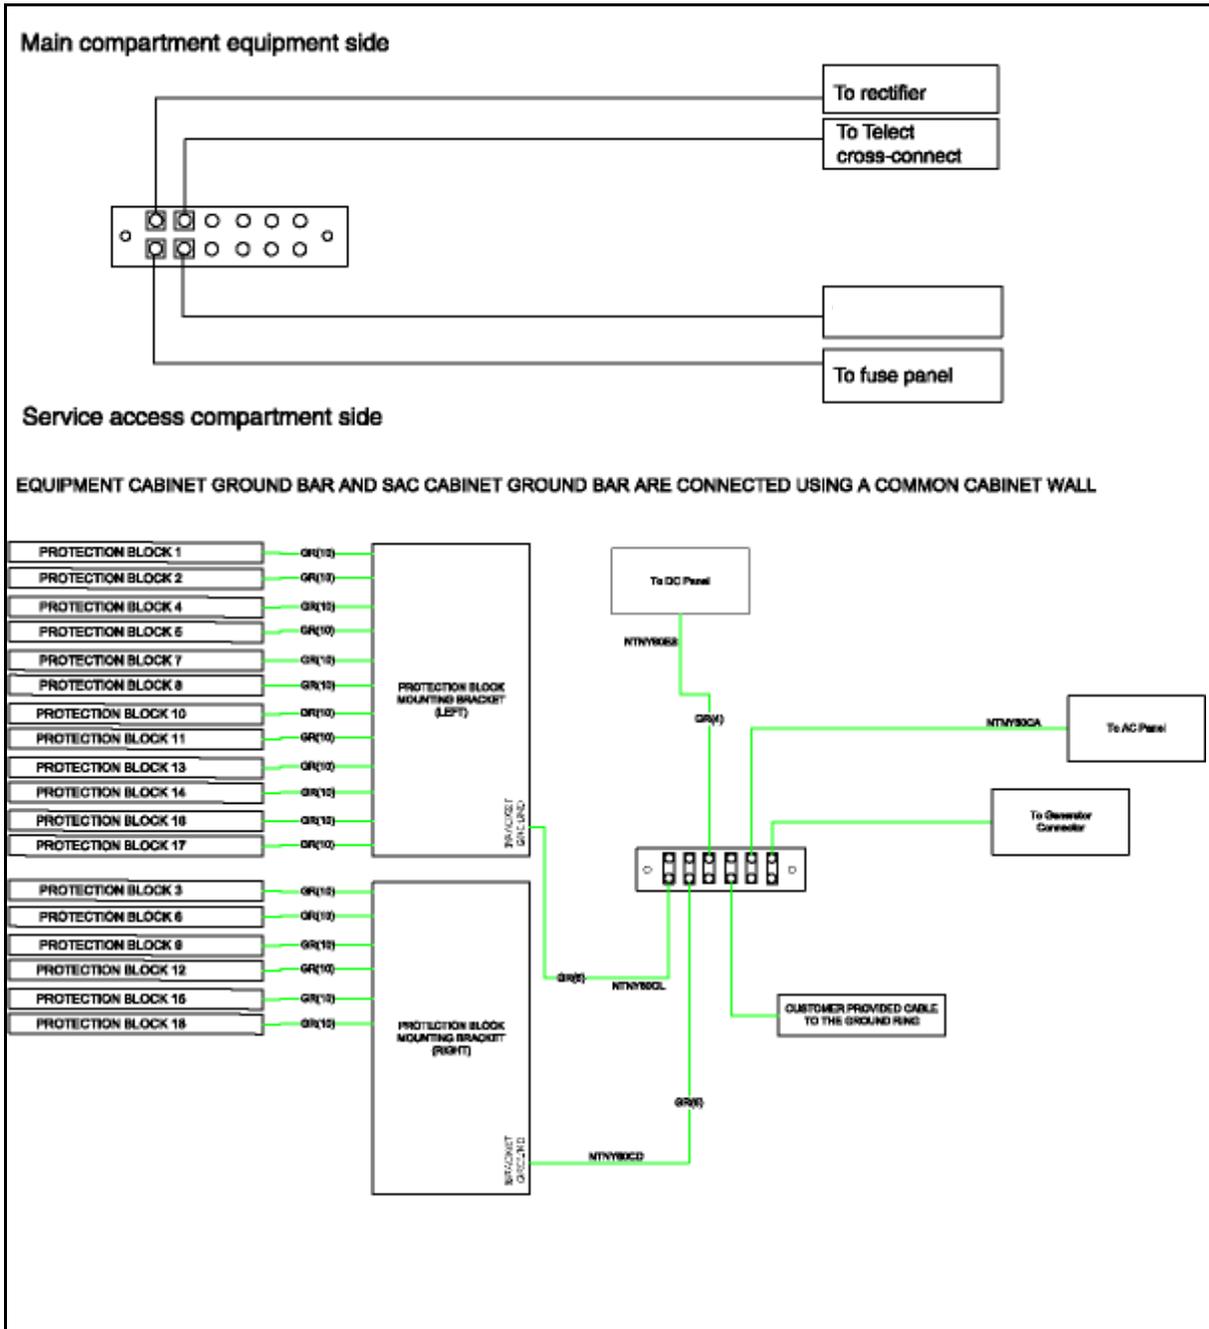
- 3 Refer to the following figure to identify system grounds.

Outside plant cabinet system ground points

4 Use local approved methods to measure ground resistance. The resistance for each ground must be ≤ 25 Ohms.
