Carrier VoIP

SAM21 Shelf Controller Fault Management

Document status: Standard
Document version: 08.02
Document date: 20 October 2006

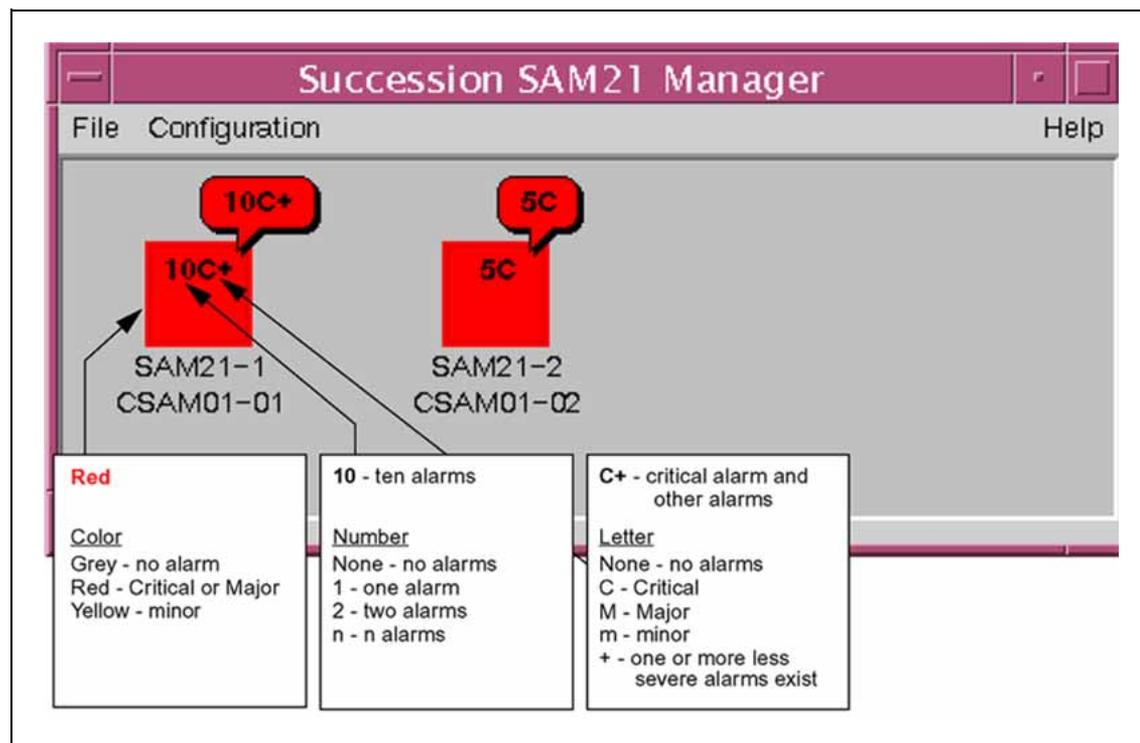
CS 2000 SAM21 Manager subnet view

A red SAM21 icon with 1M+ indicates a SAM21 with one Major alarm and one or more less severe alarms.

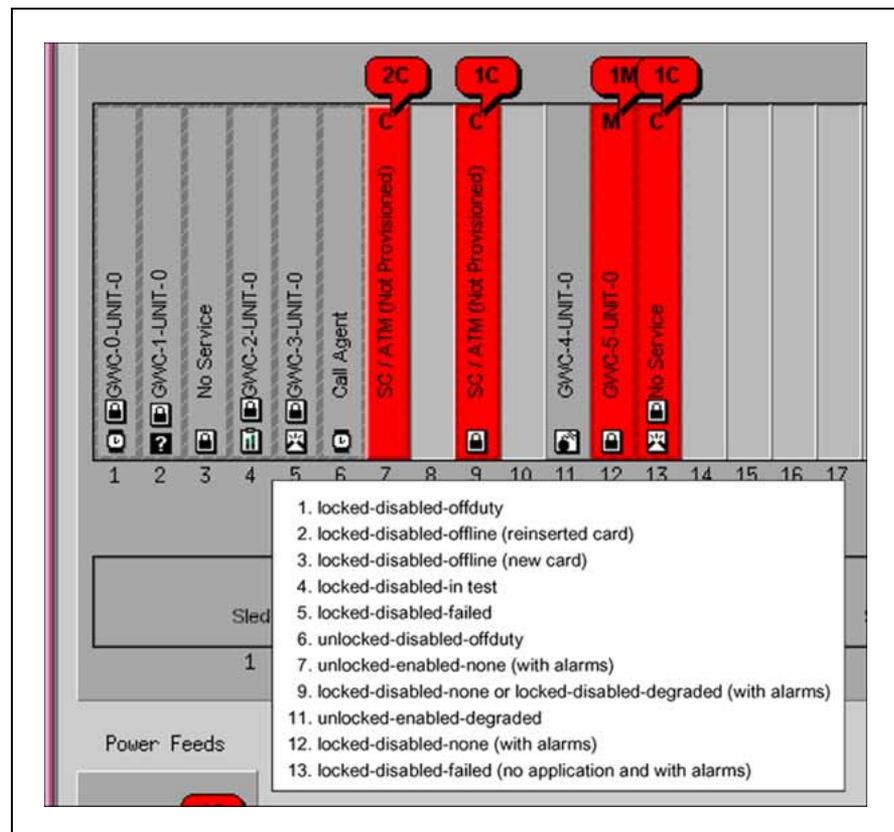
- 1 Review the following figure and determine the card icons that apply.

Note: These states also apply to SAM21 Shelf Controllers.

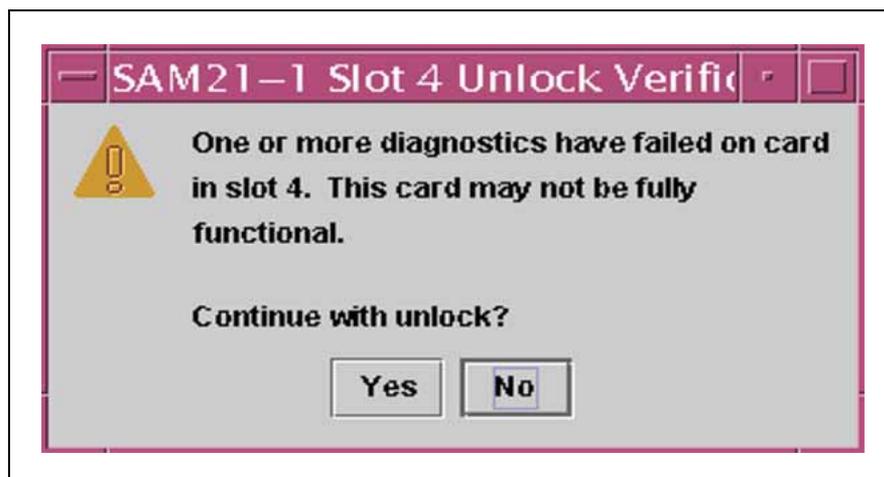
Degraded state Unlock confirmation window

The CS 2000 SAM21 Manager application opens the following window if a card failed a diagnostic test and an unlock request is made. Run brief and full diagnostics. If the card fails a second time, replace the card and contact Nortel support personnel.

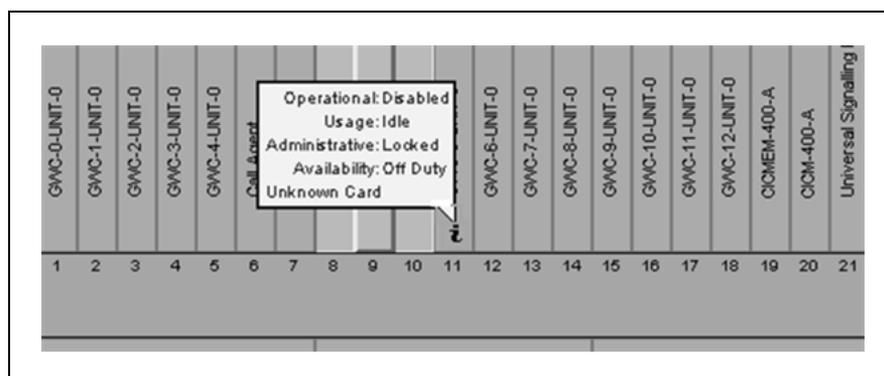
An additional shelf view card icon indicates that the CS 2000 SAM21 Manager client cannot display all the card icons. Click this information icon to view the card state information in a balloon. This icon normally indicates that the card type is not supported for the current release of the CS 2000 SAM21 Manager software.

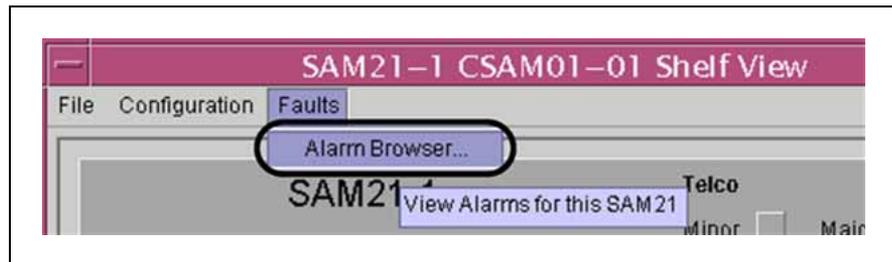
- 1 From the Subnet View, double click on the alarmed SAM21 icon to open the Shelf View window.
- 2 From the Shelf View window, select Faults from the menu bar and Alarm Browser from the drop down menu.

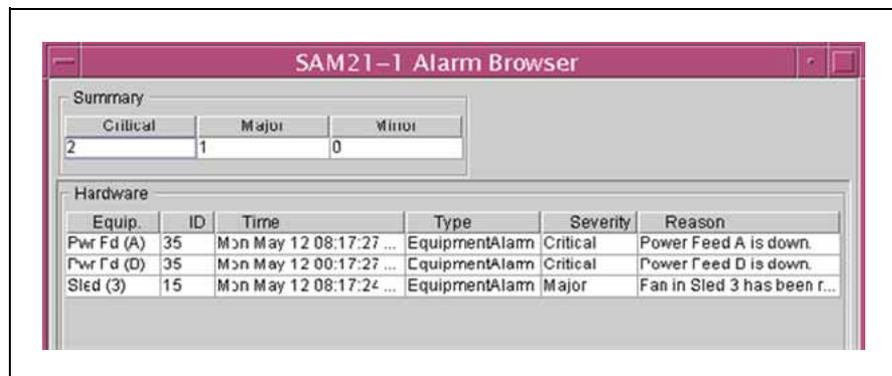
- 3 The Alarm Browser window shows alarm information for all cards in the SAM21 shelf.

Note: The alarm browser window contains information about Hardware and Services on the entire SAM21 shelf.

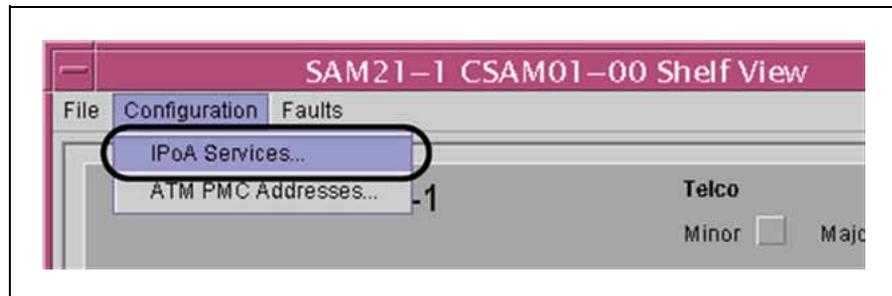
- 1 Click on Configuration and then IPoA Services from the Shelf View to open the ATM Connections window.

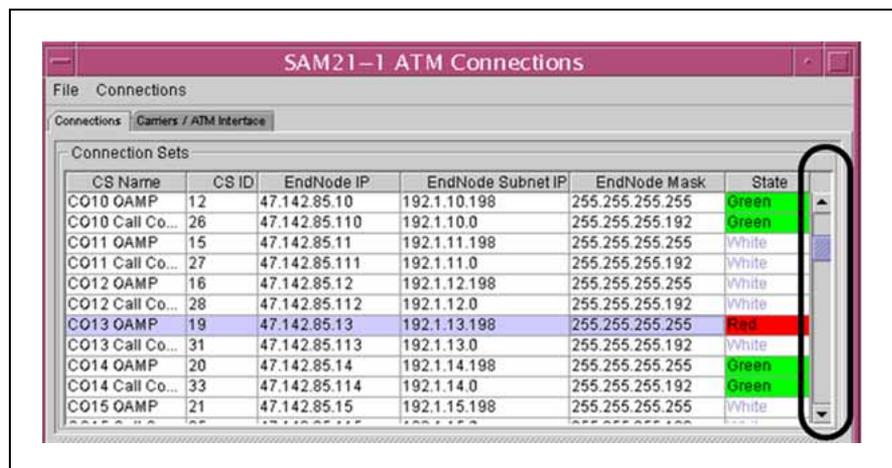
- 2 Use the Connection Sets scroll bar to locate a Connection Set (CS) that is not Green, or use the Service ID from the Alarm Browser to locate the degraded CS and select the CS.

State color	Meaning
white	The connection is in a maintenance state.
yellow	One connection member IP Path state is up and the IP Path state on the active Shelf Controller is not maintenance.

State color	Meaning
green	The IP Path state for both active and inactive Shelf Controller is up.
red	The IP Path state for the active and inactive Shelf Controllers is not up
or	
	The IP Path state for the inactive Shelf Controller is up, but the IP Path state for the active Shelf Controller is maintenance.

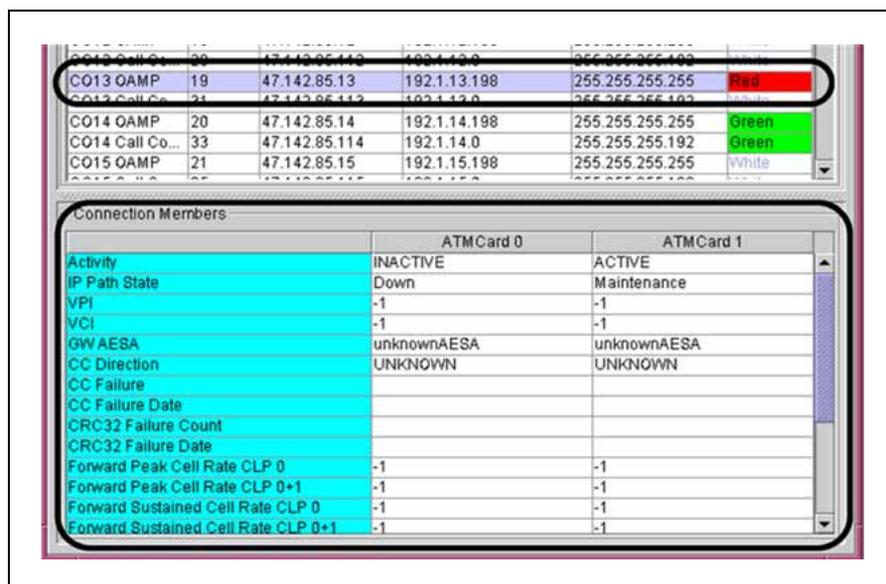
3 Review the data in the Connection Members area.

Field	Value	Meaning	Action
Activity	ACTIVE or INACTIVE	This indicates which Shelf Controller is active.	
IP Path State	Up	Connectivity is established with the far end node.	
	Down	Connectivity is not available to the far end node.

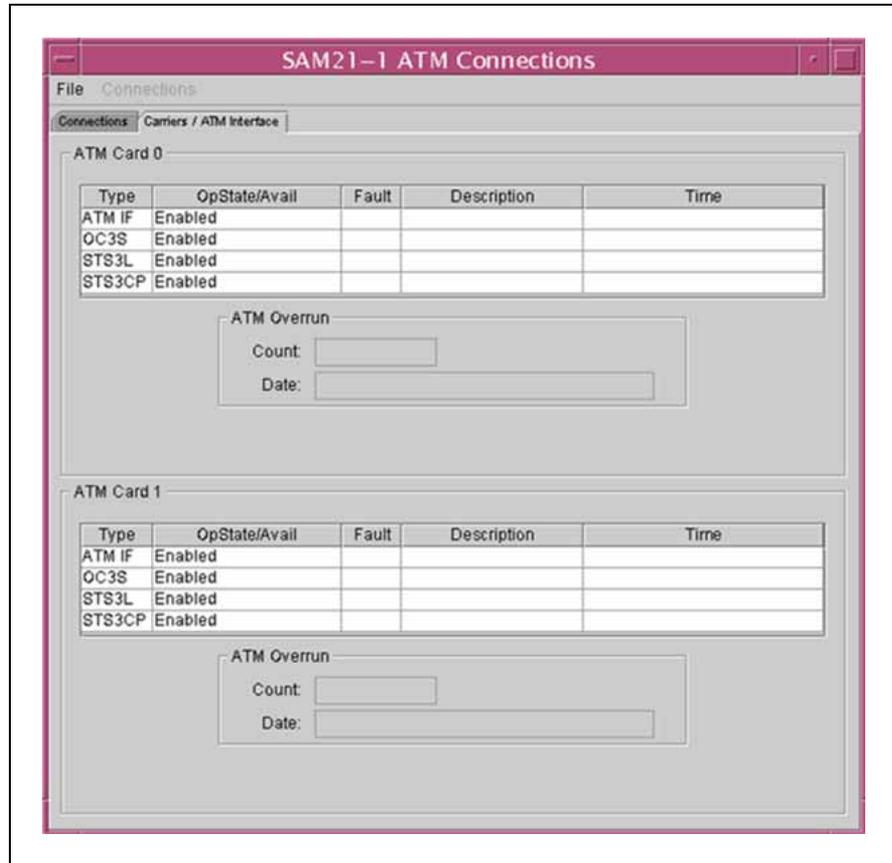
- 4 Review the data on the Carriers tab.

Fault	Action
LOS LOF	These section, line, and path faults indicate that SONET connectivity between the SAM21 Shelf Controller and the far end node is unavailable on one fiber.
AIS-L RDI-L	
AIS-P RDI-P	Check the fibers and connections between the SAM2 Shelf Controller and the far end node.
LOP

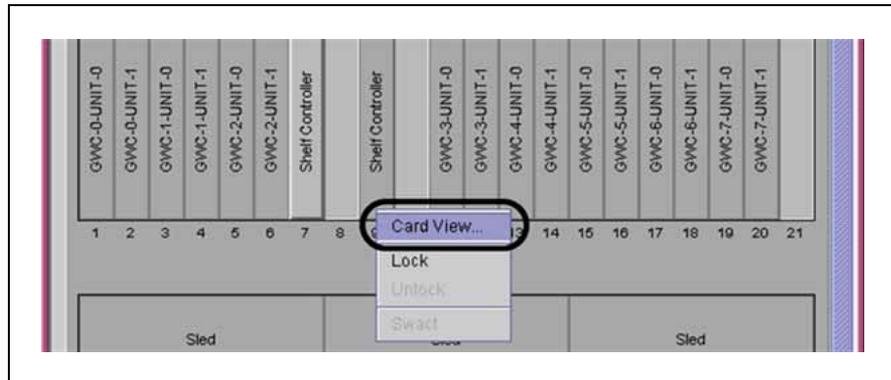
- 1 Open the Card View window for the SAM21 Shelf Controller.

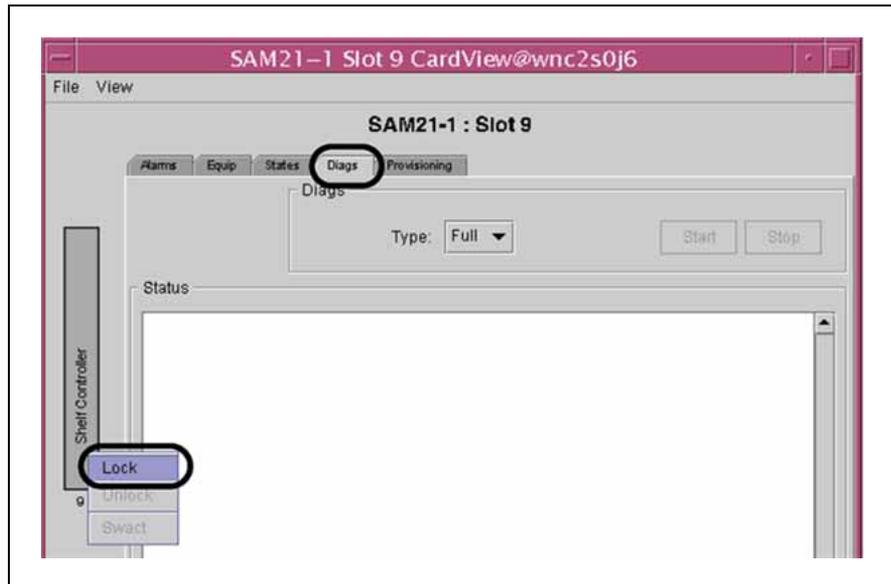
- 2 Click on the Diags tab and Lock the SAM21 Shelf Controller from the card icon.

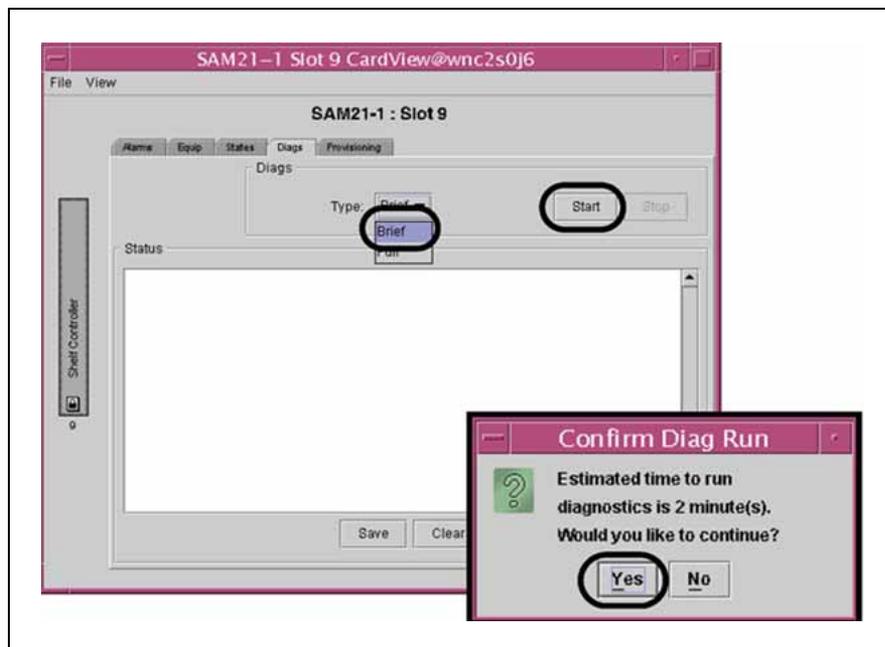
- 3 Select Brief or Full diagnostics and then Click Start and confirm the diagnostic run prompt.

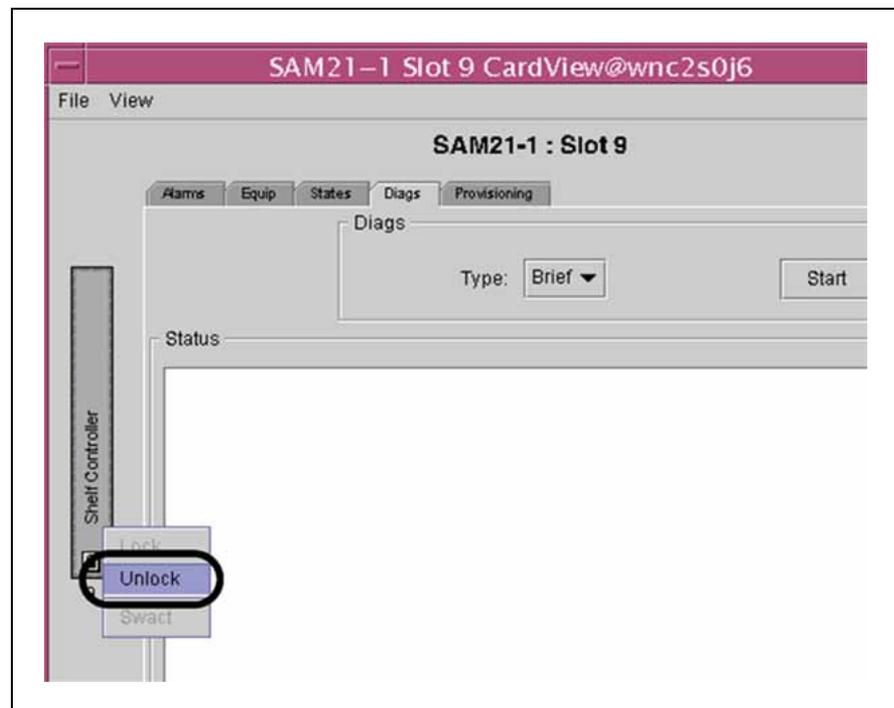
- 4 Wait for diagnostics to complete and to indicate Success.
If diagnostics fail, retry Brief and then Full. If either diagnostic fails, contact Nortel support personnel for assistance with replacing the SAM21 Shelf Controller card.
- 5 Optionally save the diagnostic messages to a file by clicking the Save button.
- 6 Unlock the SAM21 Shelf Controller.

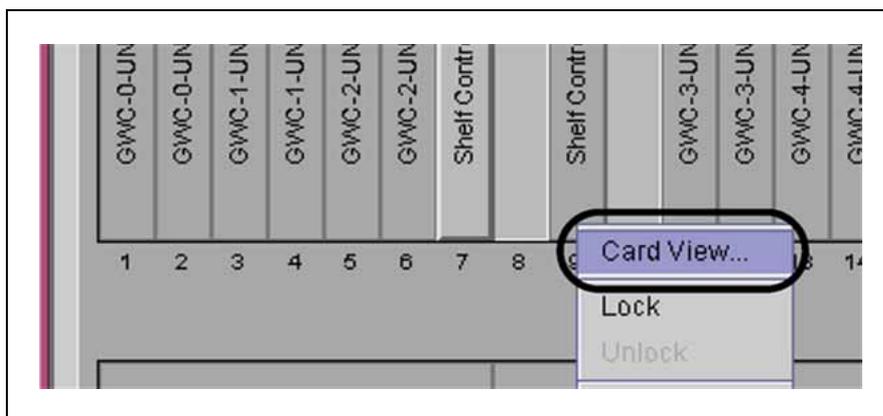
- 1 From the Shelf View, right click on the SAM21 Shelf Controller and select Card View from the context menu to bring up the Card View window.

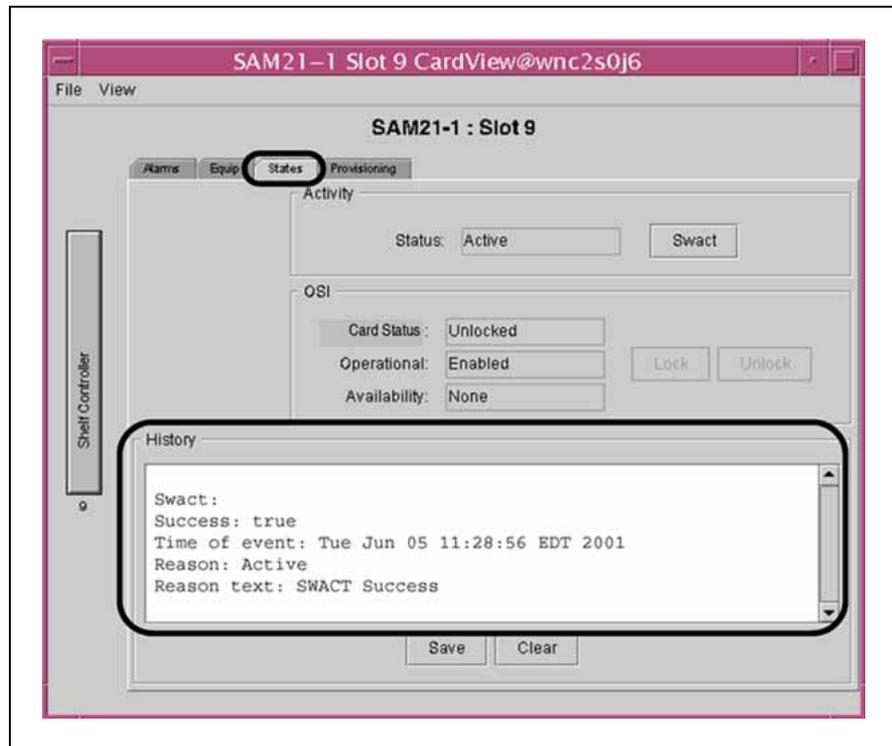
- 2 Select the States tab from the SAM21 Shelf Controller window.

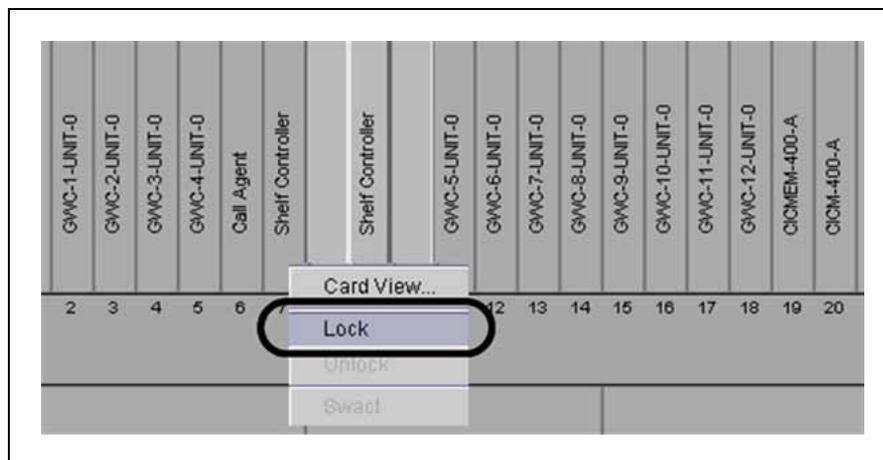
- 1 From the Shelf View, right click on the card and select Lock from the context menu.

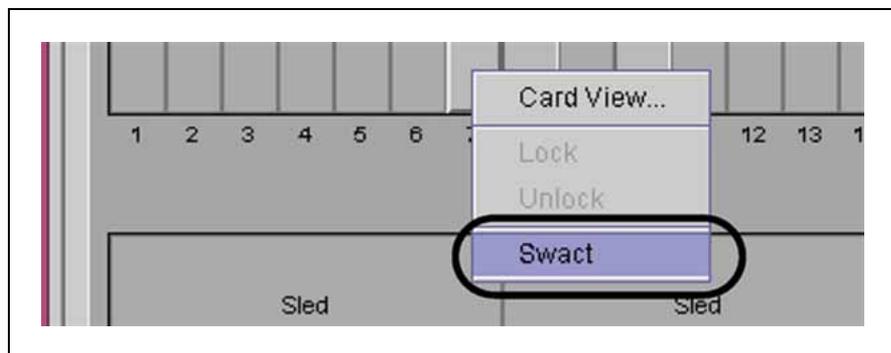
- 1 If the SAM21 Shelf Controller to be replaced is not inactive, Swact the SAM21 Shelf Controllers by right clicking on the SAM21 Shelf Controller in the Shelf View and selecting Swact from the context menu.

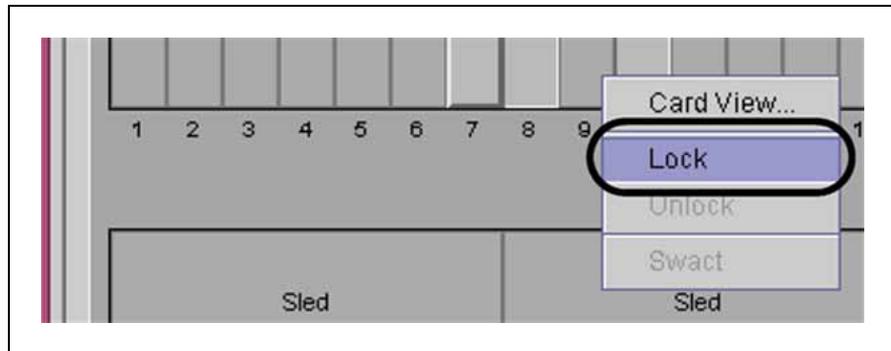
- 2 Lock the SAM21 Shelf Controller.

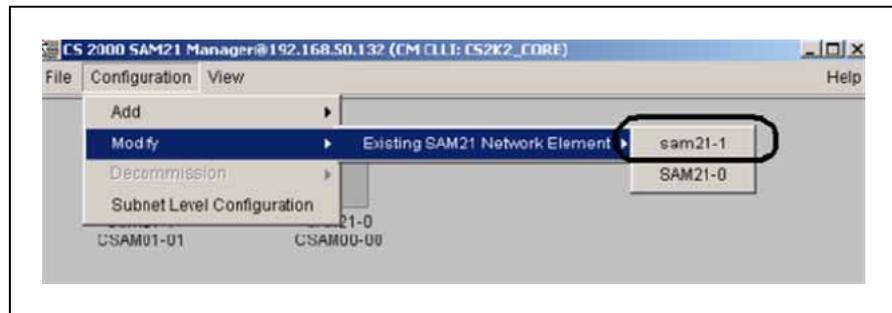
- 3 From the Subnet View window, select Configuration, Modify, Existing SAM21 Network Element, and then the SAM21 shelf from the menu bar.

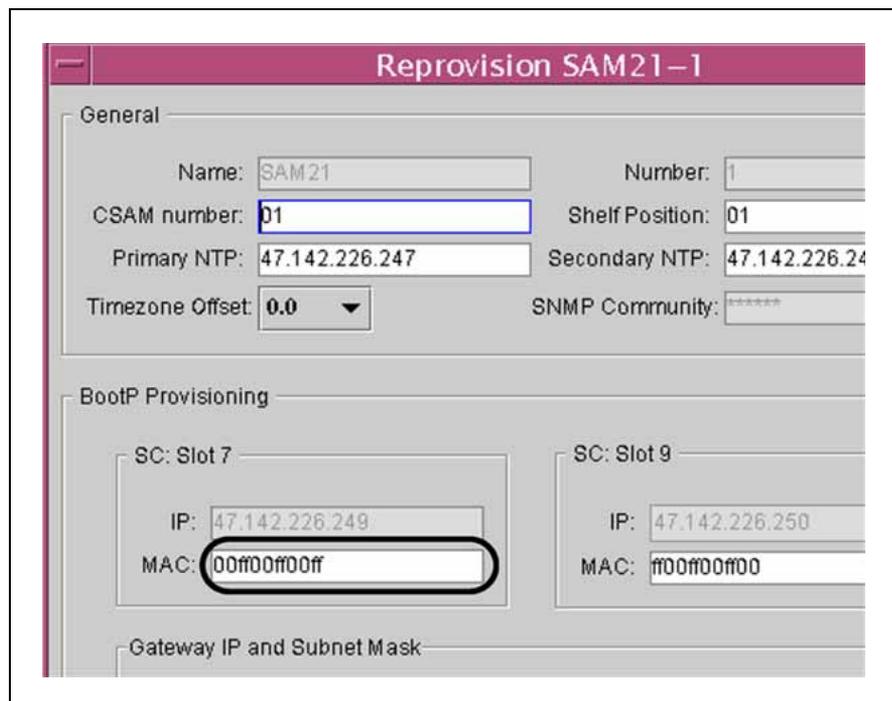
- 4 Change the MAC address provisioning to the MAC address of the replacement SAM21 Shelf Controller. The MAC address is printed on the faceplate of the SAM21 Shelf Controller.

The TYPE field in the Reprovision panel of the SAM21 Network Element menu is updated to allow you to specify either the MCP750 or the MCP820 SAM21 Shelf Controller for configuration. The following figure shows an example of the SAM21 Reprovision panel with the updated TYPE field.

The screenshot displays the 'Reprovision sam21-1' window. It is divided into two main sections: 'General' and 'BootP Provisioning'.
General Section:
- Name: sam21
- Number: 1
- CSAM number: 01
- Shelf Position: 01
- Primary NTP: 192.168.50.132
- Secondary NTP: 192.168.50.27
- Timezone Offset: 8.0
- SNMP Community: *****
BootP Provisioning Section:
- SC: Slot 7
- IP: 192.168.50.6
- MAC: 0001af07a665
- TYPE: MCP750 (dropdown menu is open, showing options MCP750 and MCP820)
- SC: Slot 9
- IP: 192.168.50.7
- MAC: 0001af08ecdb
- TYPE: MCP750 (dropdown menu is open, showing options MCP750 and MCP820)
- Gateway IP and Subnet Mask fields are partially visible at the bottom.

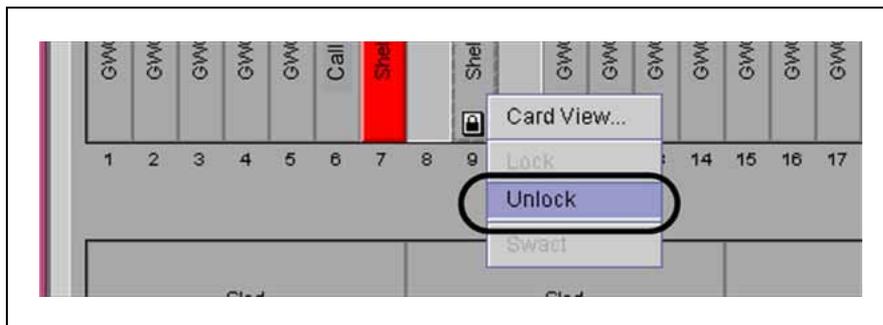
Note 2: If the replacement SAM21 Shelf Controller firmware requires an update, then the active SAM21 Shelf Controller unlocks the replacement SAM21 Shelf Controller and downloads the updated firmware. The active SAM21 Shelf Controller then applies the firmware, but does not boot the replacement. The card icon appears with a dashed outline and no lock icon. Refer to "SAM21 Shelf Controller does not unlock" in *SAM21 Shelf Controller Upgrades*, NN10067-461.

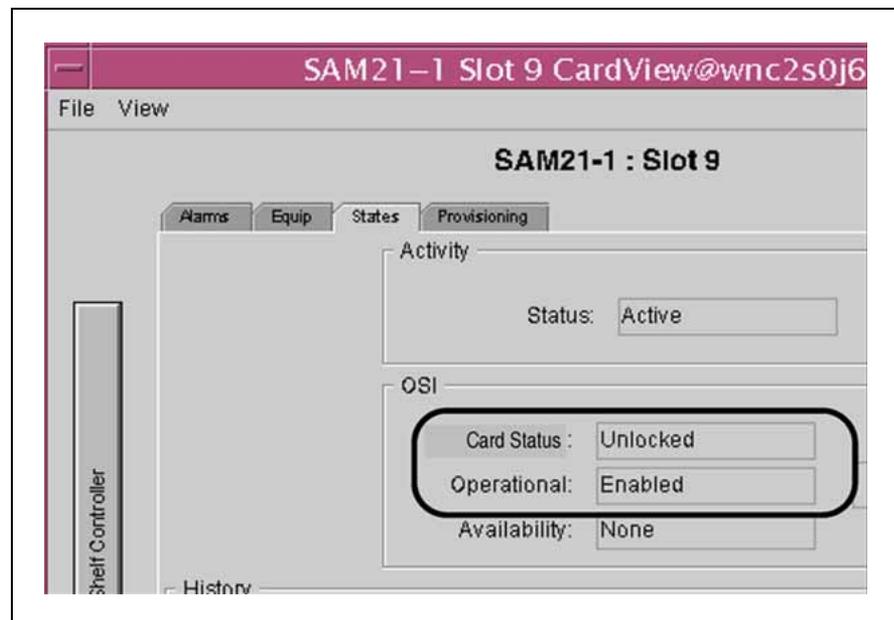
- 10 Right click on the SAM21 Shelf Controller icon and select Card View from the context menu.
- 11 Select the States tab from the Card View window and wait for the Card Status field to indicate Unlocked and the Operational field to indicate Enabled.

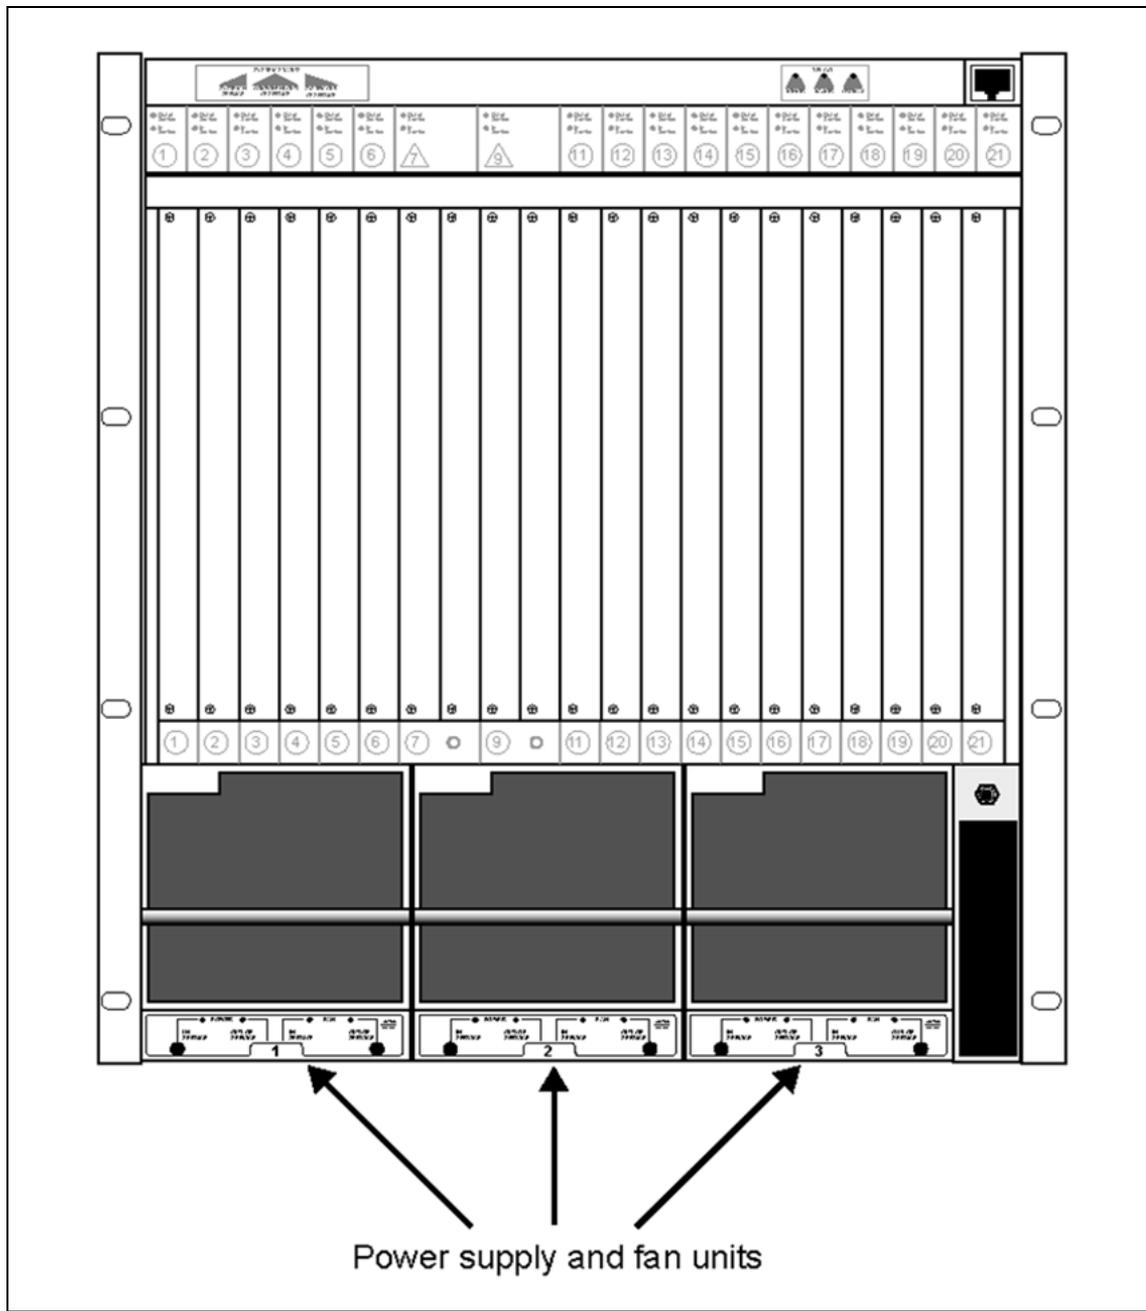
SAM21 Power Supply and Fan Units, seen from the front of the shelf

The following figure shows the locations of the SAM21 Power Supply and Fan Units, as viewed from the front of the SAM21 shelf.

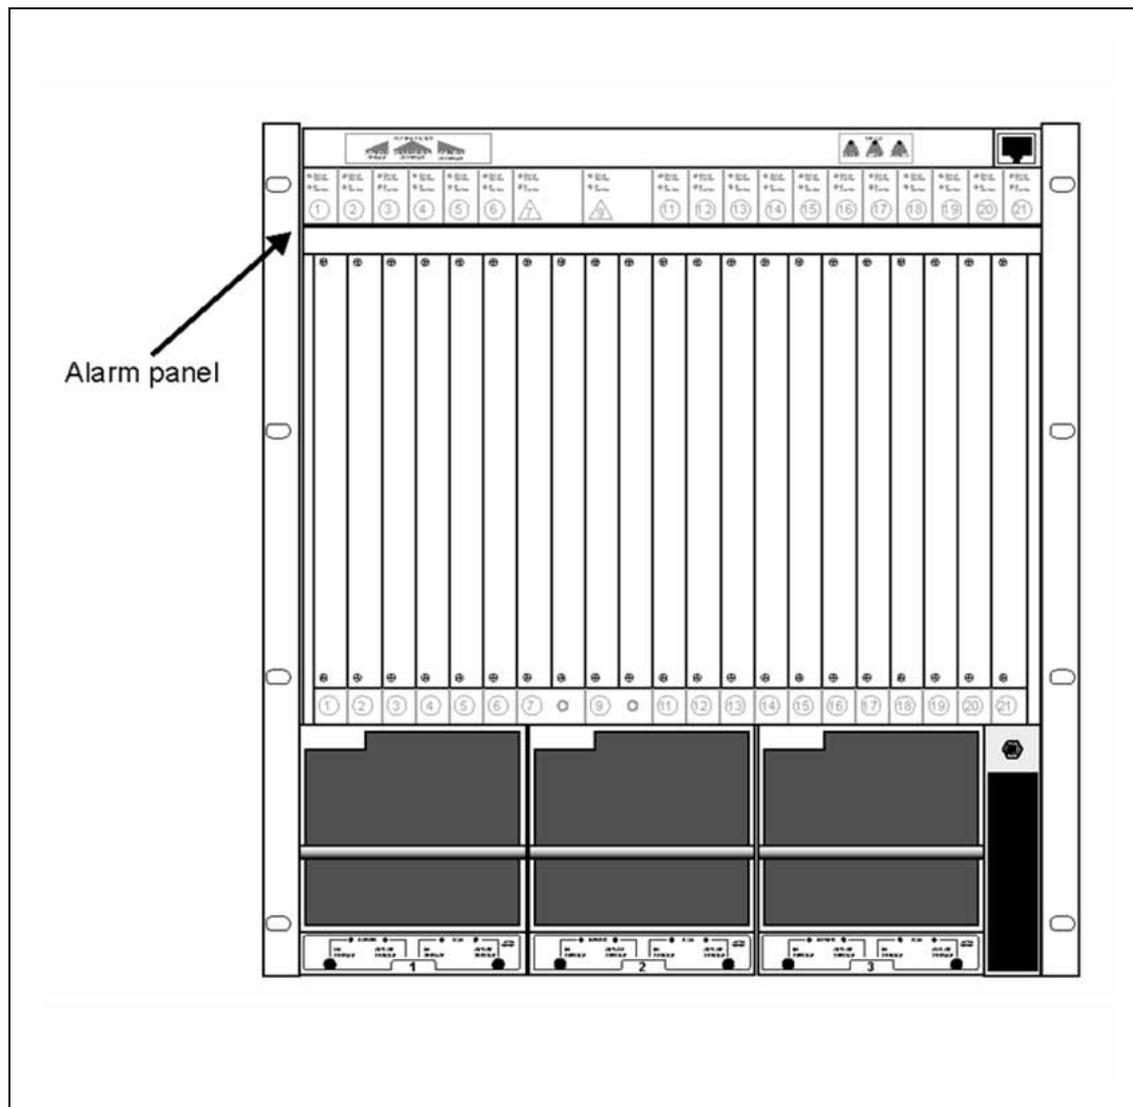
SAM21 Alarm Panel, seen from the front of the shelf

The following figure shows the location of the SAM21 Alarm Panel, as viewed from the front of the SAM21 shelf.

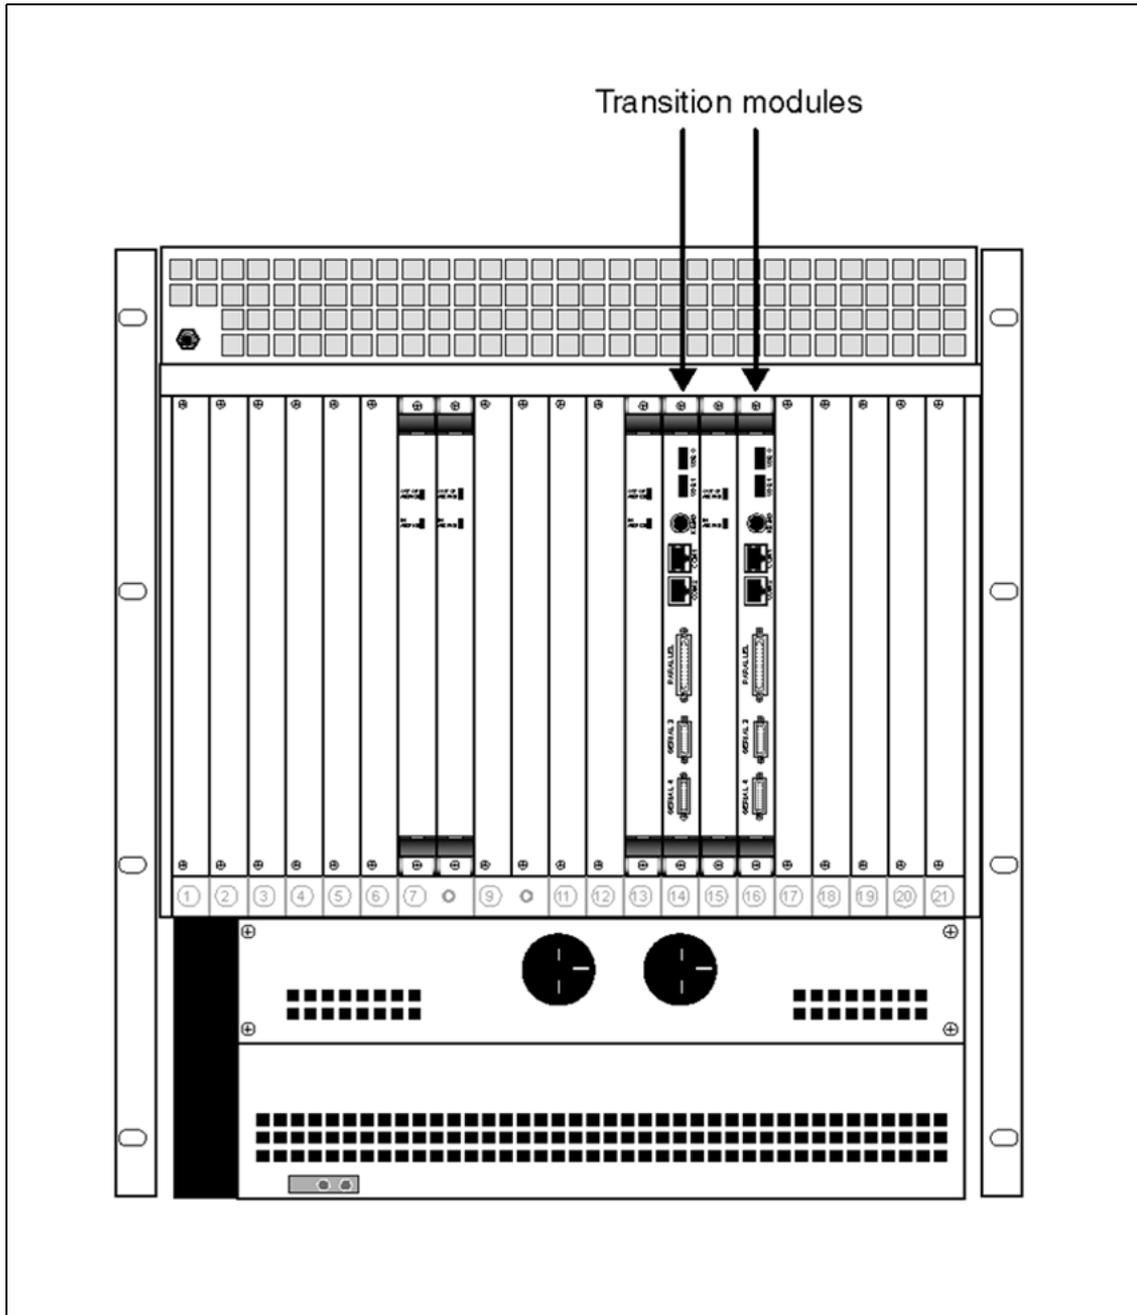
SAM21 Transition Modules, seen from the rear of the shelf

The following figure shows the locations of the SAM21 Transition Modules, as viewed from the rear of the SAM21 shelf.

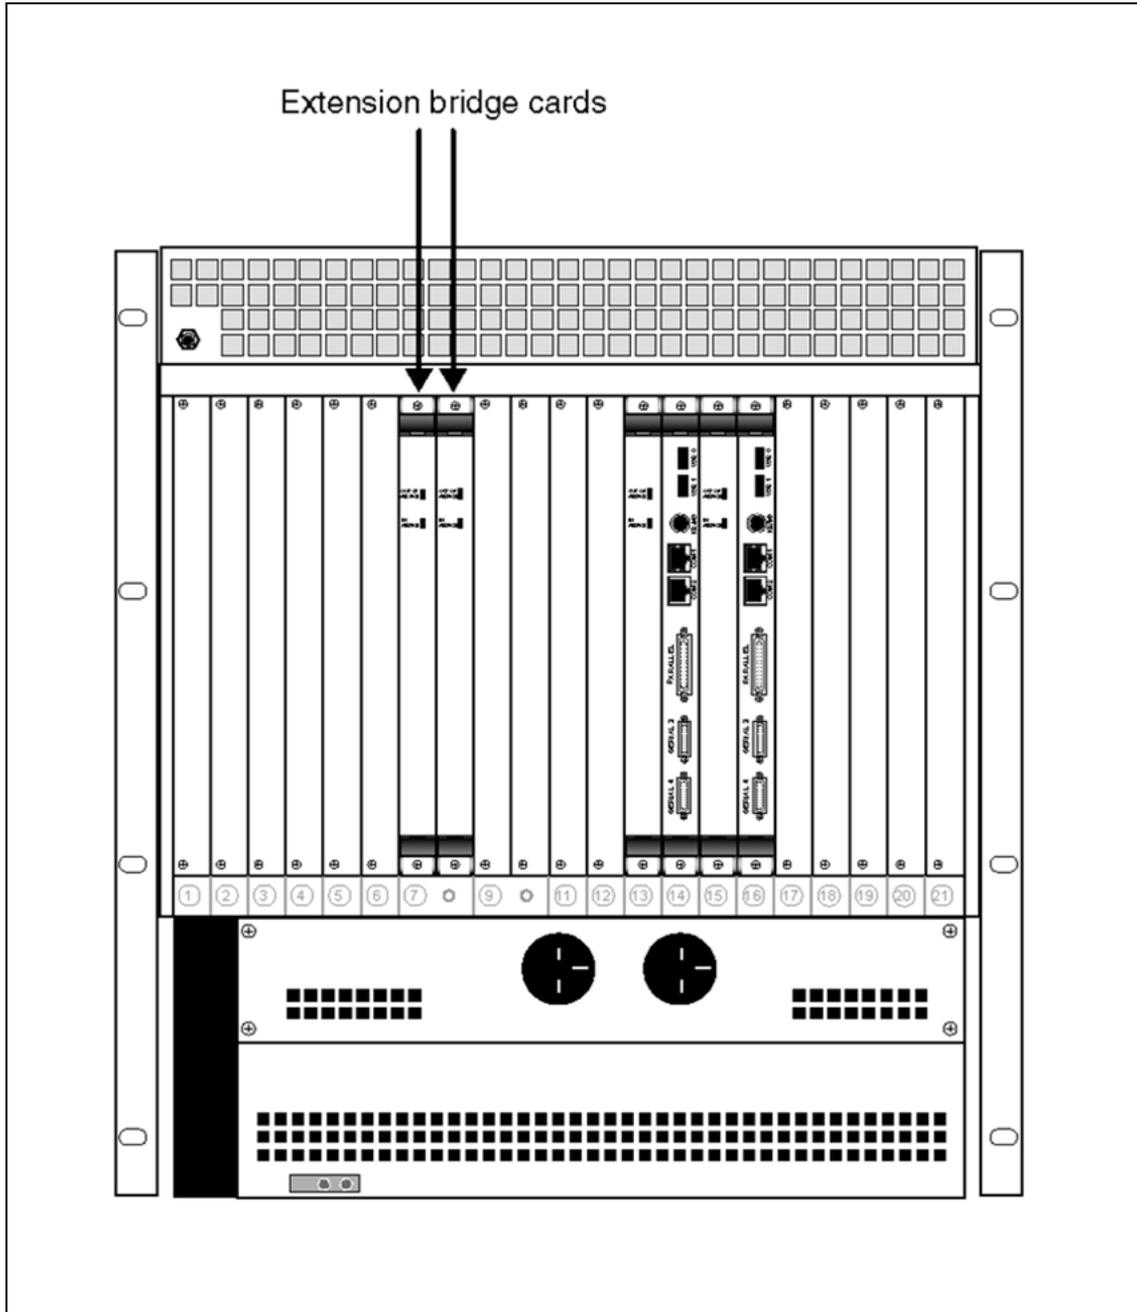
SAM21 Extension Bridge cards, seen from the rear of the shelf

The following figure shows the locations of the SAM21 Extension Bridge cards, as viewed from the rear of the SAM21 shelf.

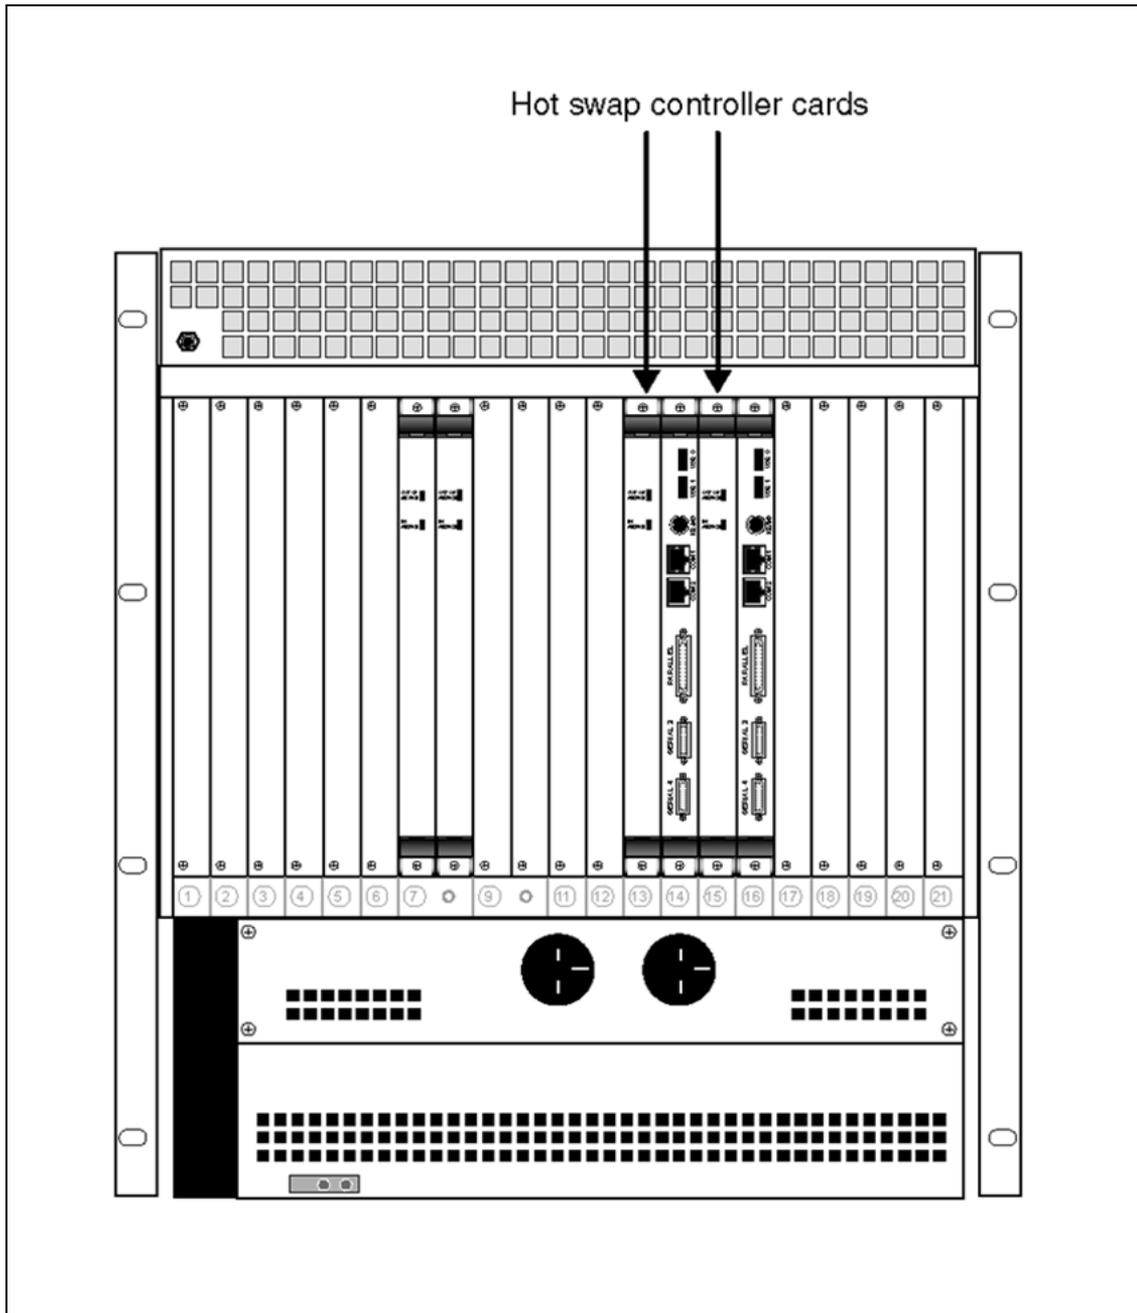
SAM21 Hot Swap Controller cards, seen from the rear of the shelf

The following figure shows the locations of the SAM21 Hot Swap Controller cards, as viewed from the rear of the SAM21 shelf.
