Meridian 1 Options 21 through 81C

# Fault Clearing Guide

Document Release: Standard 6.00

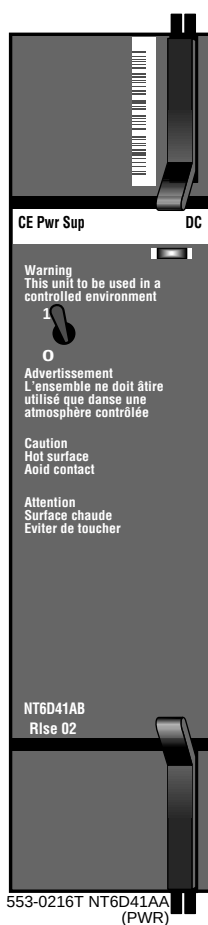
553-0216T NT6D41AA  
(PWR)

## Common Equipment Power Supply (DC)
