# InfiniBand Configuration on VMware vSphere 8

## Introduction

Two years ago, we published technical white papers detailing the setup process for [InfiniBand passthrough](#) and [InfiniBand SR-IOV](#) on VMware vSphere® 7. In response to ongoing customer inquiries about implementing these features on vSphere 8 and VMware Cloud Foundation® (VCF), we are providing an update to our original paper.

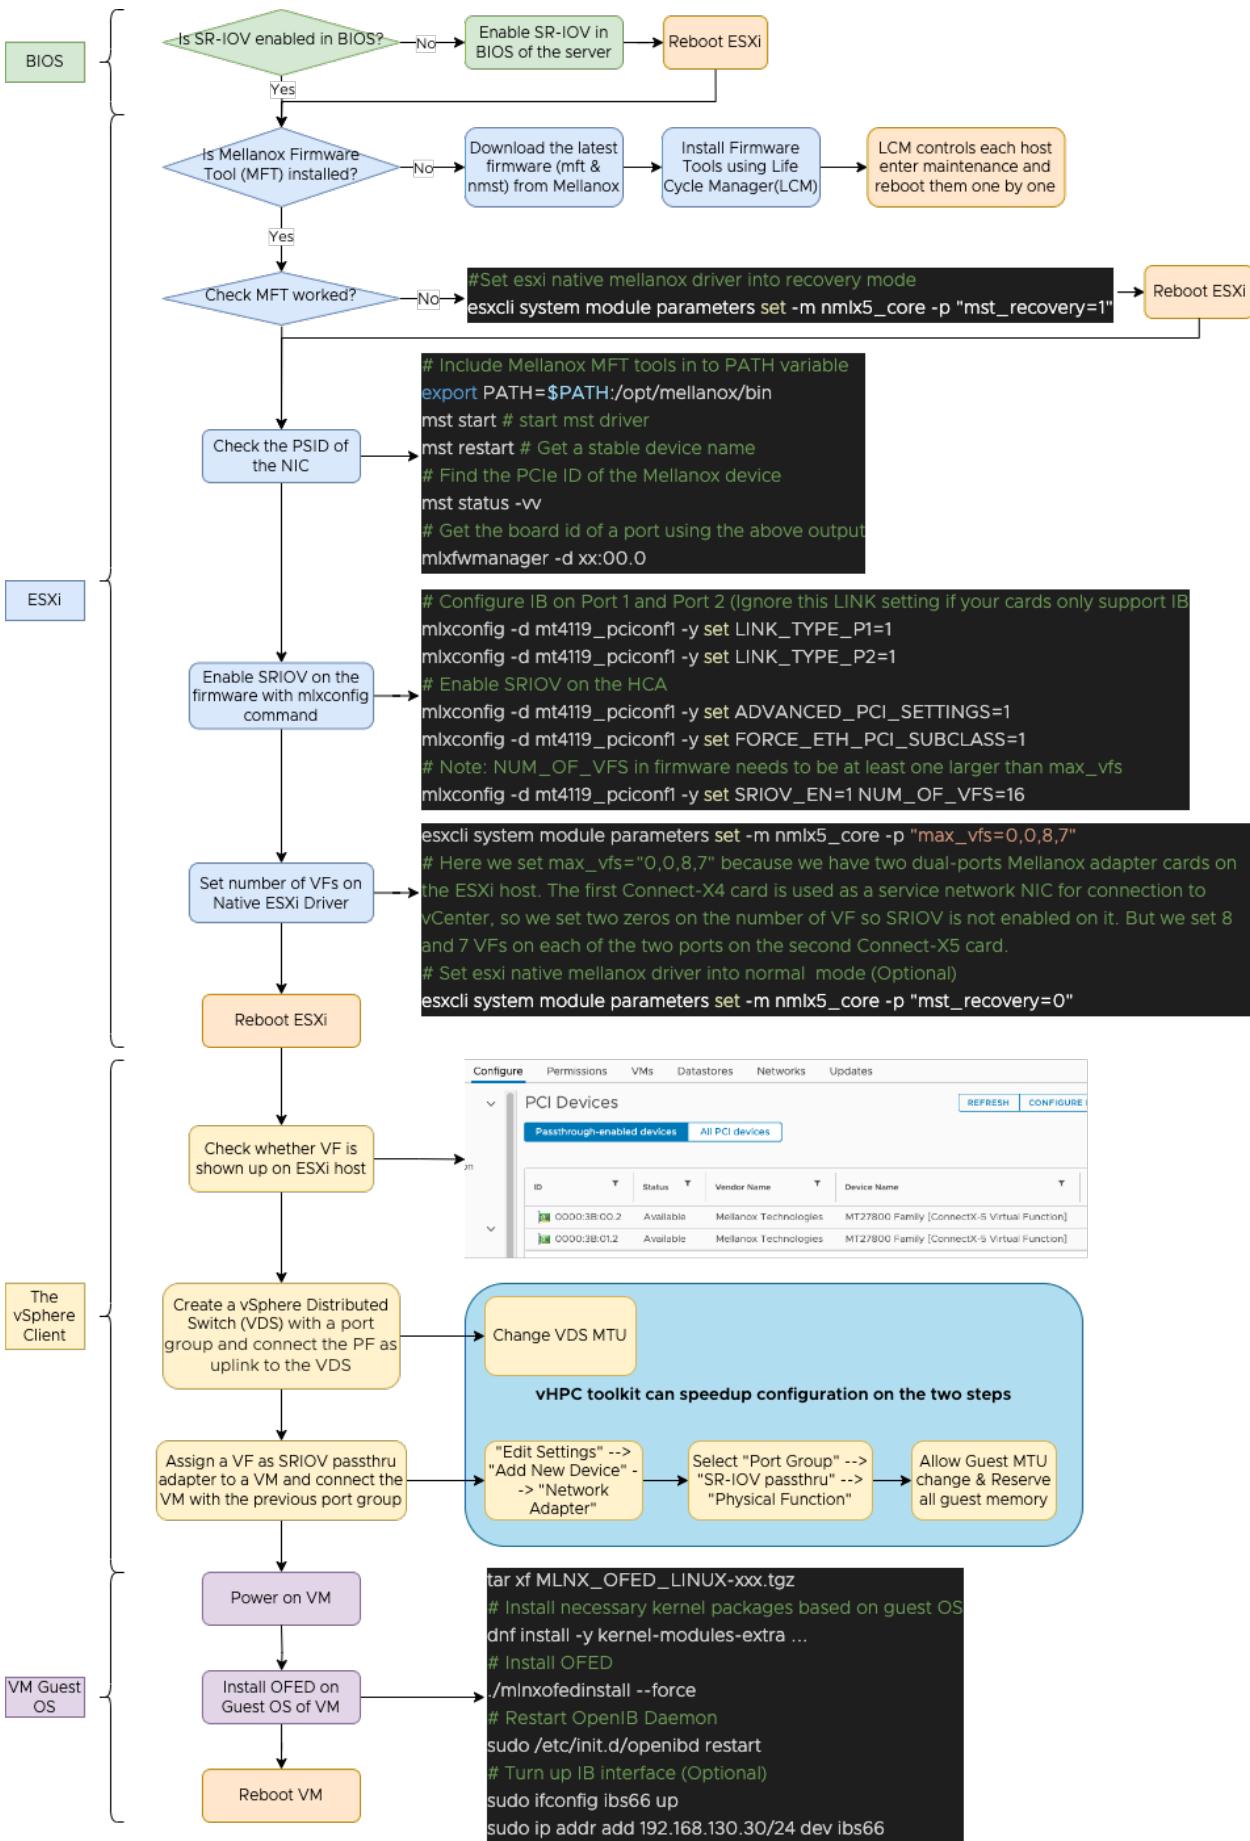
Figure 1. Flow chart to enable InfiniBand SR-IOV on NVIDIA/Mellanox ConnectX-5/6/7 in vSphere 8.x (next page)

Figure 1 shows the updated workflow. The previous paper's workflow remains valid for the most part, but this update addresses a few key aspects that require special attention.

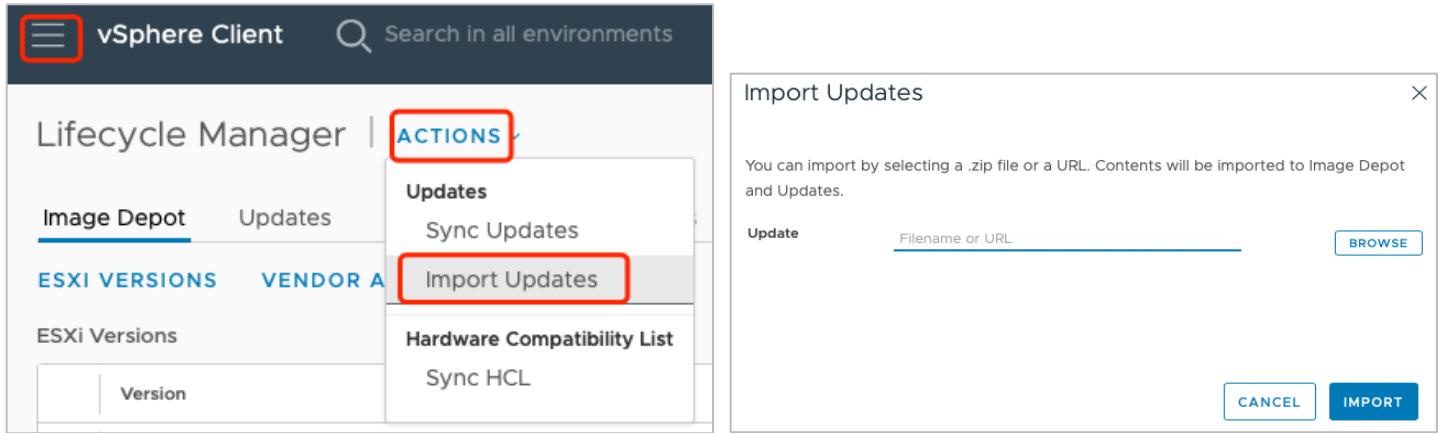
Figure 2. Use Lifecycle Manager to import MFT and MST components

1. Open the vSphere Client menu by clicking on the three lines in the top left corner next to **vSphere Client**.
2. Select **Lifecycle Manager**.
3. Select **ACTIONS > Import Updates**.

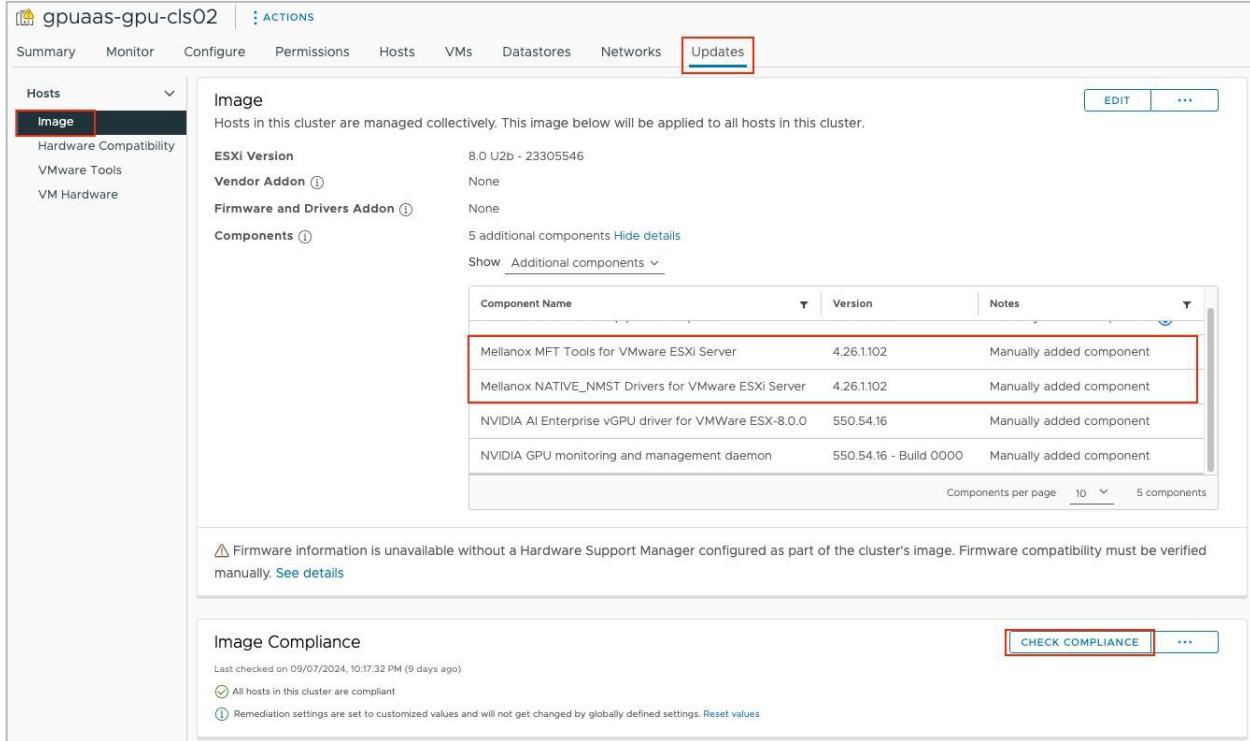
Figure 3. Use Lifecycle Manager to remediate the whole cluster

After importing the MFT packages, on the left panel, navigate to **Hosts > Updates** and click the **Images** tab in your targeted cluster. From there, you can:
