Power Systems
Isolation procedures

This edition applies to IBM Power Systems® servers that contain the POWER6™ processor and to all associated models.

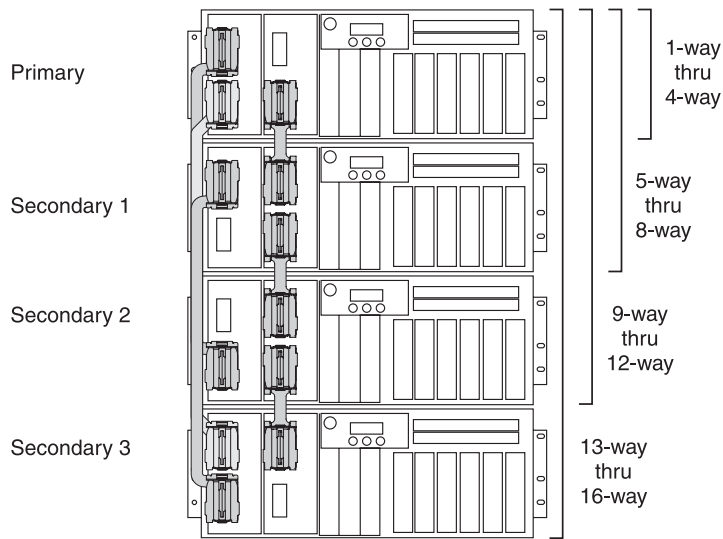
Table 15. Converting the loop number to port location labels for a 9117-MMA, and 9406-MMA

Note: If you are working on a Model MMA with multiple processor enclosures, exchange the FRU on the correct unit (primary or secondary) by matching the serial number (if available in the FRU list on the serviceable event view) or by matching the loop number to the correct unit.

Note: To simplify this information, secondary units on the Model MMA server are numbered 1 through 3-secondary unit 1 being nearest to the primary unit and secondary unit 3 being furthest.

Loop number (hex / dec)	Model	FRU position	RIO/HSL/12X port labels on system unit or processor tower
0686 / 1670	MMA primary unit	-P1-C8	-P1-C8-T1 -P1-C8-T2
0688 / 1672	MMA primary unit	-P1-C9	-P1-C9-T1 -P1-C9-T2
0696 / 1686	MMA first secondary unit	-P1-C8	-P1-C8-T1 -P1-C8-T2
0698 / 1688	MMA first secondary unit	-P1-C9	-P1-C9-T1 -P1-C9-T2
06A6 / 1702	MMA second secondary unit	-P1-C8	-P1-C8-T1 -P1-C8-T2
06A8 / 1704	MMA second secondary unit	-P1-C9	-P1-C9-T1 -P1-C9-T2
06B6 / 1718	MMA third secondary unit	-P1-C8	-P1-C8-T1 -P1-C8-T2
06B8 / 1720	MMA third secondary unit	-P1-C9	-P1-C9-T1 -P1-C9-T2
0781 / 1921	MMA primary unit	-P1-C8	-P1-C8-T1 -P1-C8-T2

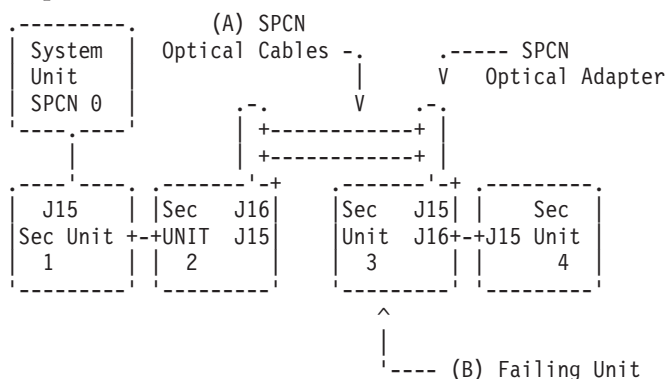
14. Do the SPCN optical cables (A) connect the failing unit (B) to the preceding unit in the chain or loop?

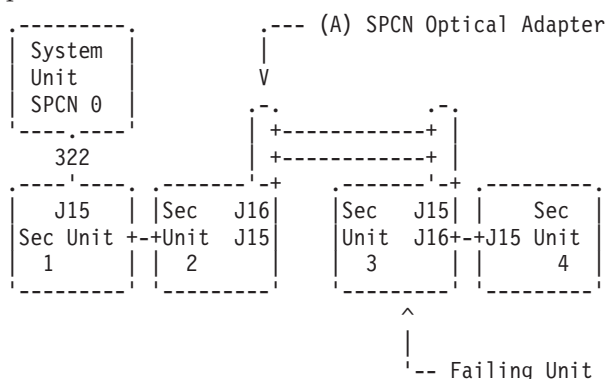
15. Remove the SPCN optical adapter (A) from the preceding frame in the string that cannot become powered on.

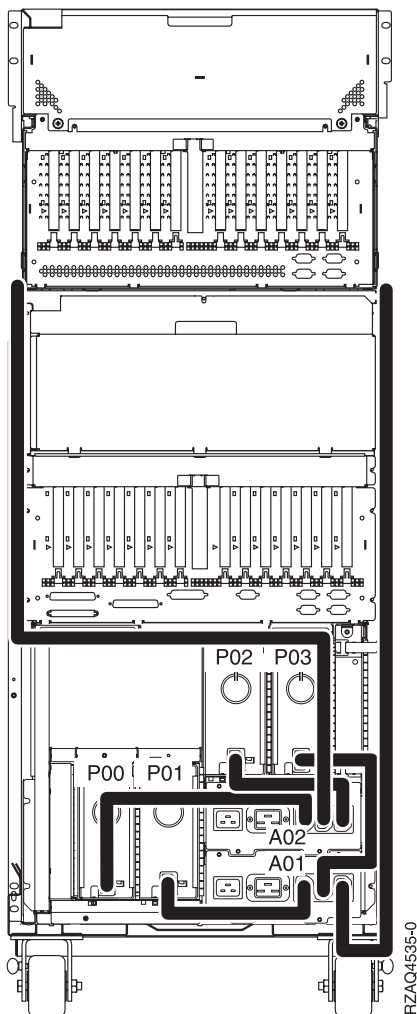
Figure 2. Dual line cord drawing for 5088, or 0588 installed on 5094

Model or expansion unit	Reference code	Locate these parts
5088 and 0588 (see Figure 2 on page 168)	1xxx 1510	ac jumper cable connected to power supply 2 and the ac module
	1xxx 1520	ac jumper cable connected to power supply 1 and the ac module
5294 and 5094 (see Figure 1)	1xxx 1500	ac jumper cable connected to power supply 0 and the ac module
	1xxx 1510	ac jumper cable connected to power supply 1 and the ac module
	1xxx 1520	ac jumper cable connected to power supply 2 and the ac module
	1xxx 1530	ac jumper cable connected to power supply 3 and the ac module
5095 and 0595	1xxx 1510	Power supply 1 and ac line cord 1
	1xxx 1520	Power supply 2 and ac line cord 2
5790, 5796, 7314-G30, 7311-D11, 7311-D20	1xxx 1510	Power supply 1 and ac line cord 1
	1xxx 1520	Power supply 2 and ac line cord 2

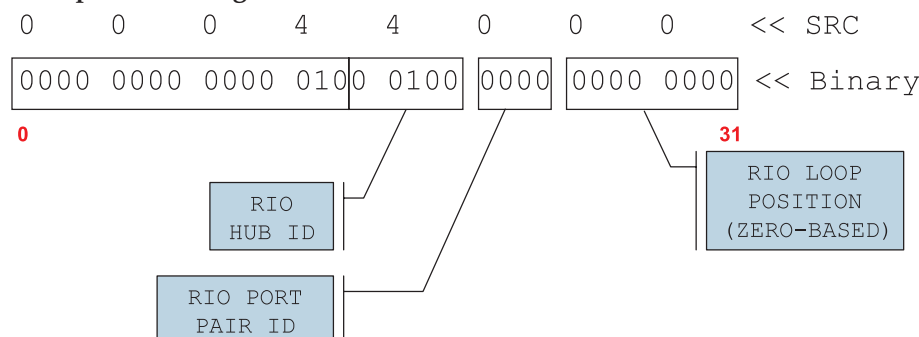
IPHAU450-1

- a. Use the following example as a guide to locate and record the following binary values from word 5 or word 6 of the SRC:
 - RIO hub ID
 - RIO port pair ID
 - RIO loop position

Example: Decoding FRU Callout 00044000

- b. Convert the binary values for the RIO hub ID, the RIO port pair ID, and the RIO loop position to decimal. Record these values for later use.
3. Each RIO hub controls two RIO loops, specified as the *first* and *second* loop. Use the following list to determine and record which of these two RIO loops is indicated in word 6 of the SRC:

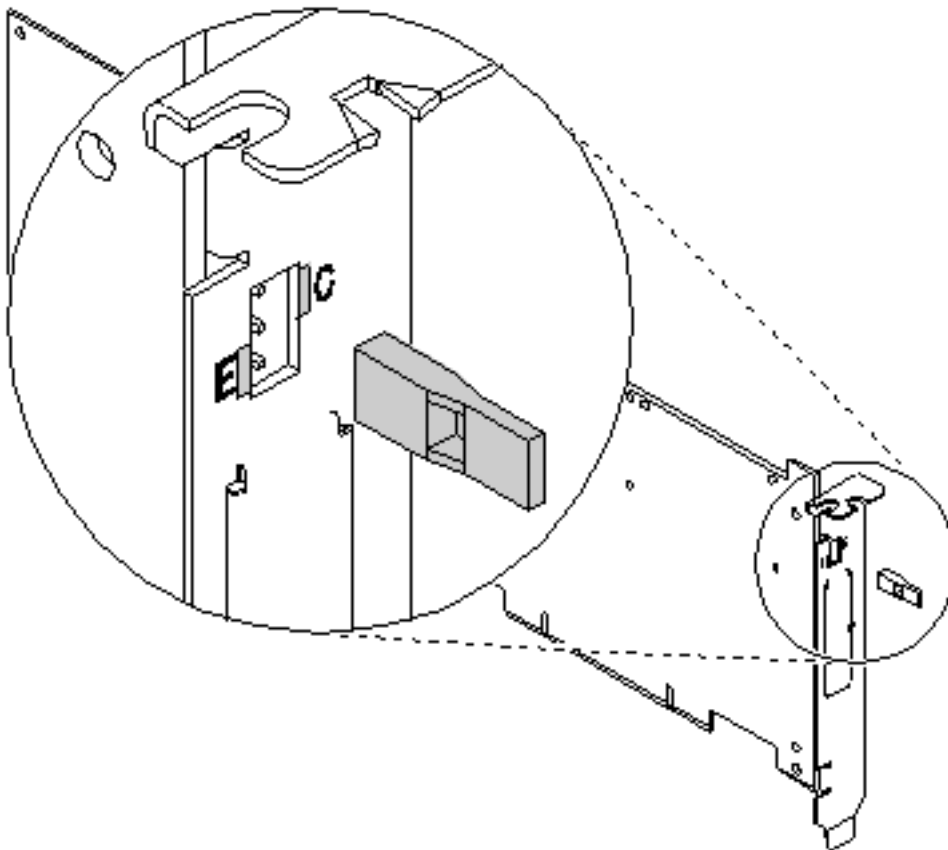
Figure 3. Changing the mode jumper

The 2748 and 2778 I/O cards support two modes: compression and enhanced. The rear of the I/O card is marked with a **C**, indicating compression mode, and an **E**, indicating enhanced mode. Three pins on the rear of the I/O card determine the mode of the card, depending on which of the pins have a jumper placed on them.

The jumper may be moved at any time, but changes only take effect during a system IPL. Refer to the illustration below while changing the mode jumper.

1. Power off the system, ensuring that no jobs are currently processing (see Powering on and powering off the system).
2. Choose from the following options:
 - To set the mode of the card to compressed (C), place the jumper on the top and middle pins.

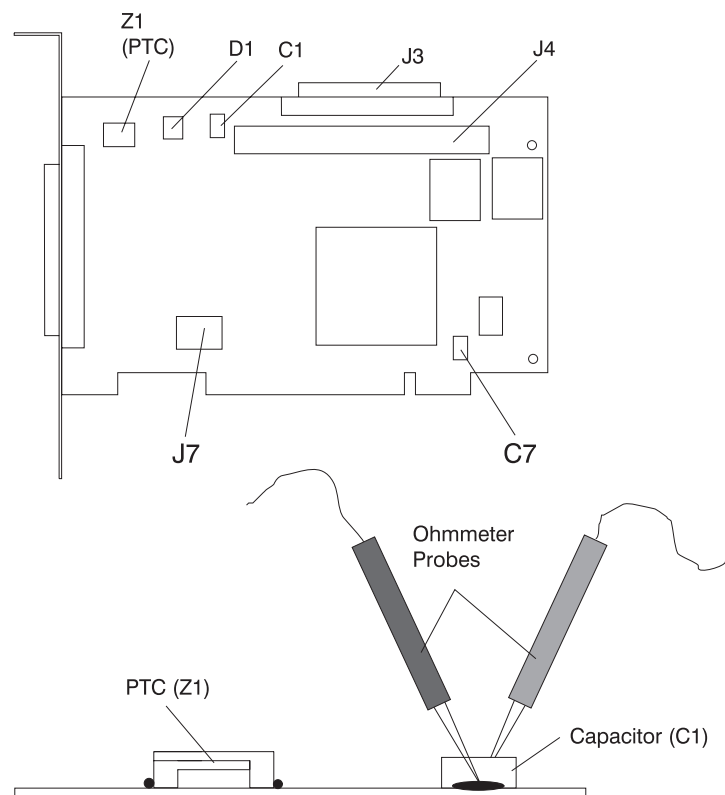
SCSI-2 Fast/Wide PCI Single-Ended Adapter

1. Ensure that system power and all externally attached device power is turned off.
2. Disconnect any internal and external cables from the adapter, then remove the adapter from the system.
3. Verify with a digital ohmmeter, that the internal PTC resistor, labeled Z1, is cool and in a low resistance state, typically less than 1/2 Ohm. Measuring across, be sure to probe both sides of the PTC where the solder joints and board come together. The polarity of the test leads is not important. If necessary, allow the PTC to cool and measure again. Refer to the following illustration.

Note: Ensure that only the probe tips are touching the solder joints. Do not allow the probes to touch any other part of the component.

4. Locate capacitor C1 and measure the resistance across it using the following procedure:
 - a. Connect the positive lead to the side of the capacitor where the + is indicated. Be sure to probe at the solder joint where the capacitor and board come together.
 - b. Connect the negative lead to the opposite side of the capacitor. Be sure to probe at the solder joint where the capacitor and board come together.
 - c. If there is no short-circuit present, the resistance reading is high, typically hundreds of Ohms.

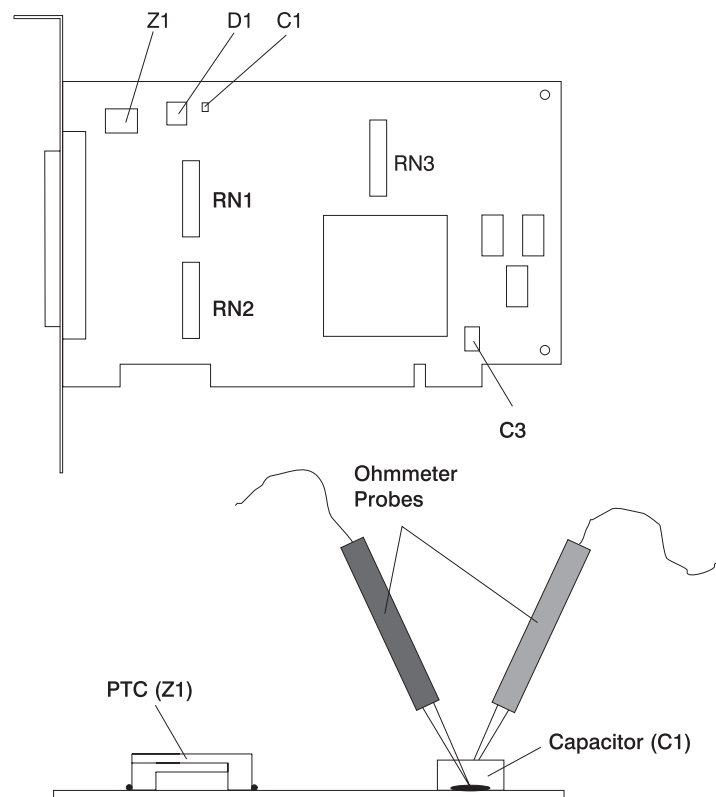
SCSI-2 Differential Fast/Wide PCI Adapter

3. Disconnect the external cables from the adapter and remove the adapter from the system.
4. Verify with a digital ohmmeter that the internal PTC resistor, labeled Z1, is cool and in a low resistance state, typically less than 1/2 Ohm. Refer to the following illustration. Measuring across, be sure to probe both sides of the PTC resistor where the solder joints and board come together. The polarity of the test leads is not important. If necessary, allow the PTC resistor to cool and measure again.

5. Locate capacitor C1 and measure the resistance across it using the following procedure:
 - a. Connect the negative lead to the side of the capacitor marked "GND". Be sure to probe at the solder joint where the capacitor and board come together.
 - b. Connect the positive lead to the side of the capacitor marked "Cathode D1" on the board near C1. Be sure to probe at the solder joint where the capacitor and board come together.

- If there is no fault present, then the resistance reading is 25 to 35 Ohms. The adapter is not faulty. Continue to the next step.
 - If the resistance measured is higher than 35 Ohms, check to see if RN1, RN2, and RN3 are plugged into their sockets. If these sockets are empty, you are working with a Multi-Initiators or High-Availability system. With these sockets empty, a resistive reading across C1 cannot be verified other than it measures a high resistance (not a short-circuit). If the resistance measurement is not low enough to be suspected as a fault (lower than 10 Ohms), continue to the next step.
