**OPERATION AND MAINTENANCE
HOT STANDBY
DR 6-135A AND 135EC
SOLID-STATE AMPLIFIER
TRANSMITTER SUBROUTINES**

This section contains the subroutines (SR) referenced from the transmitter trouble-clearing main routines (MR), main subroutines (MSR), and transmitter test and adjustment subroutines (TASR).

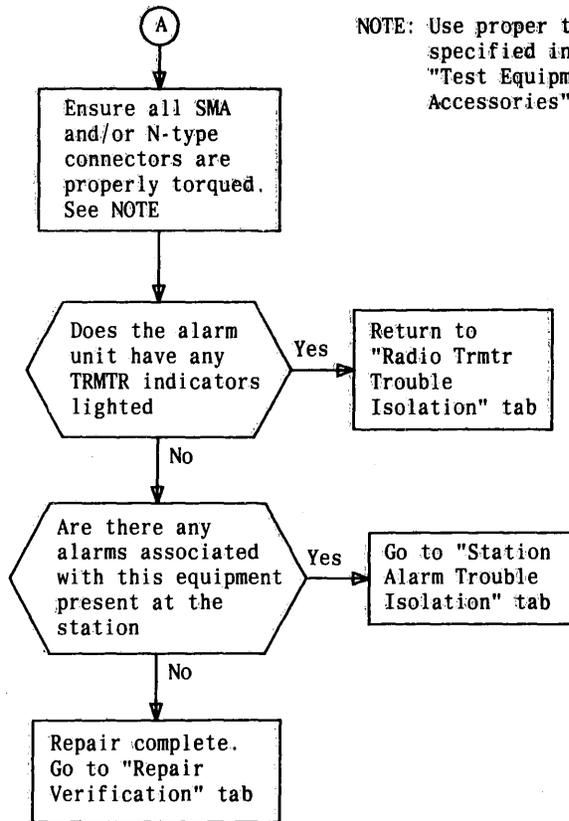
SR 1—Condition Transmitter for Repair Verification (Sheet 2 of 2)

NOTE: Use proper torque wrench specified in Table C of "Test Equipment and Accessories" tab.

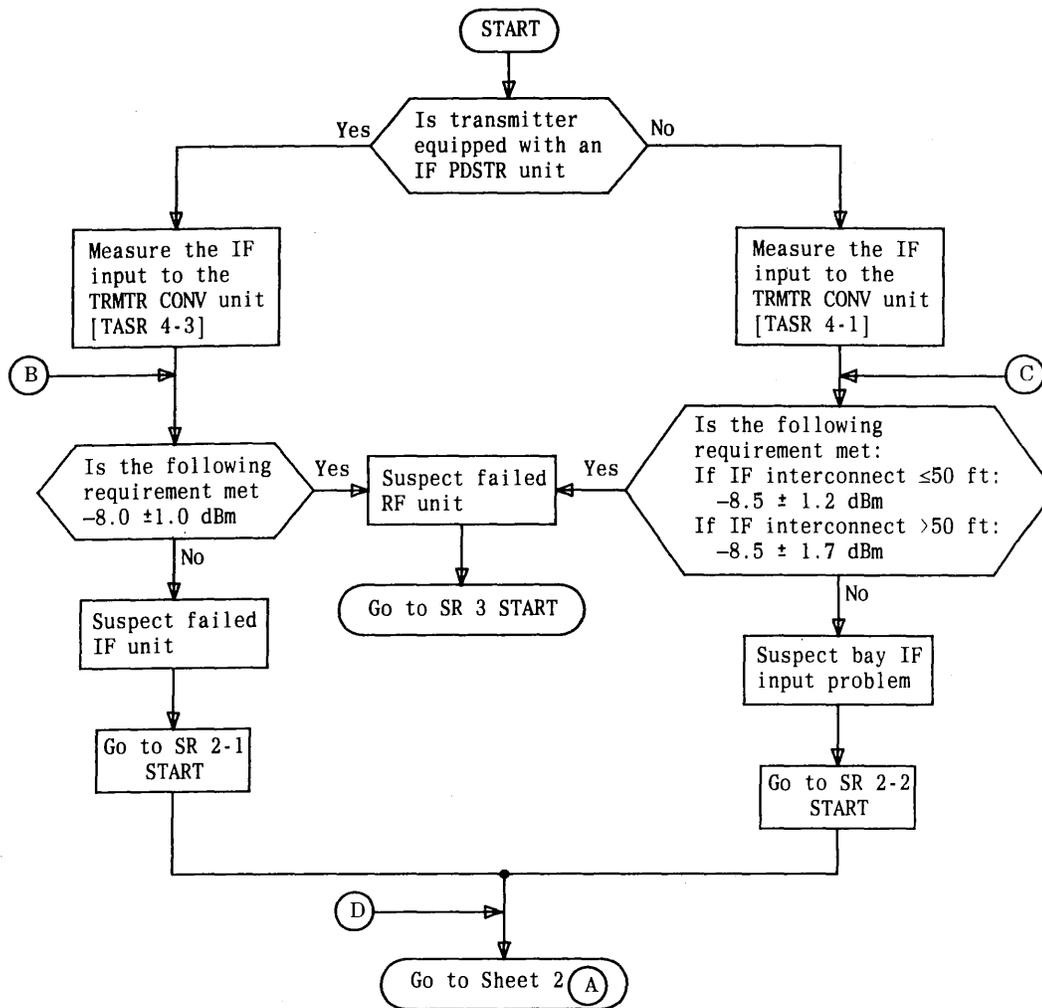
SR 2—Isolating Manual Gain Problems to Before or After TRMTR CONV Unit (Sheet 1 of 2)

CAUTION: THIS PROCEDURE IS SERVICE AFFECTING UNLESS THE PROPER MANUAL PROTECTION SWITCHING OPERATION HAS BEEN PERFORMED

PREREQUISITE: 1. PWR OUT OF RANGE indicator lighted.
 2. RF MON power not adjustable to DATA CARD value.

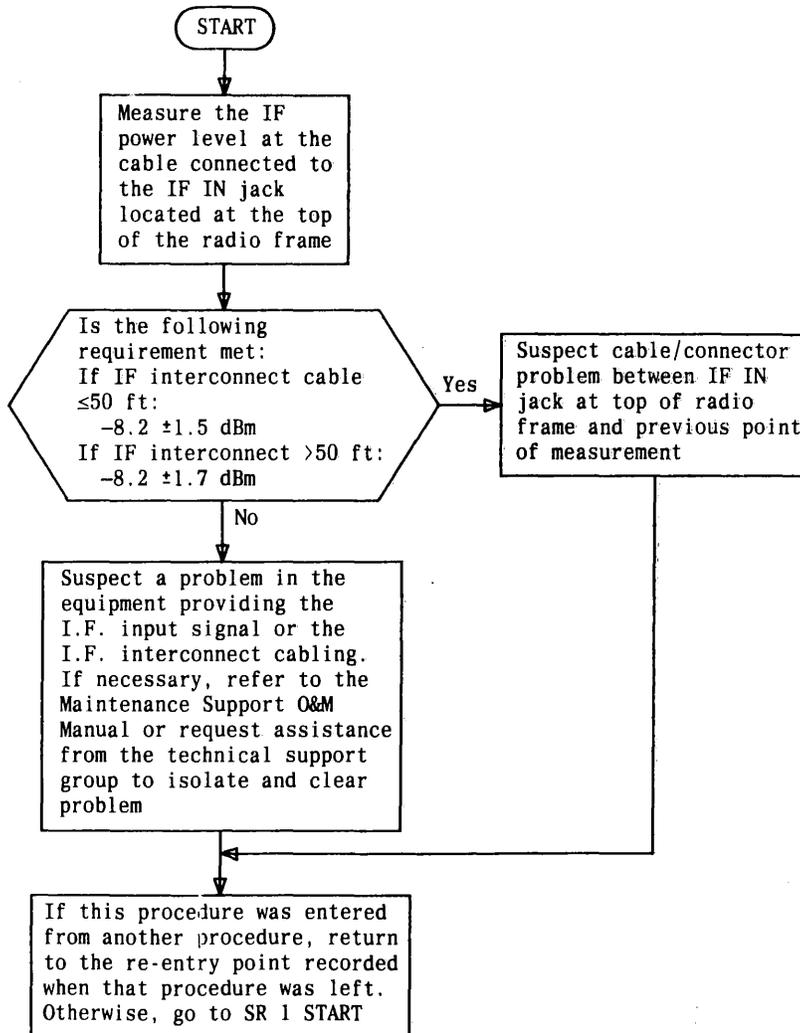
SR 2-2—Resolving Bay IF Input Level Problems

PREREQUISITE: I.F. input to the IF PDSTR unit is bad, or the I.F. input to the TRMTR CONV unit is bad when the I.F. PDSTR unit is not equipped.

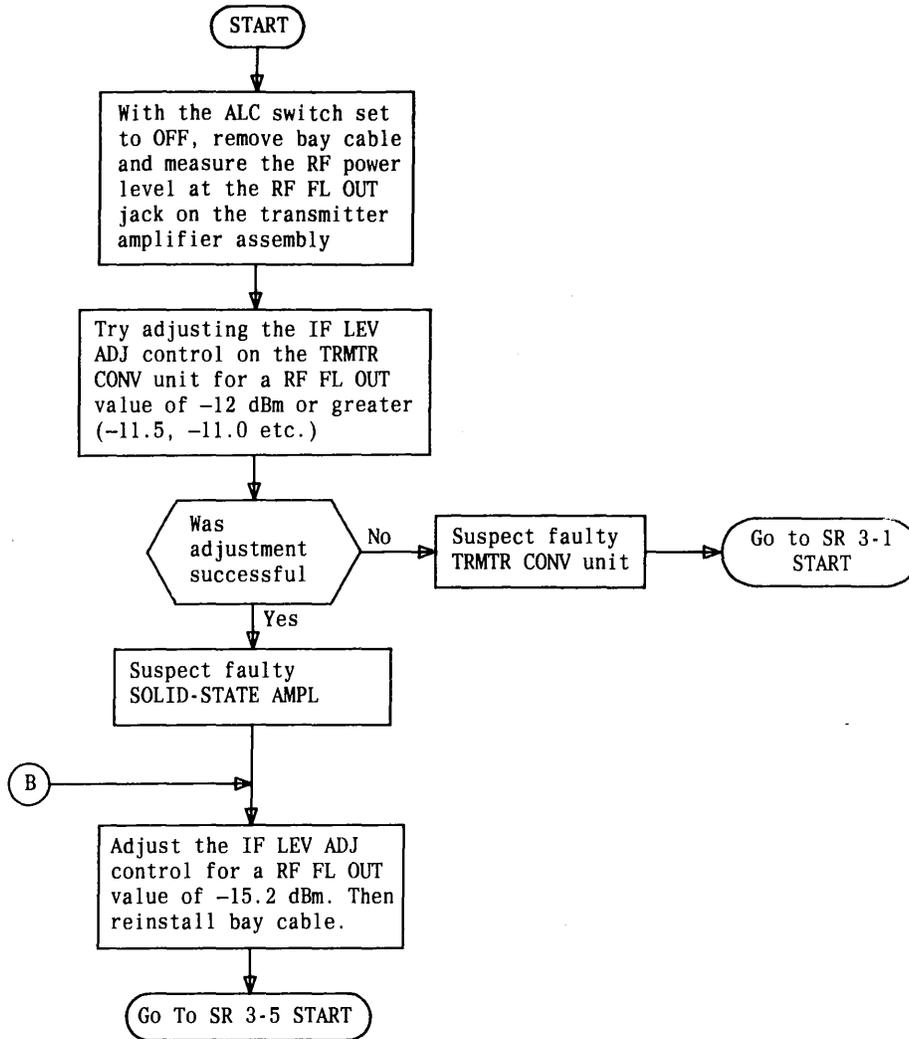
SR 3—Isolating Manual Gain Problems to Within or After TRMTR CONV Unit

PREREQUISITE: I.F. input to up-converter is good but R.F. output at RF MON jack is bad.

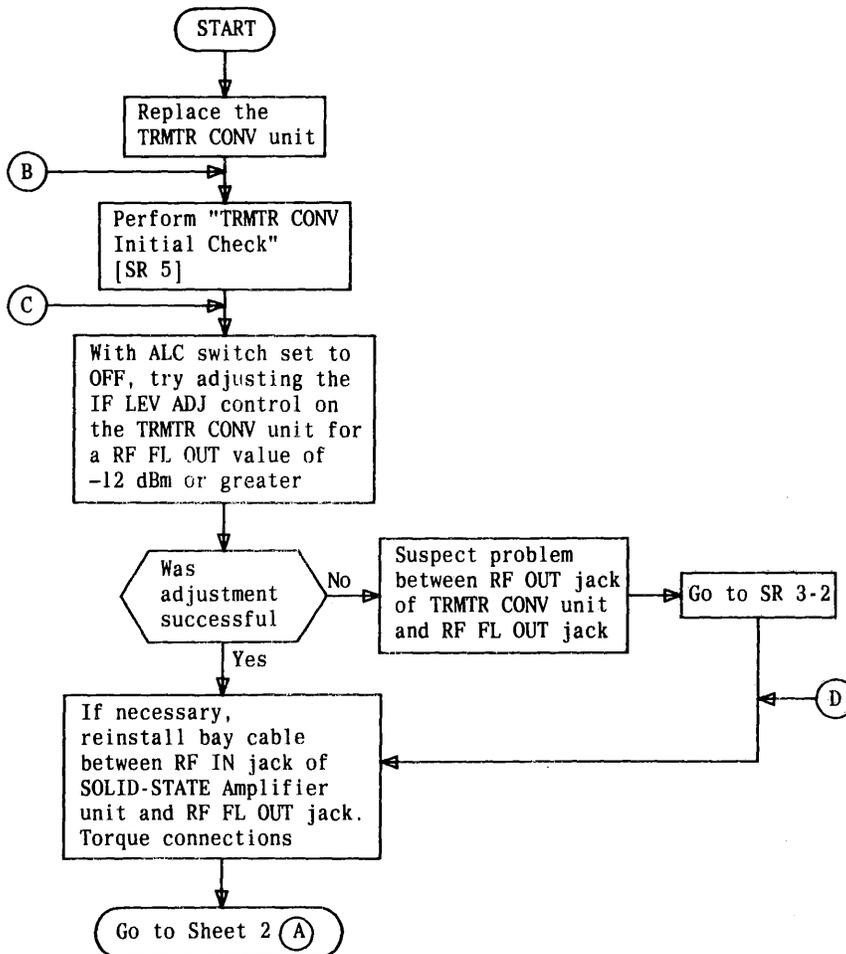
SR 3-1—Resolving Suspected TRMTR CONV Unit Manual Gain Problem (Sheet 1 of 2)

PREREQUISITE: I.F. input to up-converter is good but low or no output level at input to SOLID-STATE Amplifier (RF FL OUT jack)

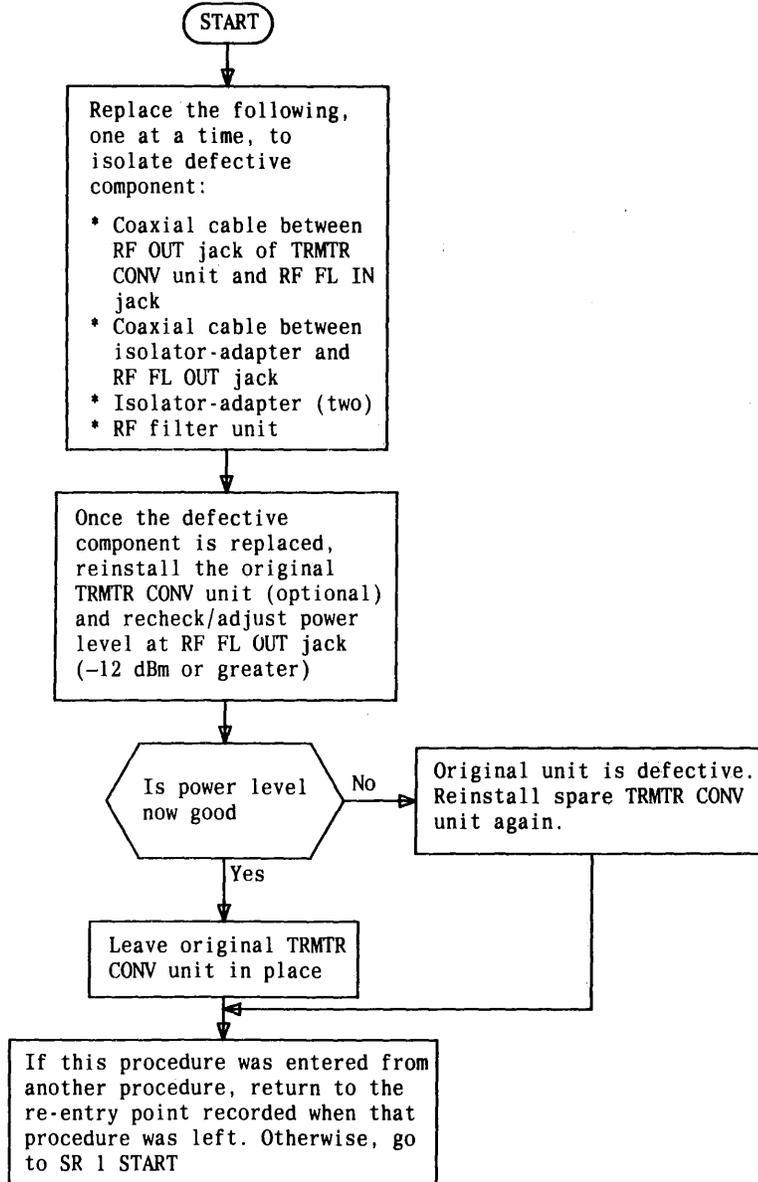
SR 3-2—Resolving Suspected Filter/Cable Problem Between Up-Converter Output and Amplifier Input

PREREQUISITE: Suspected Problem between up-converter output and SOLID-STATE Amplifier input

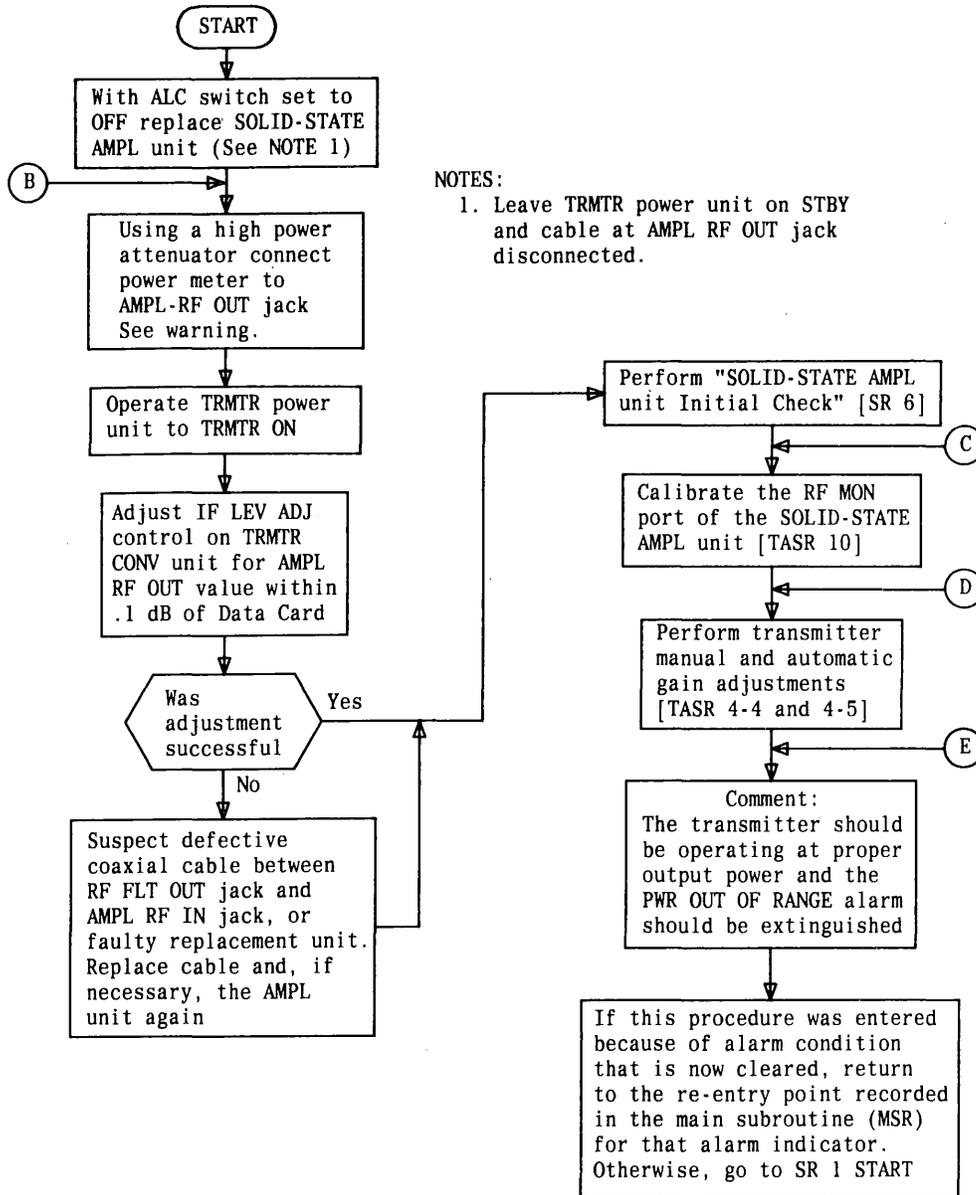
SR 3-5—Resolving Suspected SOLID-STATE AMPL Unit Manual Gain Problems

- PREREQUISITES: 1. R.F. output at RF FLT OUT jack is good but low or no output level at SOLID-STATE AMPL unit RF MON/RF OUT jack
 2. Power problem isolated to a defective SOLID-STATE AMPL unit.

1. Leave TRMTR power unit on STBY and cable at AMPL RF OUT jack disconnected.

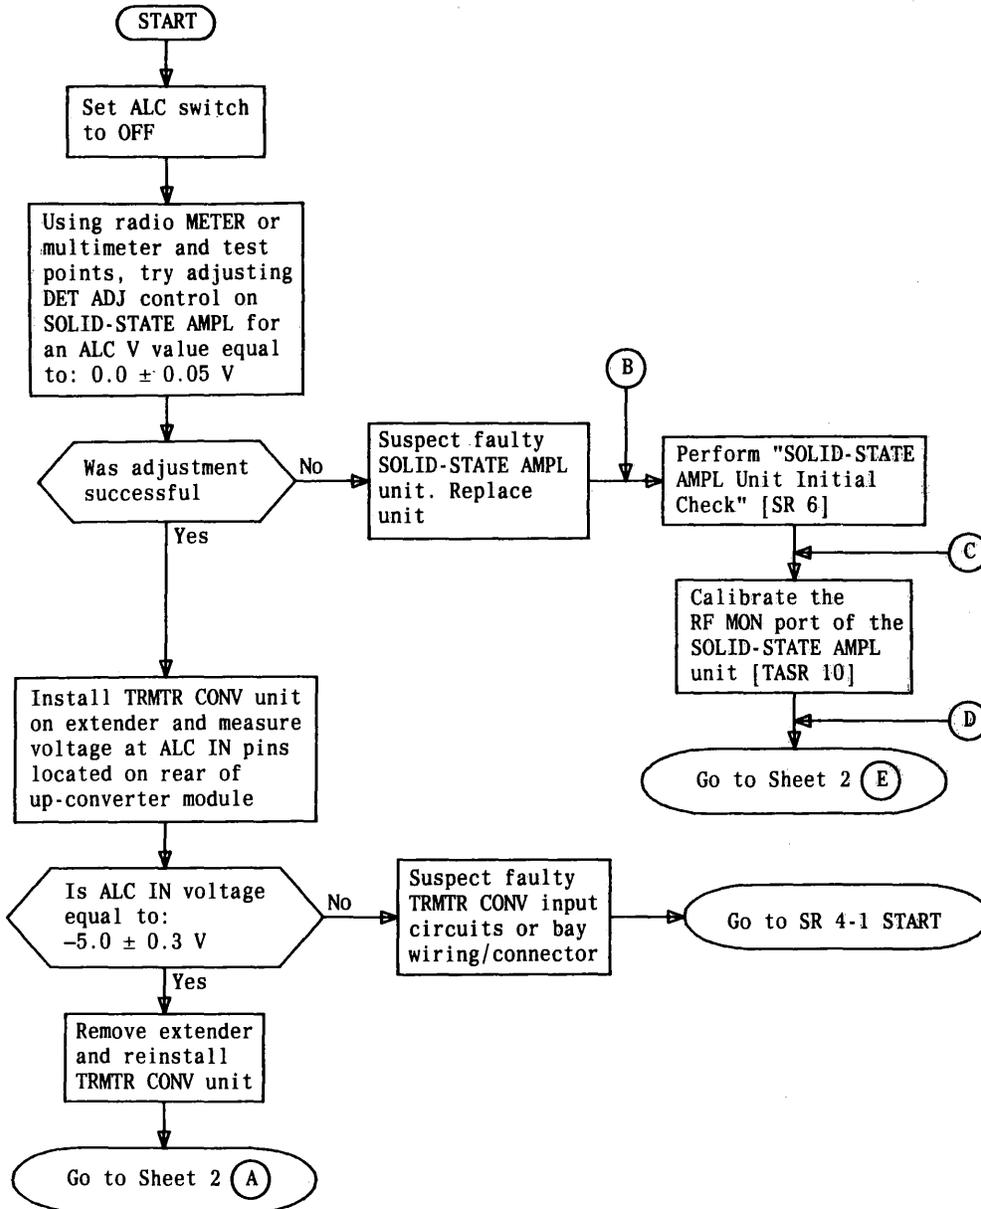
SR 4—Isolating Automatic Gain Problems (Sheet 1 of 2)

PREREQUISITE: Cannot adjust output level of transmitter in automatic mode (ALC switch set to ON) to within ± 0.1 dB of output level properly set with transmitter in manual mode (ALC switch set to OFF)

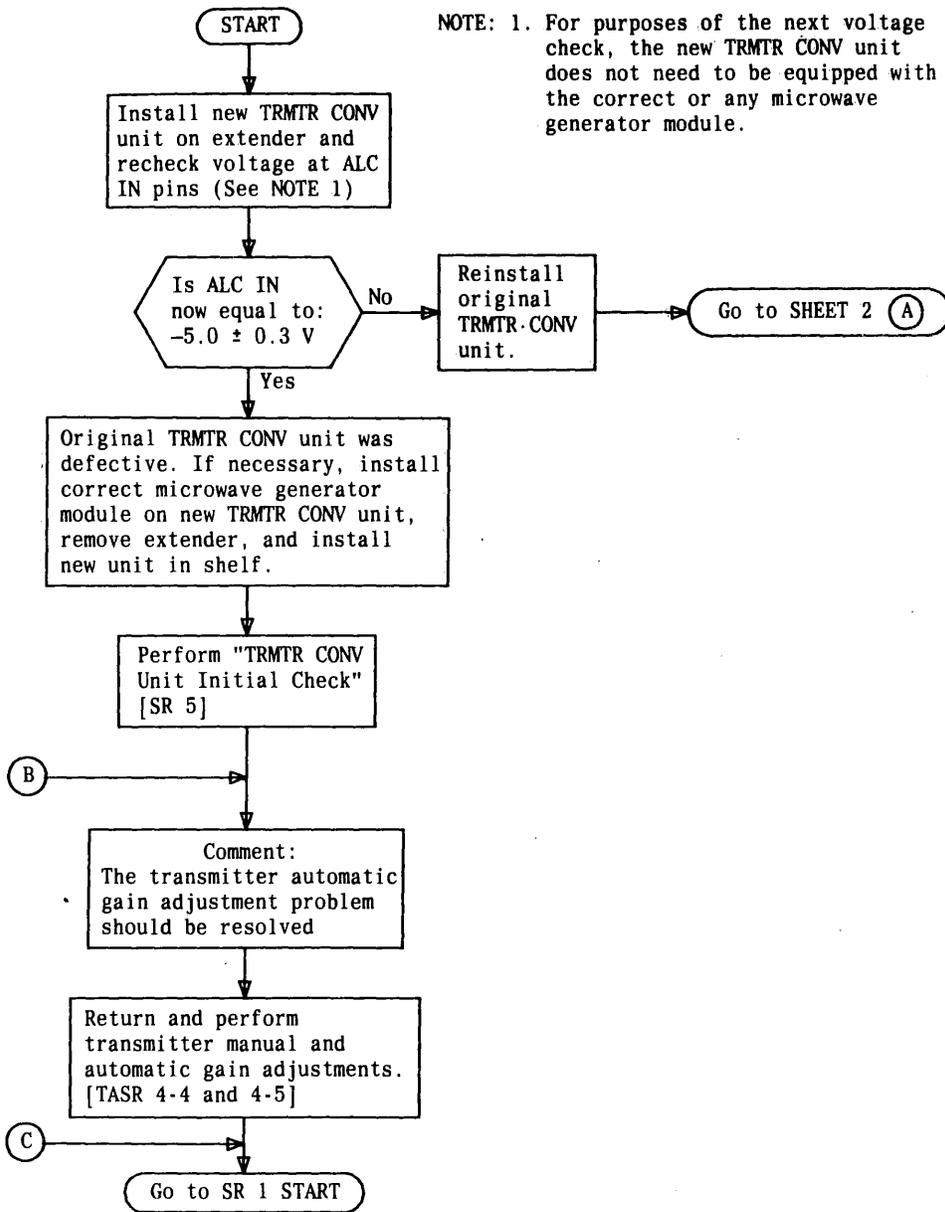
SR 4-1—Resolving Suspected TRMTR CONV Unit Automatic Gain Problem (Sheet 1 of 2)

PREREQUISITE: With ALC switch set to ALC OFF, the voltage measured at the ALC IN pins on the up-converter module is not within -5.0 ± 0.3 V

NOTE: 1. For purposes of the next voltage check, the new TRMTR CONV unit does not need to be equipped with the correct or any microwave generator module.

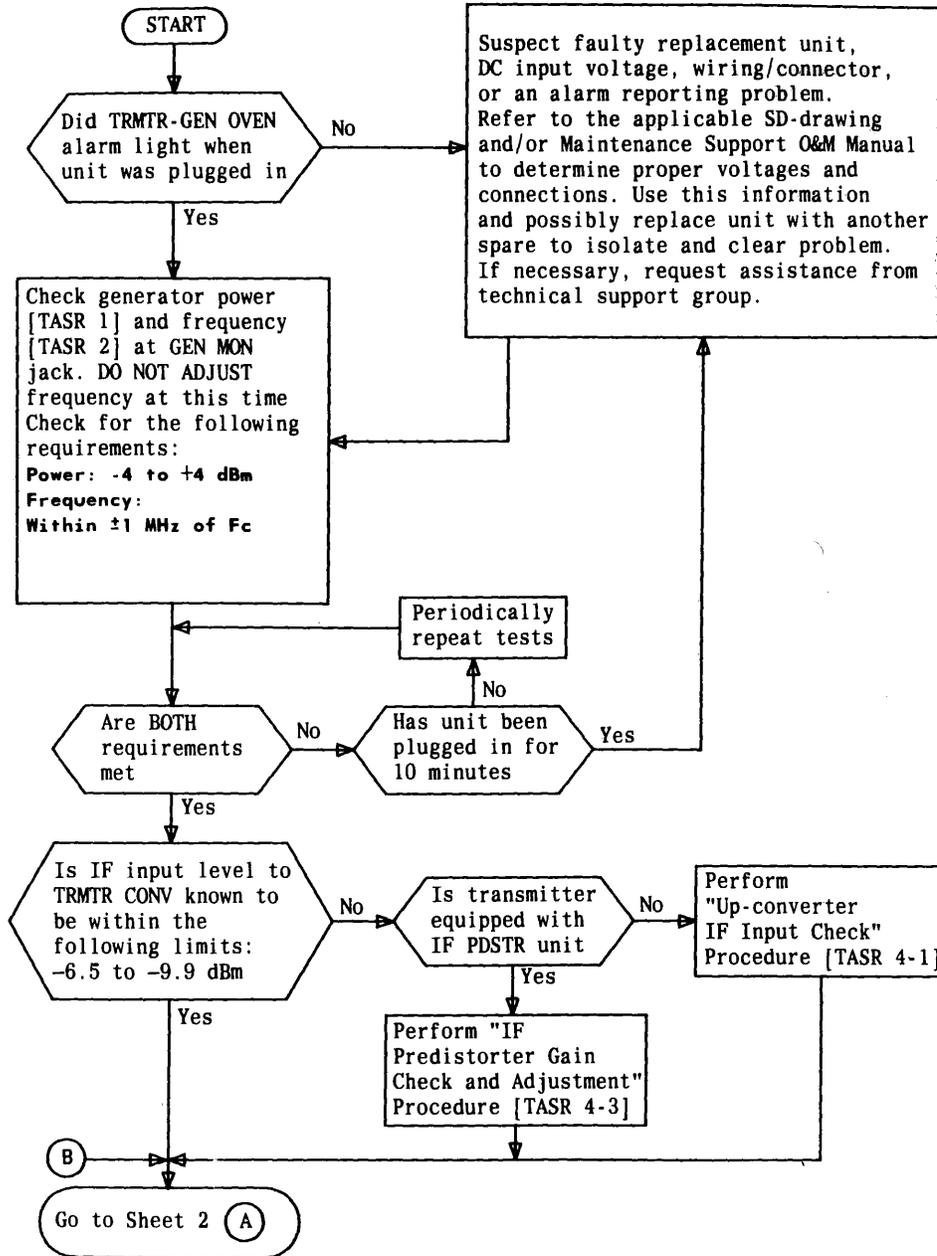
SR 5—TRMTR CONV Unit Initial Check (Sheet 1 of 2)

PREREQUISITE: TRMTR CONV unit just installed.

The status of the replaced unit at this point is usually adequate to continue most transmitter troubleshooting routines. This is especially true for those routines involving transmitter RF power or gain problems. Routines requiring temperature stabilization of the microwave generator oven of the TRMTR CONV unit (when the TRMTR GEN OVEN indicator is still lighted) should be delayed until the TRMTR GEN OVEN indicator goes off (see Final Generator Check). If this unit was replaced because of directions in another procedure, return to the instruction that called for the replacement (see *Note 1*). Generally, this will help to speed up troubleshooting transmitter alarms involving suspected TRMTR CONV problems (see Final Generator Check).

Note 1: Before returning to the referencing procedure, note the time that the TRMTR CONV unit was replaced and then periodically check the TRMTR GEN OVEN alarm indicator to ensure that it goes off within the normal time period (see *Note 2*). If the alarm indicator does not go off, dc voltage and/or wiring problems related to the TRMTR CONV unit may exist or the replacement unit is defective. Isolate and clear this problem before proceeding further with transmitter tests. Follow the instructions given in the Transmitter "GEN OVEN Alarm" tab.

Note 2: Normally, if the spare TRMTR CONV unit and microwave generator module were stored at room temperature, the TRMTR GEN OVEN indicator should go off within about 20 minutes. If the replacement units were stored in a cold environment, the time for the indicator to go off could be as long as 45 minutes.

Wait for the TRMTR GEN OVEN alarm to clear before proceeding further (see *Notes 1 and 2*). At that point, or any time after, when the generator frequency is within ± 350 kHz of the center frequency, make the transmitter manual and automatic gain adjustments. Perform Transmitter Alignment Check (TASR 5) also. If adjustments are necessary to meet alignment requirements, do the final frequency check of the microwave generator (see Final Generator Check) before making the adjustments.

For either of the above cases, the frequency (TASR 2) and power (TASR 1) of the microwave generator in the TRMTR CONV should be checked and, if necessary, adjusted about 1 hour after the TRMTR GEN OVEN alarm indicator goes off. Do not try this sooner than 1 hour since, in general, the oscillator should stabilize at its proper frequency with little or no adjustment. Go to MR 1(B) in the Transmitter "GEN OVEN Alarm" tab when this procedure is used without being directed from another routine.

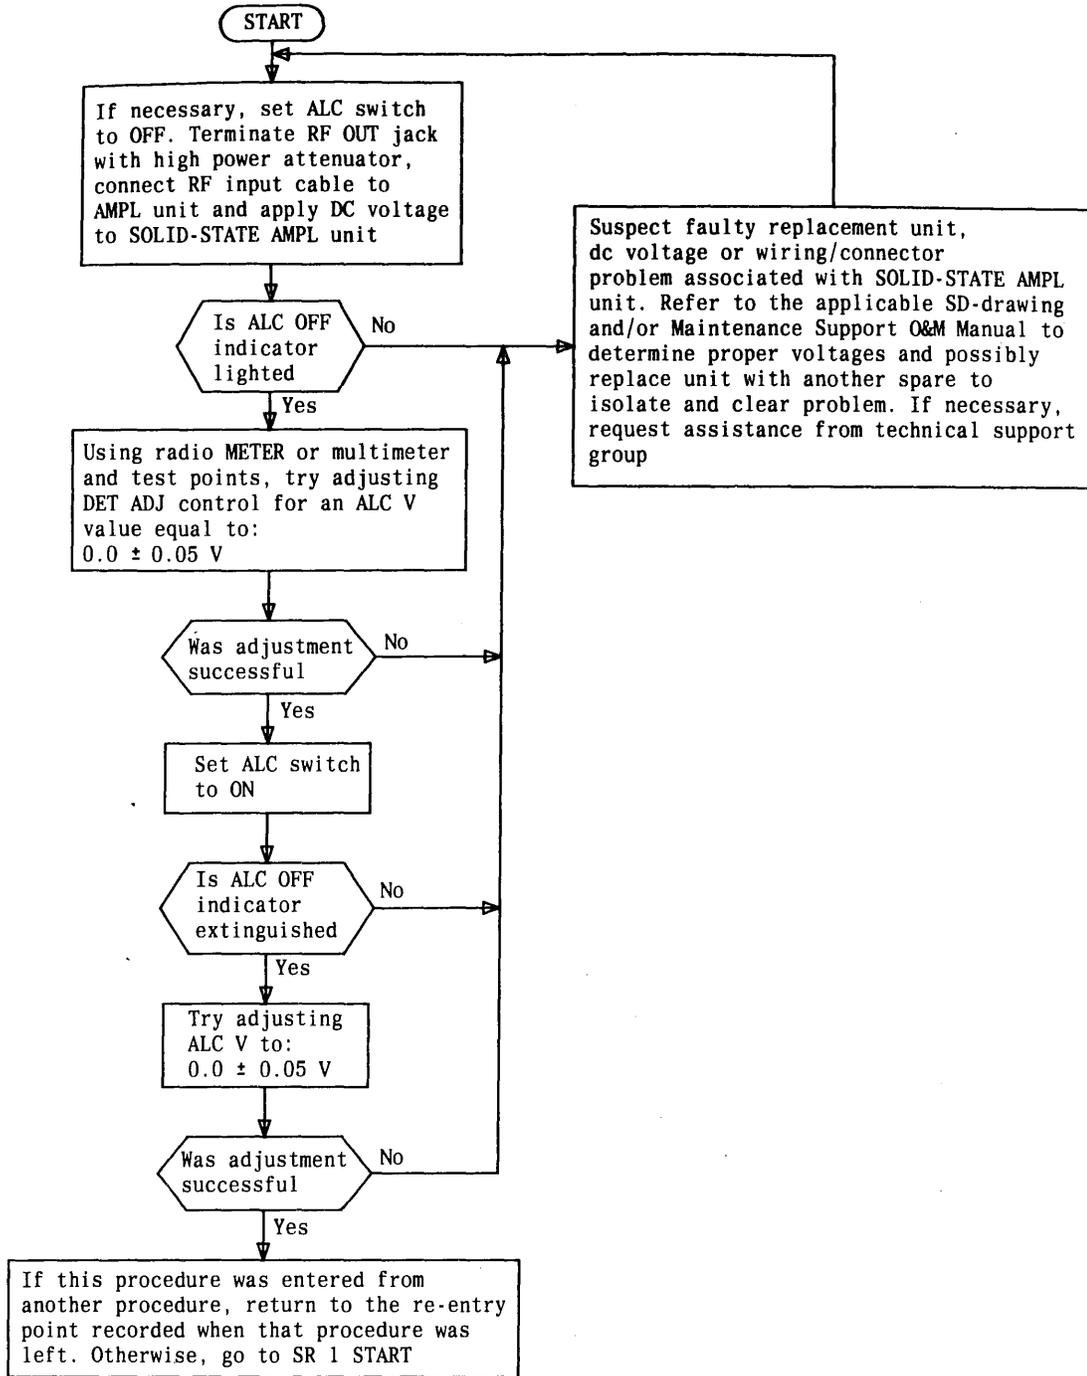
SR 6—SOLID-STATE AMPL Unit Initial Check

PREREQUISITE: SOLID-STATE AMPLIFIER unit just installed.

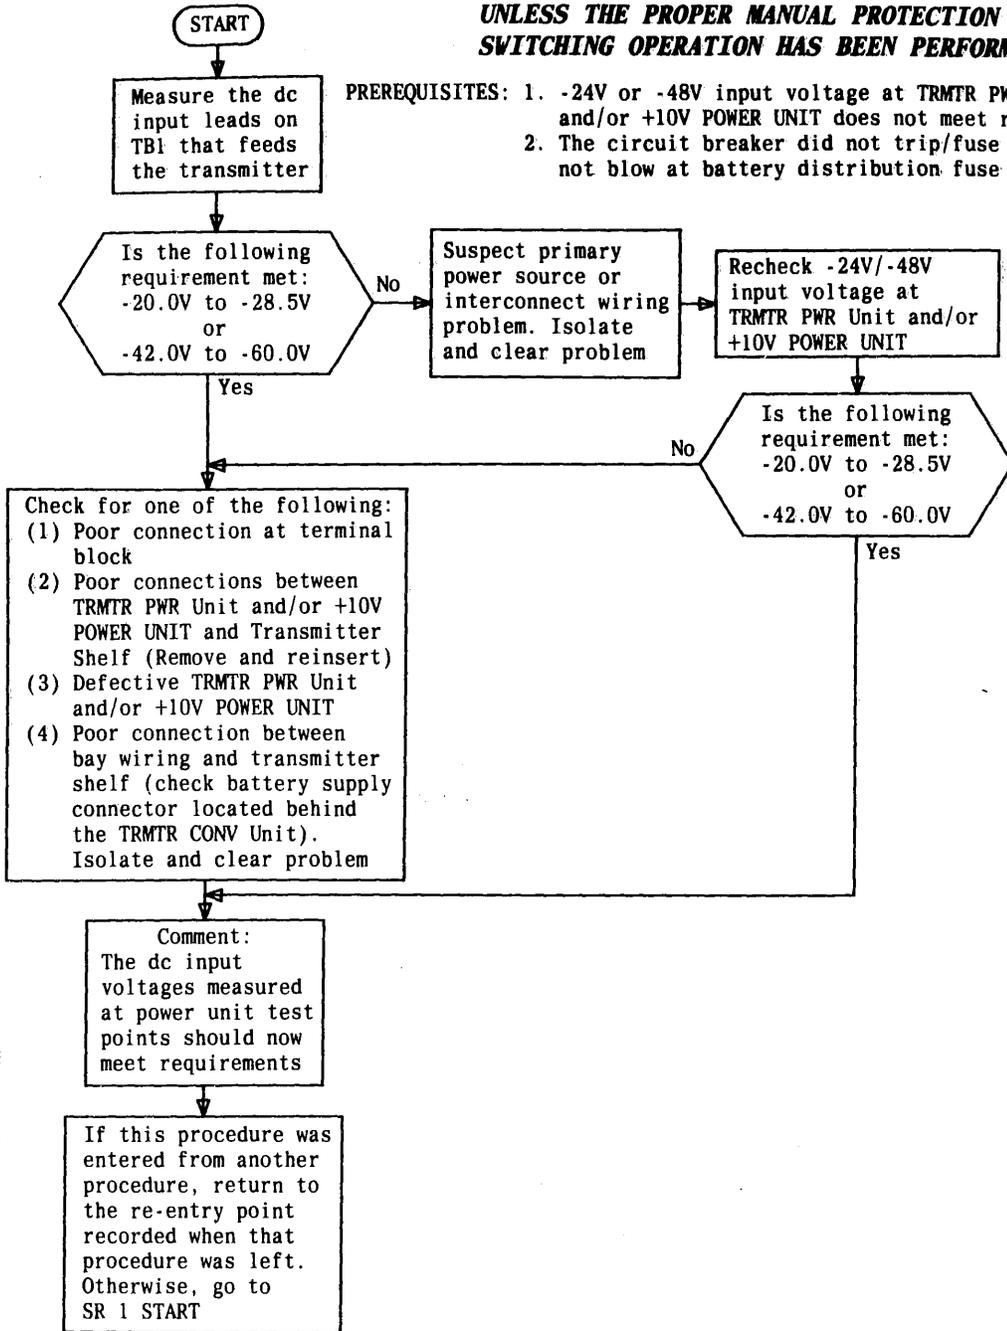
SR 10—Resolving DC Input Problems When Circuit Breaker Did Not Trip or Fuse Did Not Blow

PREREQUISITES: 1. -24V or -48V input voltage at TRMTR PWR unit and/or +10V POWER UNIT does not meet requirements.
 2. The circuit breaker did not trip/fuse did not blow at battery distribution fuse bay.

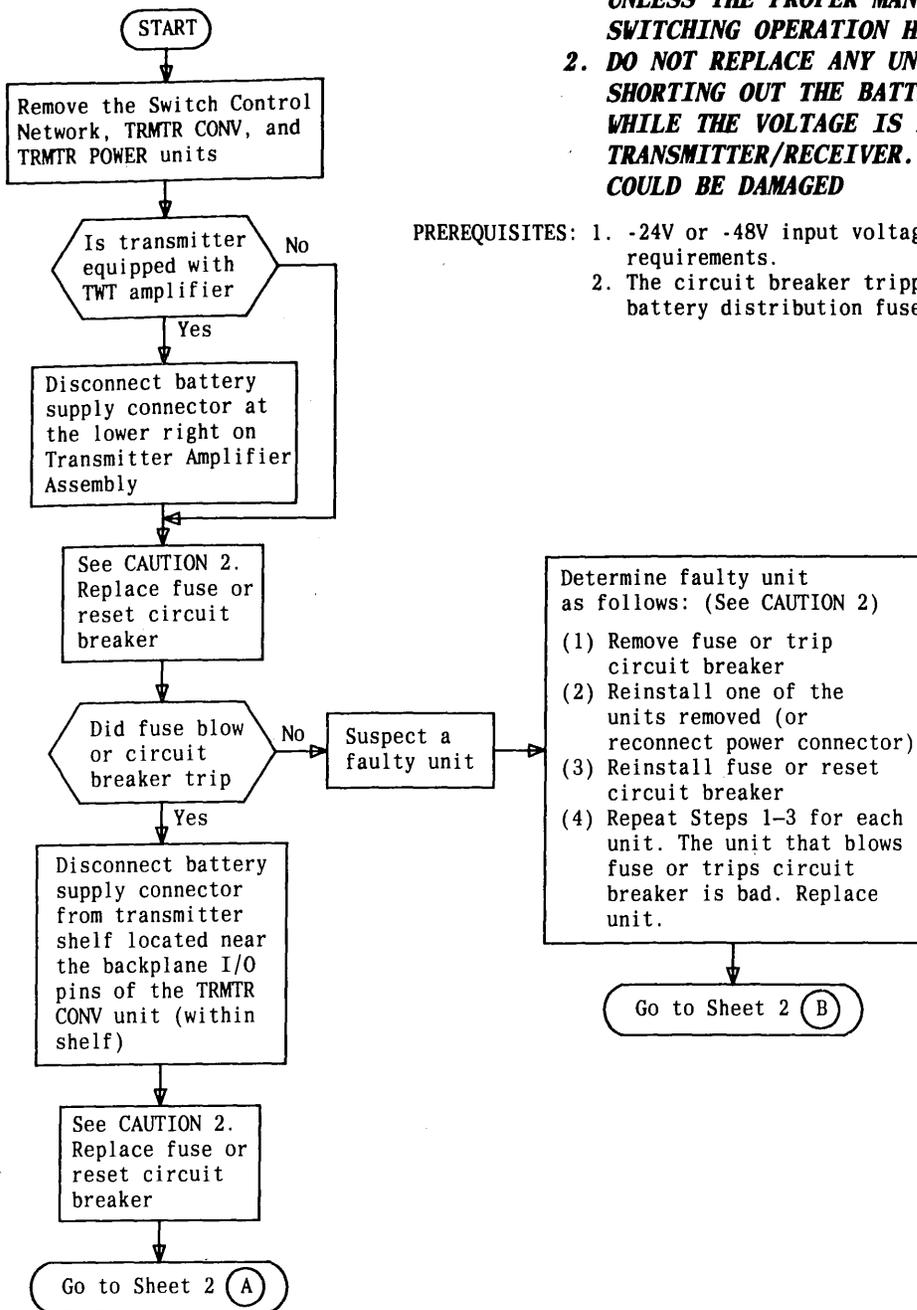
SR 11—Resolving Transmitter Shelf DC Input Problems (Sheet 1 of 2)

PREREQUISITES: 1. -24V or -48V input voltage does not meet requirements.
 2. The circuit breaker tripped/fuse blown at battery distribution fuse bay.

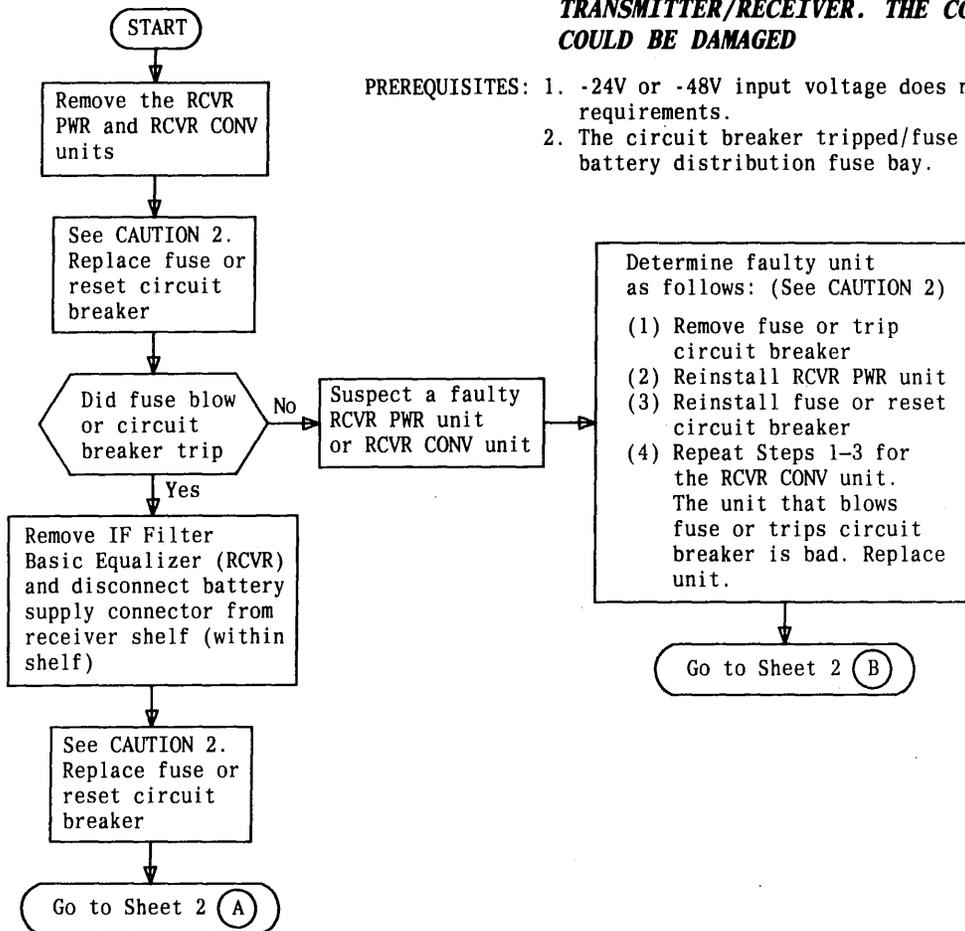
SR 12—Resolving Receiver Shelf DC Input Problems (Sheet 1 of 2)

- PREREQUISITES:**
1. -24V or -48V input voltage does not meet requirements.
 2. The circuit breaker tripped/fuse blown at battery distribution fuse bay.
