TP306983 MODIFICATION KIT

APPARATUS AFFECTED: 28LA Apparatus Cabinet.

OBJECT: To increase the filament life of the copylights by decreasing vibration.

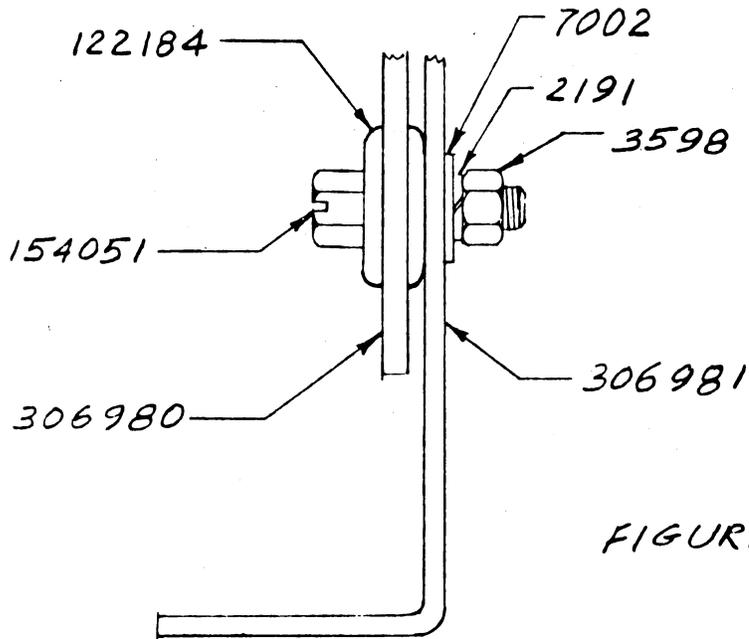
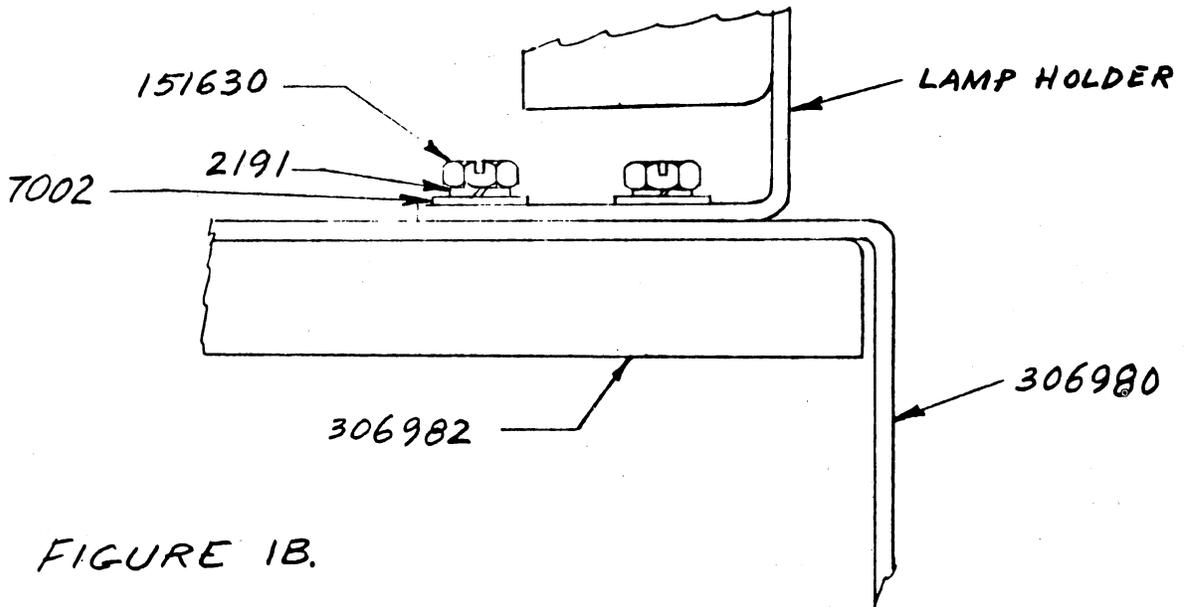
CHANGE: (Figure 1) The TP145476 copylight bracket has been replaced by the TP306980 upper bracket, TP306981 lower bracket, and the TP306982 bar. The TP306980 upper bracket and the TP306981 lower bracket are connected by means of TP154051 shoulder screws and the existing hardware.

INTERCHANGEABILITY: New and old style parts are not individually interchangeable, but are interchangeable in sets.

APPLICATION TO APPARATUS IN THE FIELD: Old style parts giving satisfactory service need not be replaced.
