END-OF-LINE INDICATOR ASSEMBLY

APPARATUS AFFECTED: 35A and 35B Teletypewriter Cabinets; 35A through 35E Electrical Service Units.

OBJECT: To improve visibility of the end-of-line indicator by placing it in the normal line of sight of the operator.

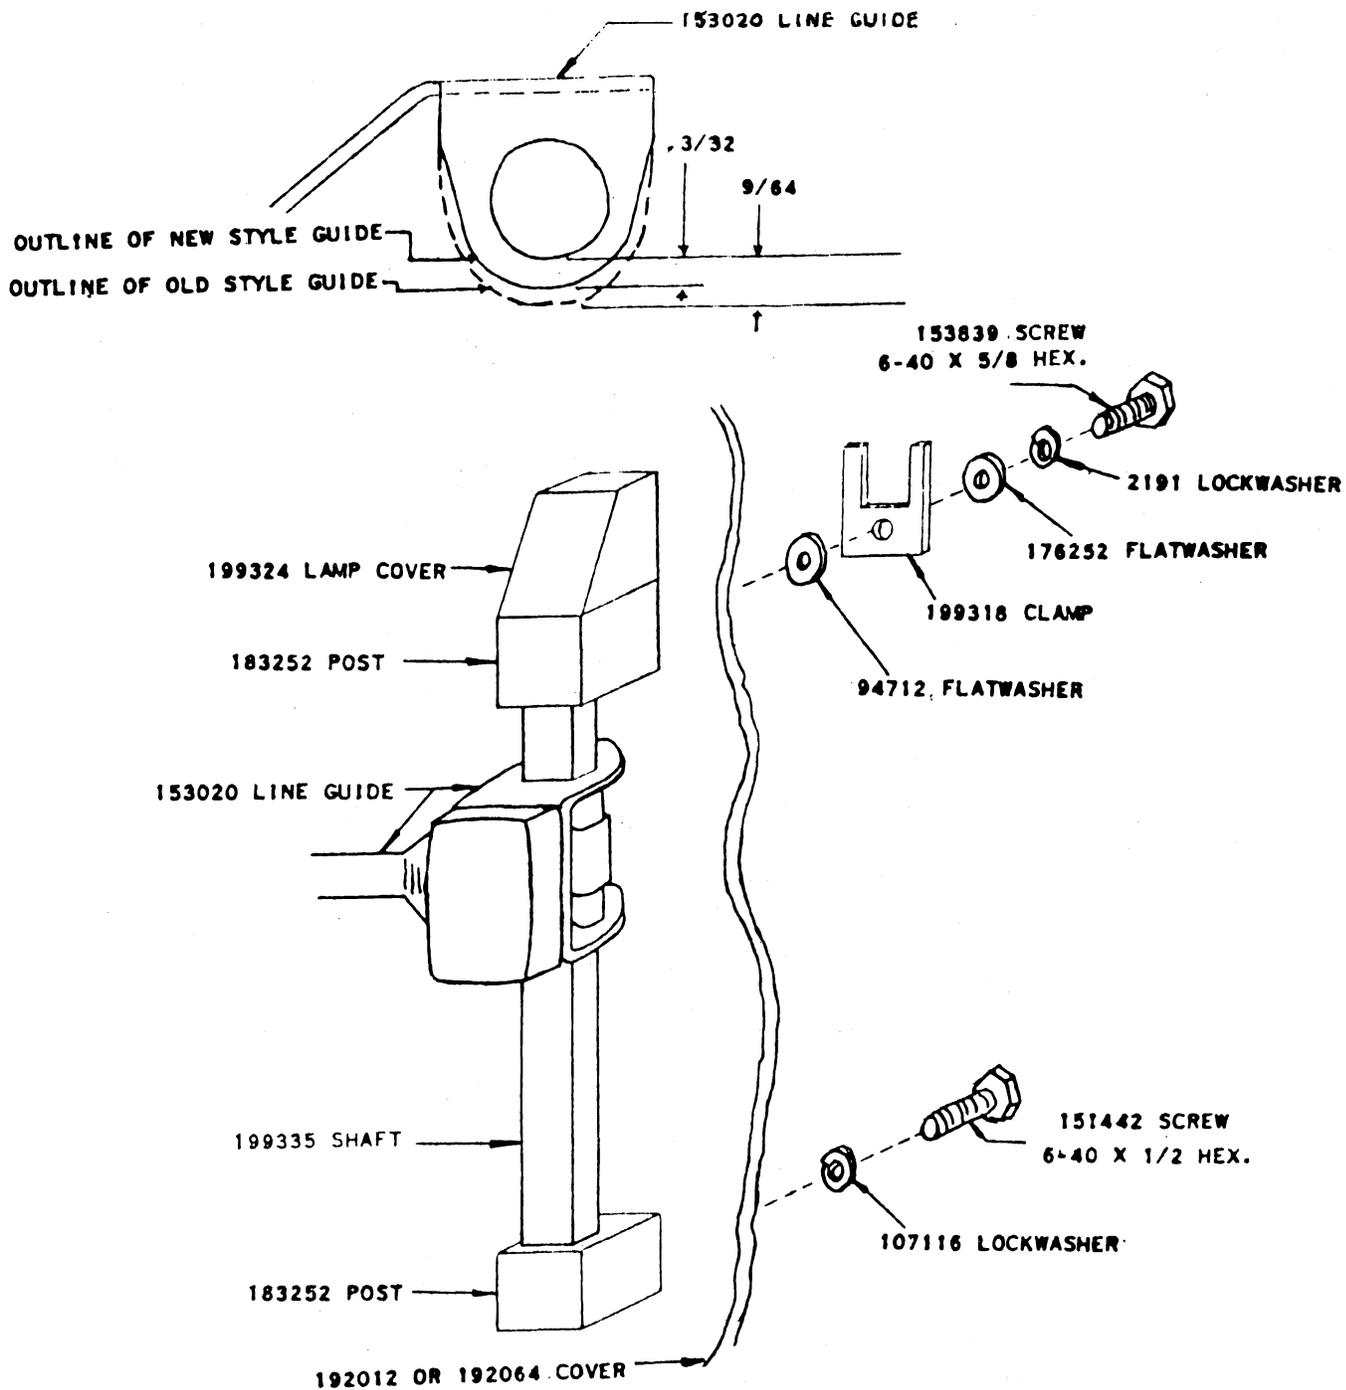
Fig. 1

- (1) A 5/16-inch by 1/2-inch rectangular cutout has been added directly above the line guide shaft.
- (2) The TP199321 bracket and the TP199323 end-of-line indicator cable with associated hardware and cable clamps have been added. (Fig. 2)
- (3) On the TP192190 line guide assembly, the TP153020 line guide has been modified to allow greater clearance between the radial section of the guide and the cover. (Fig. 1) The following old style parts are replaced by new style parts:

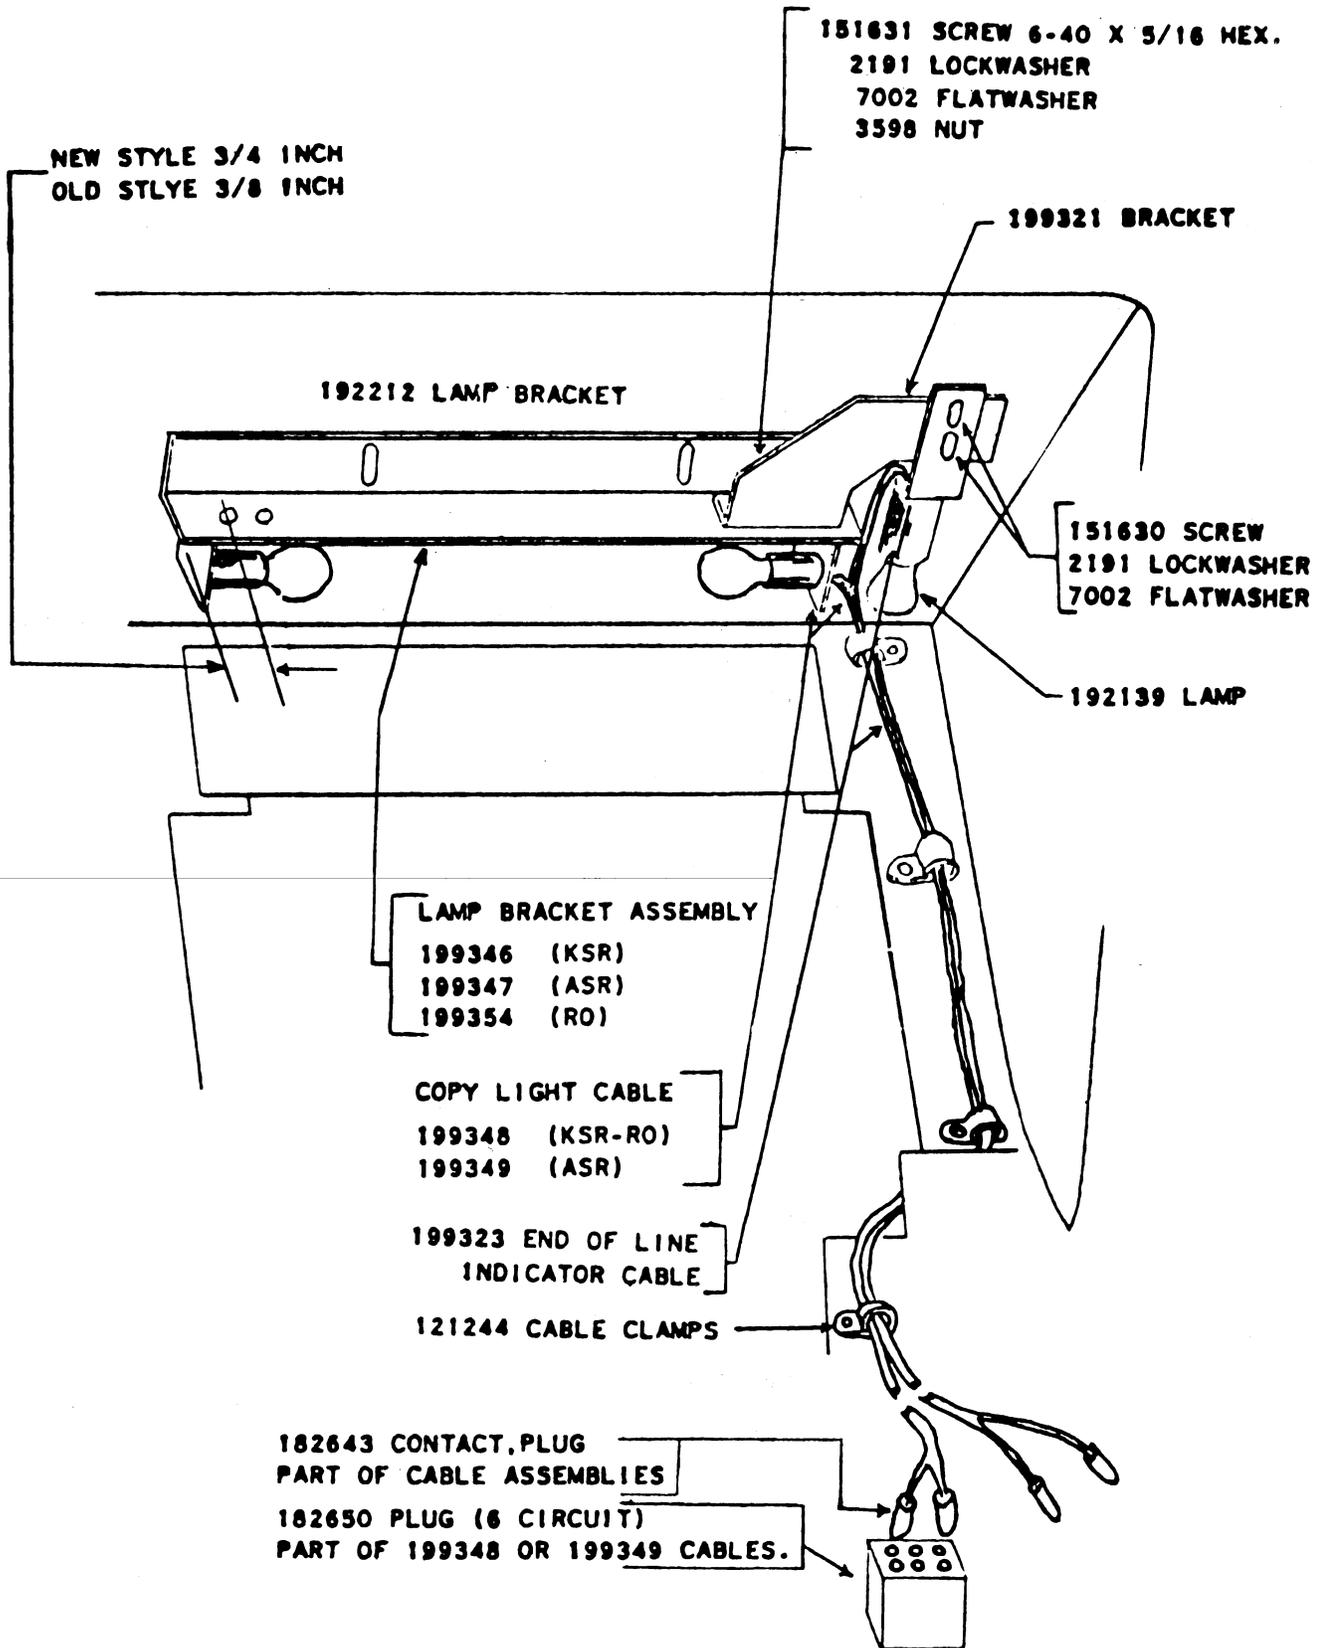
Fig. 2

- (4) The TP192205 and TP192248 lamp bracket assemblies are replaced as follows (Fig. 2):

<i>Old Style</i>	<i>New Style</i>
TP192205	TP199346 lamp bracket assembly (KSR)
TP192205	TP199354 lamp bracket assembly (RO)
TP192248	TP199347 lamp bracket assembly (ASR)

- (5) The TP192215 and TP192252 copylight cable assemblies are replaced by the TP199348 (KSR, RO) and the TP199349 (ASR) copylight cable assemblies respectively. (Fig. 2)

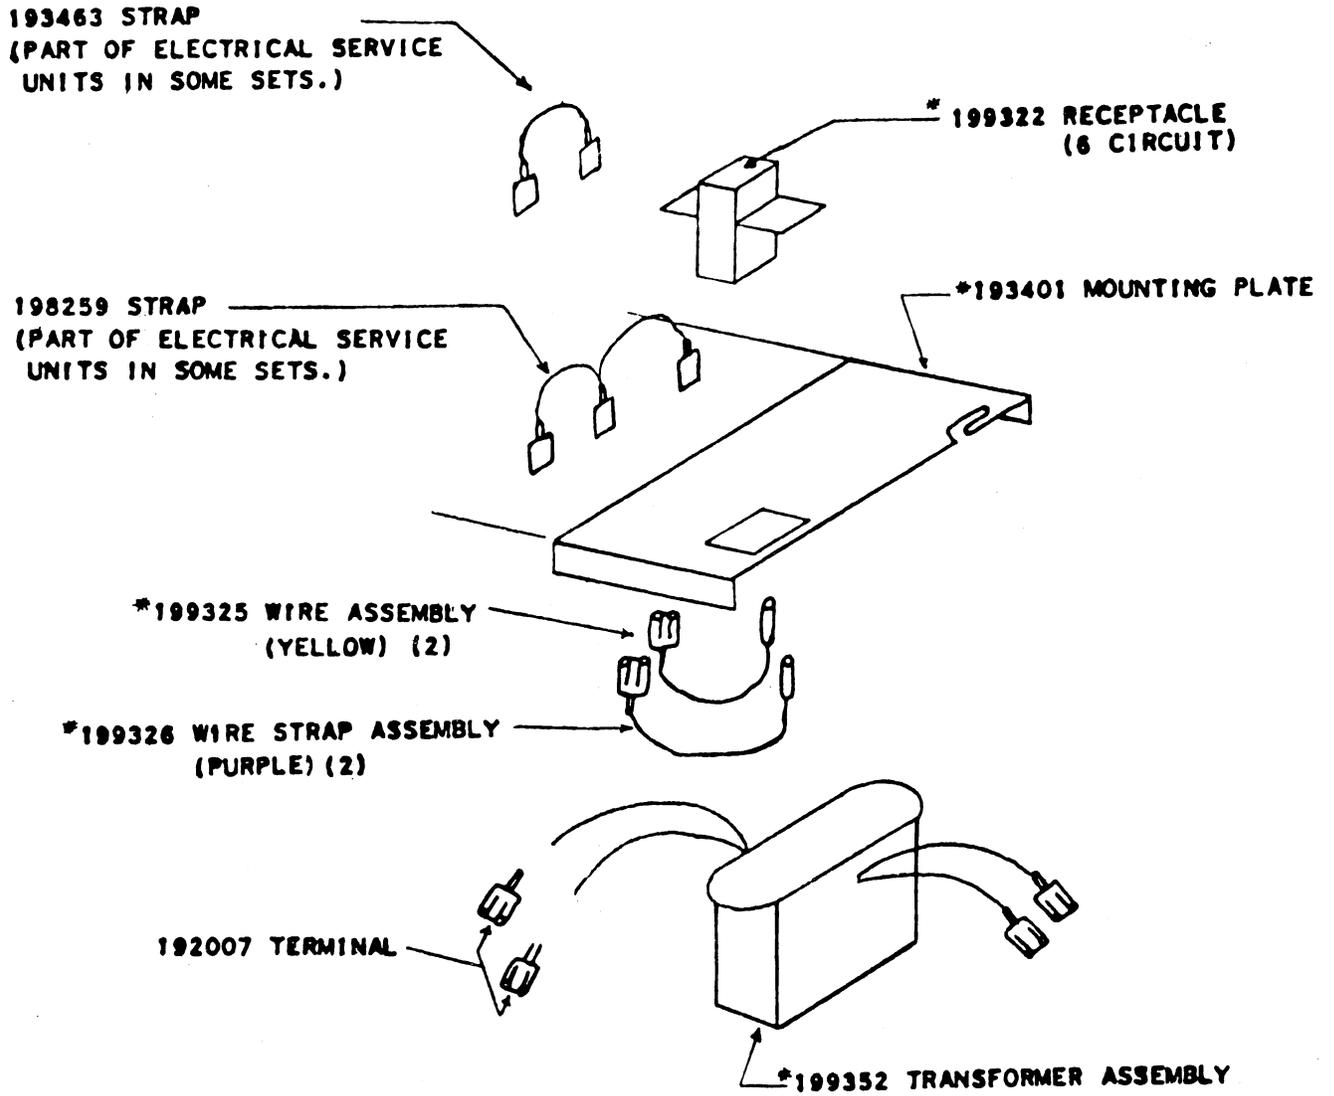
Fig. 3

35A through 35E Electrical Service Units: The TP193411 copylight transformer assembly has been replaced by the TP199350 copylight transformer assembly. (Fig. 3)

* PART OF 199350 COPY LIGHT TRANSFORMER ASSEMBLY
