APPARATUS AFFECTED: 35A-X3 Tape Teletypewriter Base

REASON: To add a fuse and mounting hardware.

Appendix 1, Section 574-204-400 Issue 1
Teletypewriter Change Notice
TCN 999 Issue 1
February, 1968

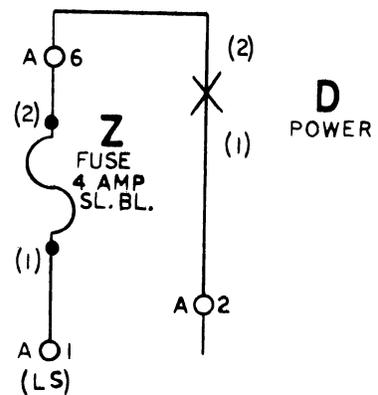
New-Style Wiring

(1B) The wiring changes required to add a fuse to the power circuit are reflected in actual wiring diagram 5868WD, Issue 8 and schematic wiring diagrams 5869WD-B1, Issue 8, 5869WD-B2, Issue 9, 7792WD, Sheet 1, Issue 2 and 7792WD, Sheet 2, Issue 3. The schematic representation of the wiring changes is as follows:

Old-Style Wiring

SUPPLEMENTAL INFORMATION: (1) When updating from the old-style to the new-style wiring the TP151819 strap on terminals 6 and 8 of the power input terminal block must be removed.

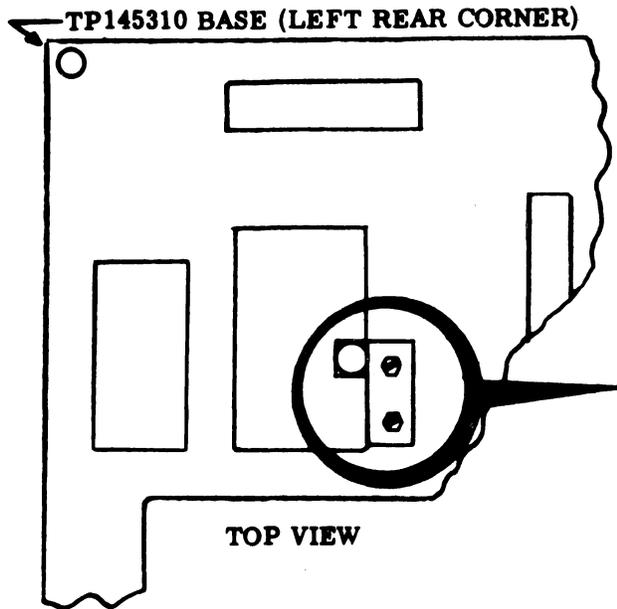
Attached Sheet 1

CHANGE: (1A) A TP328184 fuse bracket assembly is added to the 35A-X3 Tape Teletypewriter Base. The assembly consists of the following parts:

Refer to Attachment Sheet 1 for the mounting location of the fuse bracket assembly to the base.

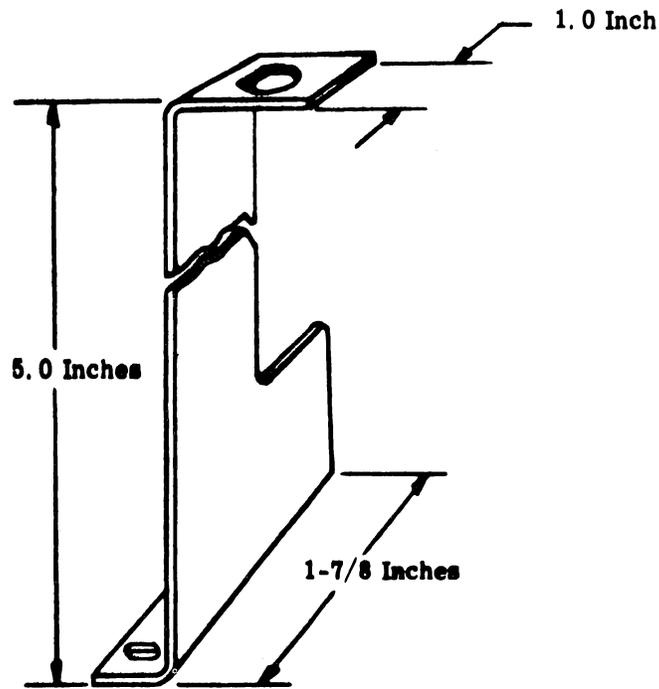
**TP328184 FUSE
BRACKET ASSEMBLY**

TP328185 cable assembly	(1)
TP185684 fuse decal	(1)
TP165680 fuse holder bracket	(1)
TP154076 nut plate	(2)
TP151630 screw, 6-40 by 1/4 hex.	(2)
TP129919 fuse, 4 amp. SL BL	(1)
TP116783 fuse holder	(1)
TP2191 lockwasher	(2)
