# 1997-2003 Ford F-150 Alternator Replacement

Replacing a non-functioning alternator

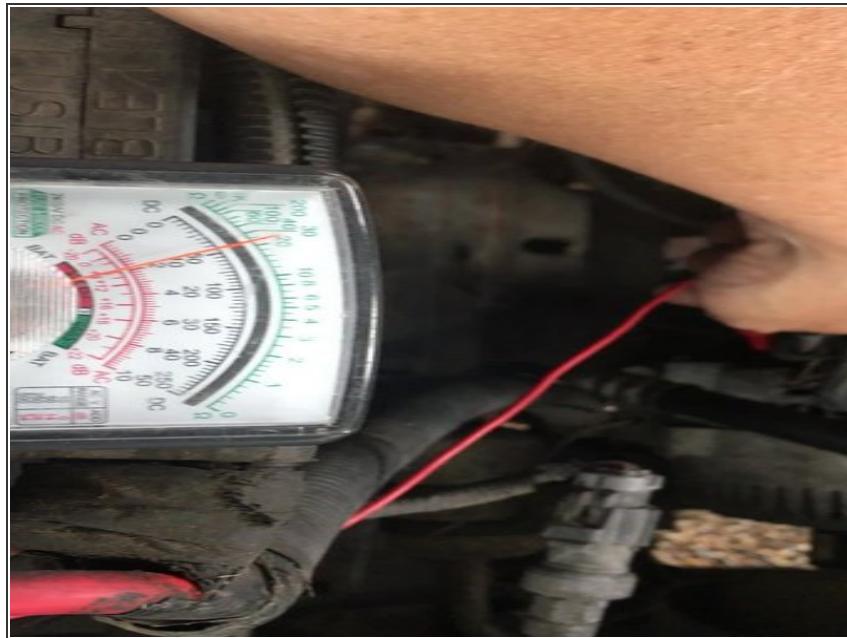
## Step 1 — Alternator

- Testing of the alternator output with the positive probe on B+ of the alternator. Even with RPM's up to 2000 there is no change in output. It even appears as if the voltage decrease to around 8 V
- This alternator needs to be replaced.

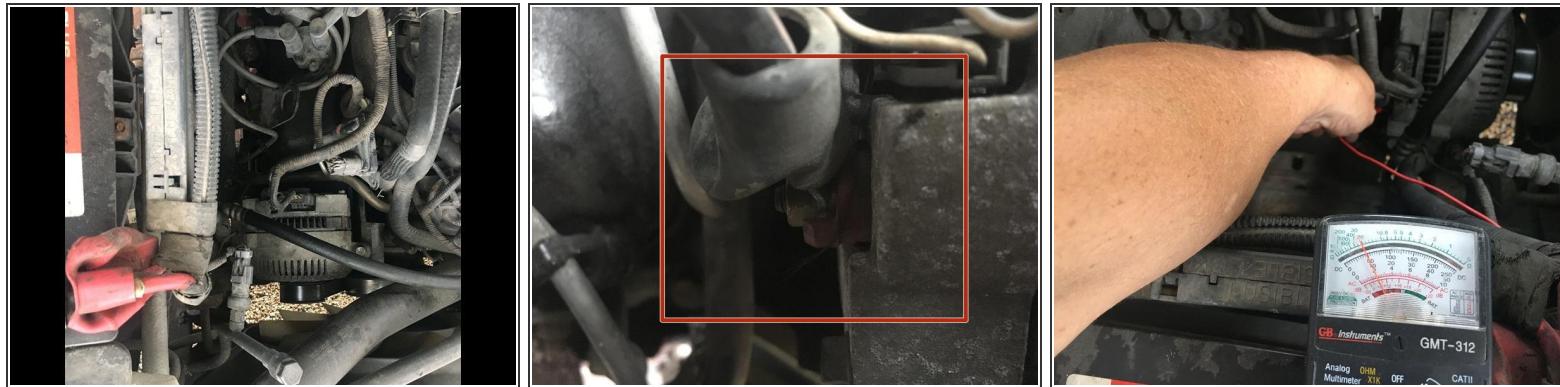
## Step 2

- Here is the alternator that is apparently not charging. First thing is to test it to make sure it is the problem.
- B+ is the post where one can test the output voltage of the alternator with a simple multimeter.

- Set the multimeter to 50 DC Volt scale. Black probe to ground and red probe to B+ on the alternator. With the engine running the voltmeter should show around 14 Volts. On this alternator the voltage does not increase and sits somewhere around 10 Volts. Good indication that it needs to be changed.

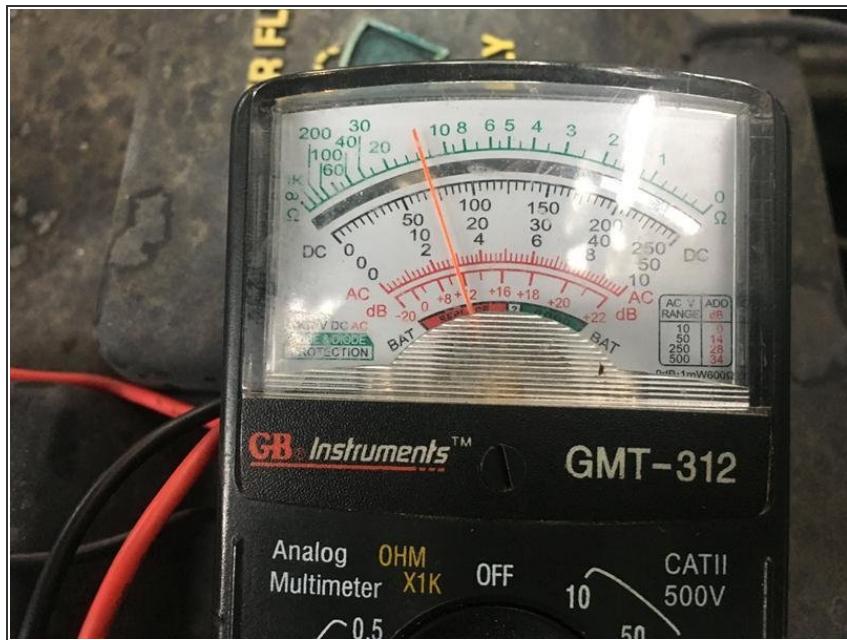
## Step 8

- Checked the voltage on the battery terminal with engine running. Shows properly between 14V - 15V
