2010 Subaru Forester P0026 Fault - RH Oil Switching Solenoid Valve and RH Oil Pressure Switch Replacement

This guide is a fix for a P0026 Fault code, which causes a engine and stability control light to come on. Also causes flashing cruise control light.

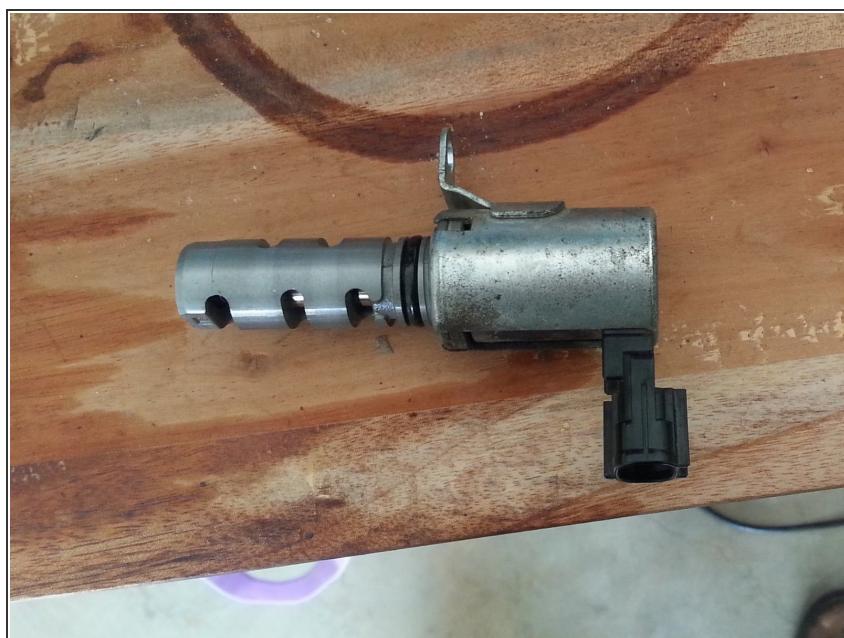
Step 6 — Remove Solenoid

- The bolt is located under the solenoid out of view. Use a size 10 socket to undo the bolt. Then

remove the solenoid. You may need to use some force or multi grips to remove the solenoid.
