# Acer Aspire V3-572-746F Touchpad Replacement

Replacing non functioning touchpad. Similar process for the keyboard or some of the other internal parts

Written By: Terry Hobbs

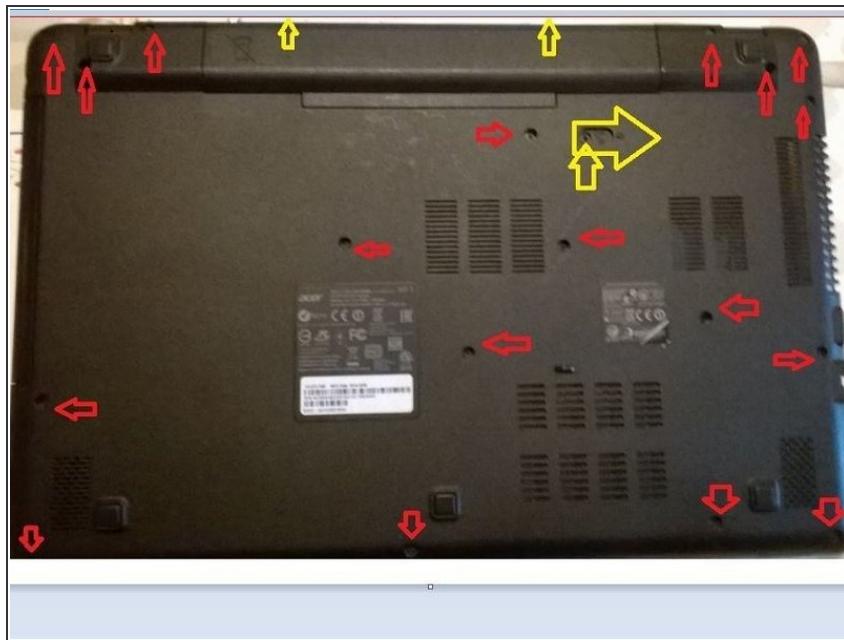
## Step 1 — Remove Back Screws

- Remove battery by sliding button (Yellow)
- Remove all screws (Red)

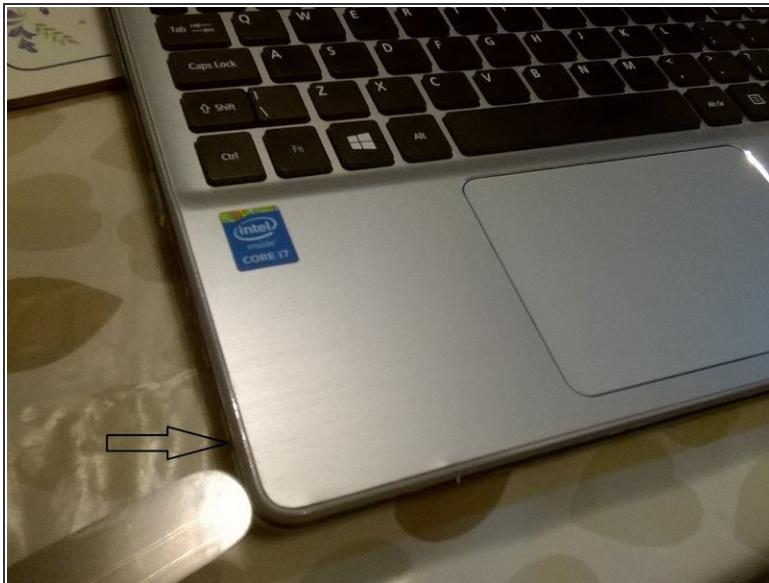
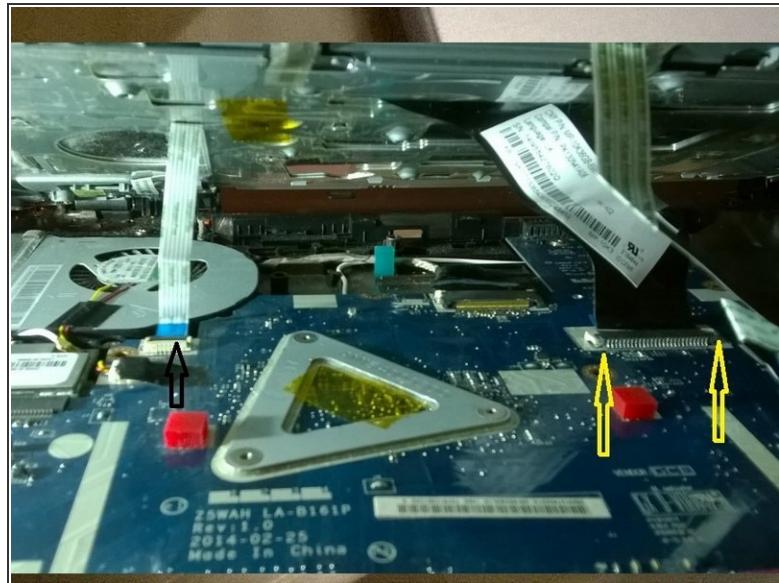
## Step 2 — Removing keyboard & front cover

- Carefully prise up the silver top cover including the keyboard. It includes the silver surround and the black hinge covers. It clips off. Do not fully remove yet.
- Carefully remove the 3 ribbon connectors. The Black arrow connector is loosened by hinging the black tab towards you. The Yellow arrow connector is removed by pushing the 2 cream tabs forward.

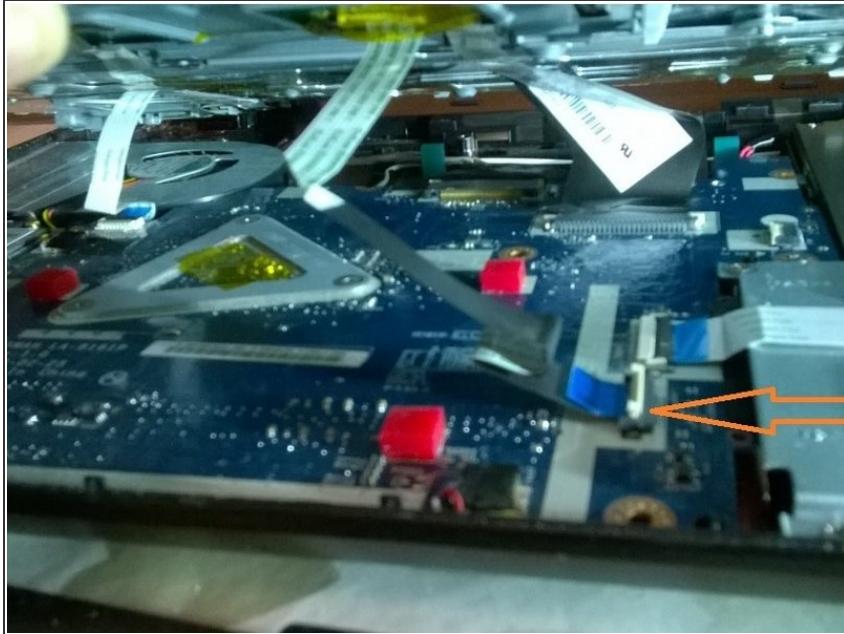
## Step 3 — Remove 3rd ribbon & keyboard

- The 3rd connector ribbon is removed by lifting up the cream tab (Picture shows it in up position).
- The keyboard & touchpad should then lift off.
