Acer Chromebook Spin 15 CP315-1H-P1K8

USB-C Port Replacement

This guide will help you successfully replace your USB-C port in the Acer Chromebook Spin 15 CP315-1H-P1K8 laptop.

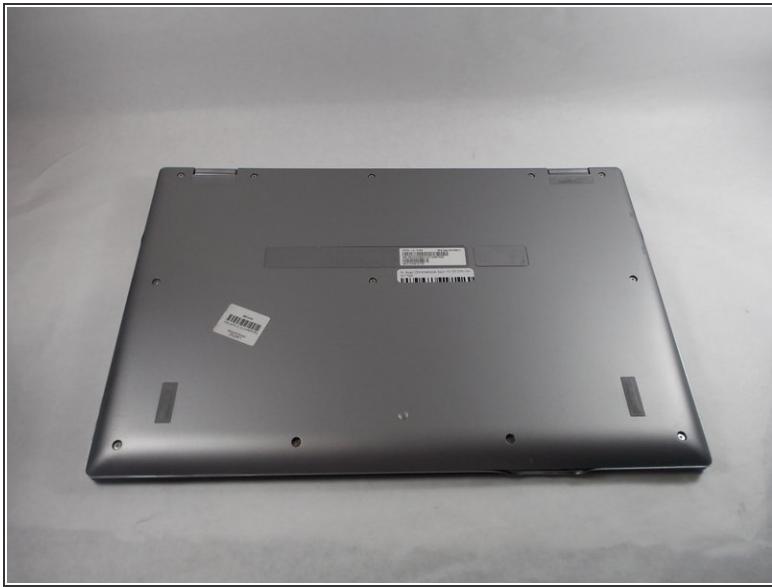
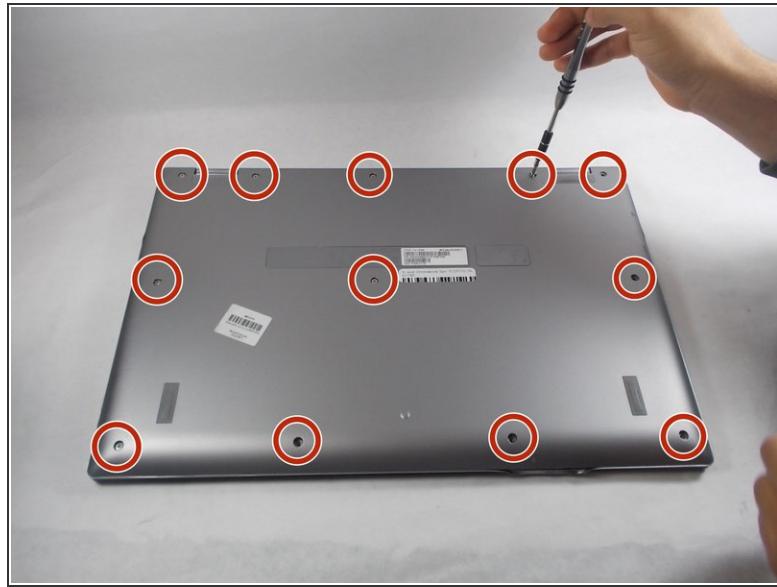
Step 1 — Back Cover

Make sure the device is fully powered off.

- Flip the computer over so that the back is facing up.
- Remove the twelve 6mm Phillips #1 screws from the bottom of the laptop.

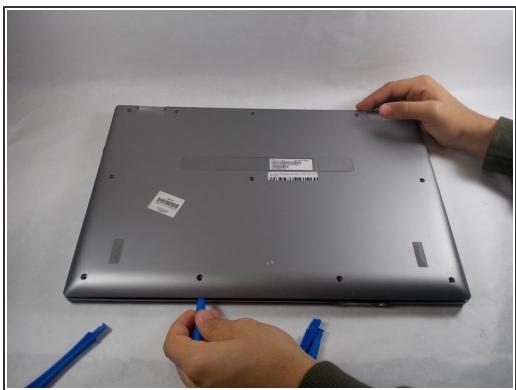
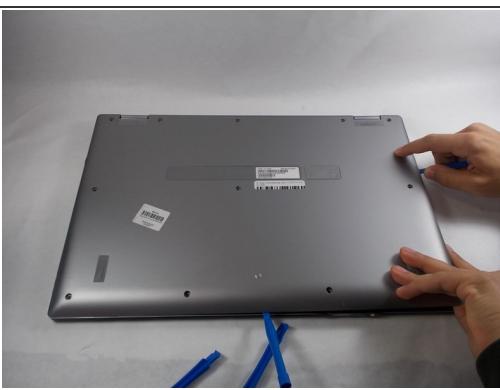
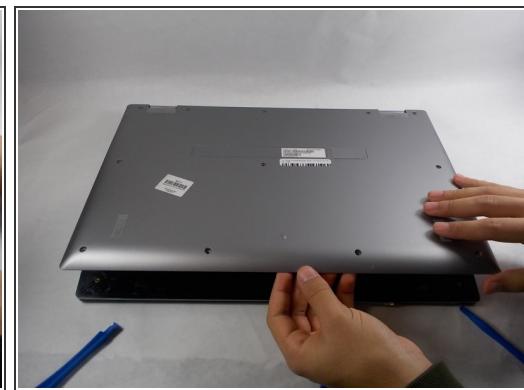
Step 2

- Use the iFixit opening tools as wedges to pry the back of the laptop off.

Go slow, making sure not to snap the plastic. With enough of a gap made, you can use your hand to finish taking off the back.

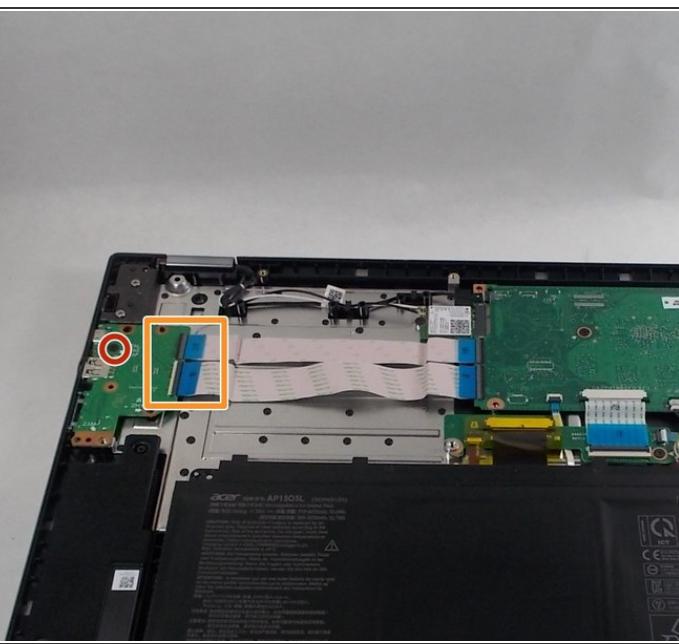
Step 3 — USB-C Port

- Remove the single 3mm Phillips #1 screw from the circuit board.
- Remove the two ribbon cables from the circuit board.
- Remove the USB-C port from the laptop.

To reassemble your device, follow these instructions in reverse order.
