# Acer Iconia Tab 8 A1-840 Buttons Replacement

Replace the volume and power buttons

Written By: taylerdurtschi

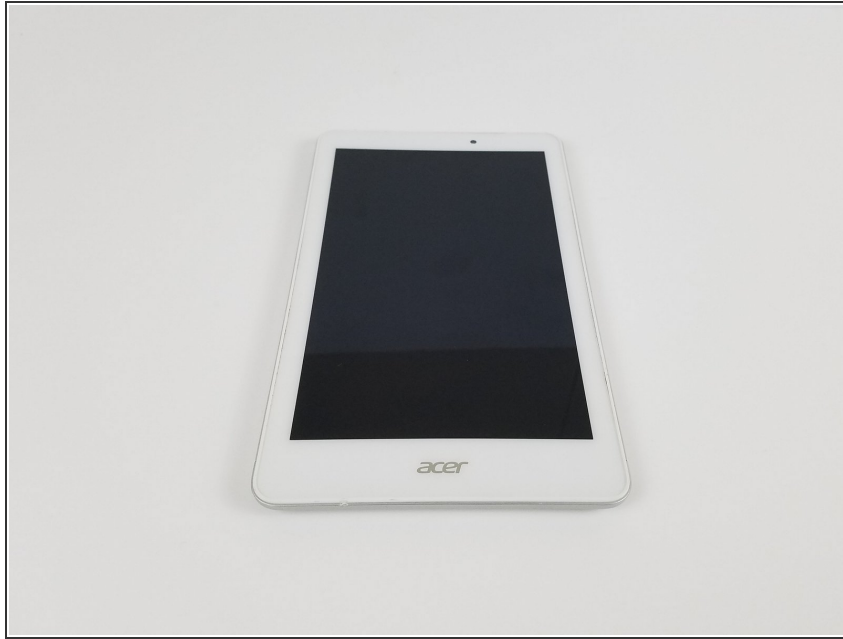
## Step 1 — Back Panel

- Power off the device
- Remove any cables that might be connected to your device
- Make sure the device is placed on a flat surface with the display screen facing up

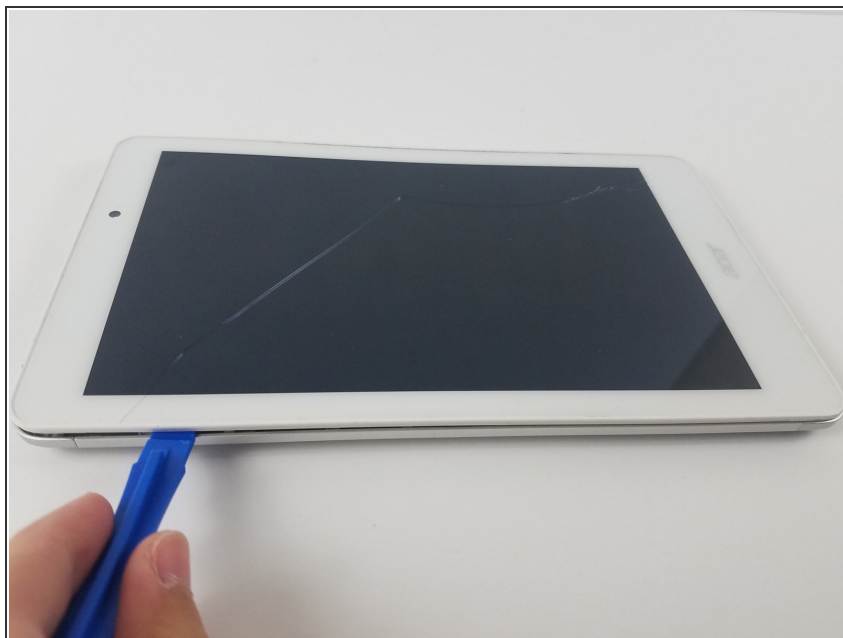
## Step 2

- Wedge the plastic opening tool in between the display screen and back panel
- ⚠ Do not apply too much pressure in order to avoid cracking the screen

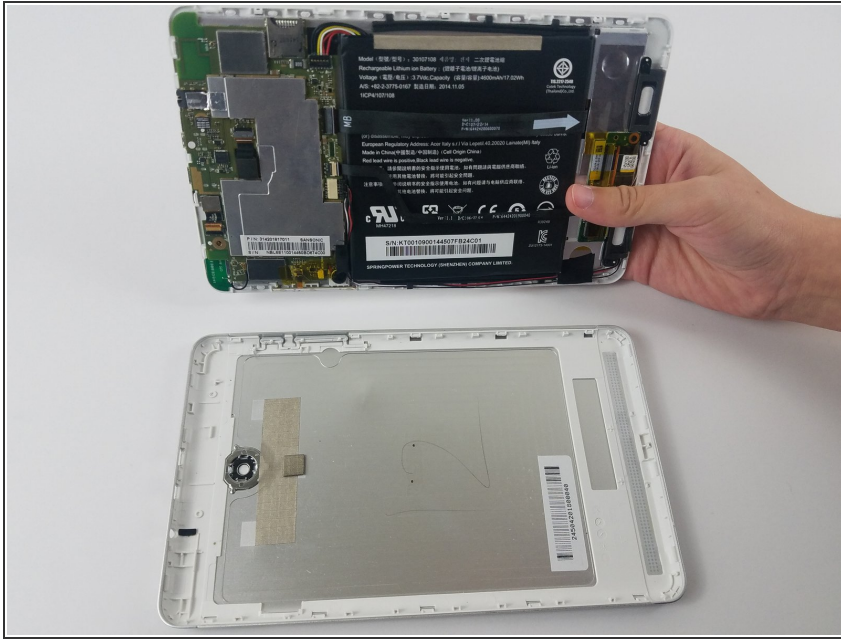
## Step 3

- Carefully separate the display from the back panel

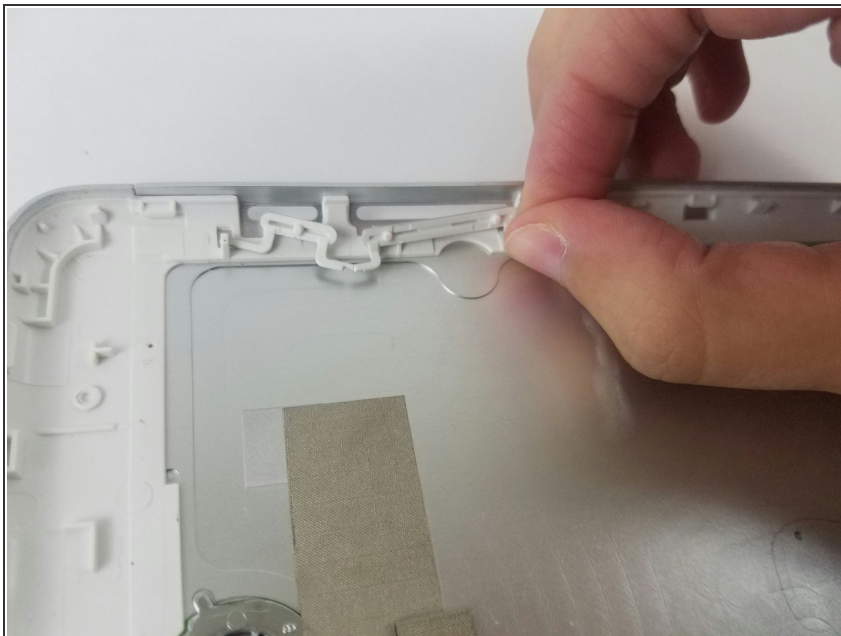
## Step 4 — Buttons

- Remove the buttons from the back panel using your fingers.

To reassemble your device, follow these instructions in reverse order.
