Acer One 10 S1003-19GY Rear/Front Camera Replacement

Replace front or rear camera for Acer One 10 S1003-19GY.

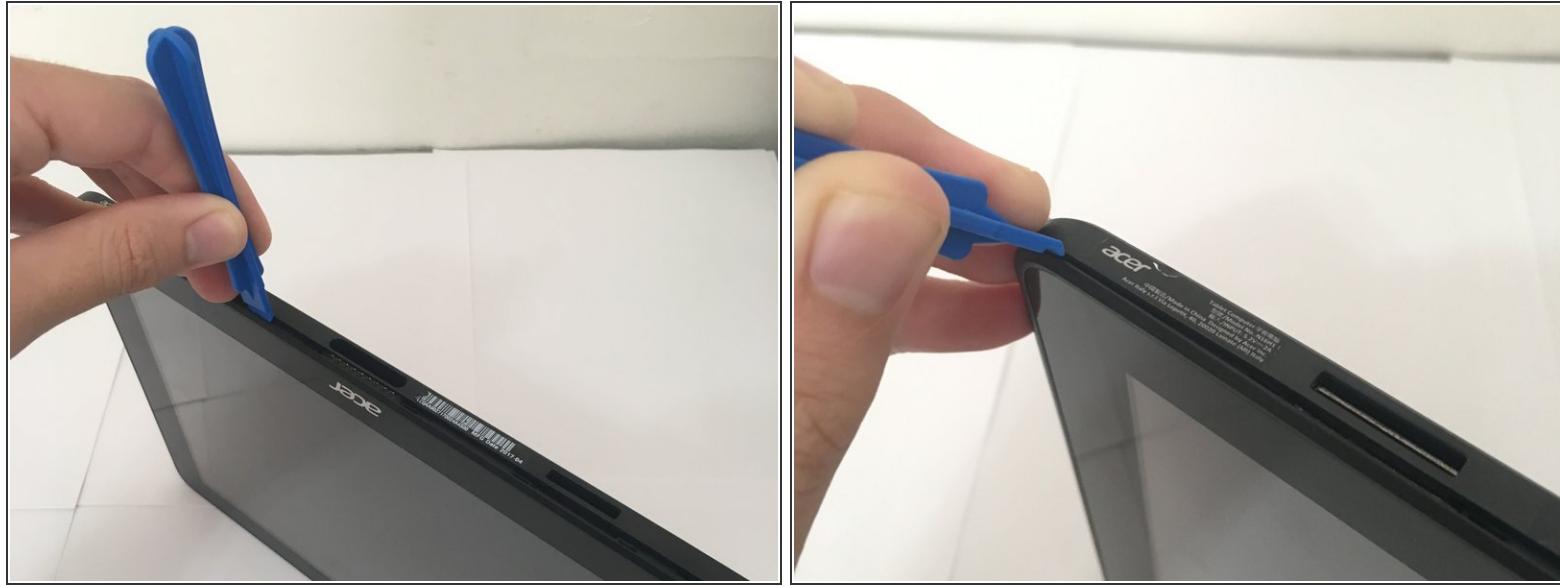
Step 1 — Back Panel

- Power off the device and make sure it is disconnected from any external devices.
- Use a plastic opening tool to create a gap between the front and back casing of the device.
- Slowly maneuver the plastic tool around the entire perimeter of the tablet to separate the front and back.

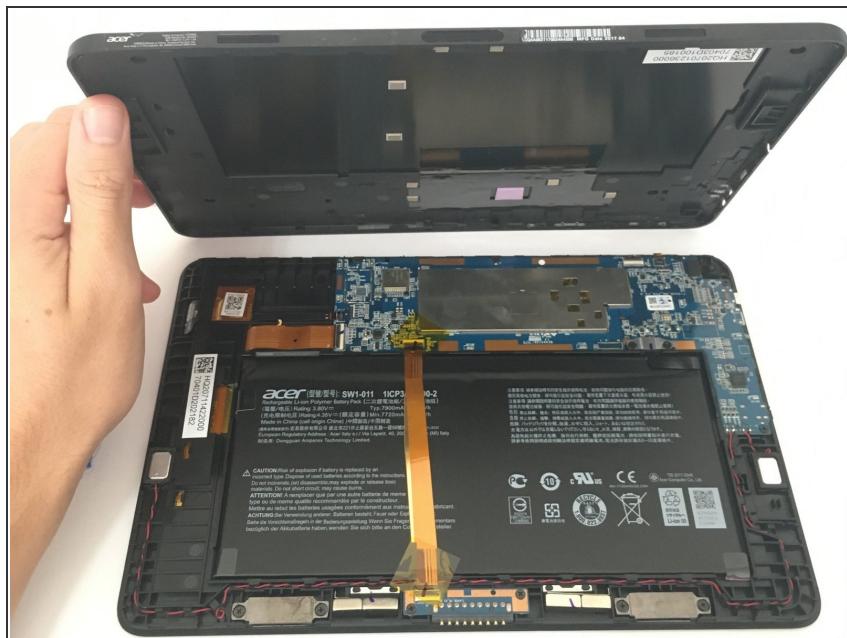
Step 2

- Set the device screen side down and remove the back casing.
