Acer Travelmate 220 Disc Drive Replacement

Replacement of optical drive.

Written By: Justin

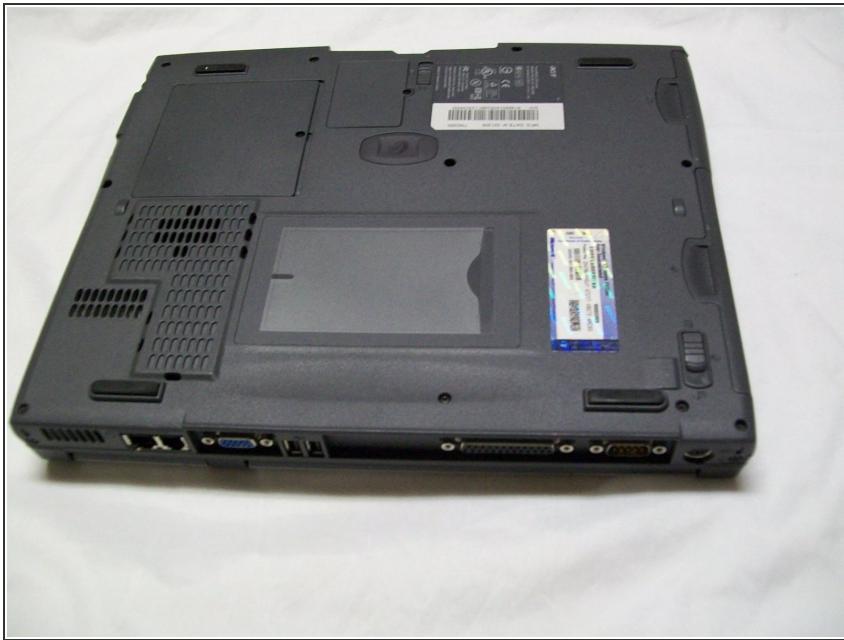
Step 1 — Disc Drive

- Flip your computer over so the bottom case is facing you.

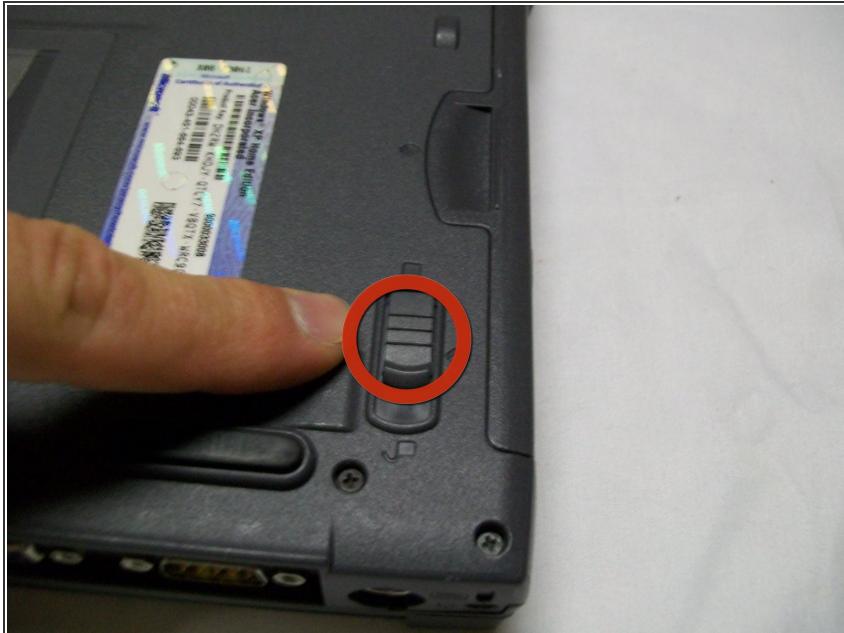
Step 2

- Locate sliding unlock button near the AC power input.

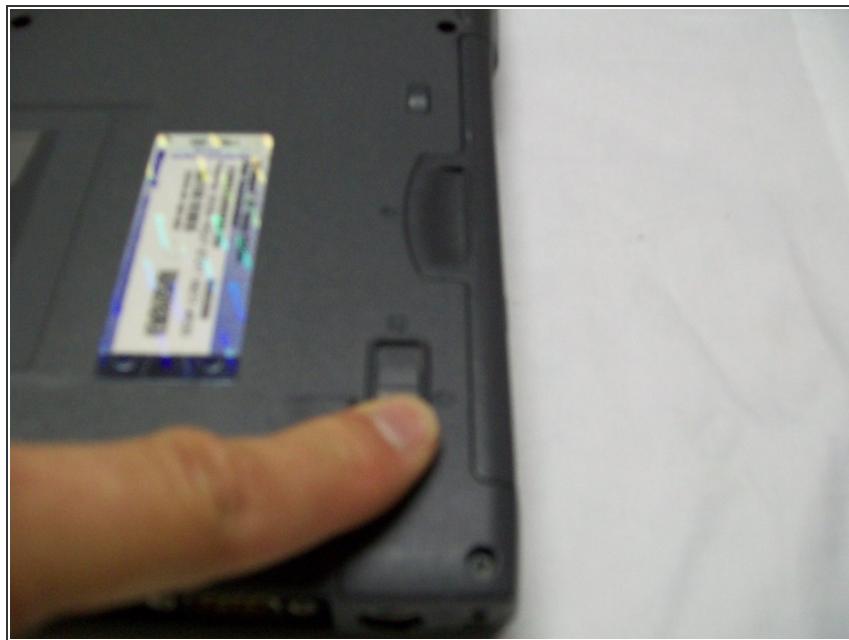
Step 3

- Slide button in the direction of unlock and hold.

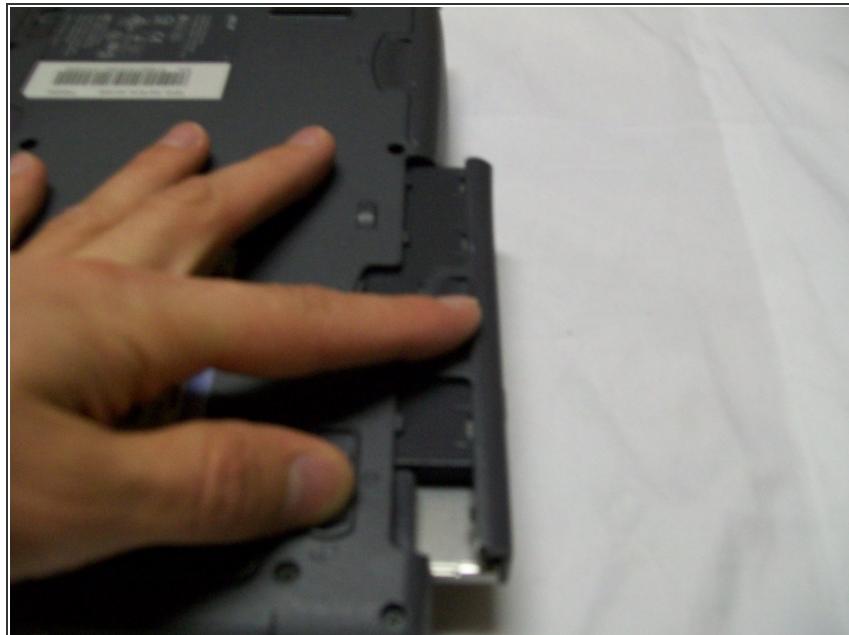
Step 4

- Gently pull the disk drive out.

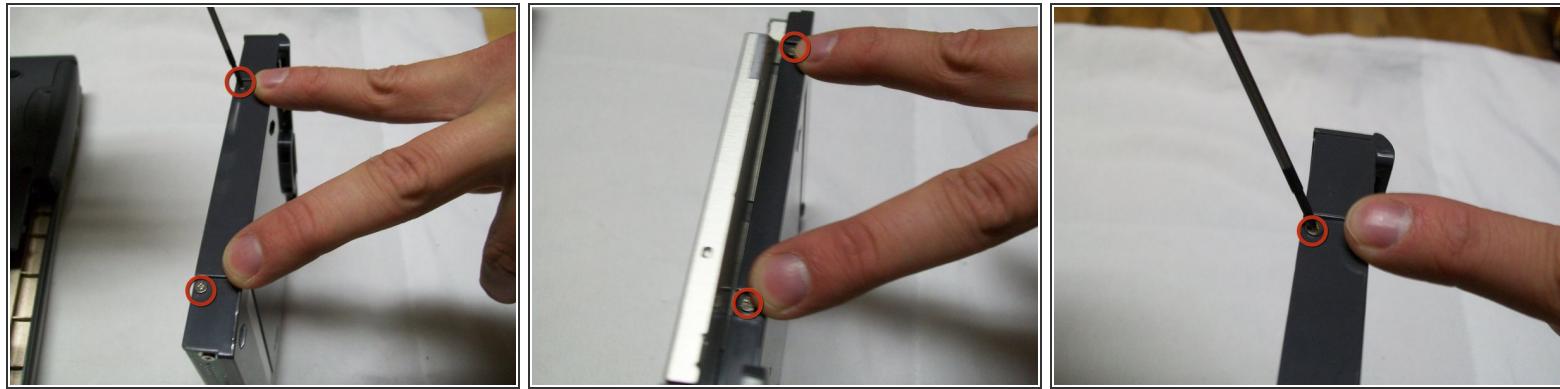
Step 5

- With a small Phillips drive screwdriver, remove the 4 screws in sides of black plastic.

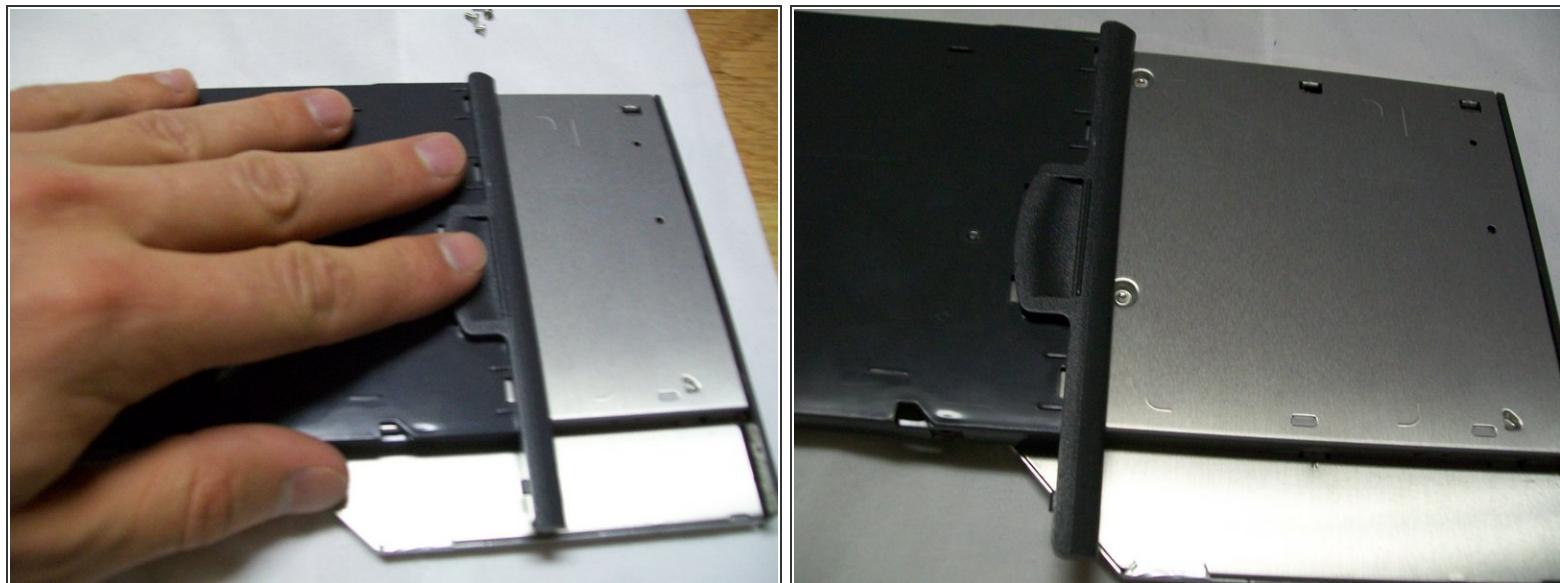
Step 6

- Pull off black plastic that covers the metal.

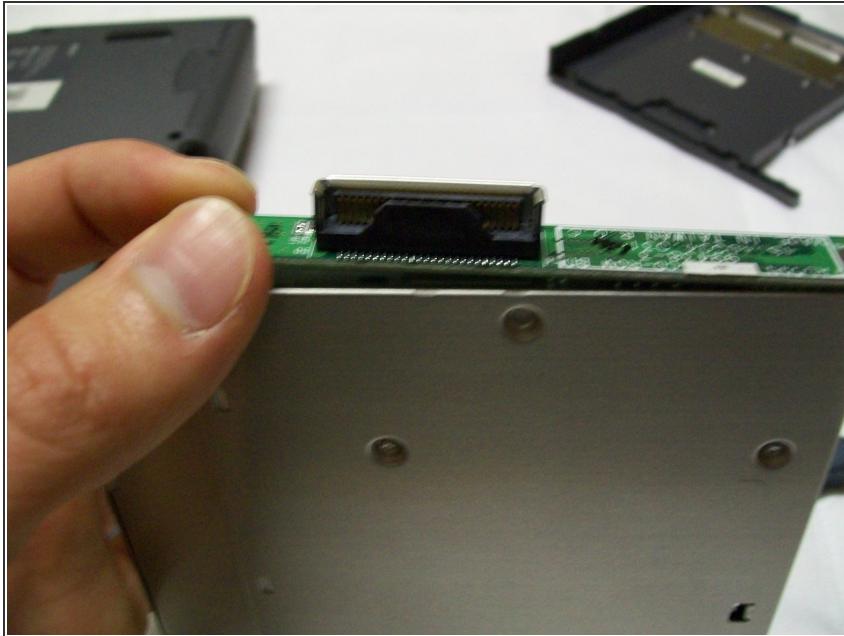
Step 7

- Locate green chip on back of drive.

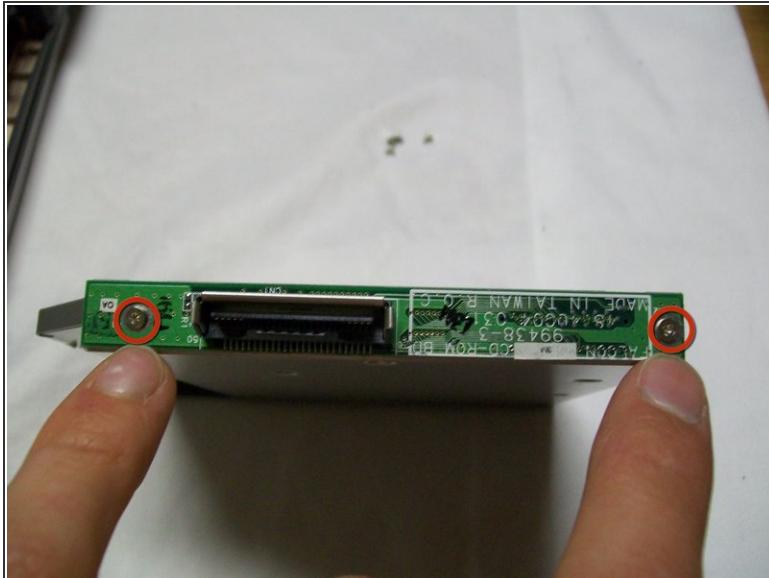
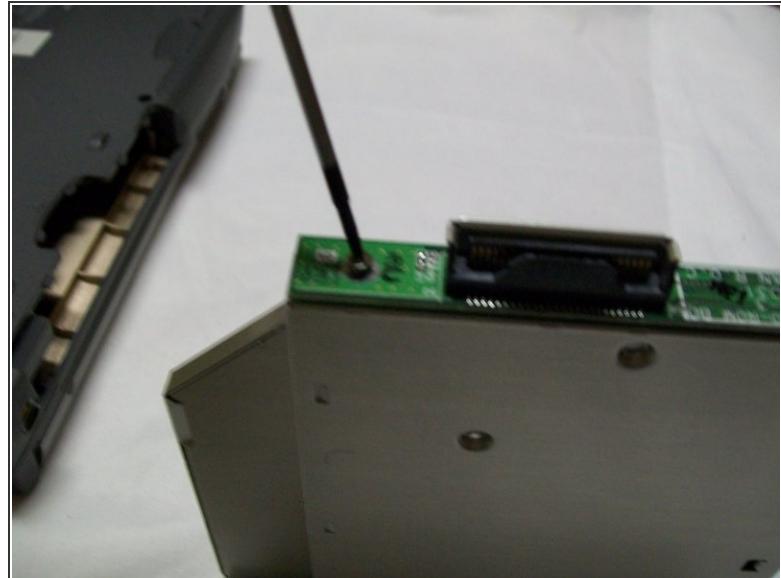
Step 8

- Remove the 2 screws securing the green chip.

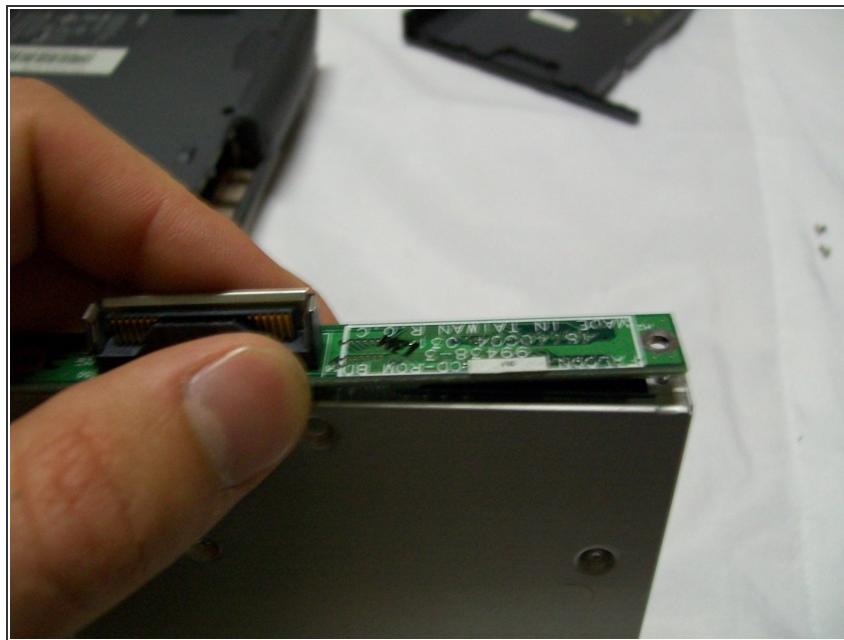
Step 9

- Firmly pull off green chip.

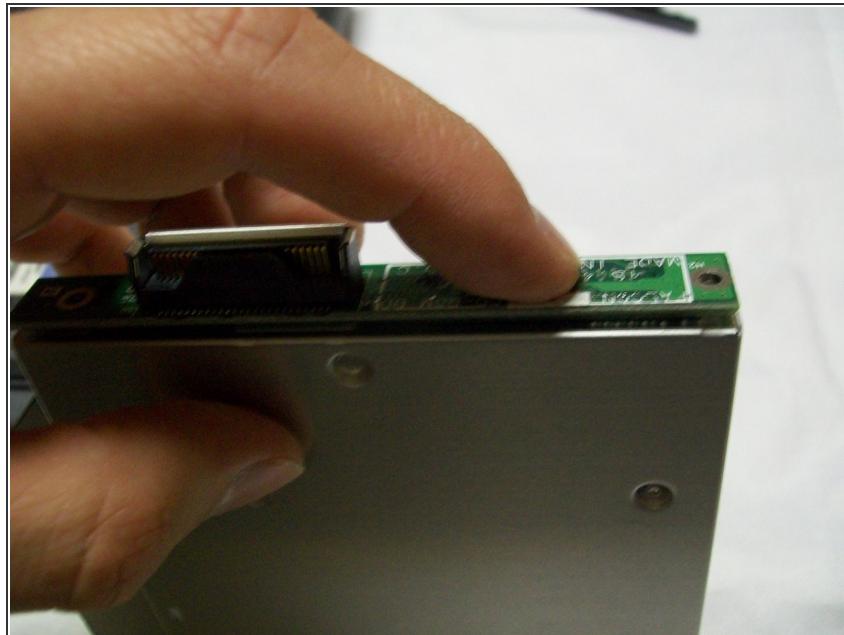
Step 10

- Insert green chip in new mechanism.

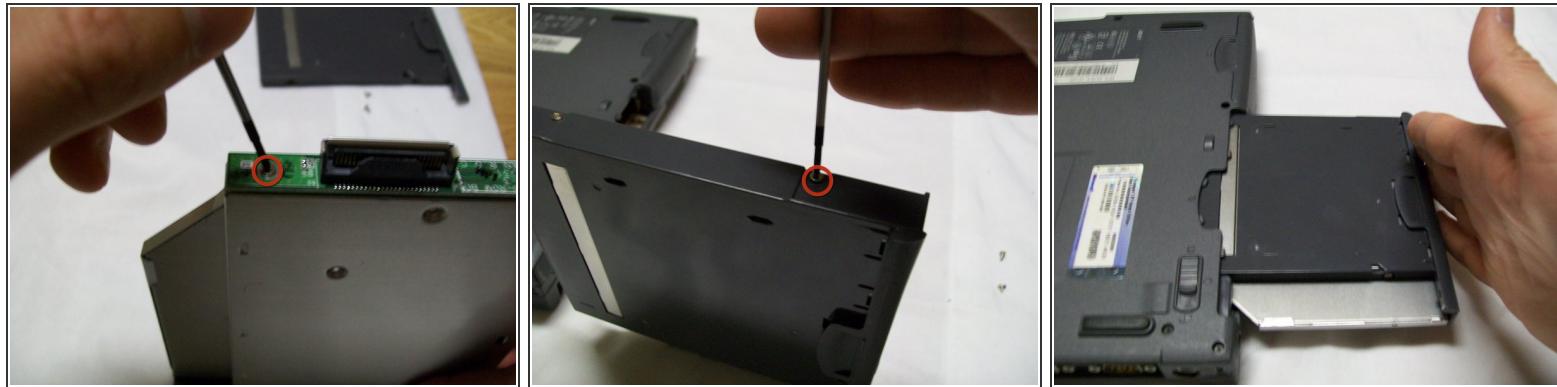
Step 11

- To reassemble your device, follow these instructions in reverse order
