Acer Travelmate 220 RAM Replacement

Replacement of RAM chips

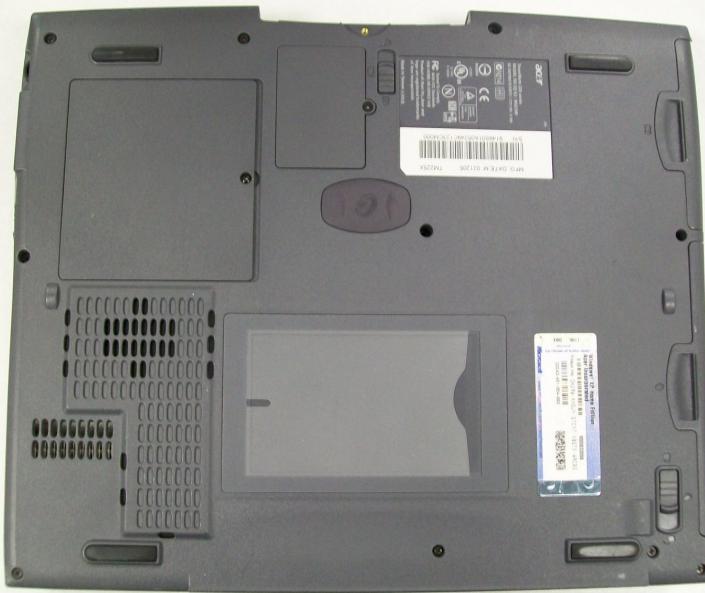
Step 1 — RAM Chip

- Place the computer with the bottom facing up.

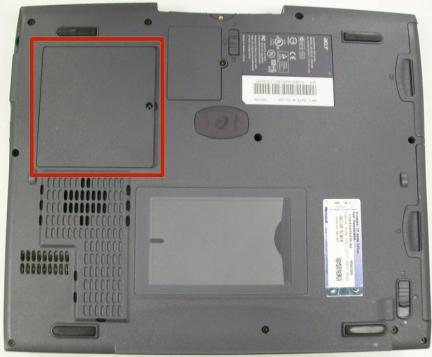
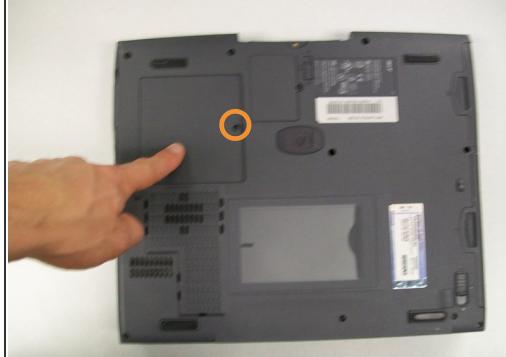
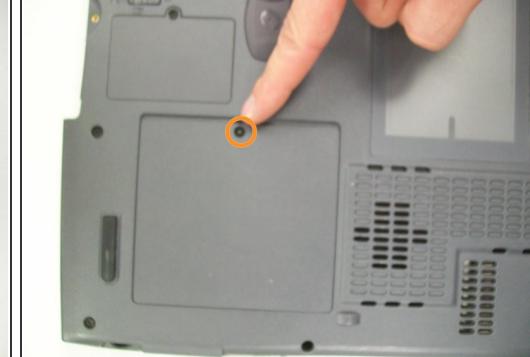
Step 2

- Locate the larger cover panel in the upper left hand corner of the computer.
- Locate the Phillips screw holding the large cover panel in place.

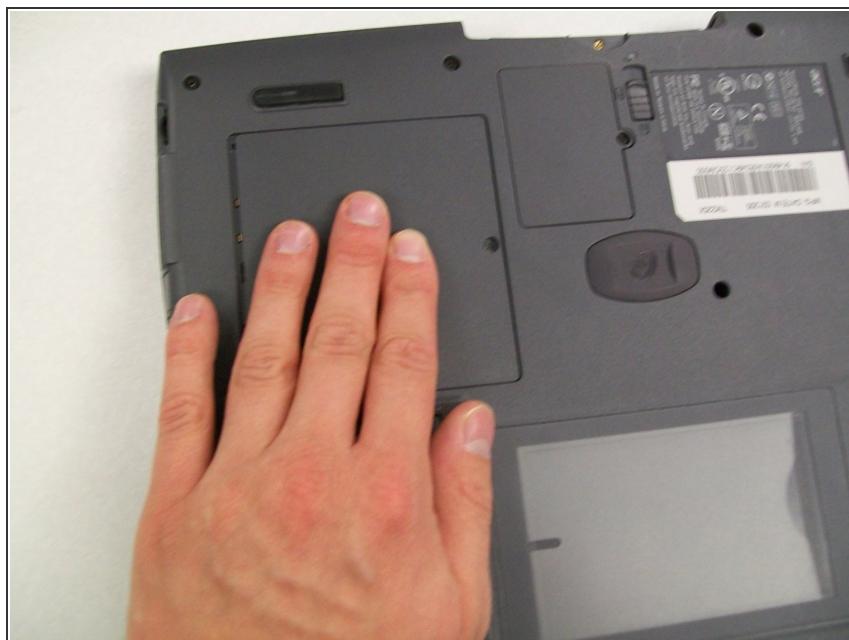
Step 4

- Slide the large cover panel to the right, until you hear a click.

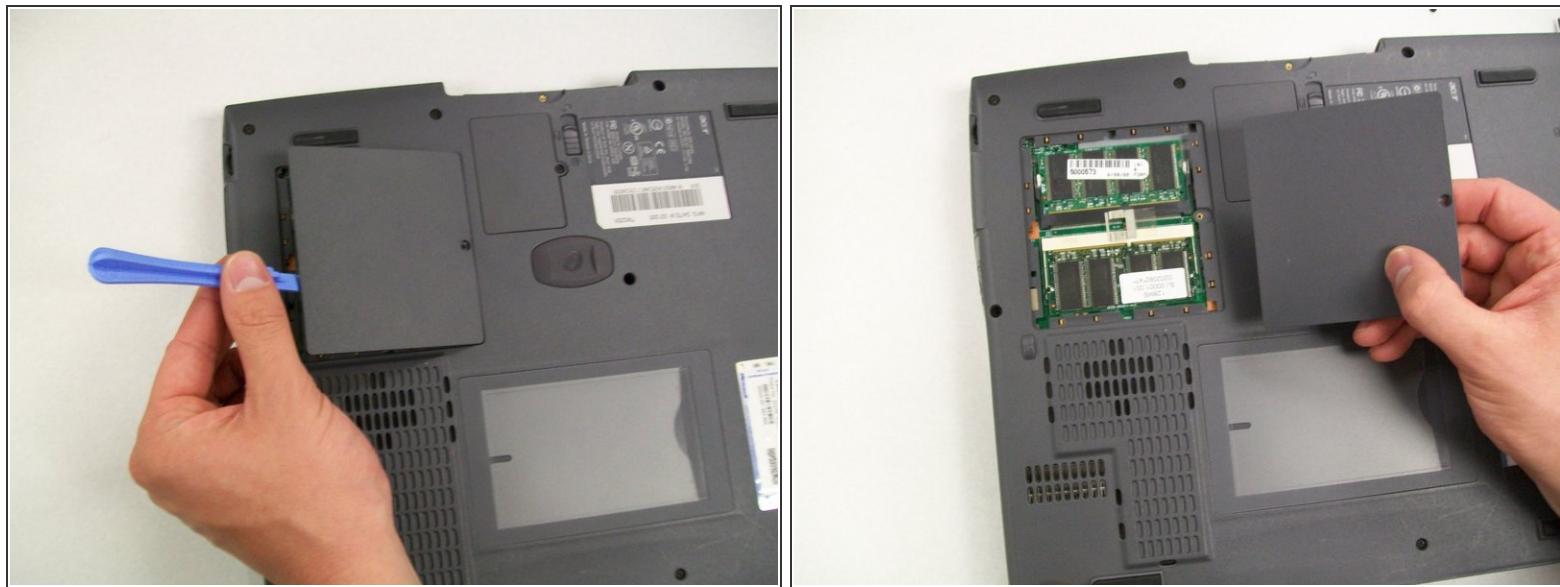
Step 5

- Place the plastic opening tool in the gap created to the left of the large cover panel.
- Pry the cover panel up and remove it from the computer.

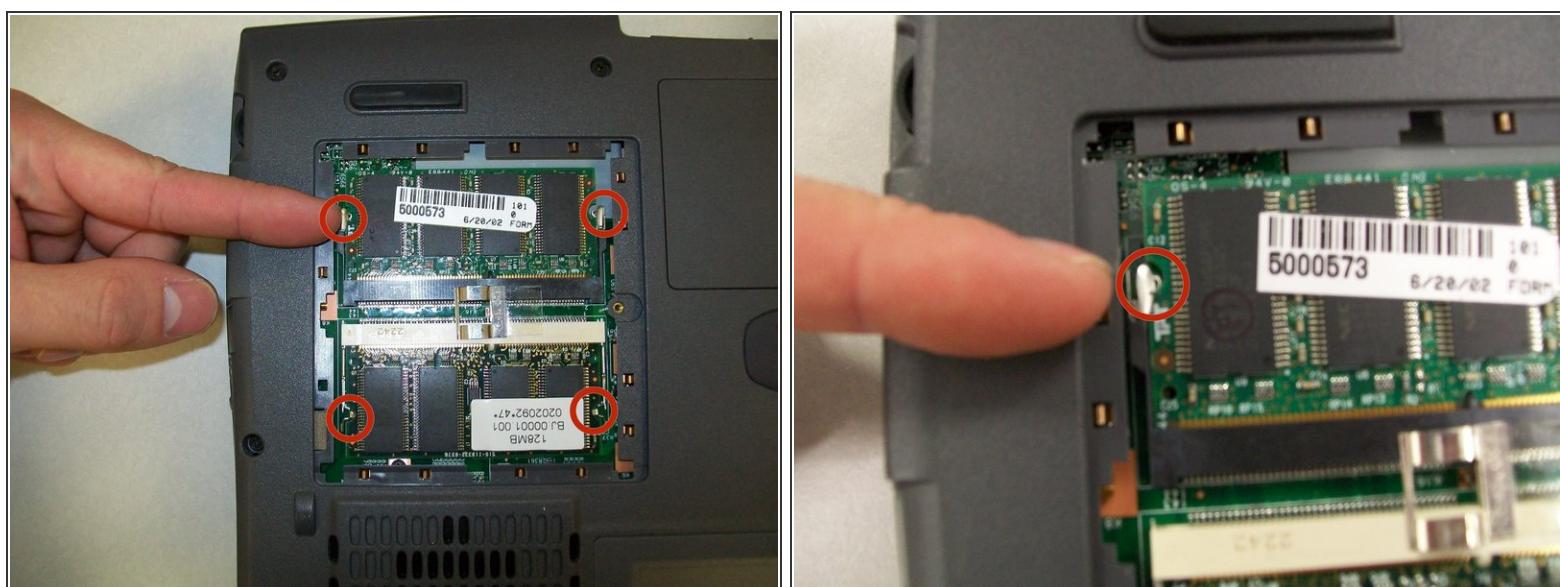
Step 6

- Locate the white plastic levers on each side of the two RAM chips.

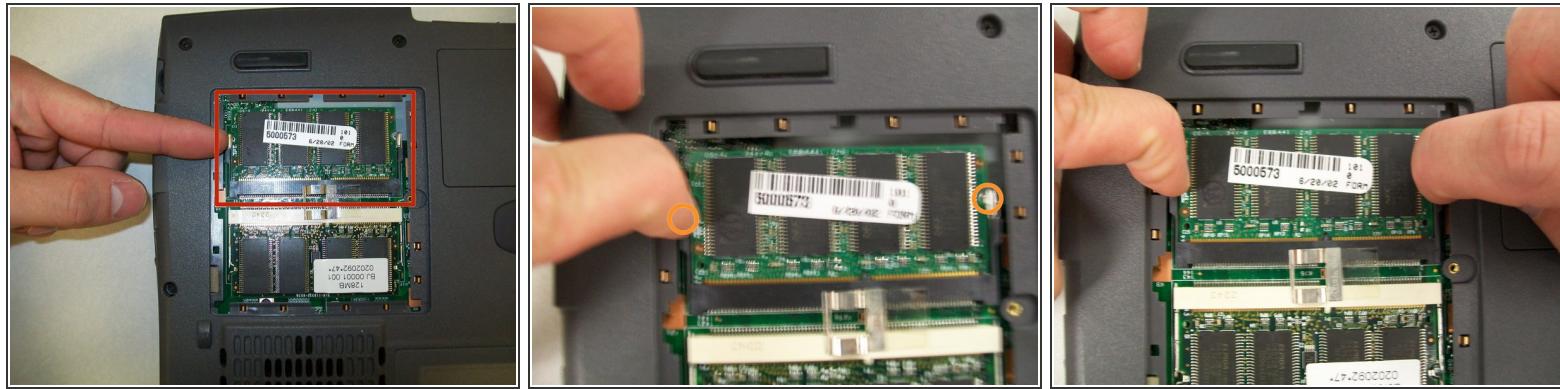
Step 7

- Locate the first RAM chip.
- Push the plastic levers away from the first RAM chip.

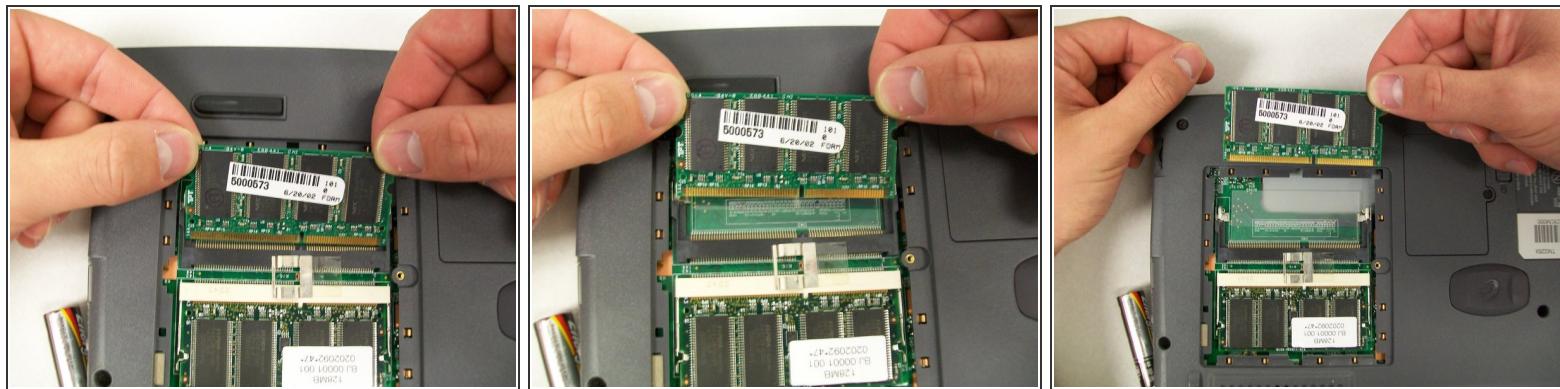
Step 8

- Lift the RAM chip from the compartment.
- Repeat steps 7 and 8 to replace the second RAM chip.
