# Adjusting the front bonnet

Fix the front bonnet closing problem or not closing to be more precise.

Written By: Dan Mihai Ile

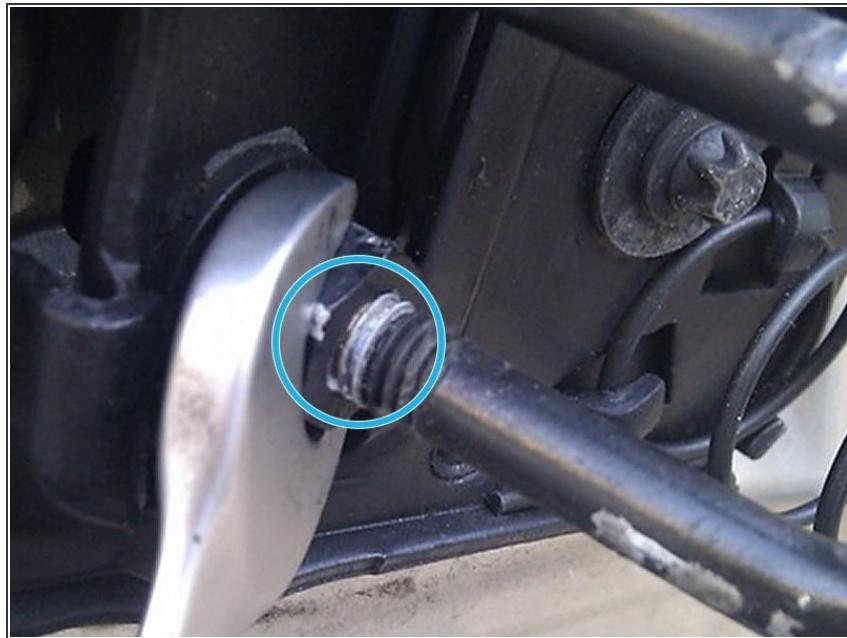
## Step 2 — Adjust closing mechanism using the screw

- Use the 13mm Wrench to screw/unscrew the bonnet closing mechanism so that it gets adjusted. Usually it needs unscrewing a little so that it reaches the closing mechanism on the car.
- The missing black paint on the screw indicates how much this bonnet closing mechanism needed adjustment

● *i* After adjusting, if unscrewing was needed and the closing mechanism screw shows unpainted parts it would be wise to spray-paint the area to protect from corrosion/rust in the future.

After adjustment the front bonnet should fully close easily when lowering.
