Altec Lansing Mini Lifejacket 2 Back Panel Replacement

This step-by-step guide will show you how to replace the back panel of your Altec Lansing Mini Lifejacket 2.

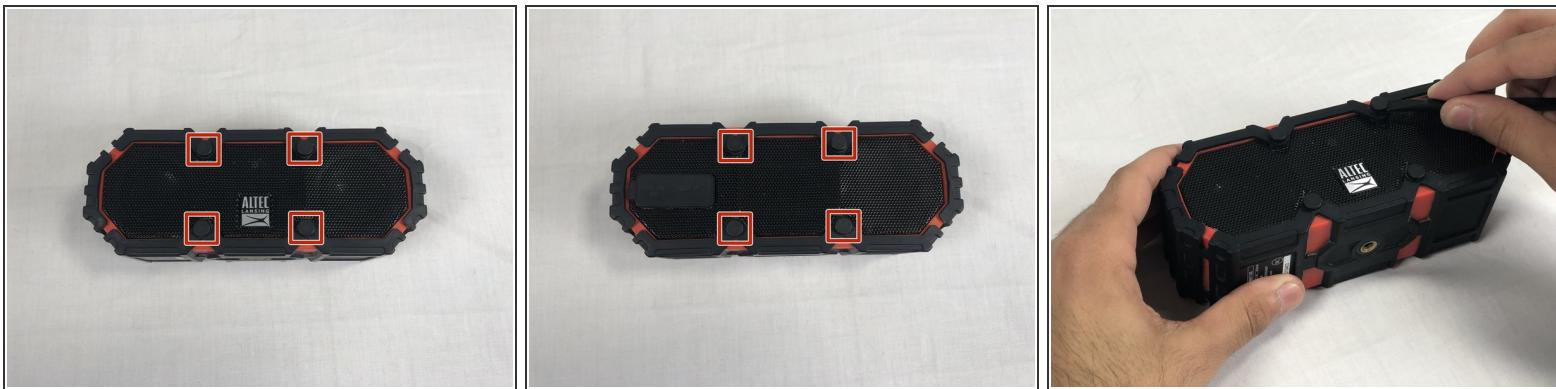
Step 1 — Back Panel

- Use the spudger to remove the eight black pins from the front and back of the wire screens.

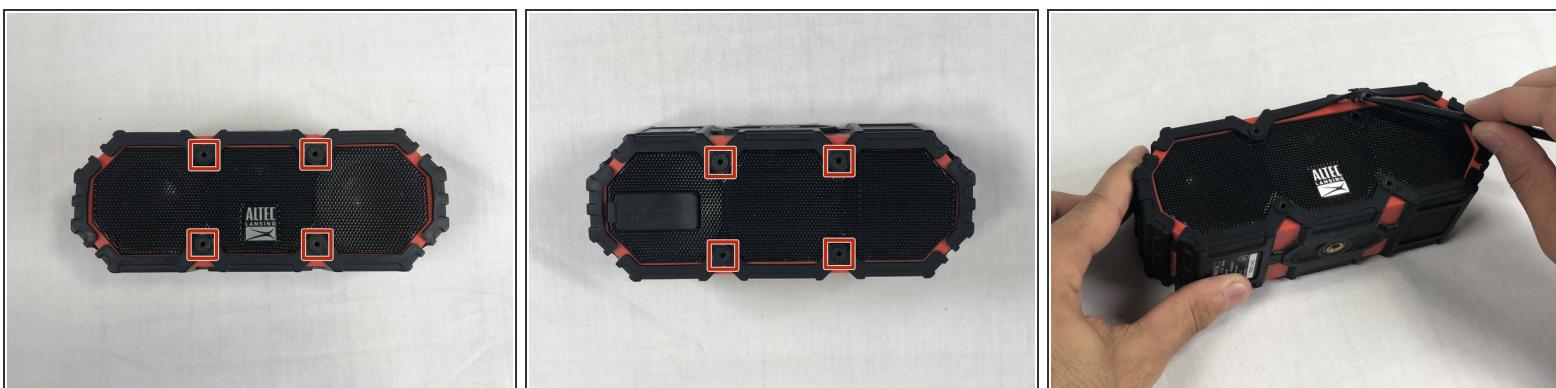
Step 2

- Detach the eight secondary pins from the front and back of the wire mesh plates with a spudger.
- *Removing the secondary pins from the rubber casing is optional.*

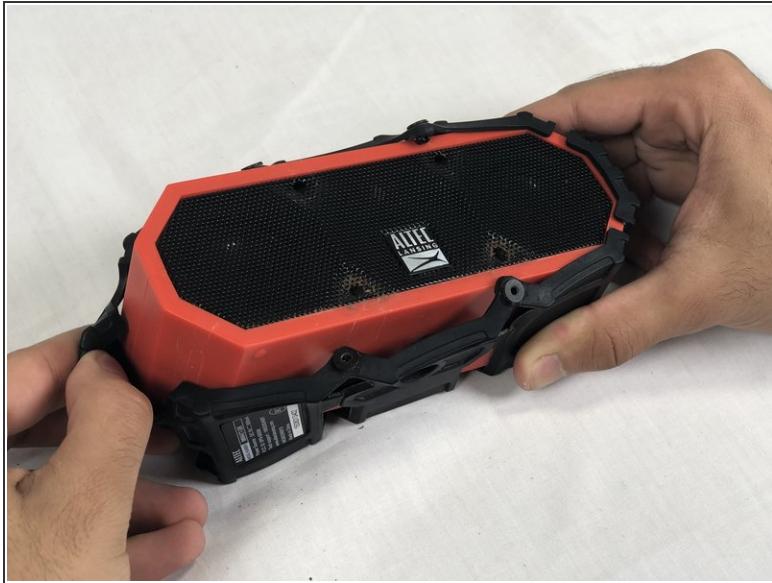
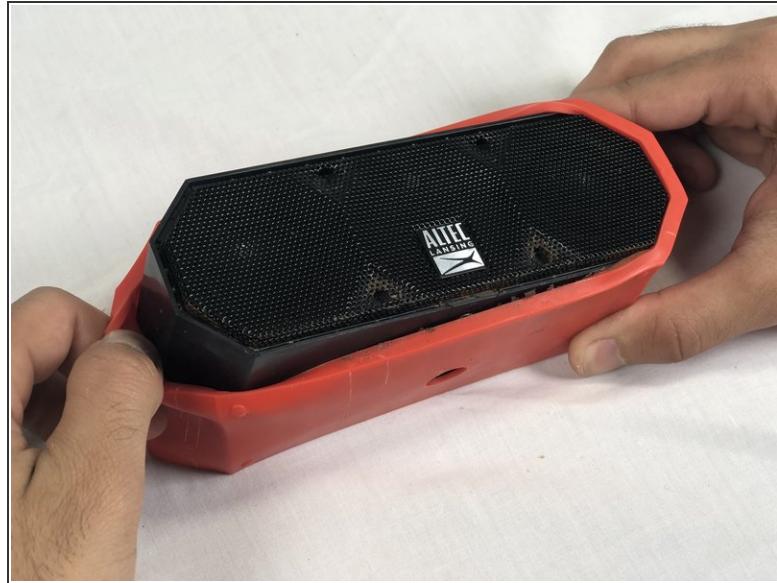
Step 3

- Remove both black and orange layers from the speaker body.

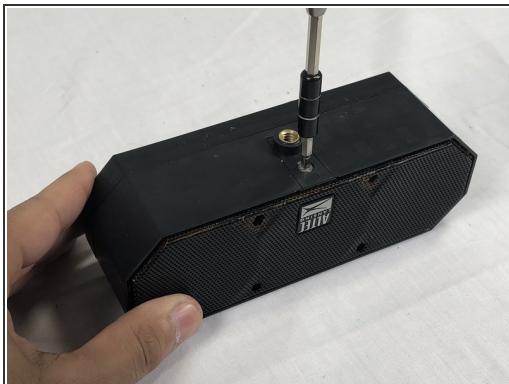
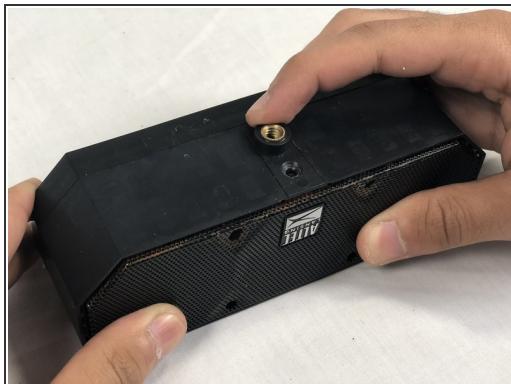
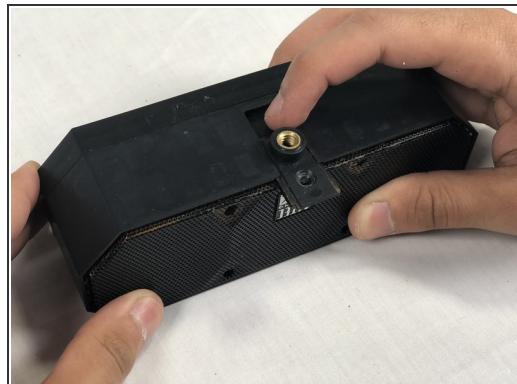
Step 4

- Remove the single 7.8mm Phillips #2 screw from the mounting plate located under the device.
- Slide the mounting plate out to remove it.

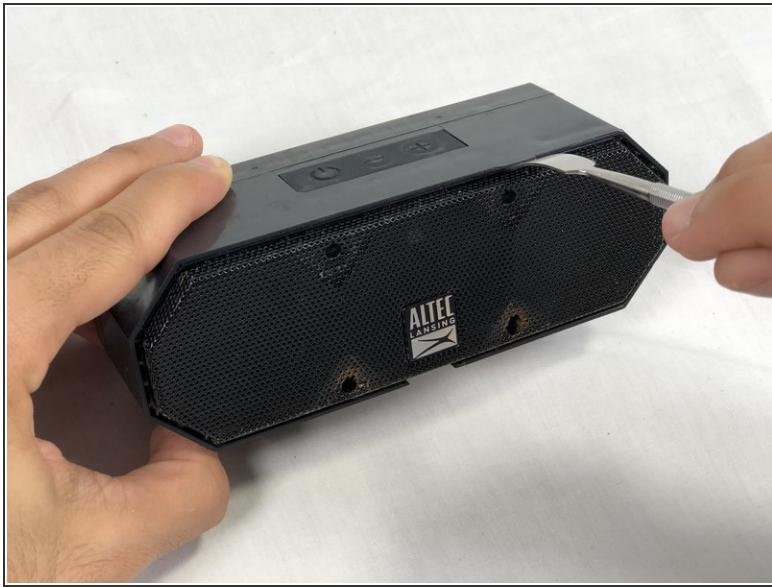
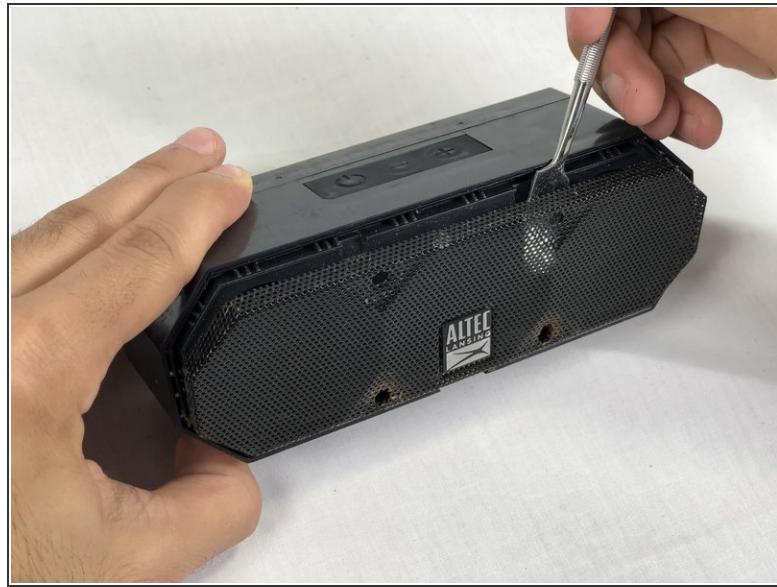
Step 5

- Pry off the wire mesh on both sides using a metal spudger.

Be gentle to avoid bending the mesh.

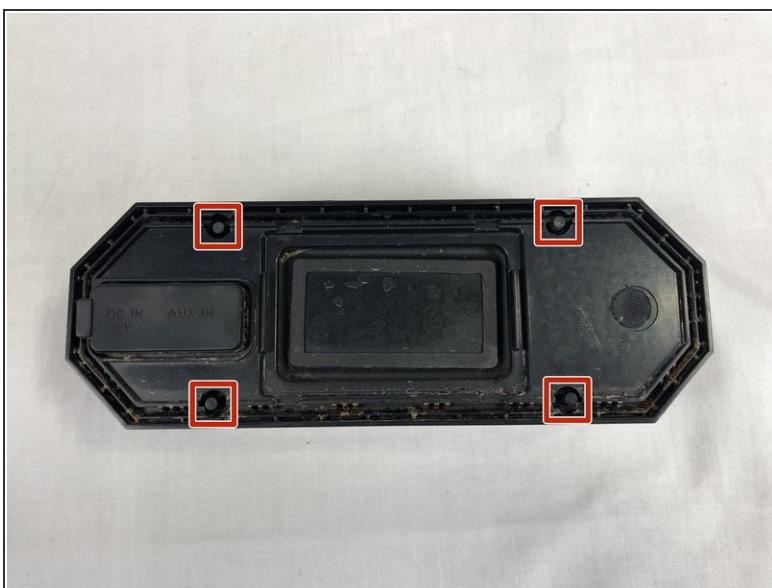
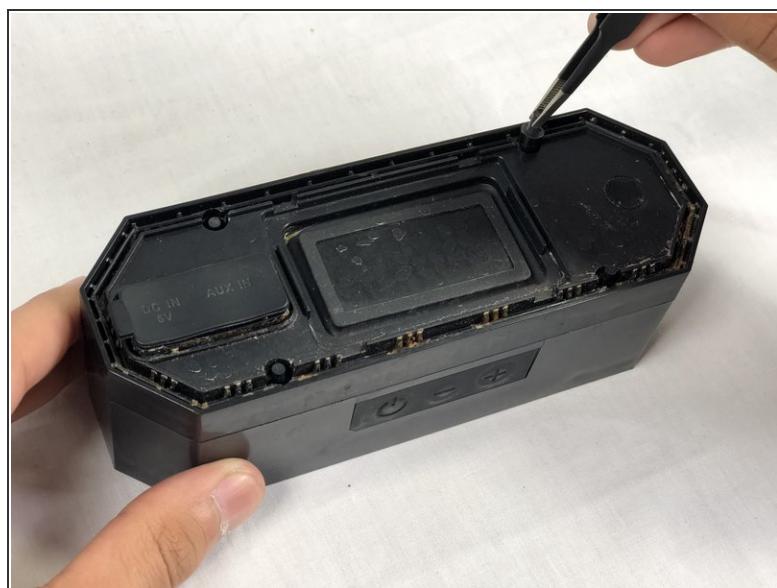
Step 6

- Using tweezers, remove the four rubber stoppers in each corner of the rear panel.

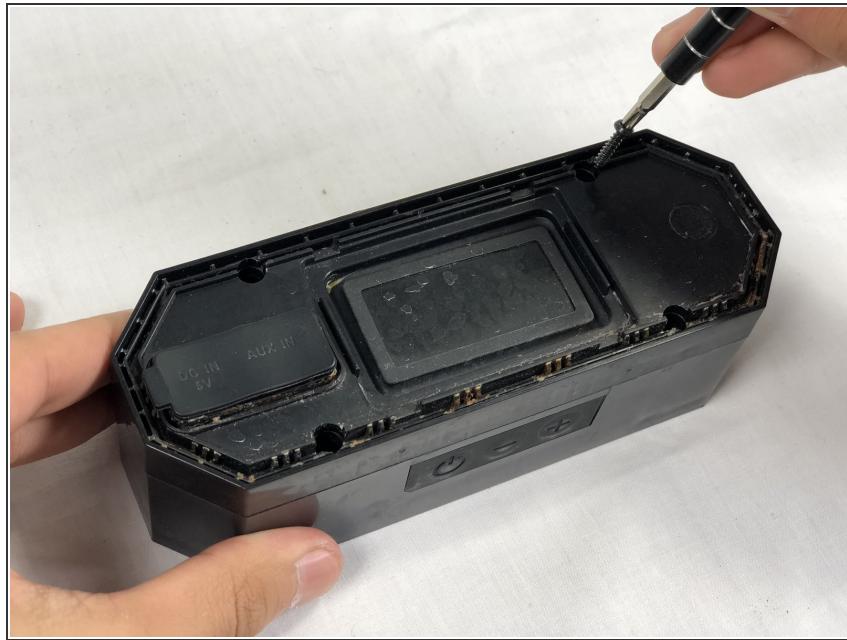
Step 7

- Remove the four 13.7mm Phillips #1 screws located underneath the rubber stoppers.

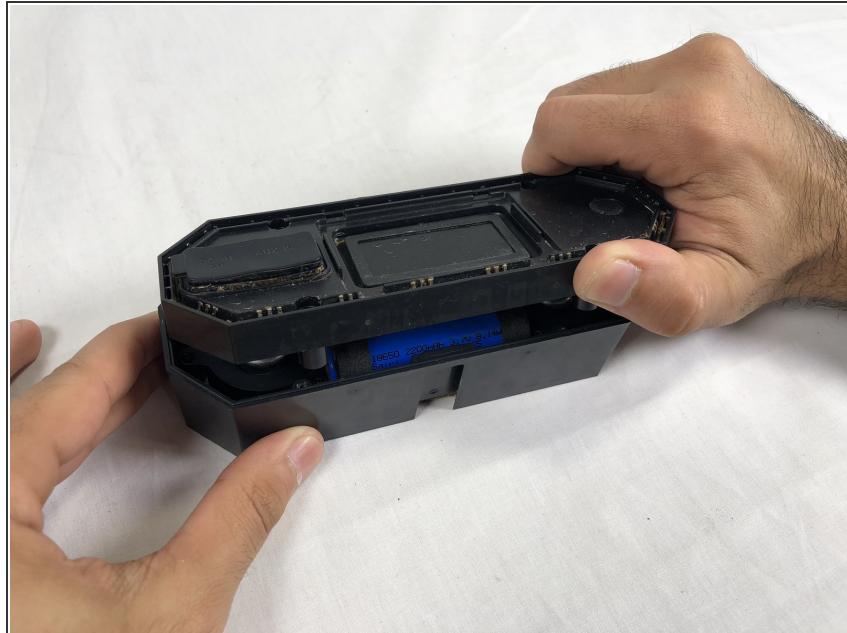
Step 8

- Pull the case apart to access the interior components.

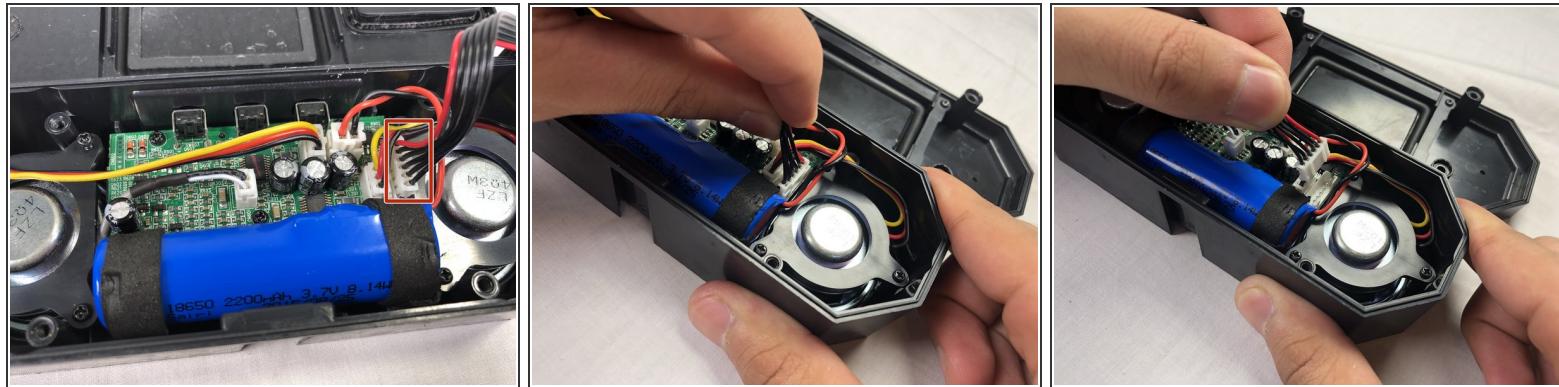
Step 9

- To remove the back panel, gently pull out its wire harness.

To reassemble your device, follow these instructions in reverse order.
