Asus Chromebook C201 Palm Rest Assembly Replacement

To replace your palm rest assembly. This is the initial guide for opportunity to replace other key components.

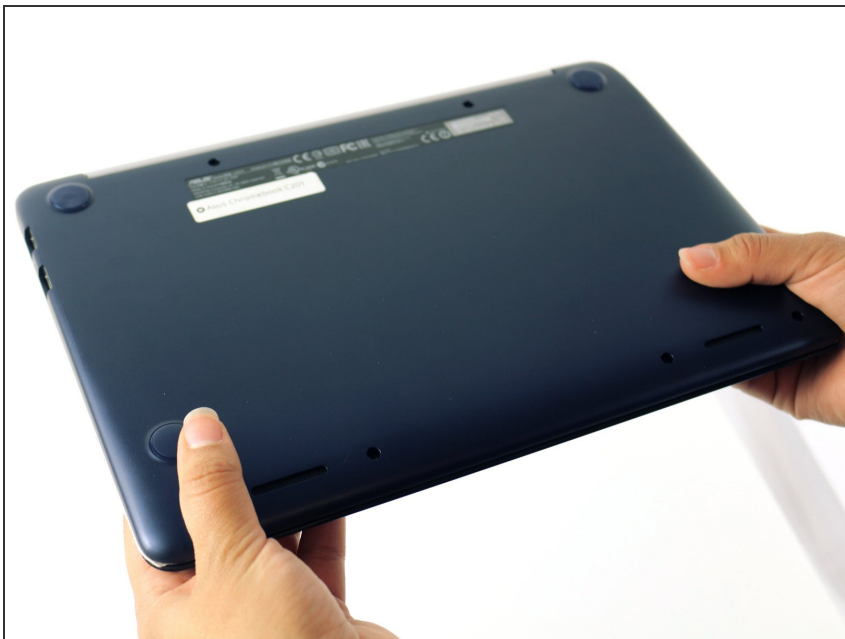
Step 1 — Palm Rest Assembly

- Flip the laptop upside down with the rear end of the computer away from you.

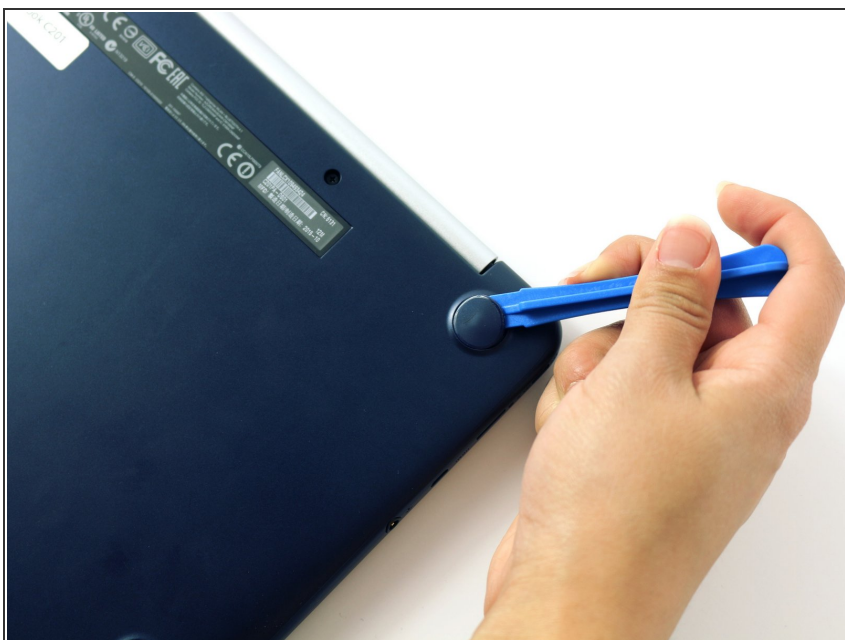
Step 2

- Remove the two rear rubber feet by using one of the small, blue plastic spudgers.

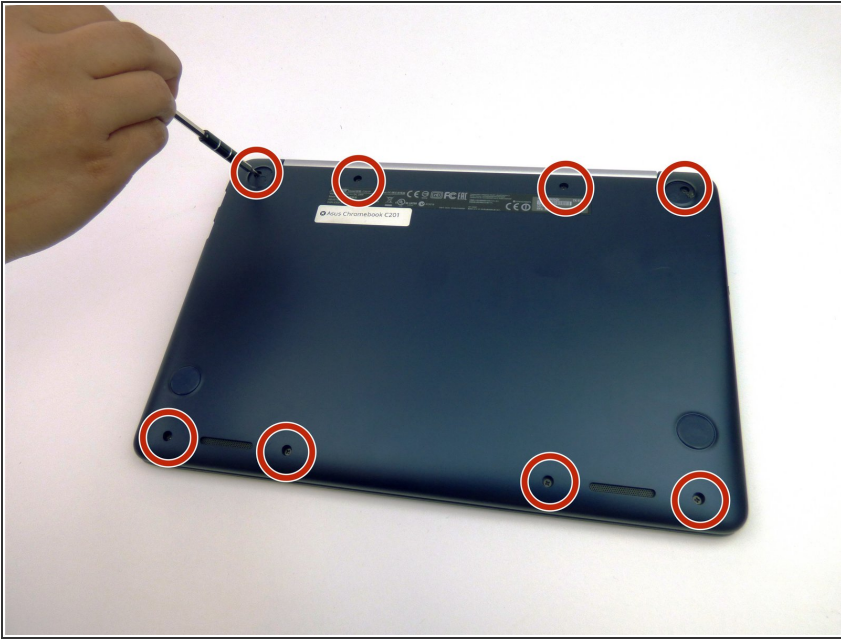
Step 3

- Use the J0 screwdriver to remove the eight 5mm black screws on the bottom of the laptop, which includes the two that were hidden under the rear rubber feet.

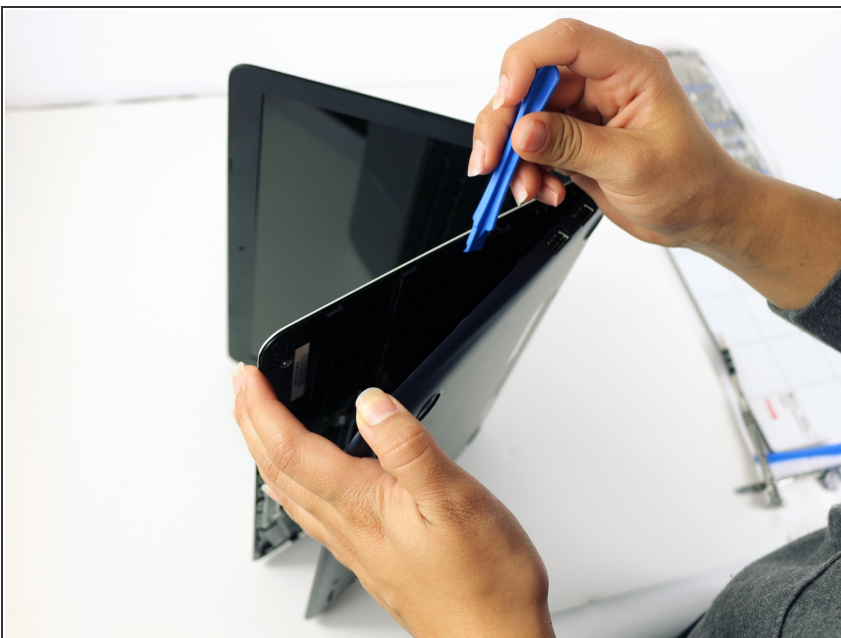
Step 4

- Turn the laptop on its side. Use a small, blue opening tool to pry the keyboard cover and laptop apart. Begin from the top right, next to the power button, and slowly work your way around to the opposite side until the keyboard cover is detached.

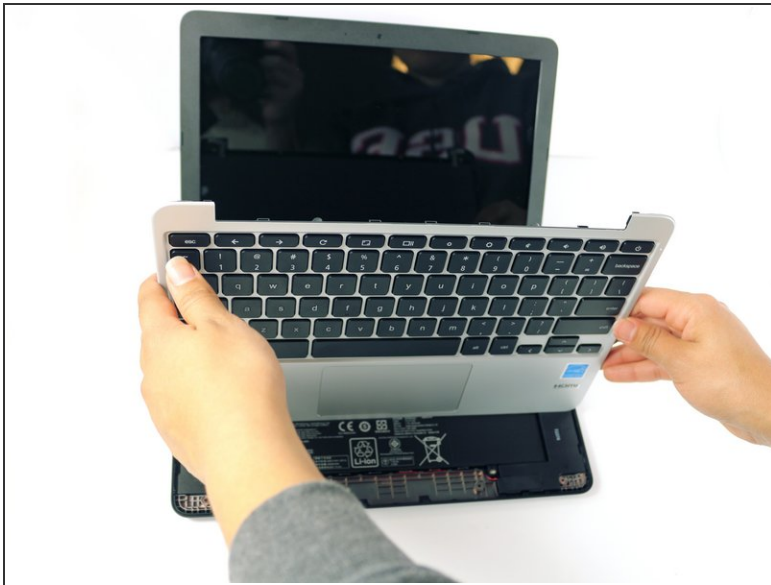
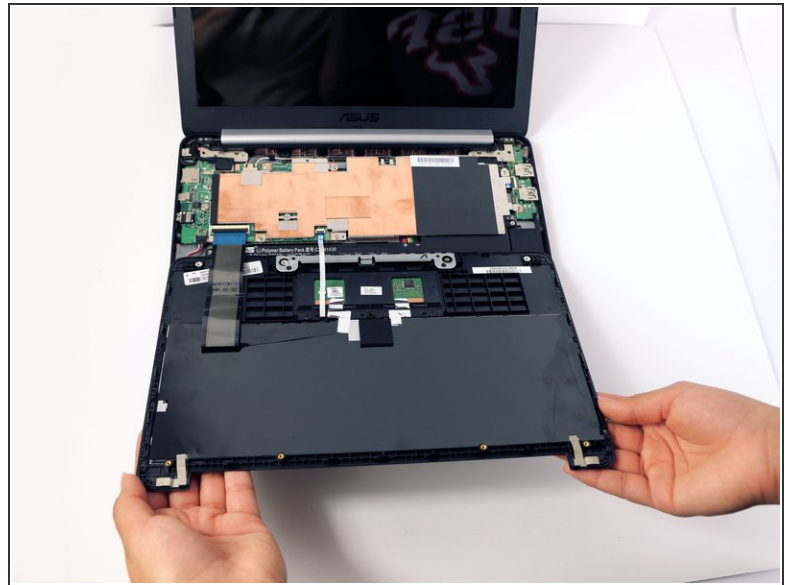
Step 5

- Gently flip the keyboard cover away from the laptop. Rest it safely upside down so the cables are not strained and are easily accessible.

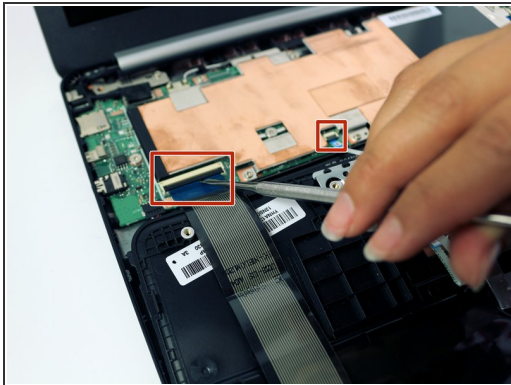
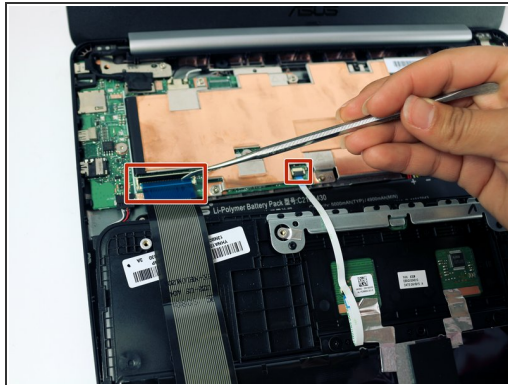
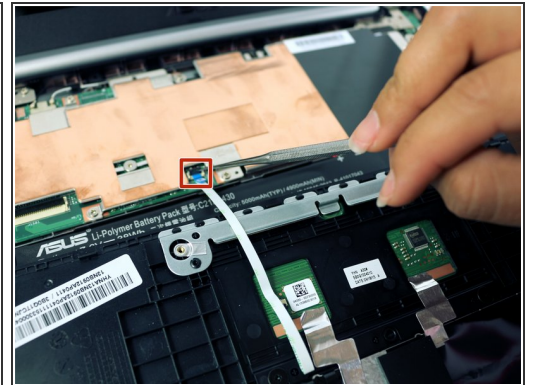
Step 6

- Use the metal spudger to gently pry up the small tabs that are clamping down on the keyboard cables.

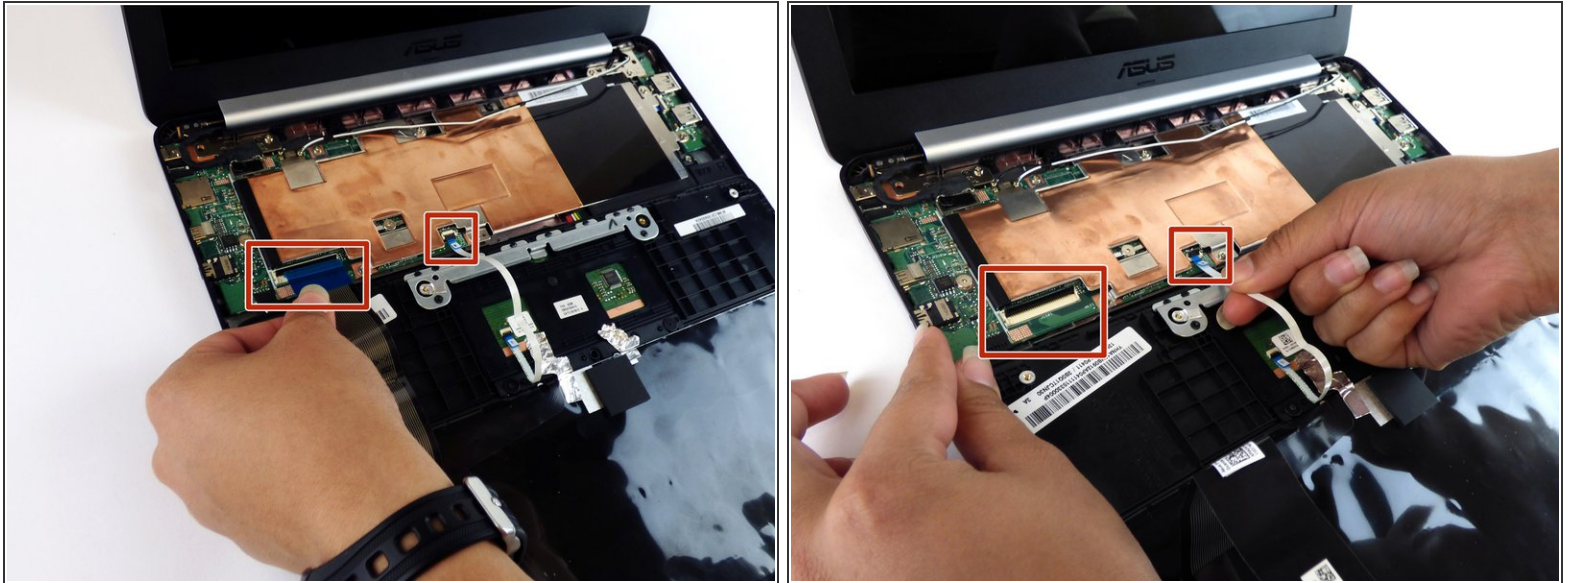
Step 7

- Carefully pull the keyboard cables out of the connecting ports that are attached to the motherboard.

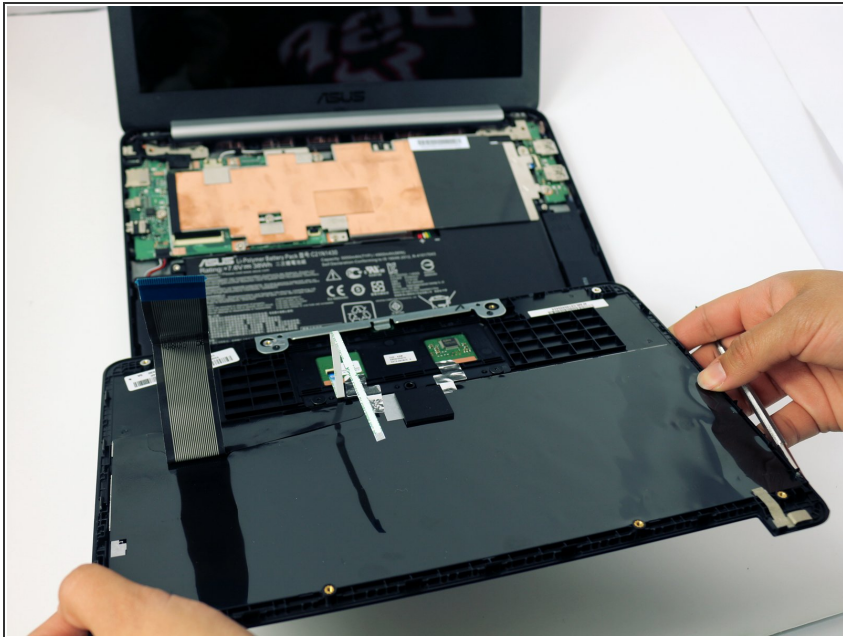
Step 8

- Remove the keyboard cover and safely place it somewhere face down.
