Beats Studio 2.0 Wireless Left Interior Side Panel Replacement

This guide will assist in replacing broken or damaged left side interior side panels of Beats By Dre Studio 2.0 Wireless Headphones.

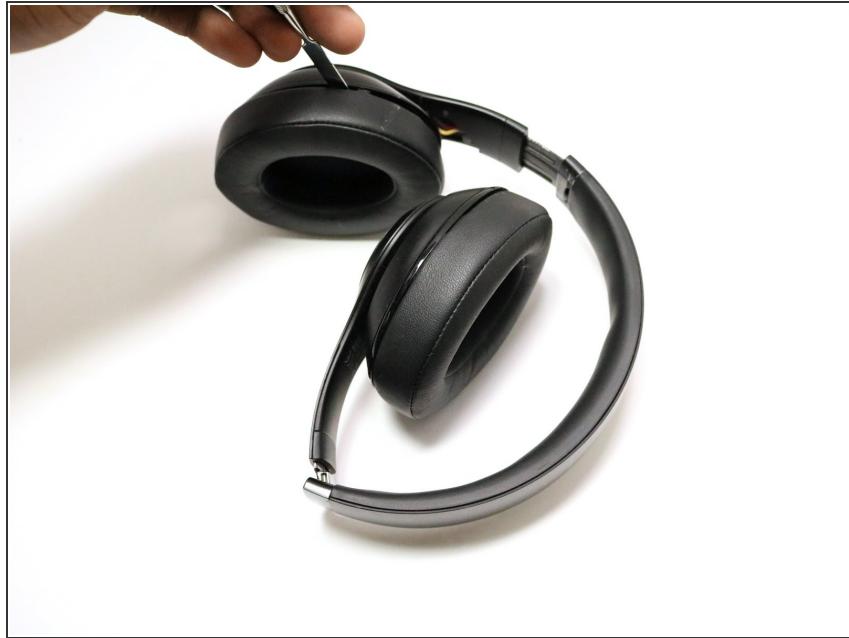
Step 1 — Left Interior Side Panel

- Use metal spudger to pry away ear cushion.

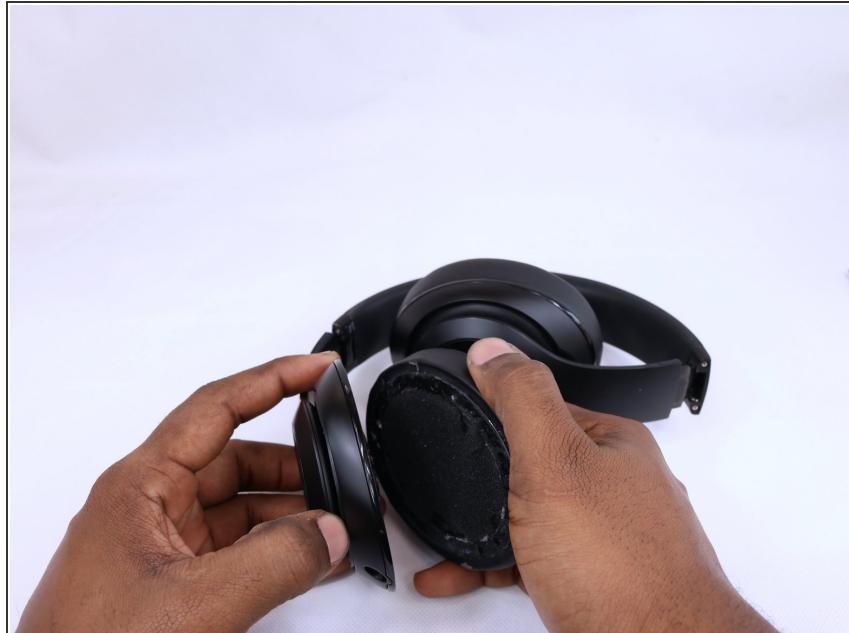
Step 2

- Remove ear cushion from headphones (attached by adhesive).

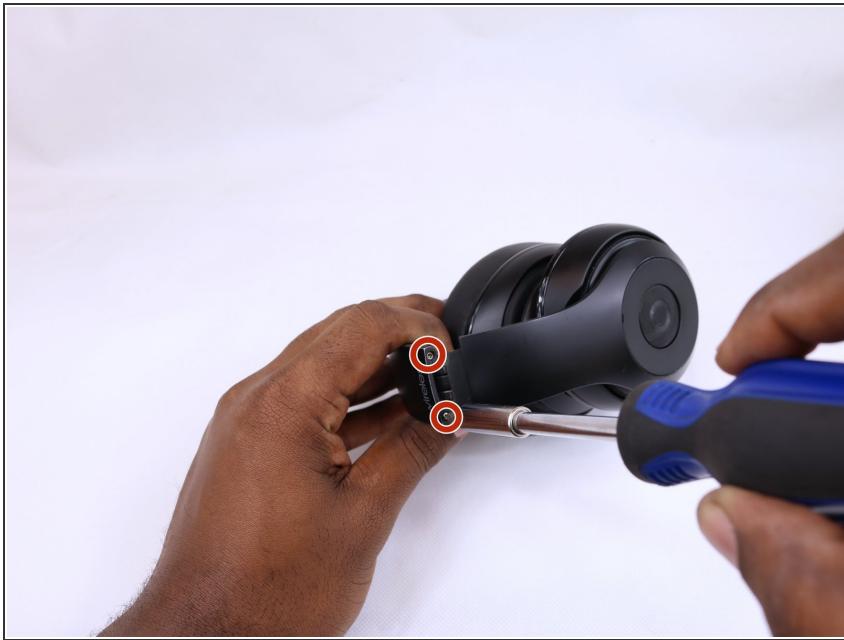
Step 3

- Remove two screws from the metal hinge using a Phillips head screwdriver to allow more motion from the speaker housing and more accessibility.

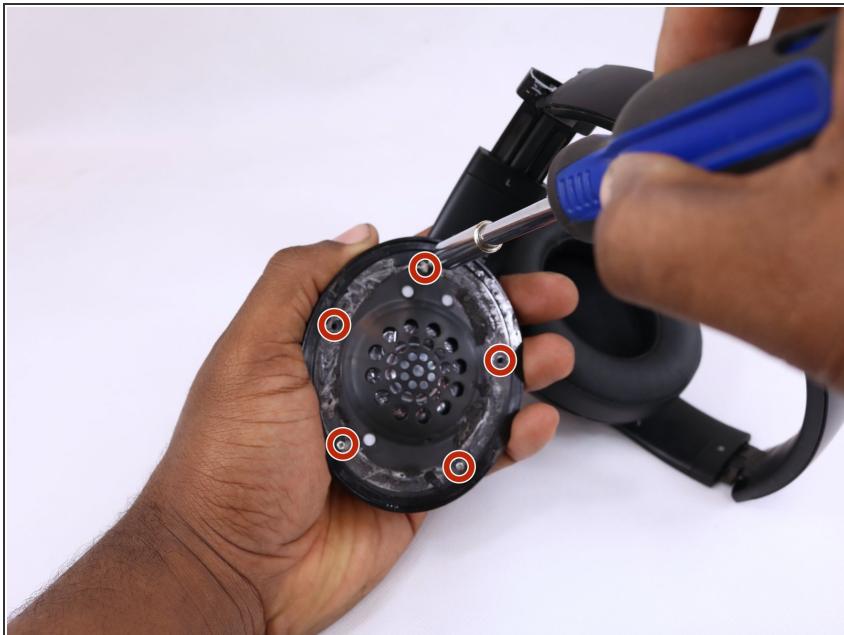
Step 4

- Remove five screws using a Phillips head screwdriver from speaker housing.

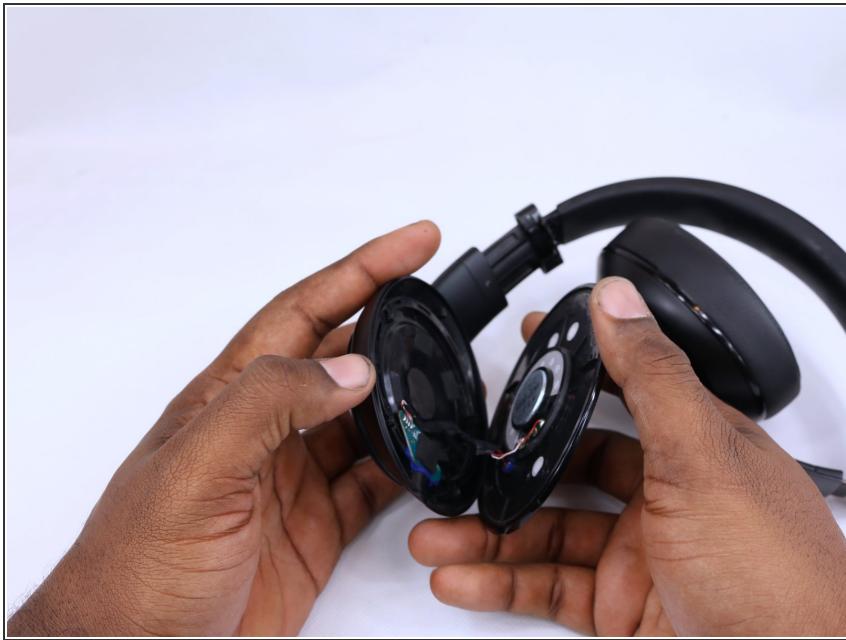
Step 5

- Pull speaker away to access second secondary housing.

Be careful not to stress wires and break solder points.

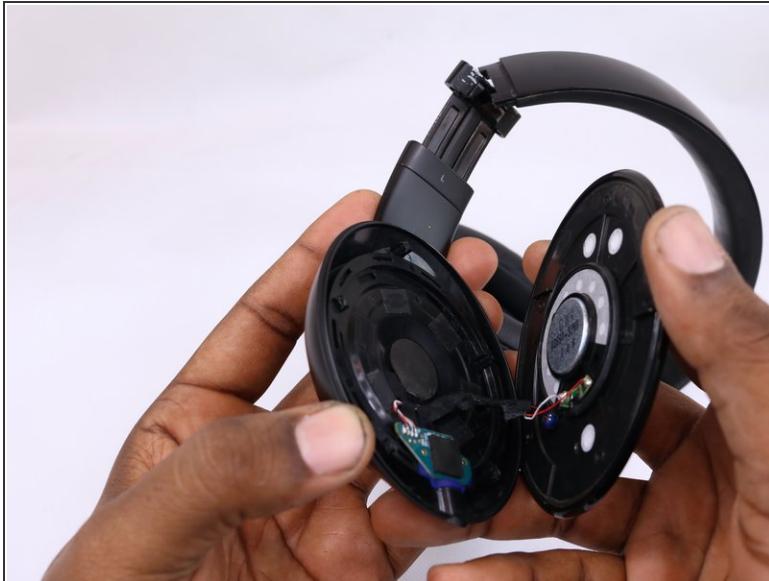
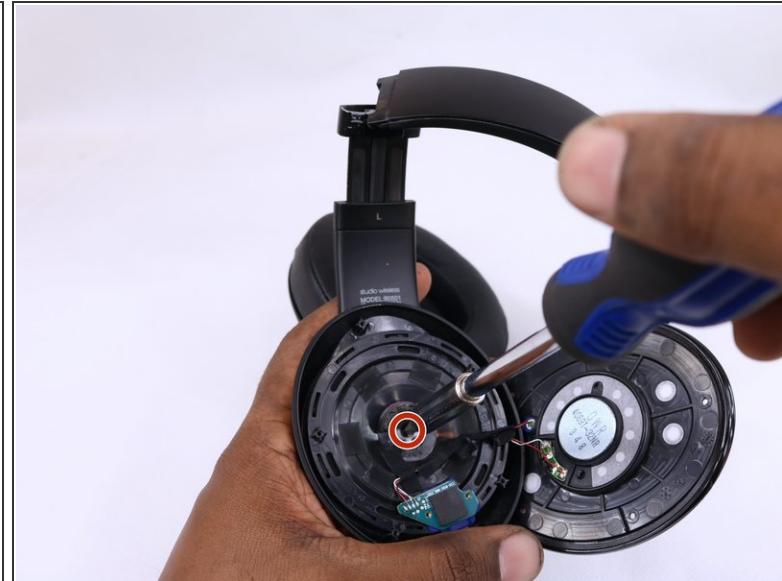
Step 6

- Raise center cover.
- Remove screw from center of housing.

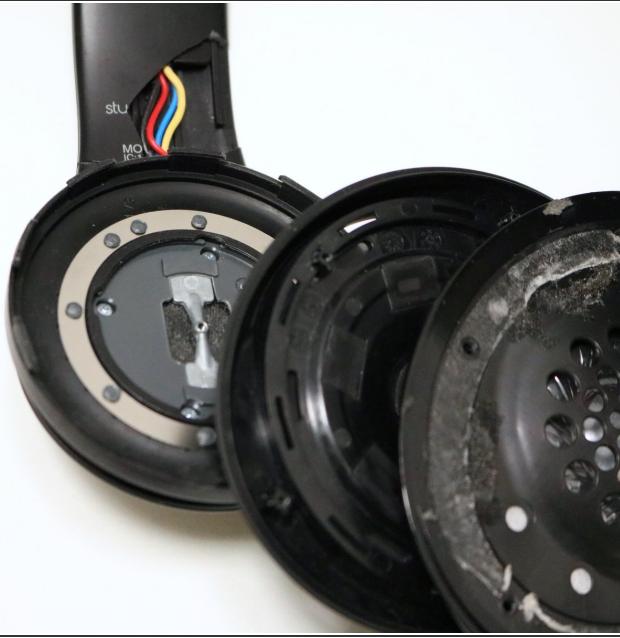
Step 7

- Pull secondary housing away gently being careful not to damage the wires.

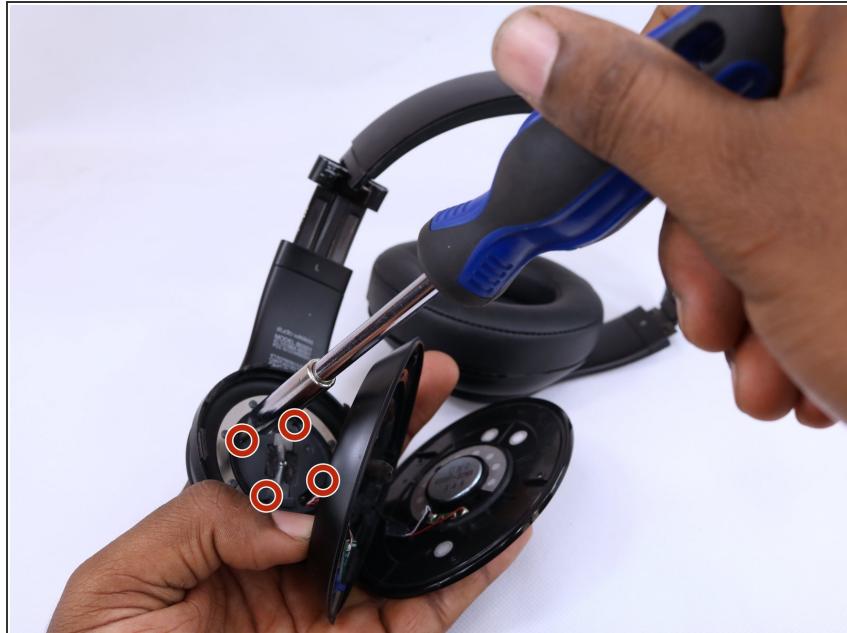
Step 8

- Remove four screws using a Phillips head screwdriver to remove the third housing.

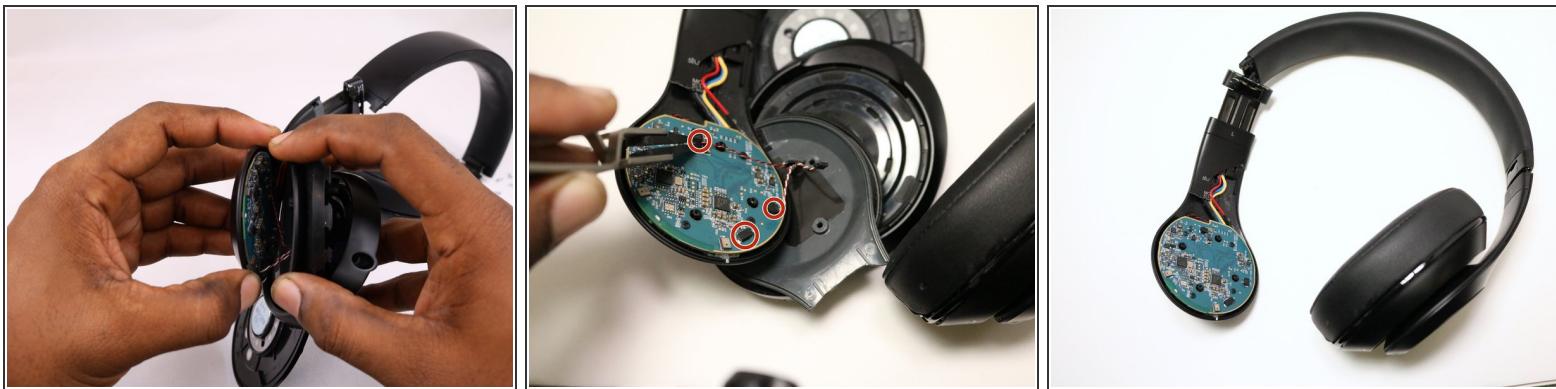
Step 9

- Disconnect wires gently.

Be gentle with the wires ensuring to pull them through with care to eliminate possible shortages.

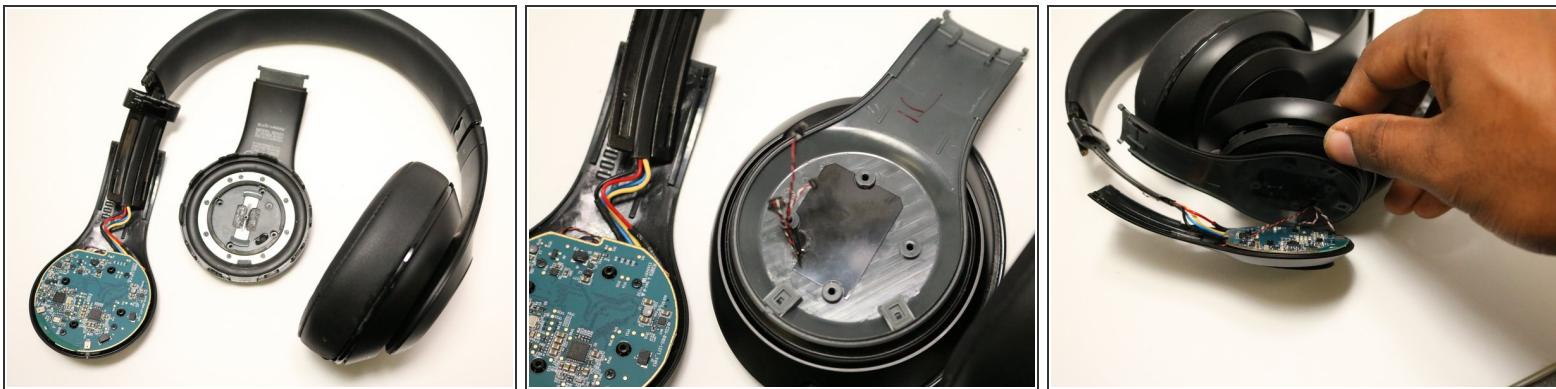
Step 10

- Pass wire through new housing and reconnect wires.

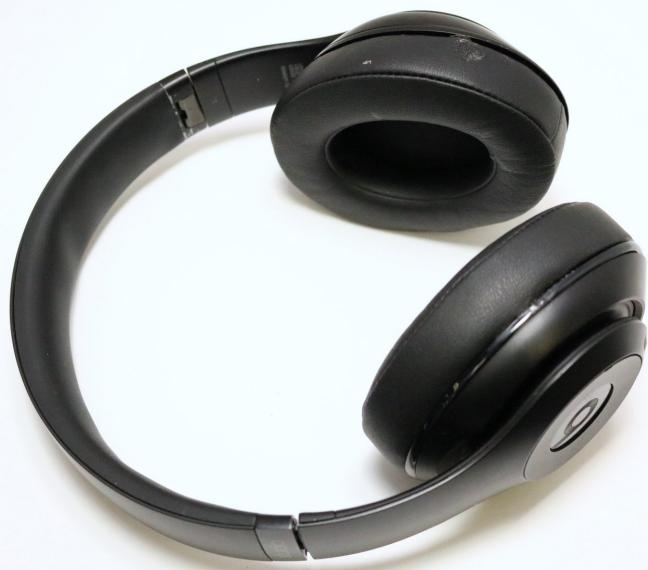
Step 11

- Snap housing into place.
